## RECORD OF CONVERSATION

**Joshua Lindberg**  
**Air Safety Investigator**  
**Central Region**

**Date:** December 3, 2020  
**Person Contacted:** Steve Mayer, accident pilot  
**NTSB Accident Number:** CEN20LA436

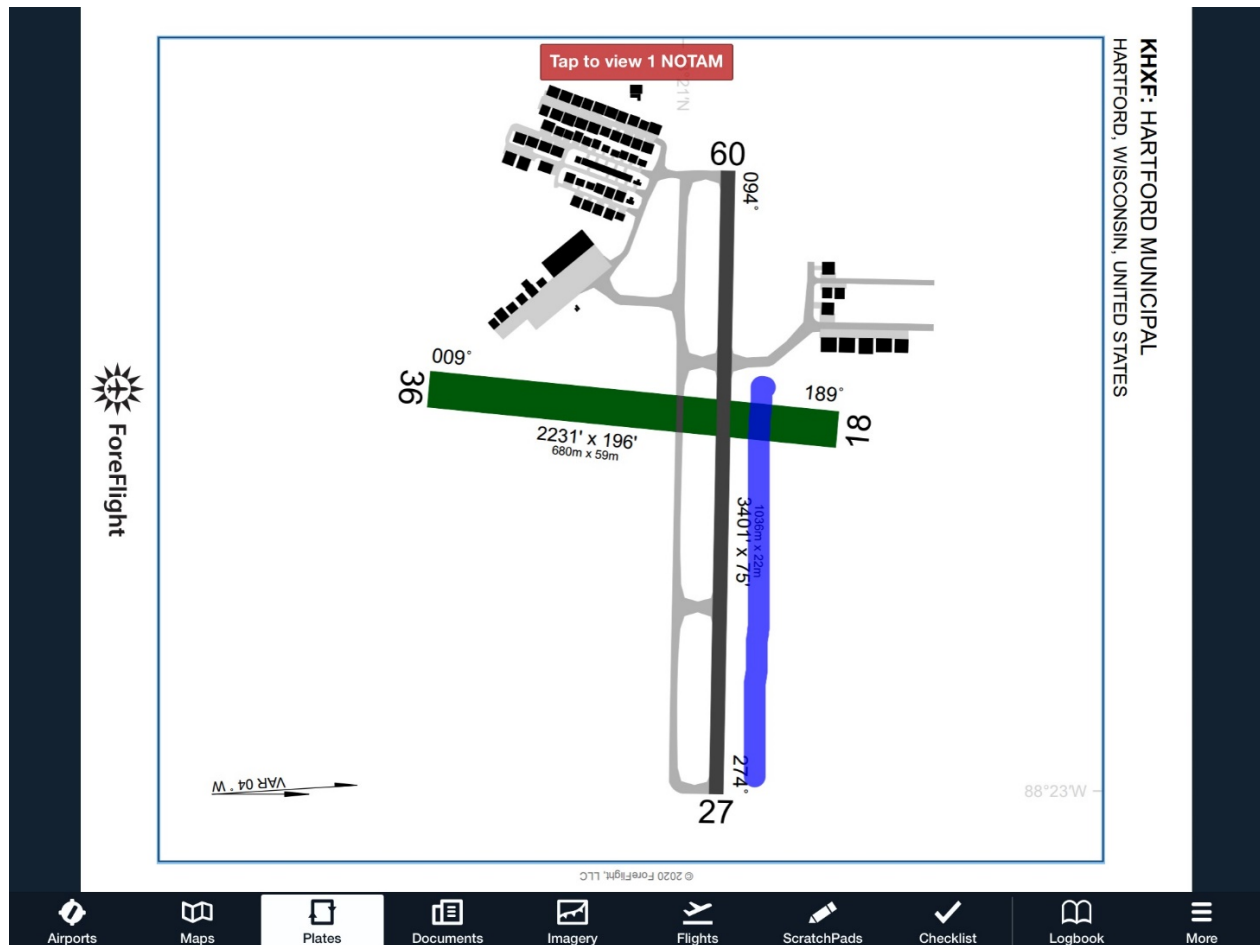
After landing he taxied and got more familiar with the tundra tires. When he was high speed taxiing, the airplane hit a 18/36 runway sign. After the accident he realized that he was looking at the updated airport diagram the wrong way. The image was flipped 180 degrees and he thought west was east and vice versa.

The blue line on the diagram was drawn by the CFI and shows the area where the grass runway was installed.
