## **NATIONAL TRANSPORTATION SAFETY BOARD**

### **Specialist's Report**

# **OPERATIONAL FACTORS**

CEN20MA044

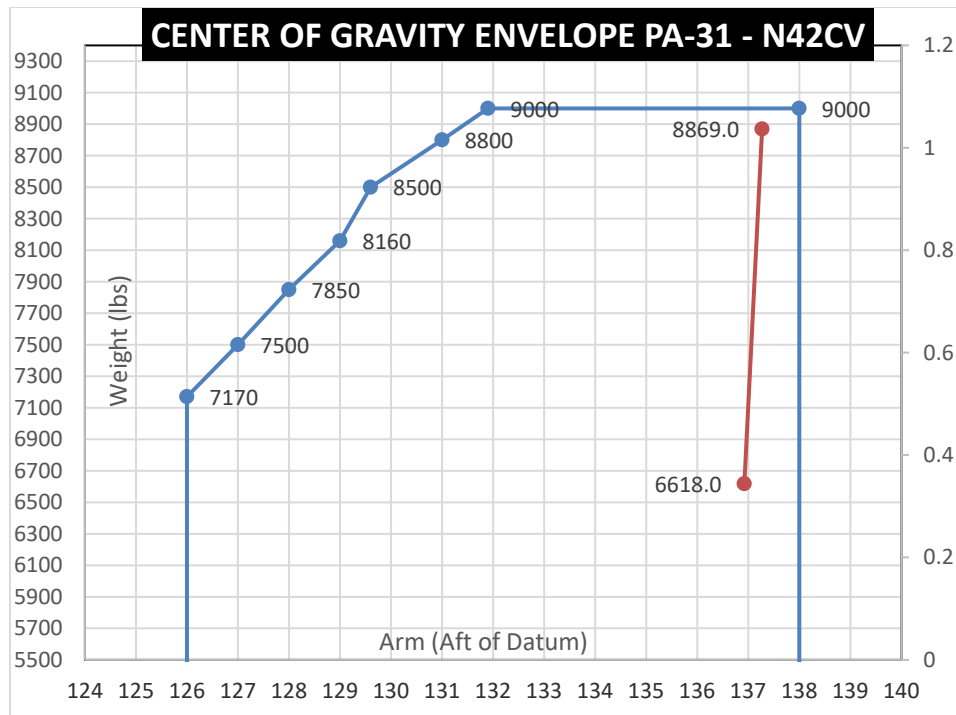
Figure 2: Center of Gravity Envelope

The figures below indicate the weight and balance of the aircraft and a graphical depiction of where calculated center of gravity would move as fuel was consumed. The weights in **bold** were the aircraft limitations from Section 2 “Limitations” of the POH. The “Rearward Limit Inches Aft of Datum” was listed as 138.0 inches<sup>17</sup>, Figure 2 below shows the CG envelope range. Additionally

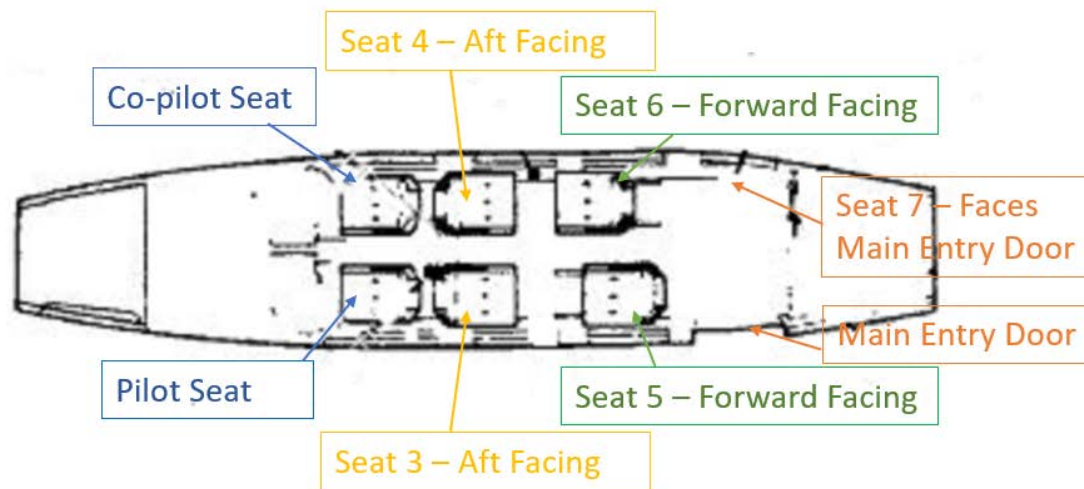
Figure 3: Seating Configuration

The PA-31T, Cheyenne, Pilot Operating Handbook, Section 7 "Description & Operation" provided the following seating configuration graph. It has been labeled for ease of reading.
