**NATIONAL TRANSPORTATION SAFETY BOARD  
Office of Aviation Safety  
Washington, DC 20594**

**SUMMARY OF AIRFRAME AND ENGINE EXAMINATION**

**CEN21FA007**

Location: Telluride, Colorado  
Date: 10/5/2020  
Time: 1304 MDT  
Aircraft: Beech S35 (S/N D-7422) N4444K

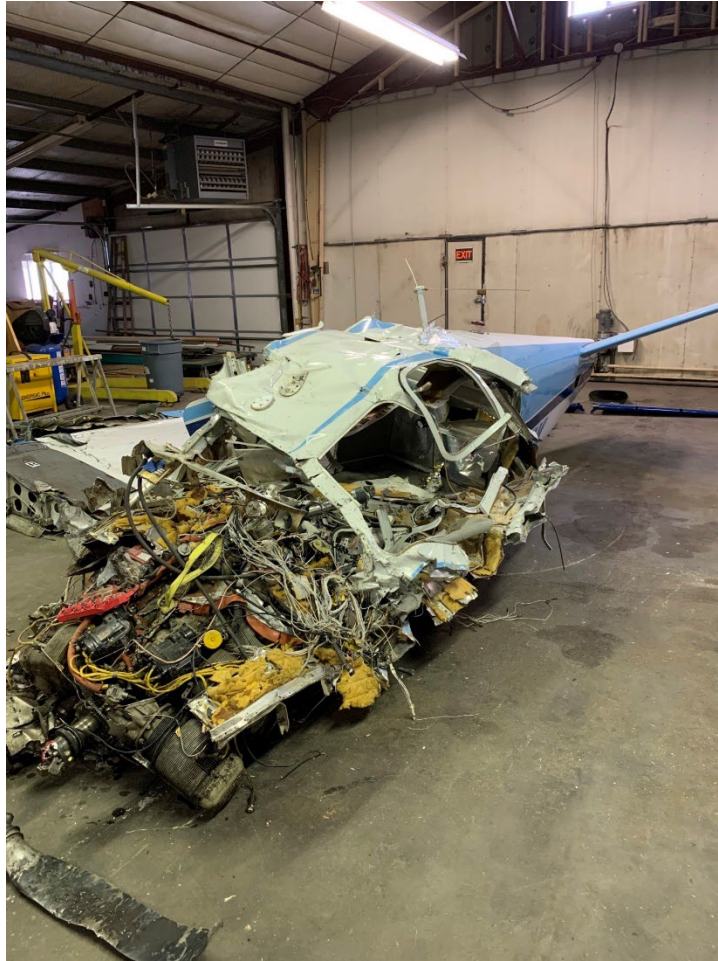
Figure 1, Airplane Wreckage in Hangar

The airplane was laid out in one of Beagles Aircraft's' hangar facilities. The left and right wings were separated from the fuselage. The engine, cockpit, baggage compartment, fuselage, and right elevator were attached. The right rudder, left elevator, rudder, and tail cone were separated. Two of the three propeller blades were present. They had been broken out of the propeller hub at the cuffs. All the components were photographed.

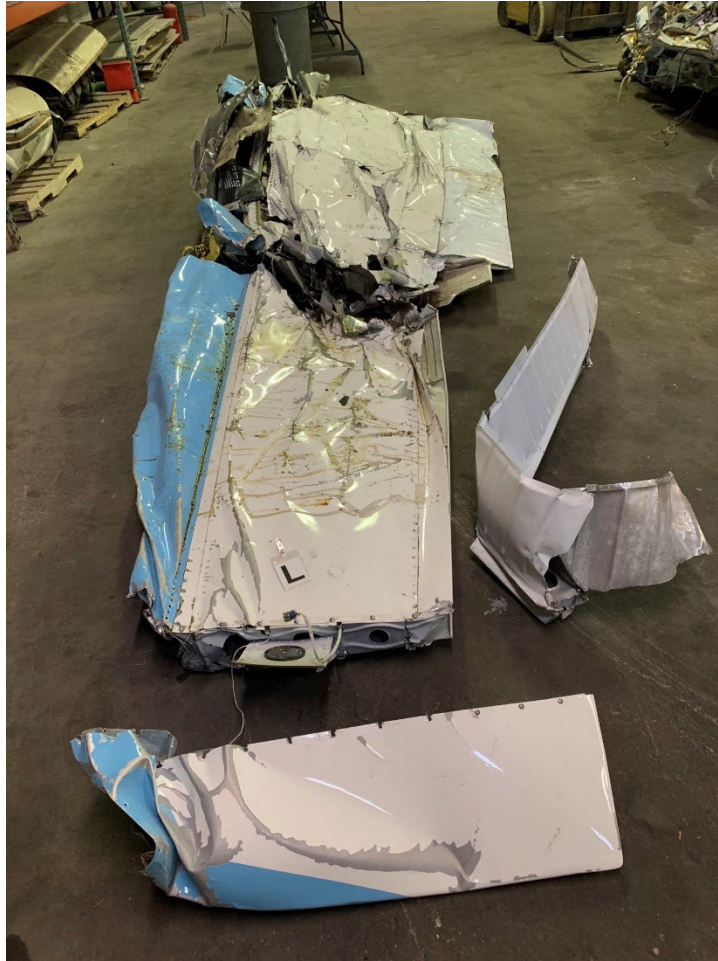
Figure 2. Left Wing

The airplane's left wing was found broken aft and cut at the root during recovery. The wing was broken into two pieces at mid span. Both sections were crushed aft and bent upward from the leading edge aft to the rear spar. The fuel bladder was broken open. No fuel was present. The wing tip was broken aft longitudinally and separated.

The left aileron push-pull tubes, linkages and cables were observed. The cables into the wing were cut at the root during recovery. The left aileron was broken and separated from the wing. It was bent upward and buckled aft. The actuator to the surface was manipulated and moved by the bellcrank. The aileron cables were traced to the bellcrank at the wing separation.

The left flap remained connected to the wing. It was in the up position and was bent and buckled. The left main landing gear was in the up position.

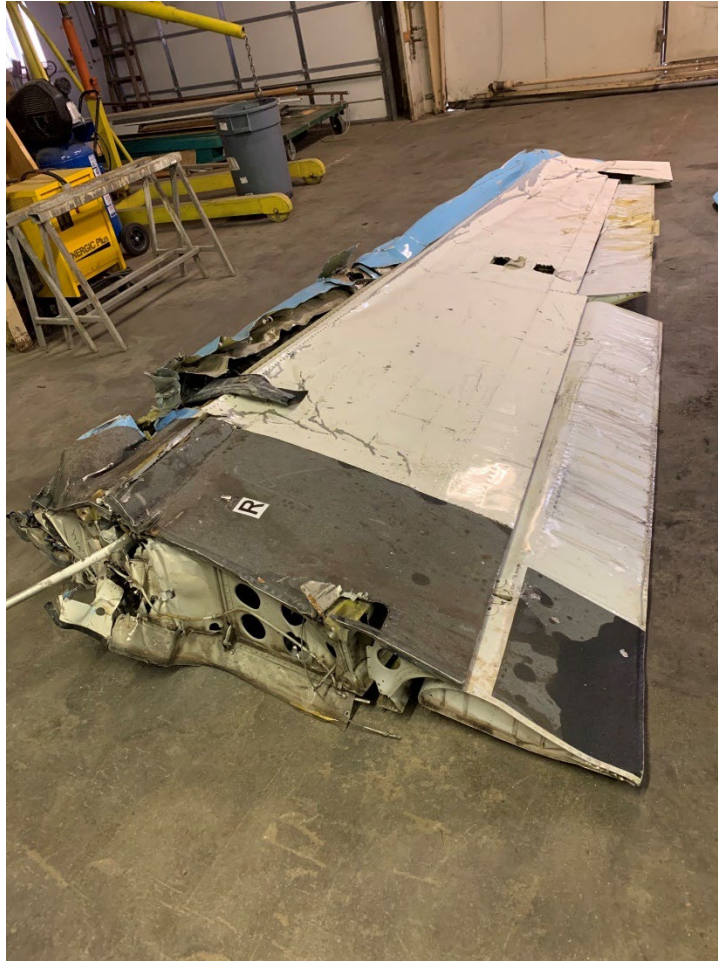
Figure 3. Right Wing

The airplane's right wing had been cut at the root during recovery. The wing was crushed aft along the leading edge to the forward spar, from the wing tip to the root. The wing tip was broken aft longitudinally and partially separated. The fuel bladder was broken open. No fuel was present.

The right aileron bellcrank, cables and linkages were located. The aileron cables into the wing were cut during recovery. Manipulation of the aileron cables moved the aileron, which was attached to the wing. The aileron was bent and buckled. The aileron cables were intact from the cockpit area to the control yoke.

The right flap was connected, bent, buckled, and in an upward position. The right main landing gear was in the up position.

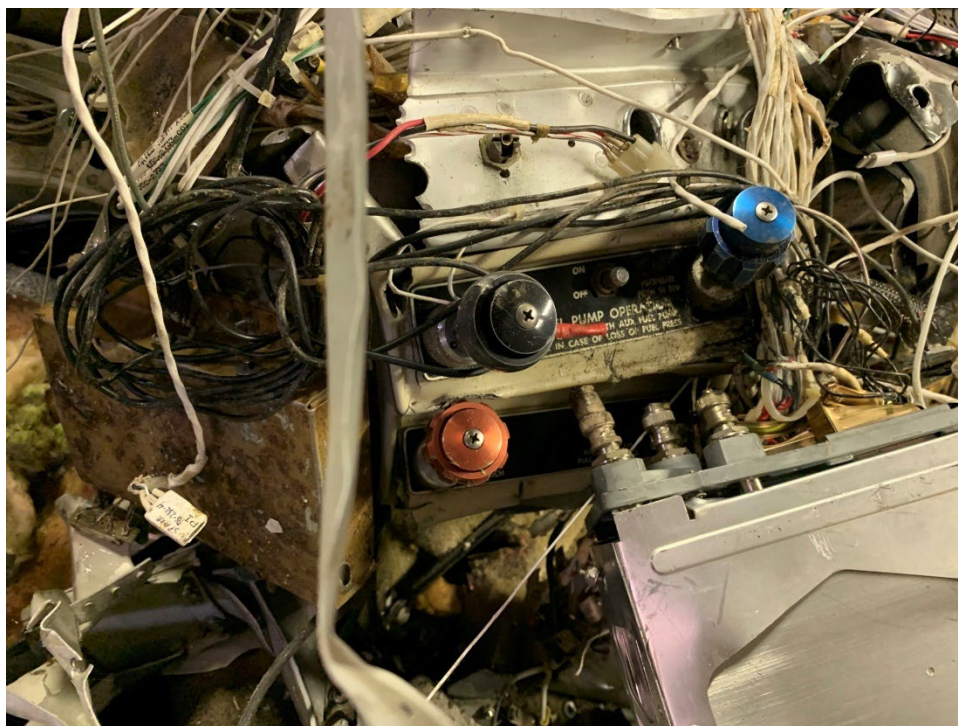
Figure 4. Throttle, Propeller and Mixture Controls

The cockpit and cabin area were broken open and crushed upward. The seats had been removed during recovery prior to the examination. The instrument panel was crushed forward and fragmented. The firewall was bent and crushed upward and forward around the engine accessories. The landing gear gearbox was observed and indicated the gear was in the up/retracted position. The throttle, propeller, and mixture knobs were observed and were fully in. The fuel selector was not located.

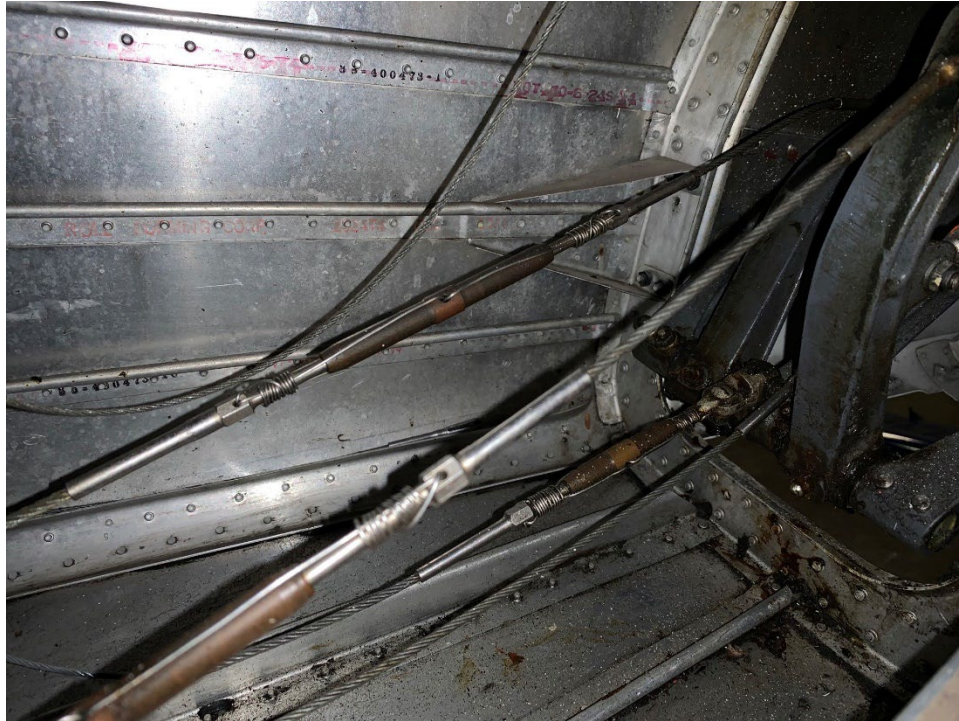
Figure 6. Control Cables to the Elevator and Rudders

Flight control cables from the cockpit to the elevators and rudders were intact through to the control surfaces' actuators.

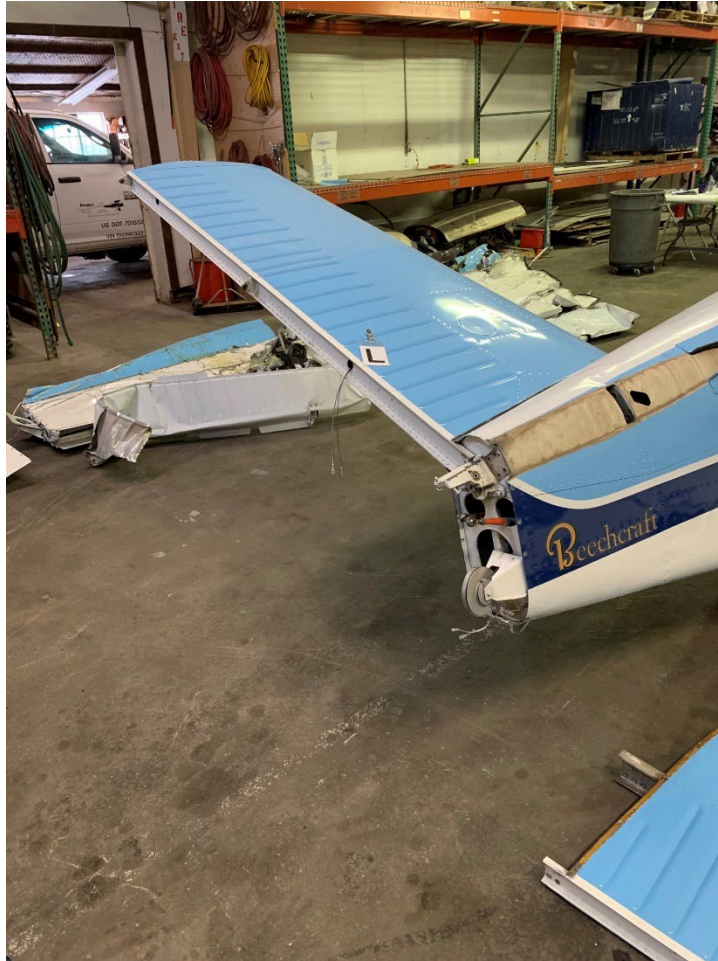
Figure 7. Left V-tail Stabilizer

The empennage components, the left and right V-tail stabilizers, the elevators, and rudders were all intact and showed little damage. The right stabilizer and the left and right elevators and rudders had been removed during recovery. The left stabilizer remained with the fuselage. The cable linkages to the control surfaces had been removed but were all intact. The tailcone was intact and showed little damage.

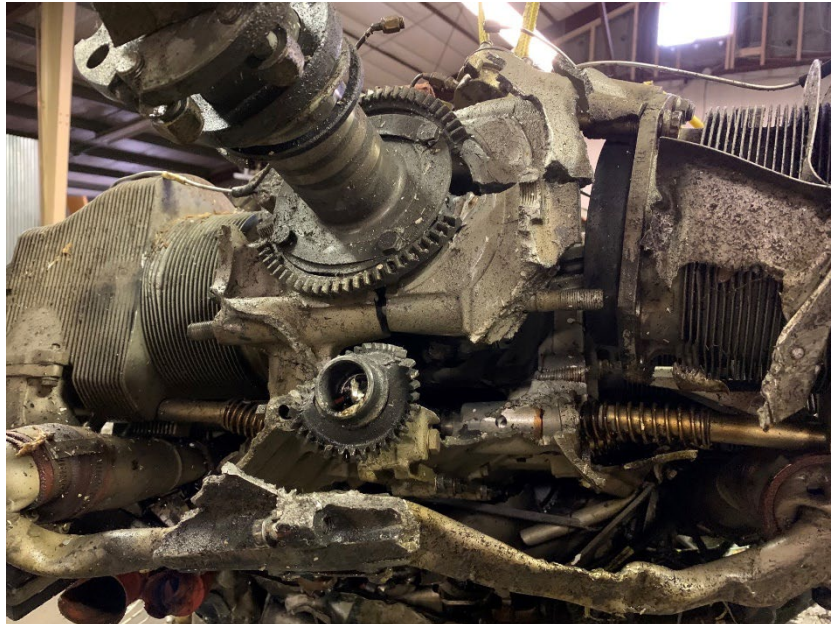
Figure 12. Engine, Front Side, Crankshaft, Camshaft, Number 5 and 6 Cylinders

The front of the engine case was broken aft and fragmented, exposing the crankshaft, camshaft, and the journals and piston rods to the number 5 and number 6 cylinders All of the

cylinder piston rods and journals, and all the pushrods to the rockers and the camshaft aft to the drive gear could be observed. The number 5 and 6 cylinders were still attached to the engine case but broken aft and downward. The front camshaft gear was bent and broken. The flange of the crankshaft had a portion of the propeller hub still mounted. The hub was broken in a torsional manner and rearward. Rotation scoring was observed on the hub remains and flange, consistent with rotation at impact.

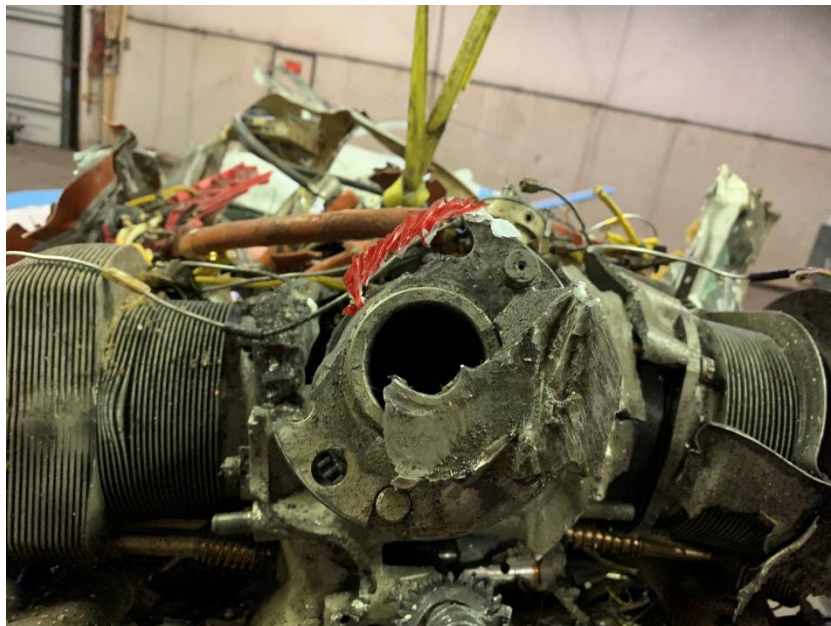
Figure 13. Flange and Remaining Propeller Hub

Engine continuity was confirmed. Torsional break of the propeller flange was consistent with rotation at impact. All physical damage to the engine was consistent with ground impact. No pre-impact anomalies were found.

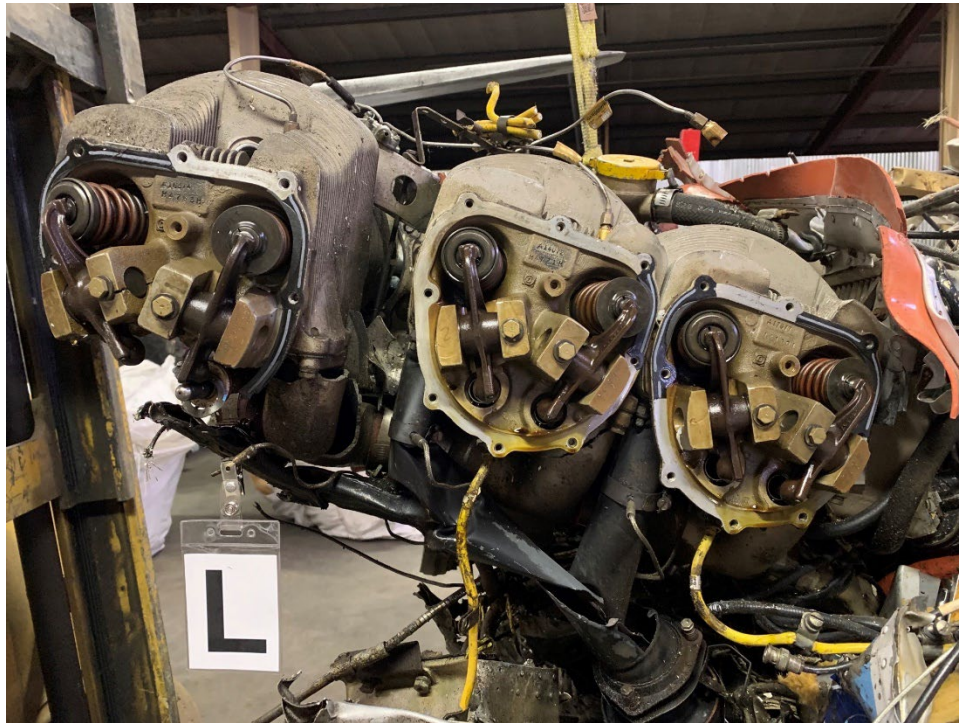
Figure 14. Engine, Left Side, Valves, Springs, and Rockers

The rocker box covers were removed, and the rockers and the intake and exhaust valves on all six cylinders were observed. All were intact and showed little damage. The number 6-

cylinder head was broken at the intake valve and the pushrod was separated. The exhaust valve rod end was exposed.

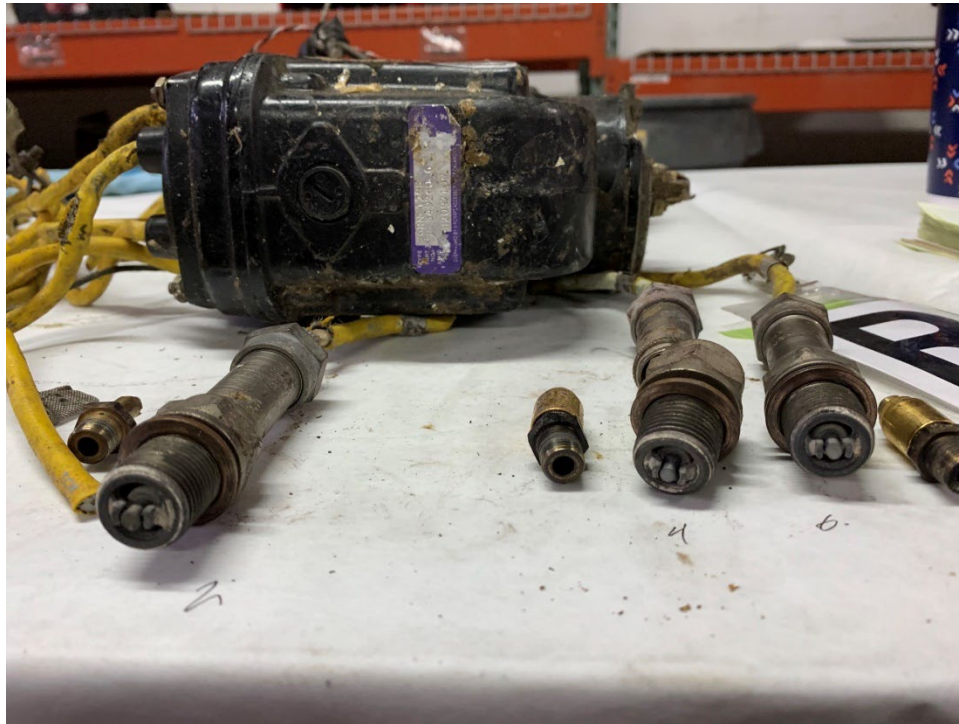
Figure 16. Left Magneto, Top Spark Plugs & Fuel Injectors, Cylinders 1, 3 & 5 (Left to Right)

The left magneto was also intact and had sustained significant impact damage. The magneto was broken out of the engine accessory section at the impulse coupling. When rotated, the impulse coupling spun freely. The drive gear in the accessories section to the left magneto was intact.

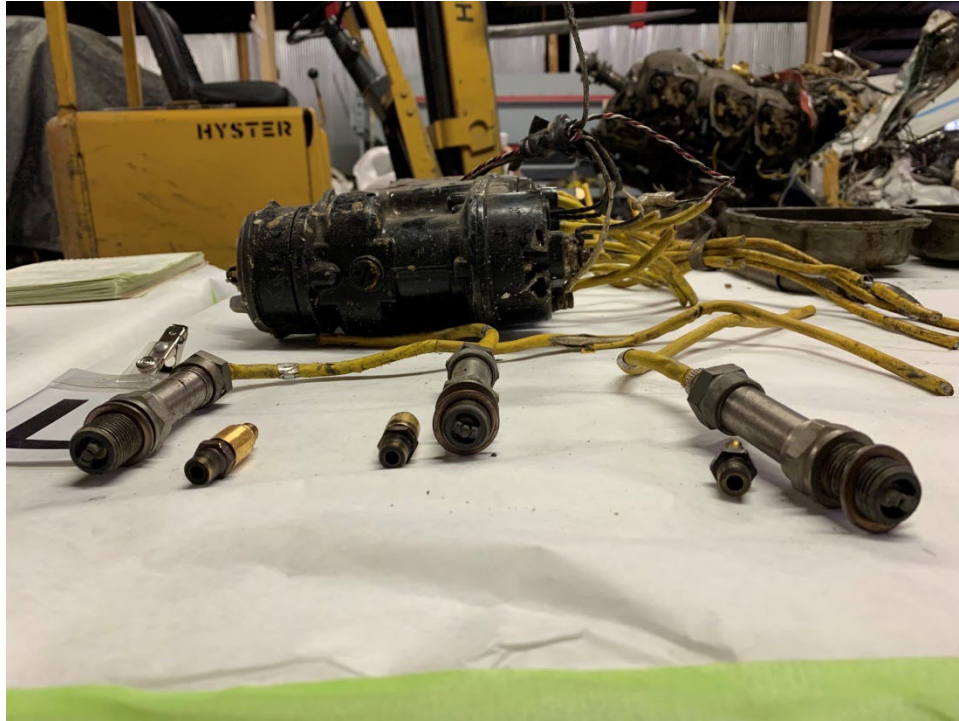
Figure 17. Right Magneto, Top Spark Plugs & Fuel Injectors, Cylinders 1, 3 & 5 (Left to Right)

The right magneto was intact but sustained significant impact damage. The magneto was broken out of the engine accessory section at the impulse coupling. When rotated, the impulse coupling spun freely. The drive gear for the right magneto in the accessories section was intact.

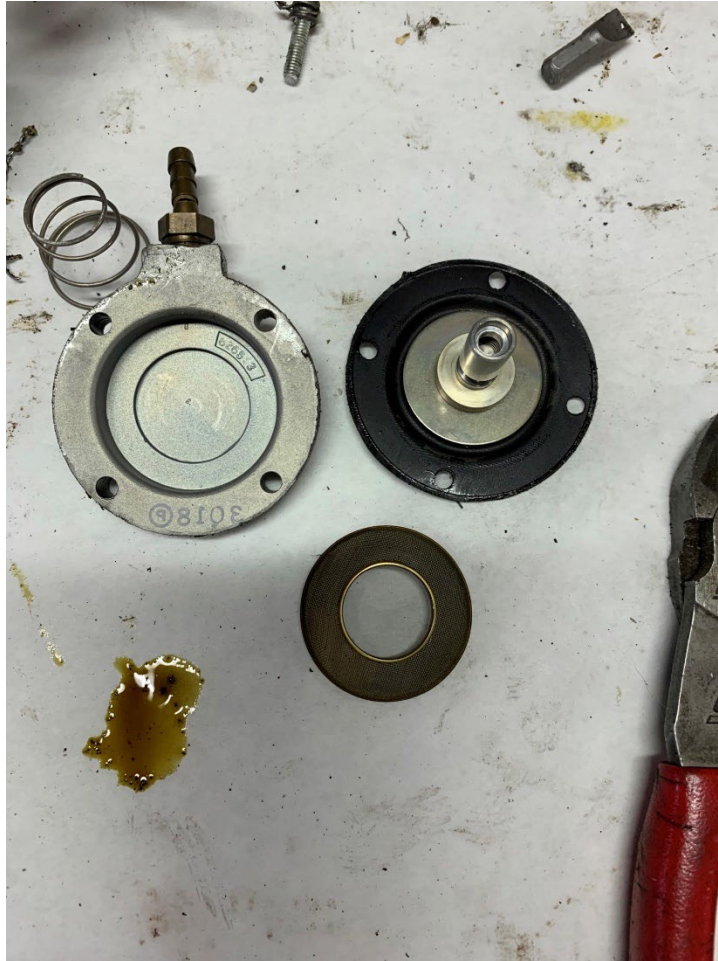
Figure 18. Disassembled Fuel Distribution Manifold

The fuel distribution manifold was removed and opened. The fuel screen was removed and examined. The screen was clean and showed no debris. No debris was observed in the manifold housing.

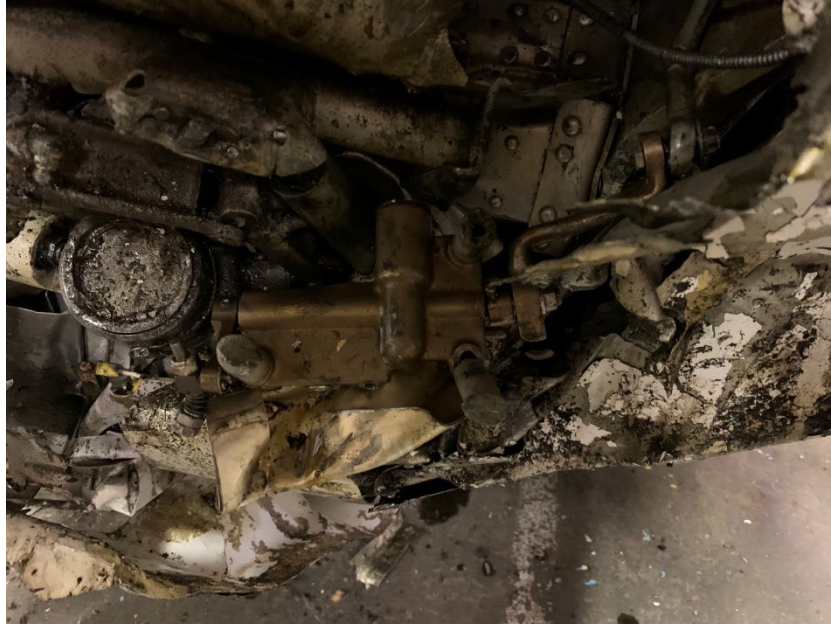
Figure 19. Throttle Body Housing

The throttle body housing was observed beneath the engine. It had been crushed upward but was intact. The fuel screen was removed and examined. The screen was clean and showed no debris.

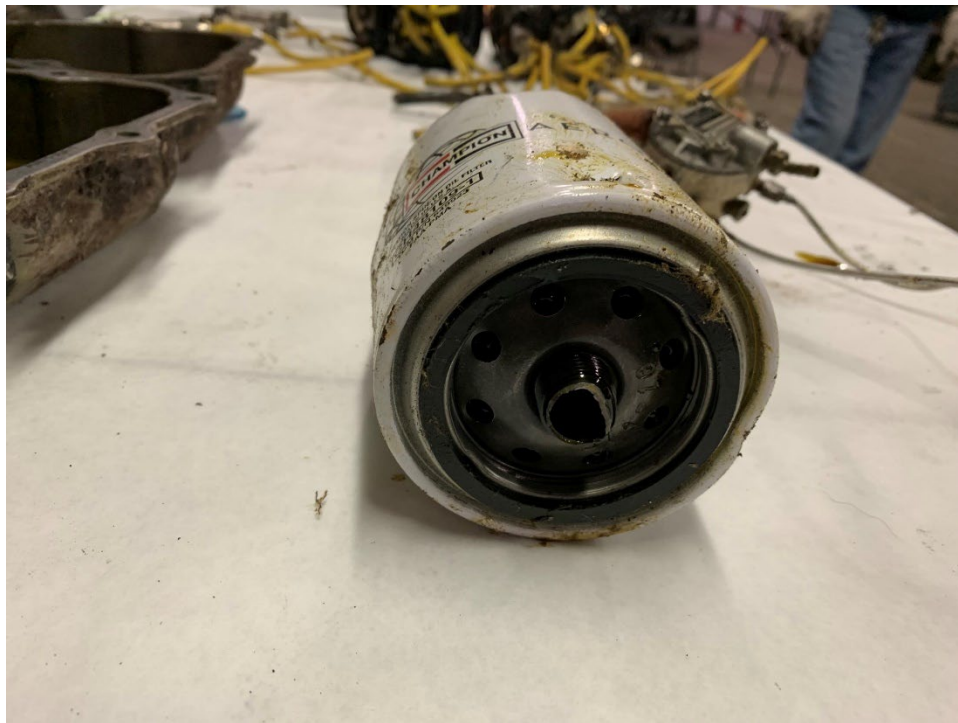
Figure 20. Oil Filter

The oil filter was broken from its housing and rested between the engine accessories case and the firewall. It was removed and observed. The filter was crushed slightly. Oil observed exiting the filter was clean and showed no debris. Information written on the filter showed it had been installed on July 28, 2020, and the tach time at installation was 5,386.31 hours.

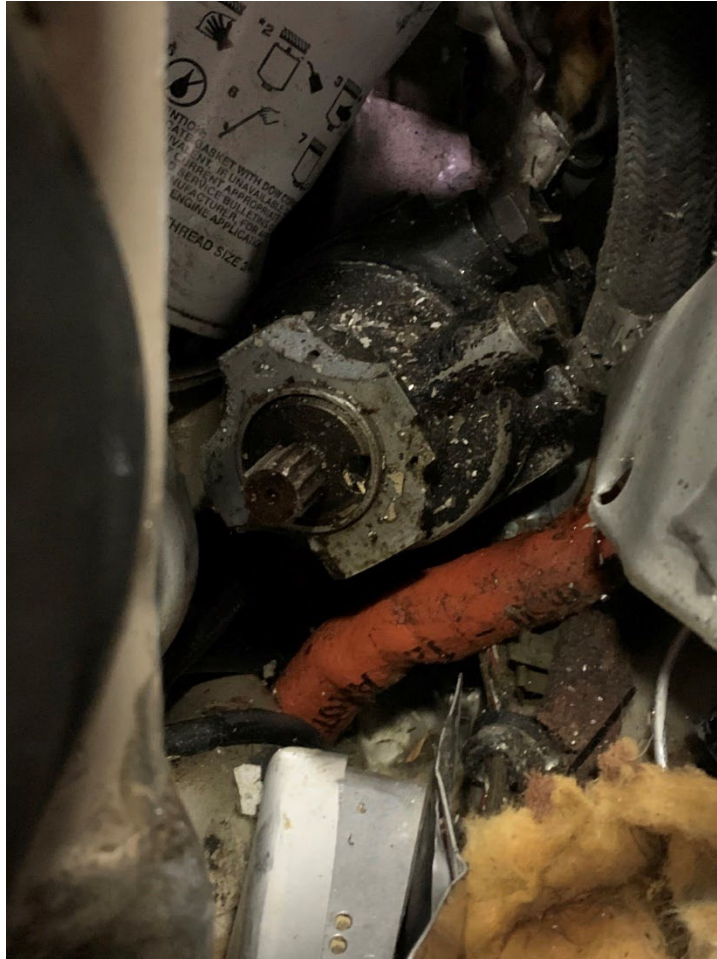
Figure 21. Vacuum Pump

The vacuum pump was separated from its housing and rested between the engine accessories case and the firewall. The pump could not be removed, but it was turned enough to see that the pump was intact and the drive gear into the pump was also intact.

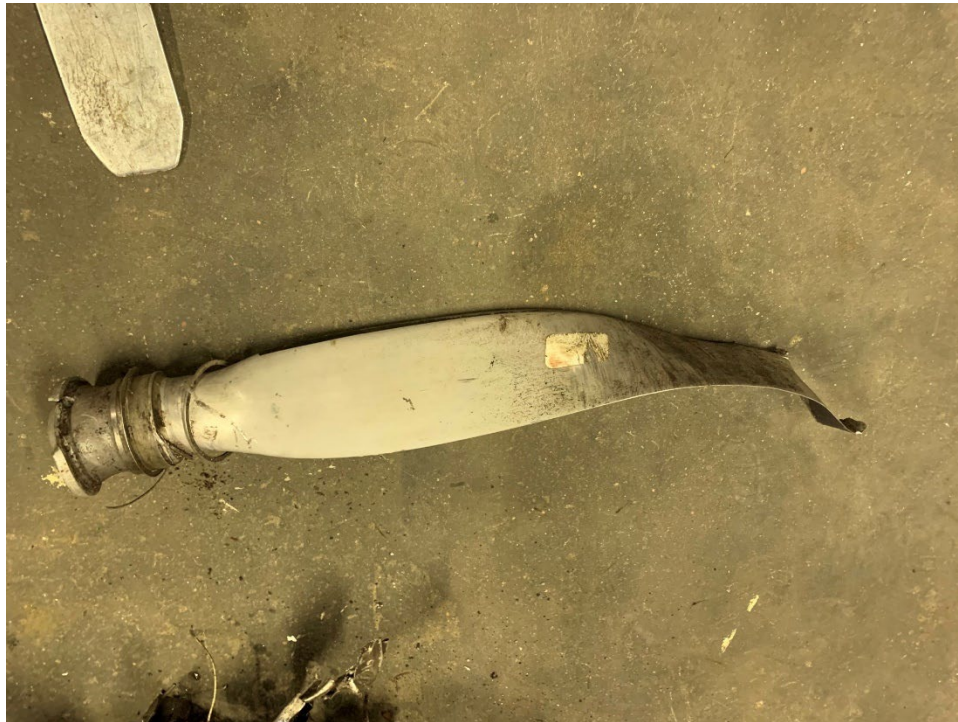
Figure 22. Propeller Blade 1

The first propeller blade was broken out at the hub and the base of the blade was crushed and broken. The blade displayed S-bending and chordwise scratches. There were nicks and gouges in the leading and trailing edges, and a four-inch piece of the tip trailing edge was broken out.

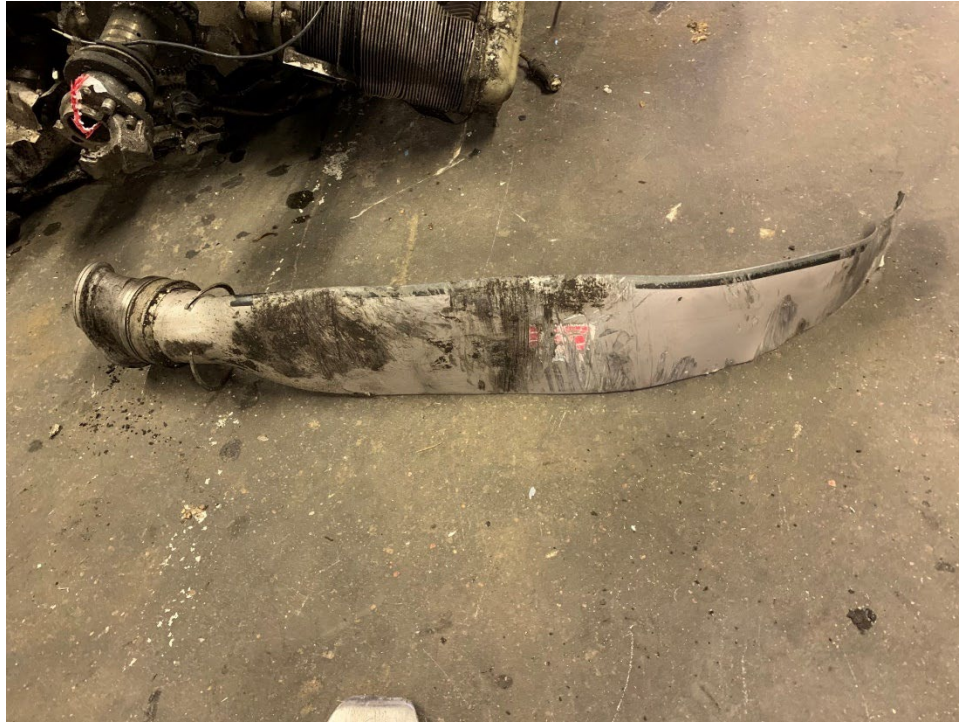
Figure 23. Propeller Blade 2

The second propeller blade was also broken out at the hub and the base of the blade was crushed inward. The blade also displayed S-bending and chordwise scratches, and there were large nicks and gouges in the leading and trailing edges of the blade.
