## **NATIONAL TRANSPORTATION SAFETY BOARD**

### **Specialist's Report**

# **METEOROLOGY**

CEN21FA026

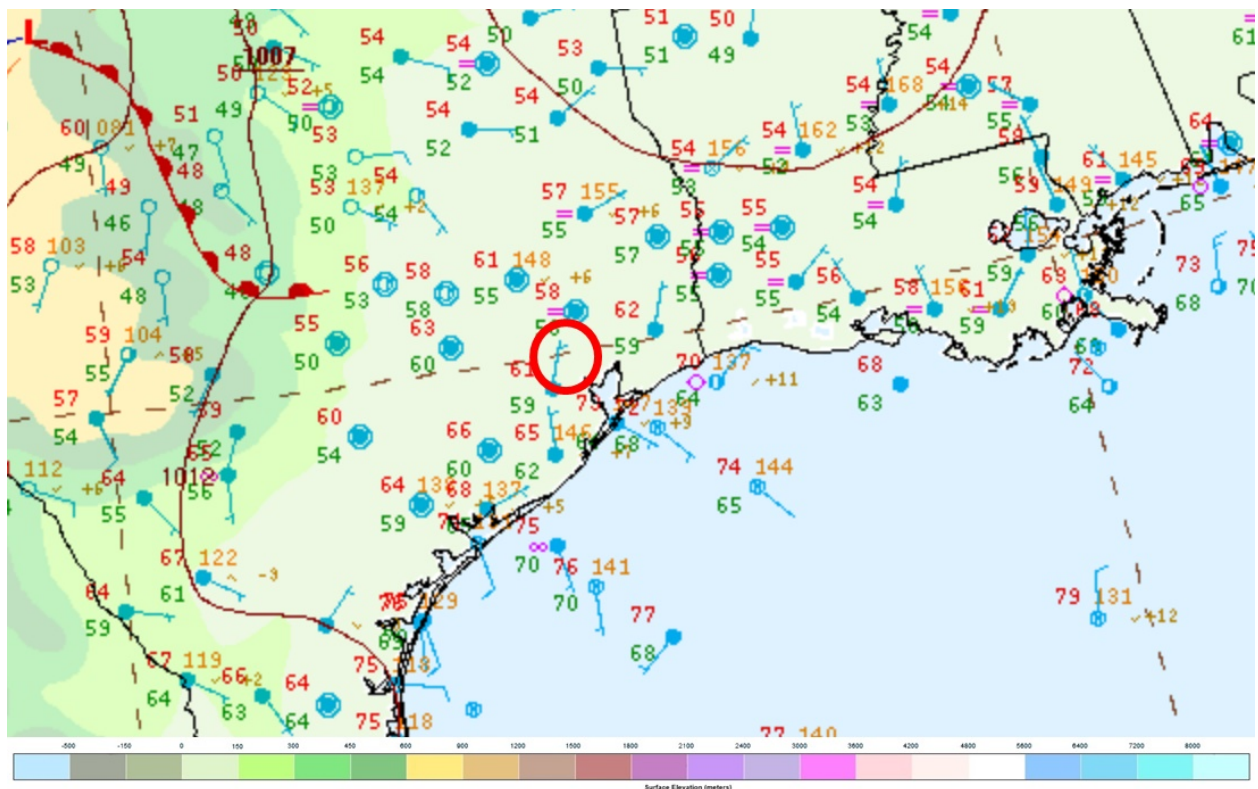
A southern section of the National Weather Service (NWS) Surface Analysis Chart for 0700 CDT is presented in figure 1. The surface analysis chart identified a low-pressure center of 1007 hectopascals (hPa) over northwestern Texas with a warm front extending southeastward into central Texas. Station models across the accident region depicted overcast conditions and light or calm winds. Mist was observed north of the accident site. Dew point depressions<sup>2</sup> ranged from 0° to 6° Fahrenheit at stations nearest the accident location.

**Figure 1** – Southern section of the NWS Surface Analysis Chart for 0700 CDT. Accident location is within the red circle.

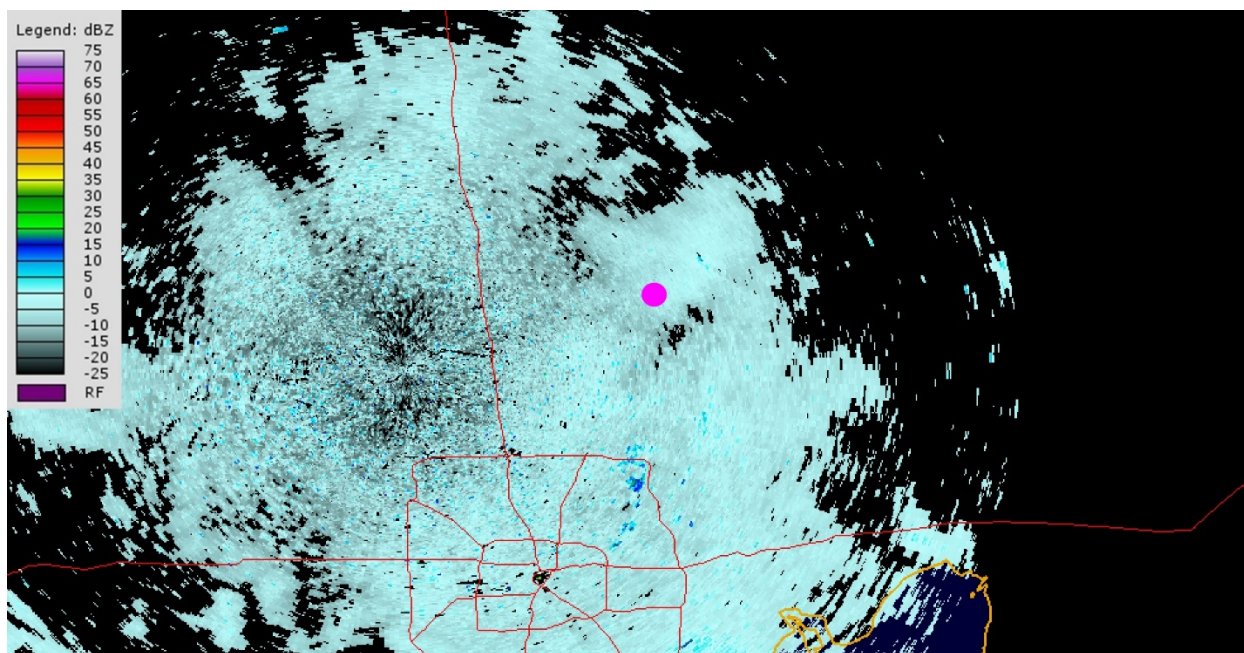
A Terminal Doppler Weather Radar (TDWR) from near IAH (TDWR site: TIAH) 0.10° tilt reflectivity image is presented in figure 2. TIAH was located approximately 24 miles west-southwest of the accident location at an elevation of about 250 feet. Assuming standard refraction and considering the approximate beam width of 0.55°, the 0.10° tilt would have “seen” altitudes above the accident location of between about 200 and 1,600 feet. The radar imagery identified mostly negative values of reflectivity across the accident region.

**Figure 2** – TIAH 0.10° reflectivity product from 0833 CDT. Accident location denoted by the purple circle.

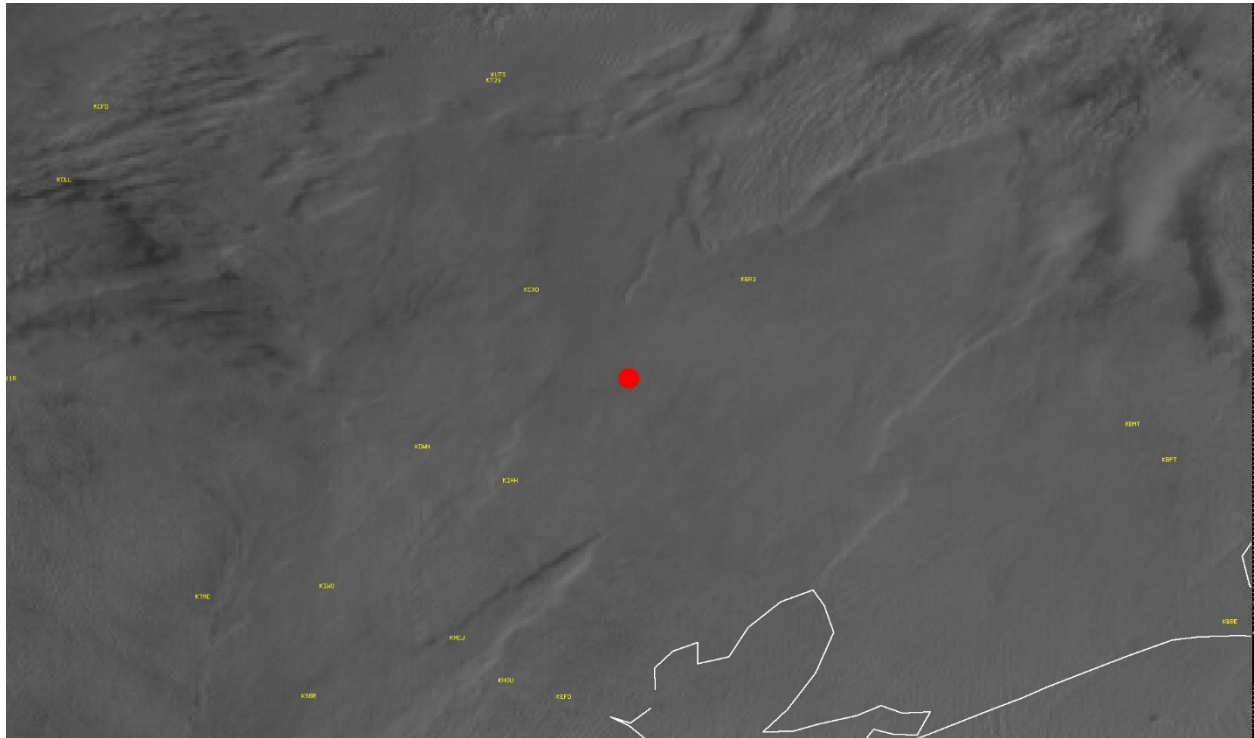
Geostationary Operational Environmental Satellite (GOES)-16 visible (0.64 $\mu\text{m}$ ) and infrared (10.3 $\mu\text{m}$ ) data were obtained from an archive at the Space Science Engineering Center at the University of Wisconsin-Madison. Images from 0836 CDT are presented in figures 4 and 5. The GOES-16 visible imagery depicted cloudy conditions over the accident region. Infrared brightness temperatures over the accident location were 15°C, which, when considering the HRRR model sounding, corresponded to cloud tops heights of somewhere below about 8,000 feet.<sup>7</sup>

**Figure 4** – GOES-16 visible imagery from 0836 CDT. Accident location is denoted by the red dot. This image has not been corrected for any parallax error.

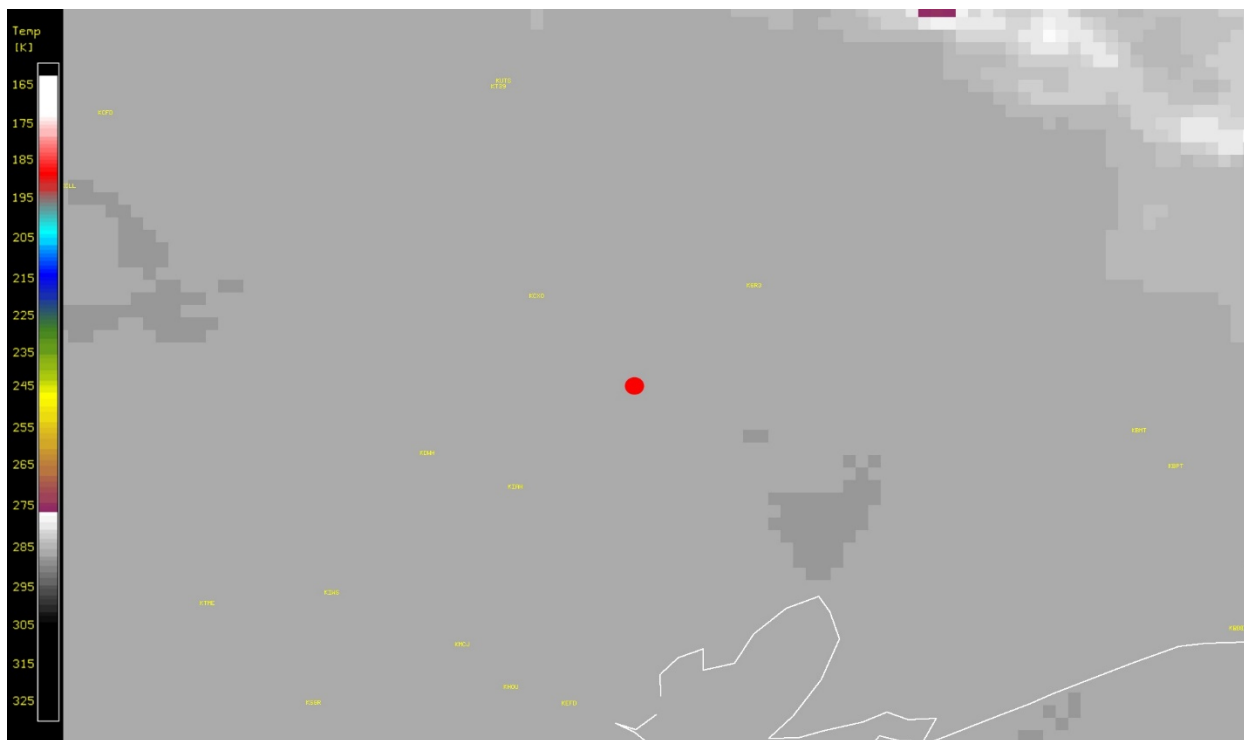
**Figure 5** – GOES-16 infrared brightness temperature imagery from 0836 CDT. Accident location is denoted by the red dot. This image has not been corrected for any parallax error.
