**NATIONAL TRANSPORTATION SAFETY BOARD  
Office of Aviation Safety  
Washington, DC 20594**

**SUMMARY OF VACUUM SYSTEM EXAMINATION REPORT**

**CEN21FA026**

Location: Woodbranch, Texas  
Date: October 25, 2020  
Time: 0837 CDT  
Aircraft: Grumman AA-5A (S/N AA5A0452) N26136

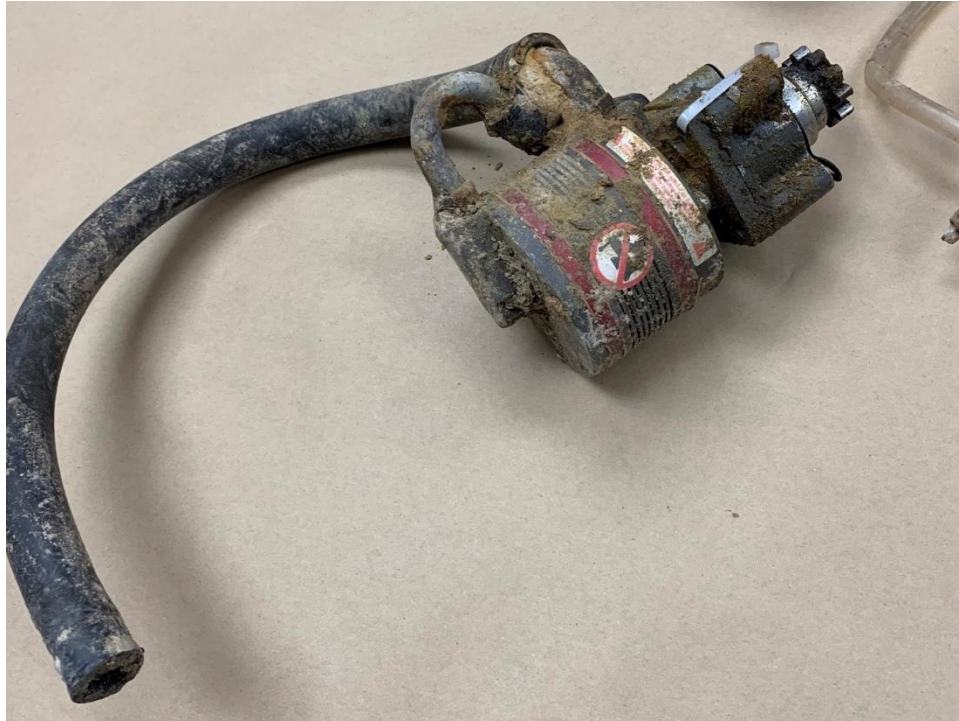
Figure 3. Vacuum Pump, Hose and Drive Coupling

The vacuum pump came with the drive coupling and pump hoses. See Figure 3. The unit was caked with dirt. The hose was broken about 10 inches from the pump outlet. An external examination of the pump showed it intact. See figure 4. The drive coupling was held to the pump by zip tie. The tie was cut, and the drive coupling removed. The drive coupling rotated freely. The top and bottom covers were removed, and the pump rotor and vanes were examined. The pump rotor was fractured in three places and showed rotational rub marks on both sides. The vanes showed normal wear. See figure 5. The top and bottom inside covers showed rotational rub marks. The bottom inside cover with the core drive plate also showed impact and rotational scoring. See figures 6 and 7. The inside of the pump stator housing showed rotational rubs. See figure 8.

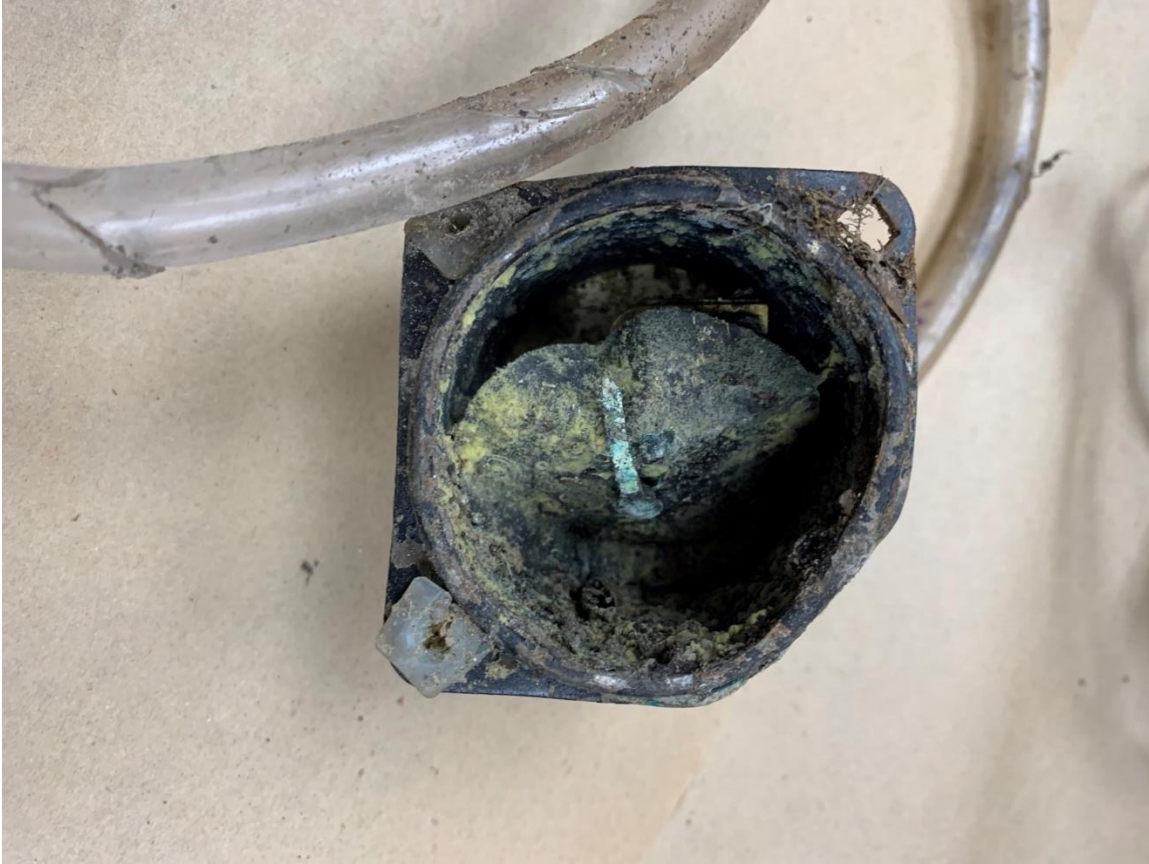
Figure 9. Suction Gauge and Vacuum Tube

The Suction Gauge was crushed inward and showed heat damage due to fire. The reading needle was pressed into the reading plate at the center. All the numbers and symbols on the plate were burned off. See figure 10. On an undamaged suction gauge, the center position would read as normal suction. The vacuum reading tube coming out of the gauge was cut in several places and severed about 25 inches from the gauge.

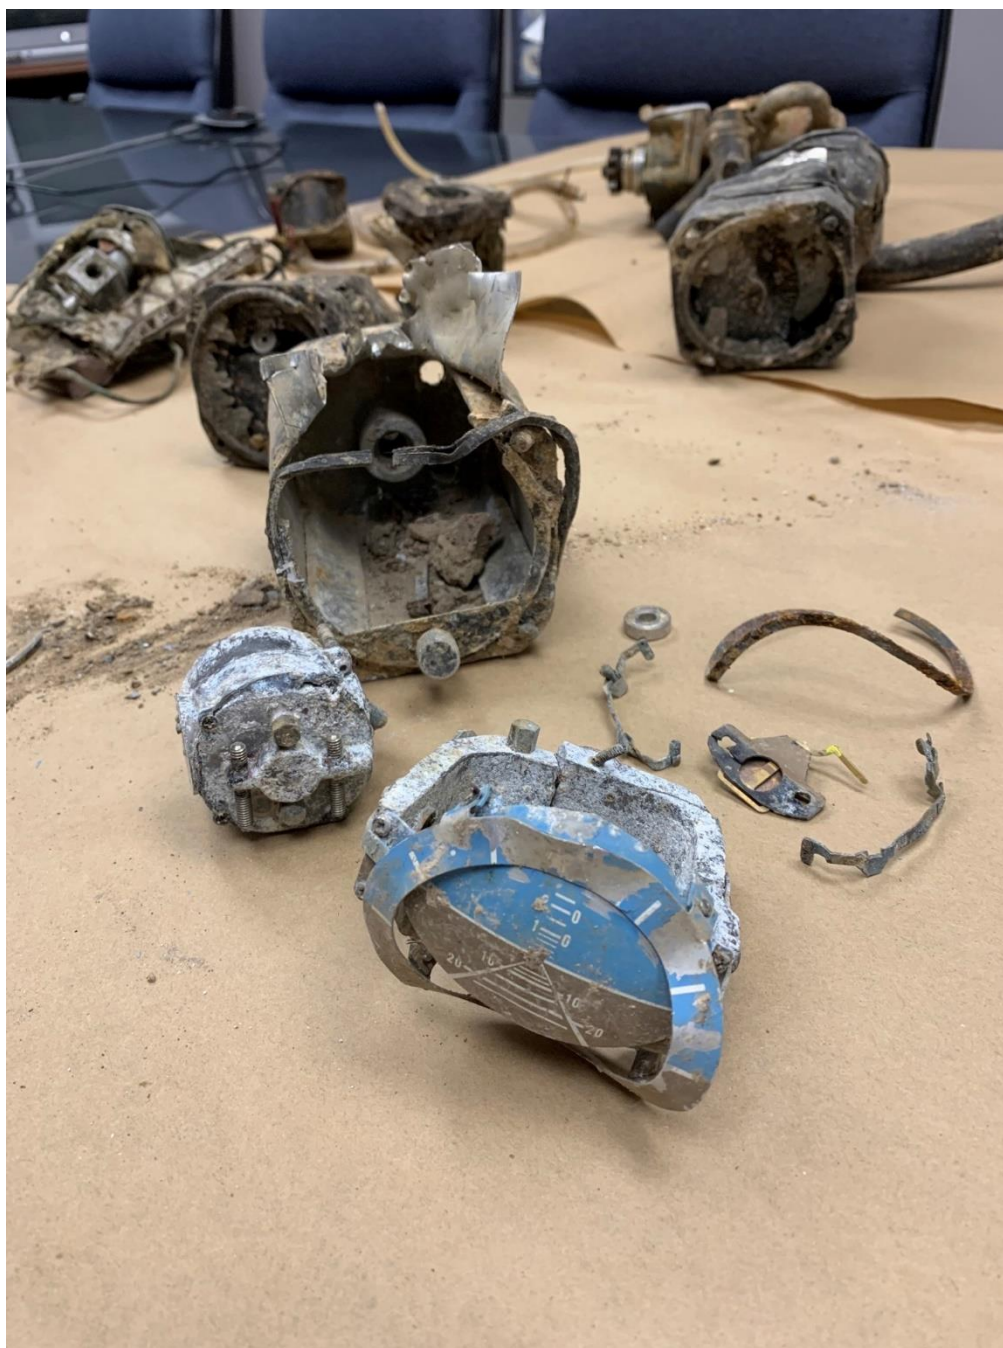
Figure 10. Attitude Indicator

The attitude indicator was broken out, the case was crushed downward, and the unit showed heat damage due to fire. The front glass was broken out and missing. See figure 10. The unit case was cut open and the artificial horizon indicator and the gyro case were removed. The gyro case was crushed downward and broken into three pieces. Two of the pieces separated when the gyro case was removed from the attitude indicator case, showing the front half of the gyro. See figure 11. The exposed portion of the gyro drum showed rotational scoring marks. The front edge of the drum was chipped and scratched. See Figure 12. The gyro case and drum showed heat damage and some rust. See figure 13. A detailed look at the gyro drum and the case showed rotational scoring marks. See Figures 14 and 15.

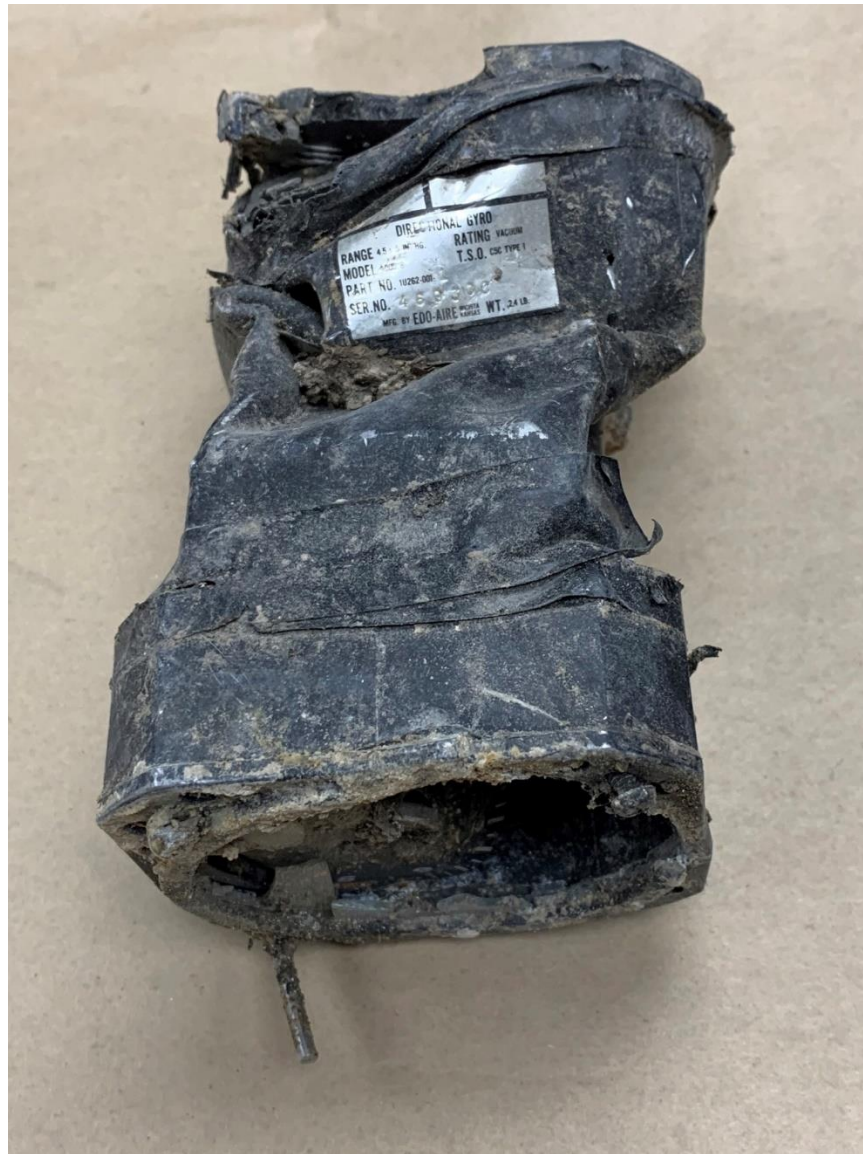
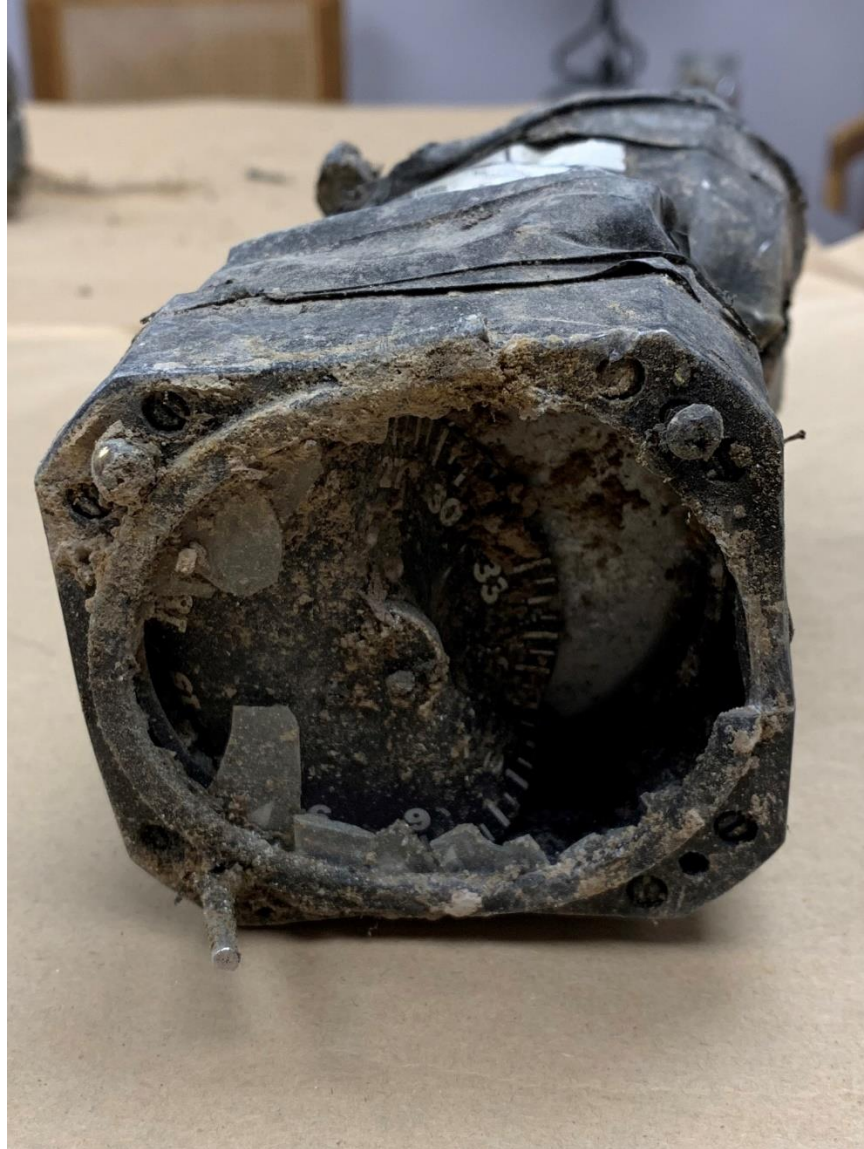
The directional gyro was broken out and the case was crushed and twisted. The front glass was broken out and the directional card was bent and crushed inward. The unit showed fire damage and rust on the front face. See figures 16 and 17. The unit was not disassembled.

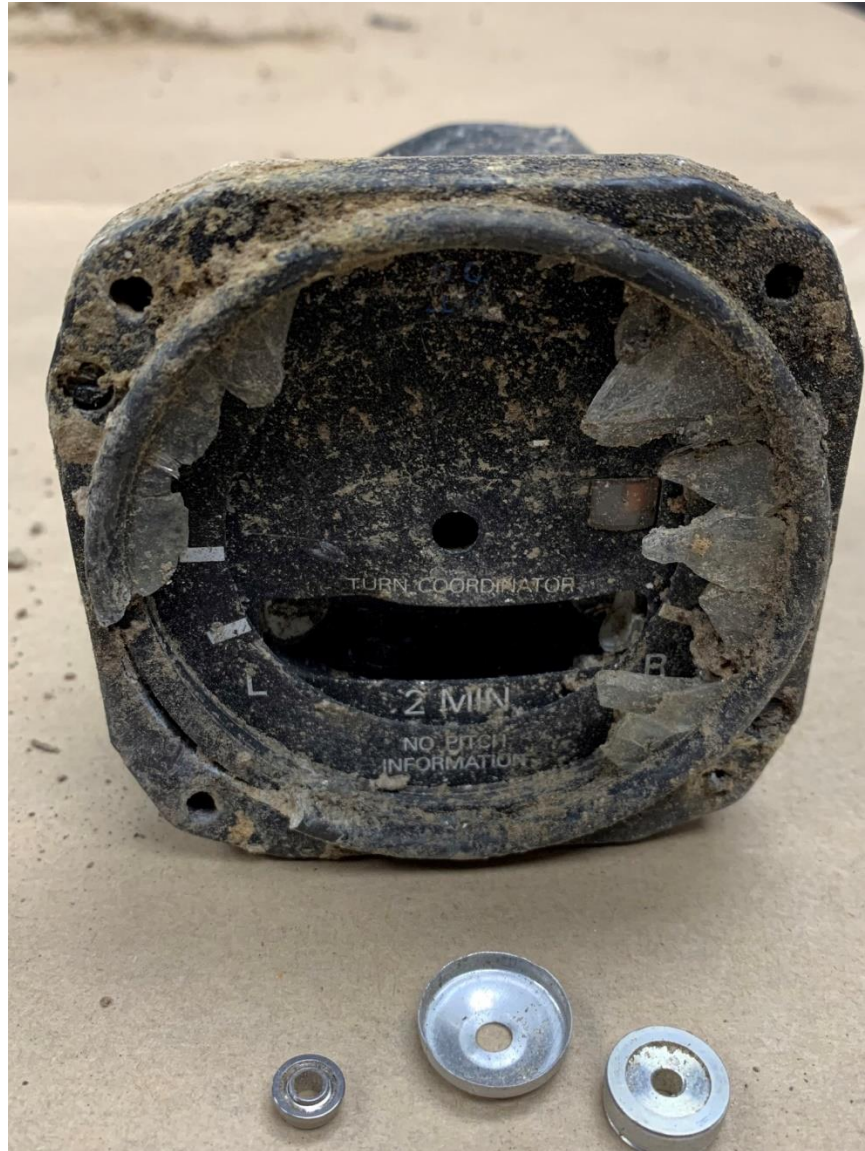
Figure 18. Turn Coordinator

The turn coordinator was broken out and crushed. The front face glass was broken out. The turn needle was missing, and the ball level was broken with glass fluid and the ball missing. The unit showed minor fire damage.
