**Photo 1 – Photo of the Accident Scene**

Photo 13 – Airframe Logbook Page – Annual Inspection

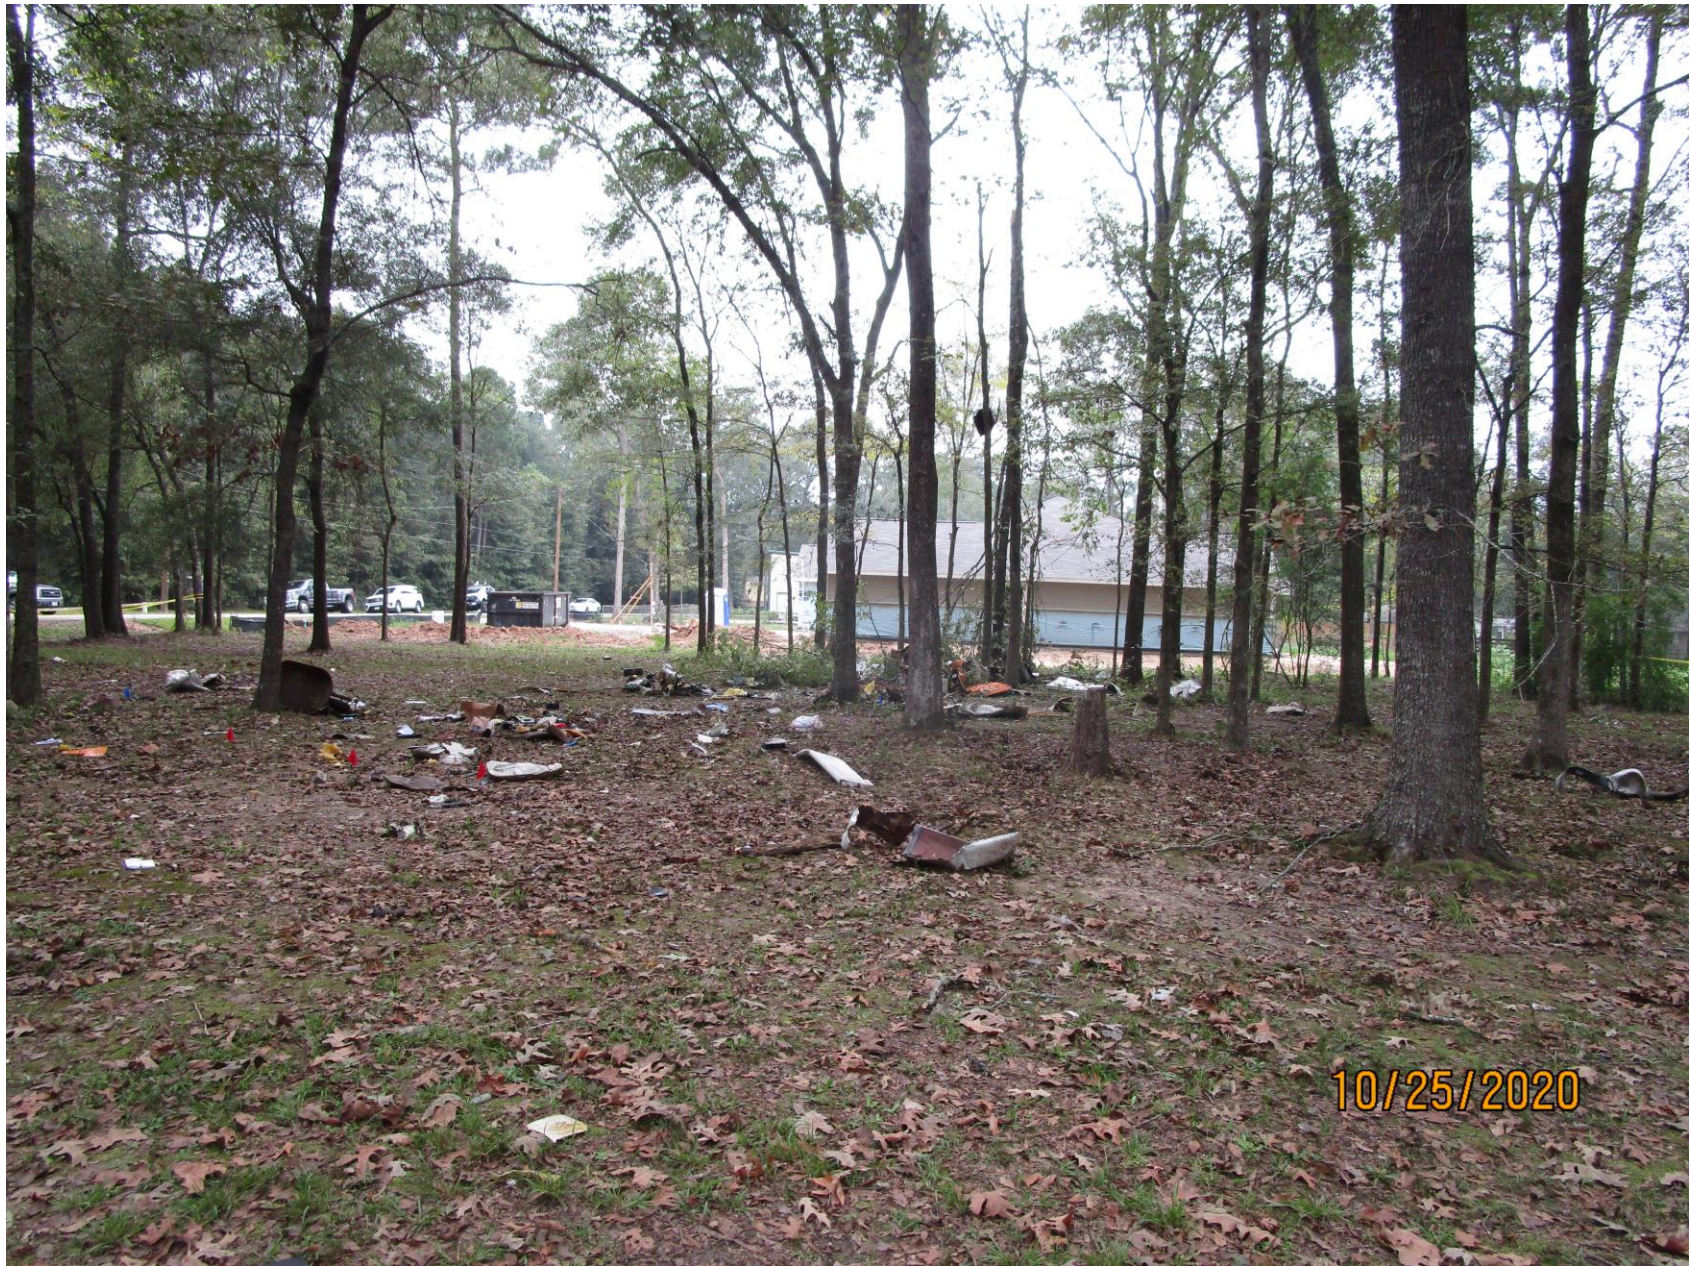
**Photo 2 – Wreckage Debris Field**

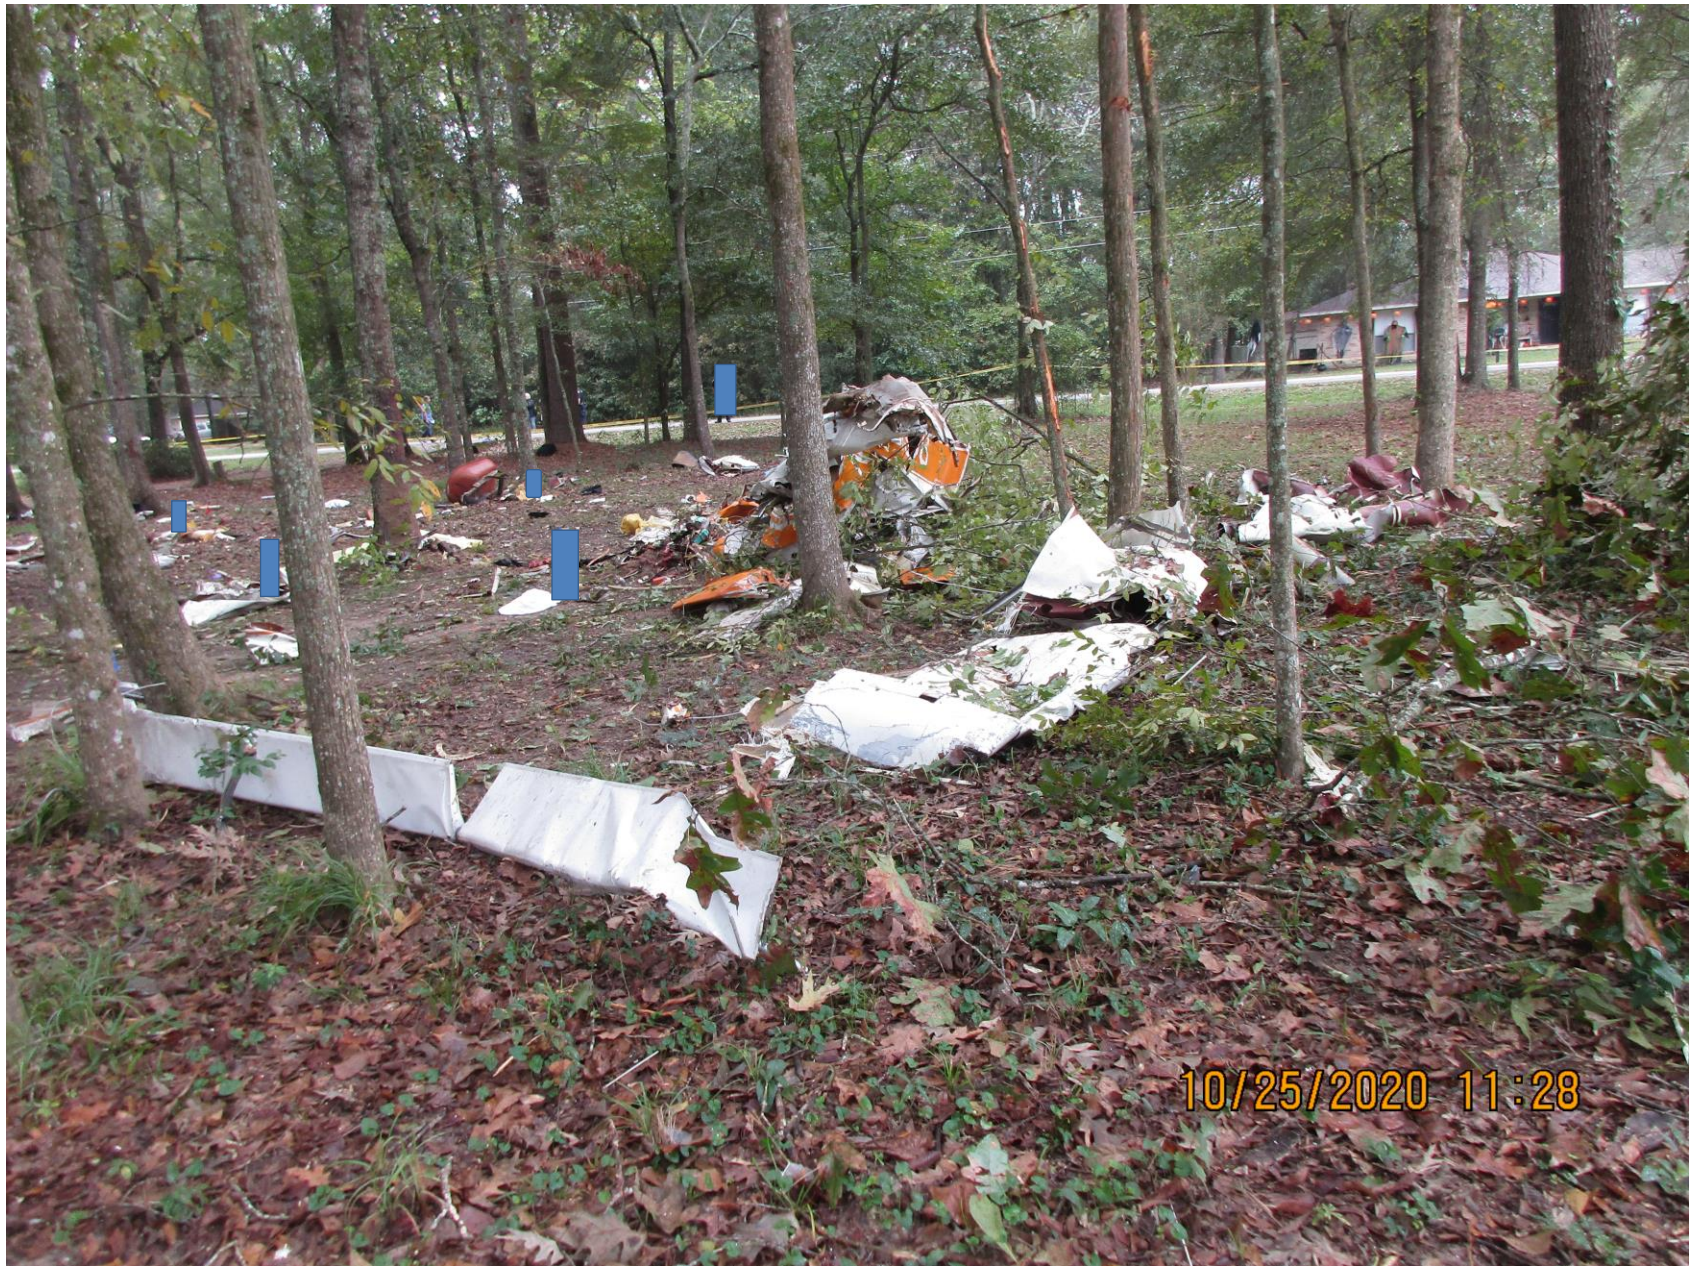
**Photo 3 – Airplane Main Wreckage, FAA Photograph**

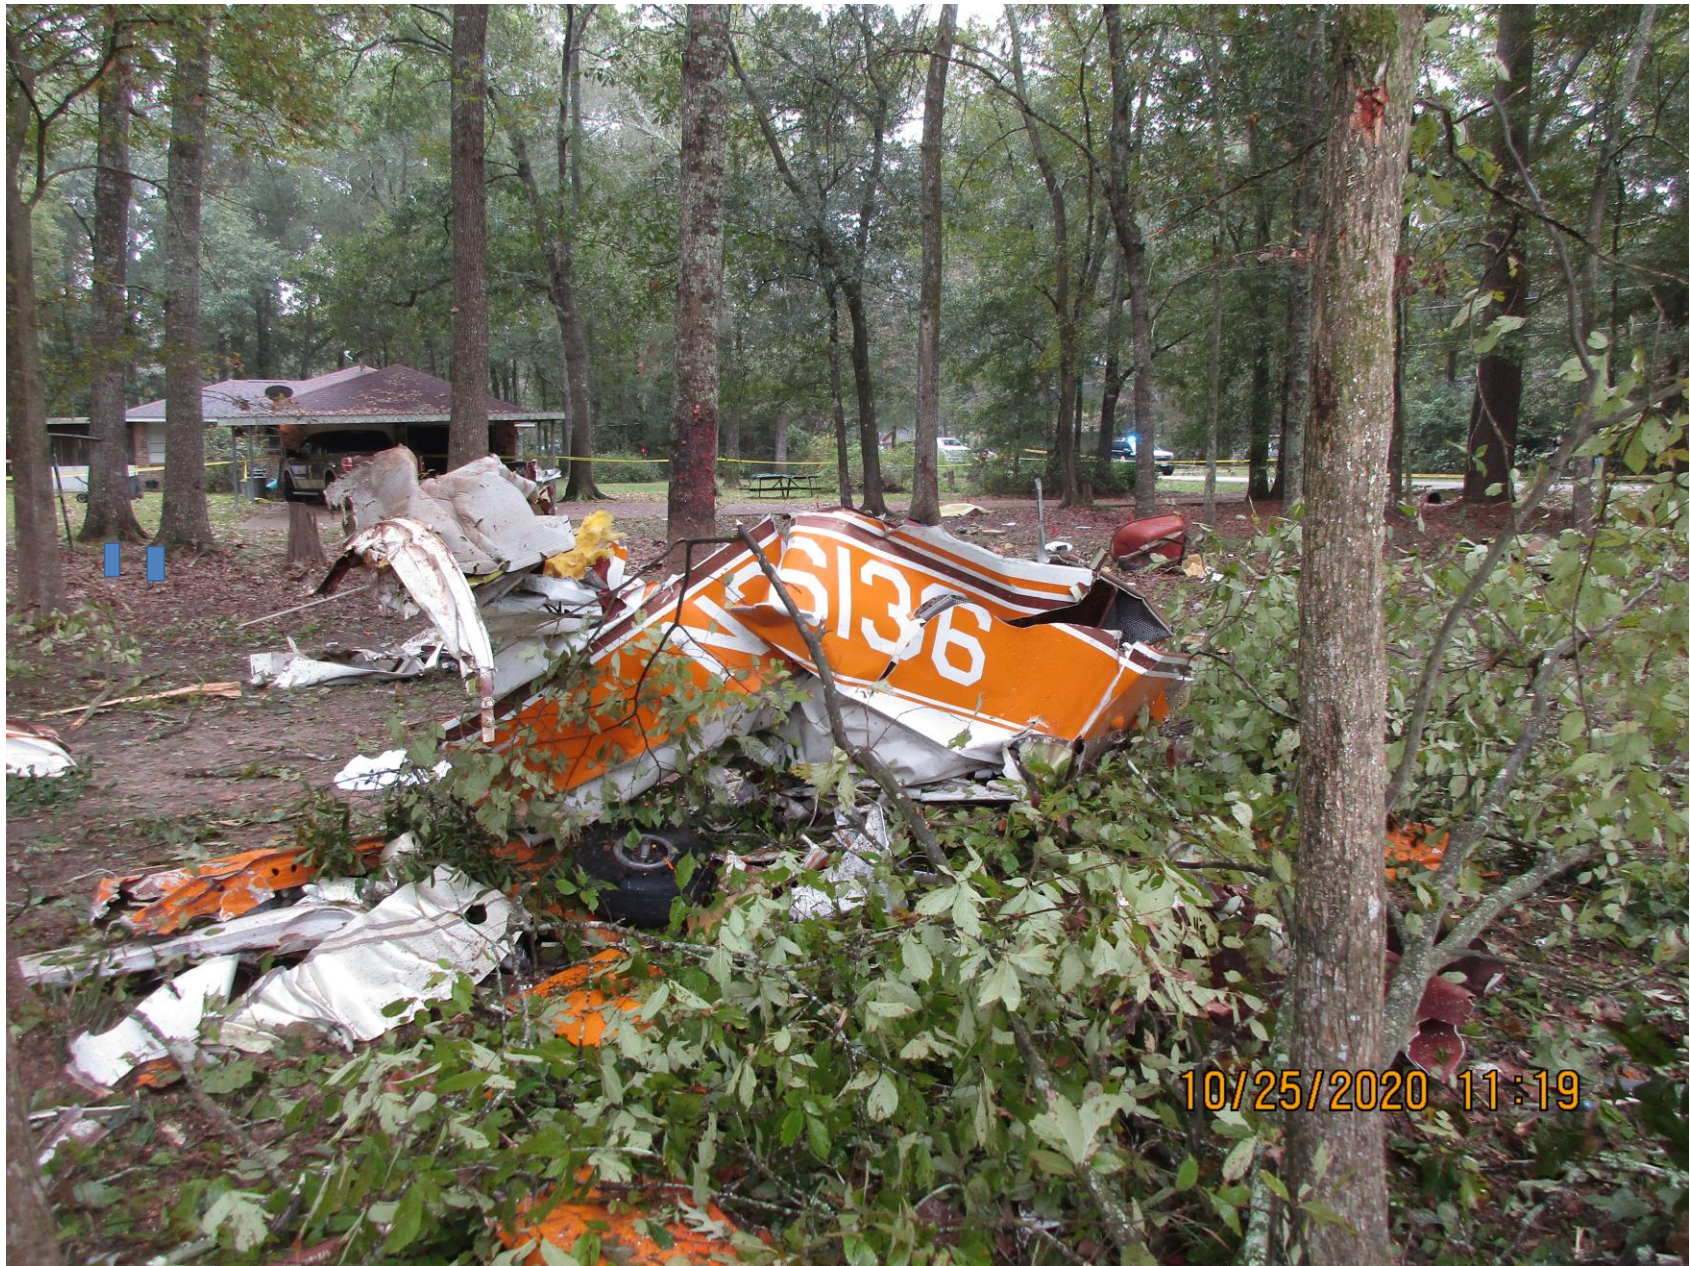
**Photo 4 – Airplane Fuselage, FAA Photograph**

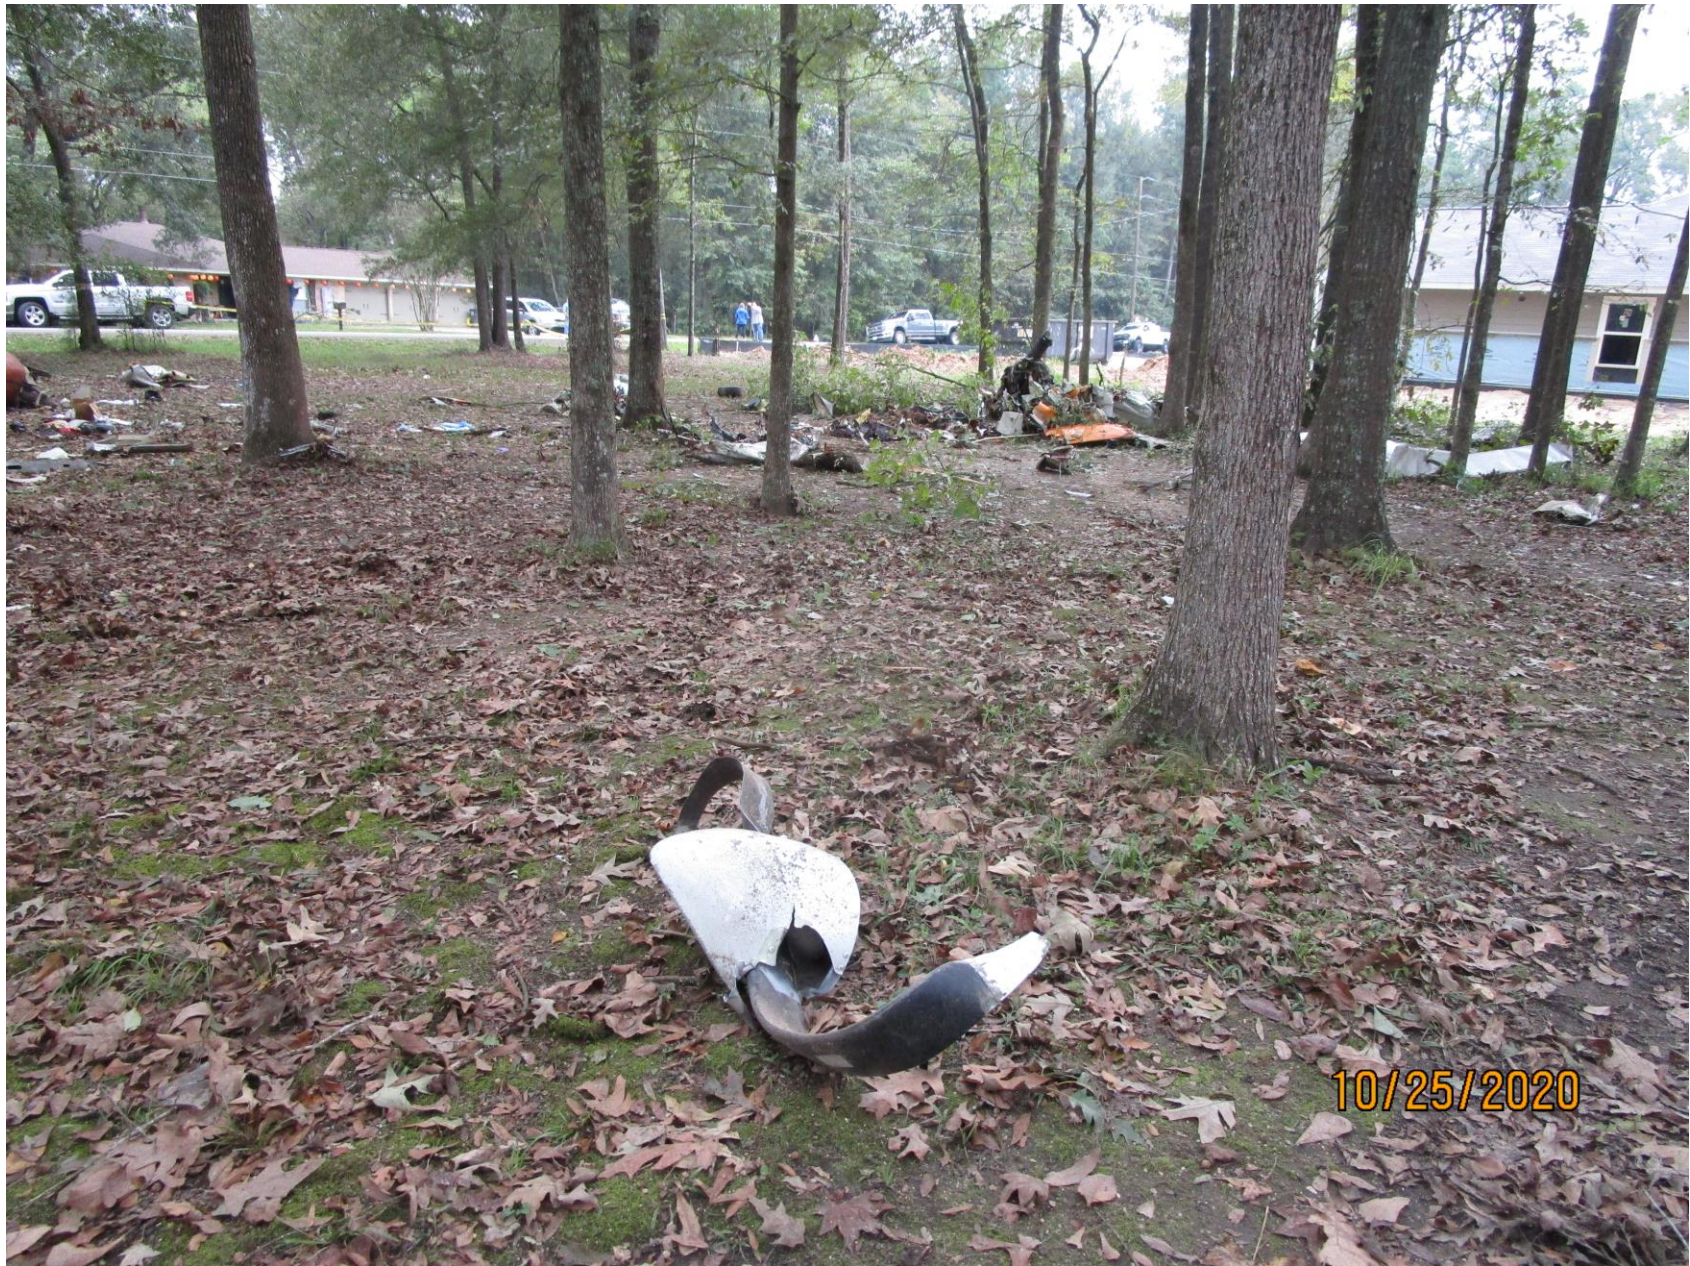
**Photo 5 – Propeller and Spinner**

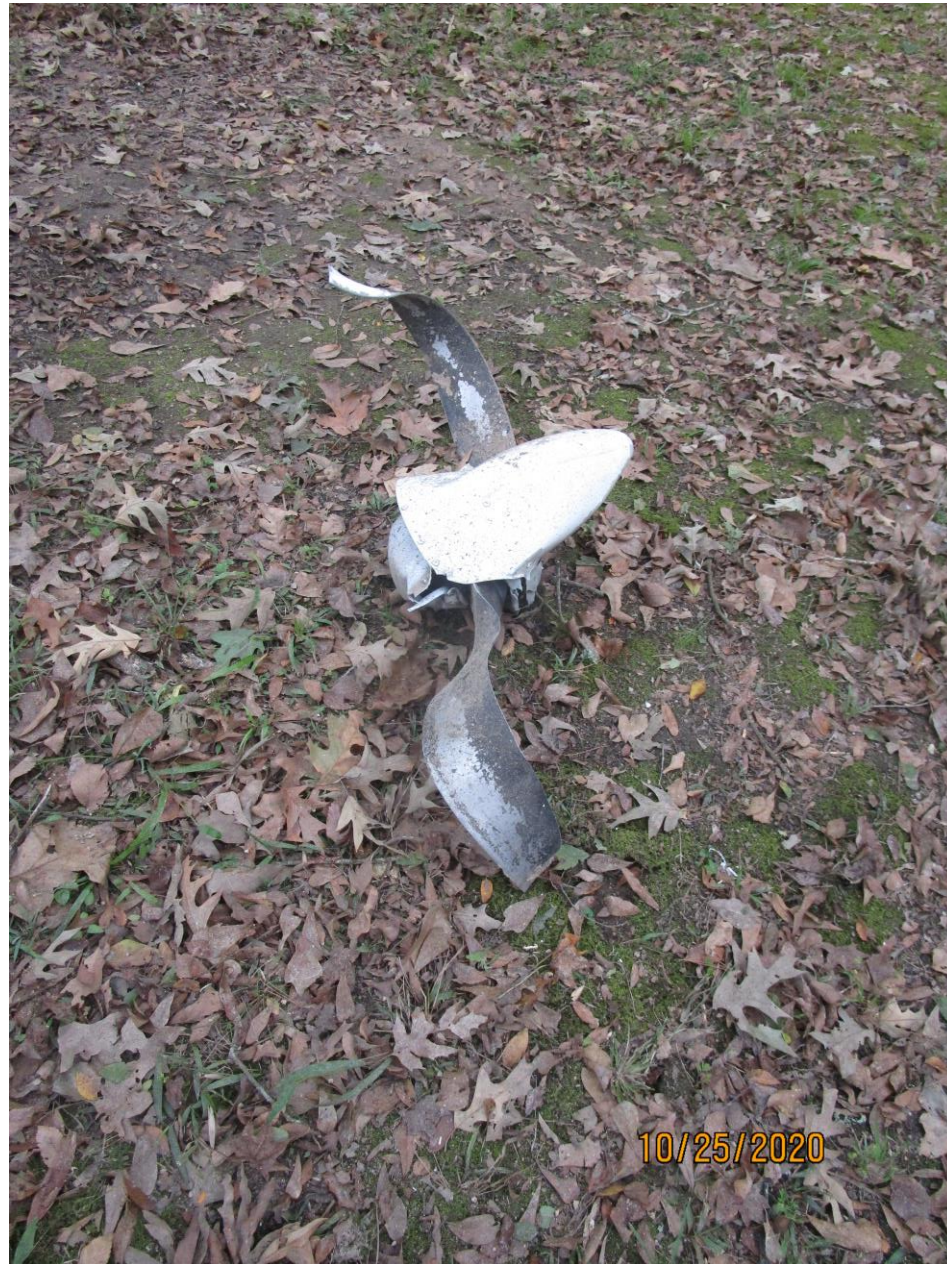
**Photo 6 – Propeller, Aft Side of Blades View**

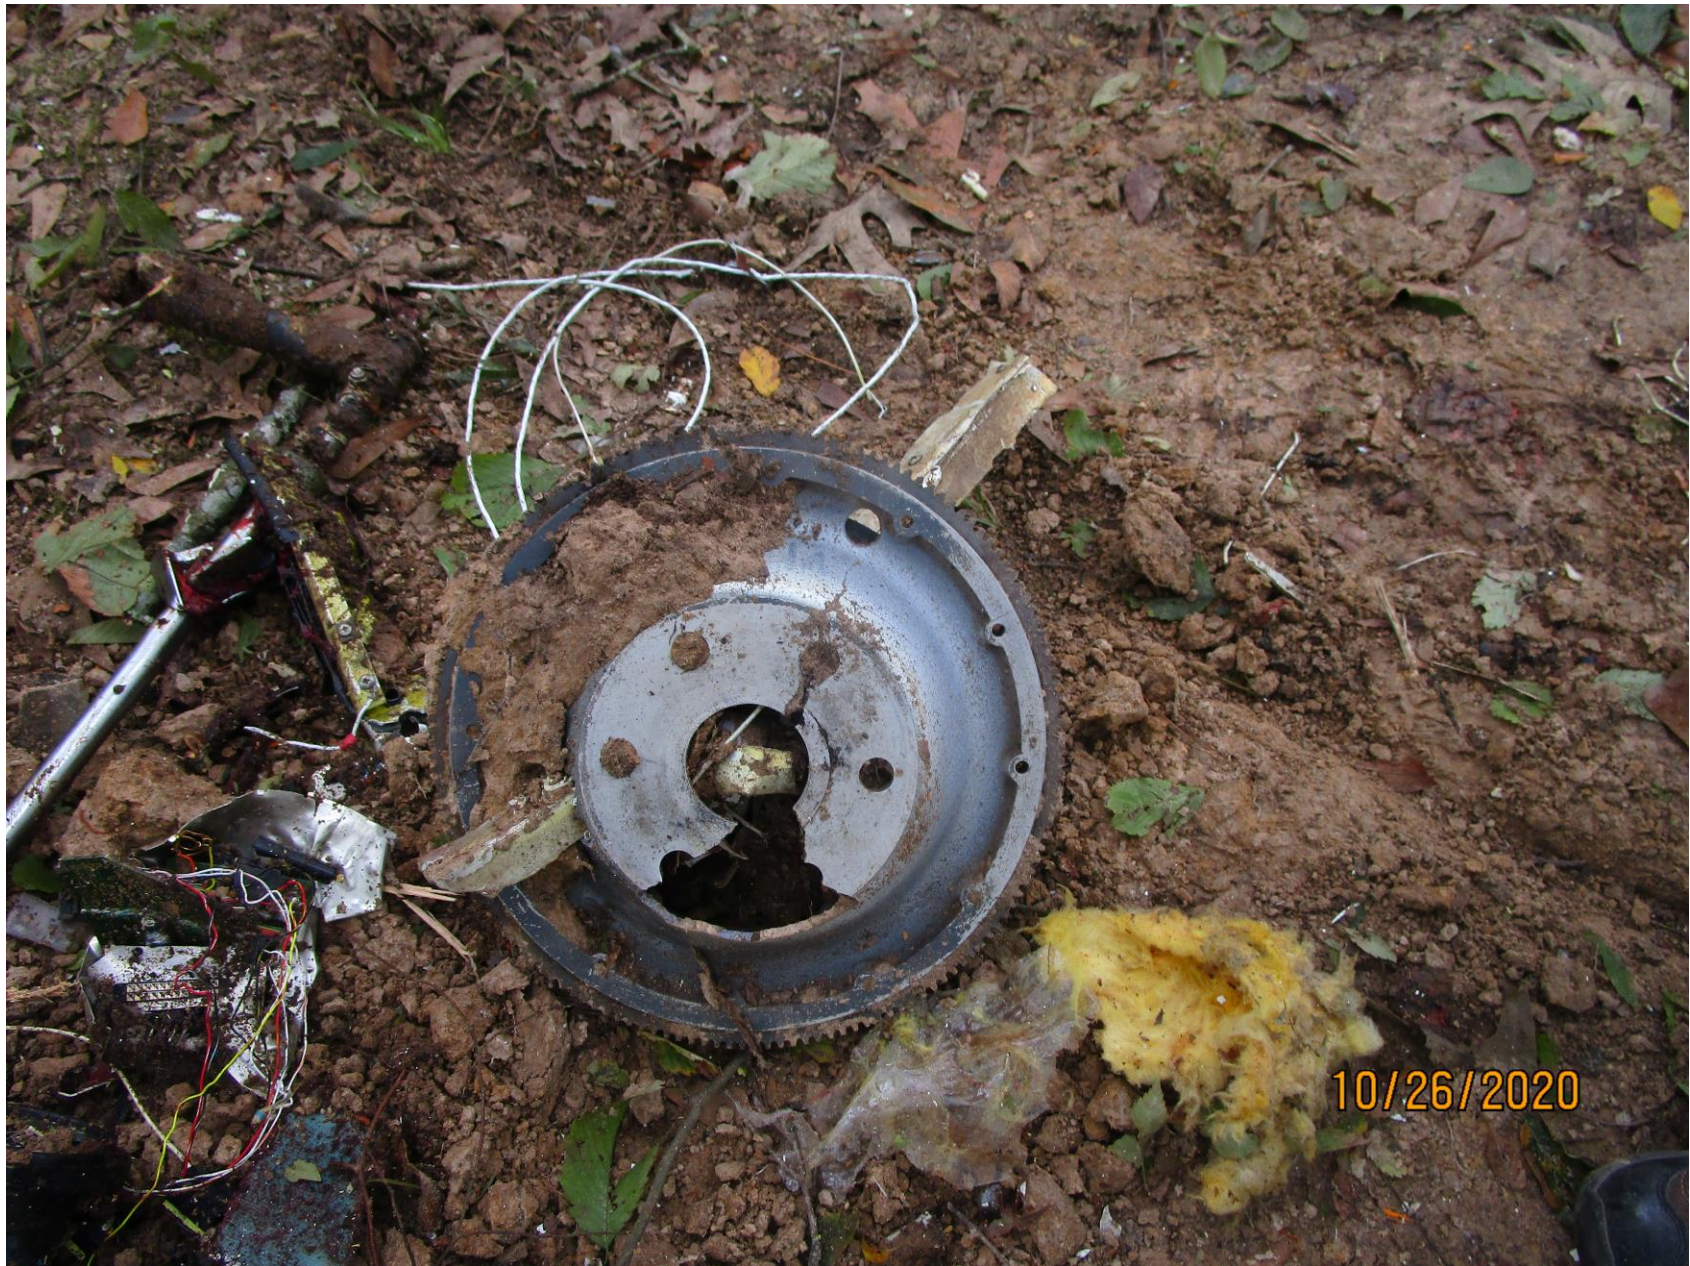
**Photo 7 – Engine Starter Ring Gear with Embedded Debris**

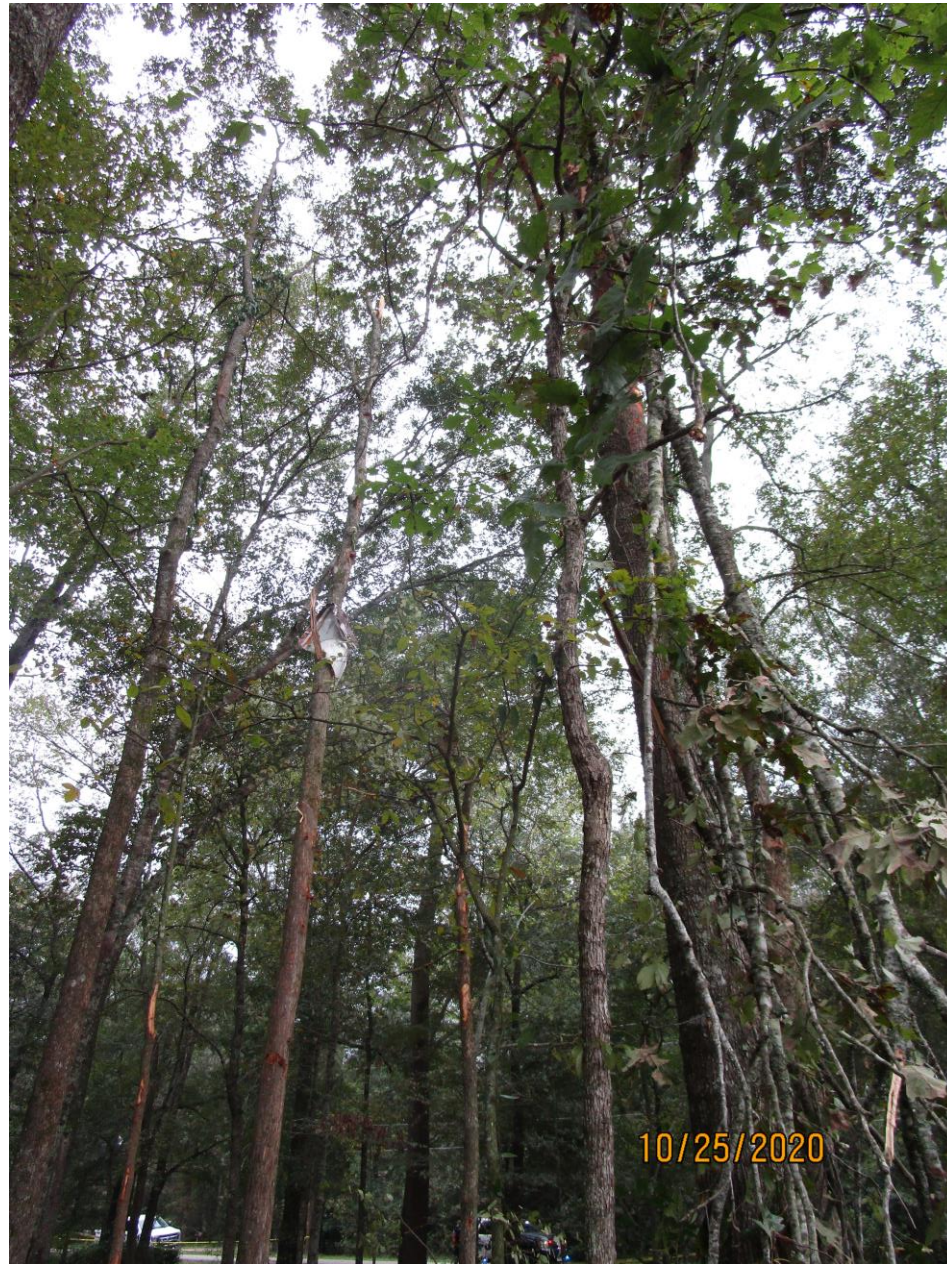
**Photo 8 – Airplane Part Embedded in Tree and Tree Damage**

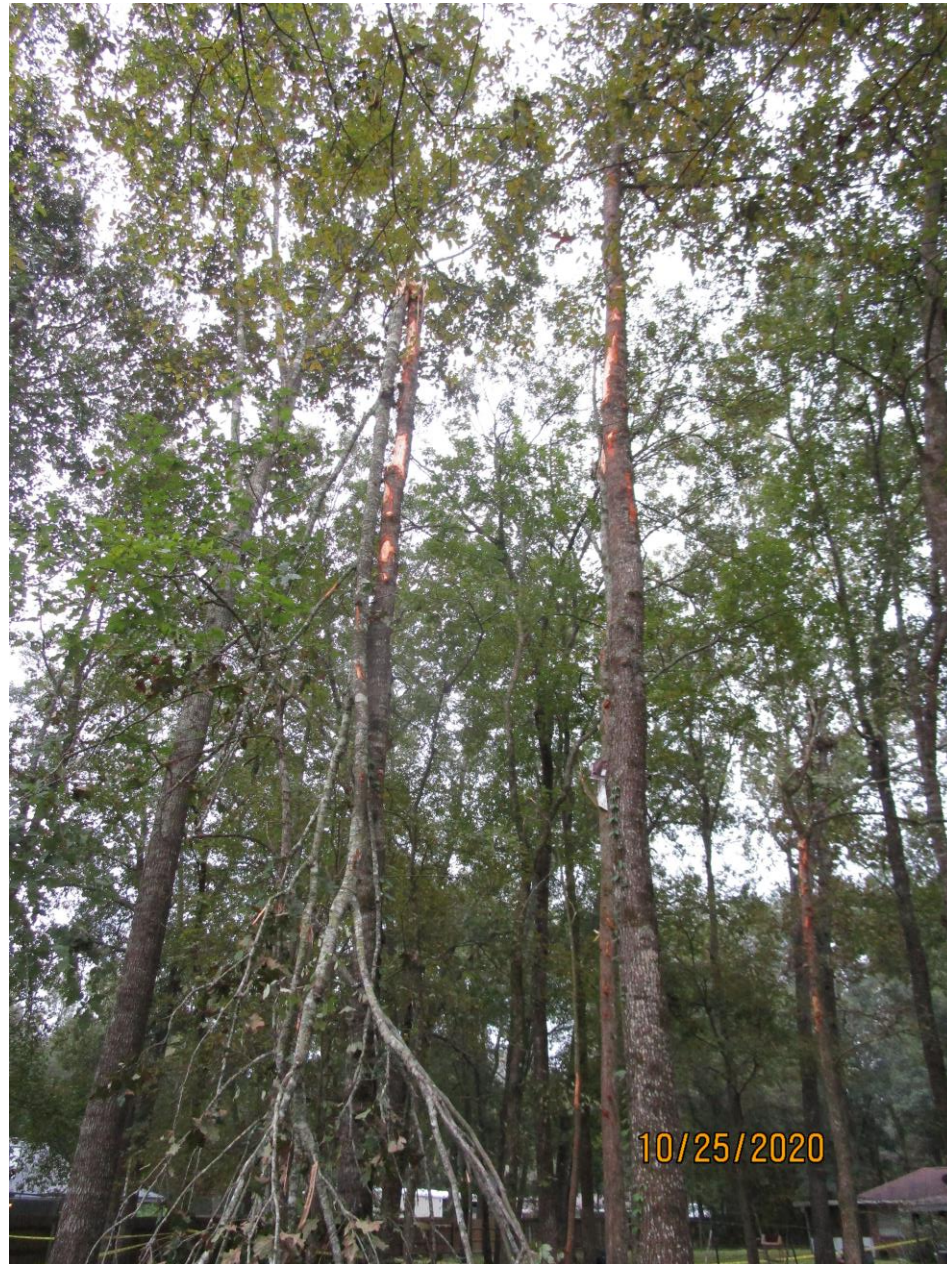
**Photo 9 – Tree Damage**

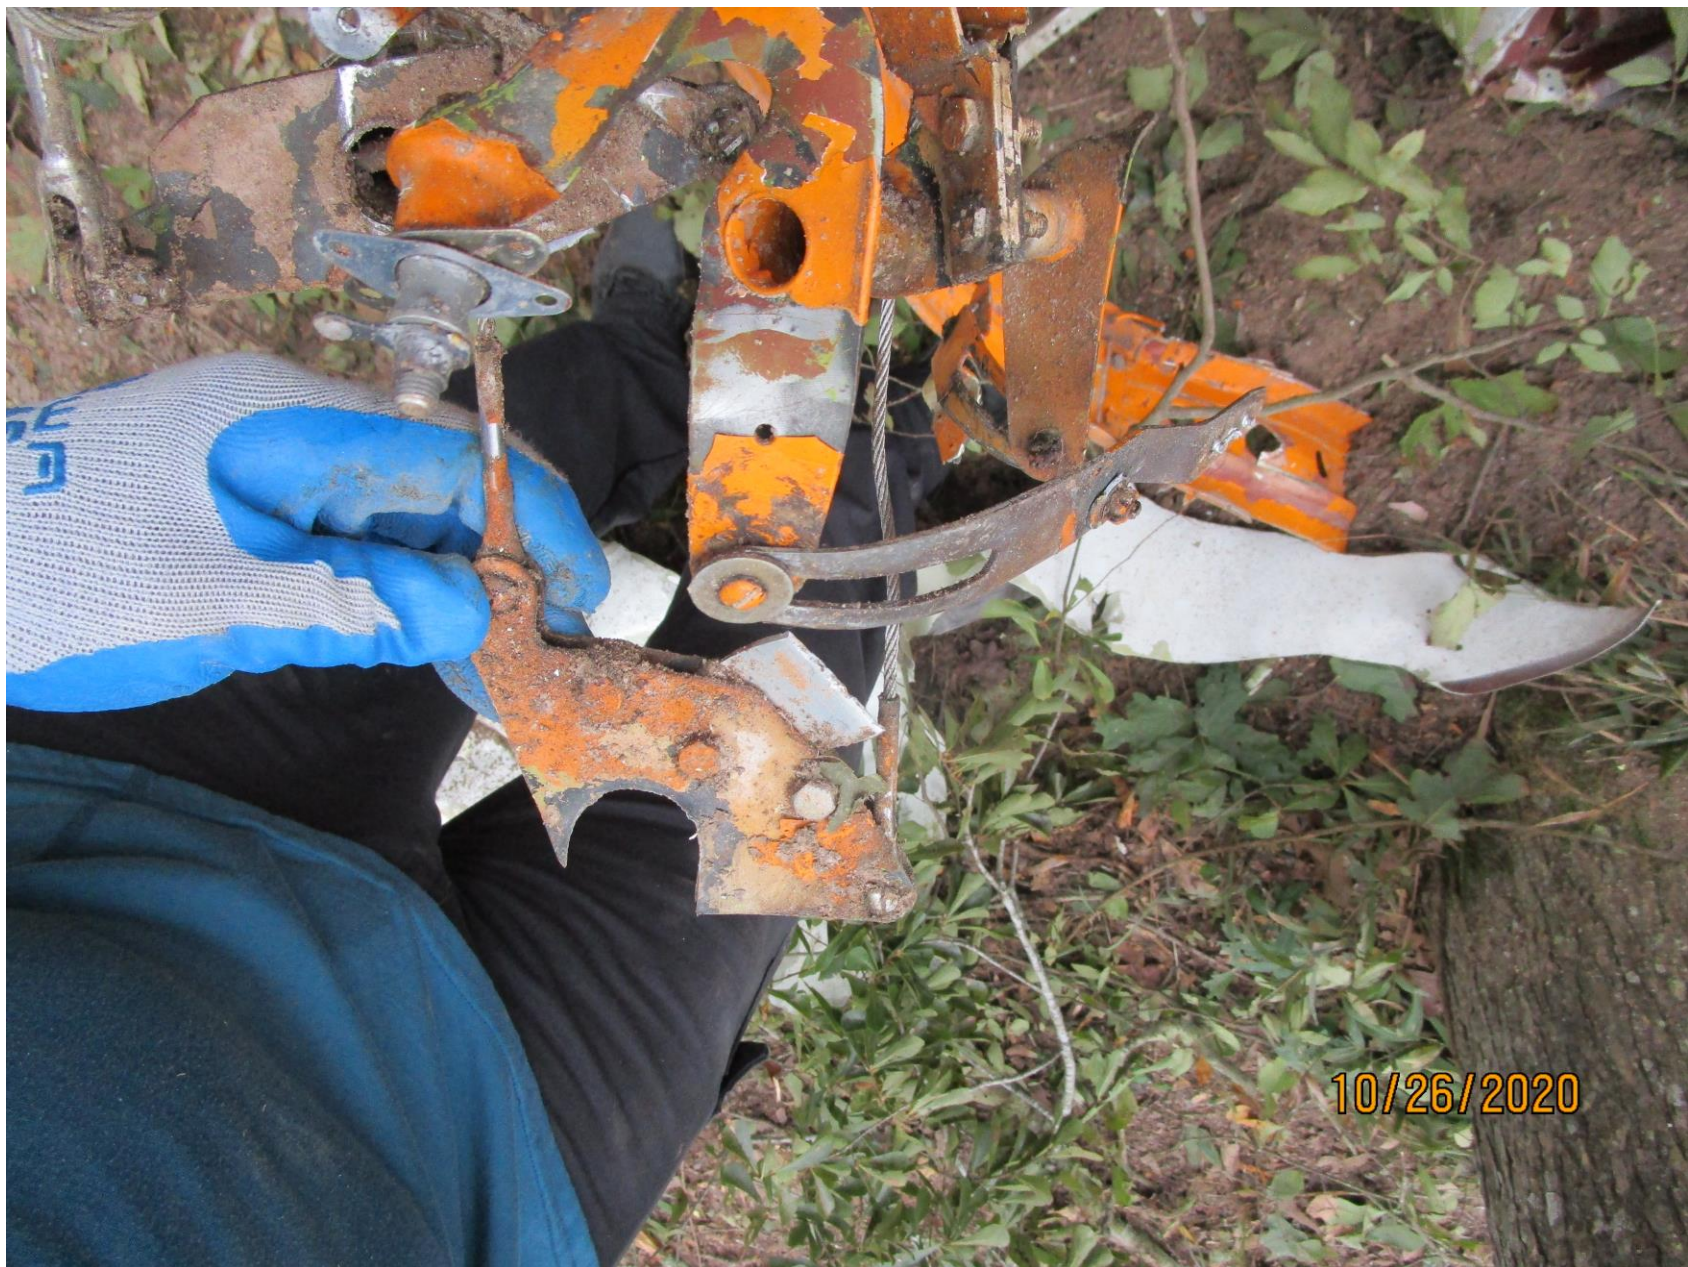
**Photo 10 – Flap Horn and Aileron Cable**

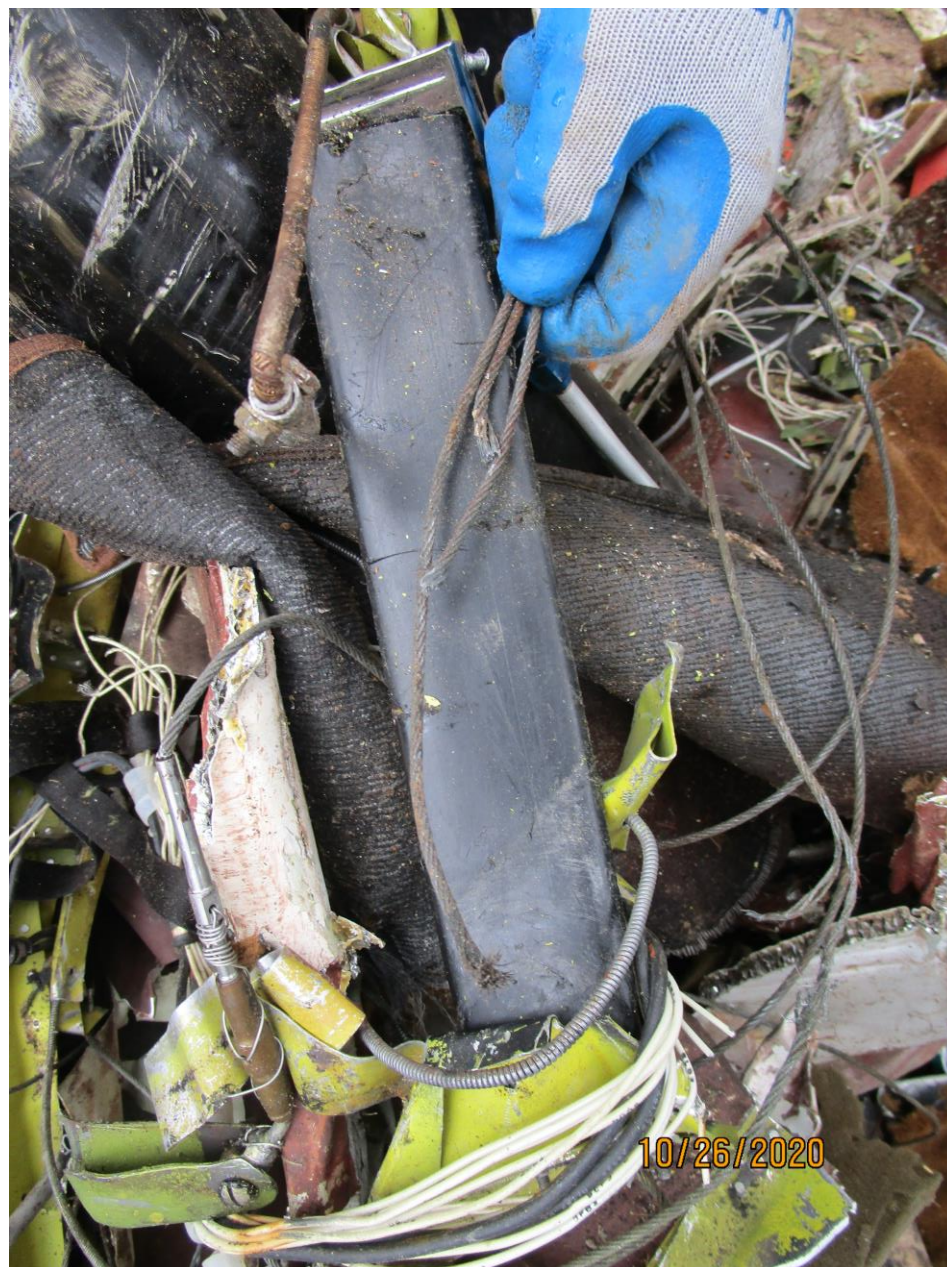
**Photo 11 – Flight Controls Cable Separations**

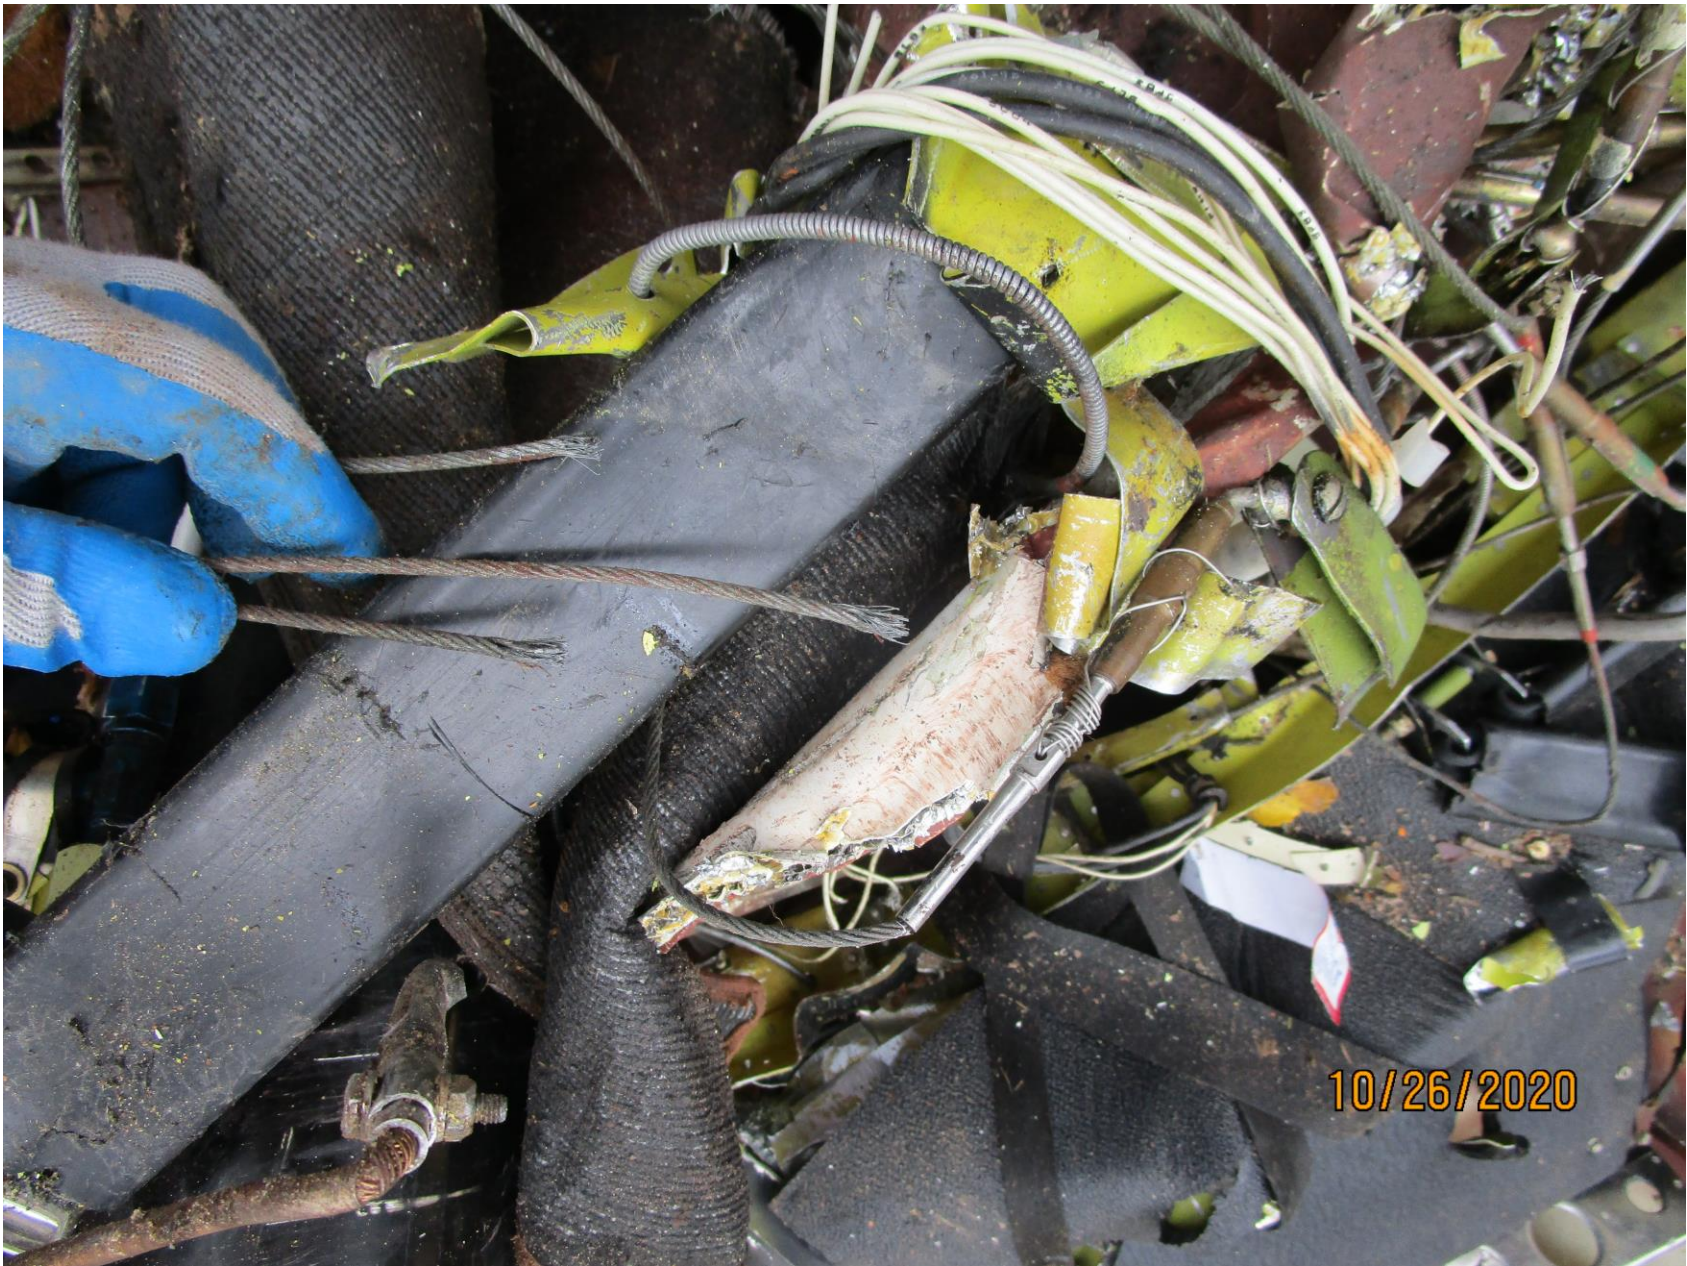
**Photo 12 – Detail View of Broken Flight Control Cables**
