**NATIONAL TRANSPORTATIONS SAFETY BOARD  
Office of Aviation Safety  
Washington, DC 20594**

**SUMMARY OF AIRPLANE EXAMINATION**

**-- CEN21FA130 --**

Aircraft: Velocity Vtwin, N13VT

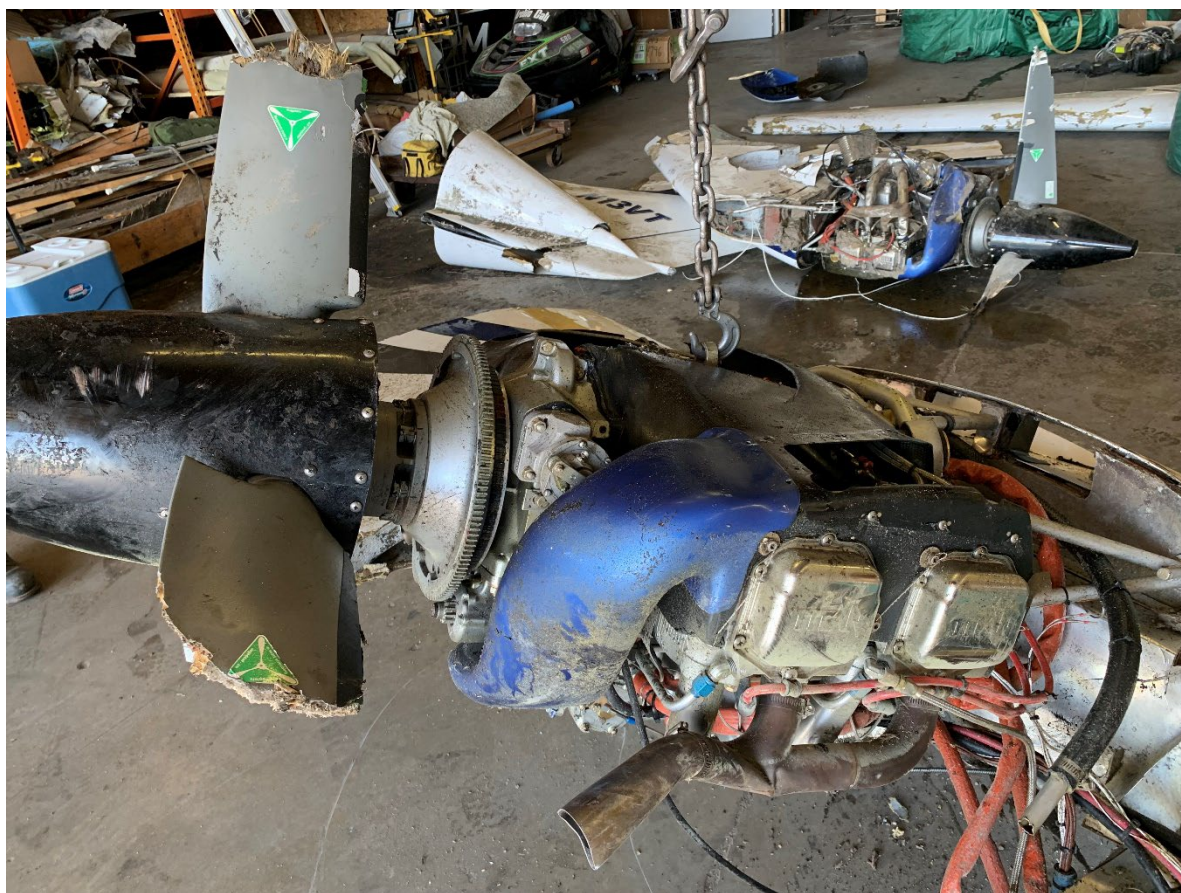
Externally, the left engine appeared intact and remained attached to its engine mount and the airframe structure. The top cooling shroud was removed to access the engine lifting ring and the engine was supported by a chain and forklift. The propeller remained attached and the root portions of all three wooden propeller blades remained attached to the hub.

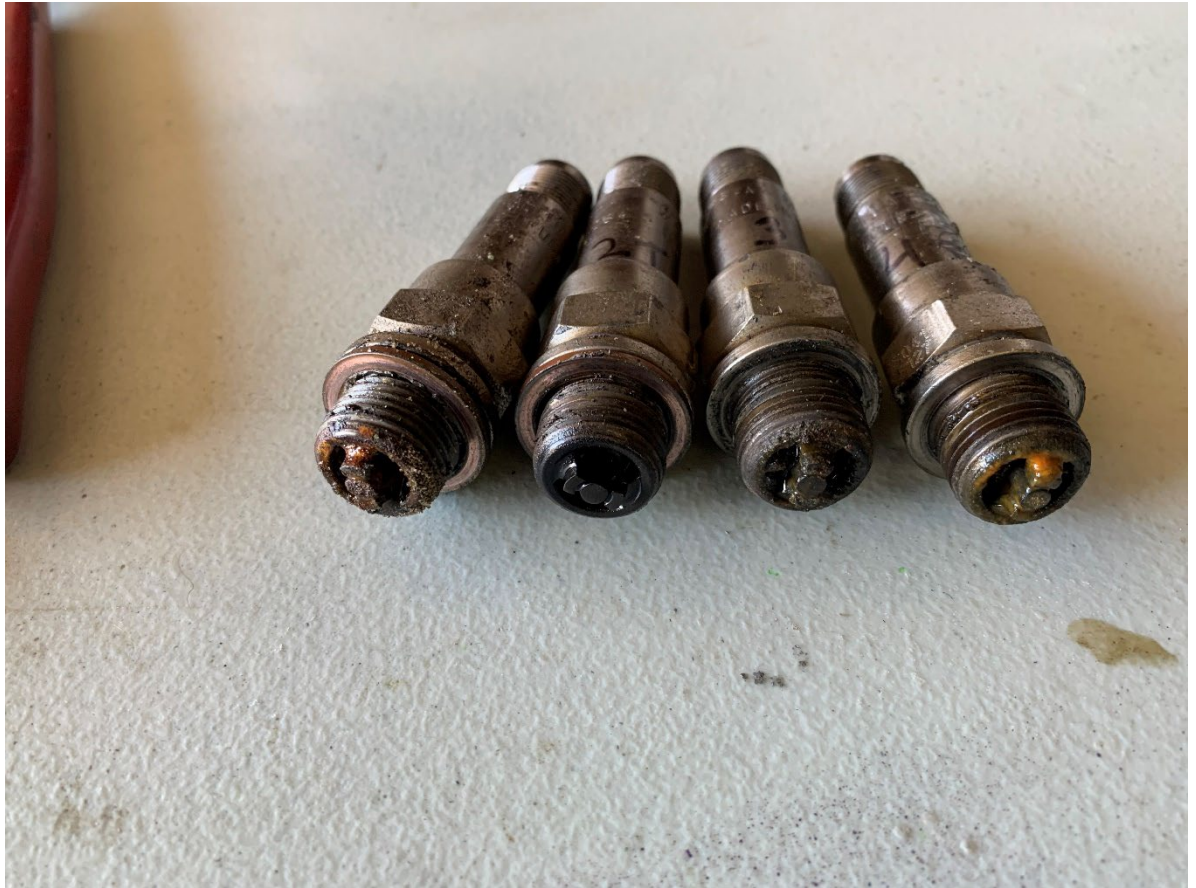
The top spark plugs were removed. The engine had been stored inverted and the top plugs were wet with oil, debris and water but otherwise appeared normal.

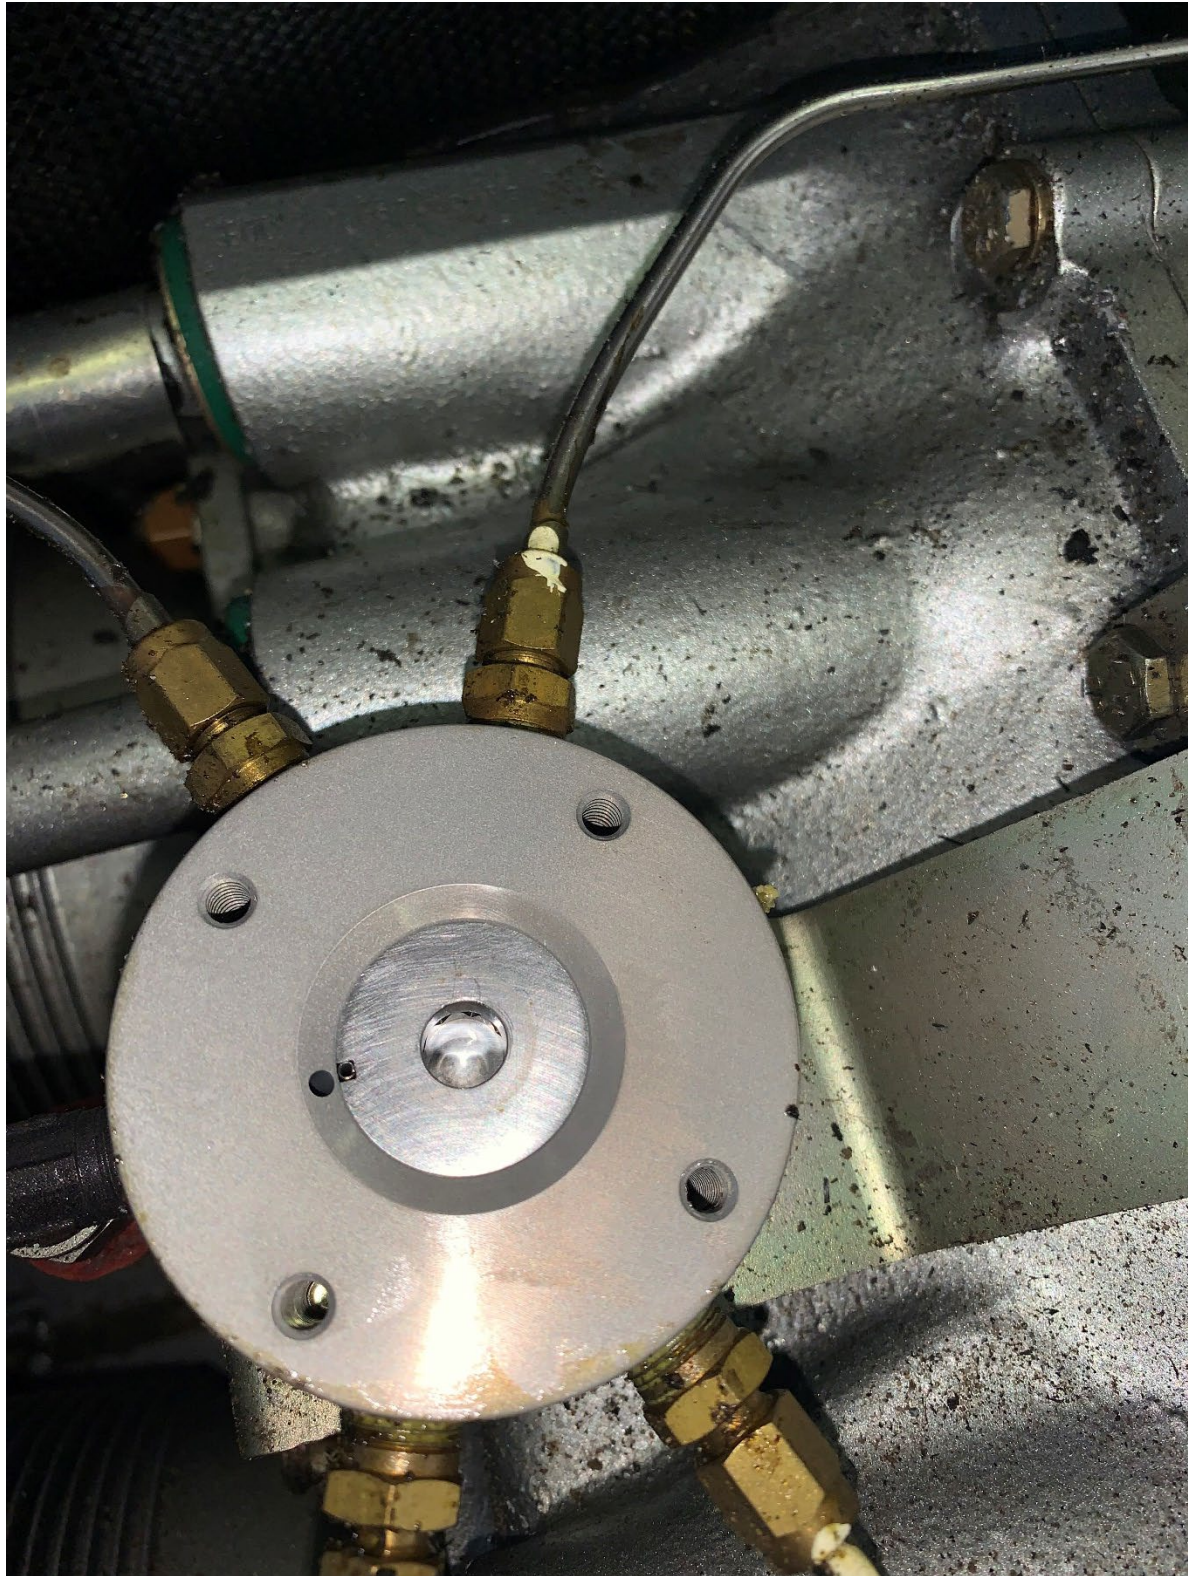
With the top plugs removed, the engine was free to rotate and no anomalies were detected during multiple rotations. A “thumb” compression verified suction and compression on all cylinders. The engine was equipped with one Slick magneto and one Emag electronic ignition. During engine rotation, spark was confirmed on all spark plug leads from the Slick magneto. The EMag ignition was removed for further examination. The cap of the fuel distribution block on the top of the engine was removed and the diaphragm appeared normal. There was a fuel present at the distribution block and it appeared clean with no anomalies noted.

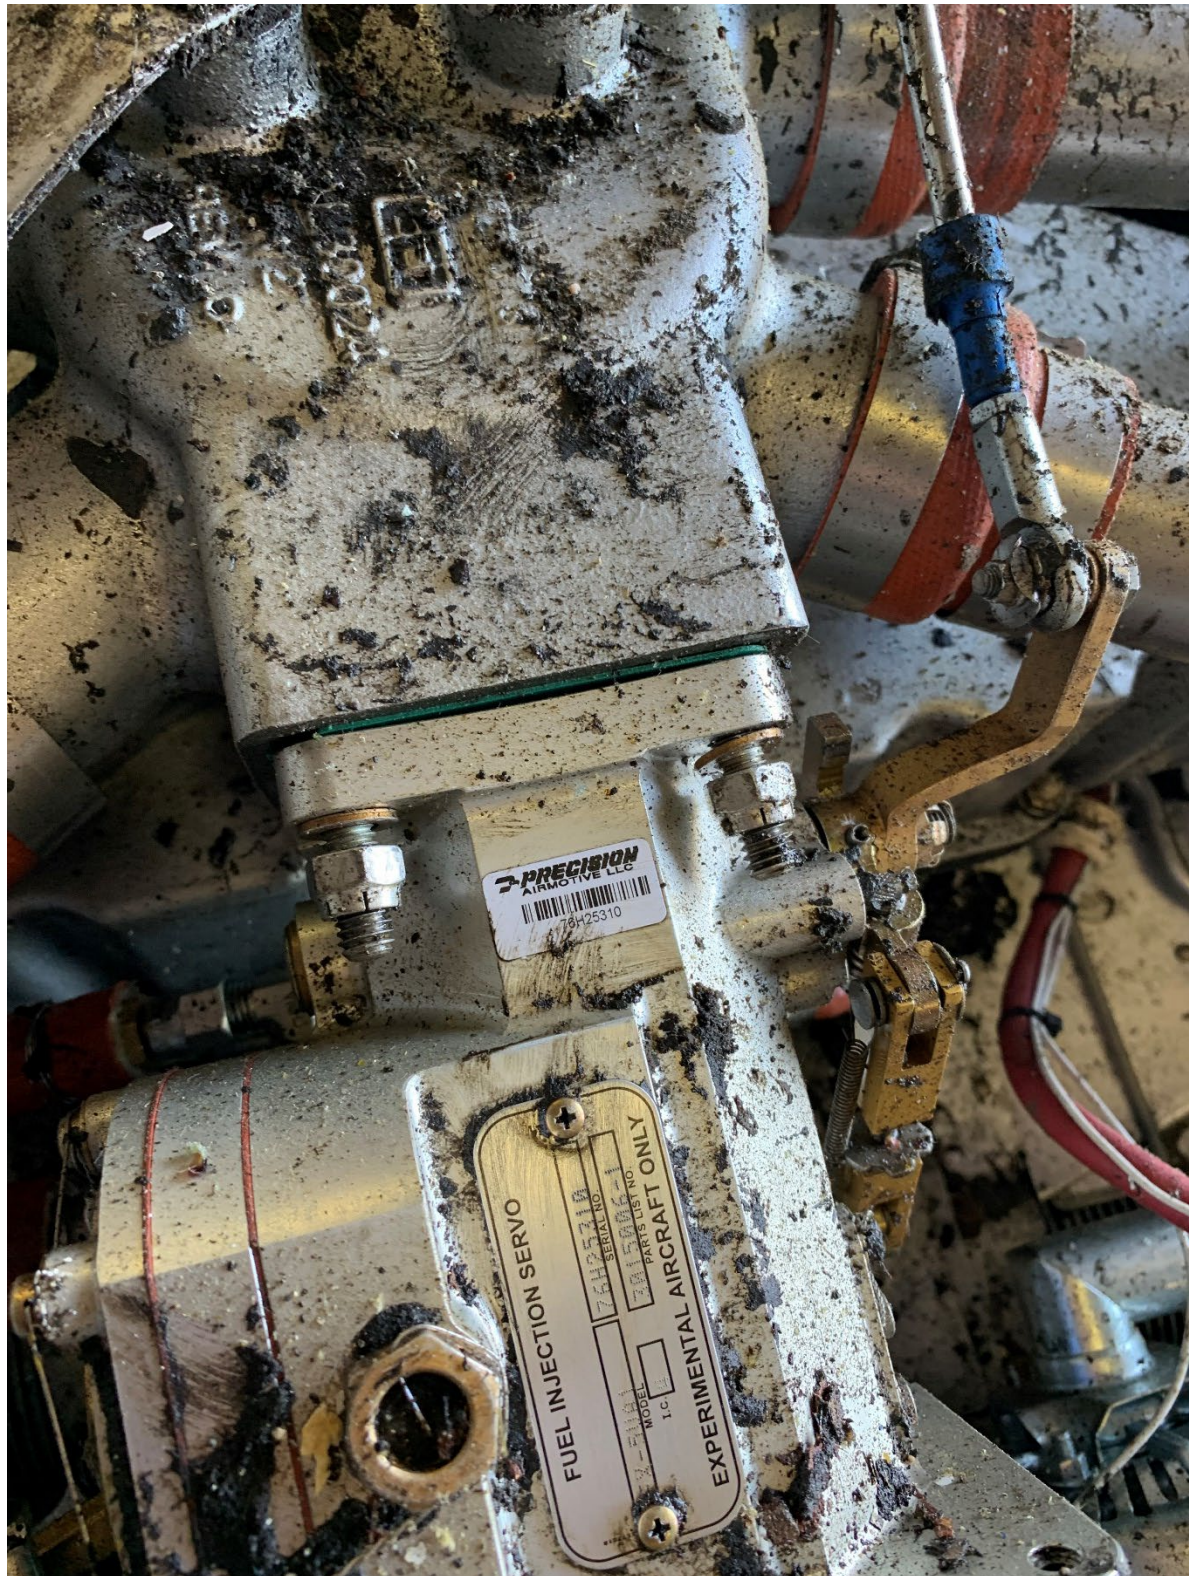
The fuel injection servo was removed from the engine and retained for further examination. The lower studs that mounted the servo to the engine had been partially pulled from the case and the flange on the servo was bent in the area of bolt attachment, consistent with impact damage.

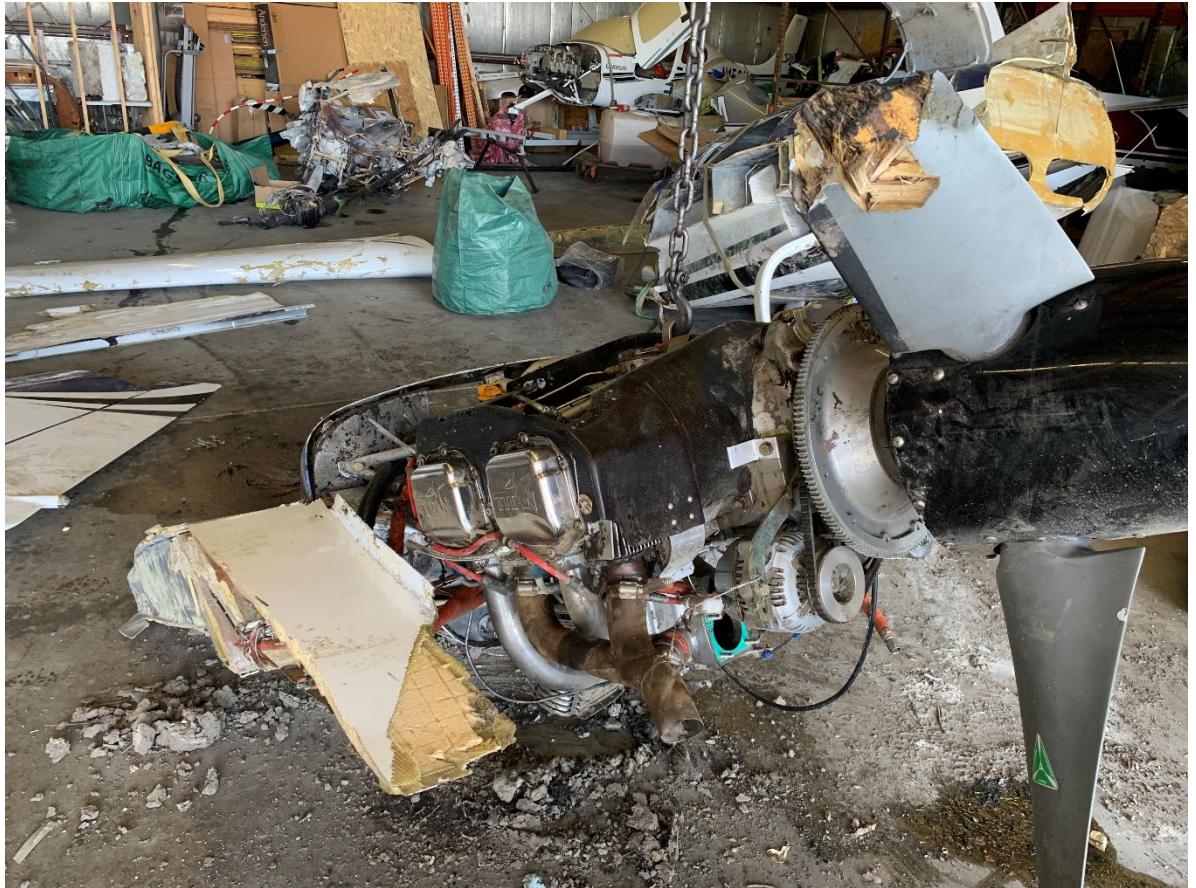
Externally, the right engine appeared intact and remained attached to its engine mount and the airframe structure. The top cooling shroud was removed to access the engine lifting ring and the engine was supported by a chain and forklift. The propeller remained attached and the root portions of all three wooden propeller blades remained attached to the hub.

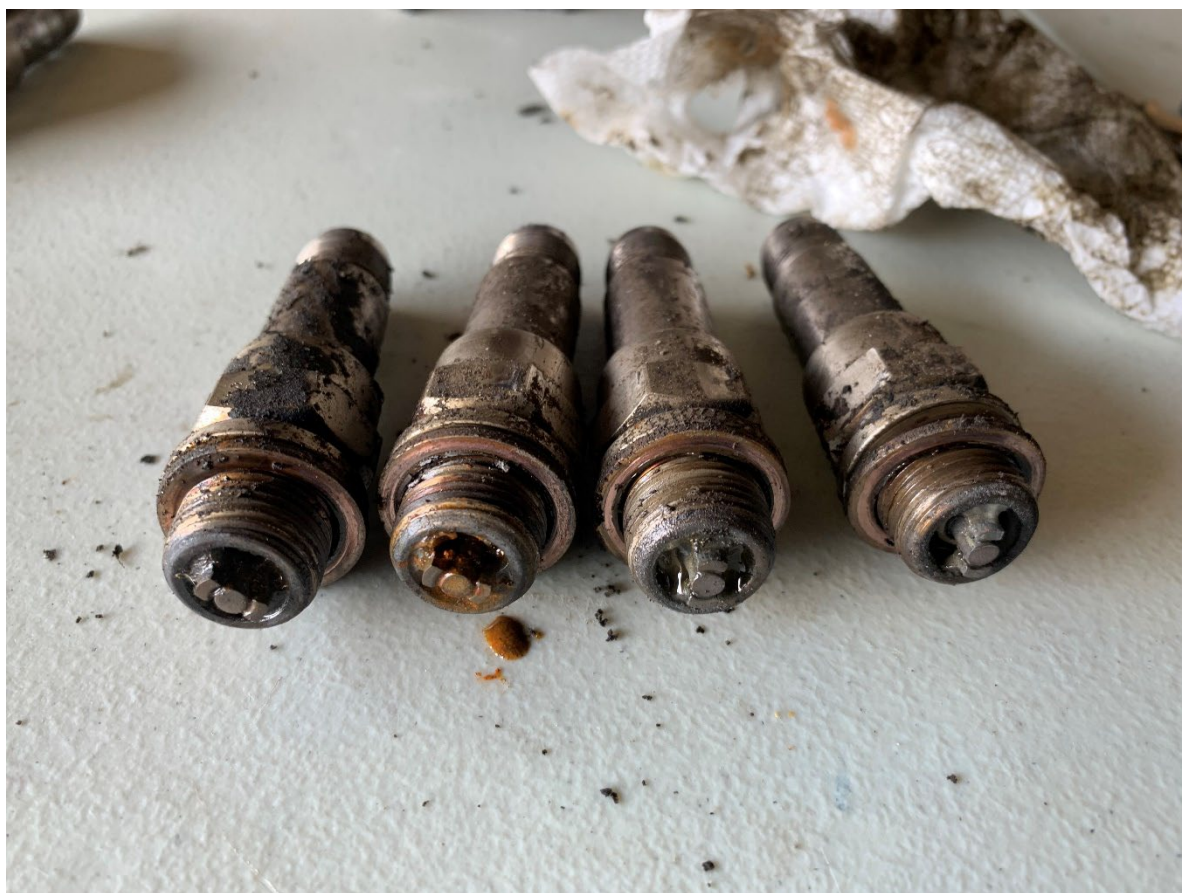
The top spark plugs were removed. The engine had been stored inverted and the top plugs were wet with oil, debris and water but otherwise appeared normal.

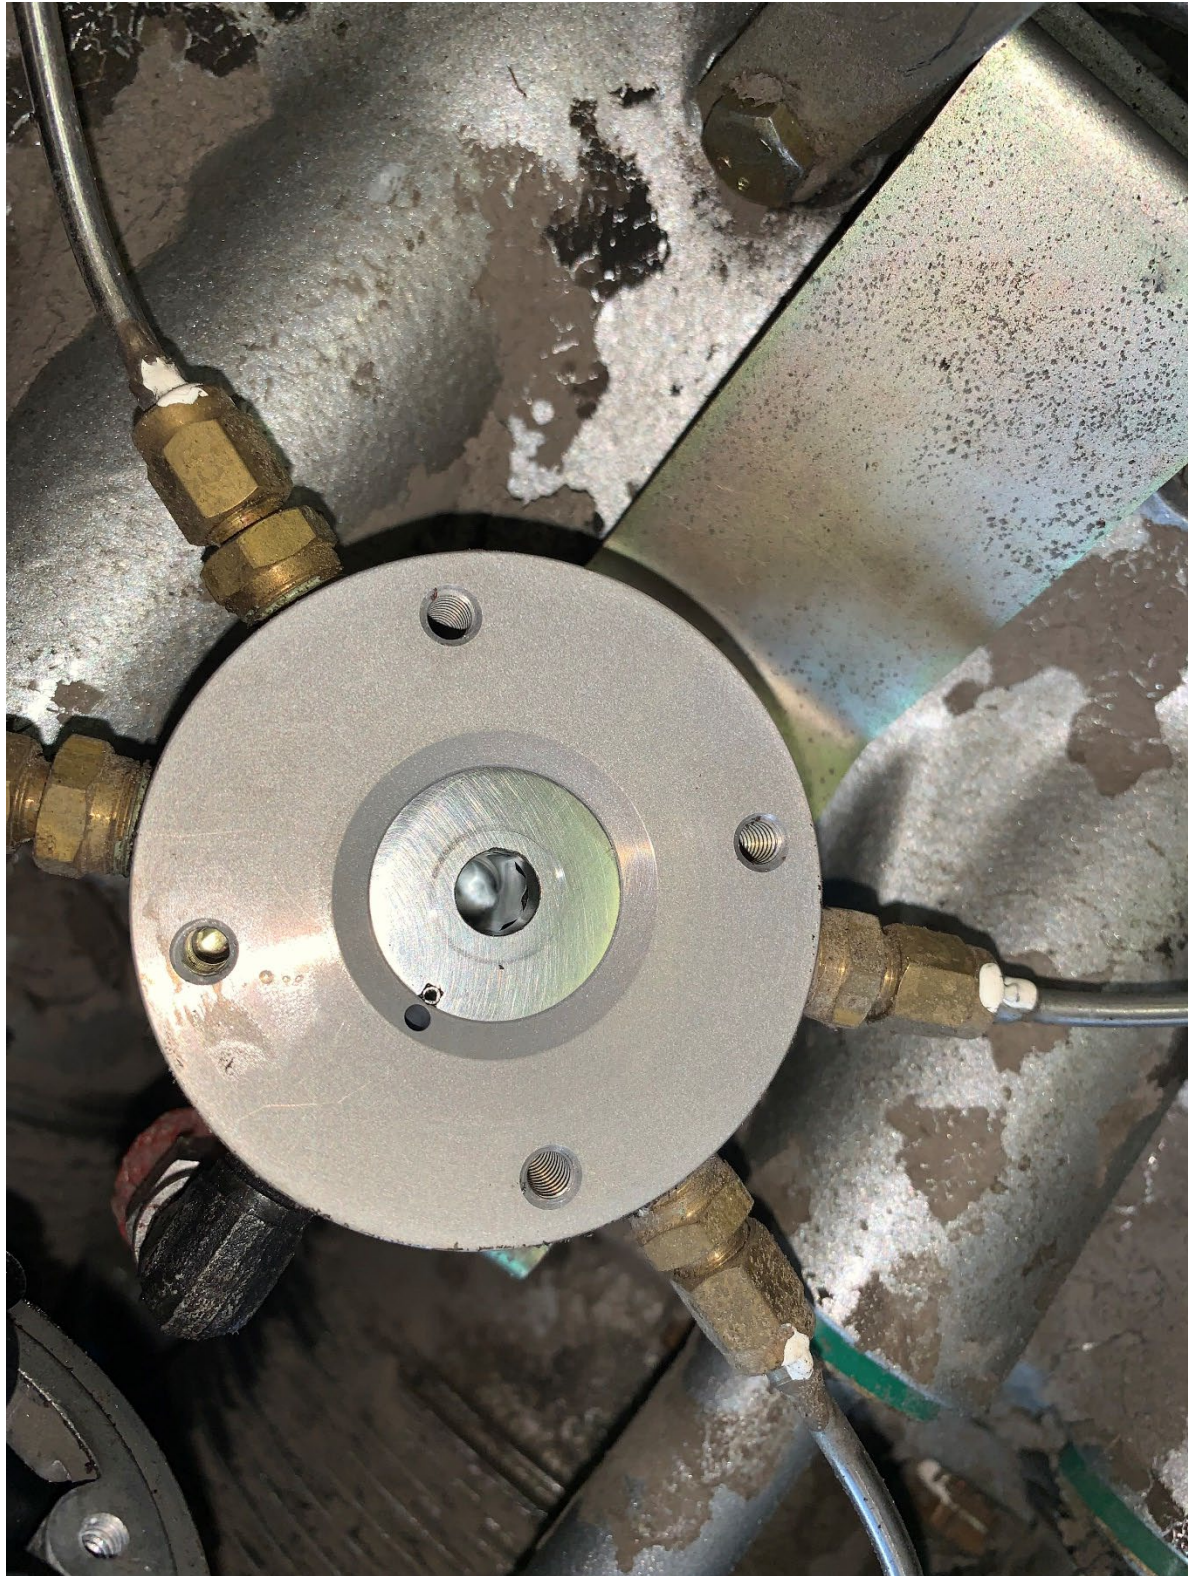
With the top plugs removed, the engine was free to rotate and no anomalies were detected during multiple rotations. A “thumb” compression verified suction and compression on all cylinders. The engine was equipped with one Slick magneto and one Emag electronic ignition. During engine rotation, spark was confirmed on all spark plug leads from the Slick magneto. The EMag ignition was removed for further examination. The cap of the fuel distribution block on the top of the engine was removed and the diaphragm appeared normal. There was a fuel present at the distribution block and it appeared clean with no anomalies noted.

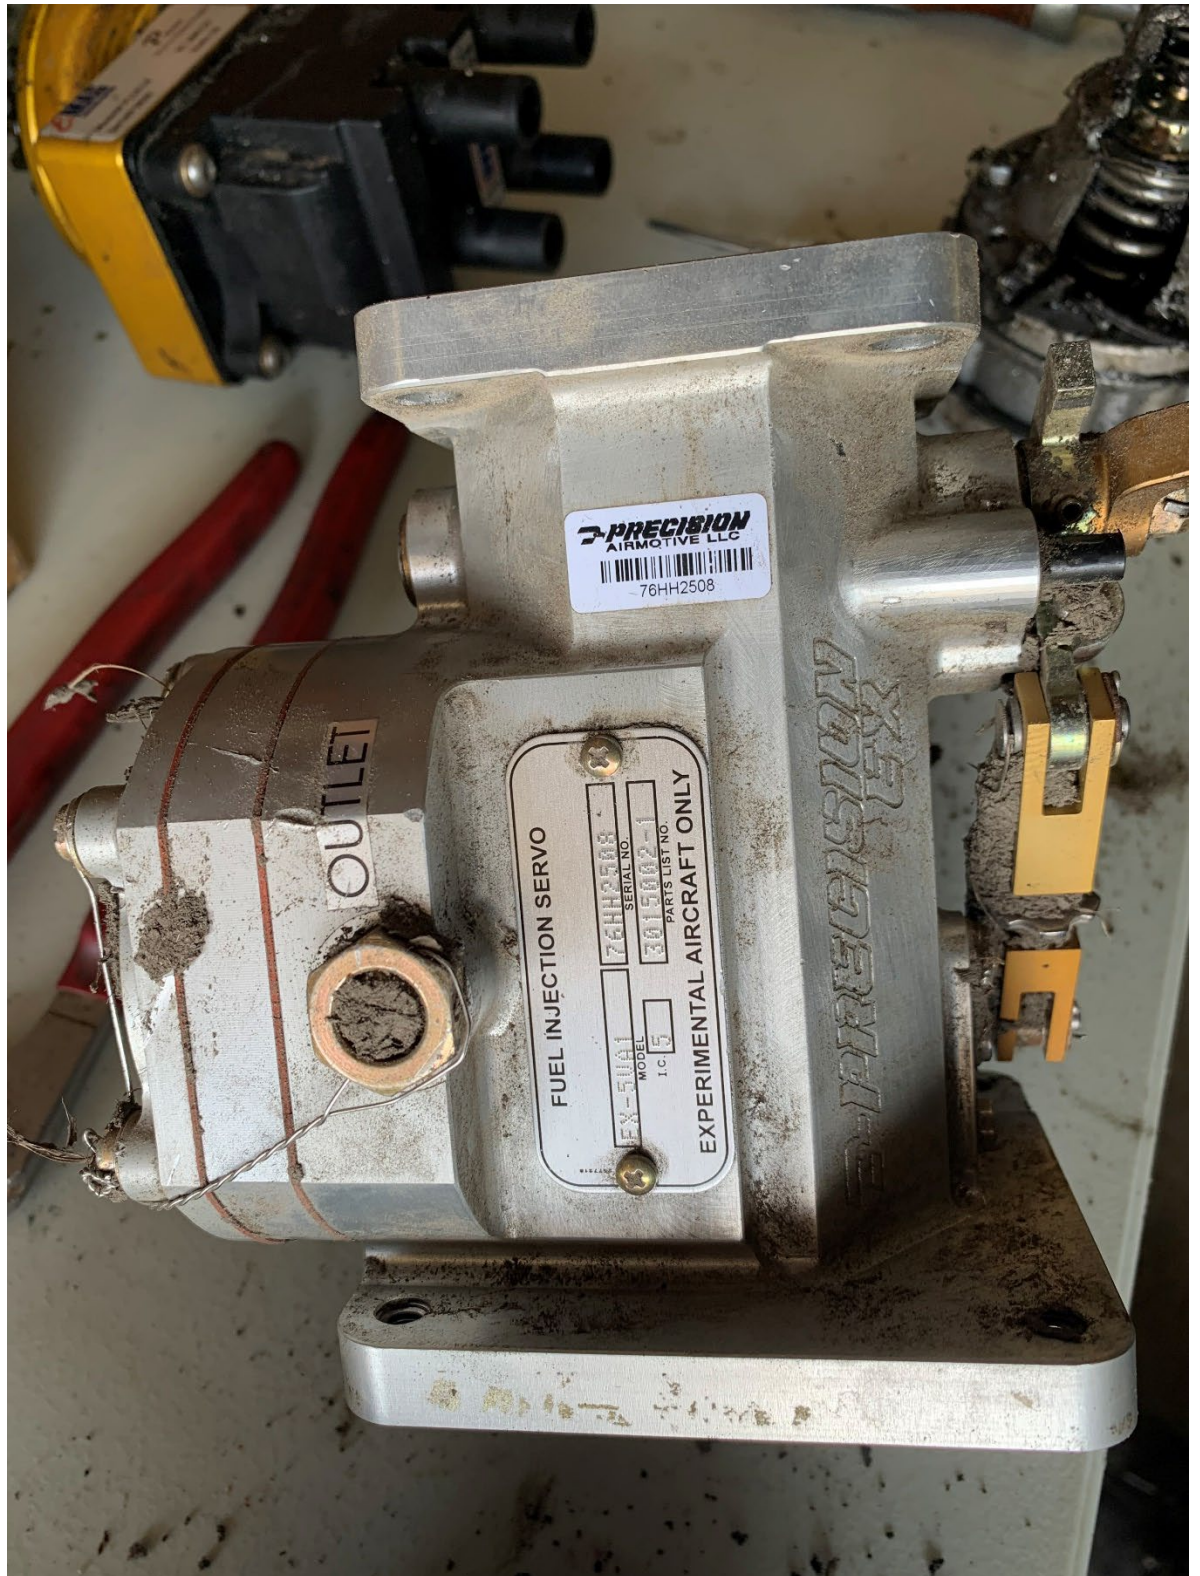
The fuel injection servo was removed from the engine and retained for further examination.

The fuel pump was impact damaged and a functional test was not possible. The fuel pump was removed and disassembled. No preimpact anomalies were noted during examination of the fuel pump components.

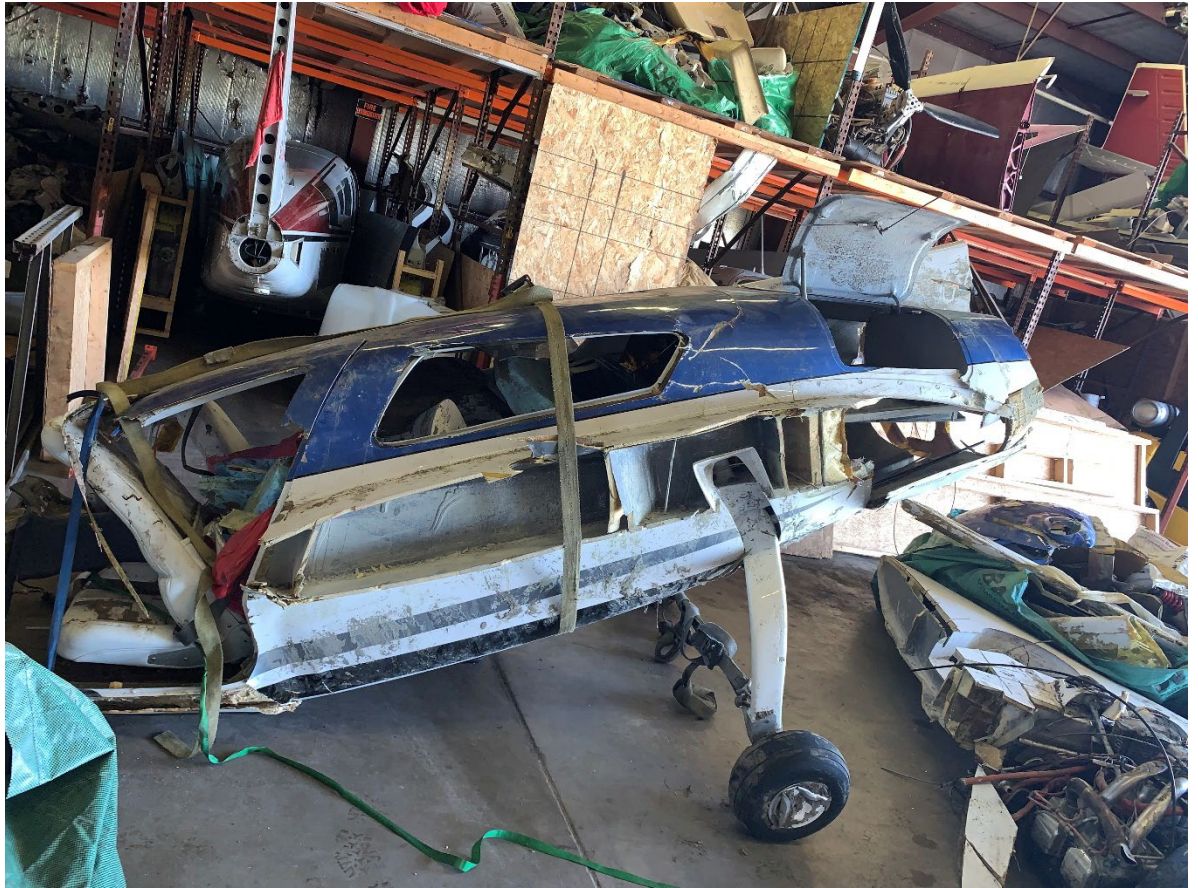
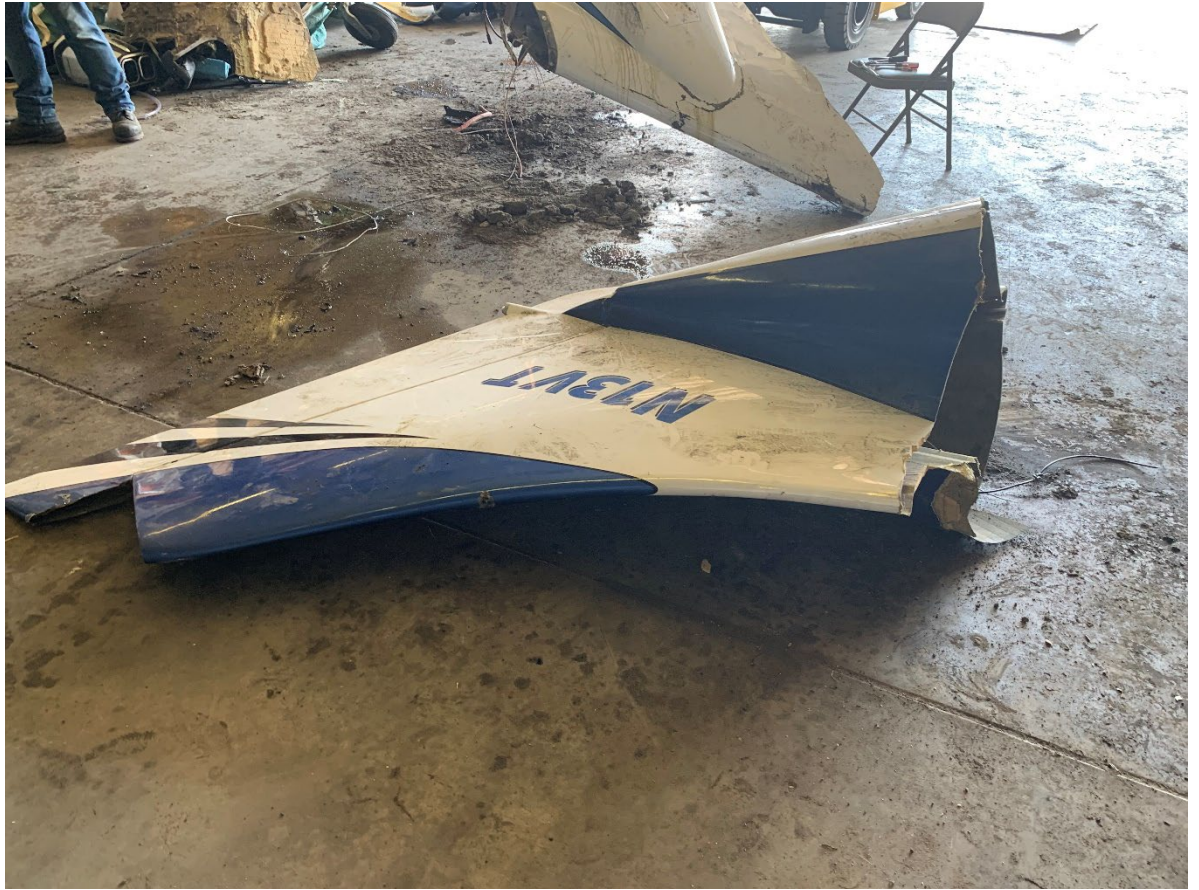
The airframe had been cut in several places to facilitate removal from the accident scene. The fuselage was predominately intact from the forward seats to the wing spar carry thru. The aft fuselage and vertical tail had been cut from the rest of the fuselage.

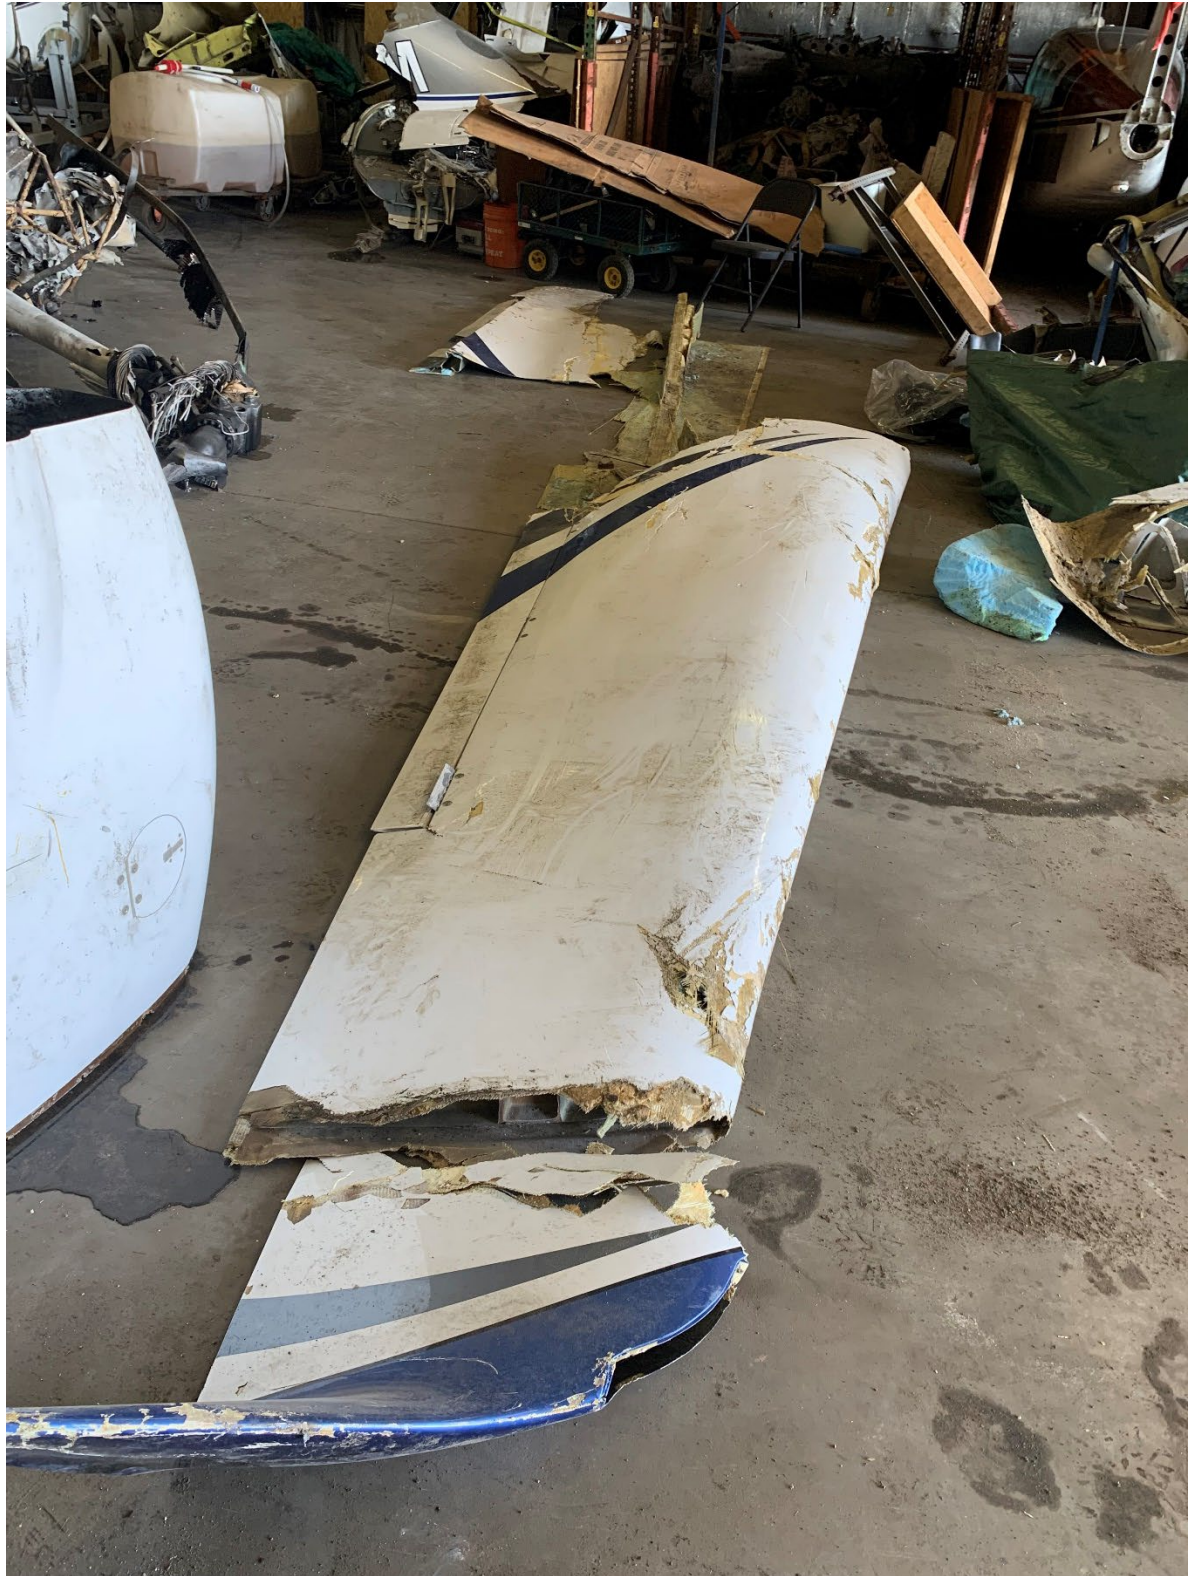
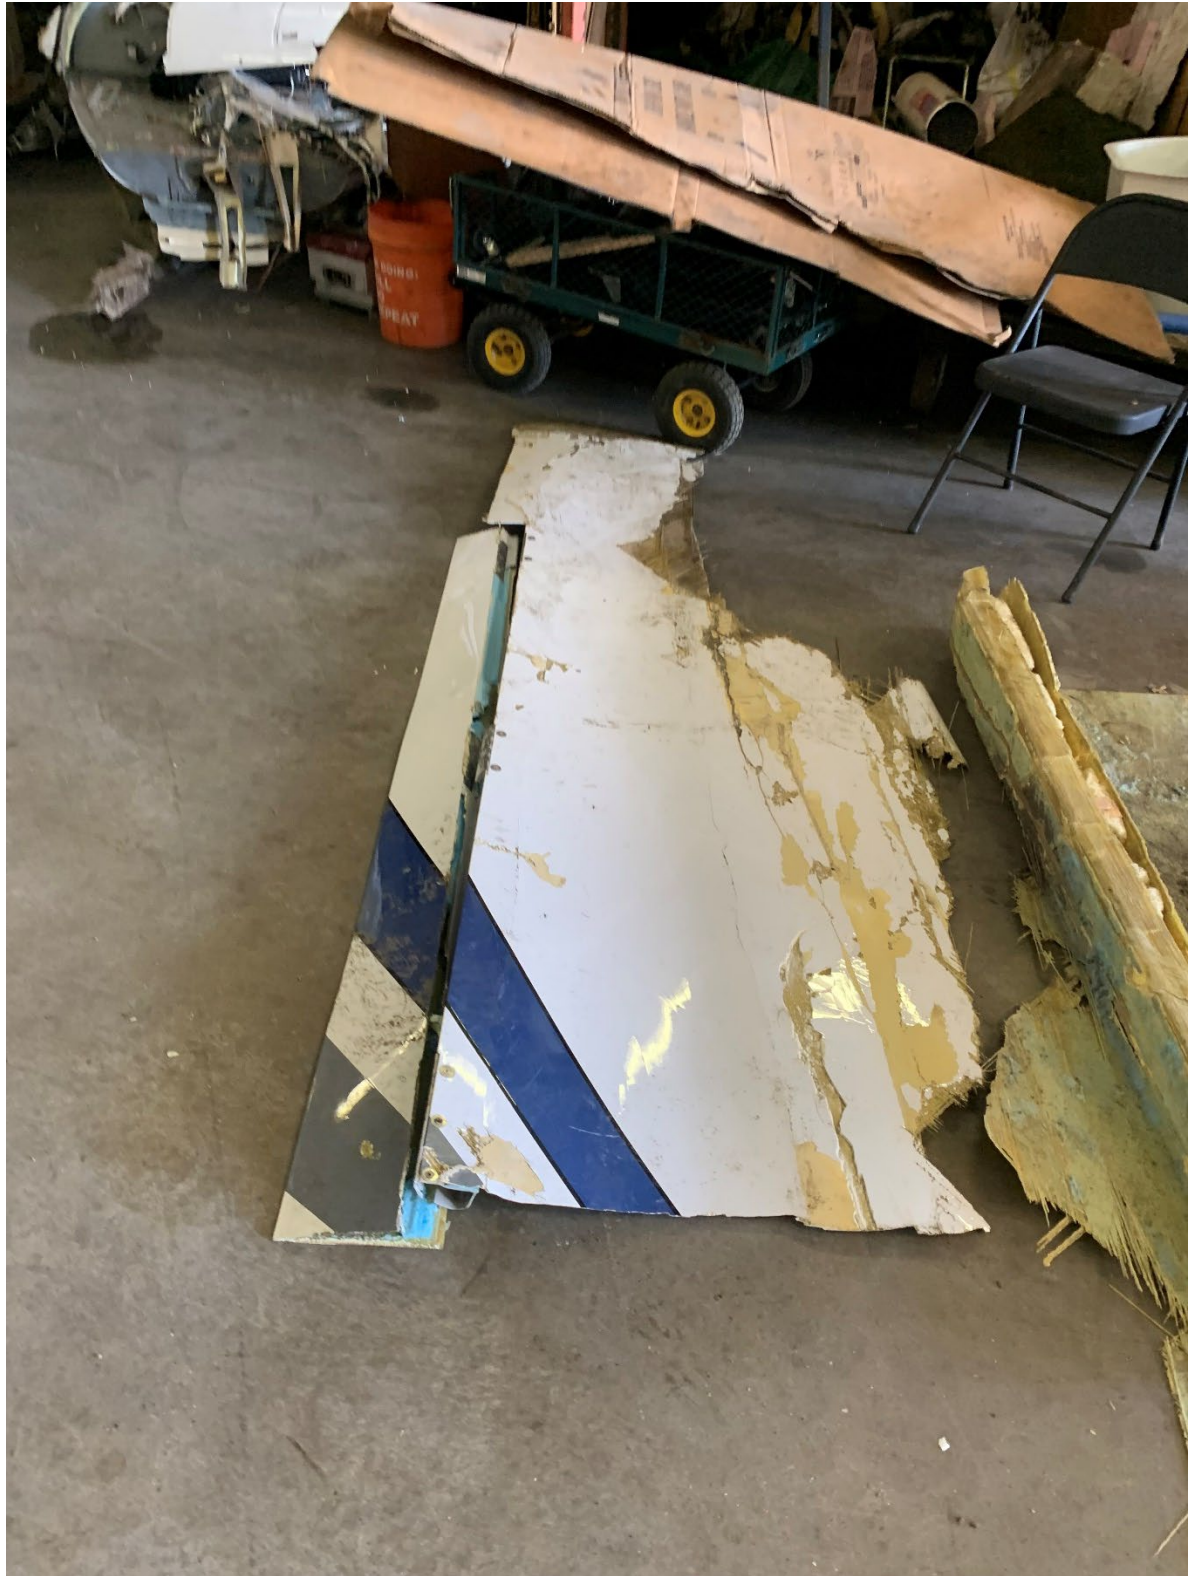
The airplane's wing had been cut from the fuselage at the juncture with the fuselage. Portions of both wings were identified within the wreckage debris.

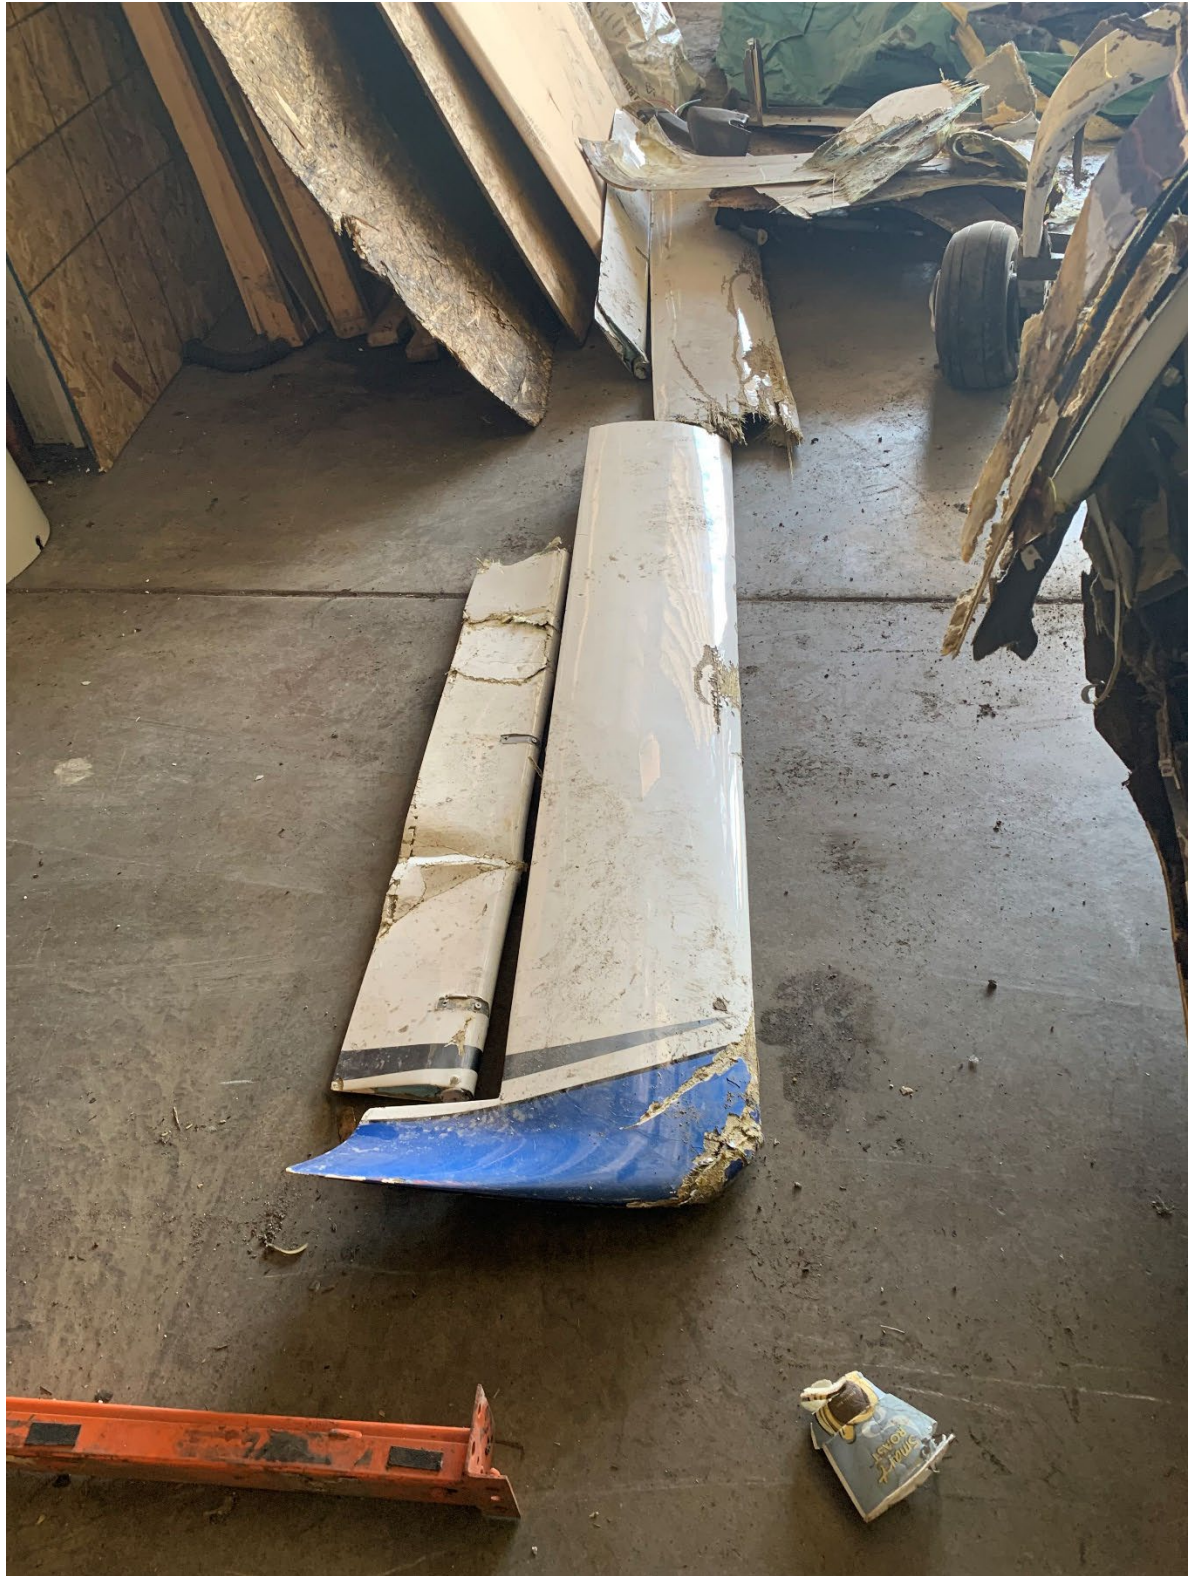
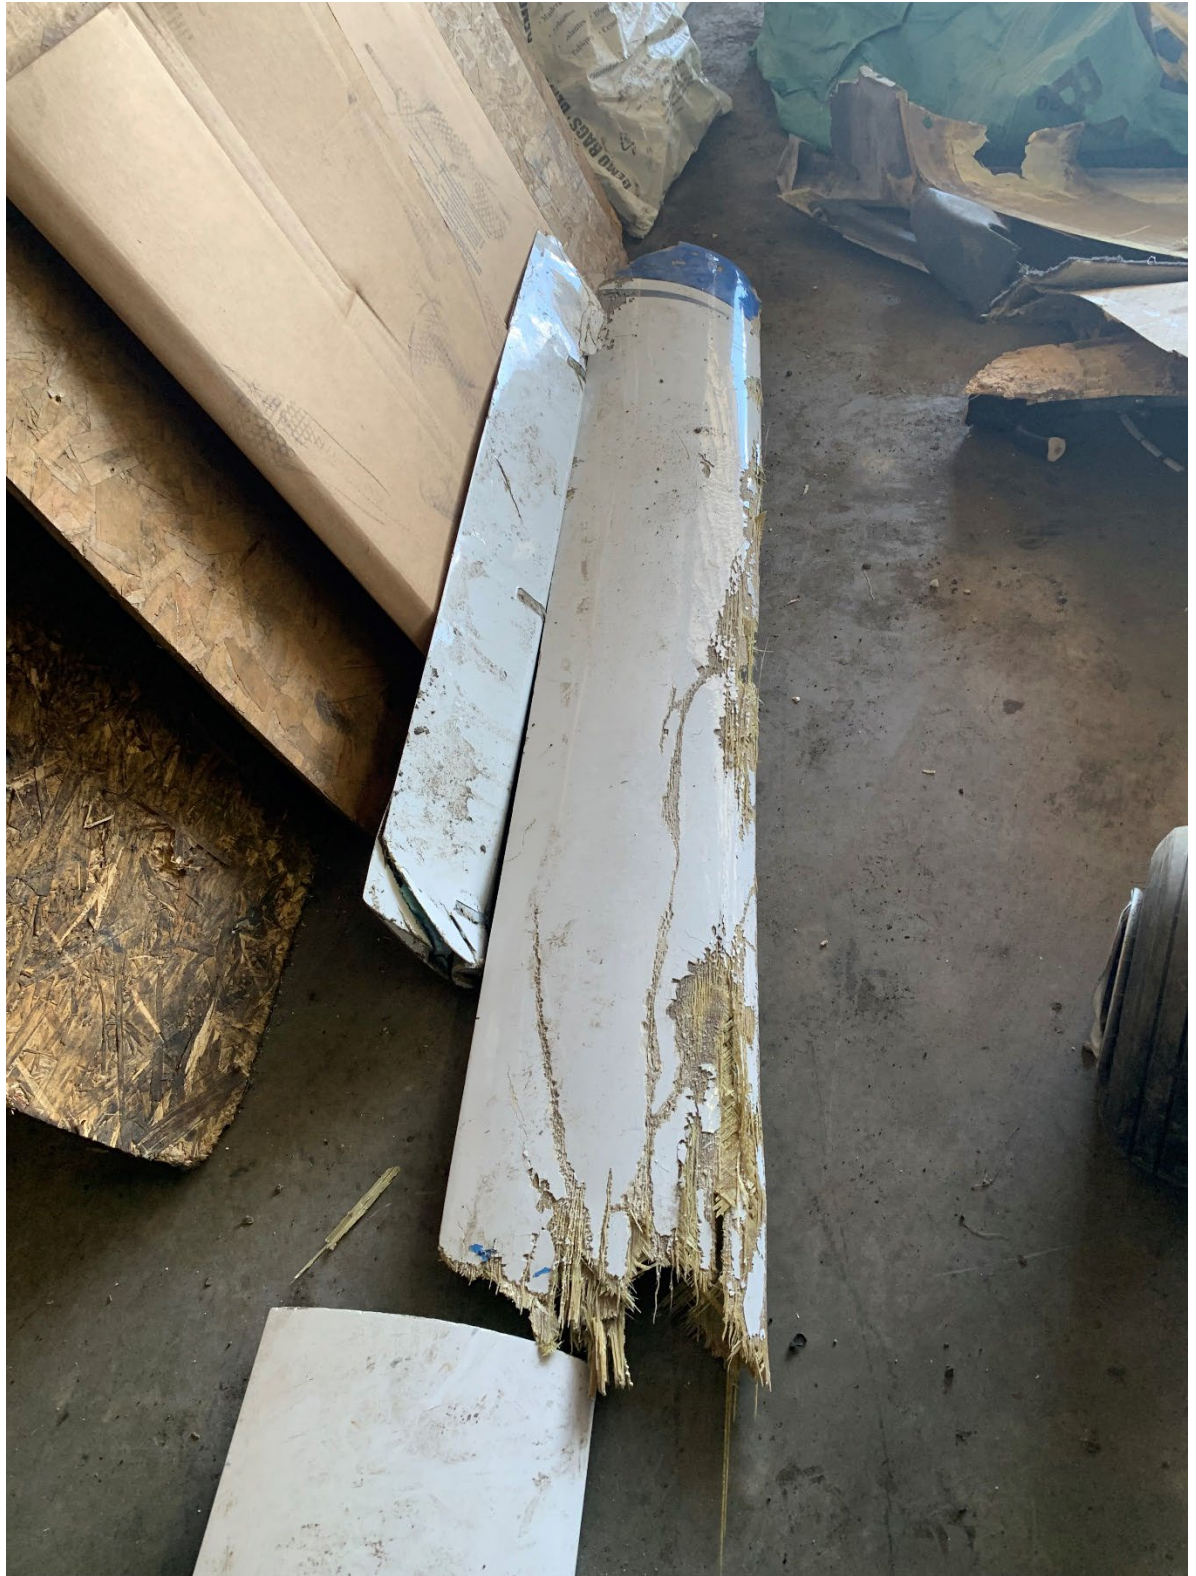
The airplane's canard surface had been cut on either side of the fuselage. Remains of the canard elevator were found within the debris.
