# National Transportation Safety Board

CEN21FA195

## FIELD EXAMINATION REPORT

CEN21FA195  
Tatum, TX  
April 19, 2021  
1346 CDT

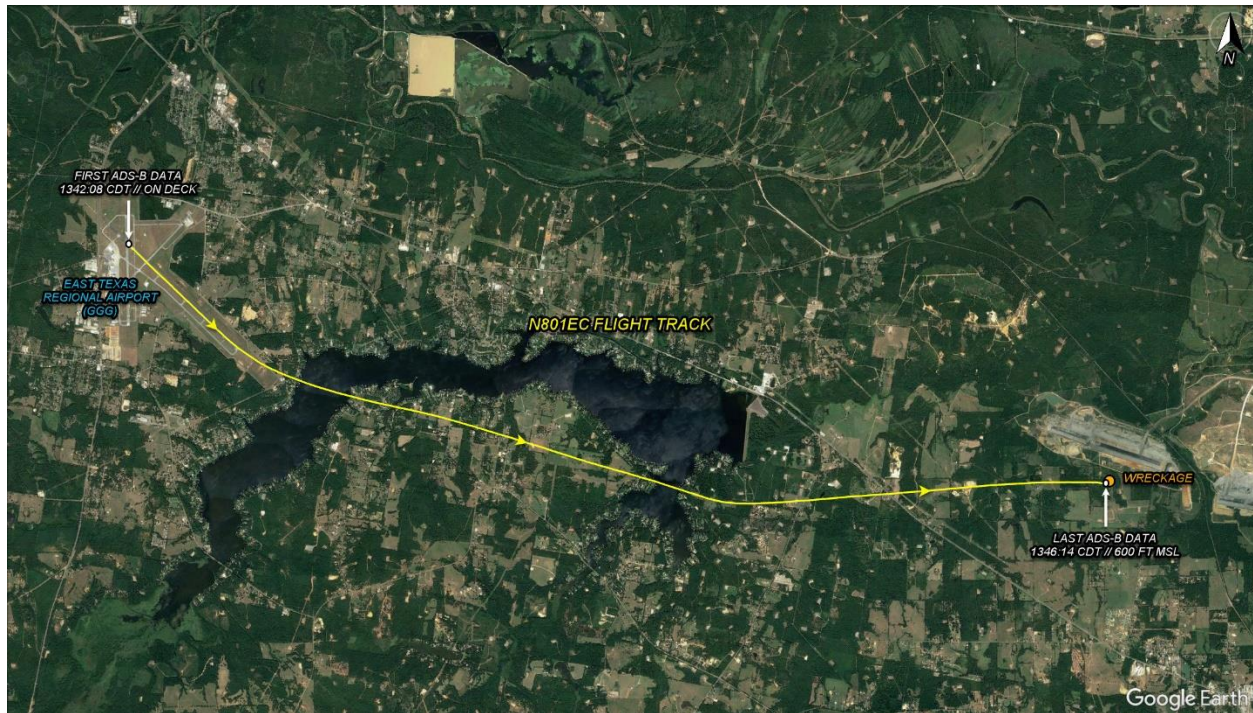
Figure 1. Flight Path (ADS-B Data)

Automatic Dependent Surveillance – Broadcast (ADS-B) data showed that the airplane took off from runway 13 at GGG about 1340. After takeoff, ADS-B data showed the airplane in a steady climb to the east of GGG. The airplane climbed to an altitude of 2,750 ft mean sea level (msl) and then descended to 2,675 ft msl. The last recorded data point was at 1346. The airplane was at 2,675 ft heading east with a ground speed of 152 kts. The airplane impacted wooded terrain about 3/4 mile east

of the last recorded data point. Groundspeeds and headings were consistent throughout the climb, with no abrupt deviations. See Figures 1, 2, and 3.
