## **NATIONAL TRANSPORTATION SAFETY BOARD**

### **Specialist's Report**

# **METEOROLOGY**

CEN21FA209

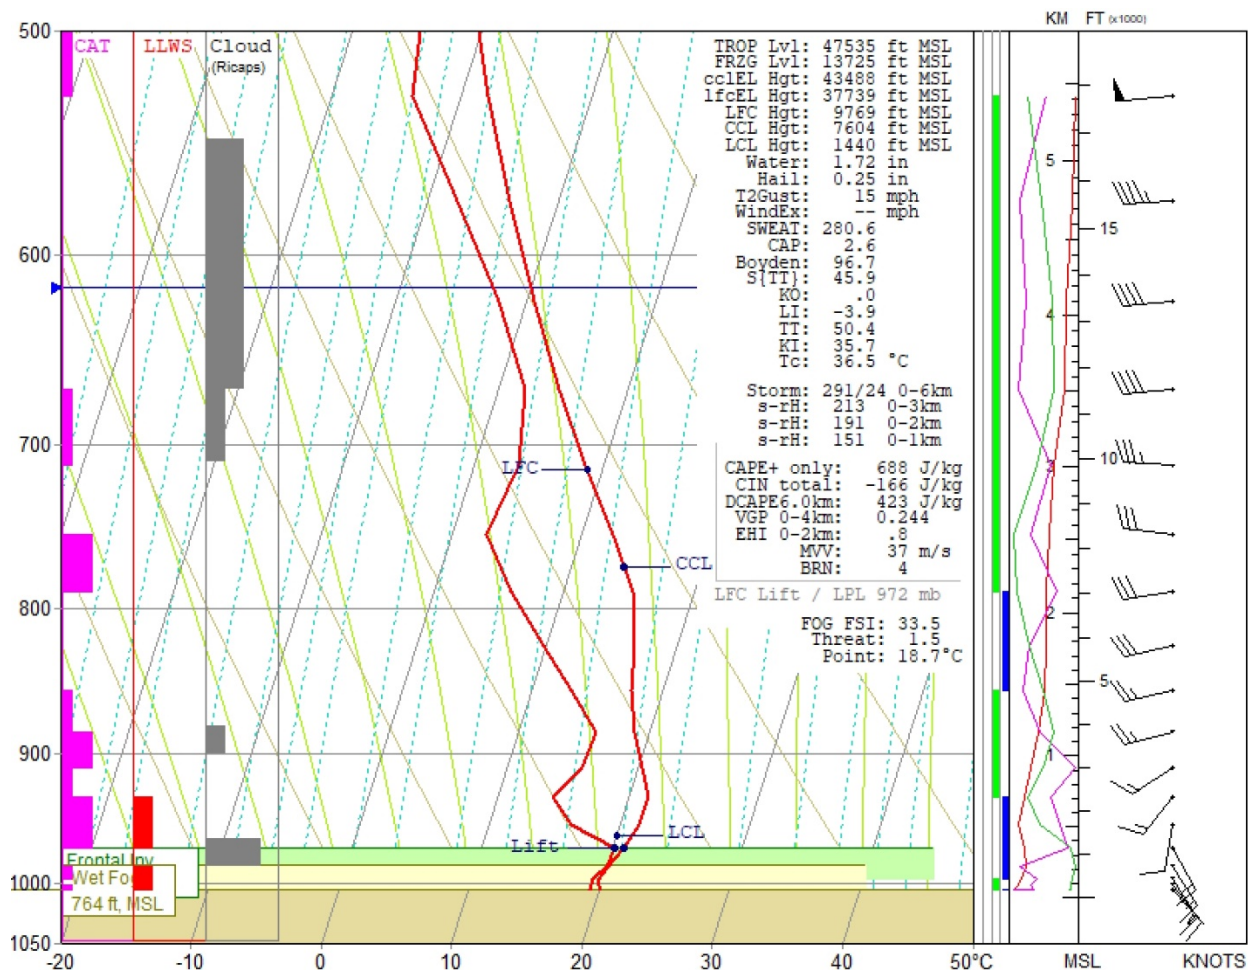
A High-Resolution Rapid Refresh (HRRR) model<sup>3</sup> sounding (figure 1) for the accident site at 2300 CDT using an elevation of 50 meters was retrieved from the National Oceanic and Atmospheric Administration's Air Resources Laboratory. The model sounding identified cloudy conditions between about 700 feet and 1,400 feet. From the surface to about 1,000 feet the wind was from the southeast at magnitudes not exceeding about 15 knots. Above 1,000 feet the wind veered to a southwest wind at about 15 knots at 2,300 feet. The RAOB identified "light" low level wind shear in a layer between near the surface and 720 feet and in a layer between about 1,100 and 2,300 feet. Light and moderate clear air turbulence was identified by RAOB below 4,000 feet.

**Figure 1** – HRRR model sounding data in SkewT/LogP format for 2300 CDT at the accident site, surface to 500 hectopascals.

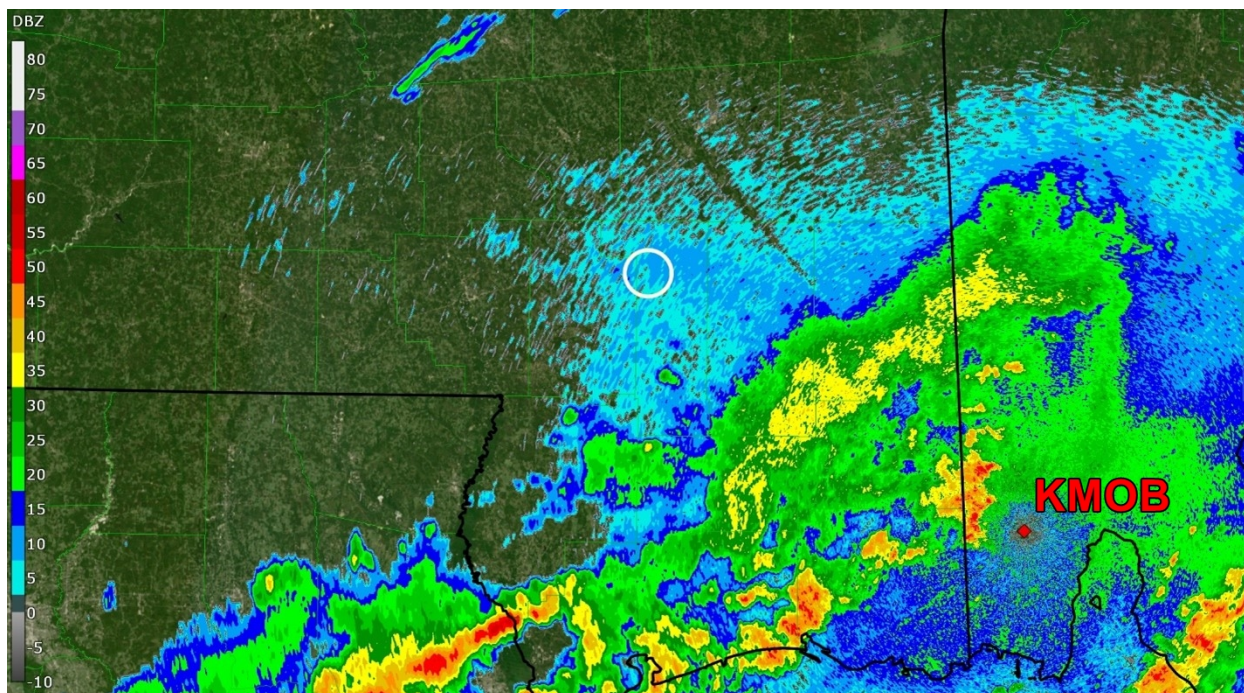
The WSR-88D<sup>4</sup> Level-II weather radar imagery from the KMOB site is presented in figure 2. KMOB was located approximately 66 miles southeast of the accident location at an elevation of about 290 feet. Assuming standard refraction and considering the 0.95° beam width<sup>5</sup> for the WSR-88D radar beam, the KMOB 0.437° tilt would have “seen” altitudes above the accident location of between about 2,900 and 9,600 feet.

**Figure 2** – KMOB 0.48° Level-II reflectivity product from a sweep initiated at 2302:57 CDT. Accident location marked by the white circle.

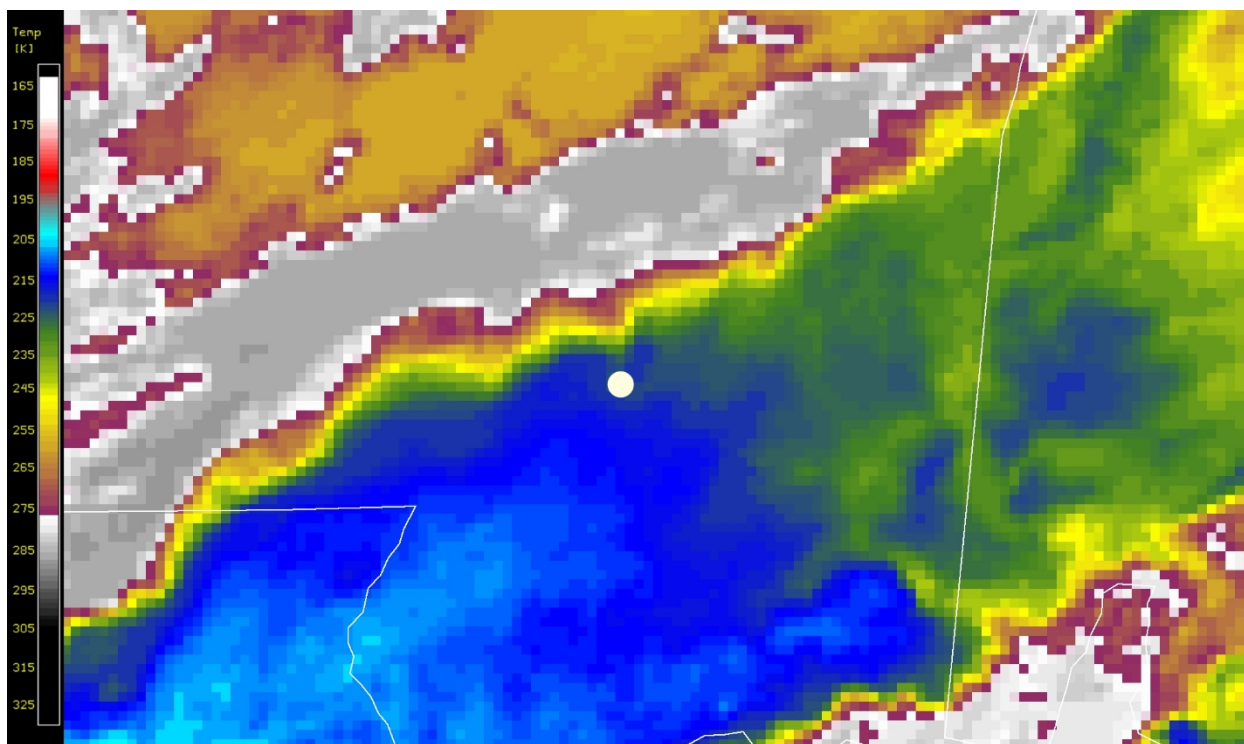
Geostationary Operational Environmental Satellite (GOES)-16 infrared (10.3μm) data were obtained from an archive at the Space Science Engineering Center at the University of Wisconsin-Madison. An image from 2301 CDT is presented in figure 3. The GOES-16 infrared brightness temperatures over the accident location were -52°C, which corresponded to a height of about 38,000 feet in the HRRR model sounding (not depicted in figure 1).

**Figure 3** – GOES-16 infrared brightness temperature imagery from 2301 CDT. Accident location is denoted by the white circle. This image has not been corrected for any parallax error.
