# National Transportation Safety Board

CEN21FA209

Aircraft Performance Study

Location: Hattiesburg, Mississippi  
Date: May 4, 2021  
Time: 23:05 Central daylight time (CDT)  
04:05 UTC, May 5, 2021  
Airplane: Mitsubishi MU-2B, N322TA

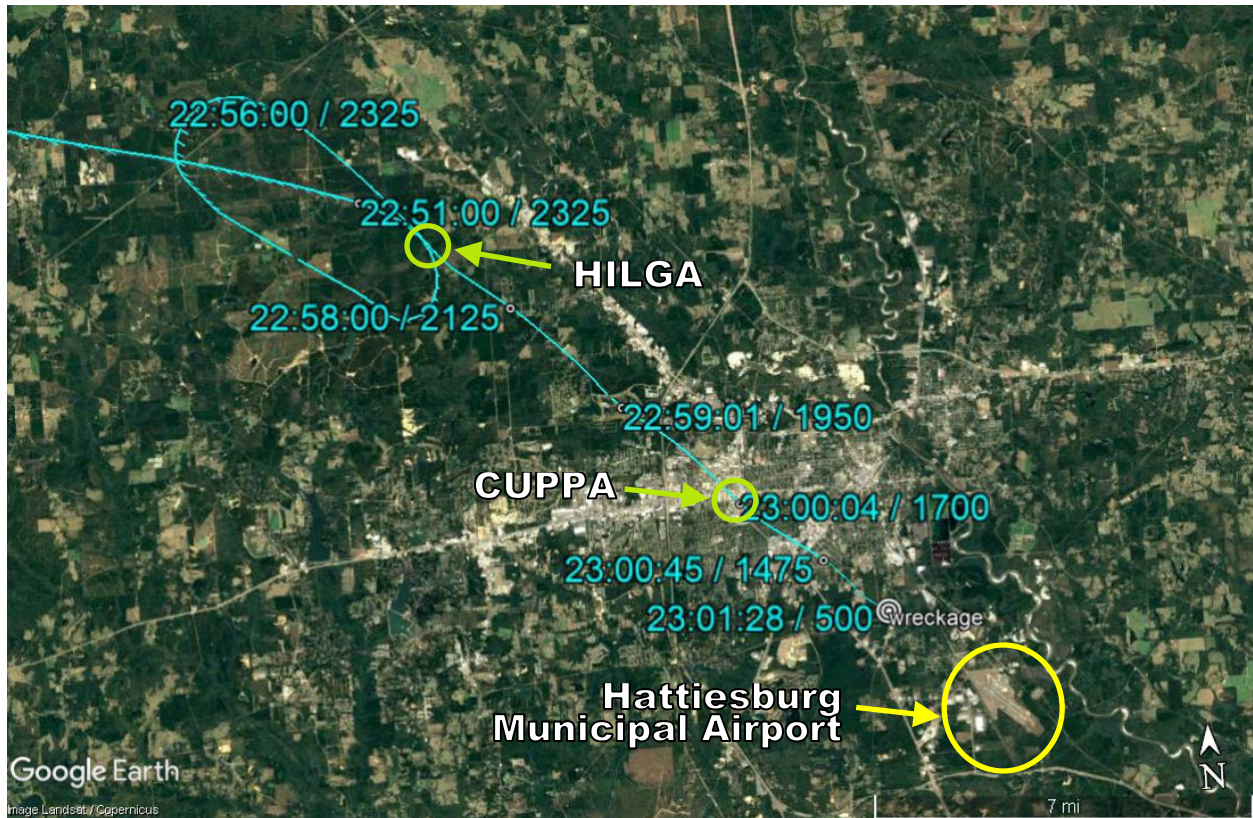
There is no control tower at KHBG, so at 22:49 the pilot asked ZHU27 for clearance for the approach. ZHU27 cleared the pilot for the approach and directed him to maintain 2,400 ft. At about 22:51 the airplane began a procedure turn consistent with the RNAV approach to runway 13 (Figure 3). By 22:58 the airplane track was aligned with the runway approach heading. ADS-B data ended at 23:01:28, 732 ft before the airplane's point of impact.

**Figure 3.** Approach flight path and impact location, selected times and altitudes (msl) annotated in blue. Waypoints HILGA and CUPPA and the airport are also indicated; see the approach chart in the Appendix.

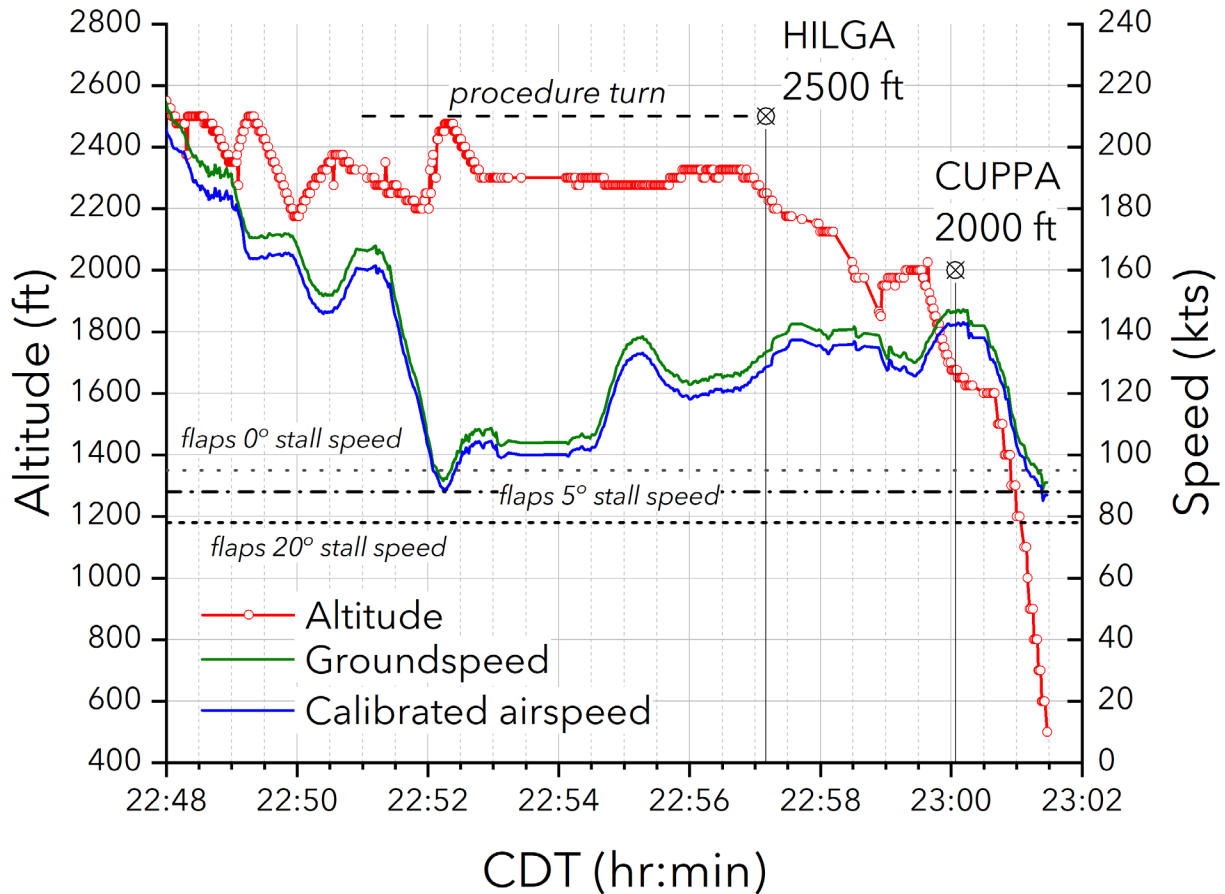
As the airplane entered the procedure turn, its altitude was about 2,300 ft and descending and the airspeed was 160 kts (Figure 4). The altitude for the procedure turn and for HILGA is listed as 2,500 ft but earlier instructions from ATC were to maintain 2,400 ft. At 22:52:12 the airplane had slowed to 88 kts of airspeed at 2,450 ft. At flaps 5°<sup>1</sup> 9,500 lbs gross weight, the airplane's wings-level power-idle stall speed would have been about 88 kts calibrated airspeed. Engine power would lower the speed at which stall occurs. For flaps 20°, the power-idle stall speed would have been 78 kts. For flaps up, the power-idle stall speed would have been 95 kts.

The airplane reached 100 kts of airspeed while descending from 2,500 ft to 2,300 ft, then accelerated to 130 kts, and slowed again to 120 kts, before more gradually regaining 140 kts while descending after leaving the procedure turn (Figure 4).

**Figure 4.** End of flight altitude (msl) and calculated groundspeed and calibrated airspeed.

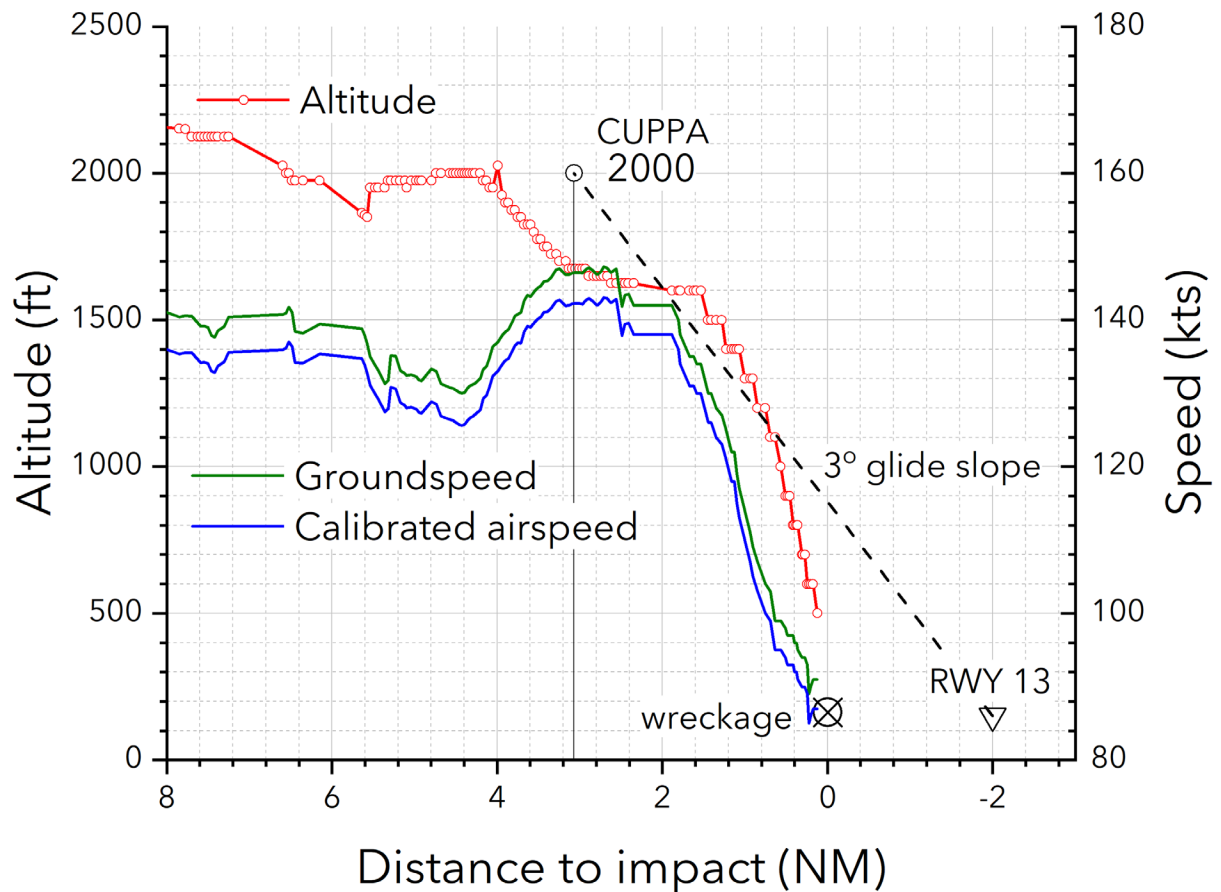
After completing the procedure turn, the airplane passed CUPPA about 300 ft low and descending (Figure 5). The airplane leveled out for about 30 seconds and by 23:00:40 was then above the recommended 3° glide path to runway 13.

The airplane then entered a descent of about 1,300 fpm and passed below glide path. The airplane continued to decelerate, reaching a calculated calibrated airspeed of 85 kts at 23:01:24, seven knots above the flaps 20° power-idle stall speed, but below the other stall speed values. Examination of the wreckage found the flaps at 20°. The final data position at 23:01:28 was 300 ft above terrain and 750 ft from the wreckage location.

**Figure 5.** End of flight with wreckage location, the threshold to runway 13, CUPPA waypoint, and approximate 3° glide slope marked.

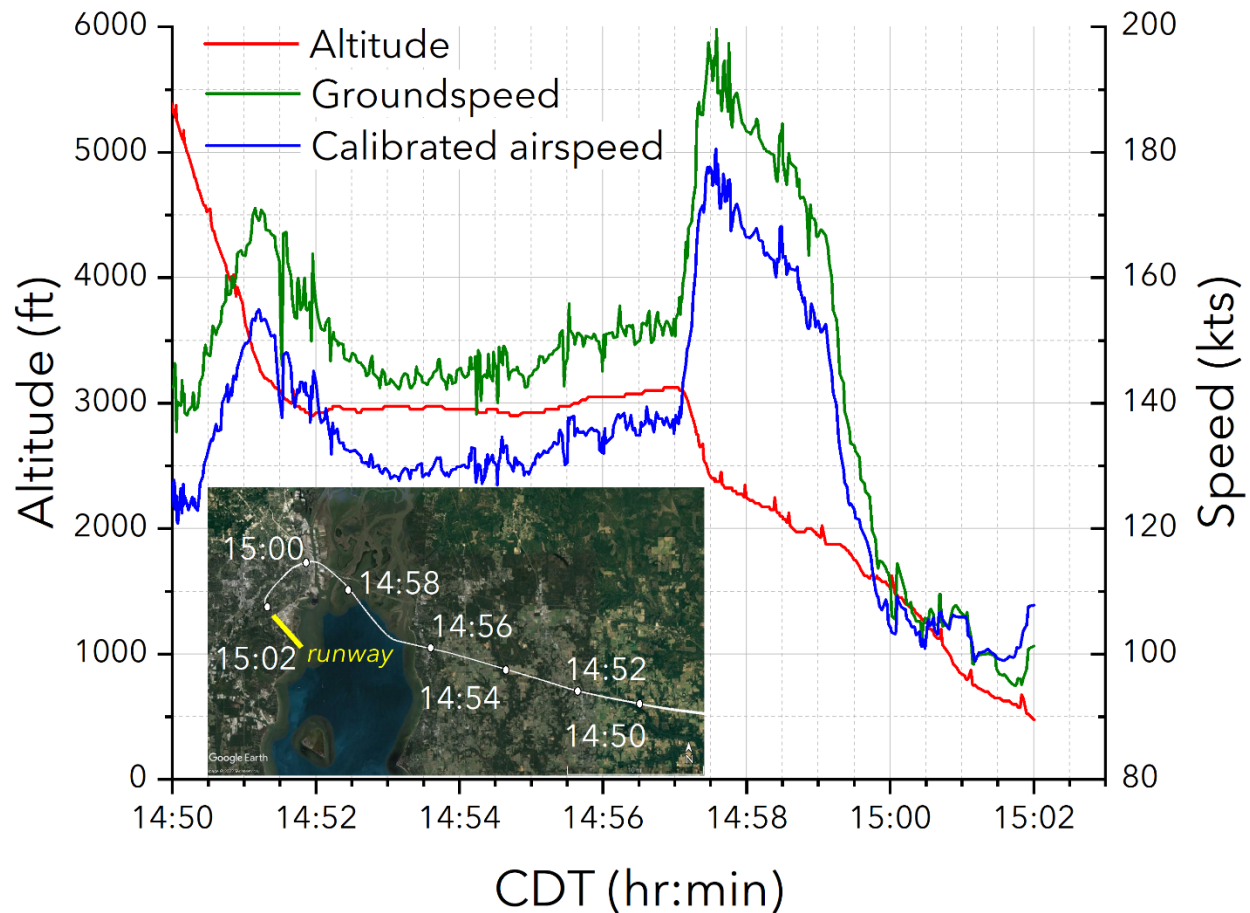
ADS-B data from the three flights prior to the accident were obtained for comparison purposes. On April 29, 2021, the airplane flew from Destin, Florida to Mobile, Alabama. Figure 6 shows the airplane's approach into Mobile. Winds were 9 kts from 140°, visibility was 10 statute miles and skies were clear. Between 14:57 and 15:00 the airplane rapidly accelerated from 140 kts airspeed to 180 kts, then decelerated to 110 kts. For a flaps 20° landing, the airplane's approach calibrated airspeed should be between 99 kts (light) and 110 kts (heavy). The airplane's final calculated airspeed was 107 kts, approximately 1.25 NM from the threshold of runway 14. The airplane was within 50 ft of the 3° glidepath when on the runway heading.

**Figure 6.** April 29, 2021 flight into Mobile, Alabama. Recorded altitude and calculated groundspeed and calibrated airspeed are shown versus local time. The inset shows the flight path to runway 14.

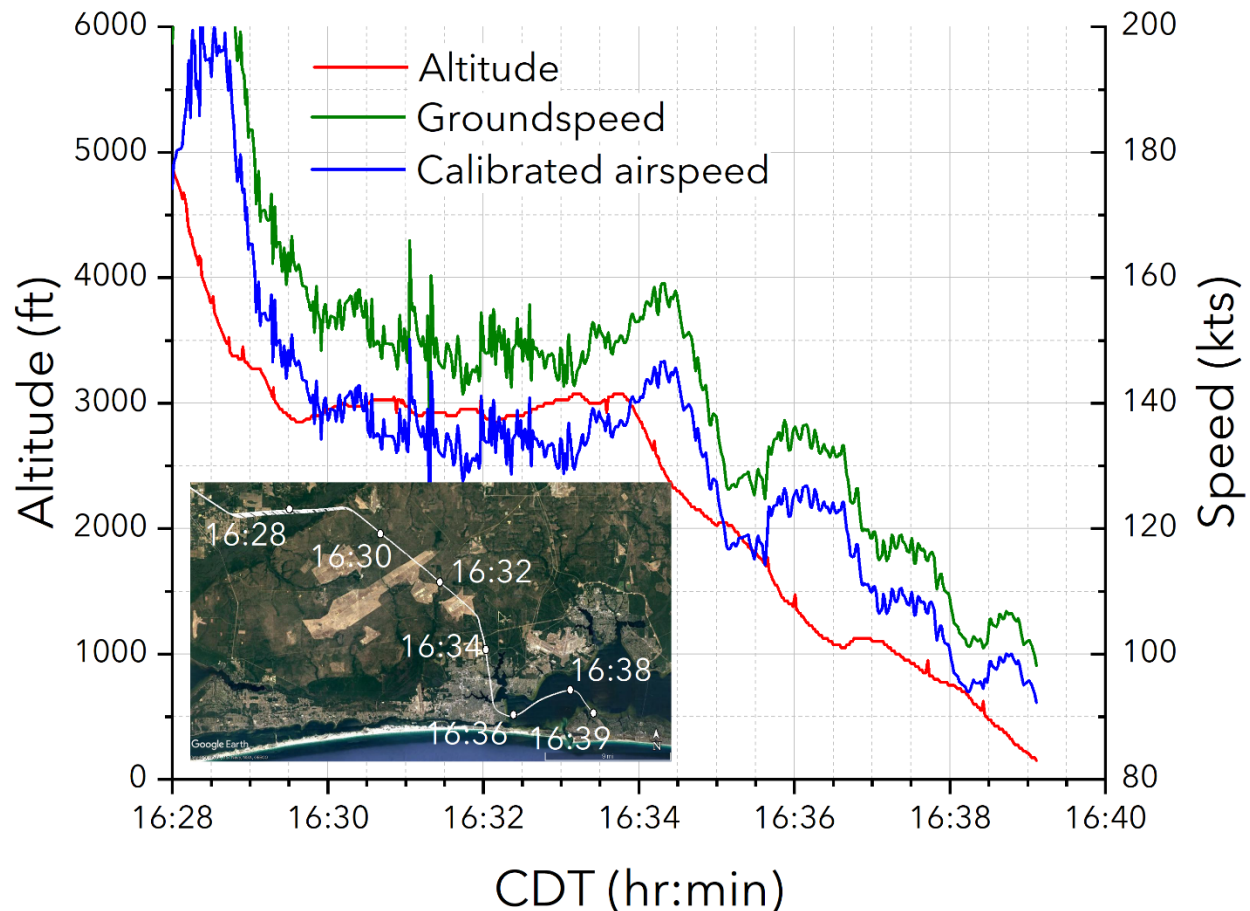
On May 1, 2021, the airplane left Mobile to return to Destin. Figure 7 shows the airplane's approach into Destin. Winds were 3 kts from 290°, skies were clear, but haze was reported. The airplane's final calculated airspeed, 1.22 NM from the threshold to runway 14, was 92 kts, slower than the recommended approach speeds for flaps 20°. The airplane was within 50 ft of the 3° glidepath when on the runway heading.

**Figure 7.** May 1, 2021 flight into Destin, Florida. Recorded altitude and calculated groundspeed and calibrated airspeed are shown versus local time. The inset shows the flight path to runway 14.

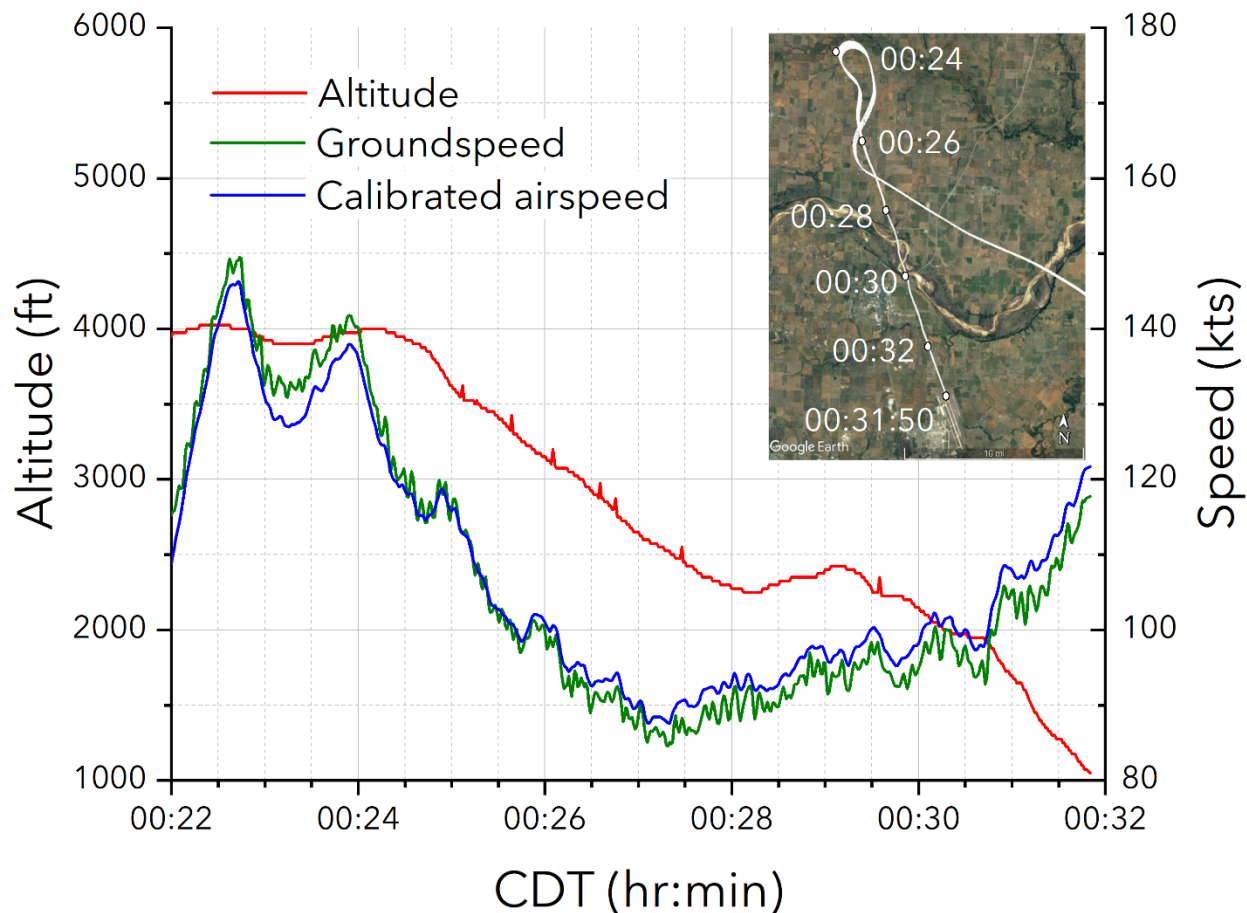
The third flight left Destin, Florida at 21:00 on May 2, 2021 and arrived in Wichita Falls, Texas at 00:32 on May 3. Both earlier flights (on April 29 and May 1) were during daylight hours and the pilot made turns onto final within 2-3 NM of the runway threshold. This flight was a night with no moon<sup>2</sup>. Winds were 9 kts from 140° and skies were clear. Figure 8 shows the approach into Wichita Falls. The airplane turned onto final at 00:24, about 18 NM from the runway threshold. It deviated slightly to the left before returning to the runway heading by 00:26. The airplane slowed from 140 kts to 90 kts before accelerating again. The final calculated calibrated airspeed, 1,200 ft from the threshold of the runway, was 120 kts. That speed was 10 kts faster than the highest approach speed recommended for flaps 20°.

**Figure 8.** May 1, 2021 flight into Wichita Falls, Texas. Recorded altitude and calculated groundspeed and calibrated airspeed are shown versus local time. The inset shows the flight path to runway 15 R.

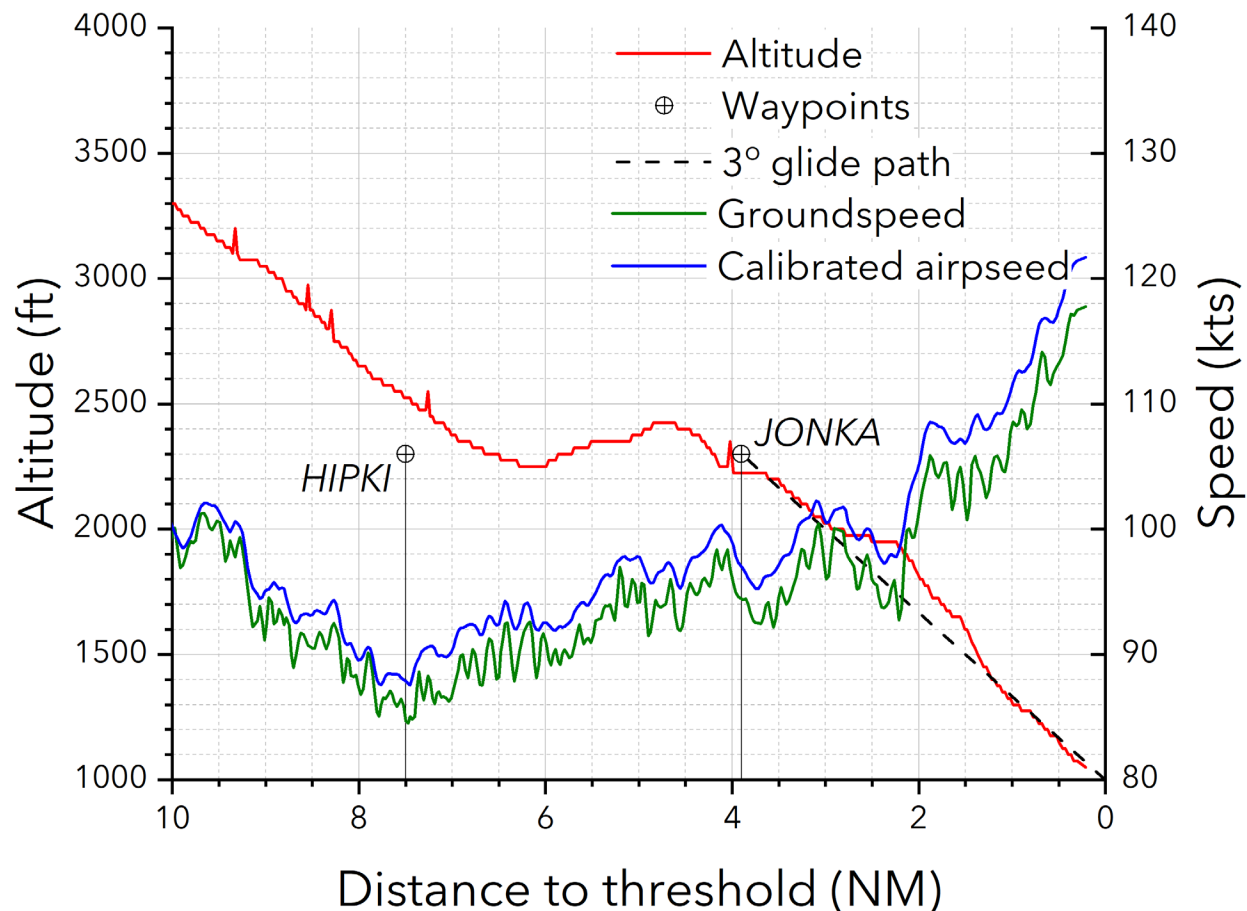
Additionally, Figure 9 shows the final approach into Wichita Falls for the final 10 NM. The altitude was slightly above and then below the altitude specified for two waypoints (see Appendix for the approach plate), and the airplane initially captured the glide path into runway 15C, stopped descending while continuing to accelerate until 200 ft above the glide path, and then recaptured the glide path again.

**Figure 9.** May 1, 2021 flight into Wichita Falls, Texas. Recorded altitude and calculated groundspeed and calibrated airspeed are shown versus distance to runway 15C threshold. The altitude and location of two waypoints and the 3° glide path are shown.
