# National Transportation Safety Board

CEN21FA209

## **SECURITY CAMERA RECORDING - STUDY**

Location: Hattiesburg, MS  
Date: May 4, 2021  
Time: 2305 central daylight time (CDT)  
Airplane: Mitsubishi MU2B; N322TA

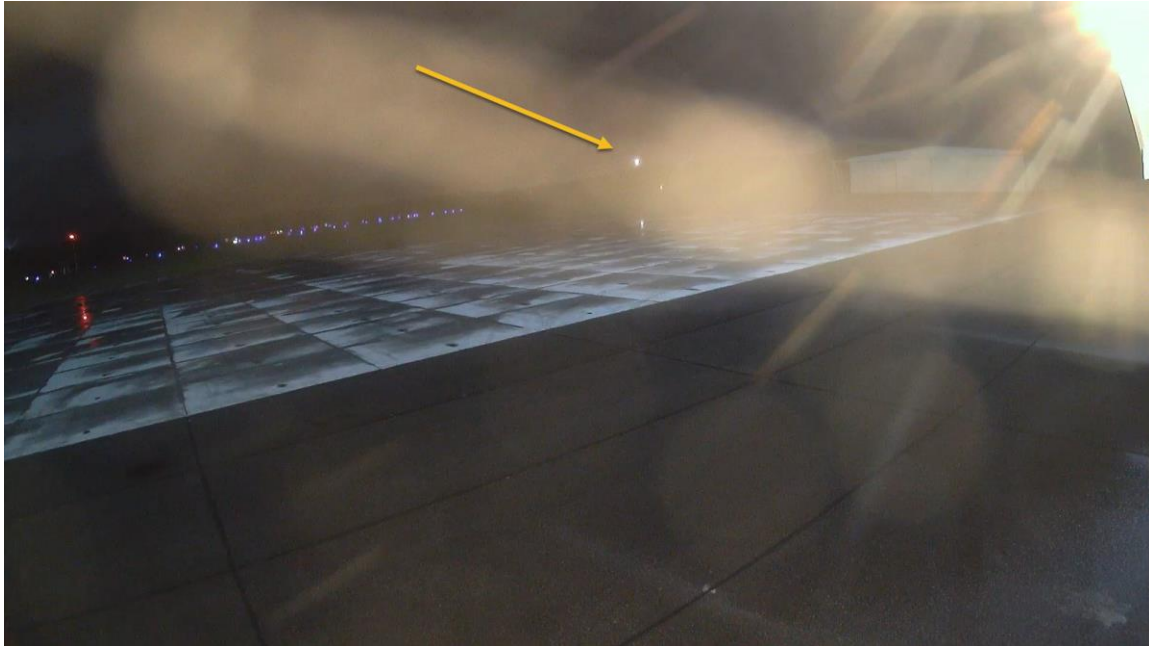
The accident recording was made at a resolution of 1916 x 1080 pixels at a frame rate of 23.98 frames per second (fps). The field of view is represented in figure 1 below, which is an exported frame from the provided video. The screen capture shows the accident aircraft represented as luminous pixels as annotated with the yellow arrow. The type of security camera system was not documented by the investigator-in-charge (IIC) or provided by the airport facility. No information was known about the system.

**Figure 1.** Image showing camera view at 21 seconds into the recording.

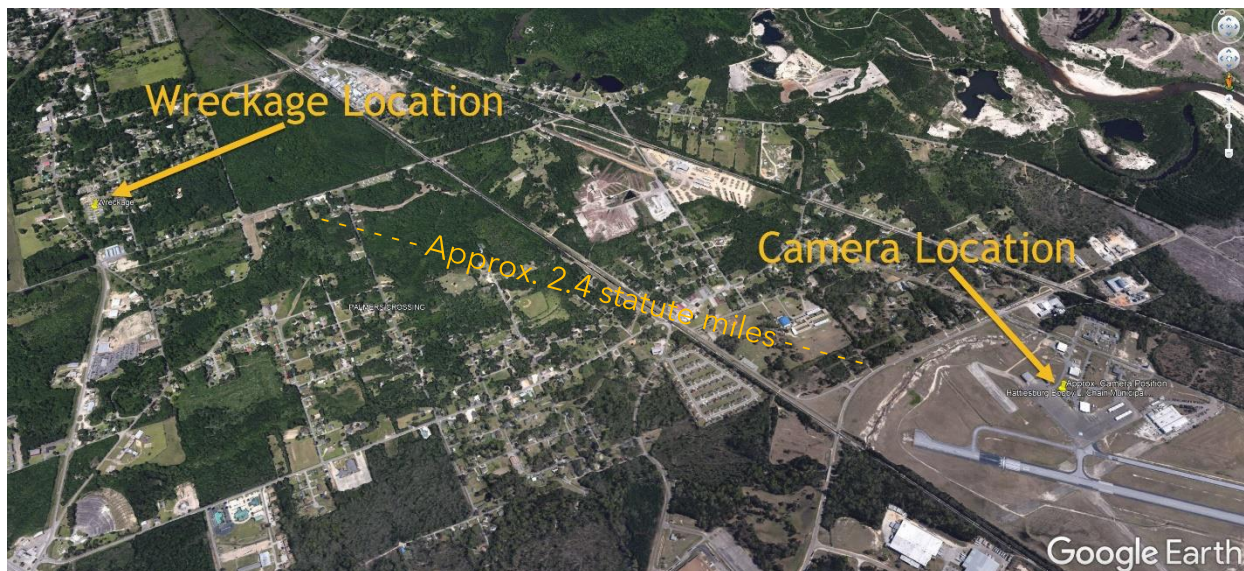
Figure 2 shows the relationship between the approximate camera location and the site of the accident aircraft wreckage. There are approximately 2.4 statute miles from the camera to the wreckage site.

**Figure 2.** The camera location relative to the accident site.

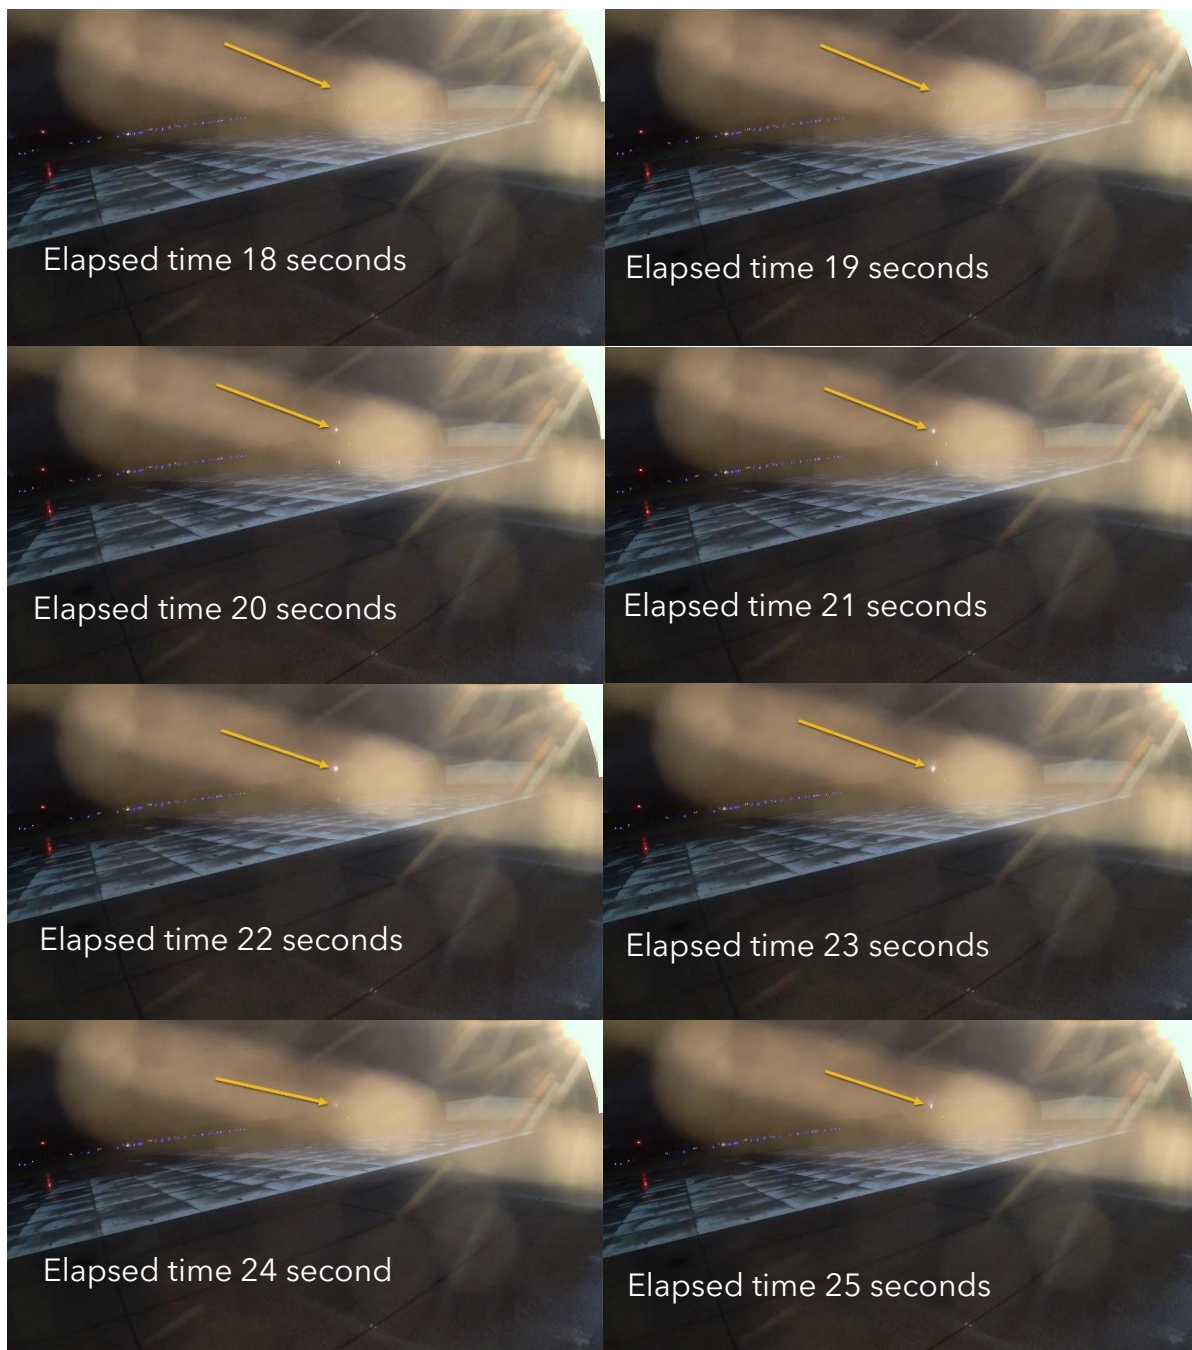
Figure 3 is a series of screenshots that show an area of illuminated pixels apparent in the recording. The elapsed time of the recording is annotated. It is important to note that prior to 18 seconds elapsed the accident aircraft was not visible in the security camera recording. Between 21 and 23 seconds elapsed, the luminosity of the light in the recording changes rapidly.

**Figure 3.** Images showing camera view when the airplane was visible from 18 seconds into the recording to 25 elapsed seconds. Between elapsed time of 21 seconds to the elapsed time of 23 seconds, the luminosity changes rapidly.

After elapsed time 25 seconds, the aircraft was no longer visible on the security recording.

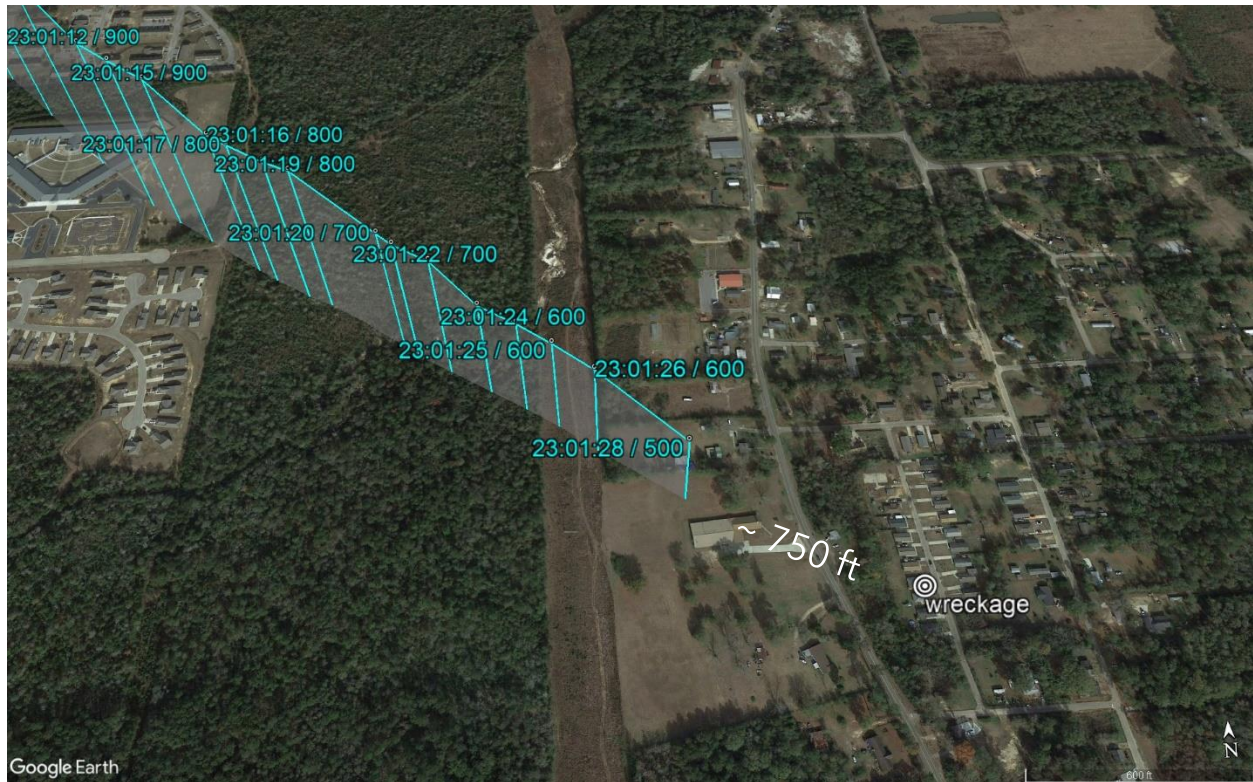
ADS-B data provided by the IIC showed the last reported data point was taken at 23:01:28 CDT at a reported altitude of 500 feet MSL. Altitude data was only recorded to the nearest 100 feet, but the airplane was descending at a rate of 1,400 fpm for the final minute of flight (reference the Aircraft Performance Study which can be found in the public docket for this accident). The elevation of the wreckage location was reported as approximately 170 feet MSL. Figure 4 shows a tracklog created from the ADS-B data with the reported altitude shown in feet MSL.

Due to lack of timing information from the security camera system, ambiguity in the ADS-B data and the rate of change of the aircraft's altitude versus the sample rate of the ADS-B data, no time correlation was possible.

**Figure 4.** A tracklog created from ADS-B data showing the altitude in feet MSL.
