# National Transportation Safety Board

CEN21FA209

## **EXAMINATION SUMMARY**

Location: Hattiesburg, MS  
Date: May 4, 2021  
Time: 2305 Local  
0405 UTC  
Airplane: Mitsubishi MU2B-60

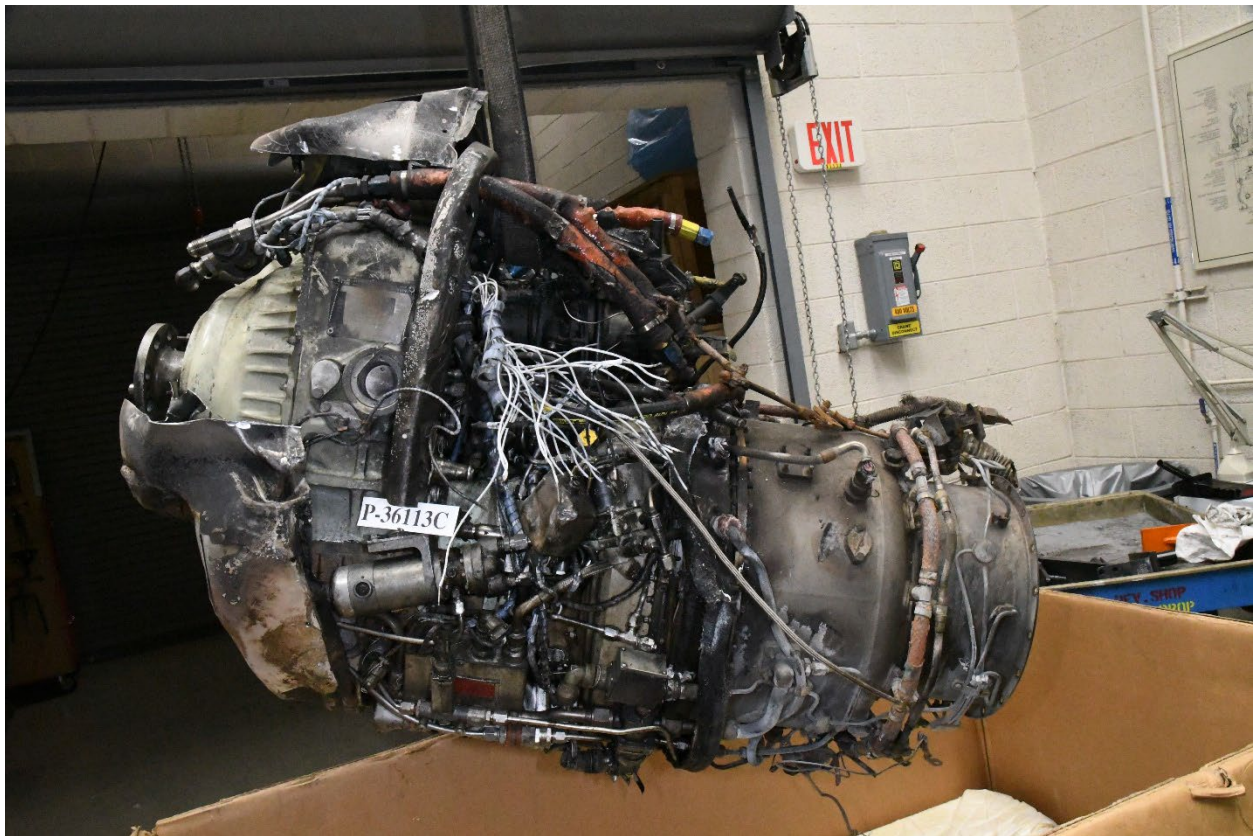
The left engine remained generally intact. There was evidence of impact and fire damage. The engine's propeller shaft and rotating group were not able to be freely rotated.

**Figure 2 Left Engine (Honeywell Photo)**

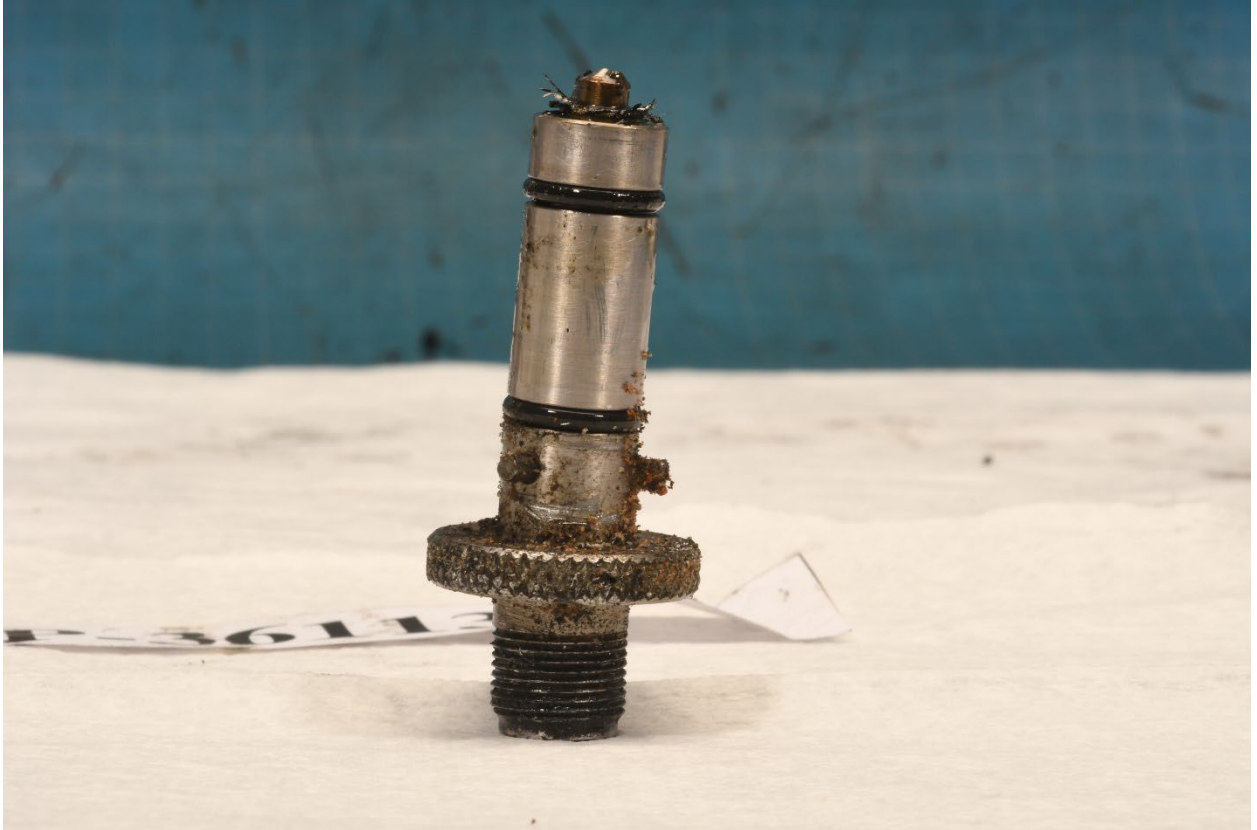
There was a large amount of earthen debris located in the engine inlet. The planetary gear assembly was intact, however the inner race of the assembly was cracked on the forward side of all four gears. The gears were able to be rotated with resistance. Rotational scoring was present on each gear at the base of the teeth, on the aft side, and aft face of the teeth. The magnetic chip detector was intact and had metallic slivers observed.

**Figure 3 Magnetic Chip Detector (Honeywell Photo)**

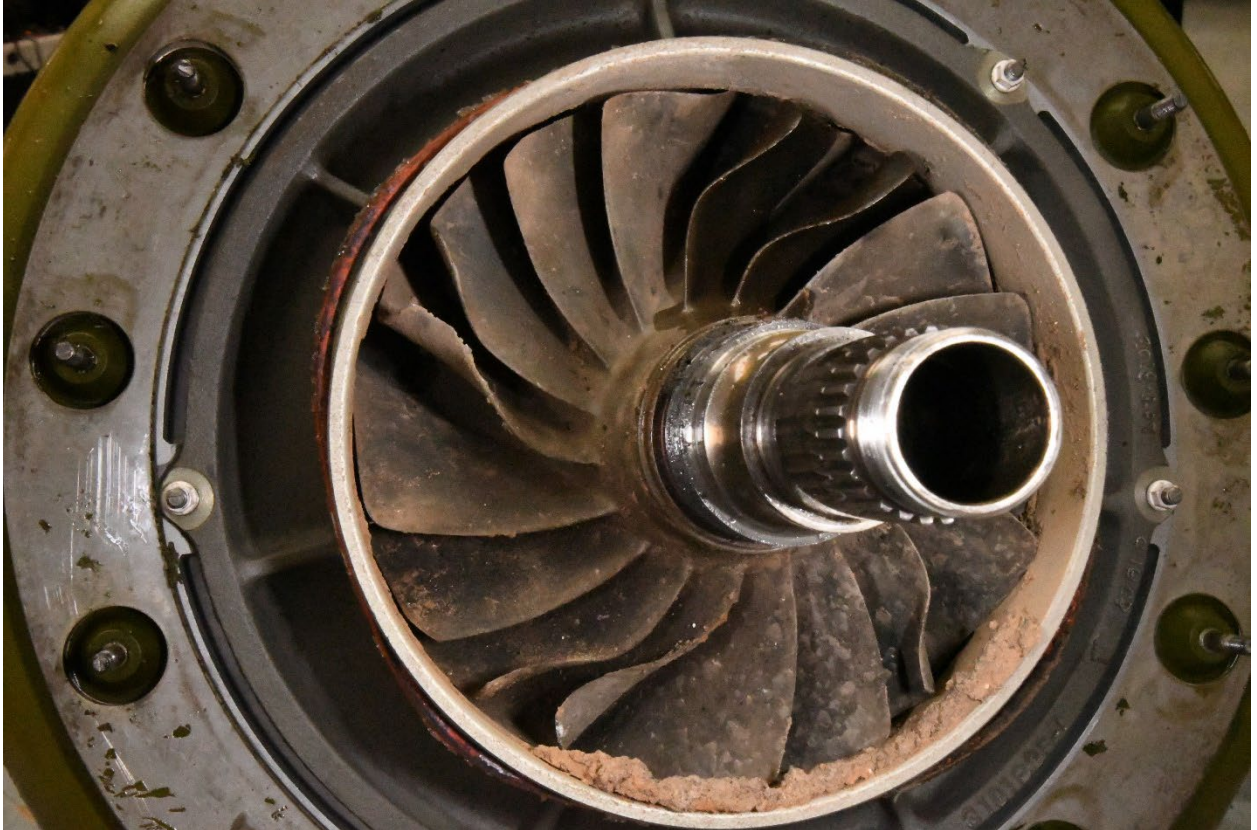
The first-stage compressor impeller shroud had earthen debris on its surface. There was light rotational scoring from the inducer to the exducer areas around 360°. Static blade marks were present from 10 o'clock to 2 o'clock positions. The compressor impeller had earthen debris present on all blades. Seven blades were bent at the inducer leading edge opposite the direction of rotation. Light rotation scoring was present from the inducer to exducer.

**Figure 4 First-Stage Impeller (Honeywell Photo)**

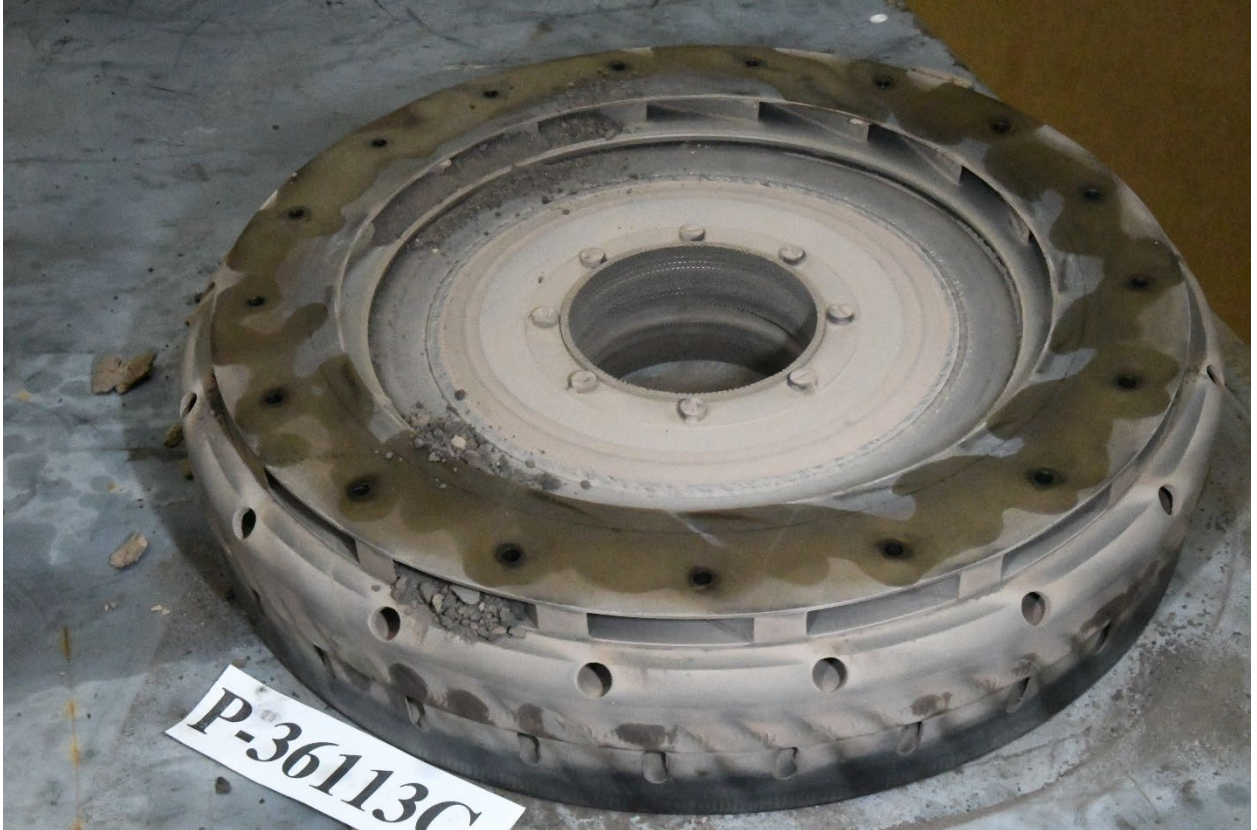
The first-stage compressor diffuser contained a large amount of earthen debris in the diffuser and packed around the vanes. Rotational scoring was present on the forward end of the bore from the 7 o'clock to 10 o'clock positions. Rotational scoring present on the aft end of the bore from the 2 o'clock to 3 o'clock positions, and from the 5 o'clock to 1 o'clock positions.

**Figure 5 First-Stage Compressor Diffuser**

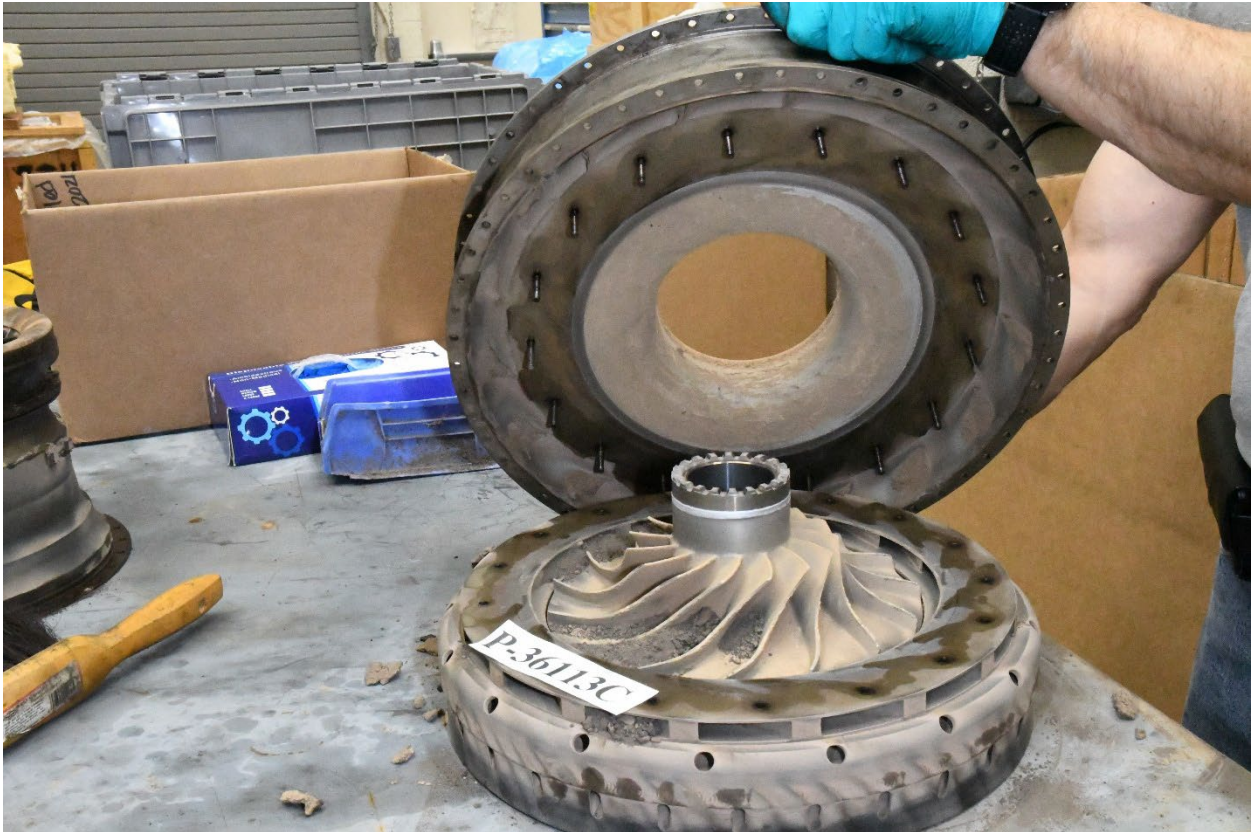
The second stage compressor housing had earthen debris build-up at the outer diameter flow path from the second-stage diffuser exit as well as earthen debris build-up on the impeller shroud. There was rotation scoring from the inducer to exducer areas around 360 degrees. Static marks were present at the shroud knee area. The second-stage compressor impeller had earthen debris adhering to all surfaces with deposits between several blades. There was rotational scoring on the forward hub just aft of the forward curvics as well as on the knee to the exducer of the blades.

**Figure 6 Second-Stage Compressor Housing and Impeller (Honeywell Photo)**

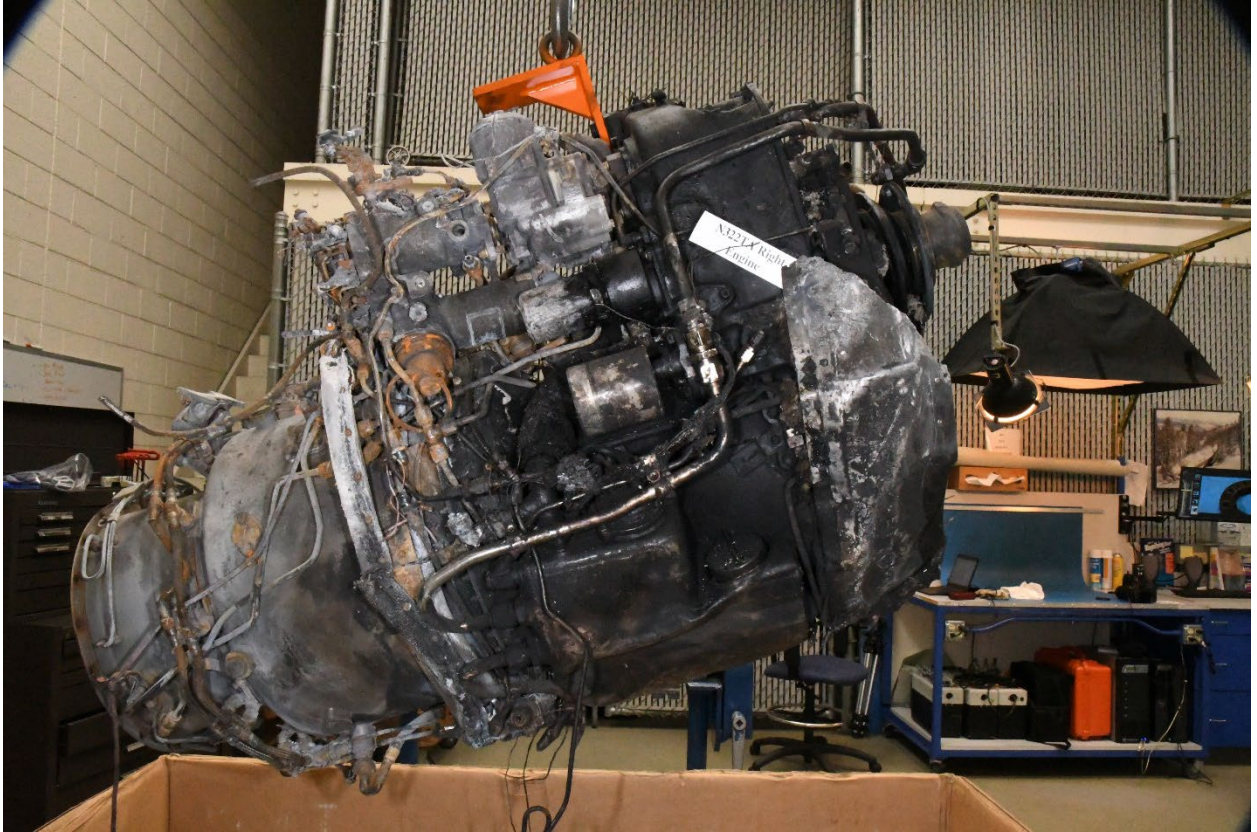
The right engine remained generally intact. There was evidence of impact and fire damage.

**Figure 7 Right Engine (Honeywell Photo)**

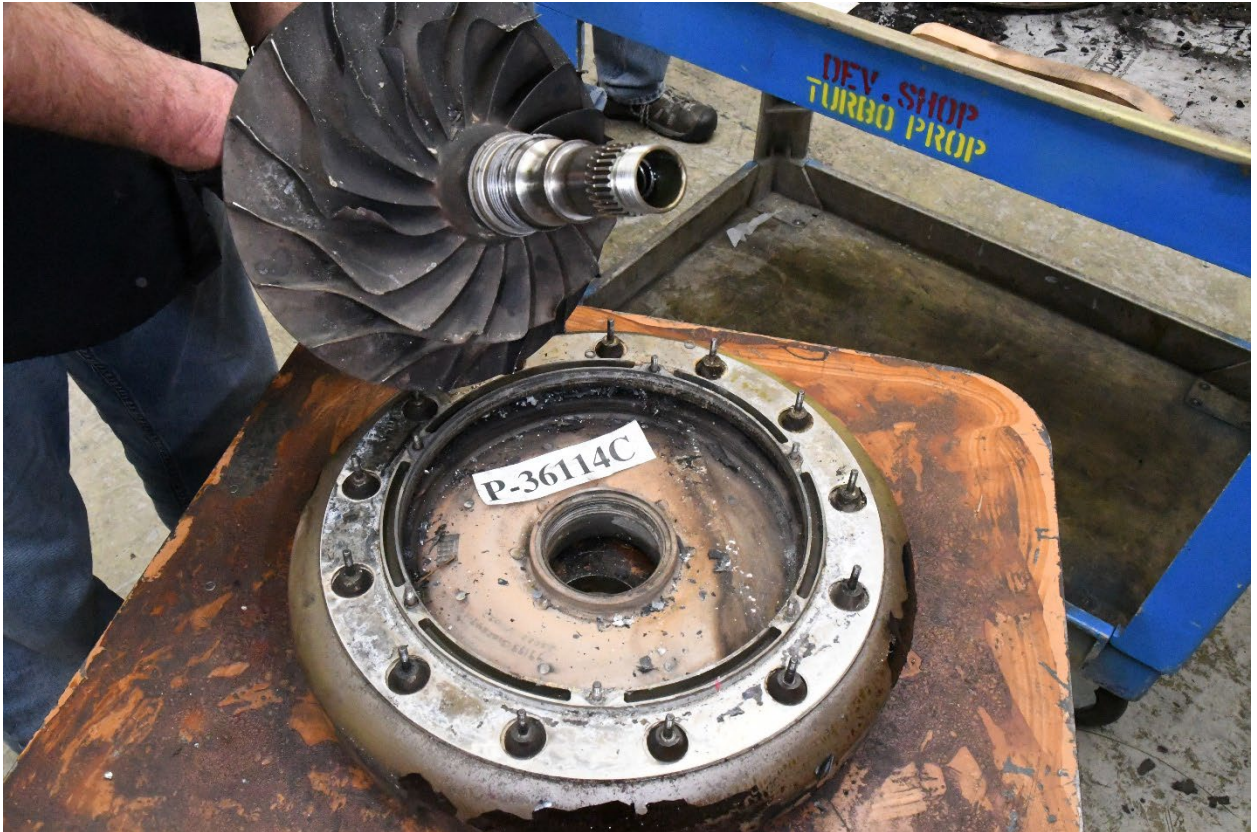
Portions of housing materials to include roofing shingles were found in the inlet area. The first-stage compressor shroud had heavy sooting over the flow path surfaces consistent with static blade position. There was rotational scoring from the inducer to knee and a lip present from the scoring at the exducer. The first-stage impeller had soot on all surfaces. There was evidence of rubbing on the blade tips from the inducer to exducer. Six blades on the inducer were bent opposite the direction of rotation. There was slight bending on several blades on the exducer opposite the direction of rotation. The first-stage compressor diffuser had earthen debris and sooting present in the flow path. A dark colored material consistent with heat coked oil was observed on the outer diameter of the diffuser. There was rotational scoring on the inner diameter around 360°.

**Figure 8 First-Stage Impeller & Diffuser (Honeywell Photo)**

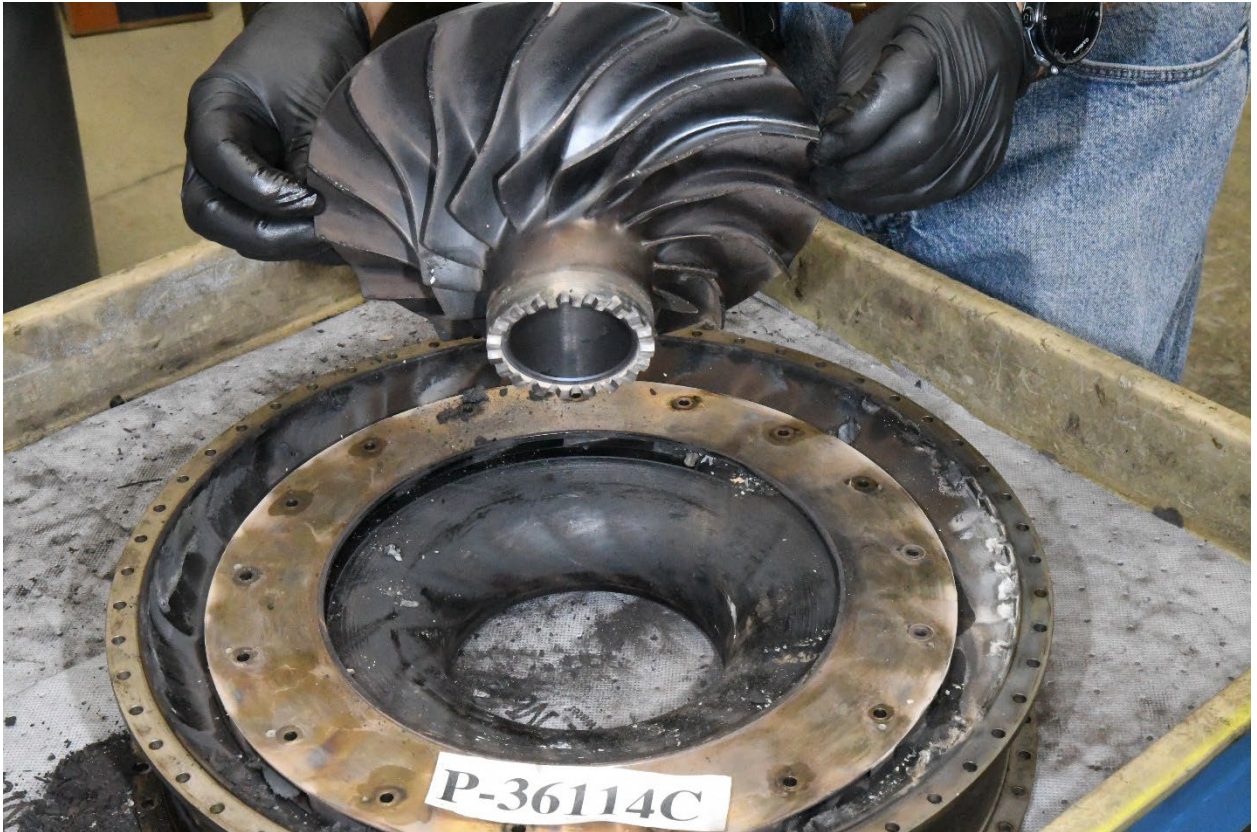
On each blade of the second-stage compressor impeller there was rotational scoring on the knee to the exducer. On the compressor housing there was rotational scoring around 360° of the knee to exducer area. There was earthen debris adhering to the outer diameter of the shroud and concentrations in the outer diameter flow path.

**Figure 9 Second-Stage Impeller & Diffuser (Honeywell Photo)**
