# National Transportation Safety Board

CEN21FA220

## **WRECKAGE EXAMINATION SUMMARY**

Location: St. Louis, Michigan  
Date: May 17, 2021  
Time: 1308 eastern daylight time  
Airplane: Cessna 182H, Registration No. N2430X

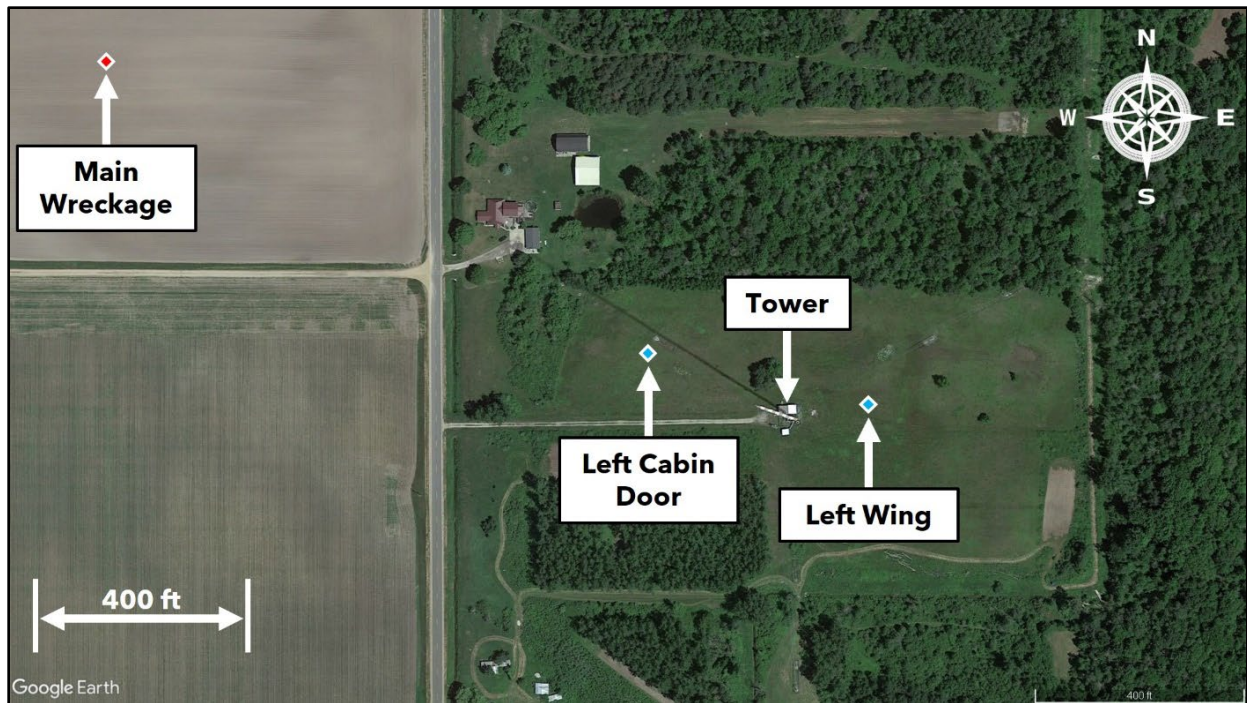
**Figure 1 - Wreckage Debris Path**

The wreckage debris path began in the vicinity of a 1,049-foot-tall tower, as depicted in figure 1. The tower was identified as Federal Communications Commission (FCC) Tower Registration No. 1007986. The location of the tower is depicted on a visual flight rules (VFR) sectional chart, as shown in figure 2. According to the VFR Sectional Chart, the top of the tower is at 1,739 ft mean sea level (msl). The tower base is at 690 ft msl. The tower design is depicted in figure 3. Photos of the tower are shown in figures 4-5.

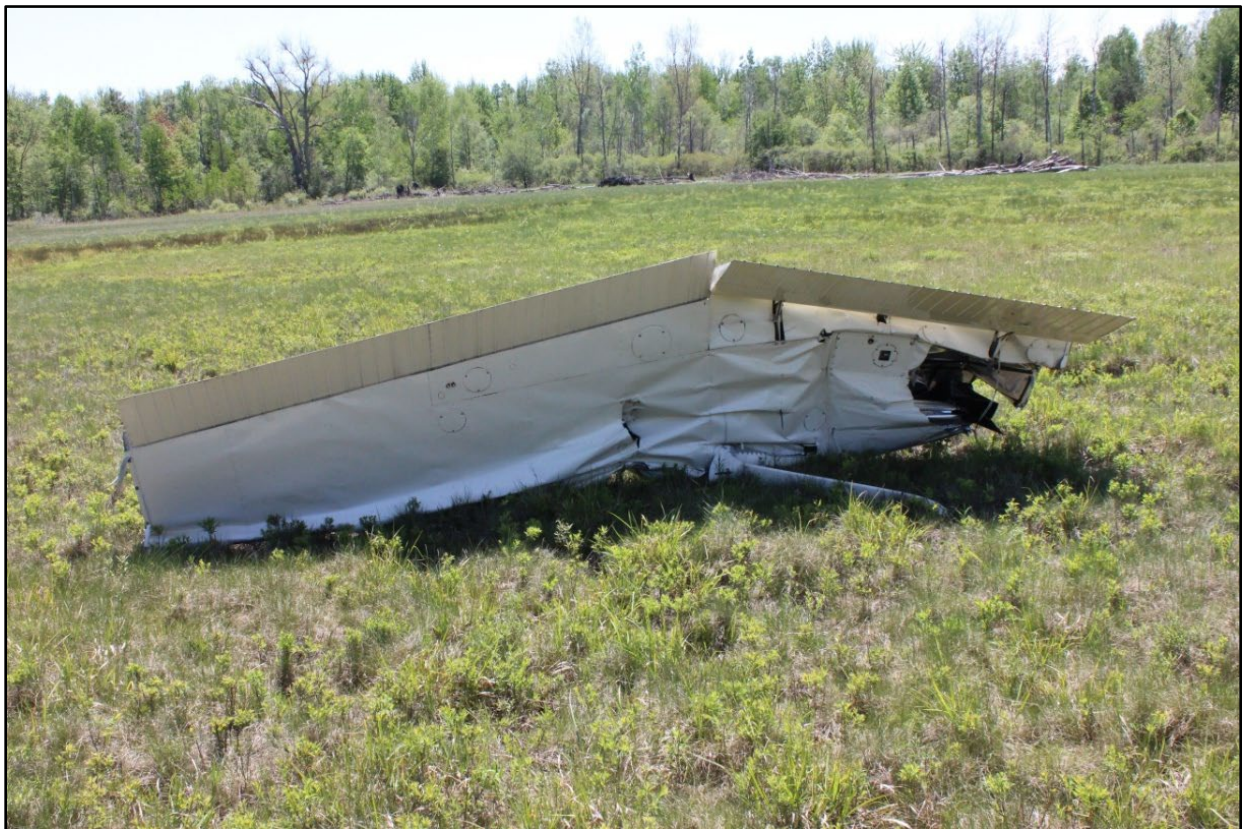
The airplane's left wing collided with a tower guy wire on the northeast side of the tower. The left wing separated from the fuselage at the wing root, as shown in figure 6. The fresh air tube located in the leading edge of the left wing, between WS23.62 and WS56.53, exhibited a U-shape compression that was consistent with the diameter of the outermost guy wires, as shown in figure 7. There were wire impact marks on the left lift strut about 4 ft from the wing attach point, which severed the strut in two portions, followed by the front spar. The damage to the left-wing lift strut exhibited a U-shaped compression about 1 inch in diameter, consistent with the diameter of the outermost guy wires, as shown in figure 8. The remaining section of left-wing lift strut with the door post was found in a tree near and just past the tower. The leading edge of the left wing separated from the main wing structure along the lateral rivet line from WS136.00 outboard including the wing tip cap, consistent with a guy wire fileting open the wing along the leading edge of the forward spar, as shown in figure 9. The left horizontal stabilizer and left elevator separated the fuselage during the impact sequence. The left horizontal stabilizer had leading edge damage consistent with the left wing impacting the surface, as shown in figure 10.

**Figure 6** - Left Wing at Accident Site

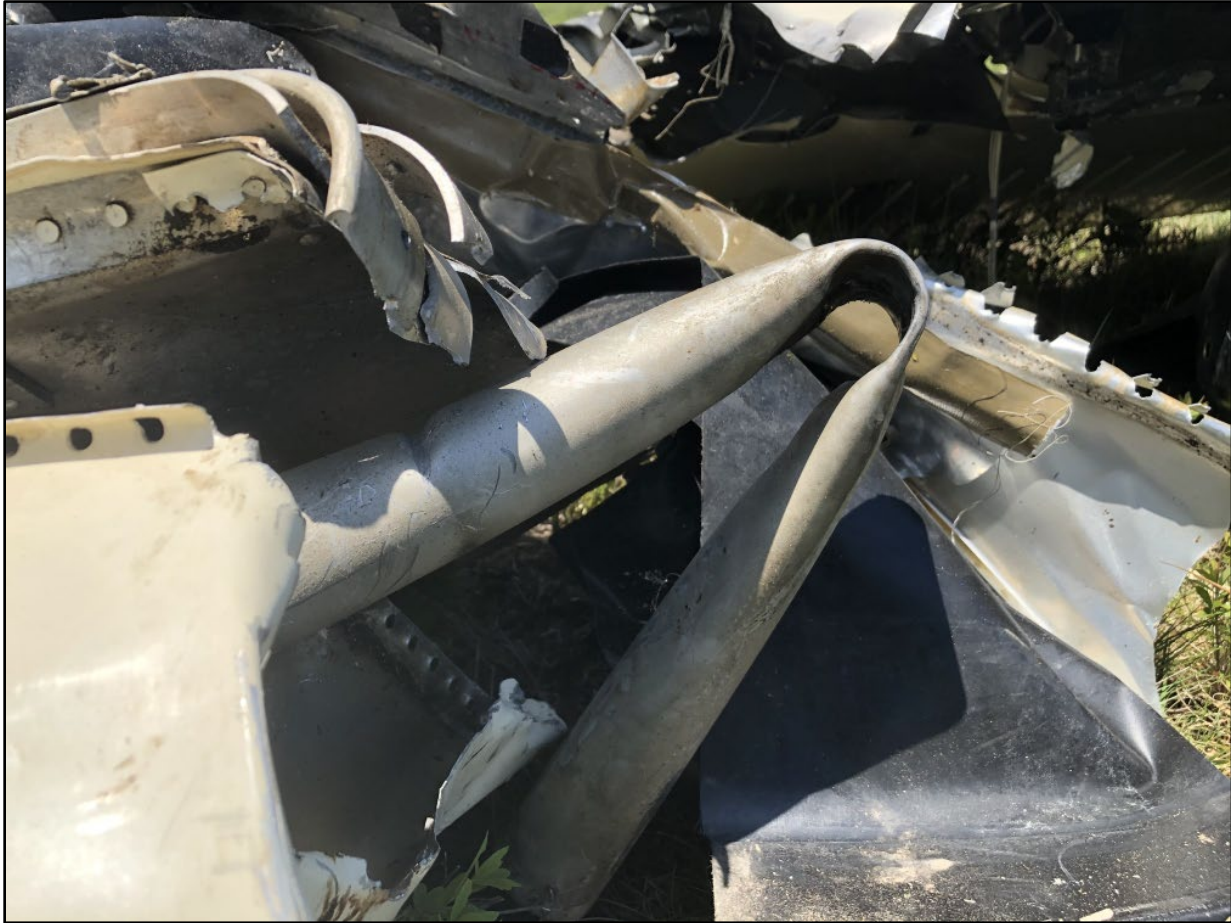
**Figure 7** - Left Wing Fresh Air Tube with U-Shape Bend

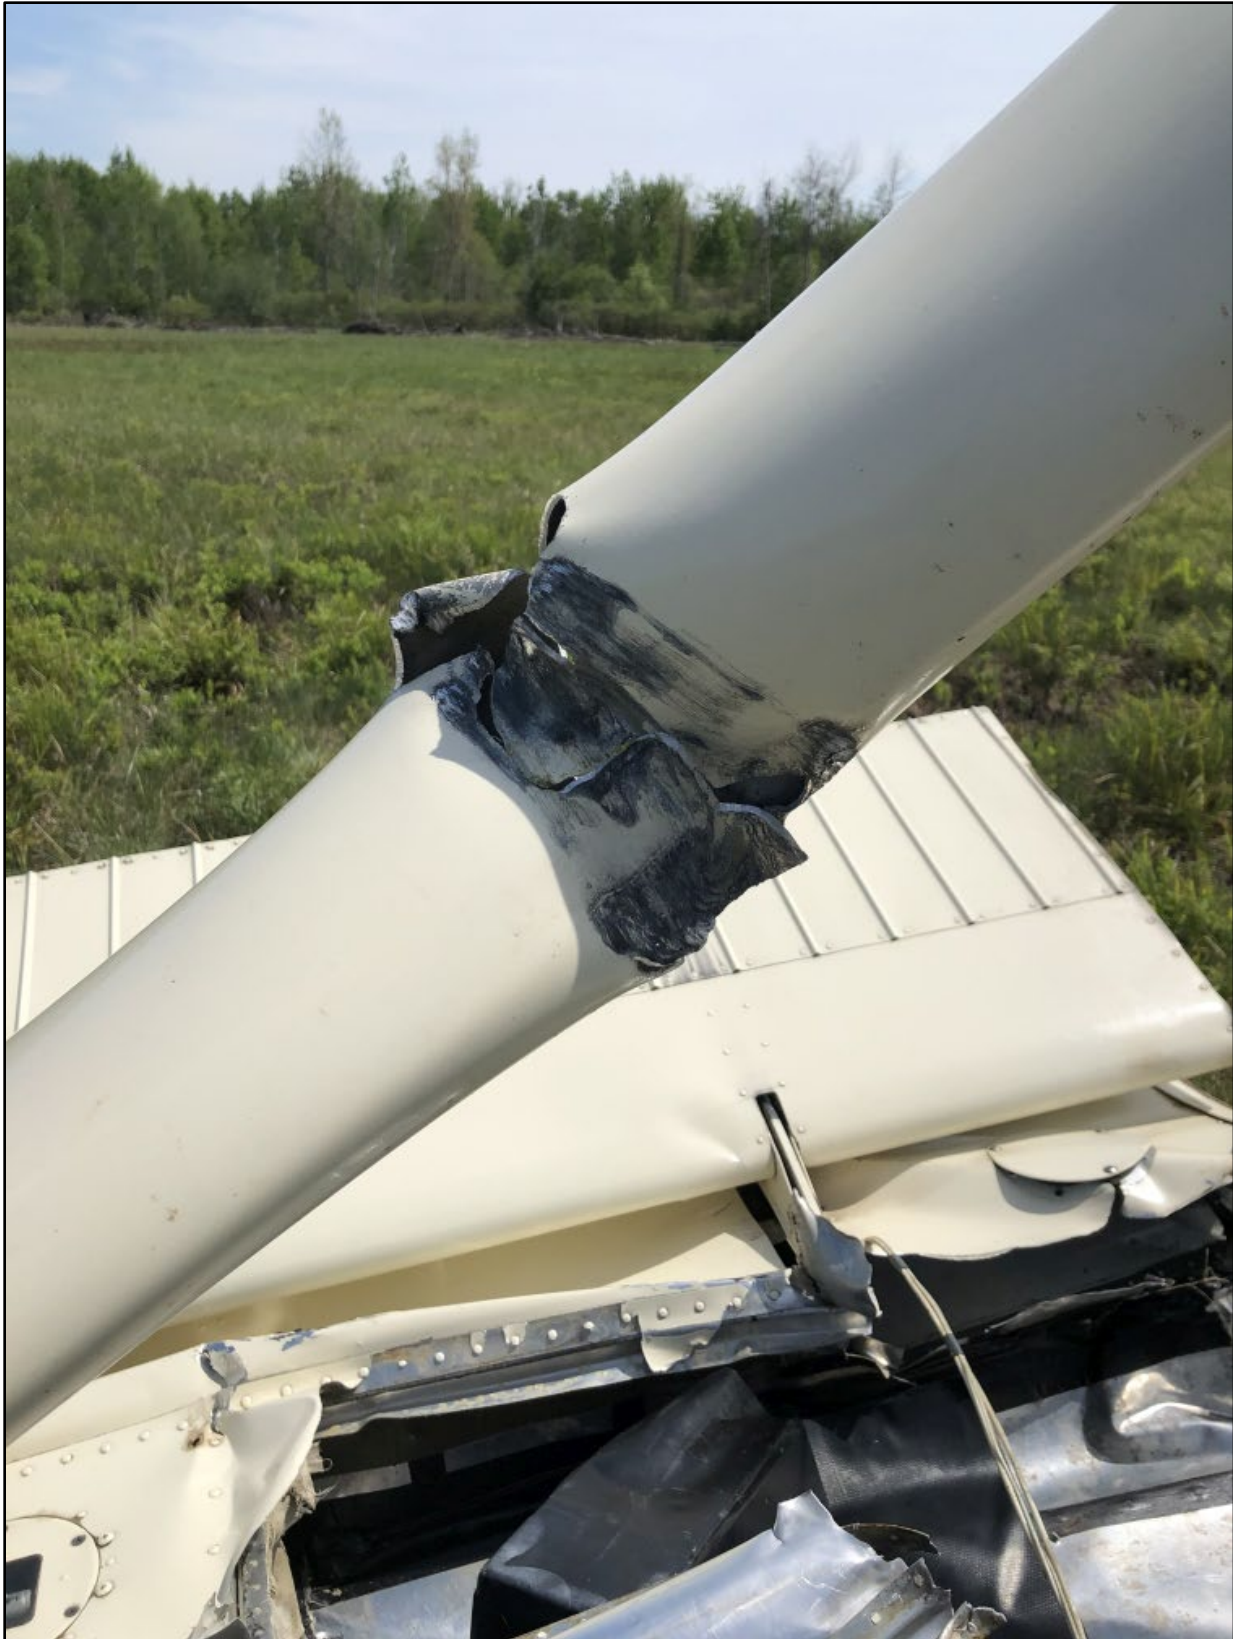
**Figure 8** - Left Wing Lift Strut Damage

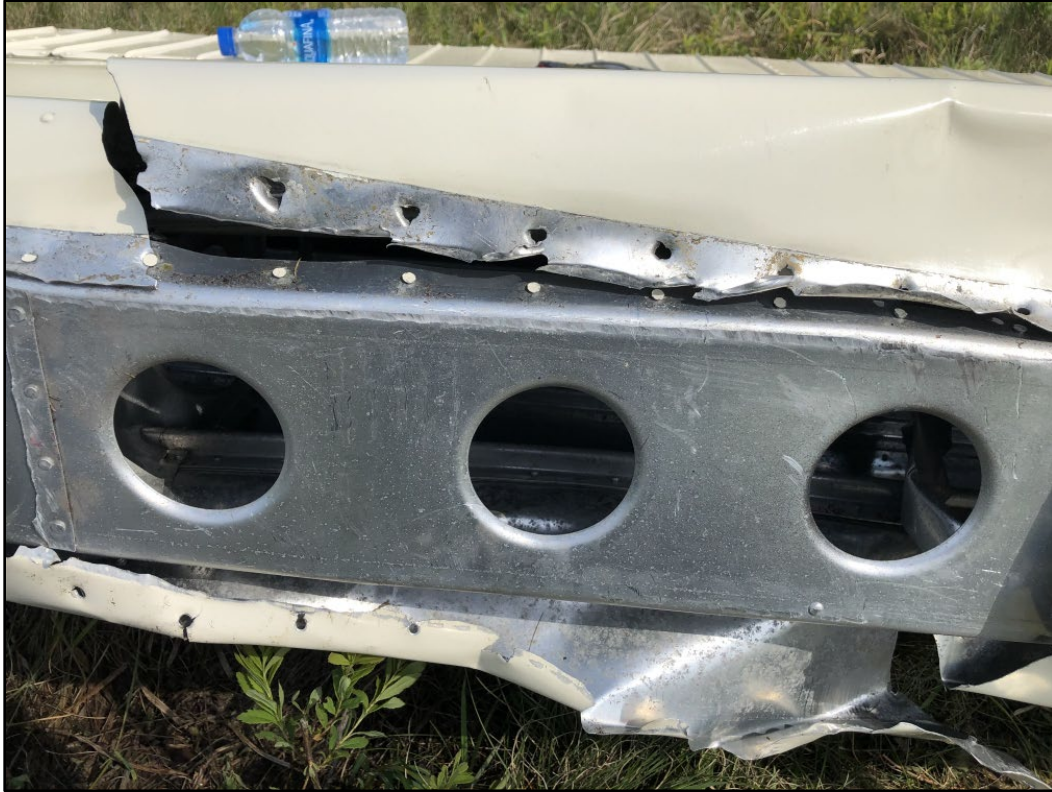
**Figure 9** - Left Wing Leading Edge and Forward Spar Damage

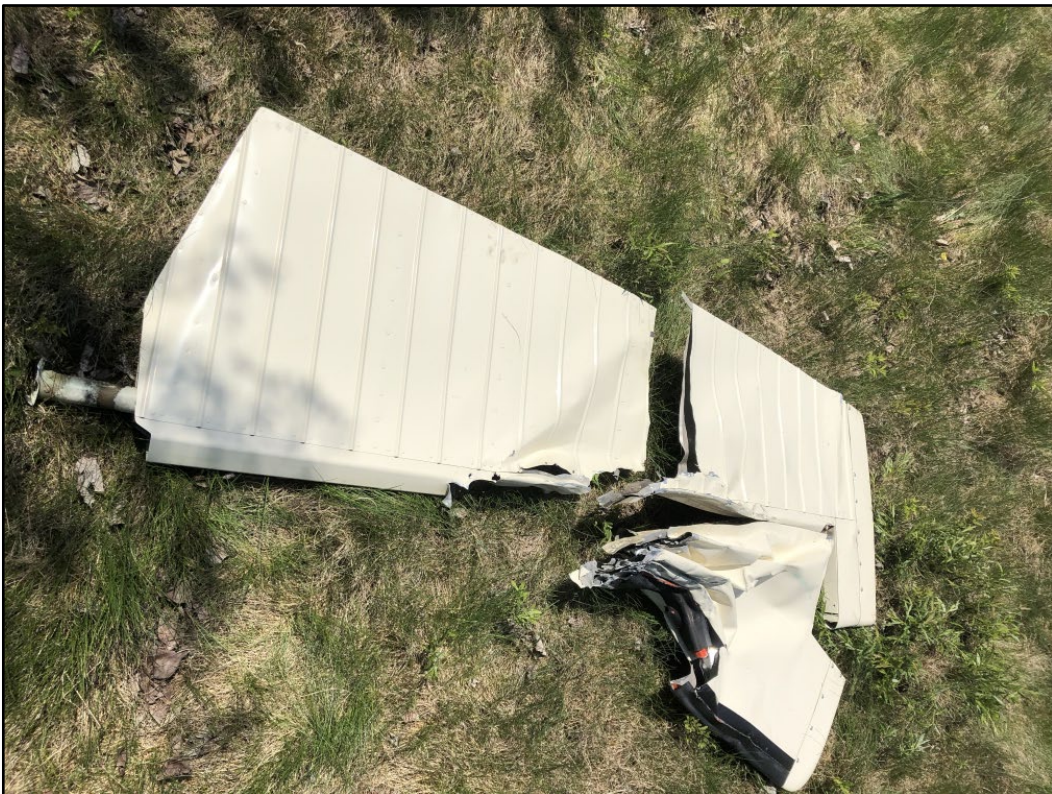
**Figure 10** - Left Elevator and Portion of Left Stabilizer

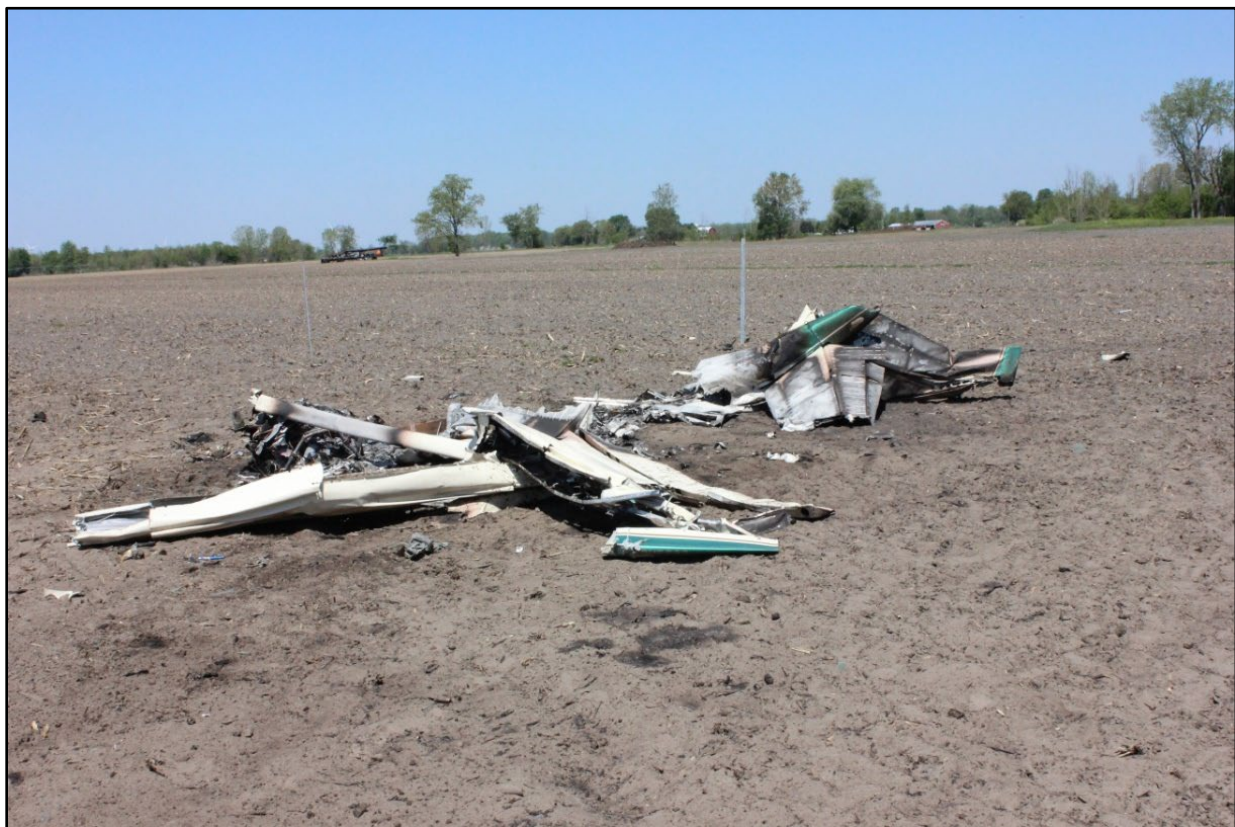
**Figure 11 - Main Wreckage**

The main wreckage was located about 0.26 nautical mile (nm) on a 297° true bearing from the tower. The wreckage came to rest inverted on a 245° magnetic heading. The fuselage was consumed by the postimpact fire, as shown in figure 11. All major airframe structural components and flight control surfaces were identified along the wreckage debris path.

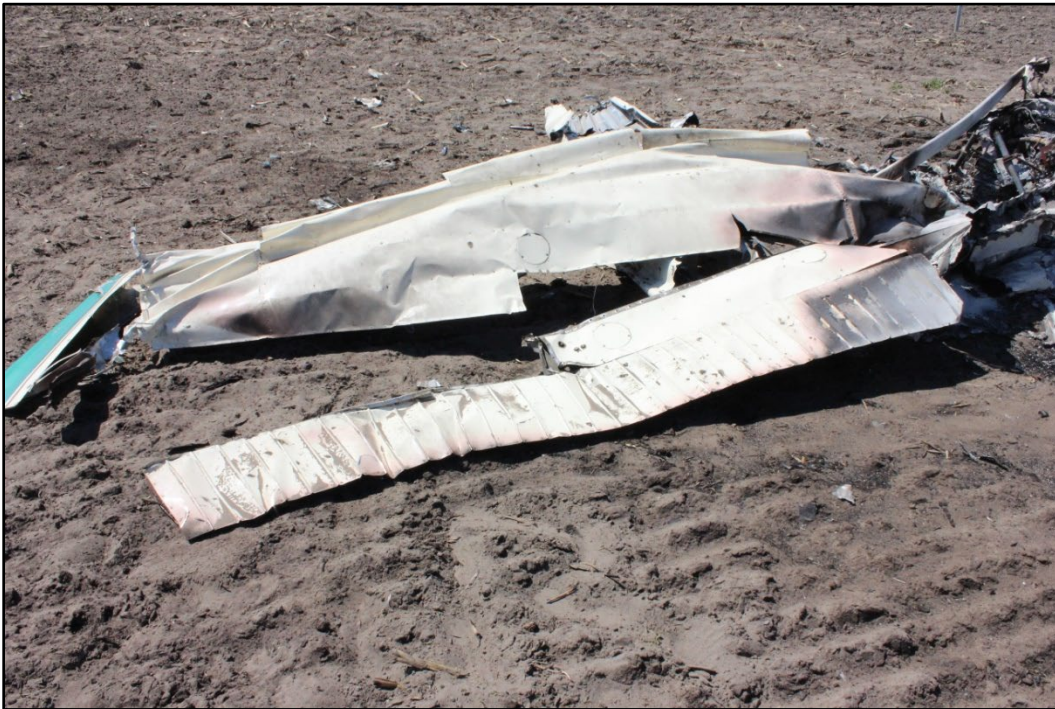
The right wing was located with the main wreckage, as shown in figure 12. The right wing exhibited thermal damage near the wing root from the postimpact ground fire. The right wingtip was present. The right-wing lift strut remained intact between the fuselage and wing attach points. The right-wing forward spar exhibited a slight S-shaped bend.

**Figure 12** - Right Wing

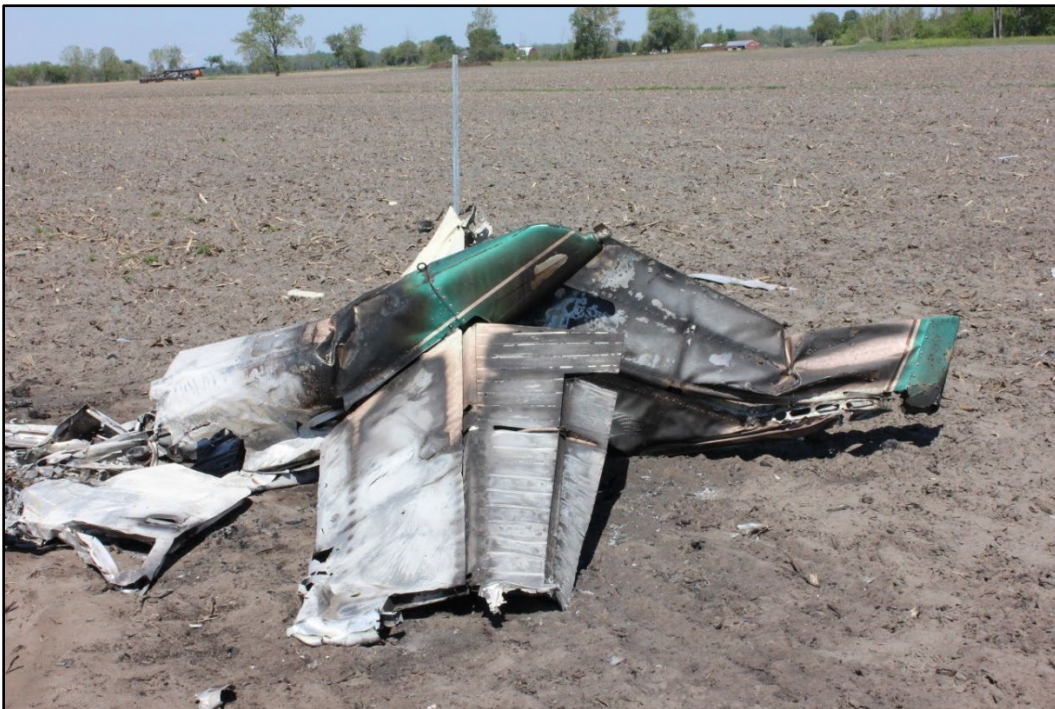
Flight control cable continuity was established from all the control surfaces to the cockpit with overload separation on the left-wing cables. The left aileron remained attached to its respective hinge points and exhibited minor impact related damage. The right aileron remained attached to its respective hinge points but exhibited significant thermal damage from the postimpact fire. The left horizontal stabilizer and elevator separated inflight and were located near the tower. The right horizontal stabilizer, right elevator, vertical stabilizer, and rudder remained attached to the aft

fuselage with the main wreckage, as shown in figure 13. The right elevator and rudder remained attached to their respective attach points.

**Figure 13** - Right Stabilizer, Right Elevator, Vertical Stabilizer, and Rudder

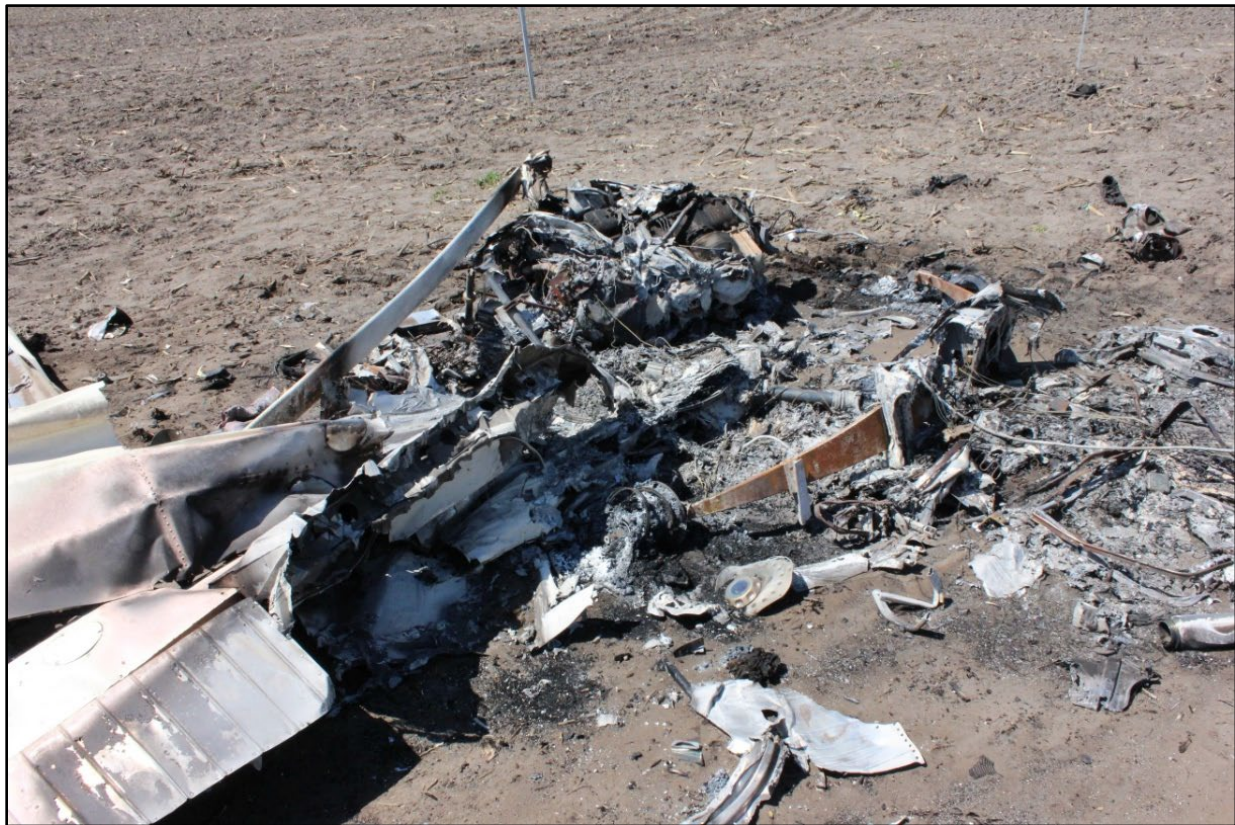
**Figure 14 - Fuselage, Cabin, and Cockpit**

The fuselage, cabin, and cockpit were destroyed by the postimpact fire, as shown in figure 14. Both main landing gear were located with the main wreckage and remained attached to the structural gear box. The nose landing gear strut was located with the main wreckage. The airframe fuel system could not be examined due to post impact damage.

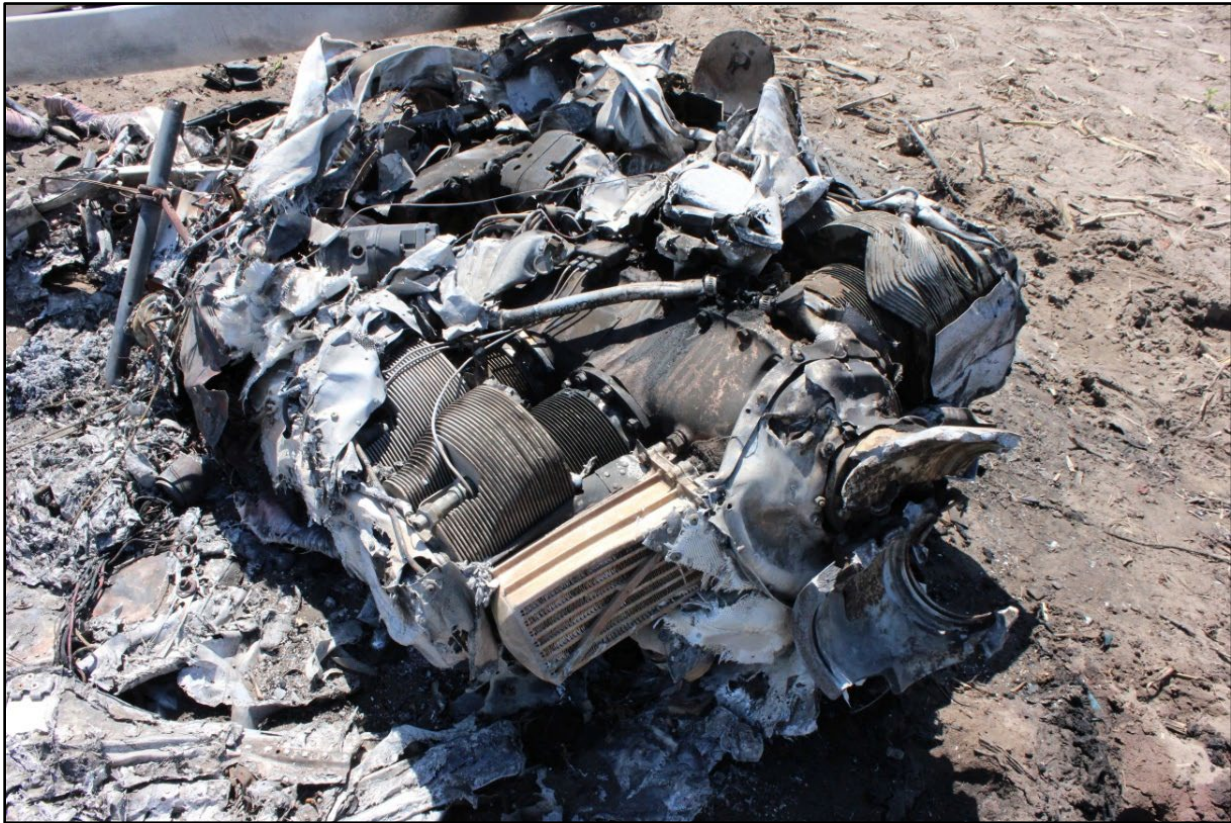
The engine remained partially attached to the airframe through control cables and exhibited significant thermal and impact damage from the postimpact fire, as shown in figure 15.

**Figure 15** - Engine at Accident Site

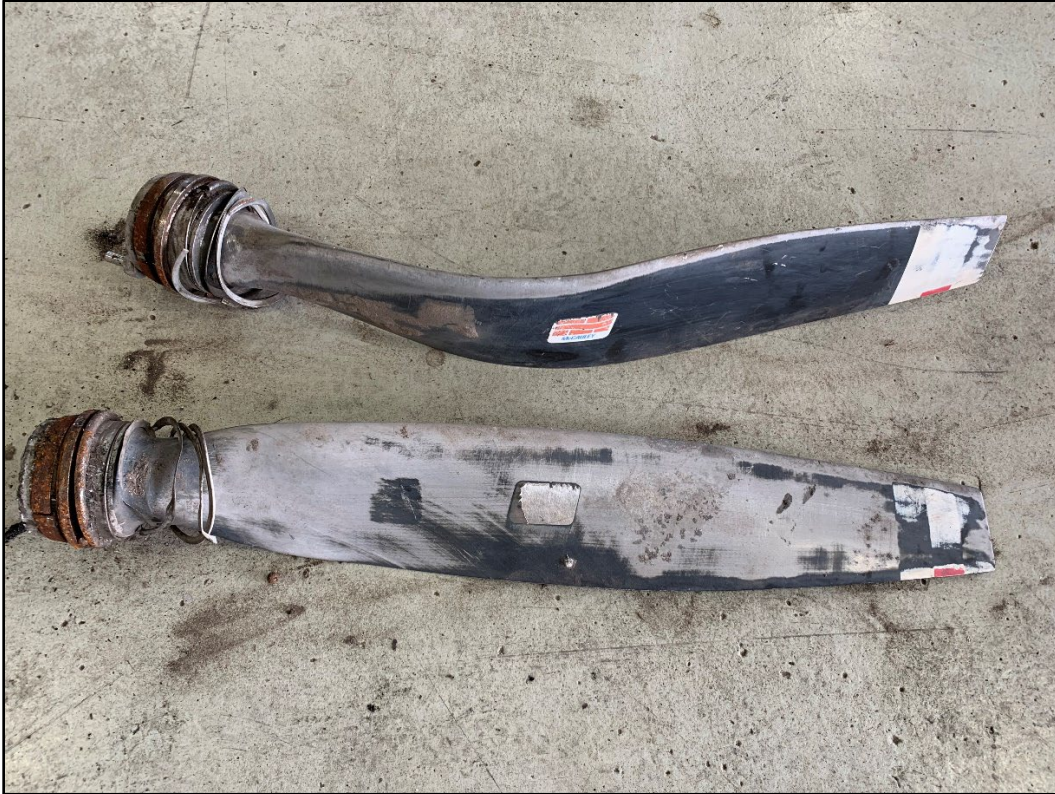
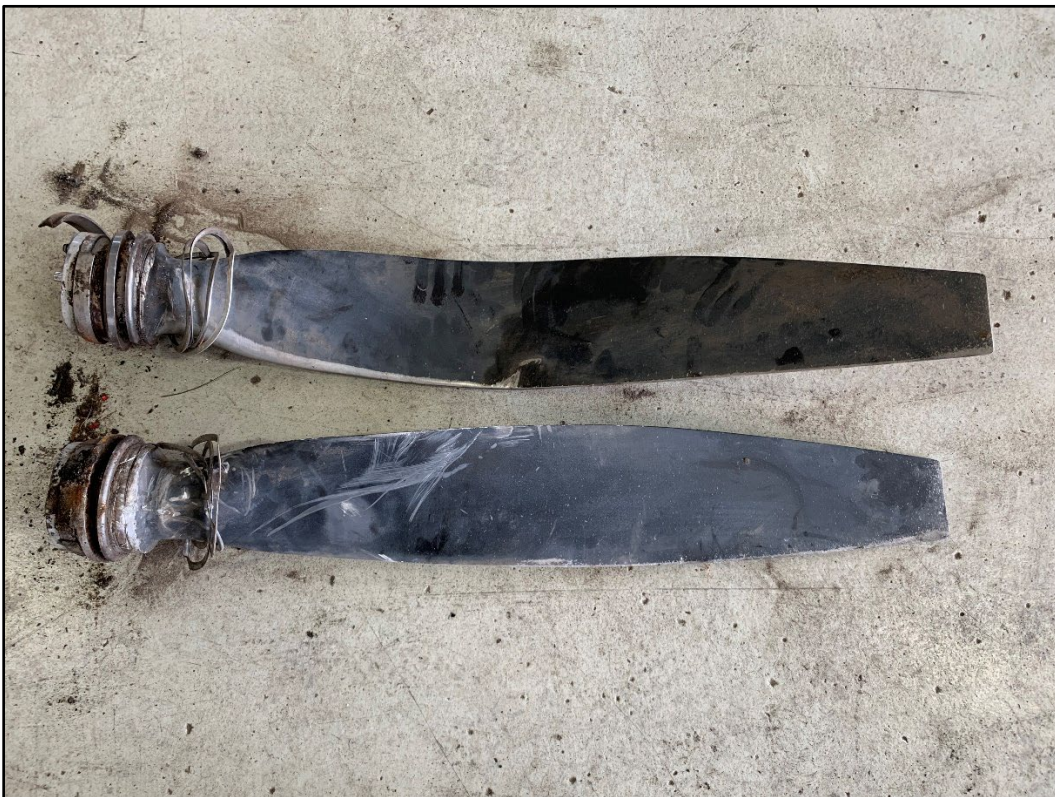
The two-bladed propeller separated from the propeller hub and was found in an impact crater about 25 ft before the main wreckage. The pitch change spring was at the bottom of the impact crater. Both propeller blades were observed with leading edge damage, bending and polishing, as shown in figure 16 and figure 17.

**Figure 16** - Propeller Blades, Cambered Side

**Figure 17** - Propeller Blades, Flat Side

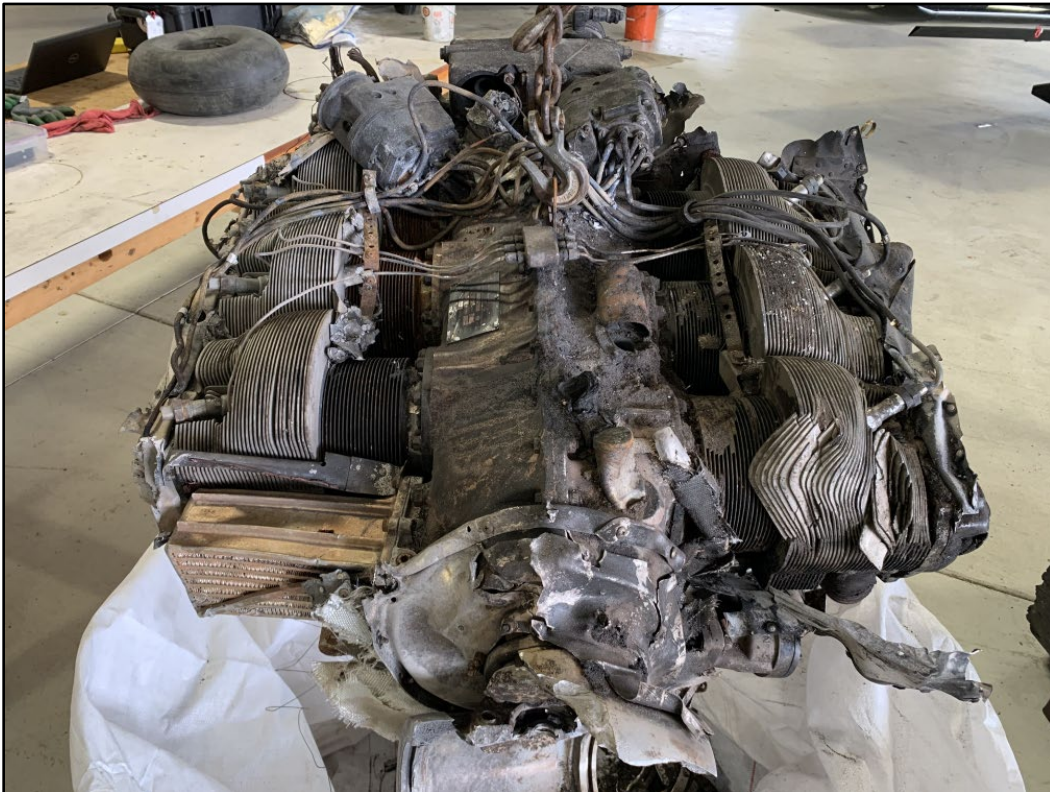
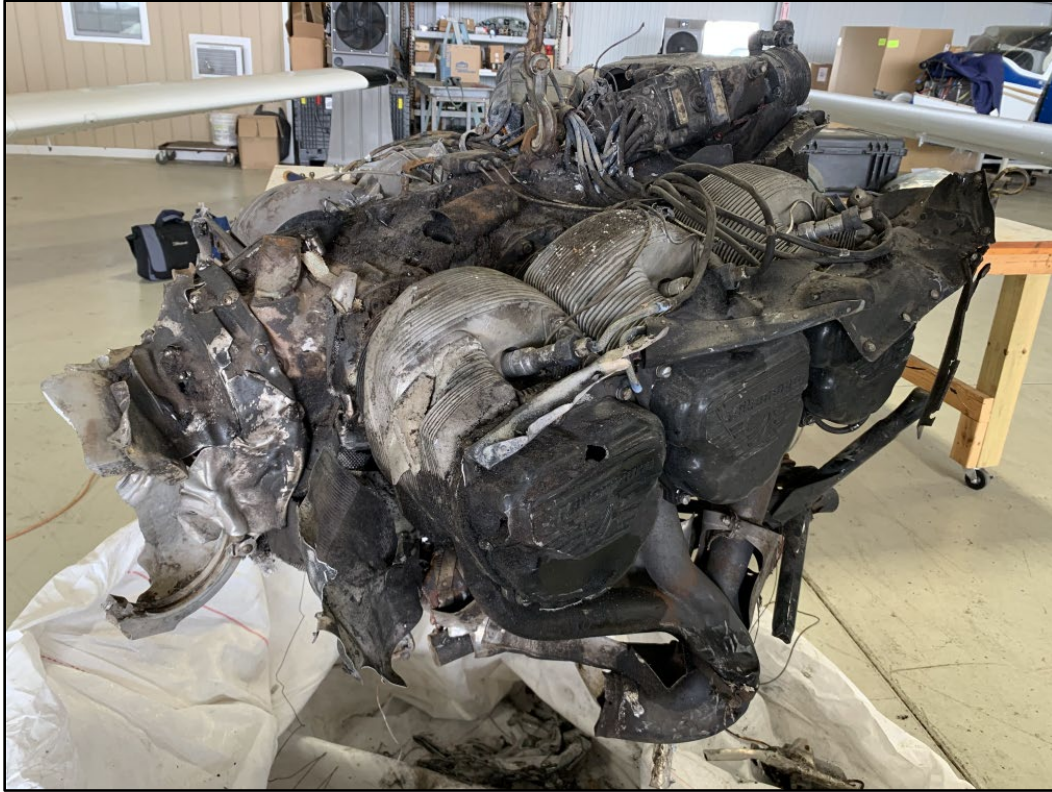
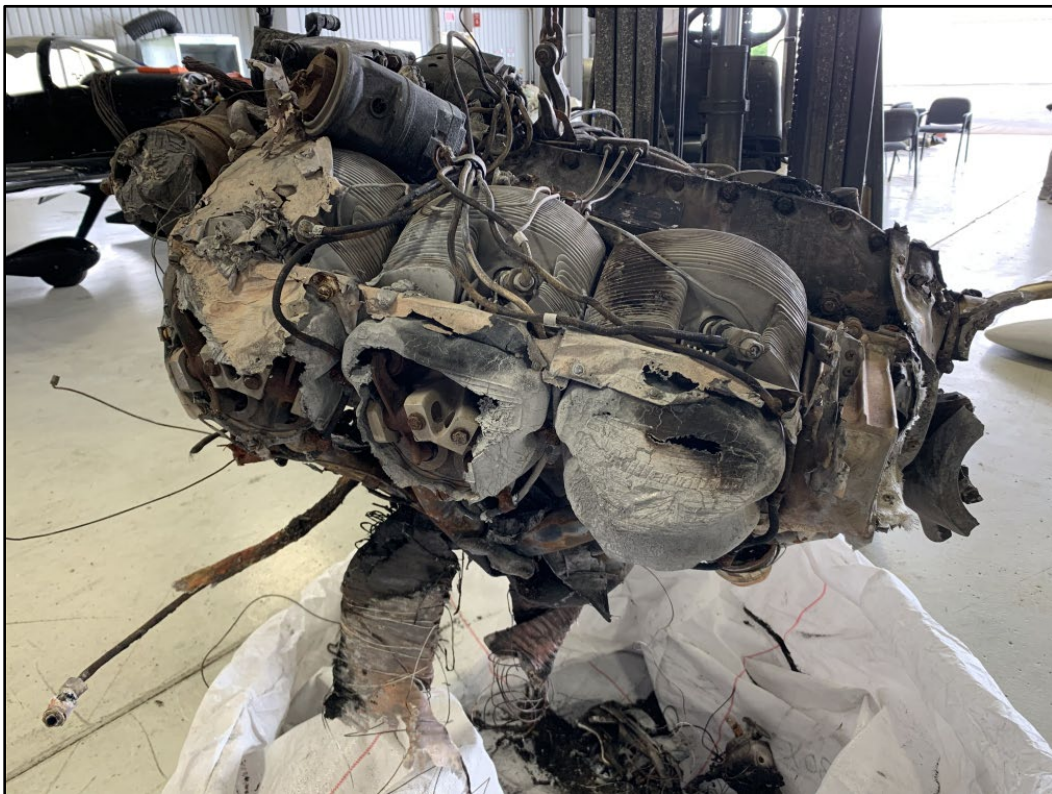
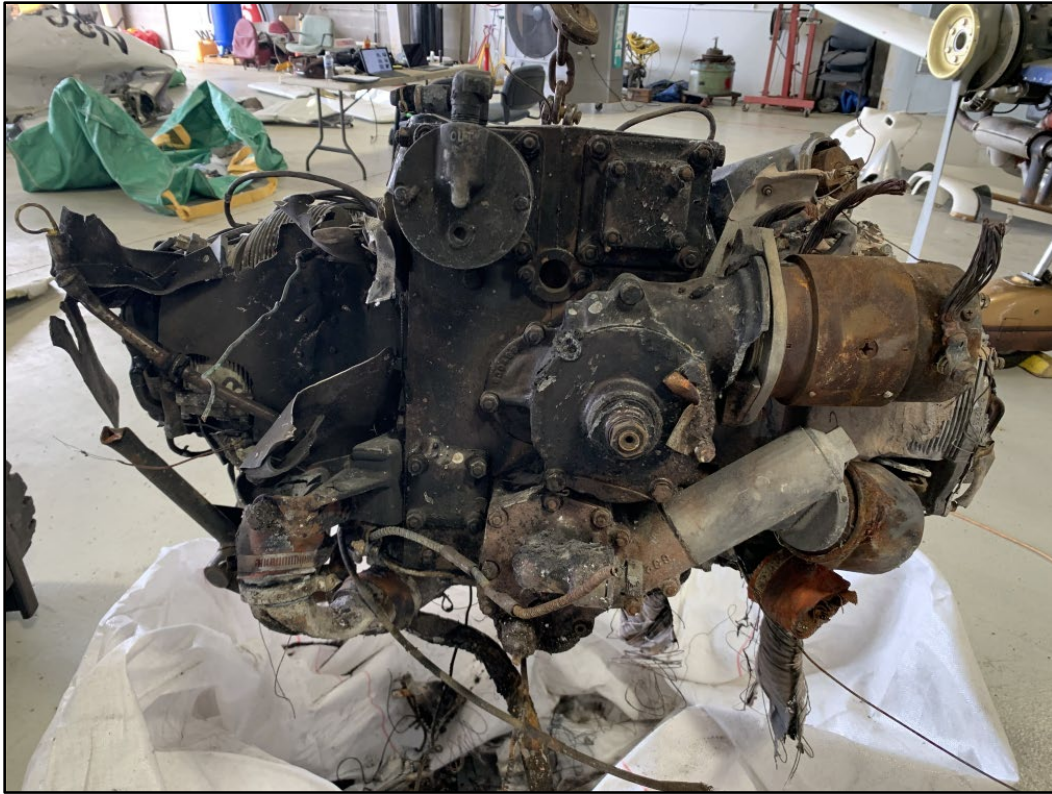
The engine was separated from the firewall before the examination, as shown in figure 18. Both propeller blades separated from the hub during impact. The spinner bulkhead was crushed aft around the engine crankcase. The exterior surface of the engine crankcase and the externally mounted engine components exhibited significant thermal damage, as shown in figures 18-21. The engine crankcase did not exhibit any holes or cracks. Engine cylinder No. 6 exhibited impact damage to the cooling fins. The rocker box covers for cylinder Nos. 1 and 3 are burned. The rocker box cover for cylinder Nos. 2, 4, and 6 remained intact.

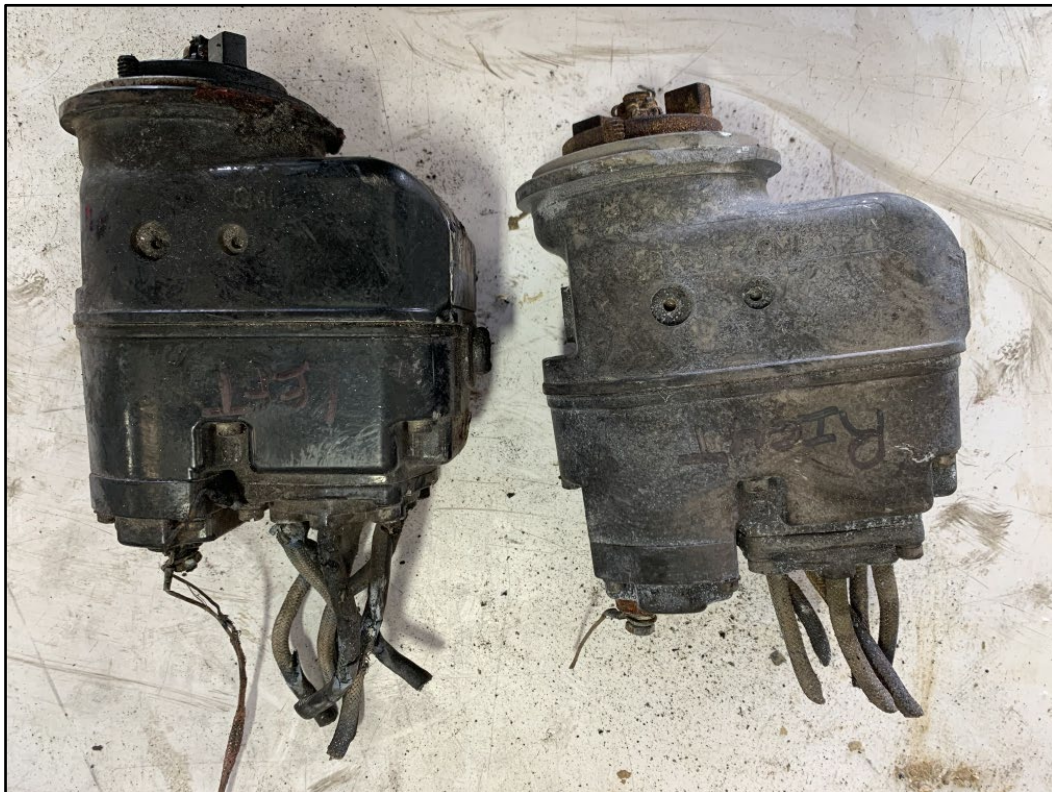
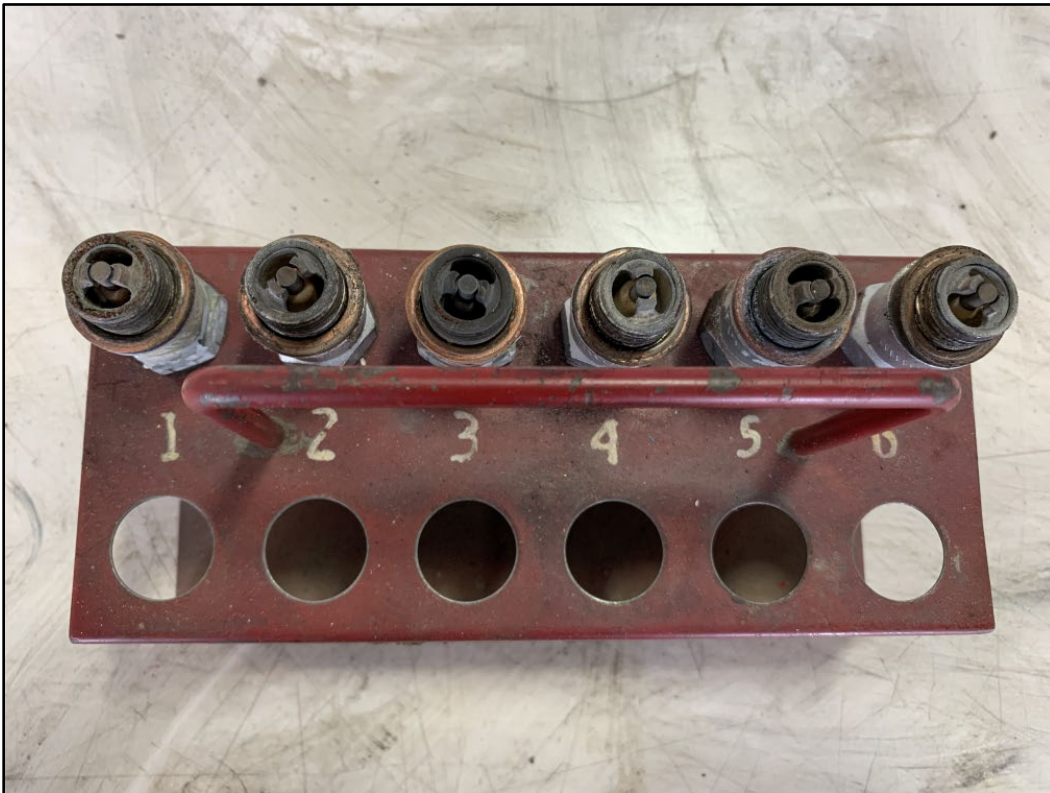
The ignition harness exhibited impact and thermal damage. All spark plugs were found securely installed. The left magneto remained attached to its respective crankcase mount pad. The right magneto has separated from the crankcase mount pad. The right and left magnetos exhibited thermal damage, as shown in figure 22, and did not function when tested. The top spark plugs were removed and exhibited features consistent with normal engine operation, as shown in figure 23.

**Figure 22** - Left and Right Magneto

**Figure 23** - Top Spark Plugs

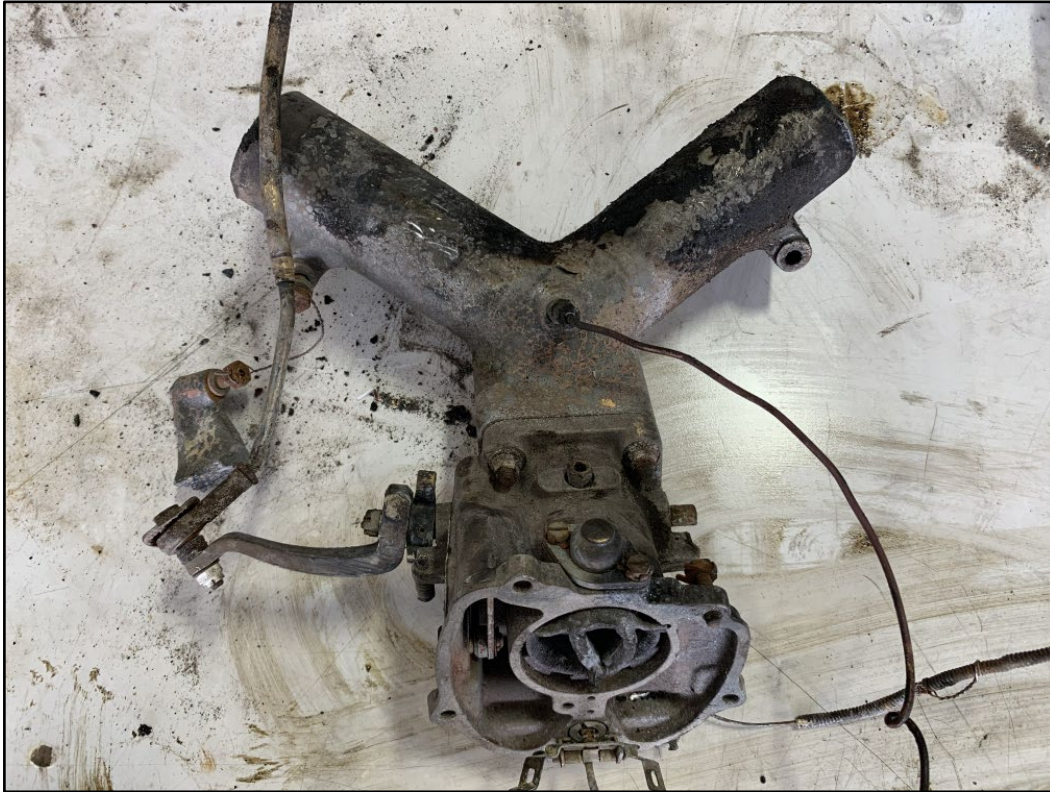
The upper half of the carburetor remained attached to the induction plenum, as shown in figure 24. The carburetor bowl and float assembly were not present.

**Figure 24** - Upper Half of Carburetor and Induction Plenum
