# National Transportation Safety Board

CEN21FA220

## **WRECKAGE EXAMINATION SUMMARY**

Location: St. Louis, Michigan  
Date: May 17, 2021  
Time: 1308 eastern daylight time  
Airplane: Cessna 182H, Registration No. N2430X

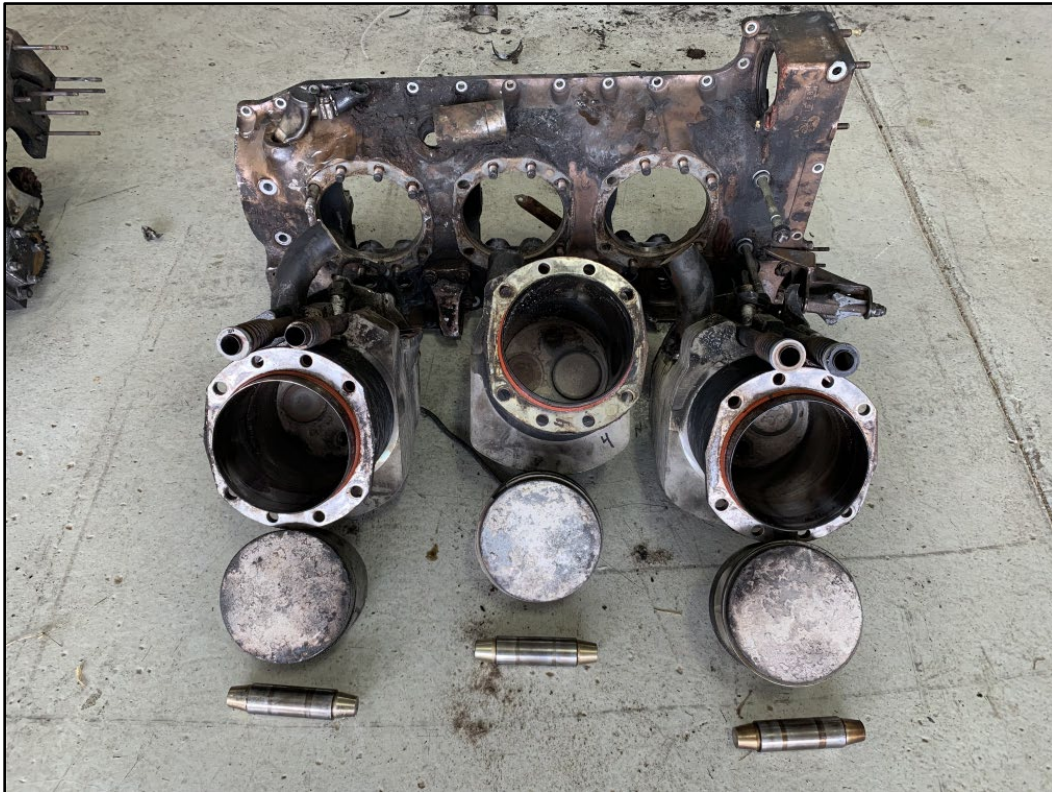
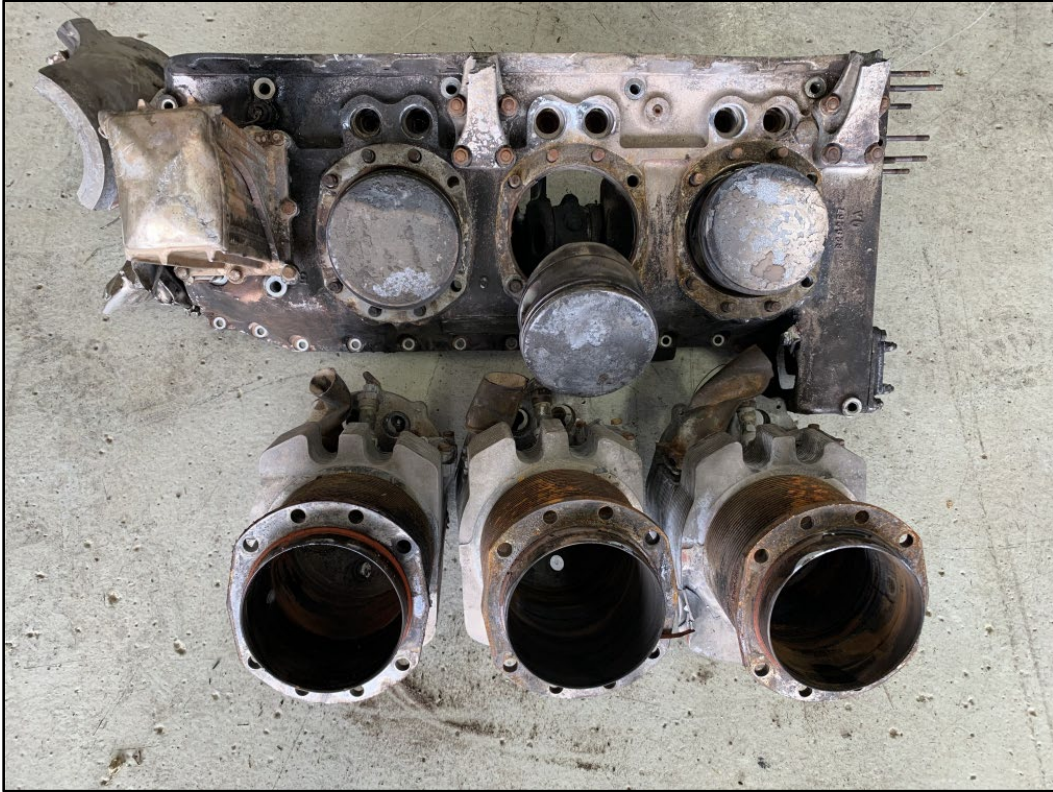
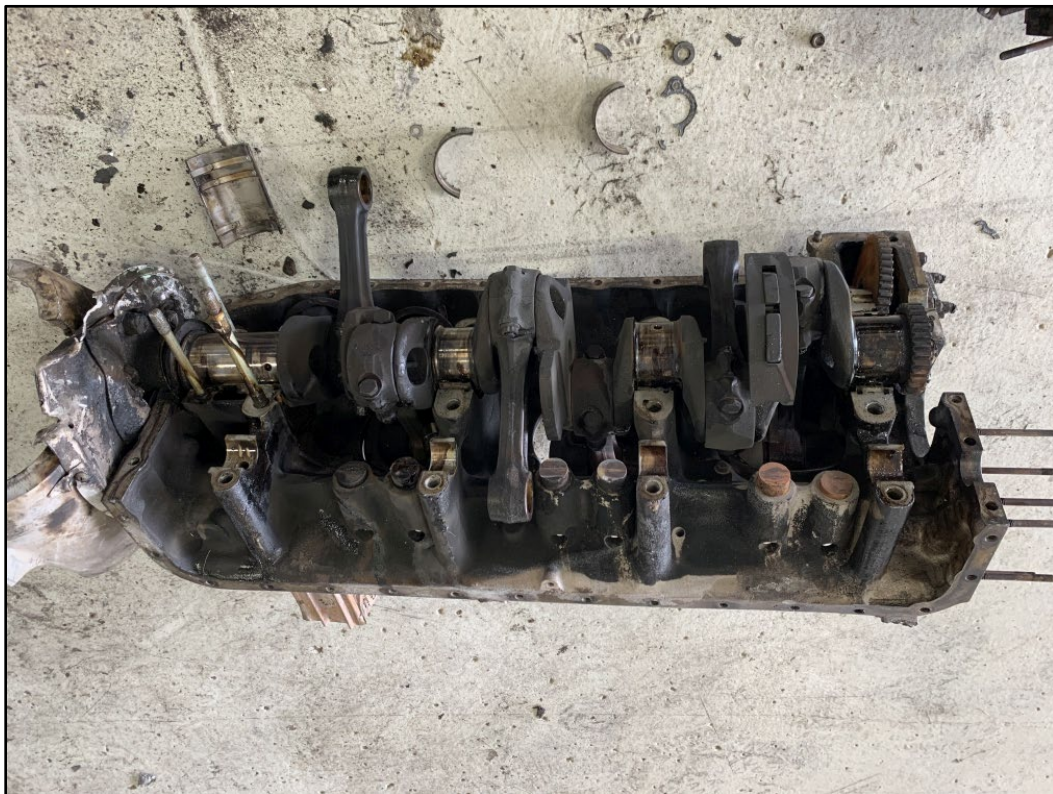
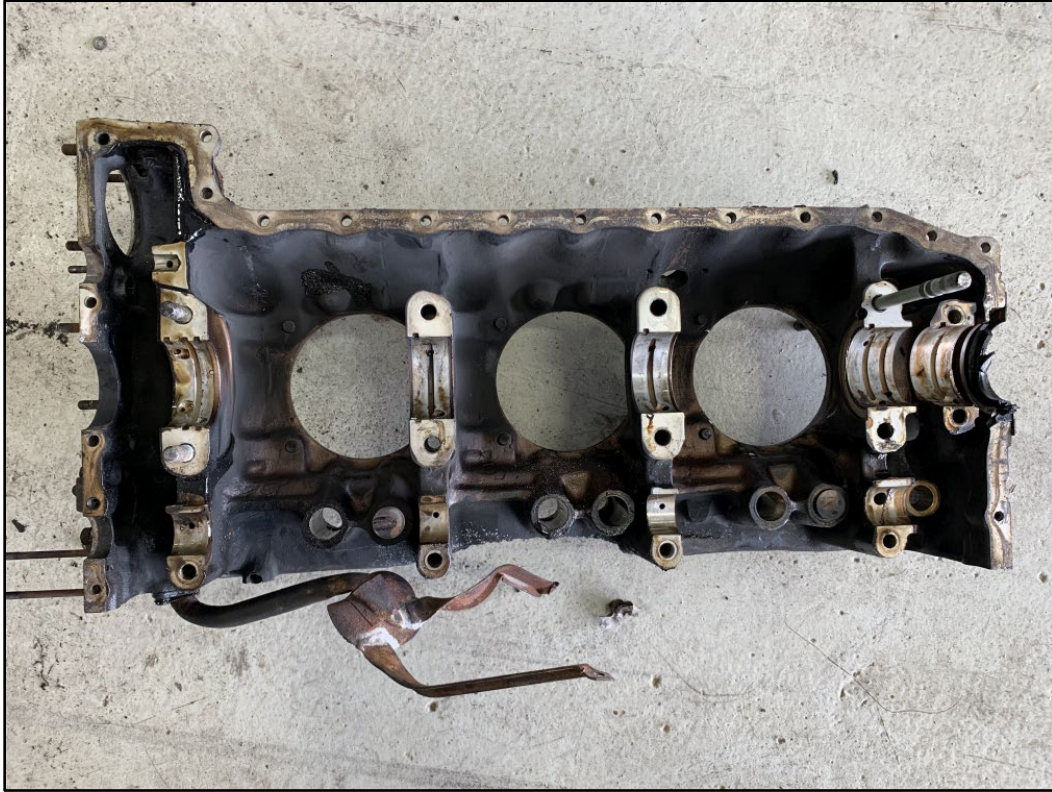
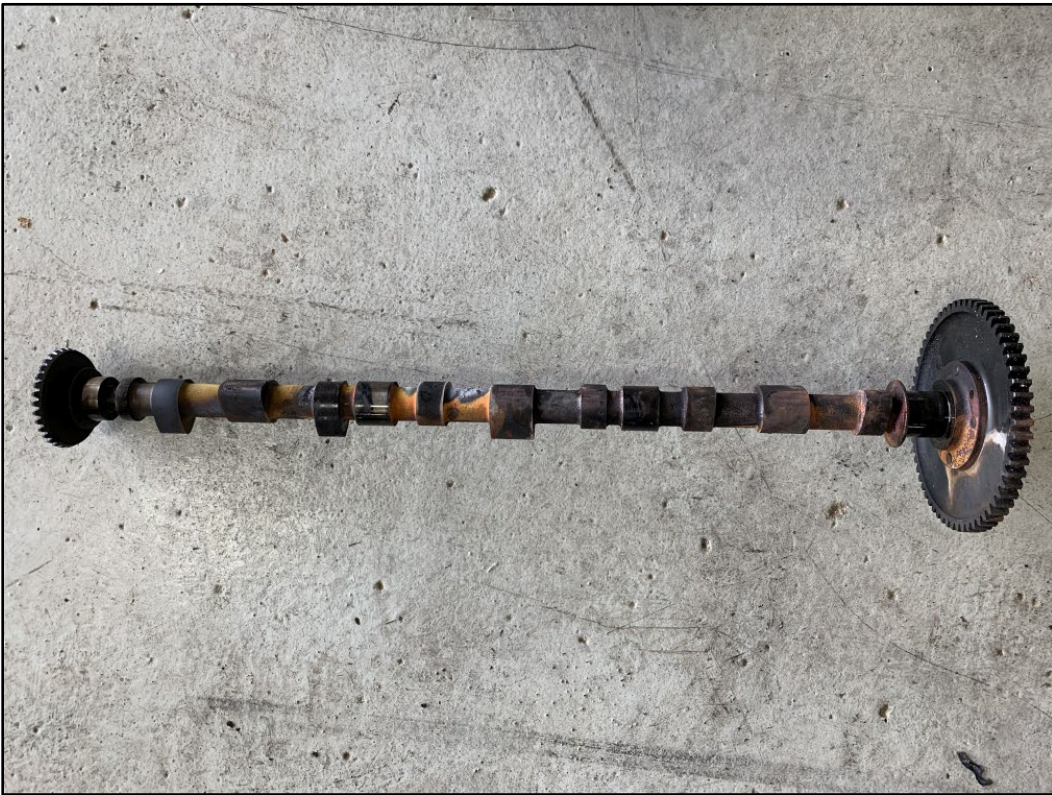
The engine crankshaft could not be rotated due to extensive thermal damage. A borescope examination of each cylinder confirmed no anomalies with the cylinders, pistons, valves, or valve seats. A full engine disassembly did not reveal any mechanical malfunctions or failures that would have prevented normal operation, as shown in figures 25-29.
