**Photo 1 – Exemplar Photo of the Accident Airplane**

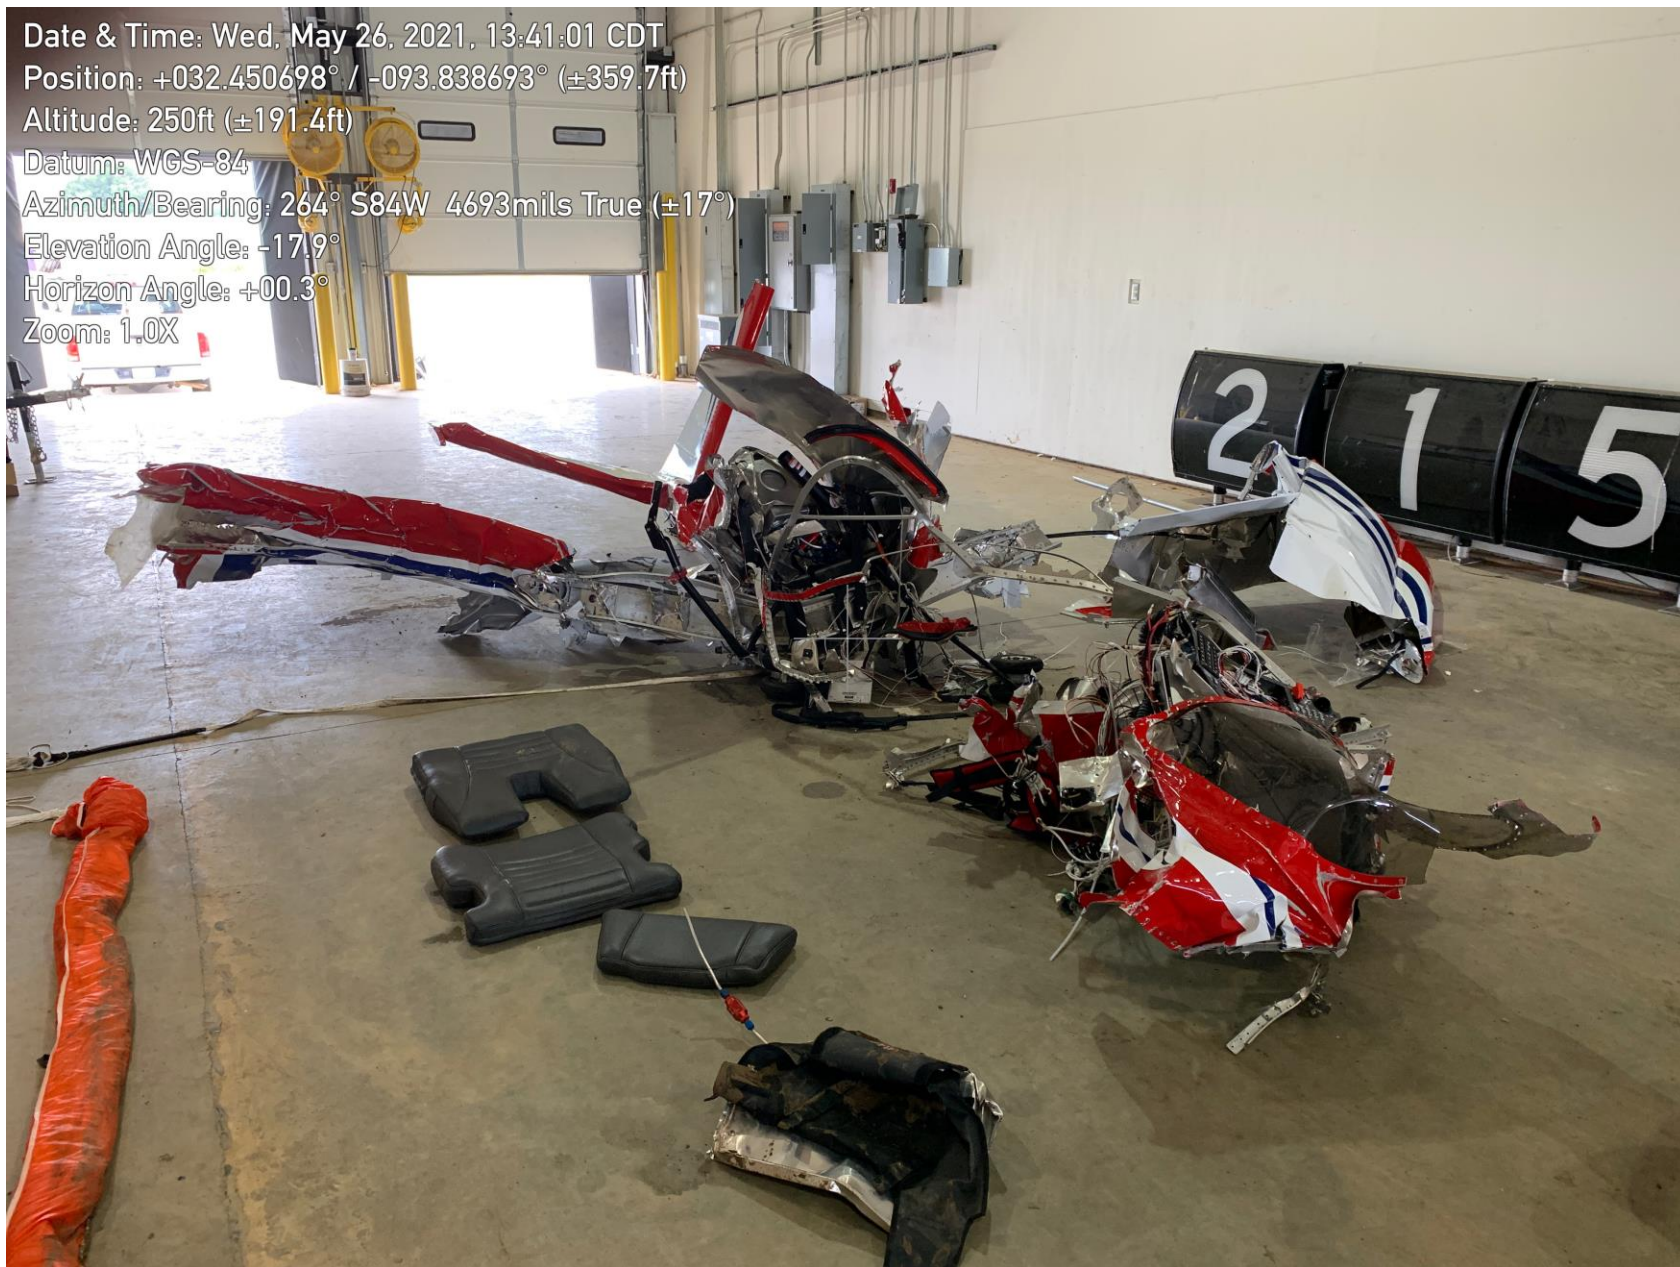
**Photo 2 – Airplane Wreckage**

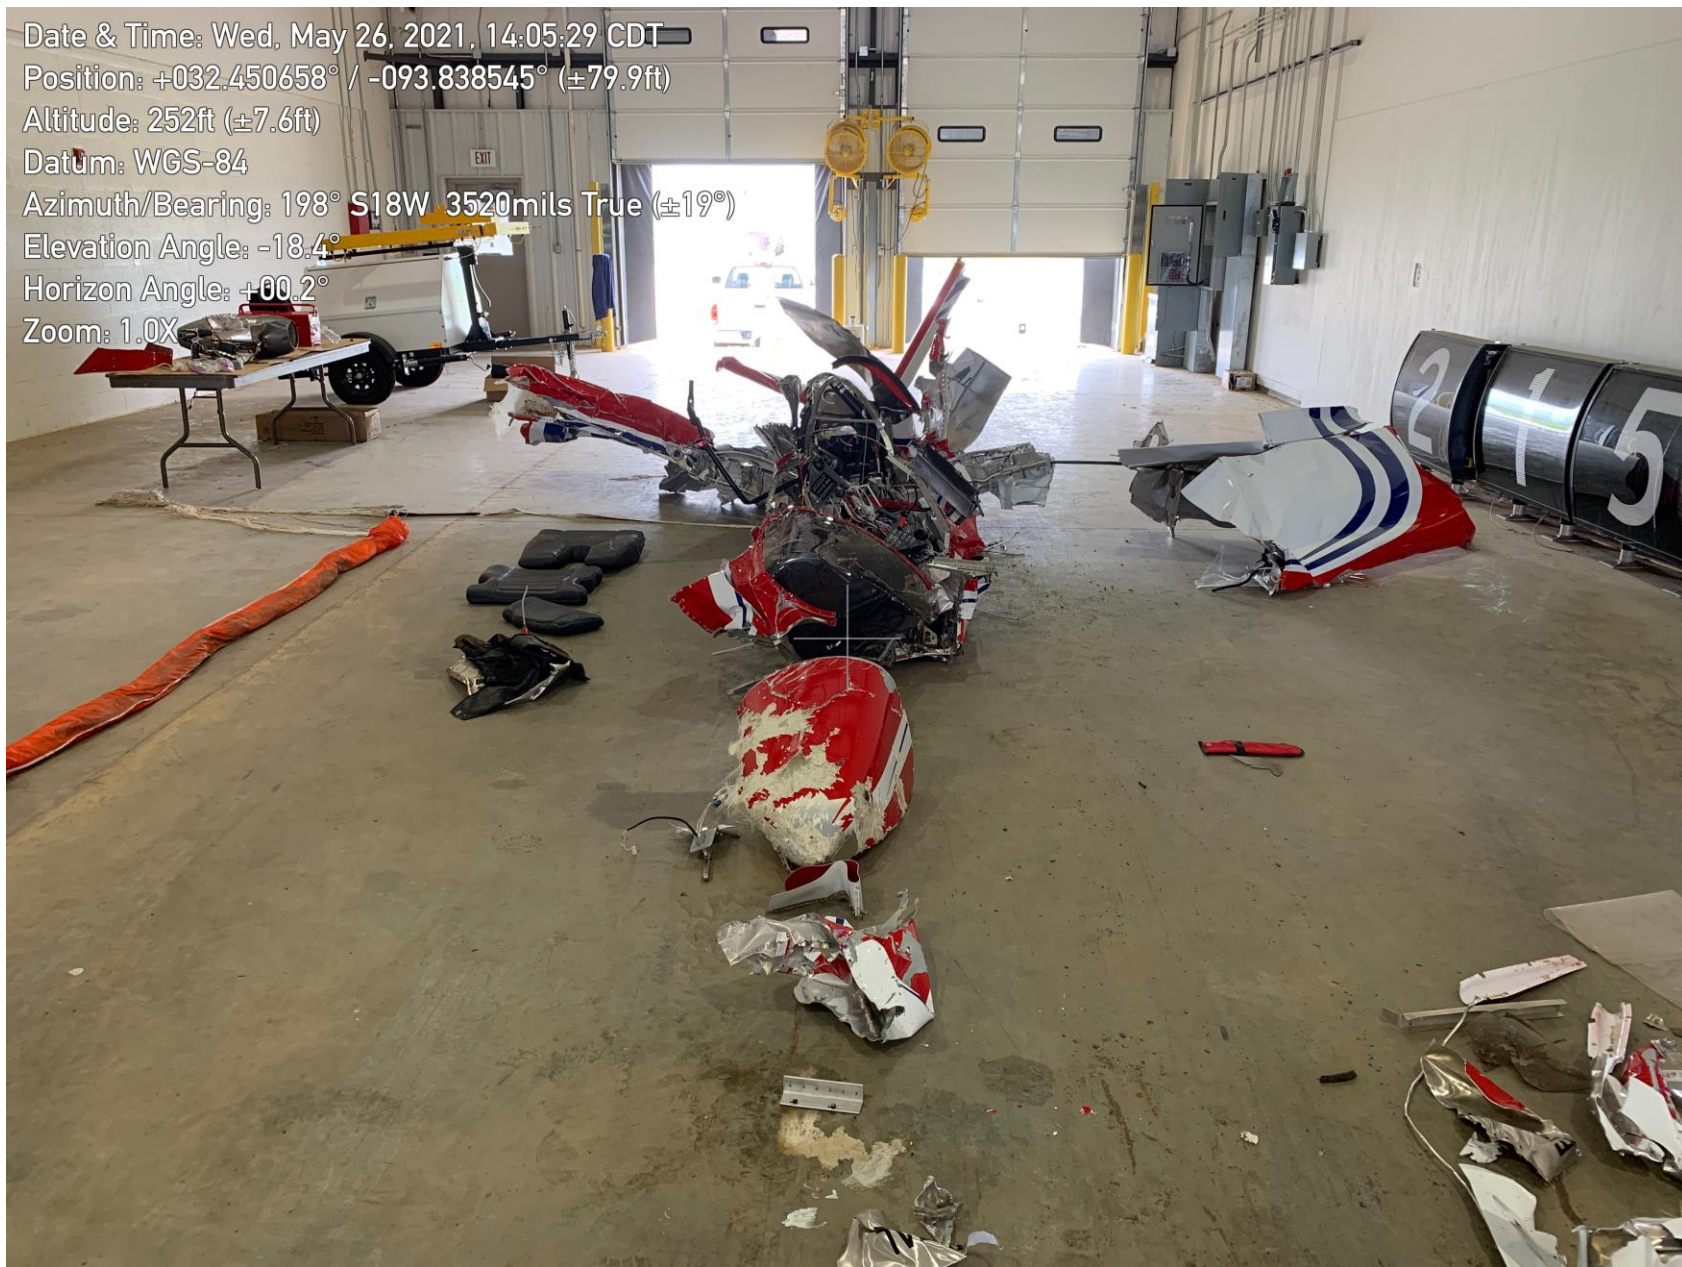
**Photo 3 – Airplane Wreckage, Front**

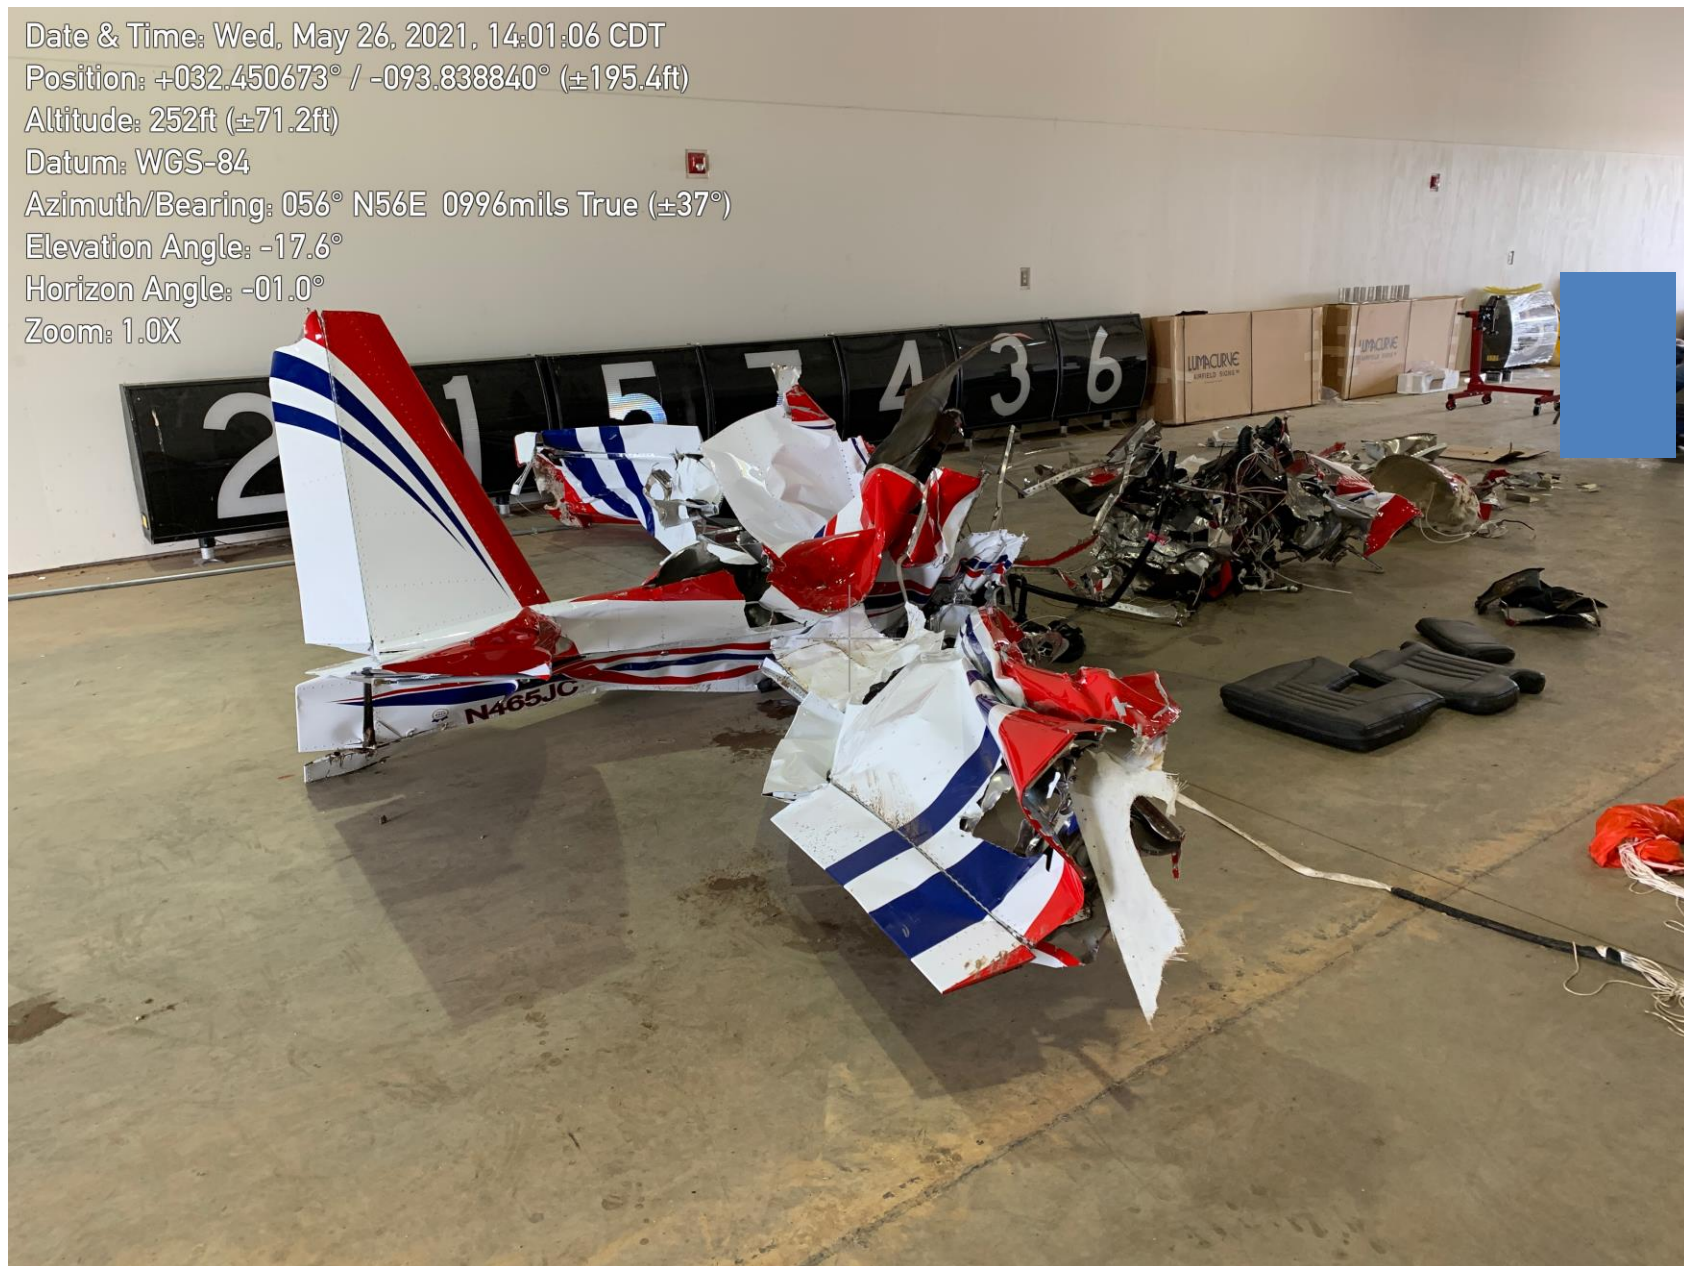
**Photo 4 – Airplane Wreckage, Right Side**

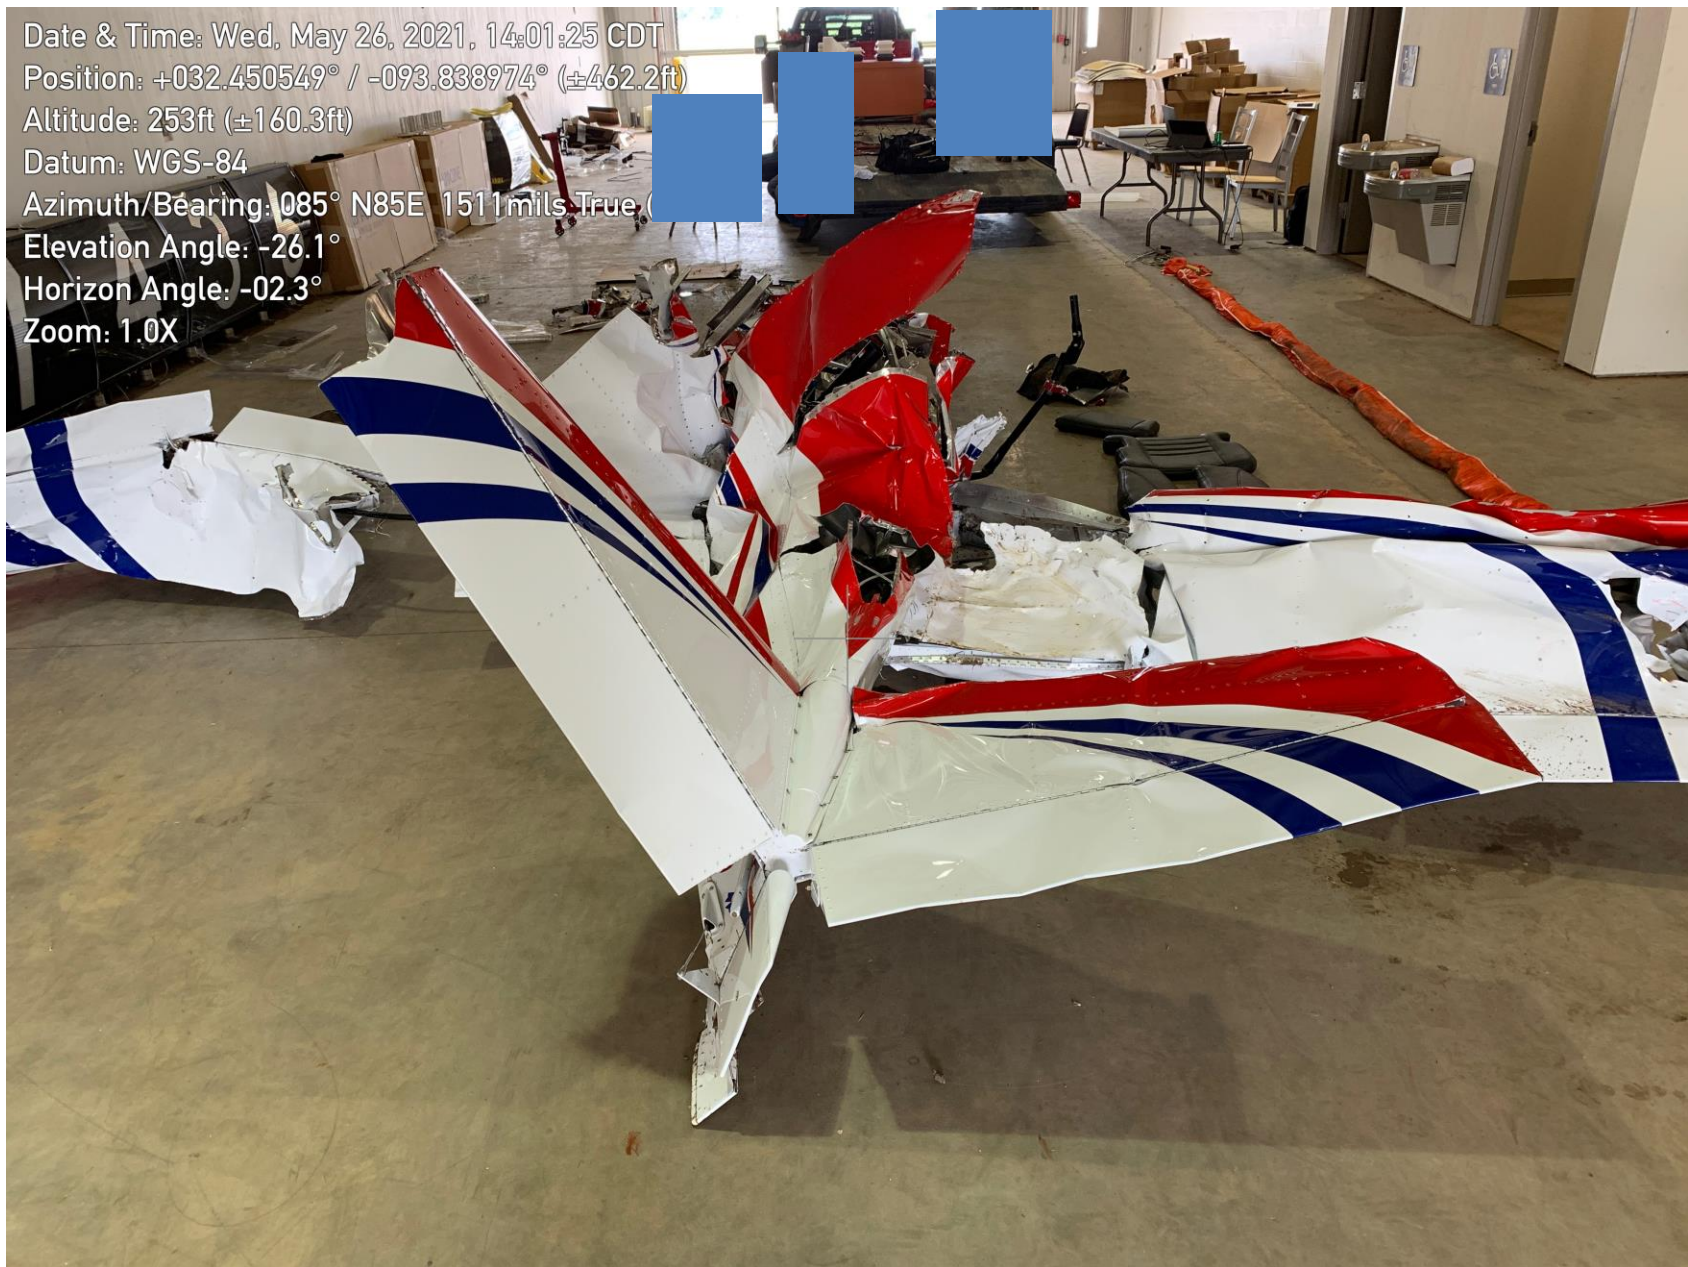
**Photo 5 – Airplane Wreckage, Aft**

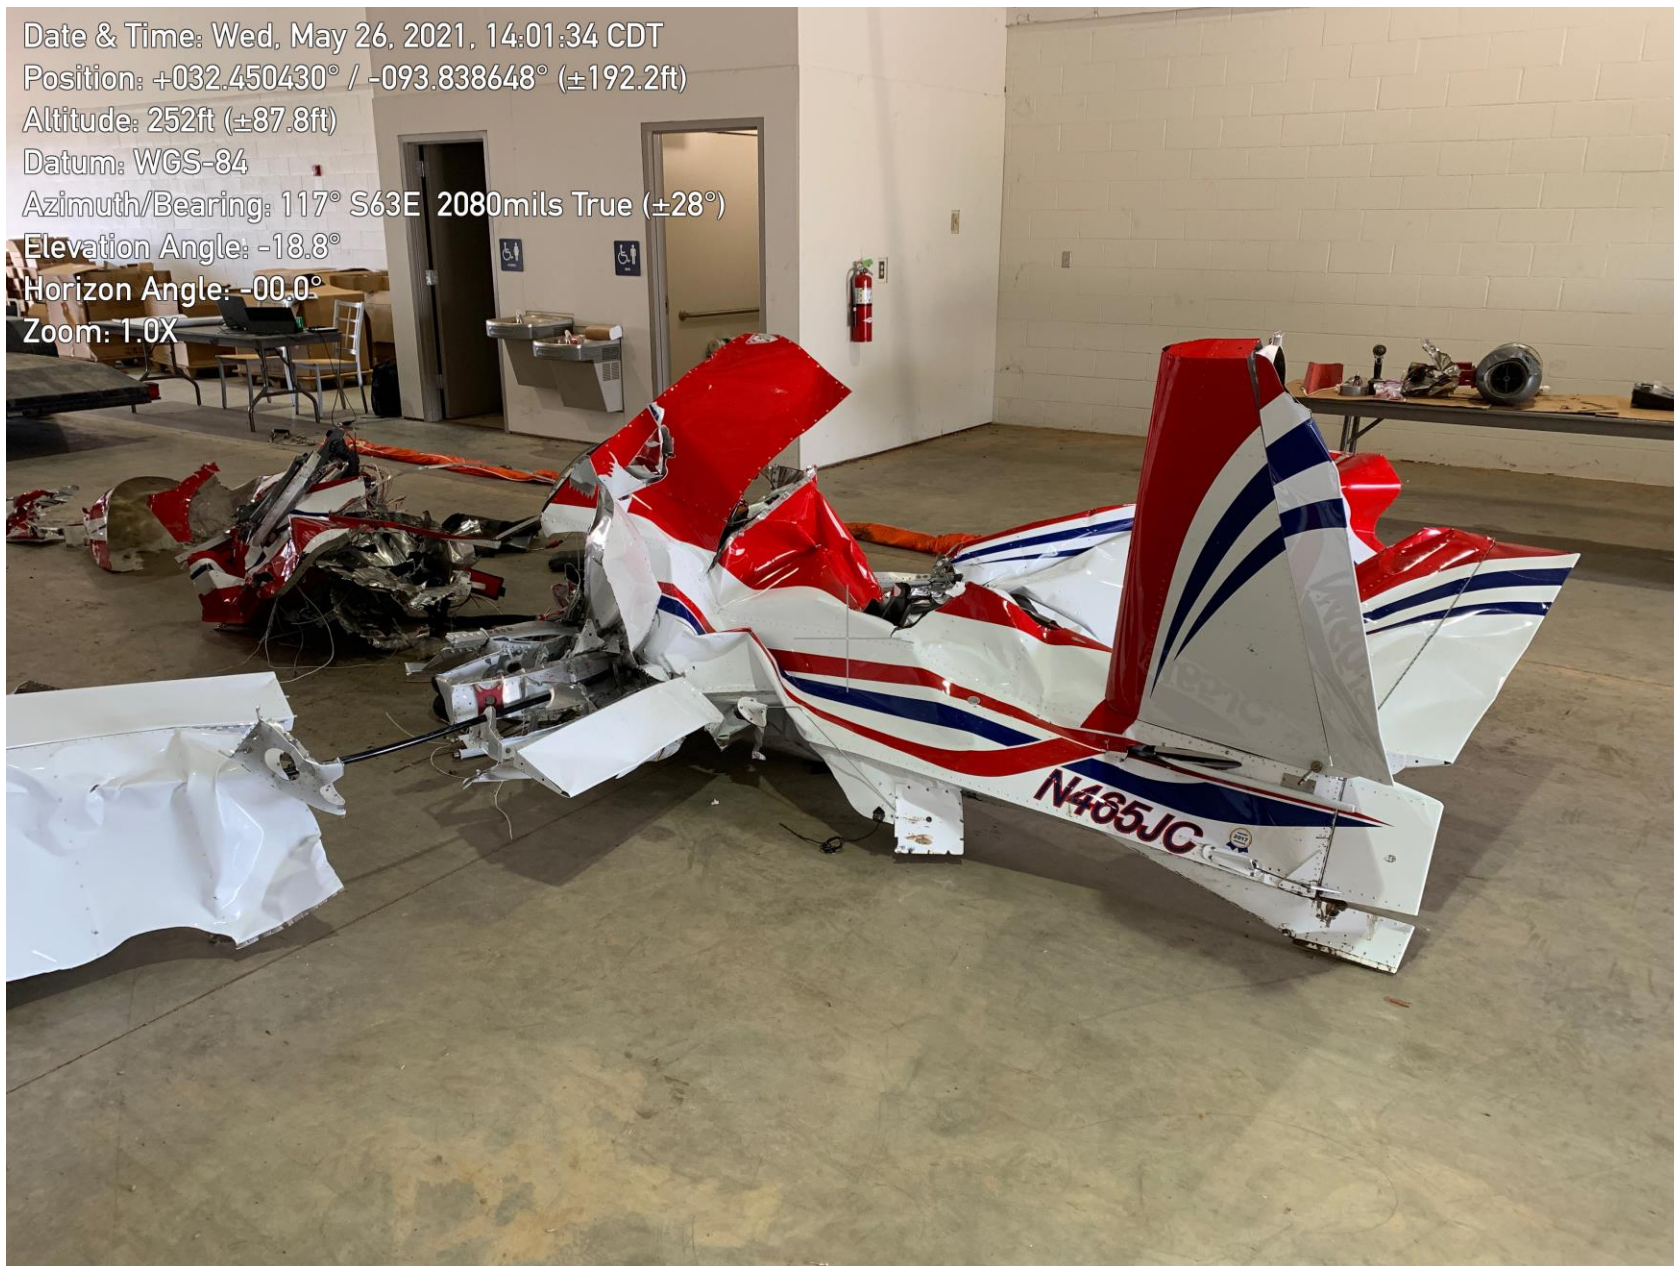
**Photo 6 – Airplane Wreckage, Left Side**

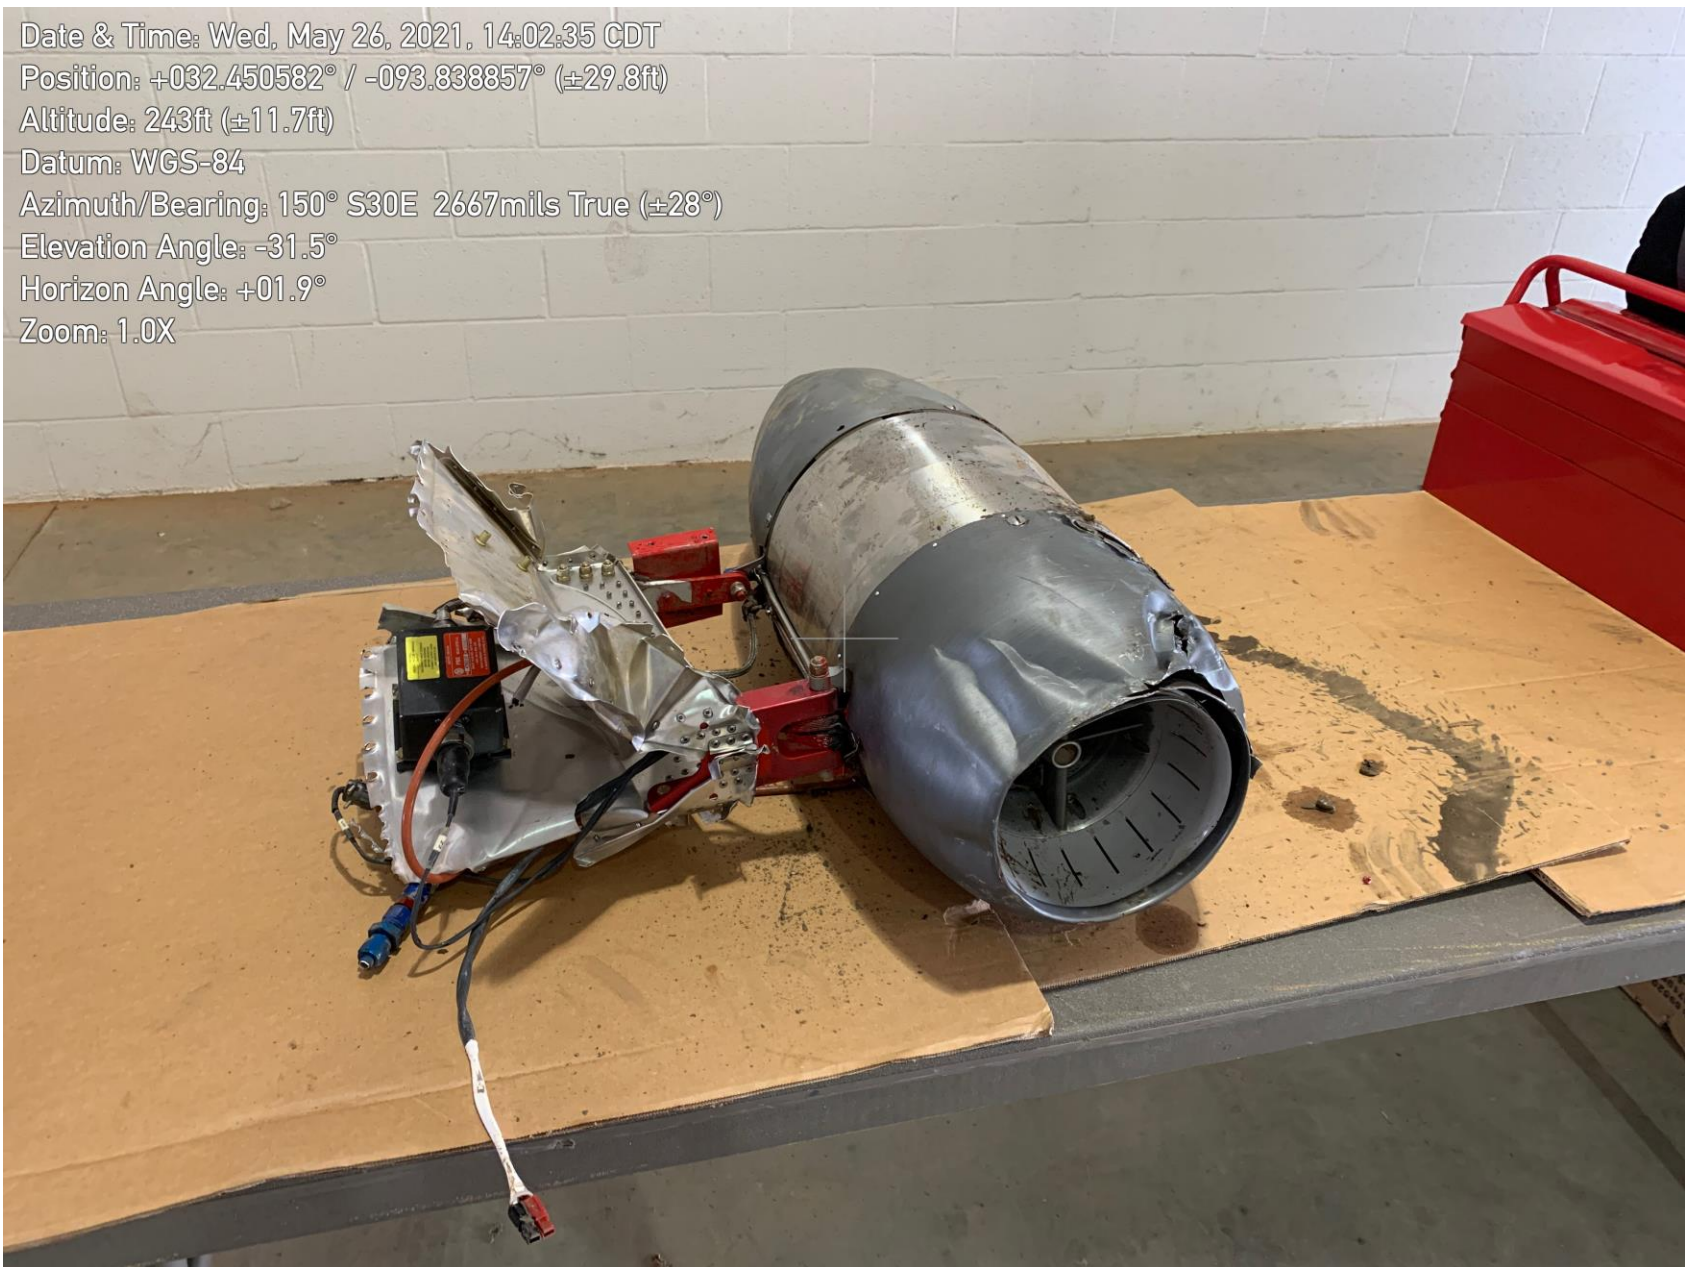
**Photo 7 – Airplane Engine and Pylon**

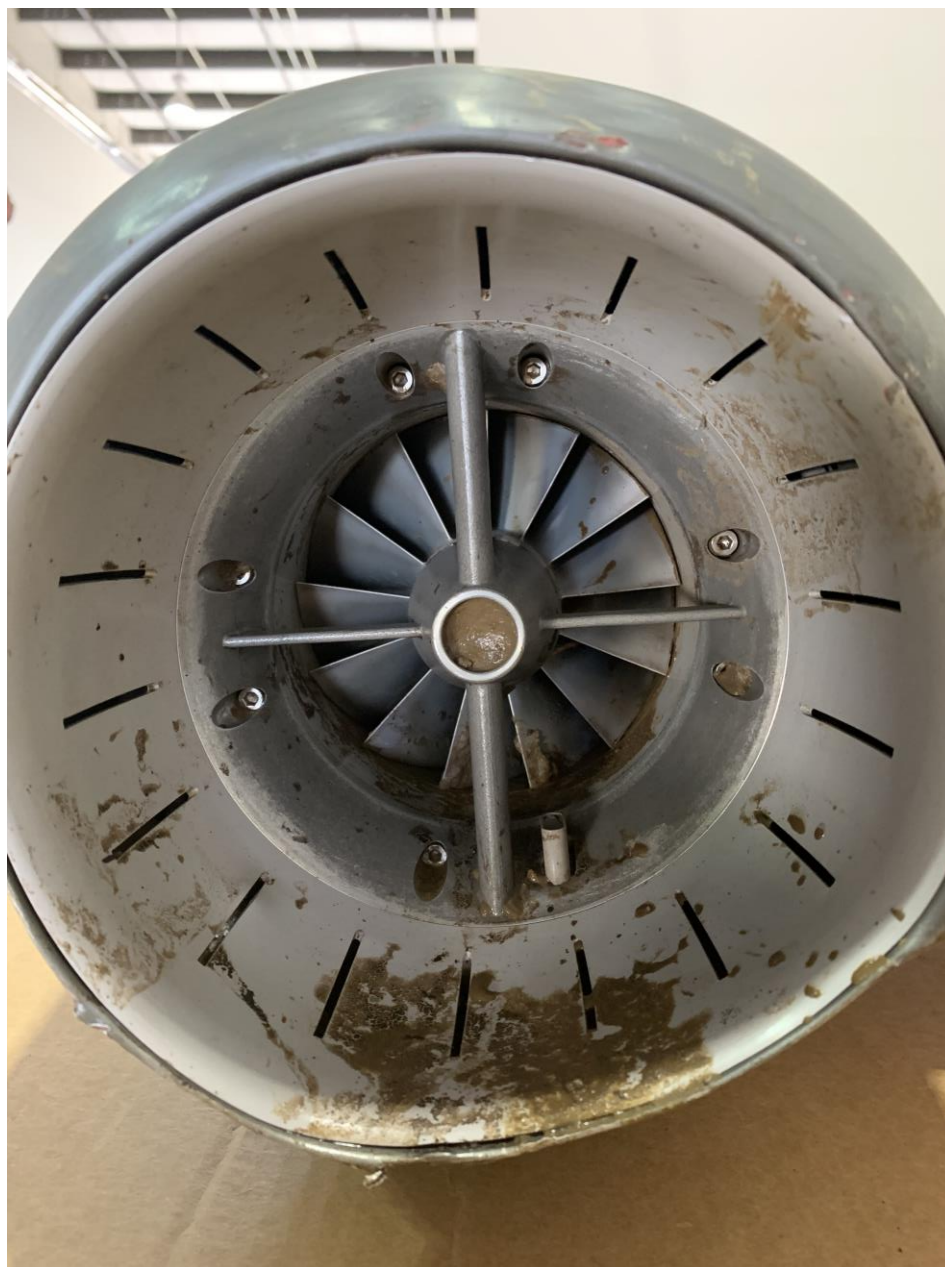
**Photo 8 – Engine Inlet**

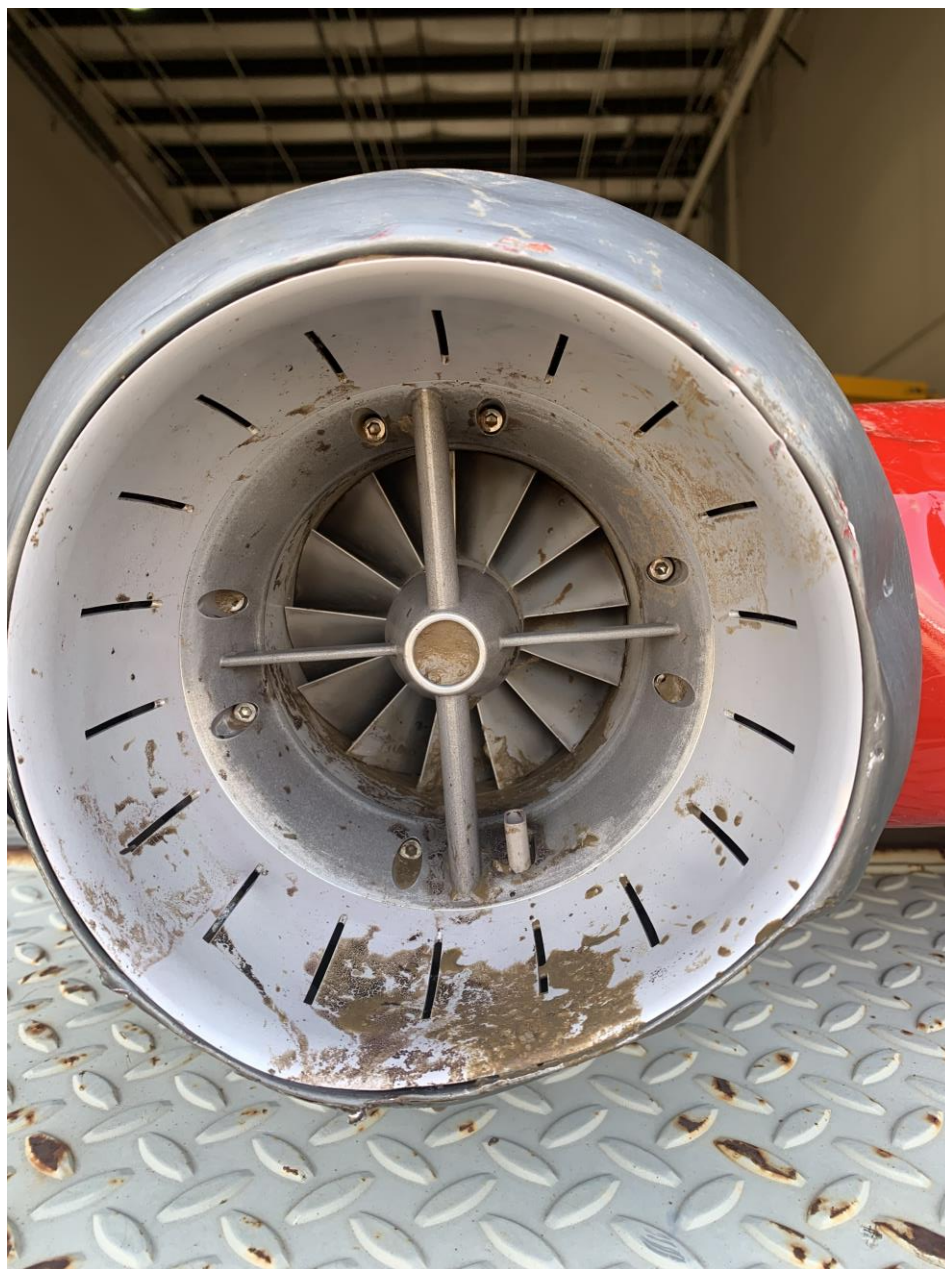
**Photo 9 – Engine Inlet and Compressor Disc**
