# National Transportation Safety Board

CEN21FA230

## FIELD EXAMINATION REPORT

CEN21FA230  
Shreveport, Louisiana  
May 23, 2021  
1447 CDT

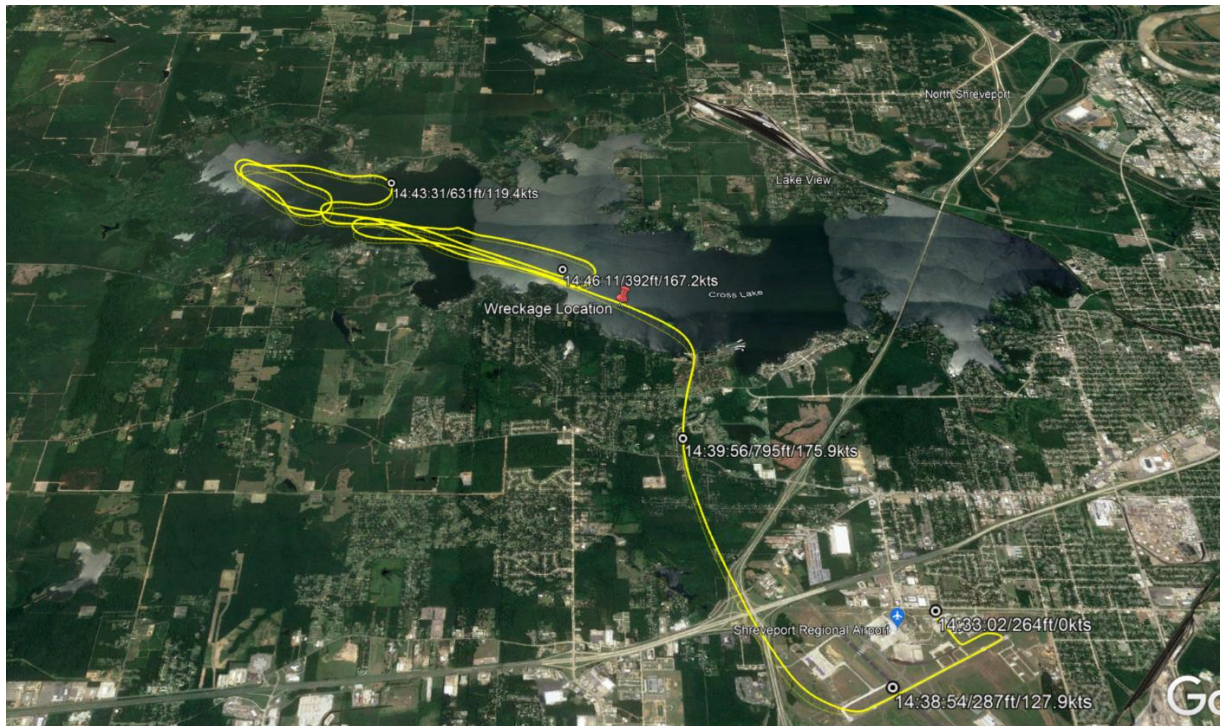
The intent of the flight was to fly over Cross Lake after departing the Shreveport Regional Airport (SHV). Automatic Dependent Surveillance Broadcast (ADS-B) track data indicated the airplane departed runway (RWY) 24 at SHV, about 1439:00. The airplane made a right turn to the northeast and proceeded to fly over Cross Lake. See Figure 1.

Figure 1. Overall Flight Track

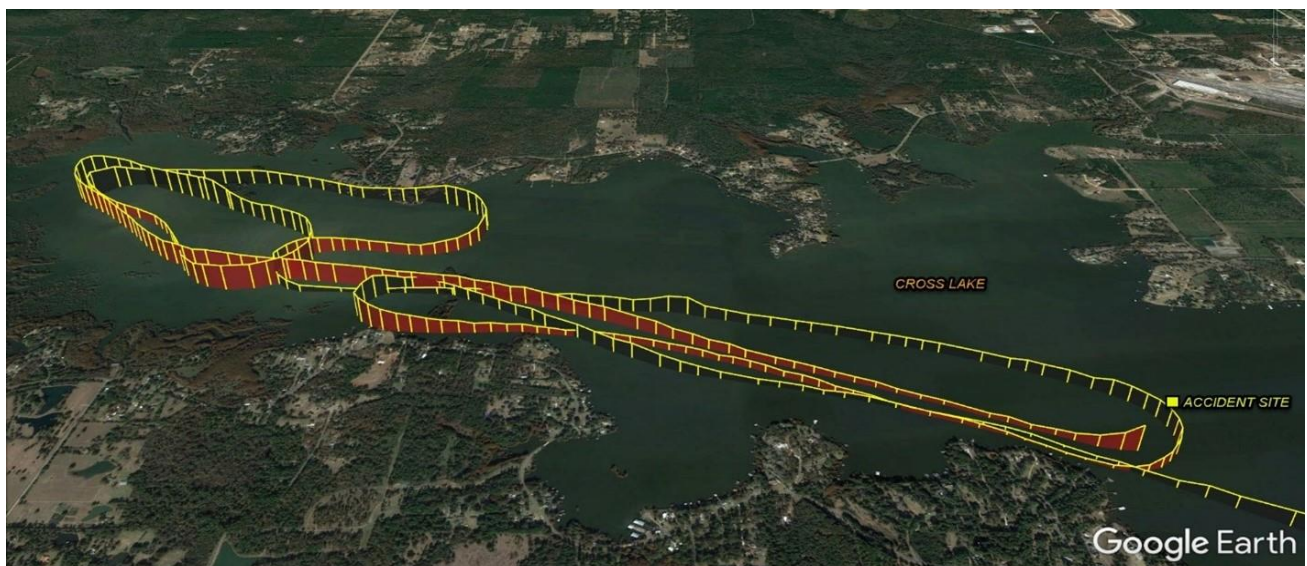
The ADS-B track data showed the airplane maneuvering low-level over the lake until track data was lost at 1446:14. See figure 2.

Figure 2. Flight Path Over Cross Lake and the Accident Location

At the last track data point, the airplane was over Cross Lake at an altitude of 625 ft MSL, 142 kts ground speed, and on a 100° heading. An onboard Garmin GDU 460 cockpit display recorded 13 minutes and 9 seconds of the airplane's flight. At the last recorded point at 1446:20, the airplane was about 400 ft AGL, 170 knots
