### NATIONAL TRANSPORTATION SAFETY BOARD Office of Aviation Safety Washington, DC 20594

#### SUMMARY OF AIRCRAFT EXAMINATIONS

-- CEN21FA238 --

On May 28, 2021, about 1048 eastern daylight time, a Lancair Evolution airplane, N515DL, was destroyed when it was involved in an accident near McDermott, Ohio. The private pilot and passenger were fatally injured. The airplane was operated as a Title 14 *Code of Federal Regulations* Part 91 personal flight.

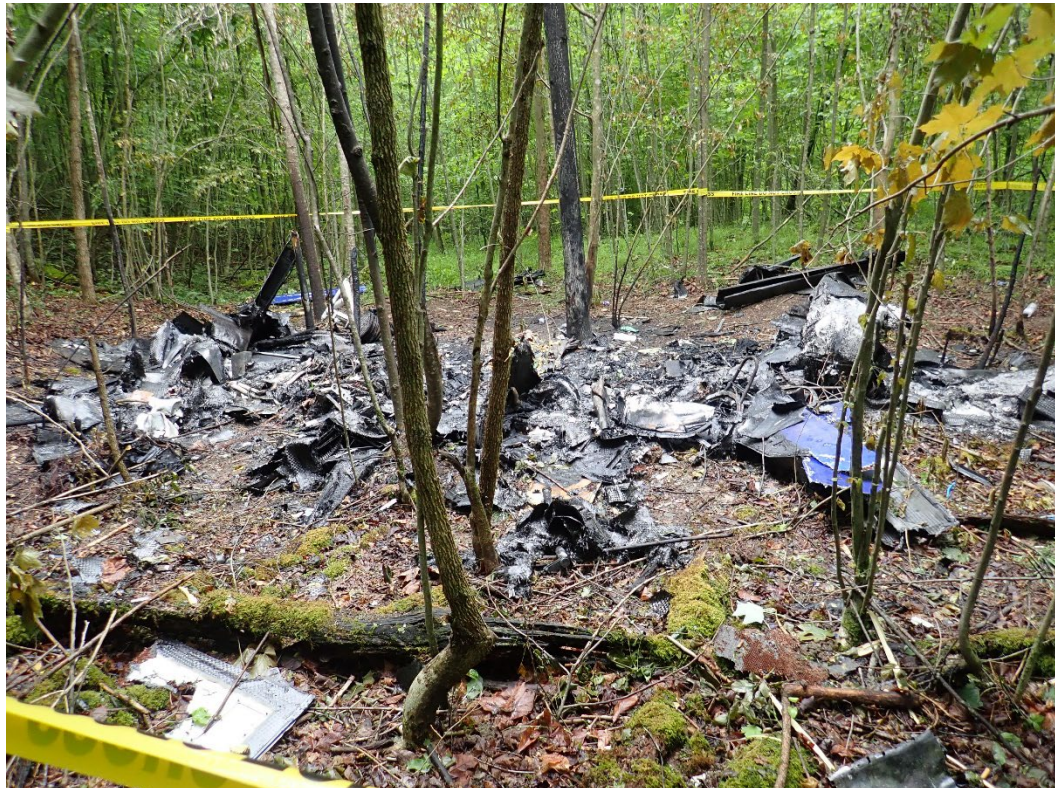
The airplane descended at a nearly vertical angle and impacted into a forested area. The wreckage was significantly fire damaged (reference Photo 1).

*Photo 1 – Accident Site*

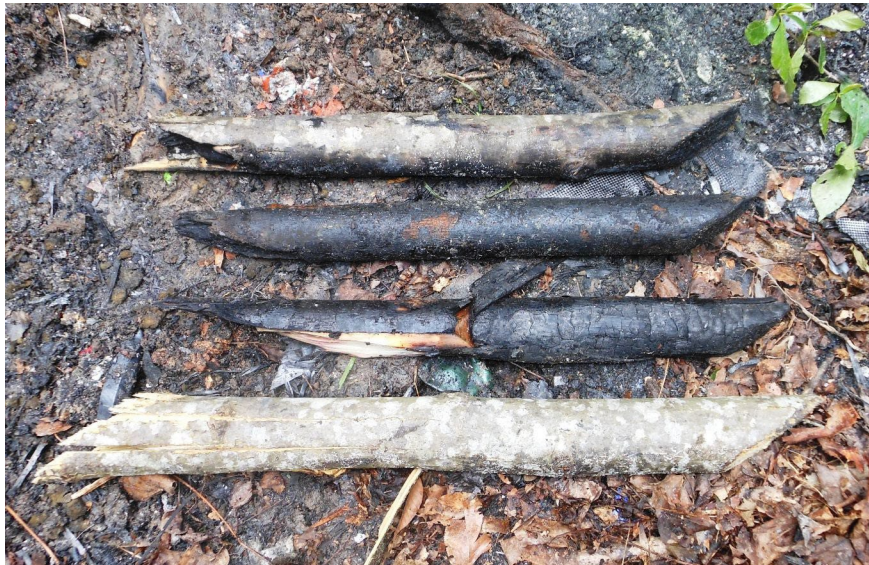
Several tree branch cuts consistent with propeller impact were found at the accident site (reference Photo 2).

*Photo 2 - Cut tree branches*

The tree branch segments ranged in length from 2 ft to 2.5 ft long. Based on 1,900 engine rpm, the segment lengths were consistent with an airplane descent rate of about 15,000 to 19,000 feet per minute.

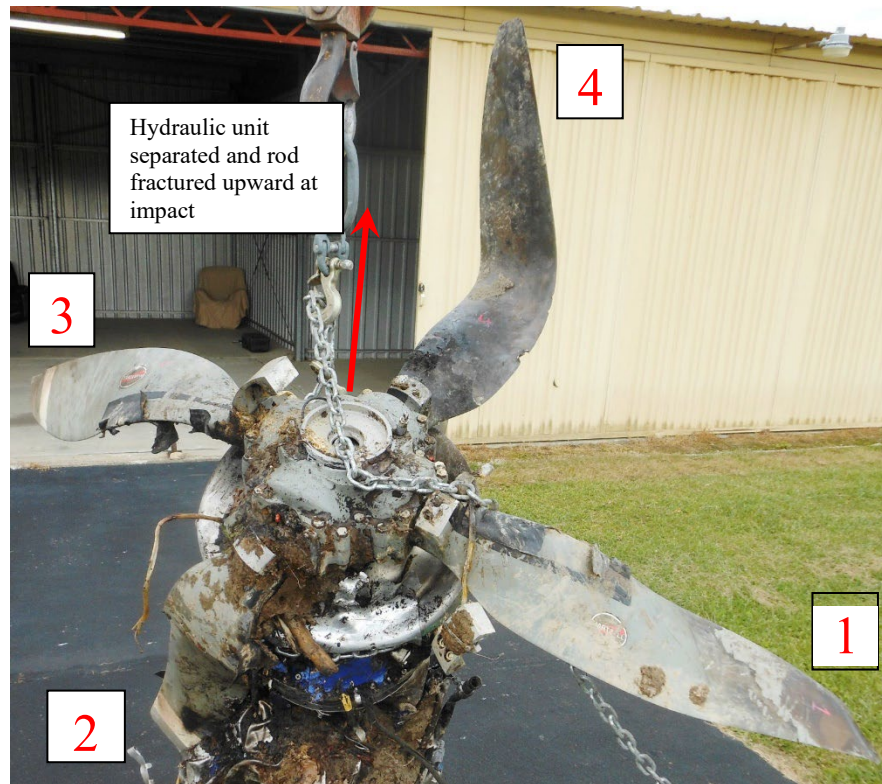
The propeller blades were numbered #1 through #4 counter-clockwise as viewed from the aft side (reference Photo 3).

*Photo 3 – Propeller at airport hangar*

Blades #1 through #3 had chordwise/rotational scoring, and blades #1 and #3 were bent aft and twisted toward low pitch. Blade #1 had S-bend characteristics and blade #3 was bent opposite rotation. Blade #1, #2, and #4 counterweights fractured from the blade.

Blades #1, #3 and #4 could be partially rotated by hand force, consistent with the pitch change mechanism (knob and/or fork) being fractured. All four blades were in an

operational or low pitch blade angle range (not feathered).

Propeller damage was consistent with impact into terrain while turning under power in a normal blade angle range of operation, with the propeller not feathered.

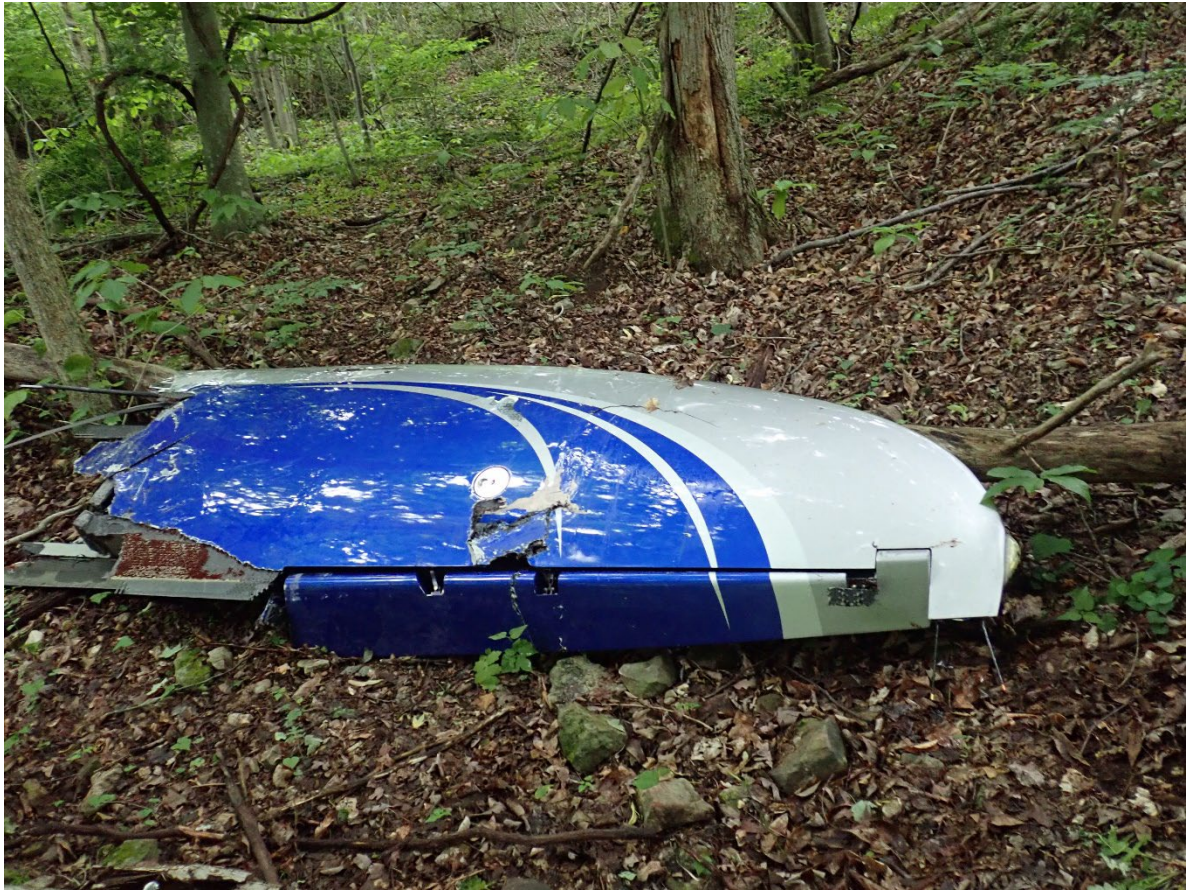
The outboard section (11 ft) of the right wing (see Photo 4) was separated outboard of the landing gear well. The upper surface of the right wing contained impact marks near the fuel cap from the leading to trailing edge.

*Photo 4 – Right wing that separated inflight*

Visual examination of the wing revealed areas exhibiting fracture features consistent with overstress failure, as well as evidence of areas consistent with possible bond line abnormalities.

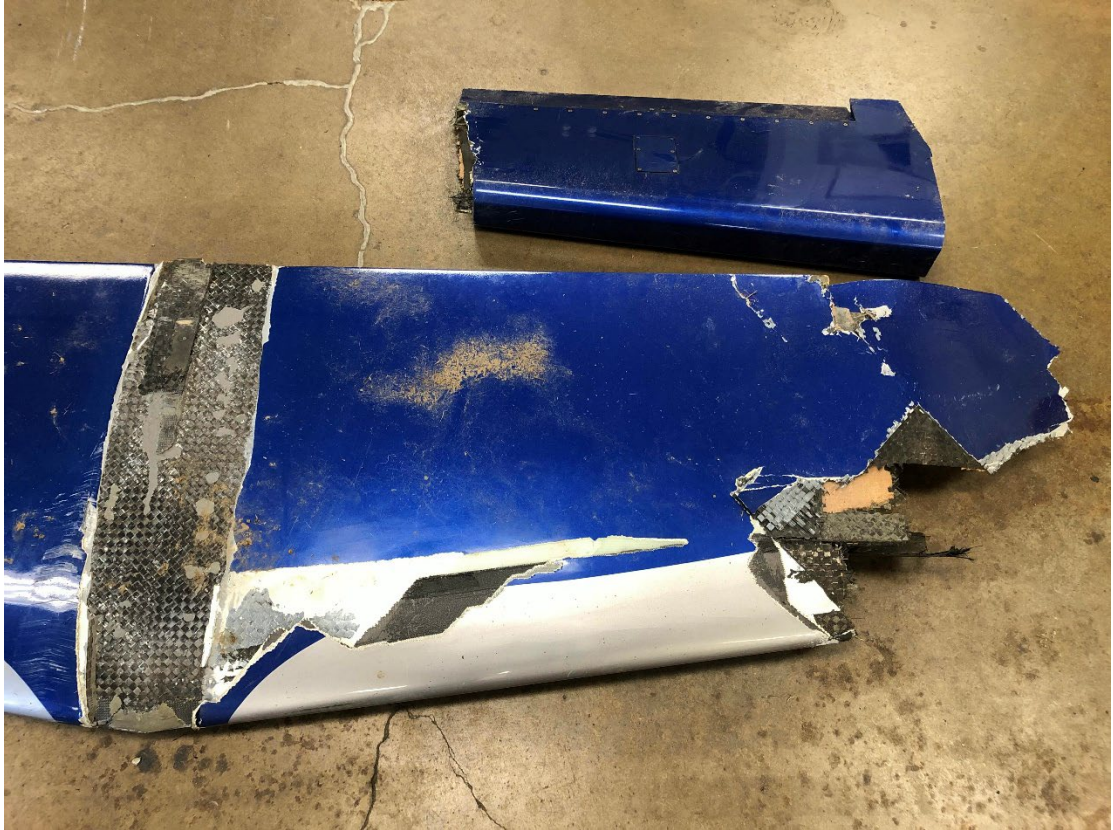
Most of the horizontal stabilizer and a 3 ft section of the left elevator (see Photo 5) were recovered by law enforcement in a corn field about ¾ mile northeast of the main wreckage. The outboard 3 ft of horizontal stabilizer separated and was not yet recovered.

*Photo 5 – Horizontal stabilizer and left elevator that separated inflight*

The upper surface of the horizontal stabilizer exhibited evidence fracture features consistent with overstress failure, as well as possible bond line anomalies between the vertical stabilizer and horizontal stabilizer mating structures.

The lower surface of the horizontal stabilizer to empennage exhibited fracture features consistent with overstress failure, as well as evidence of possible bond line abnormalities.

A review of the build documents and visual examination of the horizontal stabilizer upper surface revealed the omission of additional structural reinforcement angles common to the outboard surfaces of the vertical stabilizer and the upper surface of the horizontal stabilizer.

The left side elevator was separated from the horizontal stabilizer, with the left-hand elevator center hinge fitting twisted counterclockwise when viewed from the aft position. The examined fractures exhibited features consistent with an overstress failure.
