# NATIONAL TRANSPORTATION SAFETY BOARD

## MATERIALS LABORATORY FACTUAL REPORT

Report No. 22-012

Place : McDermott, Ohio  
Date : May 28, 2021  
Vehicle : Lancair Evolution, N515DL  
NTSB No. : CEN21FA238  
Investigator : Mike Folkerts, AS-CEN

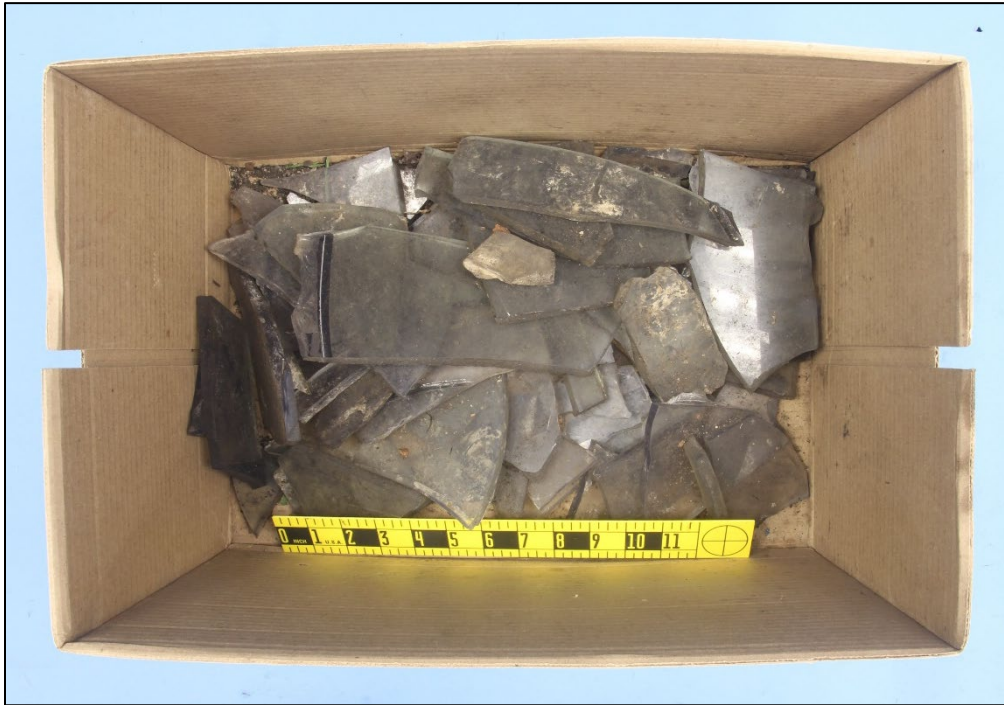
Pieces of the windshield from the accident airplane as recovered from the impact location were received as shown in figure 1. Although no evidence of a pre-impact failure was noted in the preliminary findings, the pieces were submitted for examination at the request of the NTSB laboratory.

Figure 1. Overall view of the box of submitted windshield pieces.

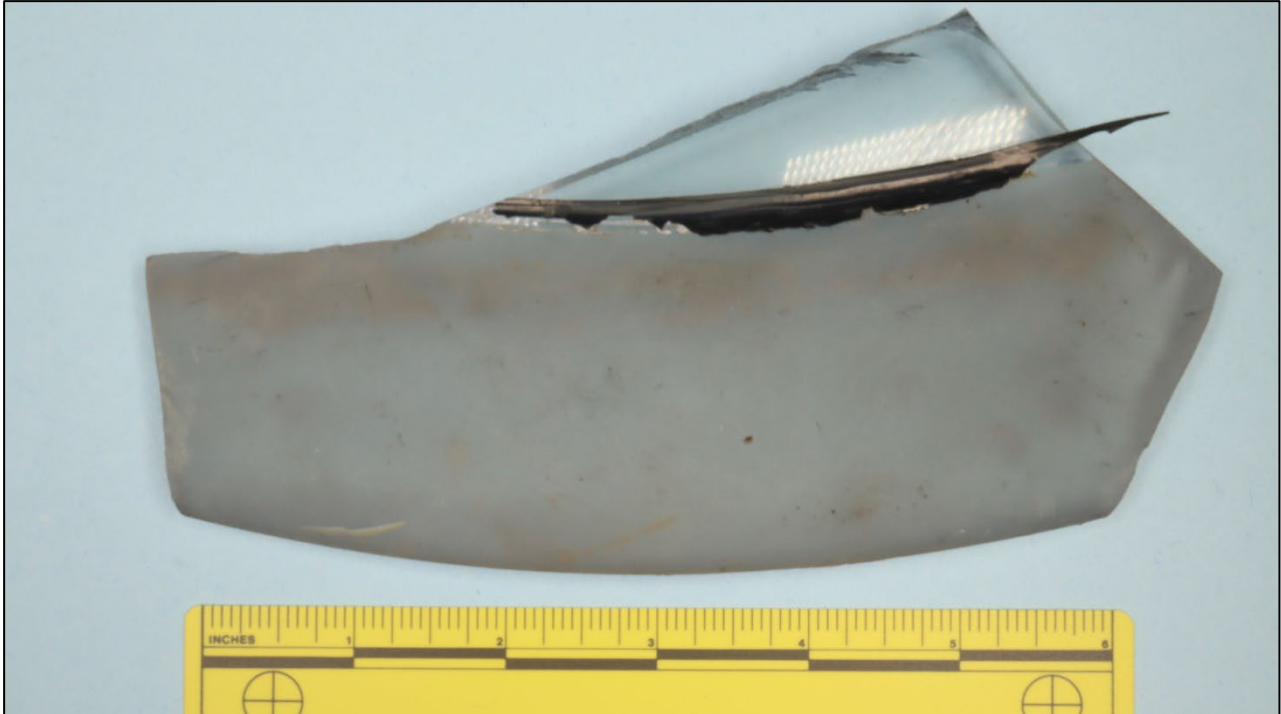
As installed in the airplane, the interior and exterior surfaces around the perimeter of the windshield are roughened and bonded to the composite fuselage. Most of the pieces shown in figure 1 were middle pieces that did not intersect the bond area at the windshield perimeter. Among the submitted pieces, the piece shown in figure 2 was selected as a representative sample of the windshield bond area and edge profile that was chosen for further examination.

The thickness of the windshield was measured on the clear portion of the piece shown in figure 2. The thickness measured 0.3733 inch

Figure 2. View of a piece from the windshield perimeter after cleaning with a solution of Alconox and water and light brushing.

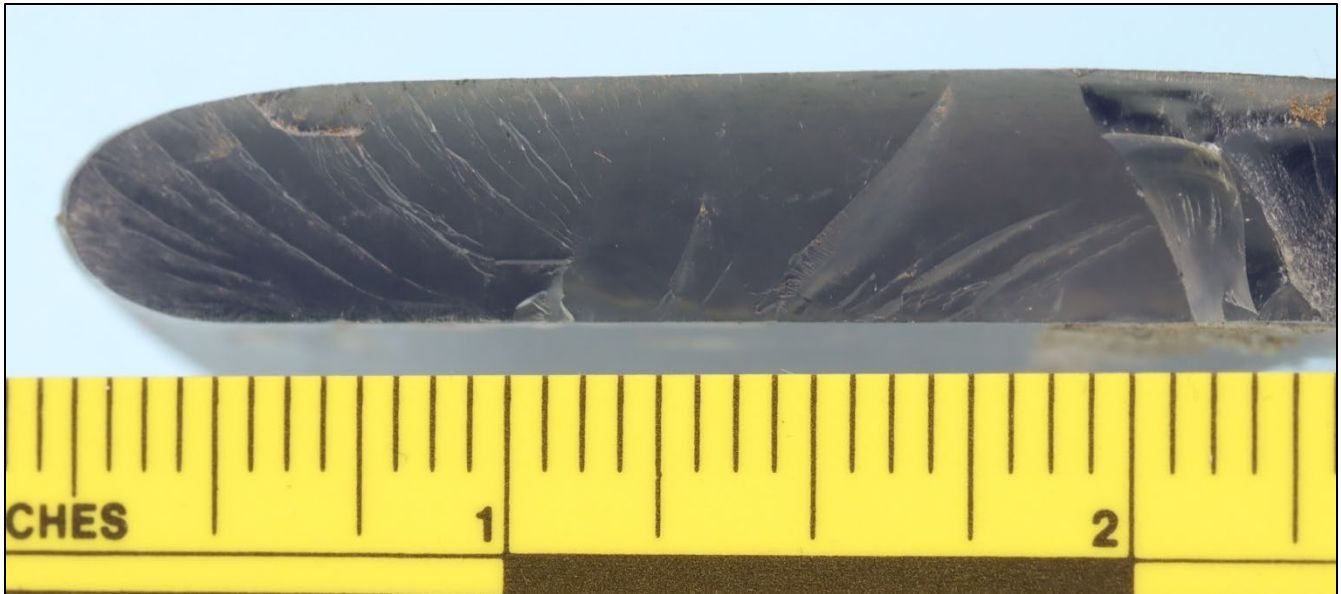
The selected windshield piece was cleaned using a solution of Alconox and water, and surface debris was removed by gentle brushing with a soft-bristle brush. The finished outer edge of the selected piece had a rounded profile as shown in figure 3, a feature consistent with the profile shown in build instructions for the window installation.

Figure 3. Fracture surface on the piece from figure 2 showing the rounded profile at the outer edge.

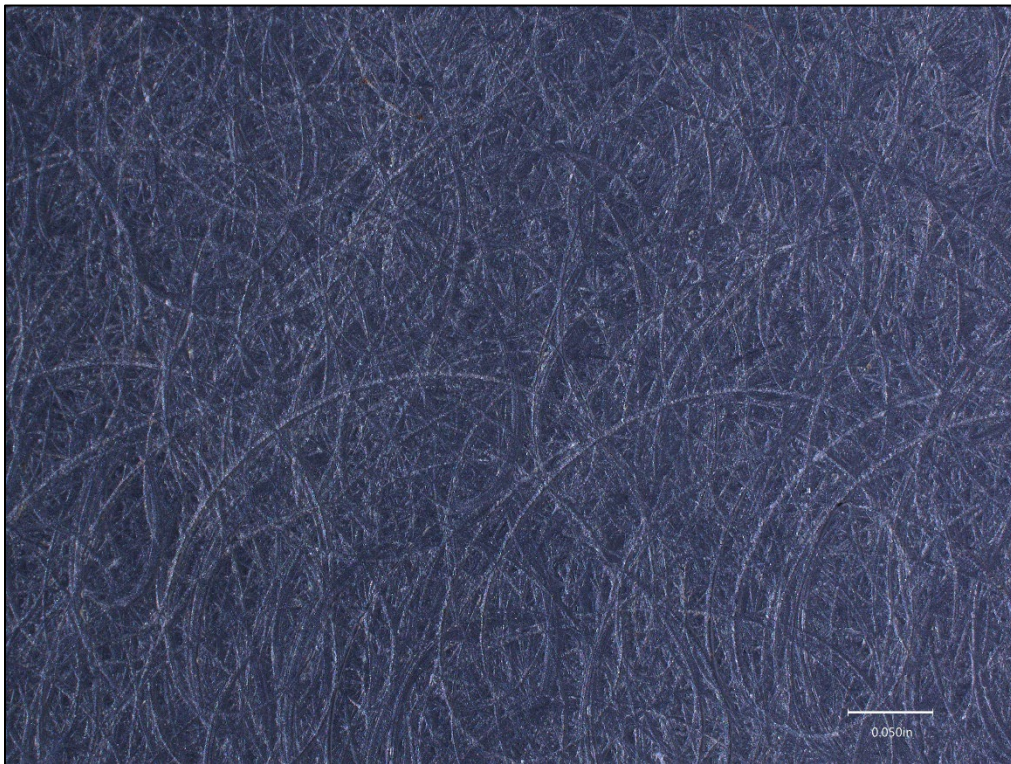
The bond areas had a frosted appearance as shown in figure 2. Upon closer examination, a scratch pattern of overlapping elliptical scratches was observed as shown in figure 4. According to build instructions, the bond area of the windshield is sanded with a dual action (DA) sander with 40-grit paper to produce a frosted appearance before the windshield is bonded to the frame.

Figure 4. Typical scratch pattern on the bond surface on the exterior of the piece shown in figure 2.

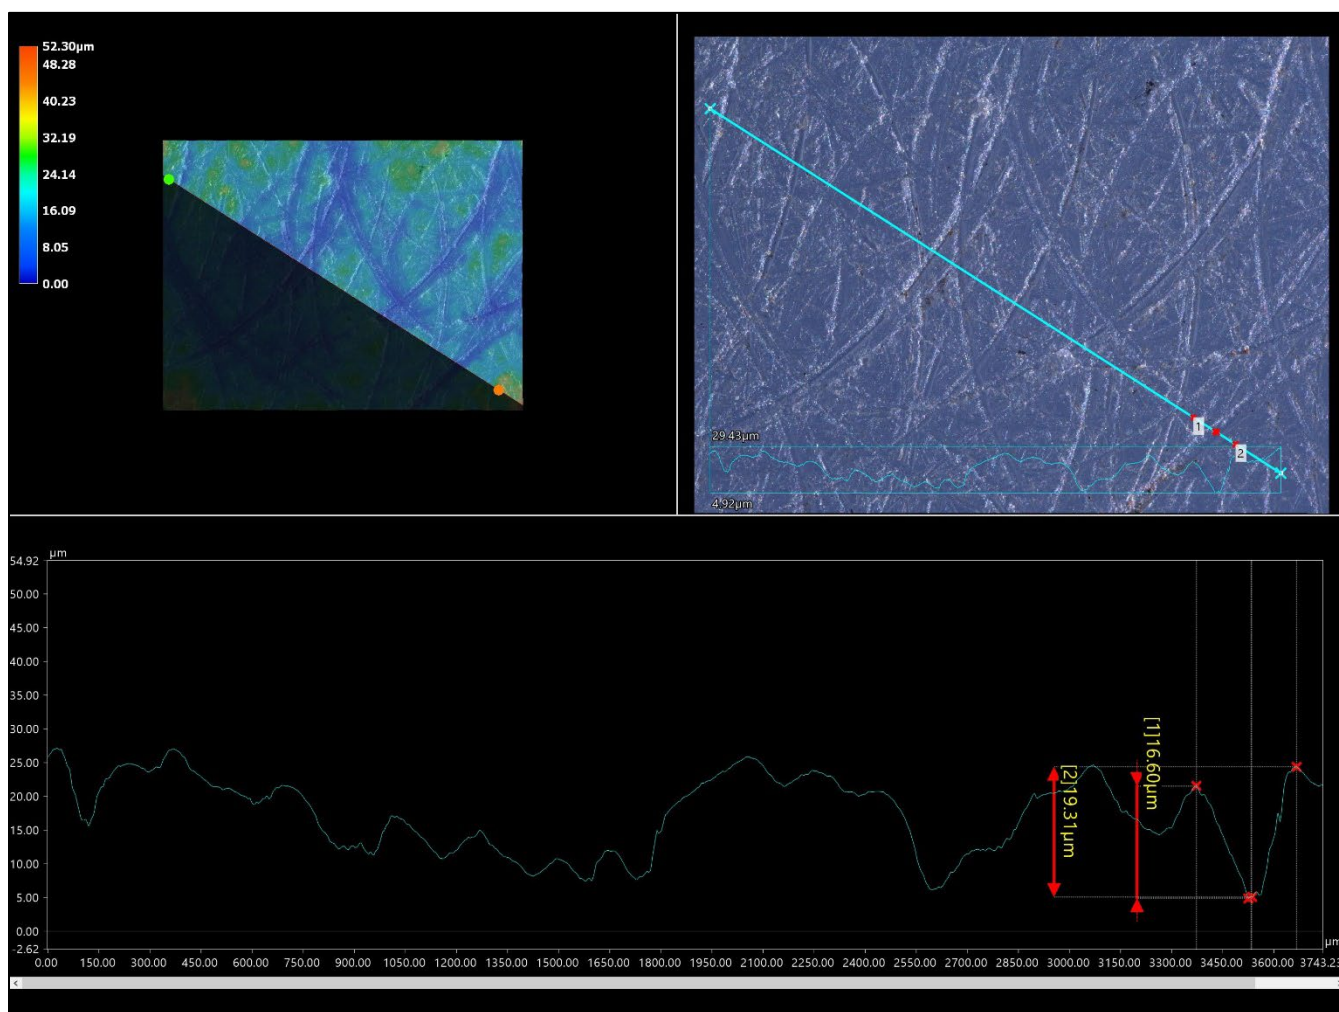
to the entire field of view, and a color-coded depth profile was obtained. Next a depth profile chart was obtained for a linear trace across the surface. The resulting image and profile measurements for the typical area of scratches is shown in figure 5. The deepest scratch in the field of view had measured peak-to-valley height difference of 0.00067 inch to 0.00075 inch (17 micrometers to 19 micrometers).

Figure 5. Color-coded 3D height map (upper left) of the bond surface area (upper right image) with relatively deep elliptical scratches near the origin and a chart showing relative height differences along the trace shown by the blue line in the upper right image.

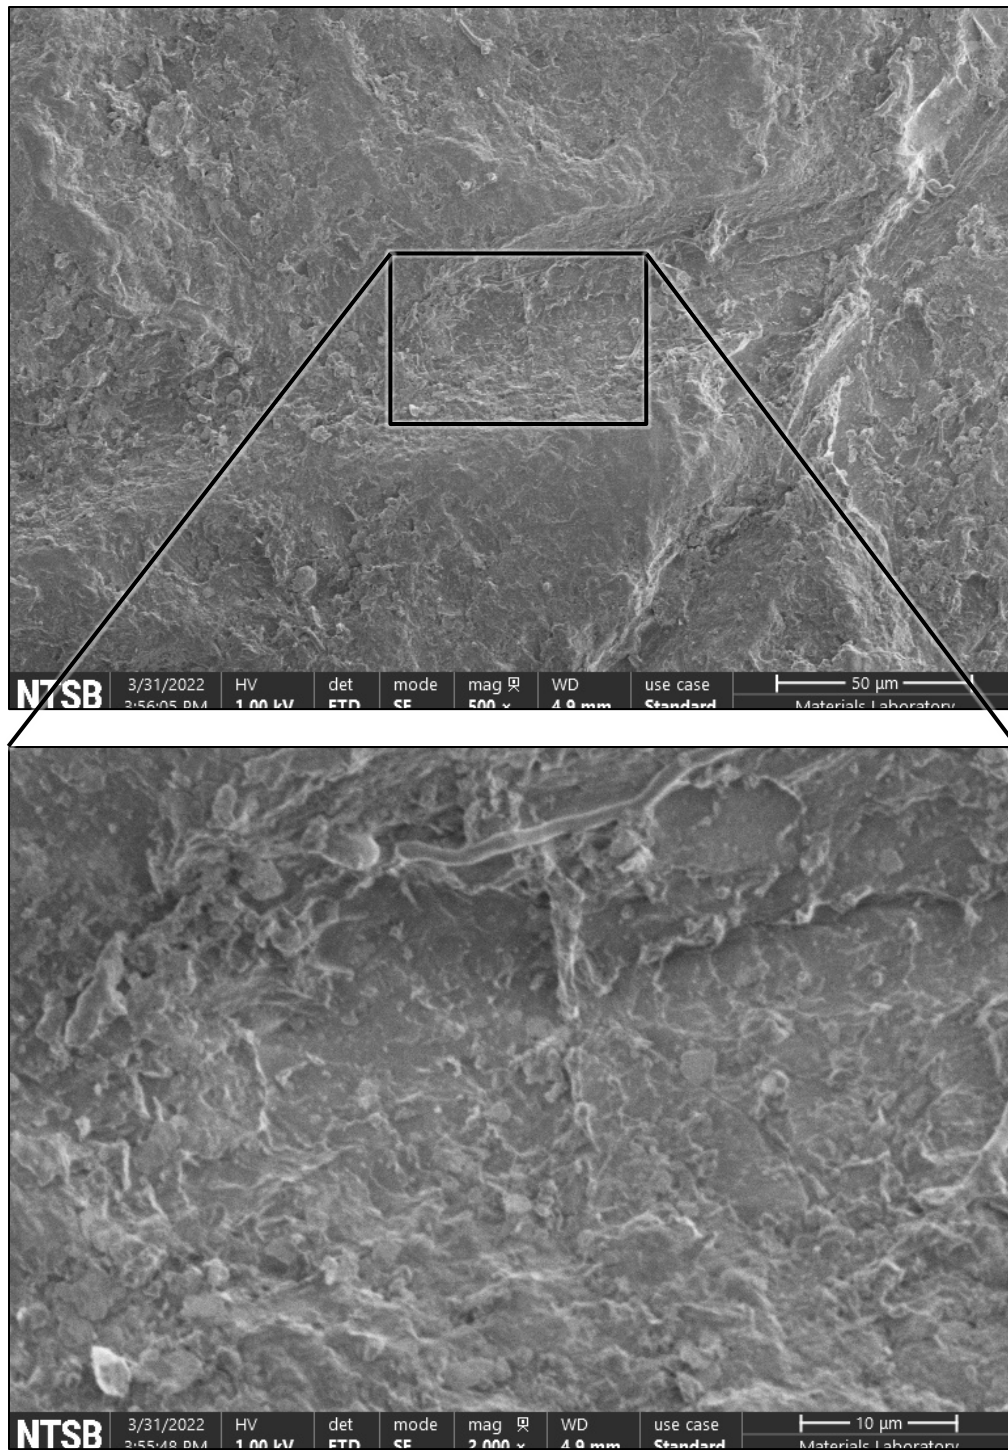
Next, the windshield piece shown in figure 2 was examined using a scanning electron microscope (SEM). The bond surface scratches were examined at varying magnifications, and the typical appearance of scratches on the bond surface are shown in figure 6.

Figure 6. SEM images of the bond surface.
