# NATIONAL TRANSPORTATION SAFETY BOARD

## MATERIALS LABORATORY FACTUAL REPORT

Report No. 21-067

Place : Paragould, Arkansas  
Date : June 15, 2021  
Vehicle : Air Tractor 502B, N6088K  
NTSB No. : CEN21FA270  
Investigator : Samantha Link, ASI-CEN

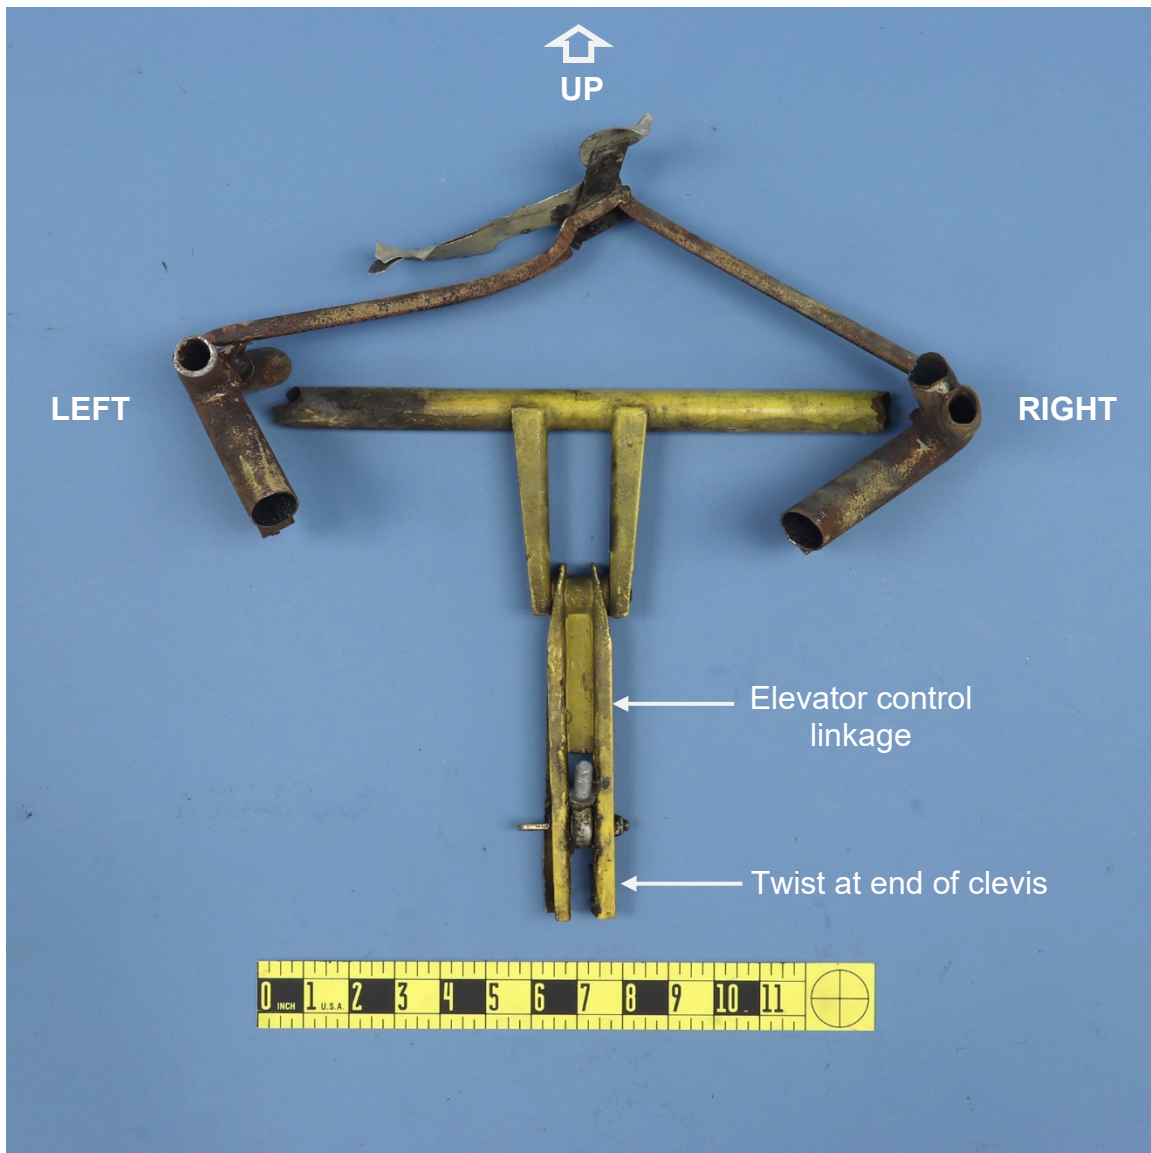
Two pieces from the aft fuselage frame of an Air Tractor 502B were sent to the NTSB Materials Laboratory for examination, as shown in figure 1. The first piece consisted of a left-side upper node, a right-side upper node and a top cap that bridged the nodes. Most of the tubes that formed each node had been cut, but two tubes on the right side were fractured and exhibited slanted fracture surfaces that were consistent with tensile overstress. The second piece consisted of a cross-brace tube that joined the top left node to the top right node and two arms T-welded near the center of the tube that extended downward. At the end of the arms, an elevator control linkage was attached with a pin, which allowed the lower end of the linkage to rotate forward and aft. The forward and aft motion transferred pilot control input to a cable that controlled elevator pitch. The ends of the cross-brace tube were fractured where they joined the left- and right-side nodes, as seen in figure 1. In addition, the control linkage clevis exhibited twist deformation such that the lower end of the left arm had rotated aft and the lower end of the right arm had rotated forward (clockwise twist when viewed below looking up).

**Figure 1:** The aft fuselage frame pieces, as received, viewed aft looking forward.

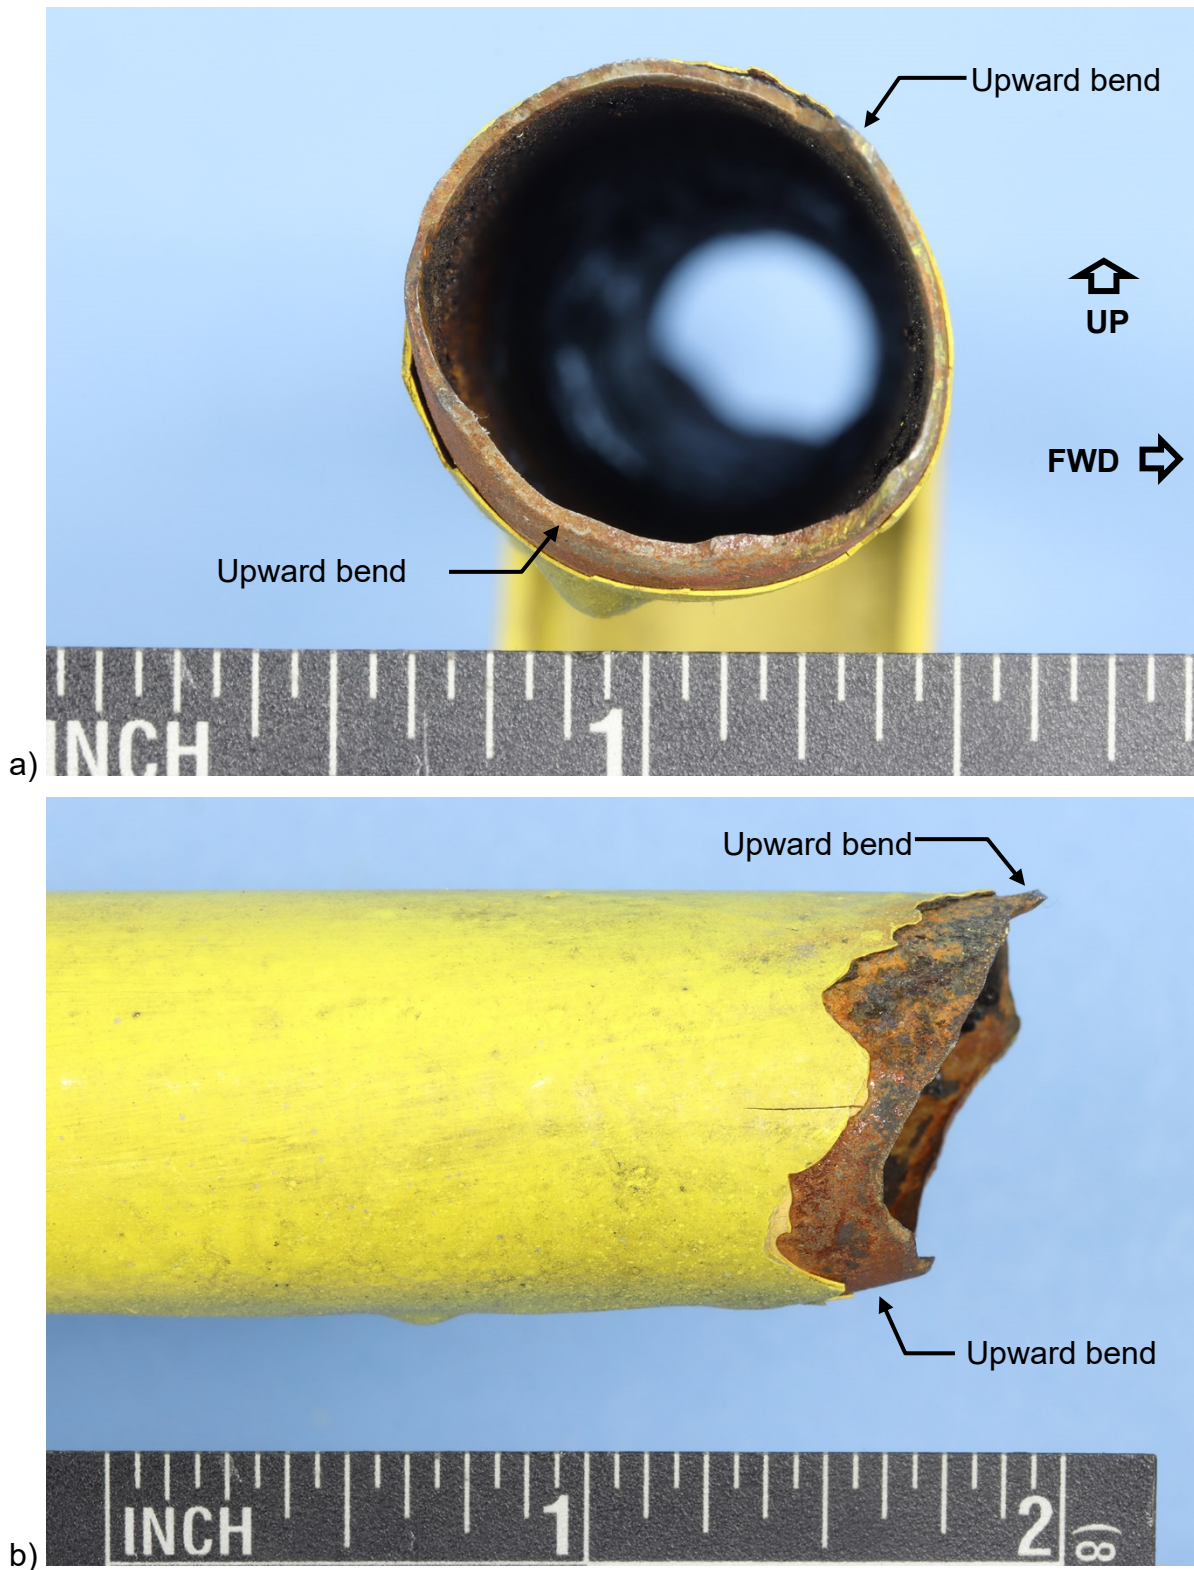
The pieces were cleaned using an alkaline detergent and a soft nylon brush, in accordance with standard laboratory procedures. The cross-brace tube fractures were then examined with the aid of a stereomicroscope. Images of the right-side fracture are shown in figures 2a – c and images of the left-side fracture are shown in figures 3a and b. The fractured tube walls all exhibited either transverse shear features or 45° inclined slant fractures, consistent with overstress. The right side of the tube exhibited upward bending along the forward-top and bottom-aft portions of the tube just inboard of the fracture, as indicated in figures 2a and b and the mating fracture on the node-side exhibited downward bending, as indicated in figure 2c. Similar bending features were observed on the left-side fracture. Whereas the right-side fracture was comparatively planar, the left side

fracture progress along a longitudinal and helical path in one location (the upper forward quadrant). Taken as a whole, the features were consistent with a shear/torsion overstress fracture on the right end of the cross-brace, followed by an overstress fracture of the left end of the cross-brace in a mixture of shear, torsion, and bending.

**Figure 2:** The right-side fracture of the cross-brace tube; a) longitudinal view of the fracture; b) side view showing deformation at the tube end near the fracture. The tube is viewed looking down and forward;

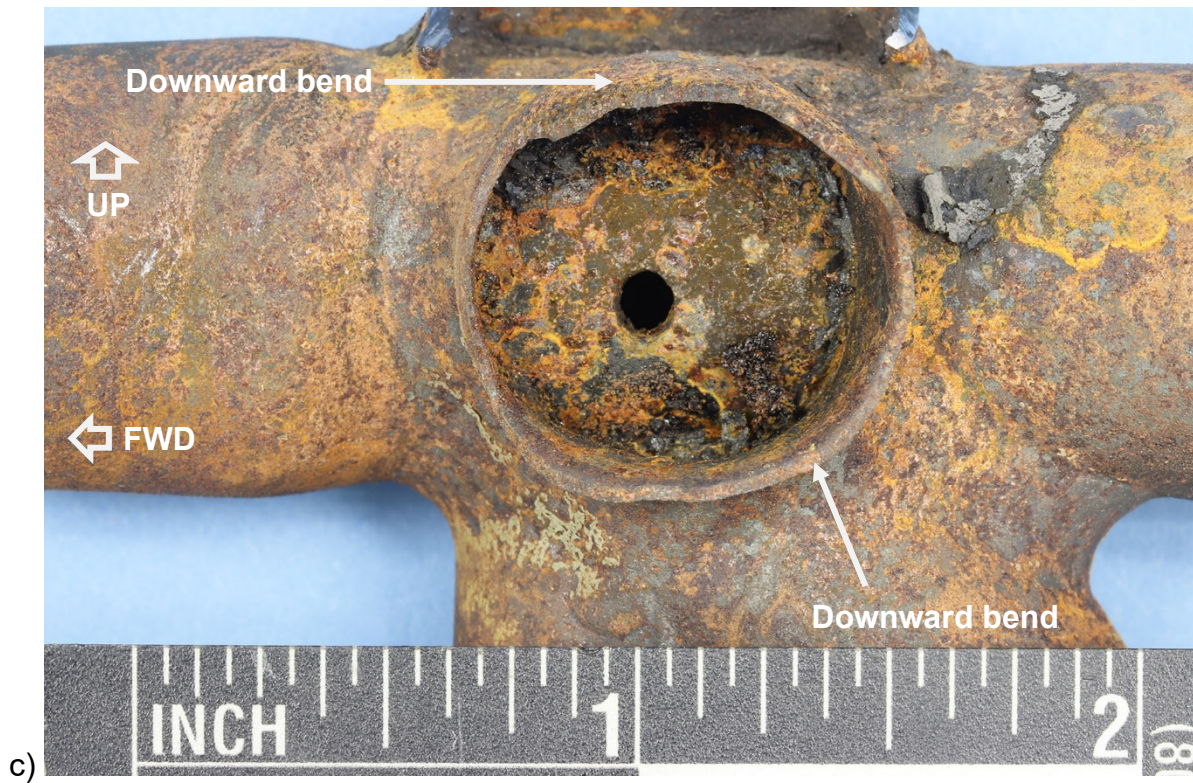
**Figure 2 (cont.):** and c) image of the mating fracture at the right-side node, showing downward bending of the tube wall along the top and bottom.

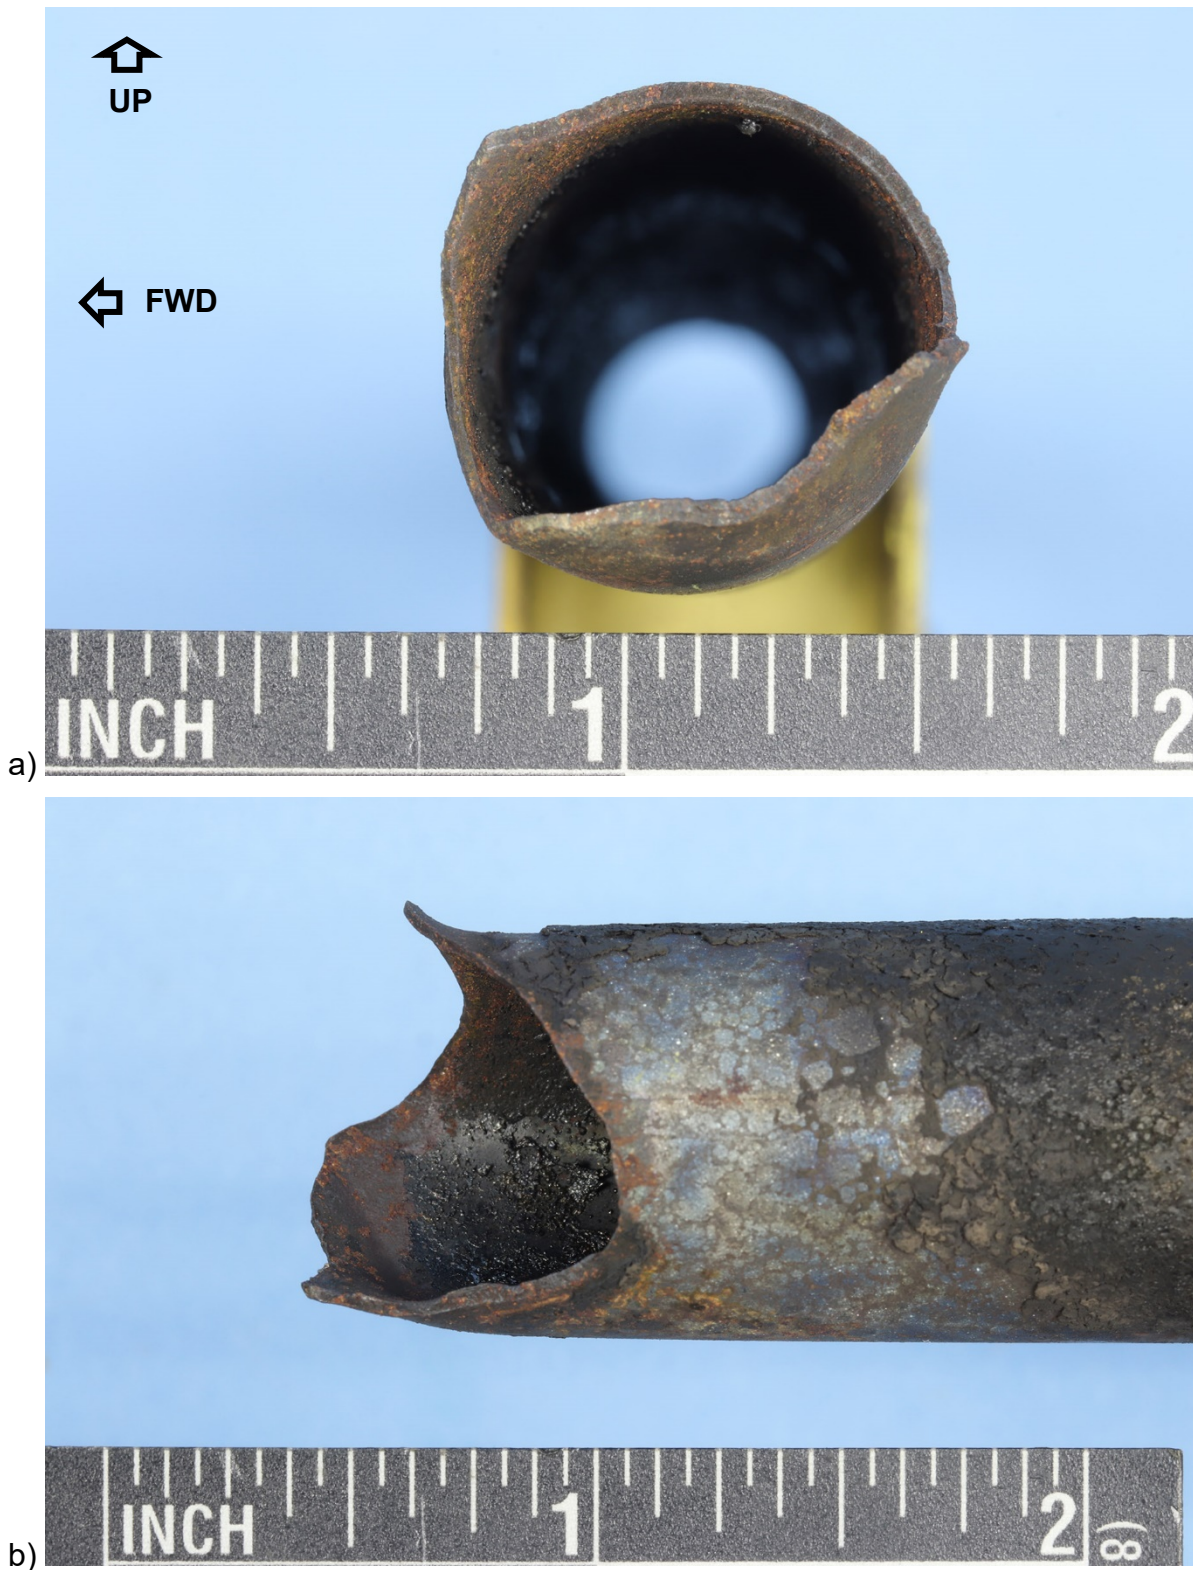
**Figure 3:** The left-side fracture of the cross-brace tube; a) longitudinal view of the fracture; b) side view showing deformation at the tube end near the fracture. The tube is viewed looking down and forward.
