## **NATIONAL TRANSPORTATION SAFETY BOARD**

### **ON SCENE OBSERVATIONS**

**CEN21FA270**

Location: Paragould, AR  
Date: June 15, 2021  
Aircraft: Air Tractor AT-502B, Registration N6088K, Serial #502B-0281  
NTSB IIC: Samantha Link

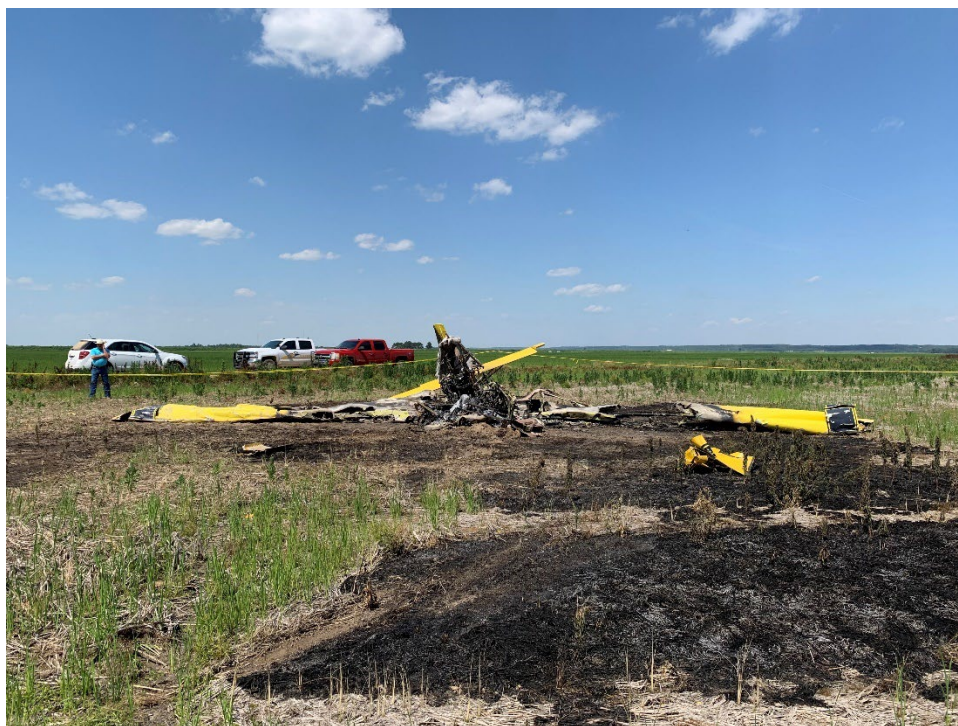
Figure 1: Front of Airplane

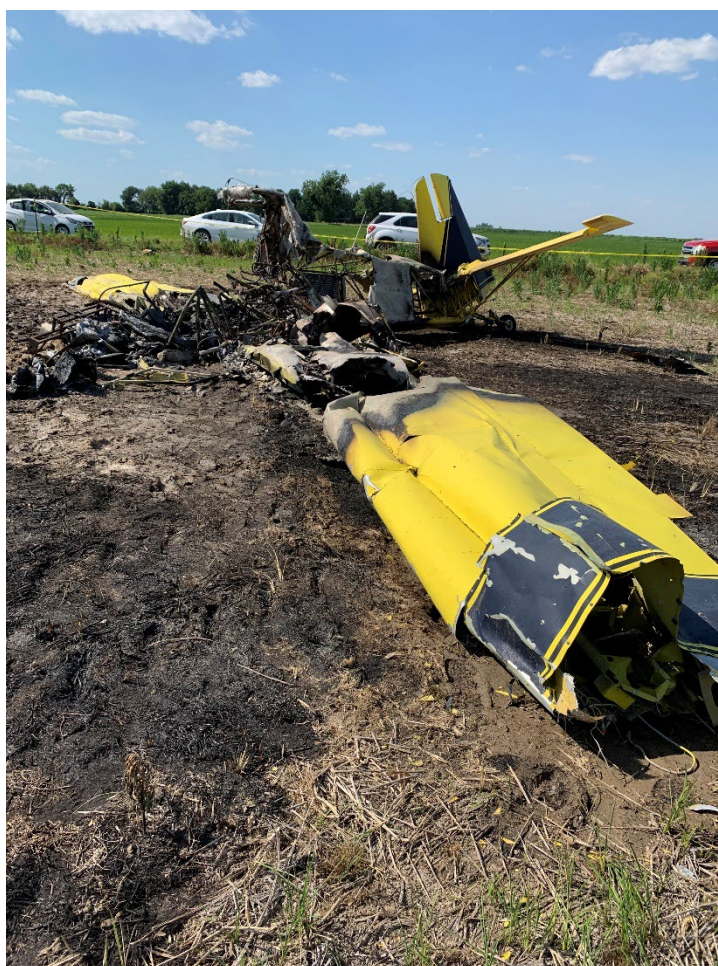
Figure 2: Forward Left side of Airplane

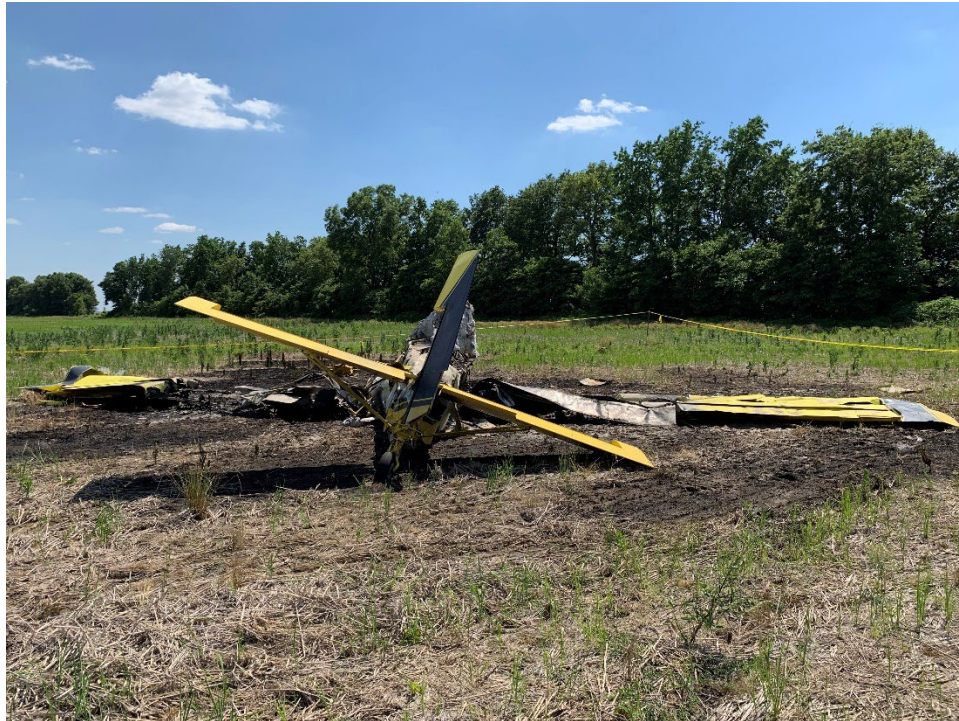
Figure 3: Aft Side of Airplane

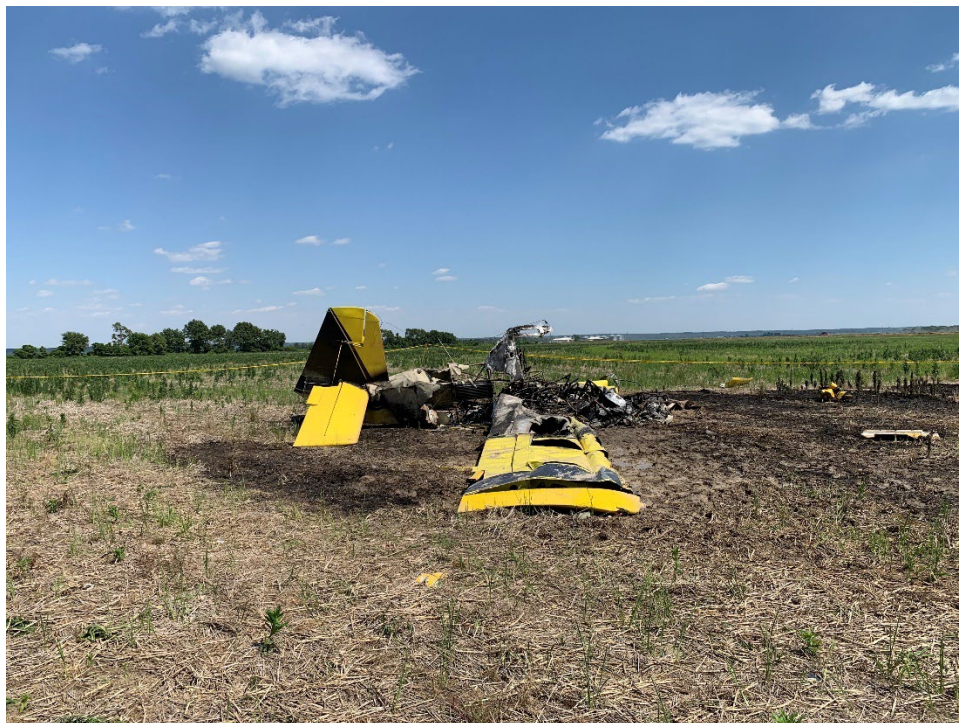
Figure 4: Right Side of Airplane

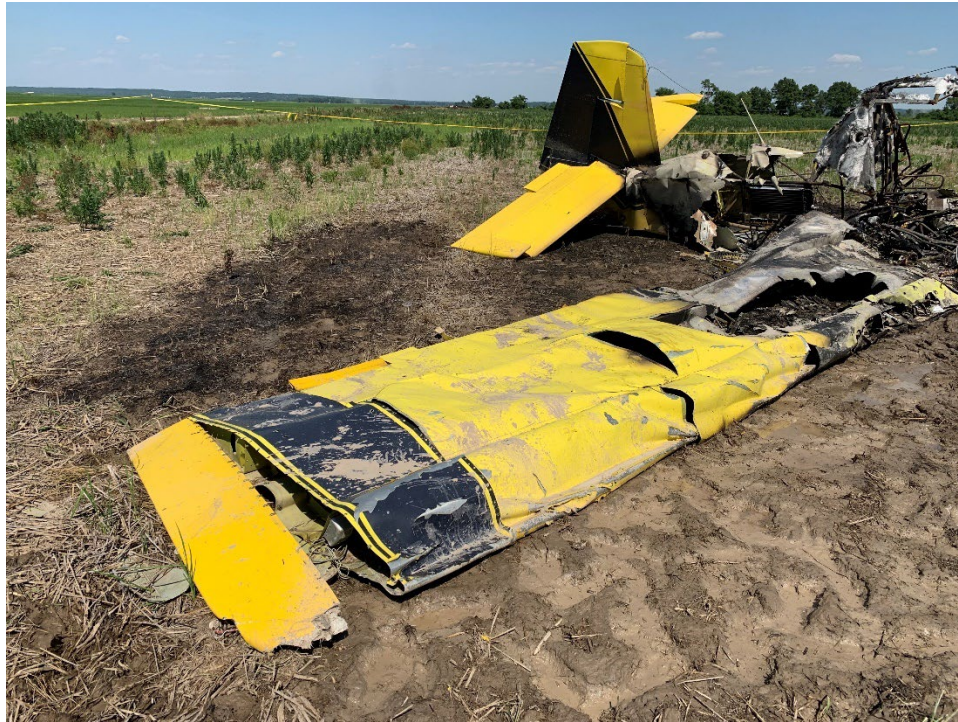
- The outboard portion of the right wing remained whole.
  - The aileron was attached to its attachment points.
  - The leading edge was crushed aft.
    - 45-degree wrinkles in the upper wing skin.

Figure 5: Right Wing

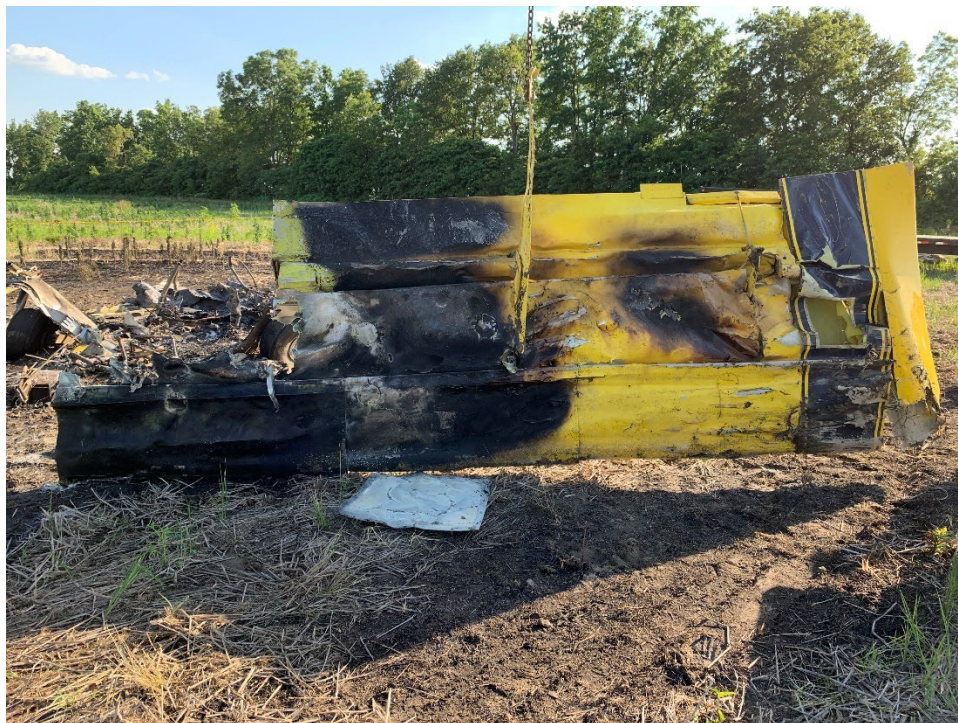
- The underside wing skin exhibited some wrinkling and thermal damage.
- The flight control system was extensively damaged.
  - The rudder controls were manipulated by hand from the rudder pedal assemblies to the rudder control horns.

Figure 6: Underside of Right Wing

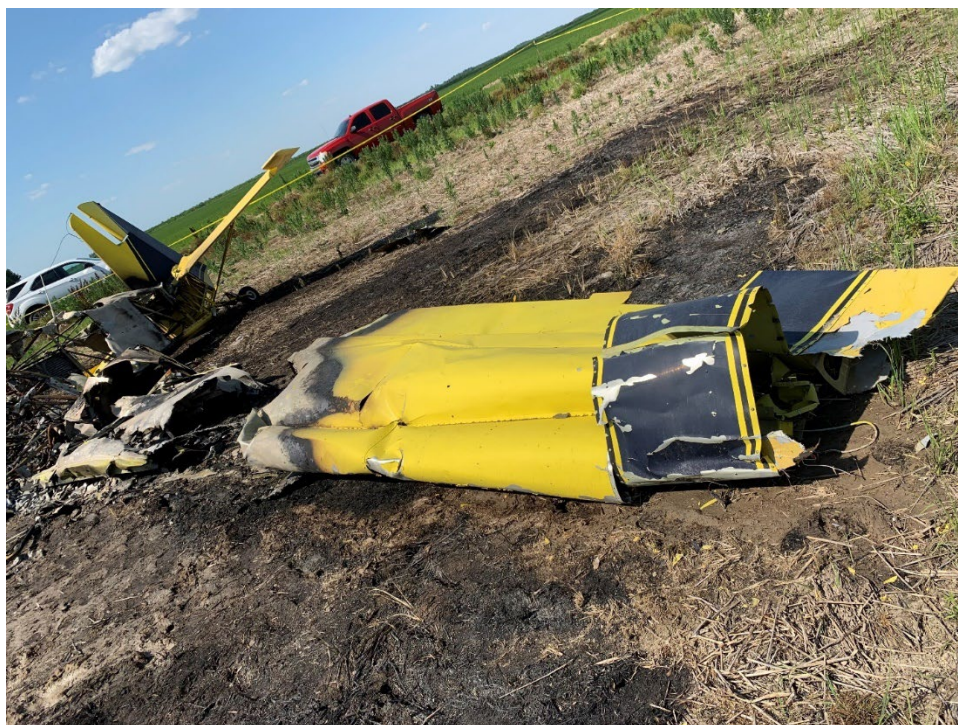
- The gear leg and wheel exhibited thermal damage.
- The leading edge of the outboard left-wing exhibited aft crush damage.
  - The skin on the wingtip exhibited a large upward bulge.

Figure 7: Left Wing

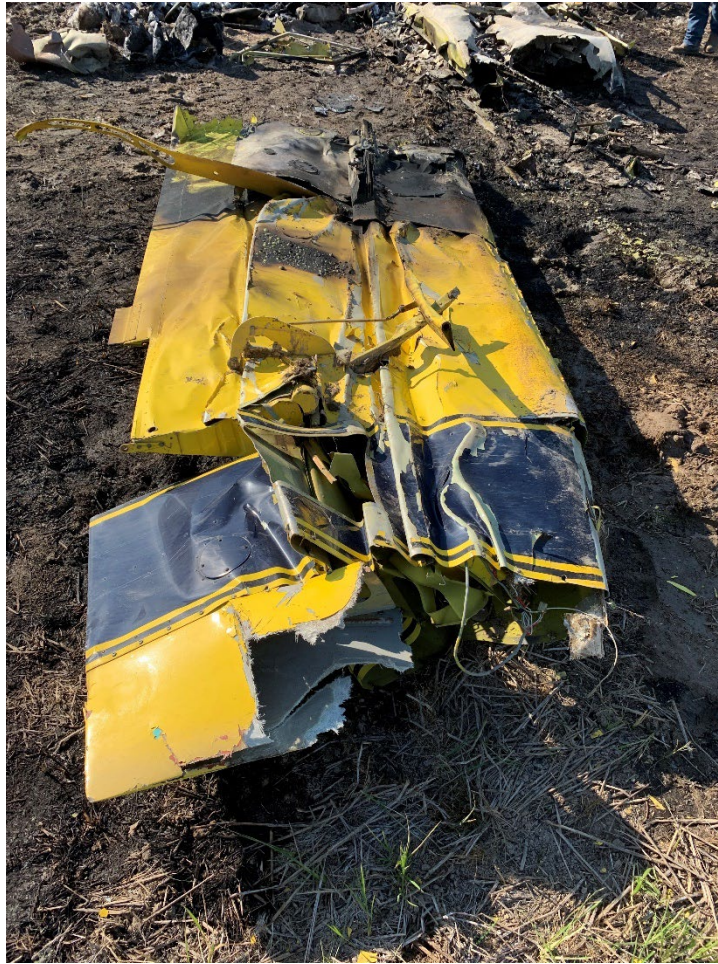
- The aileron remained attached to most of its attachment points.
  - The lower wing skin exhibited extensive aft rippling.
- The aft fuselage exhibited extensive thermal damage up to the empennage.

**Figure 8: Underside of Left outboard wing.**

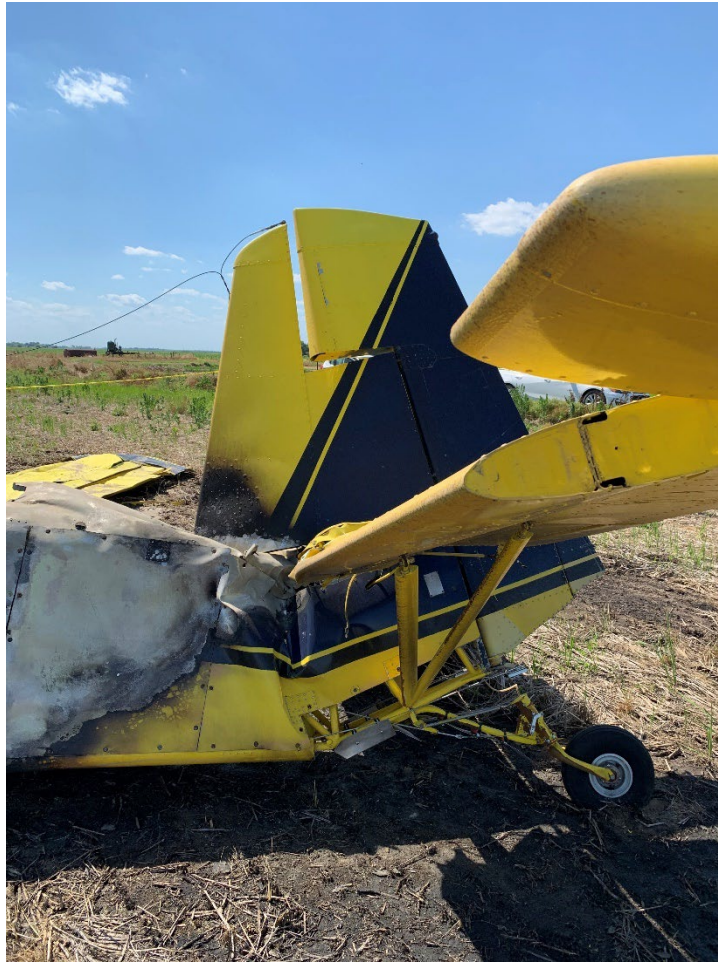
- The lower fuselage immediately below the forward portion of the vertical stabilizer was bent about 45-degree angle.
  - The left side horizontal impacted the side of the aft fuselage.

**Figure 9: Bend in Empennage**

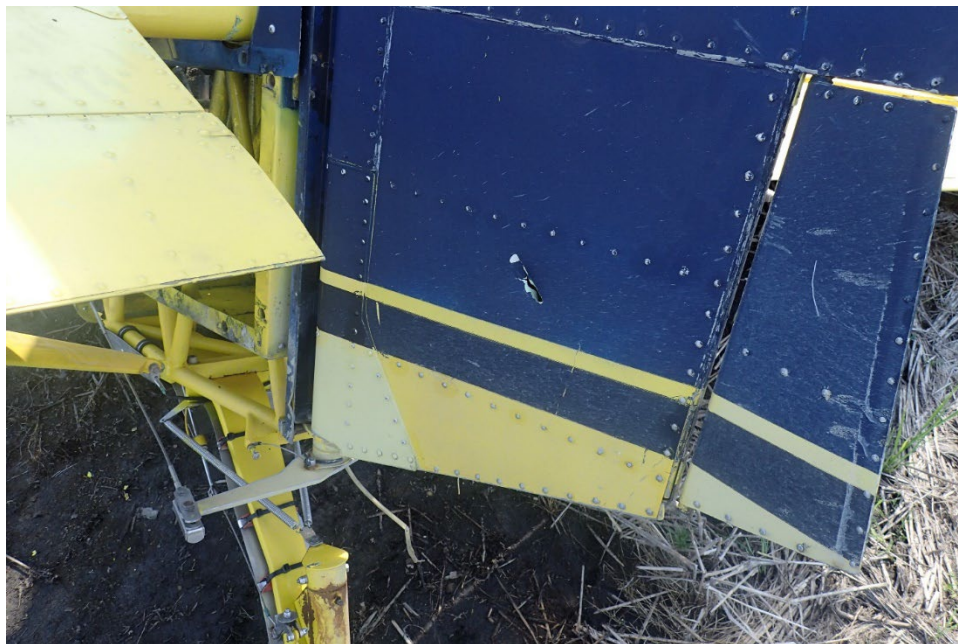
- The tip weights remained secured in place within the flight control surfaces.
    - A small puncture was noted on the lower left side of the rudder consistent with impact from the elevator.

**Figure 10: Puncture on Lower Left side of Rudder**

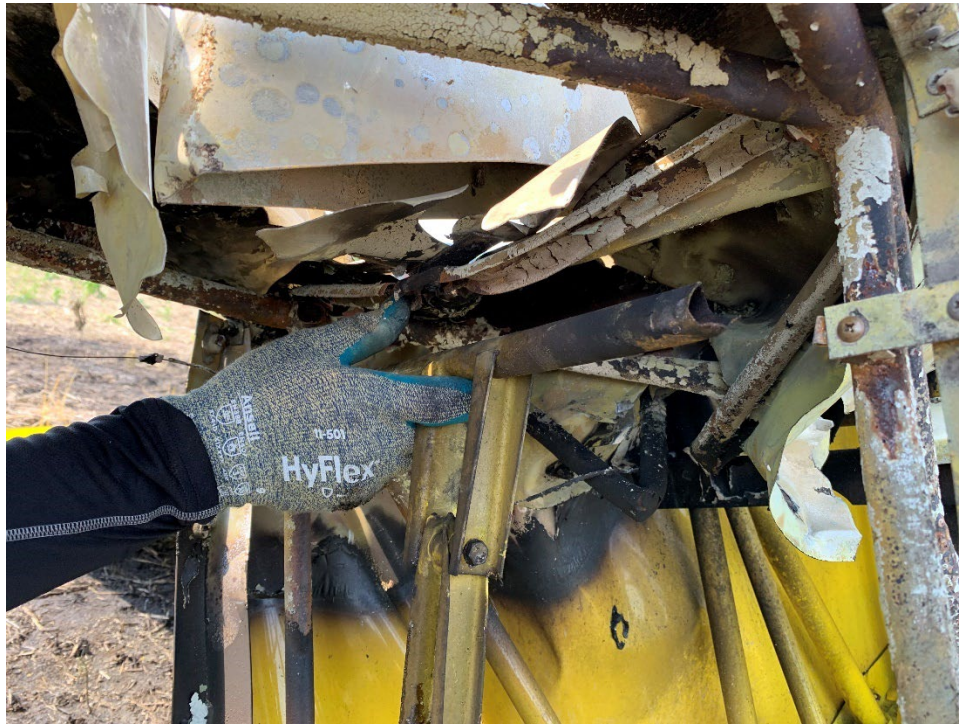
- The area between the forward idler and the aft idler was not present consistent with thermal damage.
    - The crossbar, which connects the aft idler to the upper airframe, was fracture separated on the airframe side.

Figure 11: Crossbar for Elevator Control aft Idler.

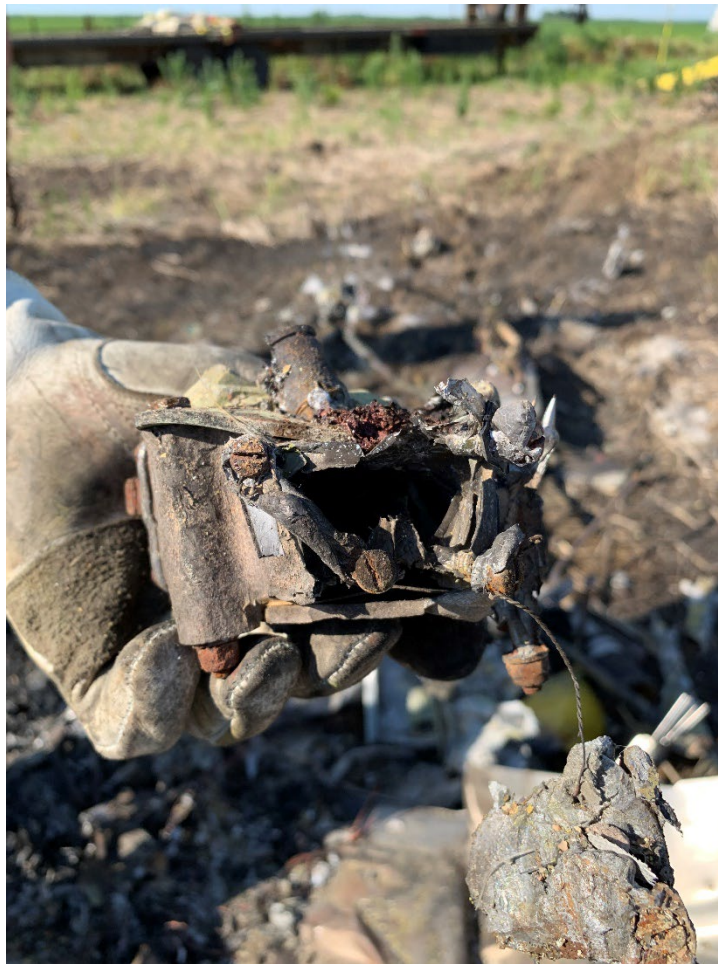
- The fuel control valve was located, and its internal components were destroyed.
  - The fuel control handle was present, but was fracture separated from the valve itself.

Figure 12: Fuel Control Valve

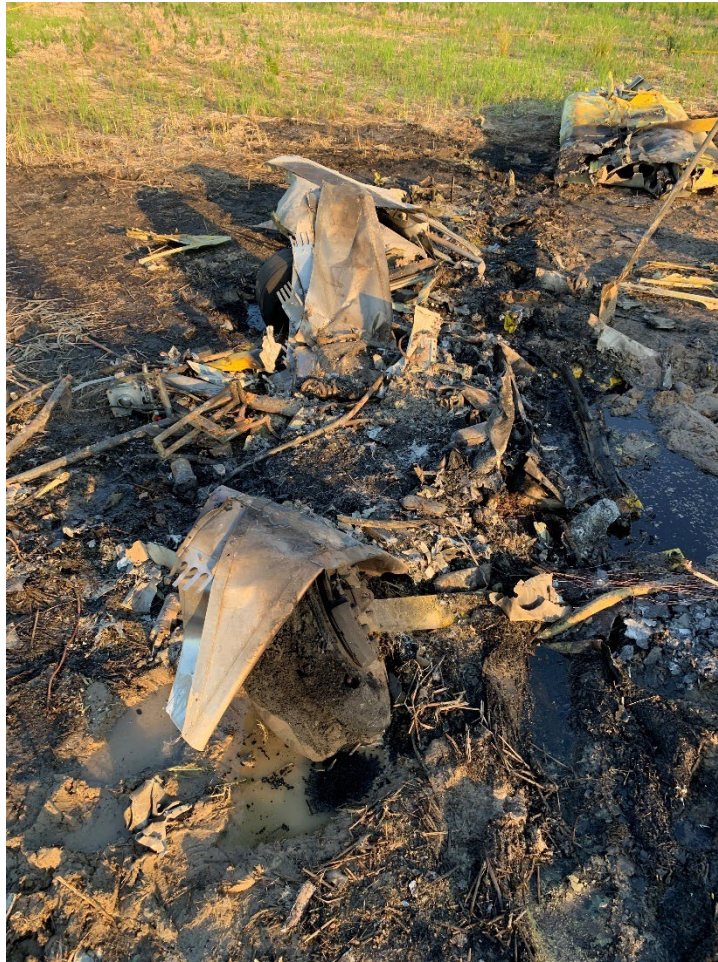
- Flap actuator was found and exhibited extensive thermal damage.
  - It was in the full extended position, but the motor was fracture separated.
- The spreader system:
  - The hopper was consumed by fire. Fiberglass residue was present ontop of the engine.
  - The wastegate was fracture separated from the system.
  - The spreader dispersing triangle was flattened in between the main landing gear, lower fuselage, and the ground.

Figure 13: Spreader

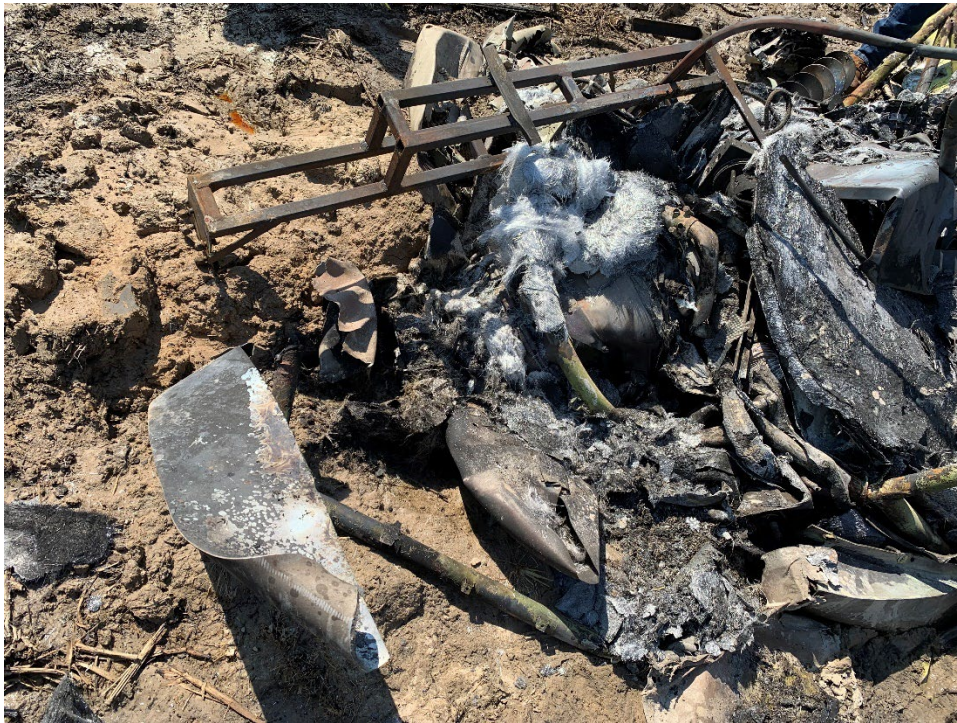
- The engine was embedded into the ground and only one propeller blade was exposed.
- The engine was removed from an about 18-inch muddy hole and two of the blades remained attached at the hub.

Figure 14: Engine Embedded into the Ground

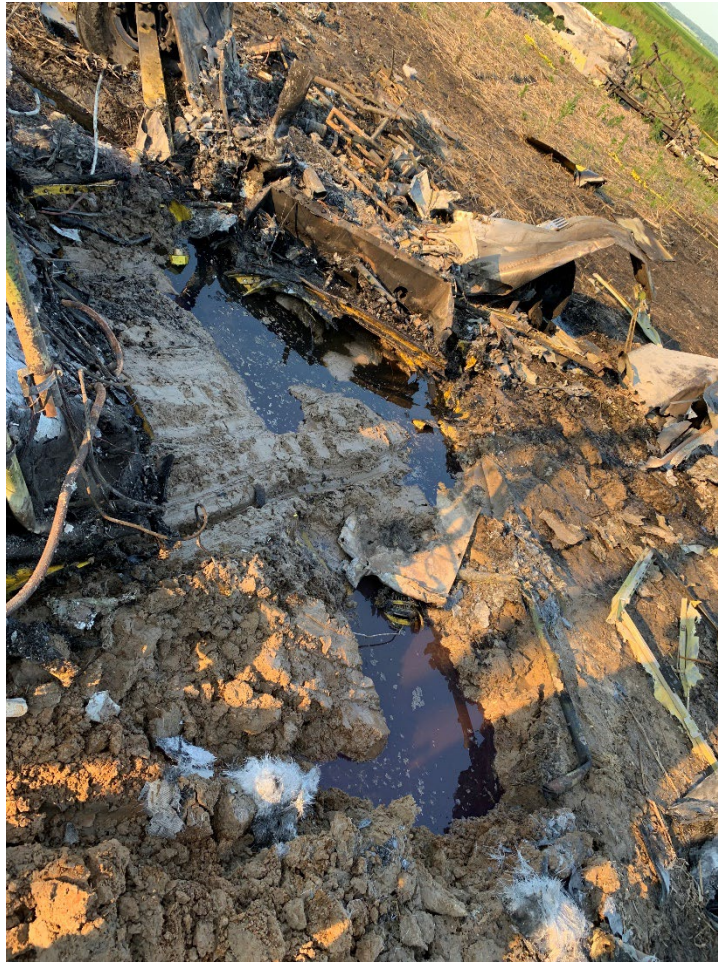
**Figure 15: Engine Hole**

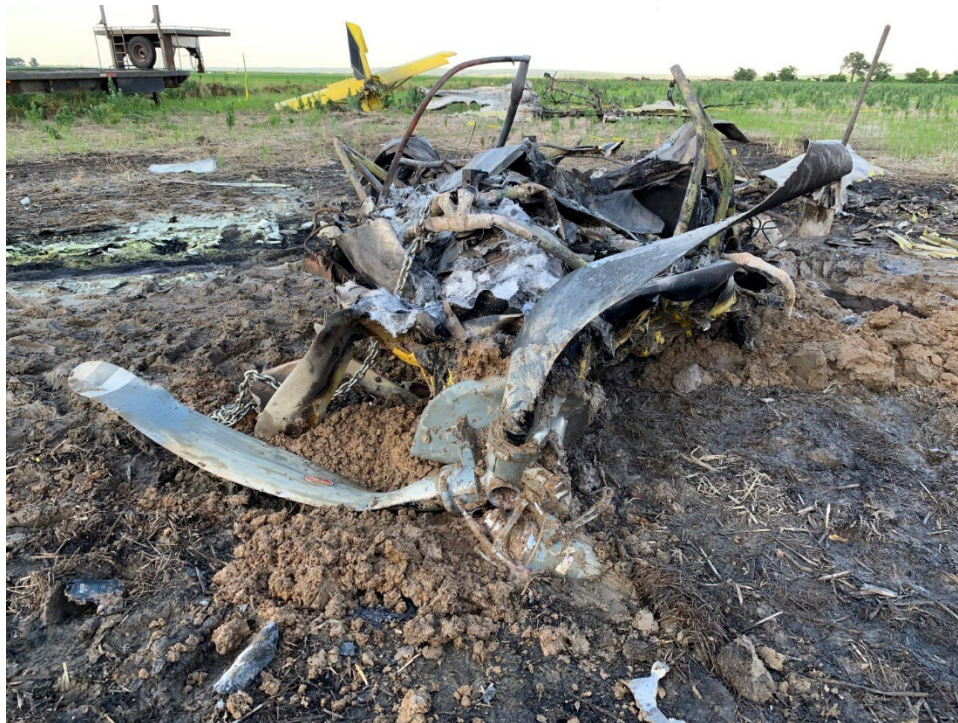
- The engine was heavily covered in fiberglass residue, dirt, and mud.
- The airplane's spinner was mostly fracture separated and fragments were found in the hole. A portion of the spinner was pushed aft past the propeller blades and pressed against the hub itself.

**Figure 16: The Propeller Assembly and Front of Engine**

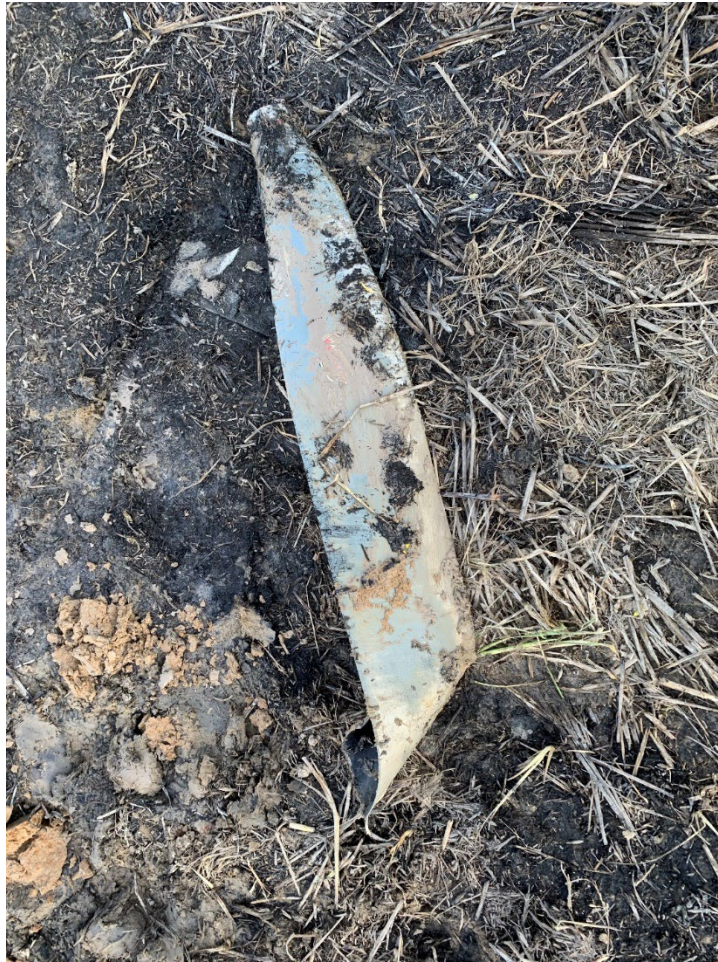
- One blade was fracture separated from the engine near the blade root and found in the hole underneath the engine.
    - The fracture surface was consistent with overload.

- The blade was bent slightly aft about midspan and curled aft on the outboard end. The blade tip was fracture separated.
  - The second blade was bent forward slightly outboard of the blade root. And the blade tip trailing edge was curled aft. The blade exhibited thermal damage throughout.

**Figure 17: Fractured Propeller Blade**

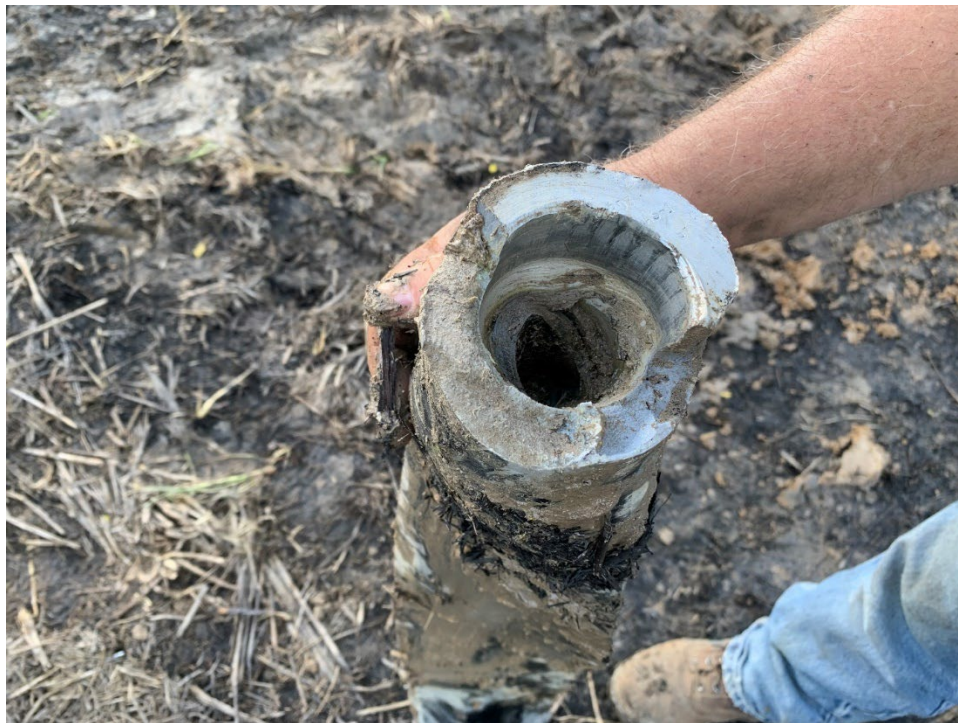
**Figure 18: Fractured Propeller Blade Fracture Surface**

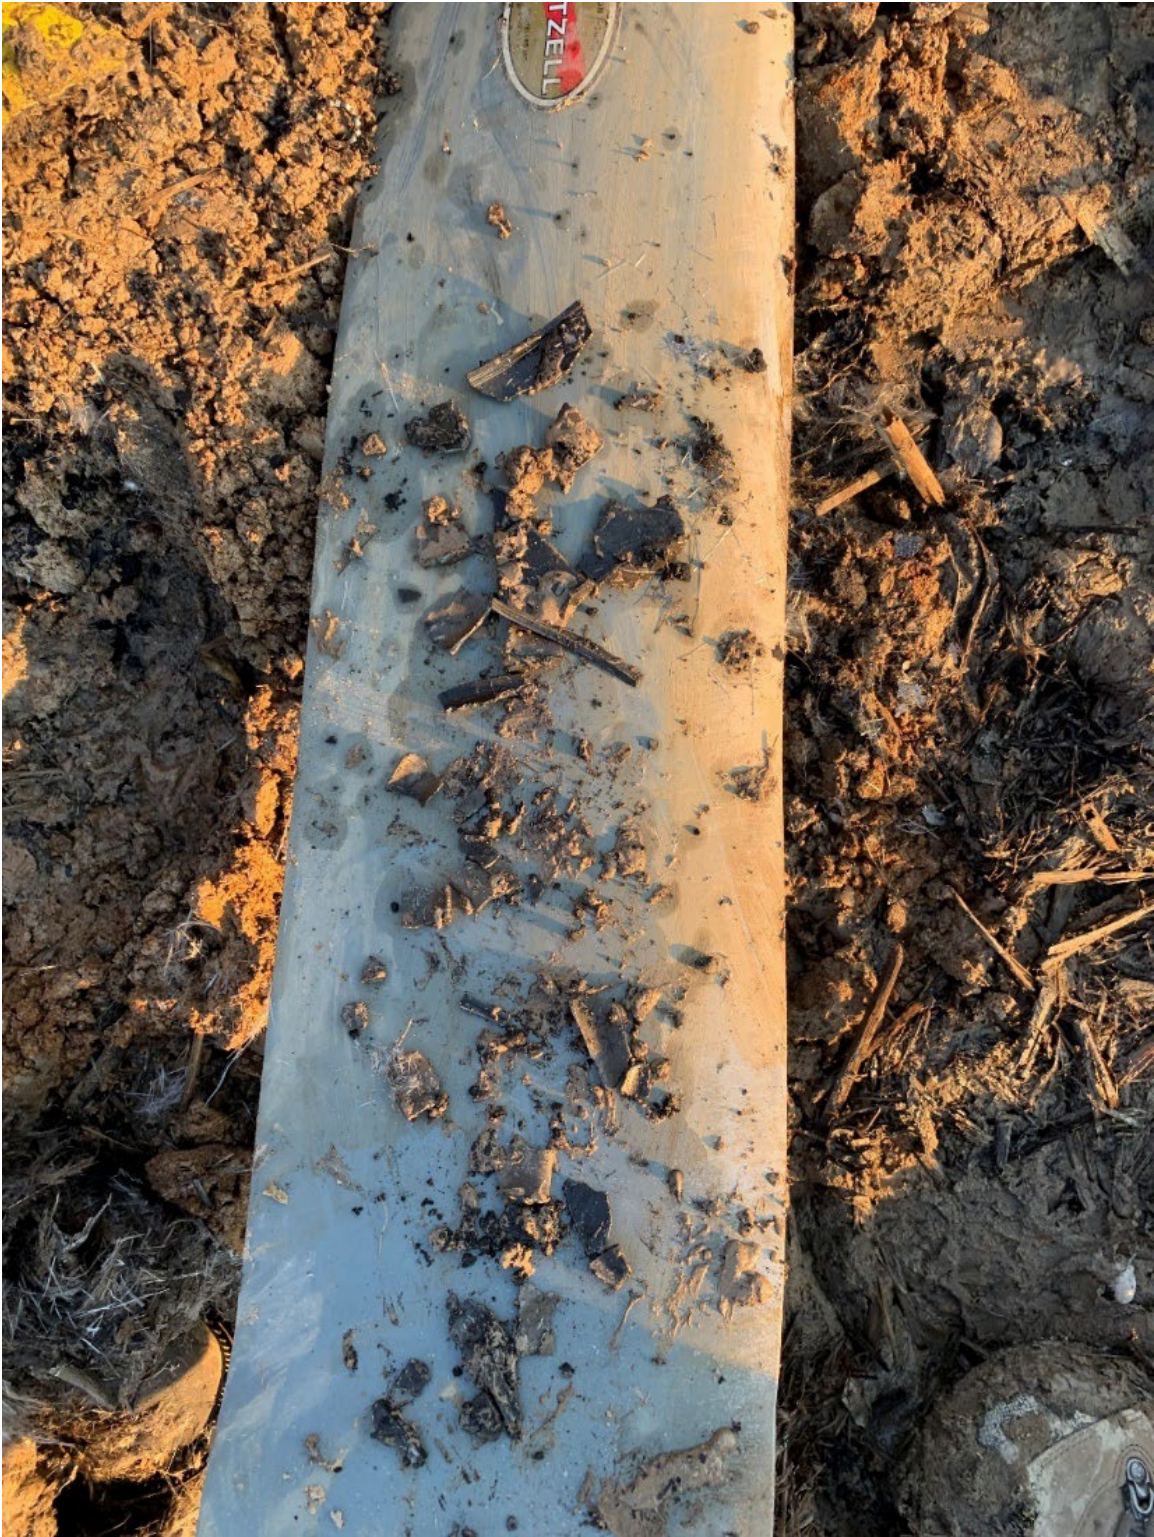
Figure 19: Power Turbine Blade Fragments removed from Exhaust.

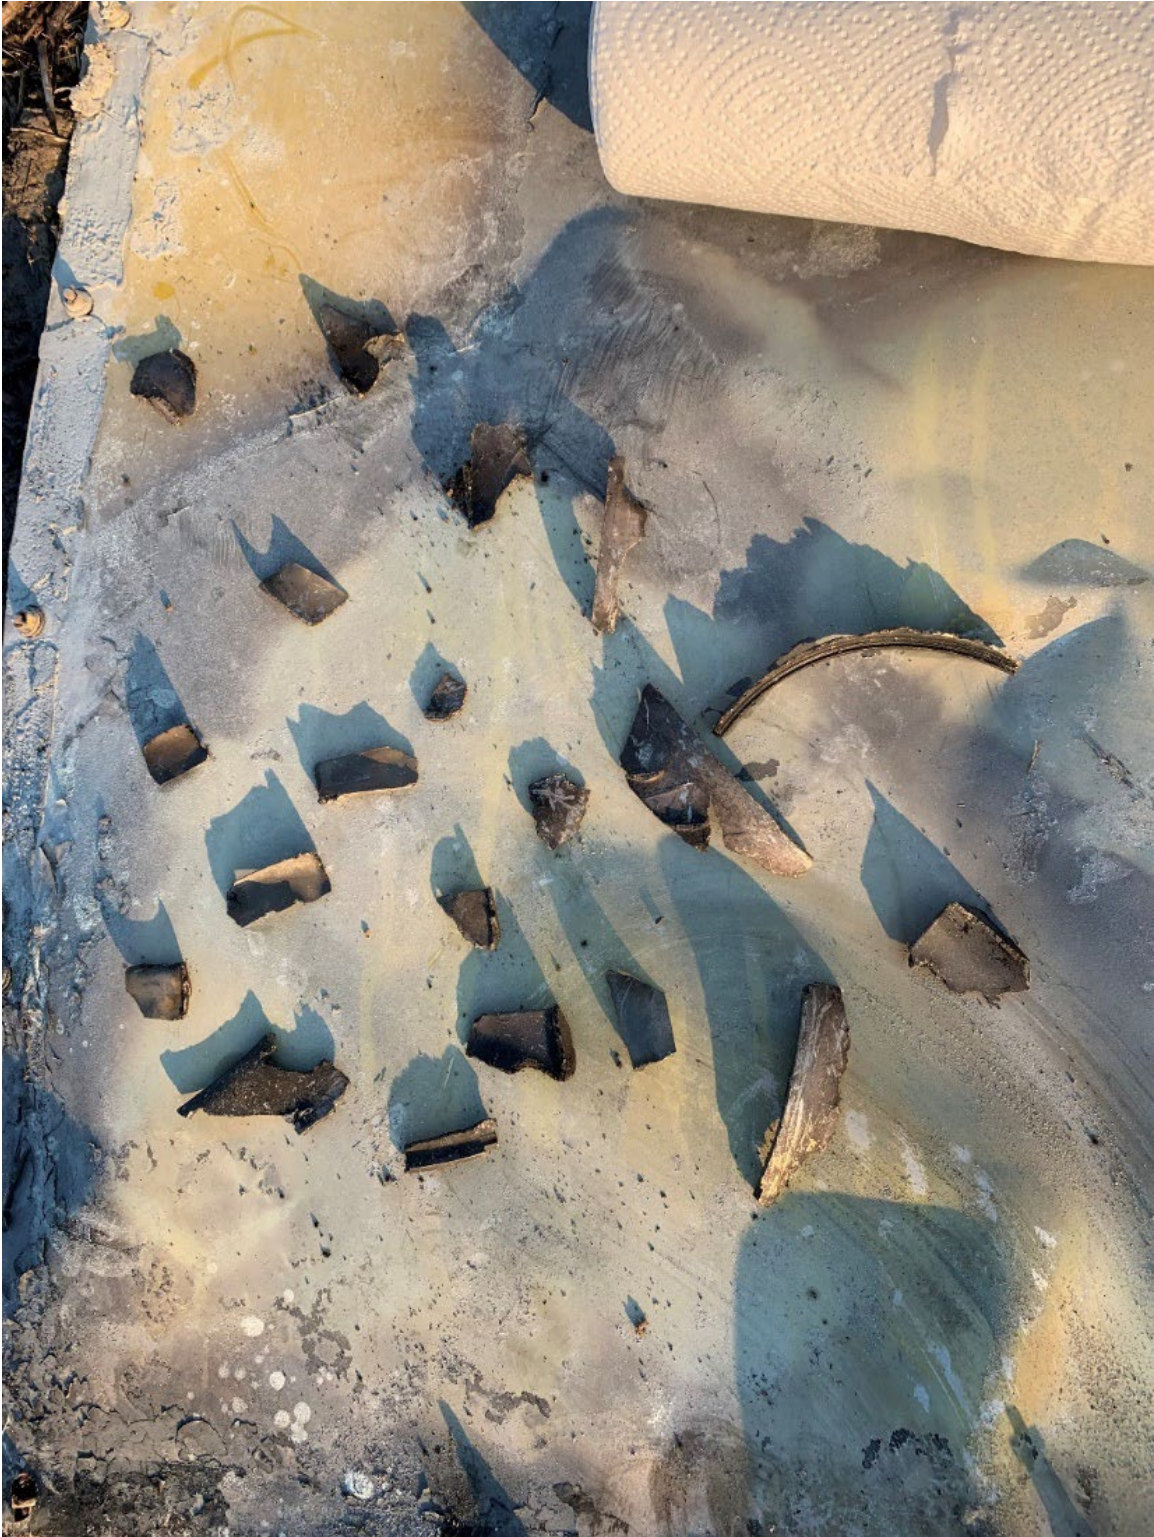
Figure 20: Fragments of Power Turbine Blades, Vane Ring, and Shroud.

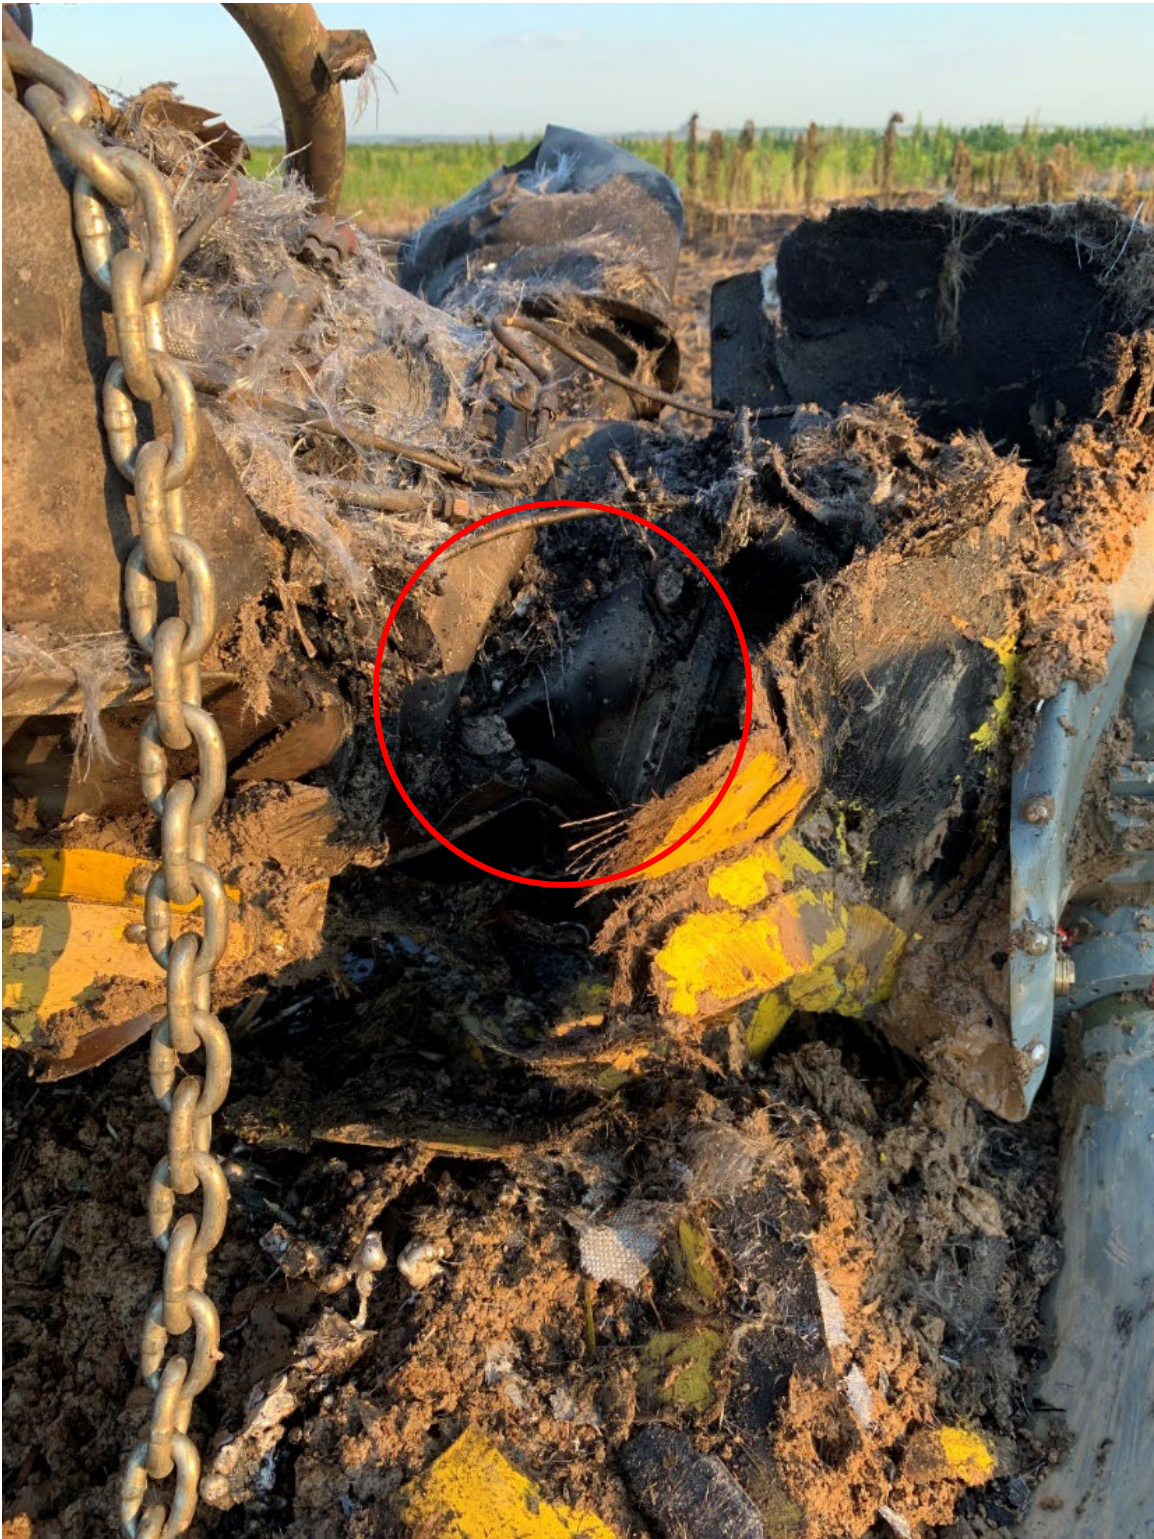
- Deformation and buckling was noted on the top and side of the reduction gearbox housing.
- The exhaust case sustained compressive damage, including angled consecutive folds consistent with impact damage.
- The exhaust tube on the right side of the engine was flattened and fracture separated from its port.
  - Many power turbine blade, vane ring, and shroud fragments were found loose within the port.
    - Several were removed and some were cleaned.
- The gas generator case sustained deformation and buckling.
- The engine housing was fracture separated exposing the axial compressor.
  - The first stage compressor rotor airfoils are bent in the opposite direction of rotation.
    - Environmental debris was noted inside of the compressor.

Figure 21: Engine Exhaust Case

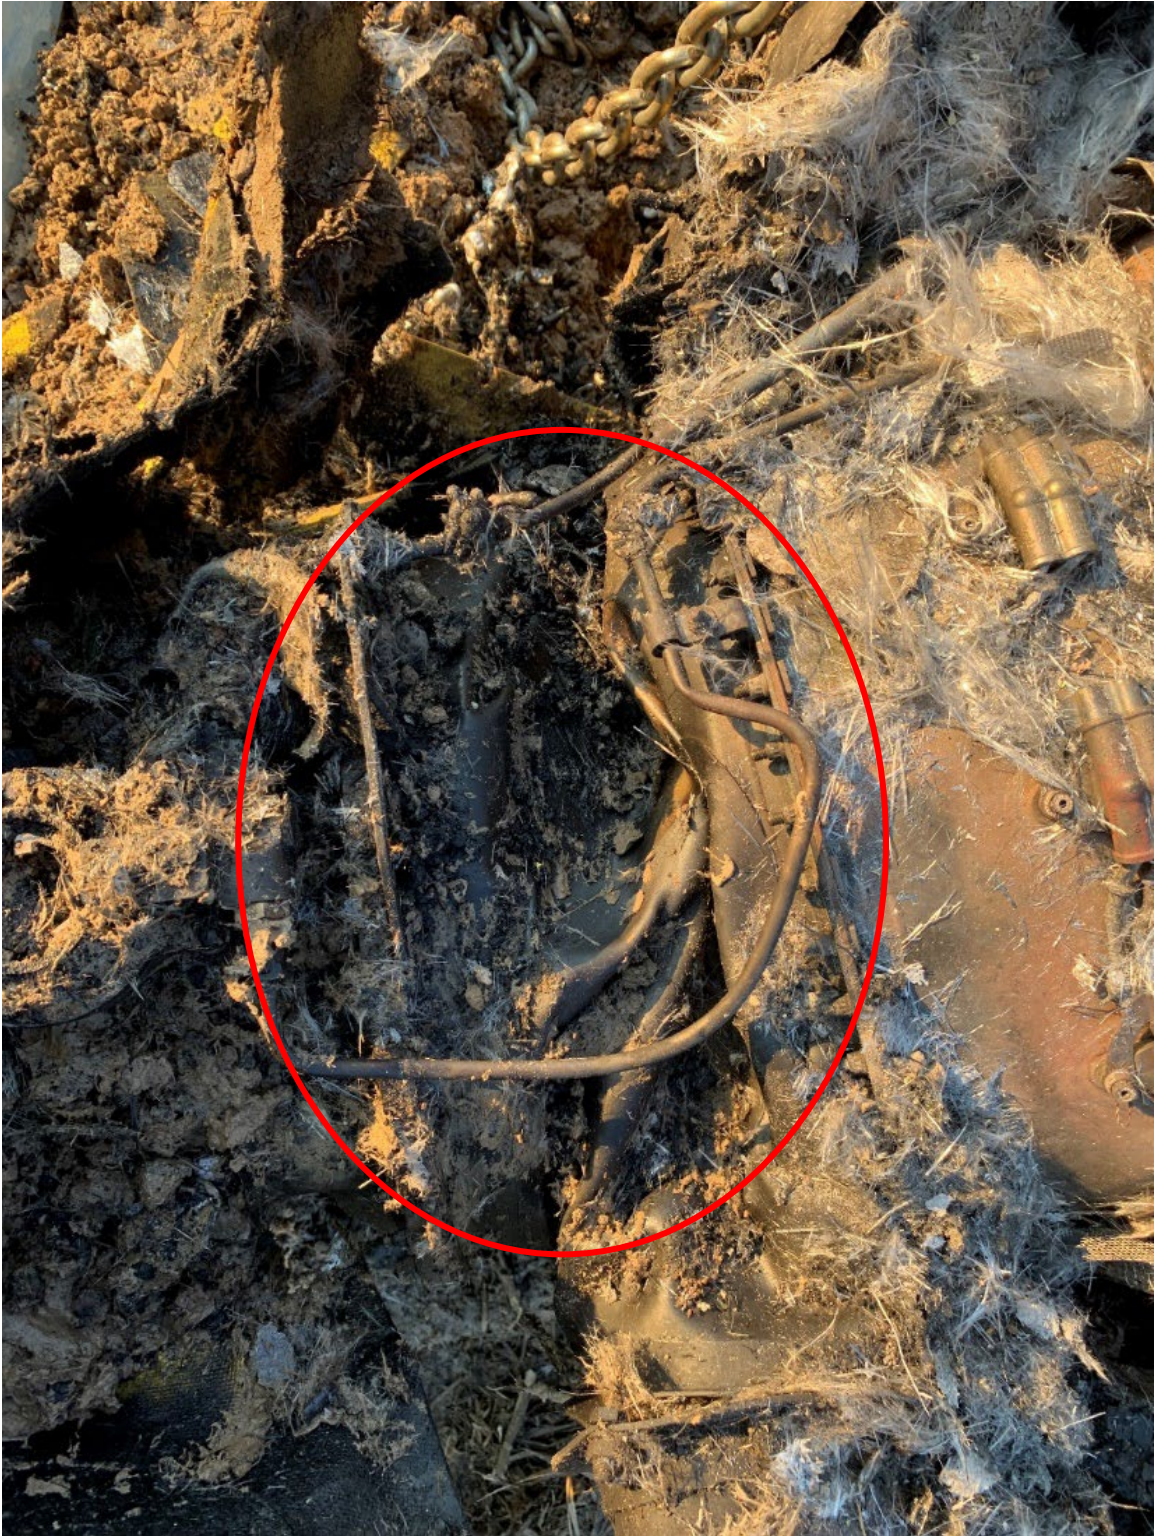
Figure 22: Deformation and Buckling on top of the Reduction Gear Housing.

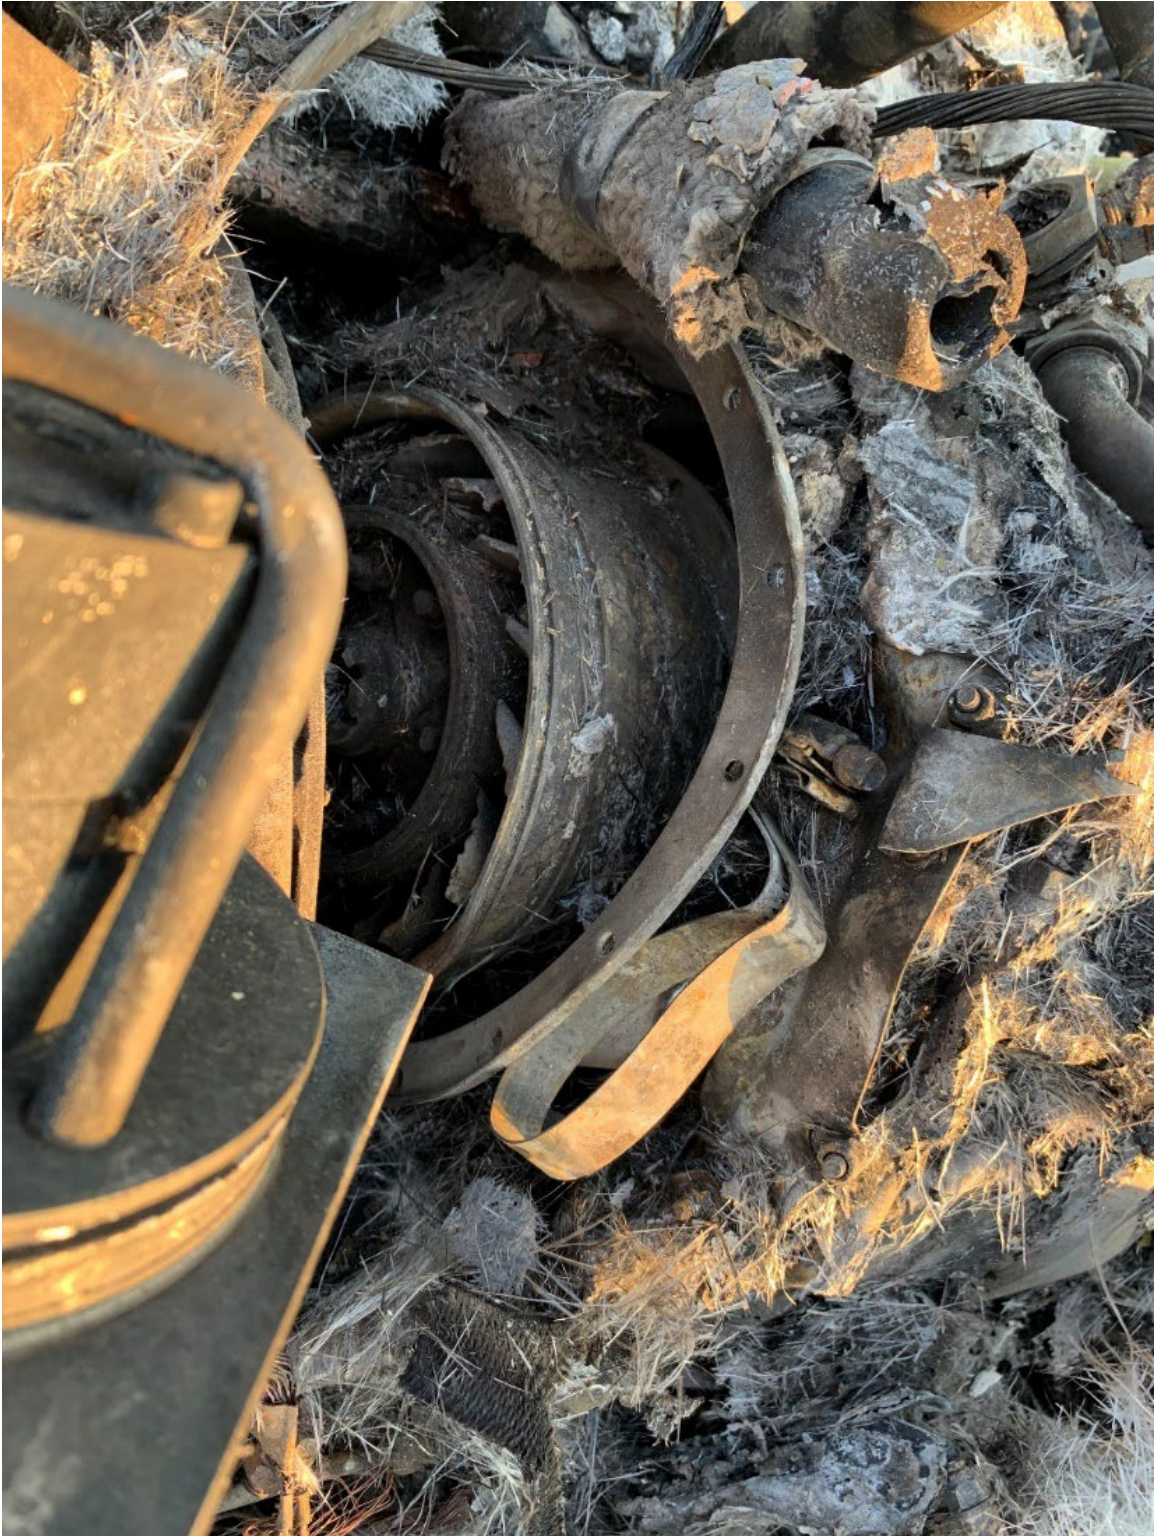
Figure 23: Housing Fracture at the Axial Compressor.
