## **NATIONAL TRANSPORTATION SAFETY BOARD**

### **ON SCENE OBSERVATIONS**

**CEN21FA270**

Location: Paragould, AR  
Date: June 15, 2021  
Aircraft: Air Tractor AT-502B, Registration N6088K, Serial #502B-0281  
NTSB IIC: Samantha Link

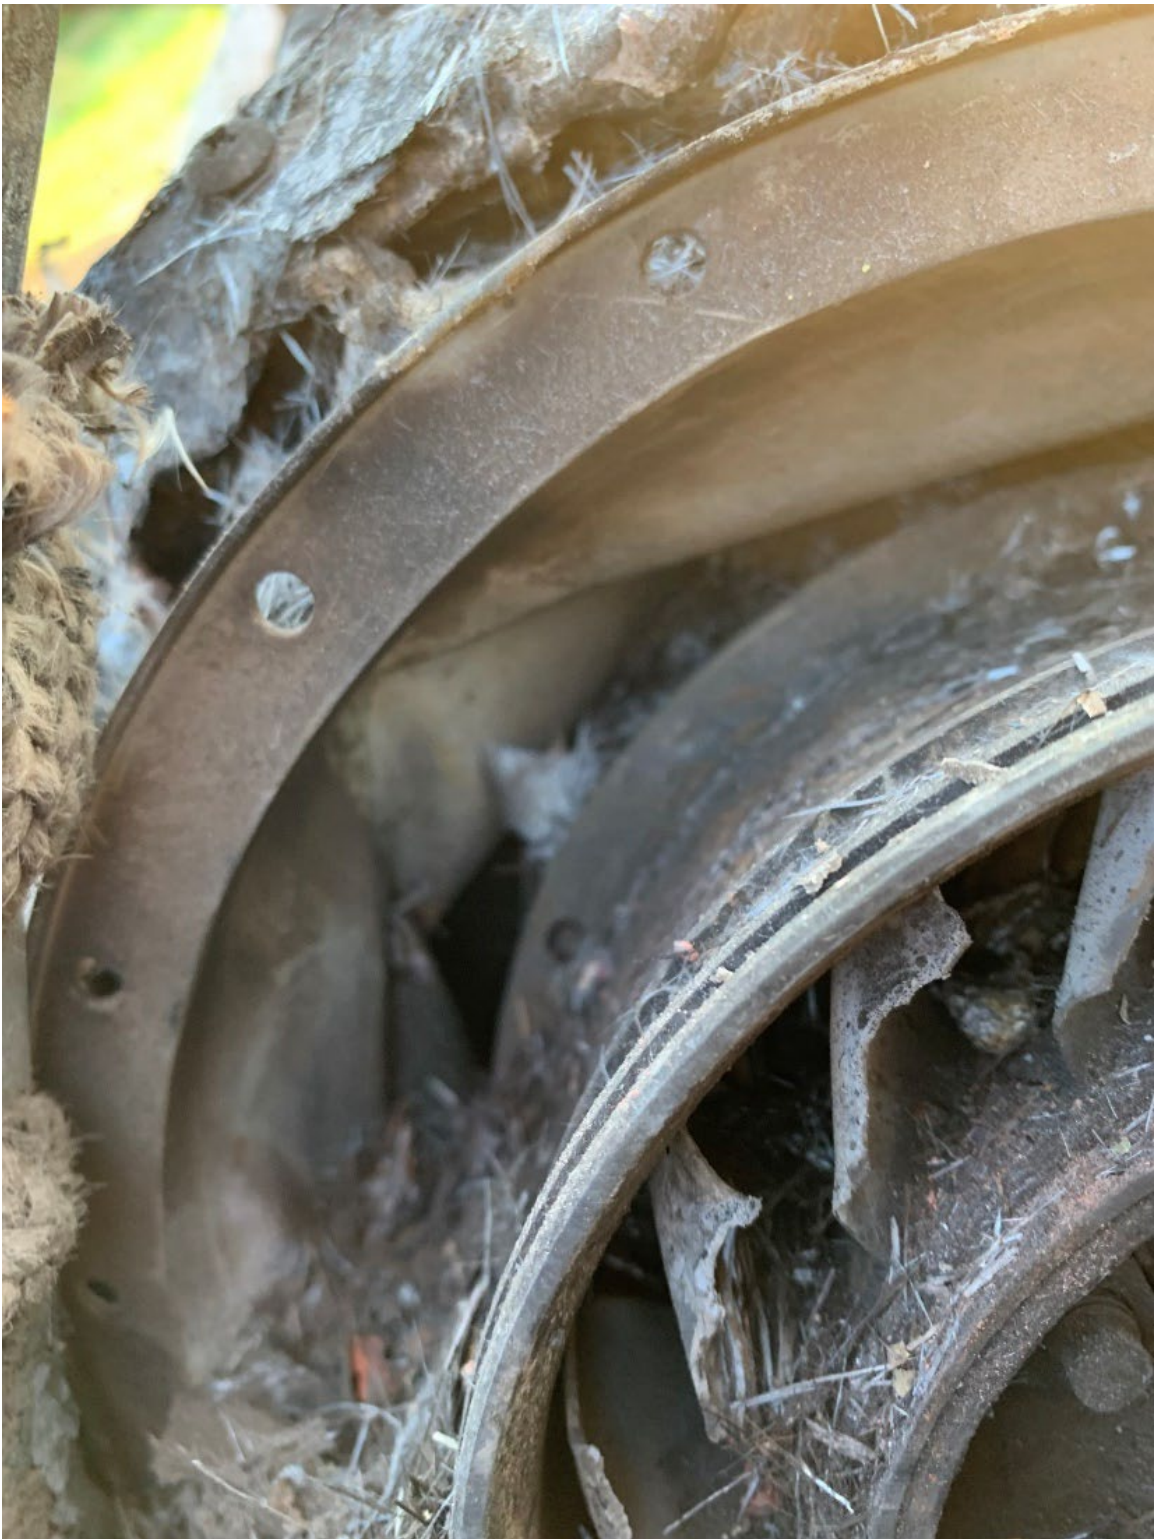
Figure 24: The First Stage Compressor
