# NATIONAL TRANSPORTATION SAFETY BOARD

## MATERIALS LABORATORY FACTUAL REPORT

Report No. 21-079

Place : Parker, Colorado  
Date : June 16, 2021  
Vehicle : Antenor Velazco Lancair Evolution, N704AK  
NTSB No. : CEN21FA272  
Investigator : Michael Hodges, AS-CEN

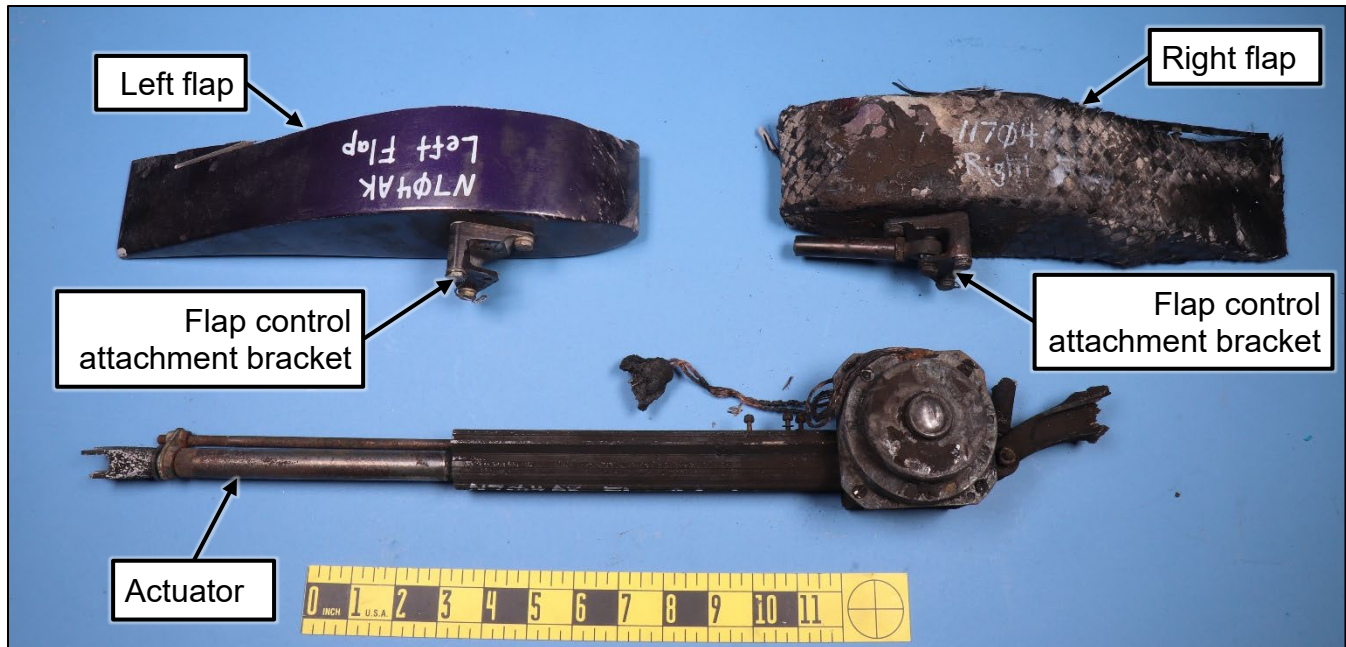
An overall view of the submitted components is shown in figure 1. The right flap and the actuator were blackened and degraded consistent with exposure to heat and fire. Rod ends, control rods, and arms attached to the actuator were fractured and had rough features in slant planes consistent with overstress fracture including fractures under relatively high temperatures.

Figure 1. Overall view of the submitted flap pieces and the flap actuator.

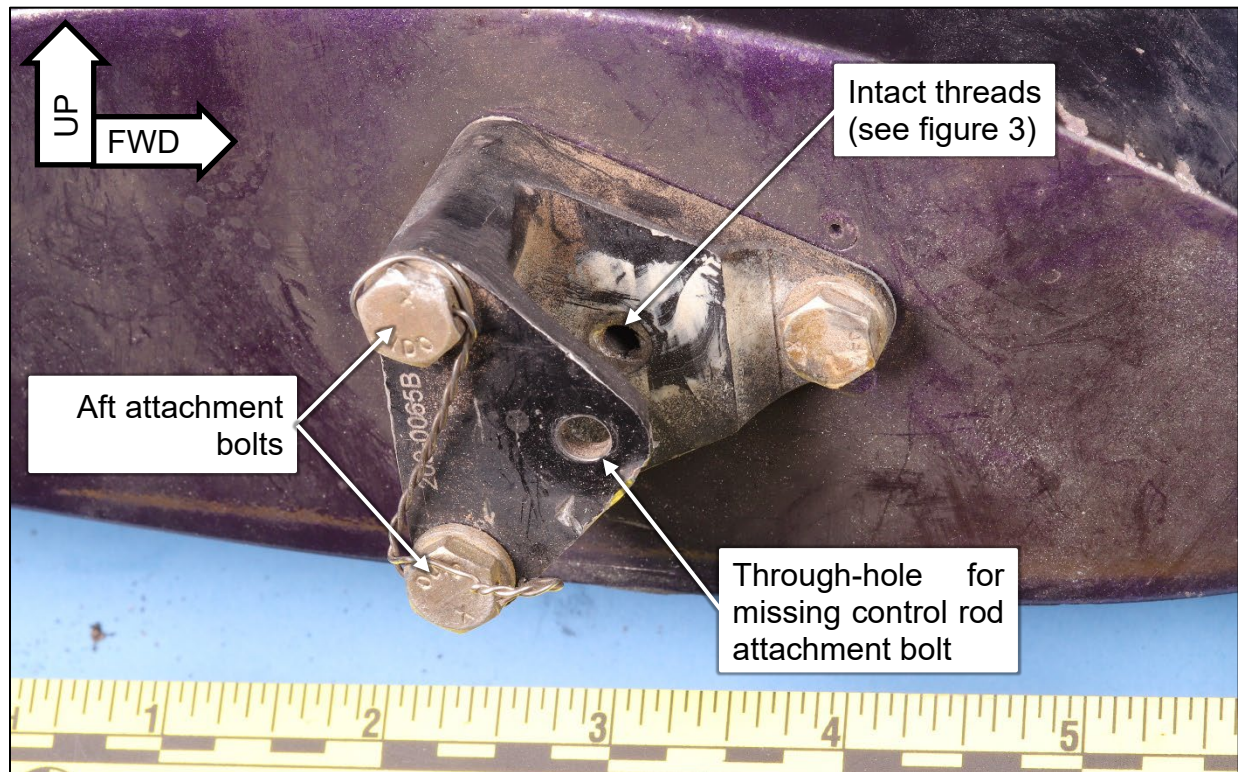
The flap control attachment bracket at the inboard end of the left flap is shown in figure 2. The flap control rod end and associated attachment bolt were missing from the assembly. However, threads for fastening the missing flap control rod attachment bolt were observed intact in the attachment bracket as shown in figure 3. The area around threaded hole was rubbed consistent with off-axis contact with the outboard end of the flap control rod attachment bolt. Corresponding off-axis contact deformation was observed at the edge of the control rod attachment bolt through-hole on the inboard side of the bracket.

The aft attachment bolts for the flap control attachment bracket were secured with safety wire (see figure 2). The free end of the safety wire at the lower aft attachment bolt was bent over and both wires had a straight flattened end face consistent with a cut end.

Figure 2. Flap control attachment bracket on the inboard end of the left flap showing a missing flap control attachment bolt.

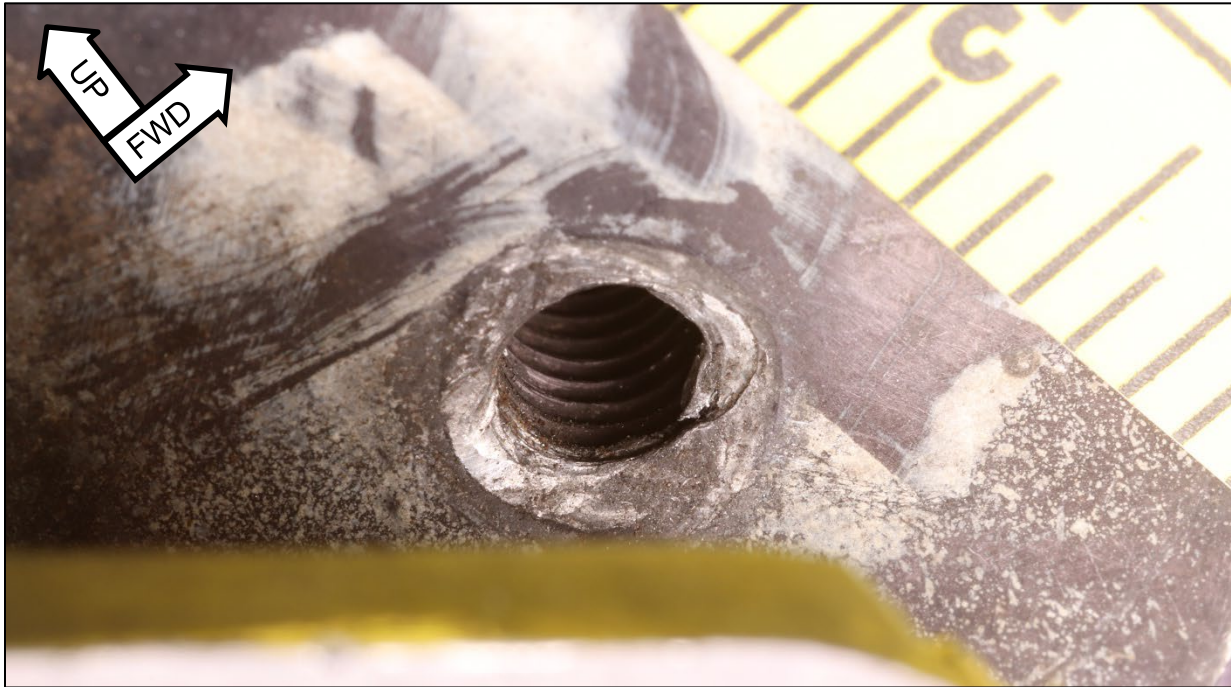
Figure 3. Intact threads in the left flap control attachment bracket associated with the missing flap control attachment bolt.

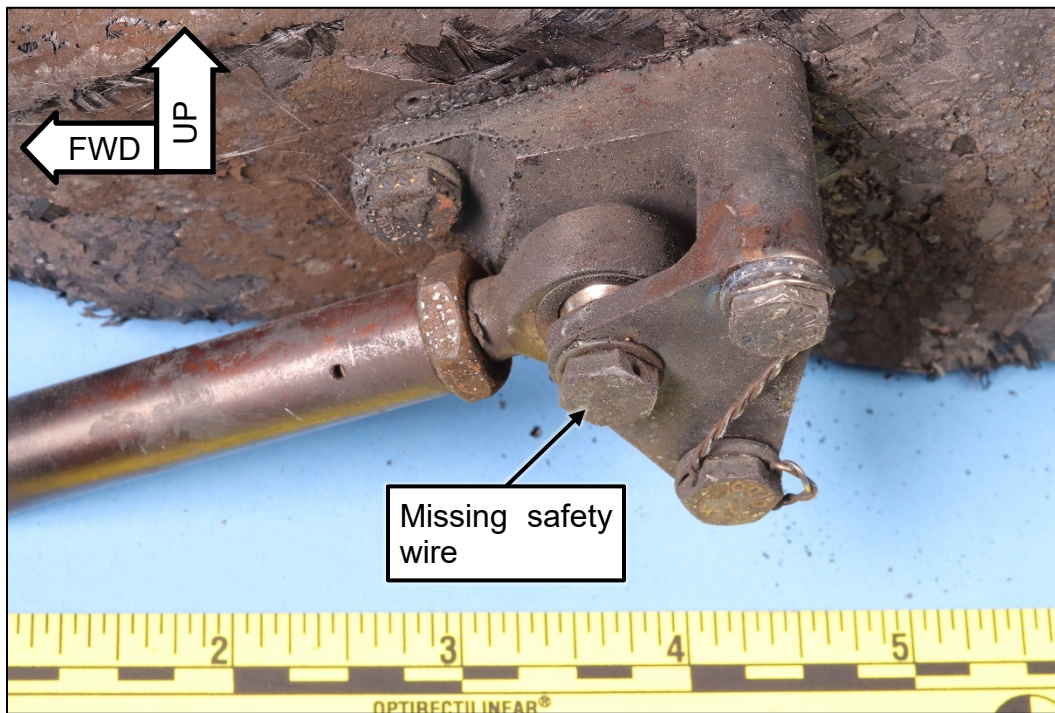
The flap control attachment bracket at the inboard end of the right flap is shown in figure 4. A piece of the right flap control rod remained attached to the bracket with an intact control rod attachment bolt. Similar to the left attachment bracket, the aft attachment bolts for the right flap control attachment bracket were secured with safety wire as shown in figure 4. The free end of the safety wire at the lower aft attachment bolt was bent over and both wires had a straight flattened end face consistent with a cut end.

While the head for the right flap control rod attachment bolt was drilled for use with safety wire, no safety wire was observed attached to the control rod attachment bolt.

On October 4, 2021, Evolution Aircraft Company issued Service Advisory SA016-0036 regarding inspection of Evolution aircraft attach points. Service Advisory SA016-0036 includes an illustration of the flap control system from the Evolution Build Manual that states, "Safety wire bolt through bearing" associated with arrows pointing to the right and left flap control attachment brackets. The service advisory also shows a photograph of a proper flap control rod attachment with safety wire securing the control rod attachment bolt to the upper aft attachment bolt for the bracket. In the photograph, the lower aft attachment bolt has a torque stripe for detecting bolt head movement but does not have safety wire.<sup>1</sup>

Figure 4. Inboard end of the right flap showing the control attachment bracket with attached rod end and missing safety wire from the flap control attachment bolt.
