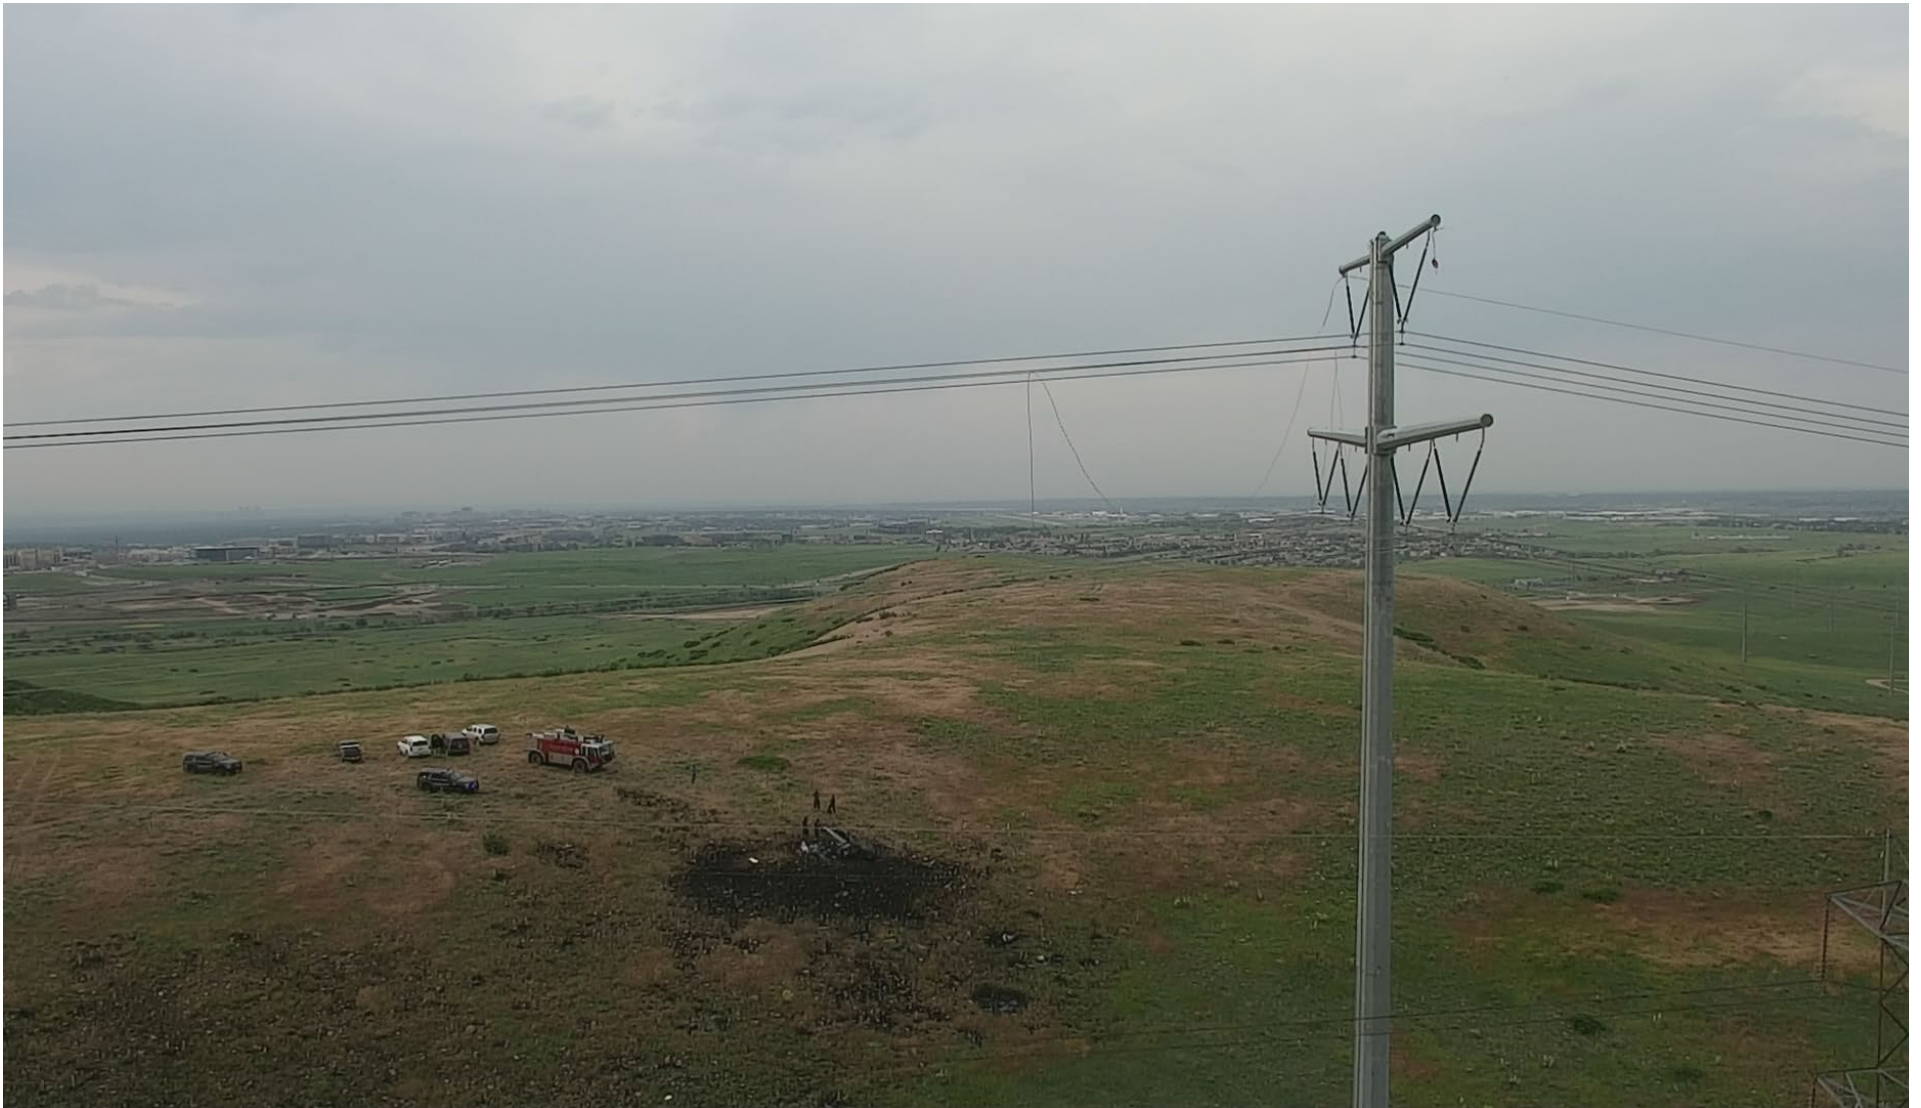
**Photo 1 – Aerial view of the transmission static lines and the accident site, looking to the north (courtesy of the South Metro Fire Rescue Authority).**

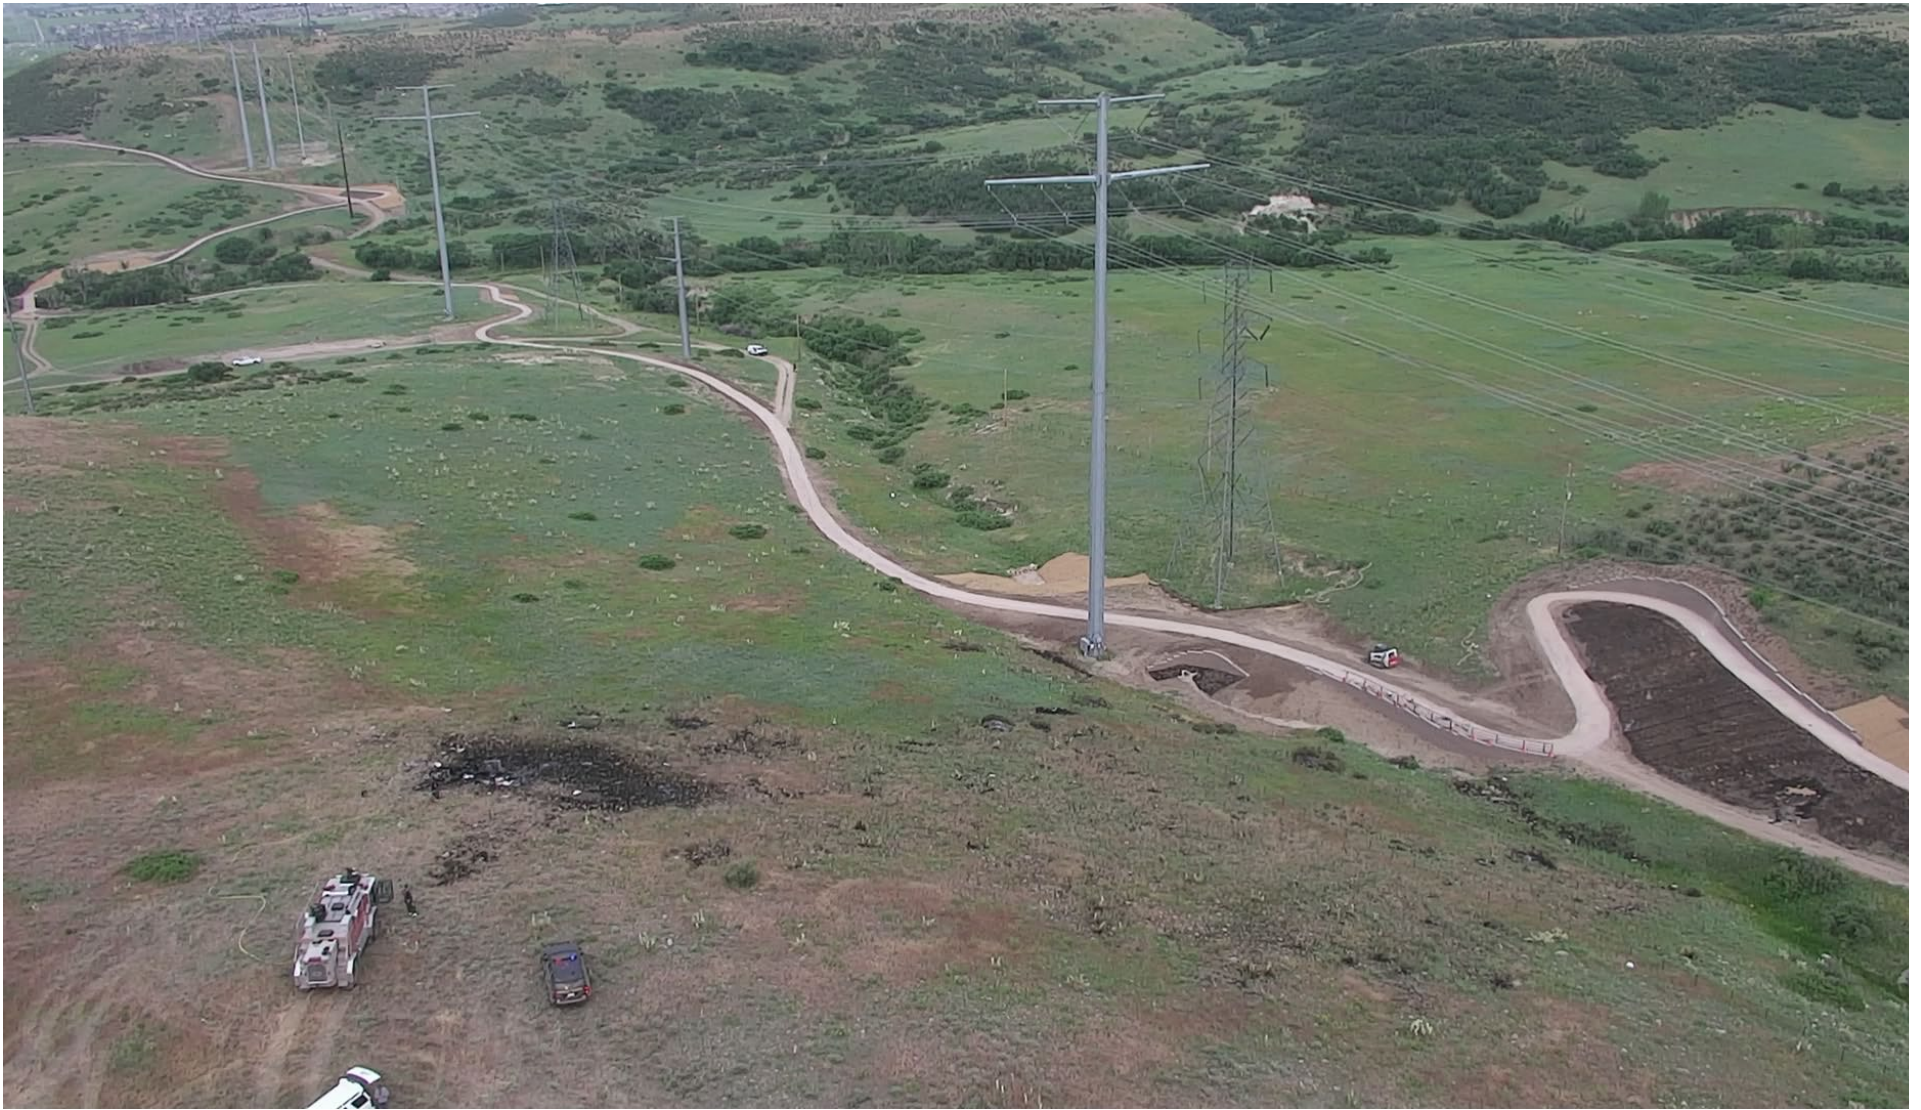
**Photo 2 – Aerial view of the transmission static lines and the accident site, looking to the east (courtesy of the South Metro Fire Rescue Authority).**

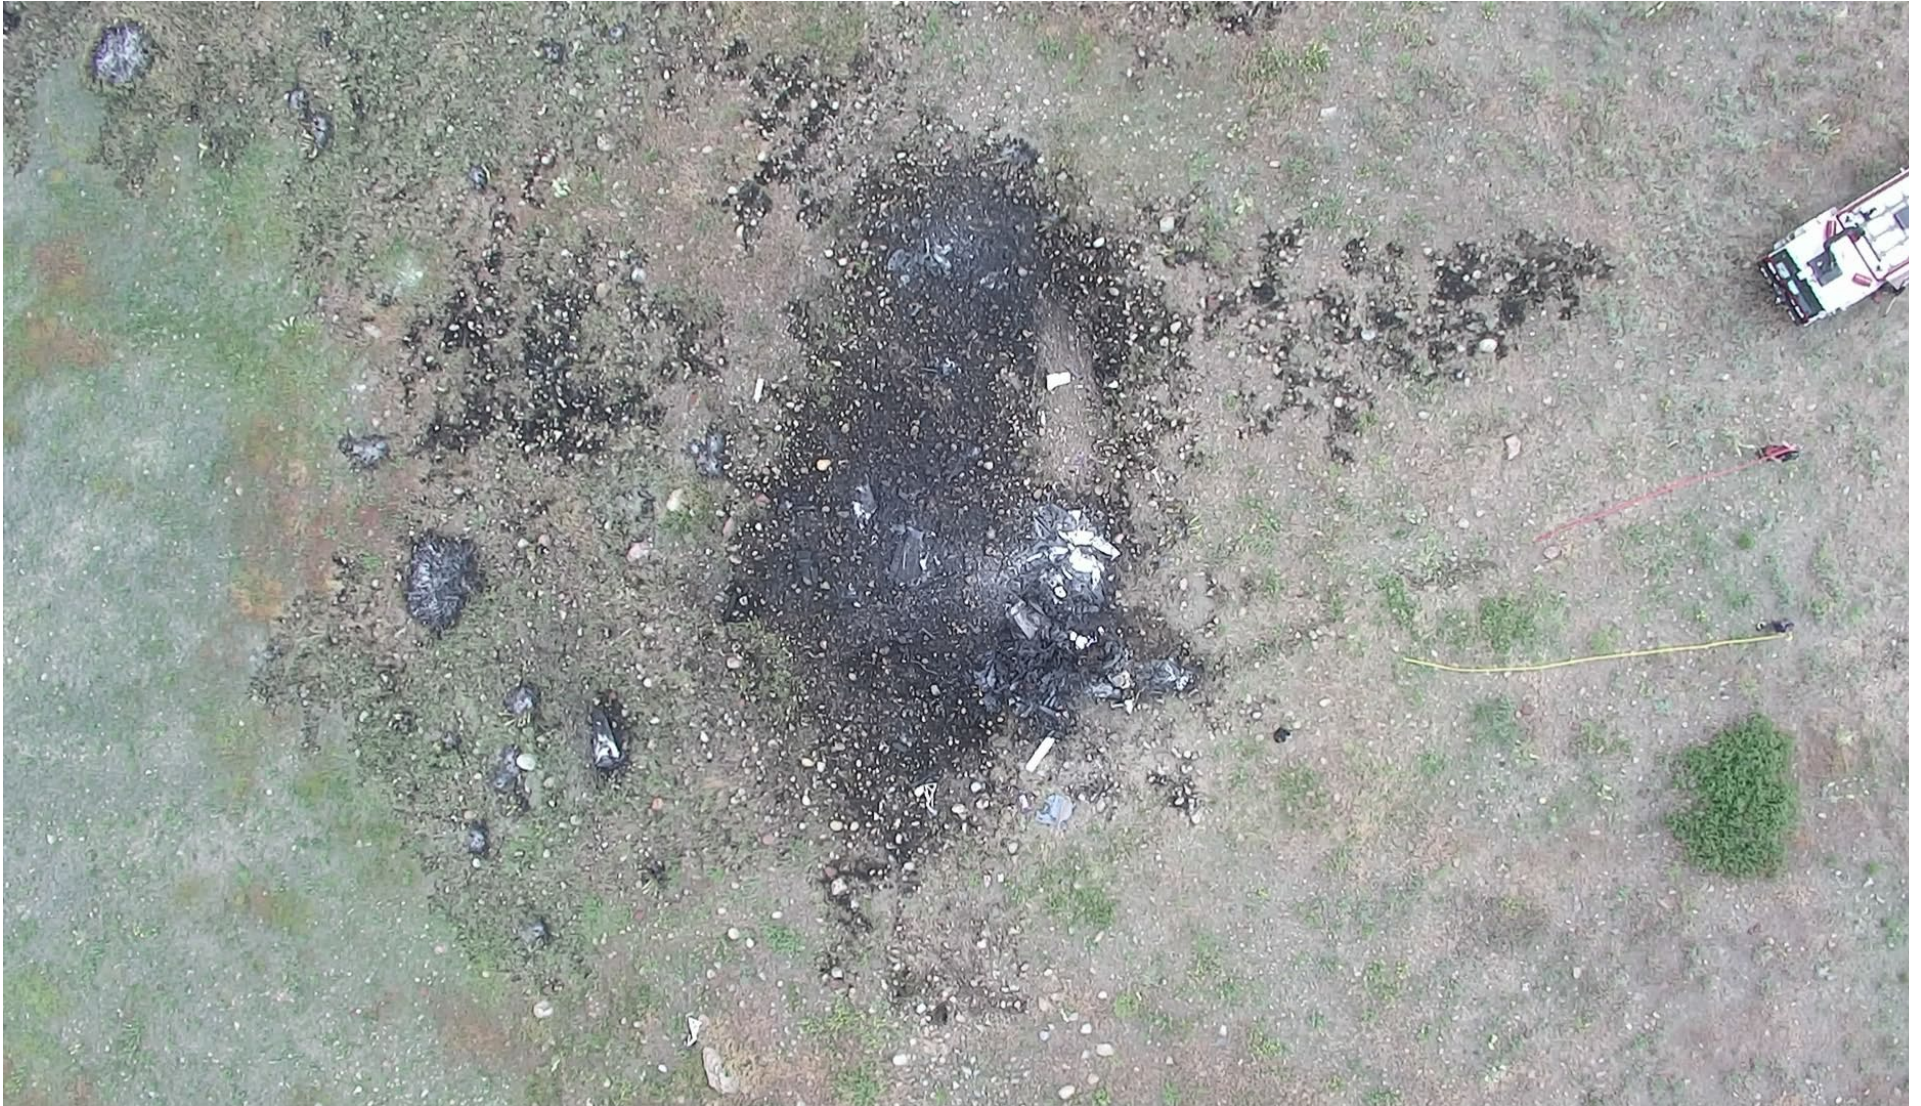
**Photo 3 – Aerial view of the accident site, from a direct overhead perspective (courtesy of the South Metro Fire Rescue Authority).**

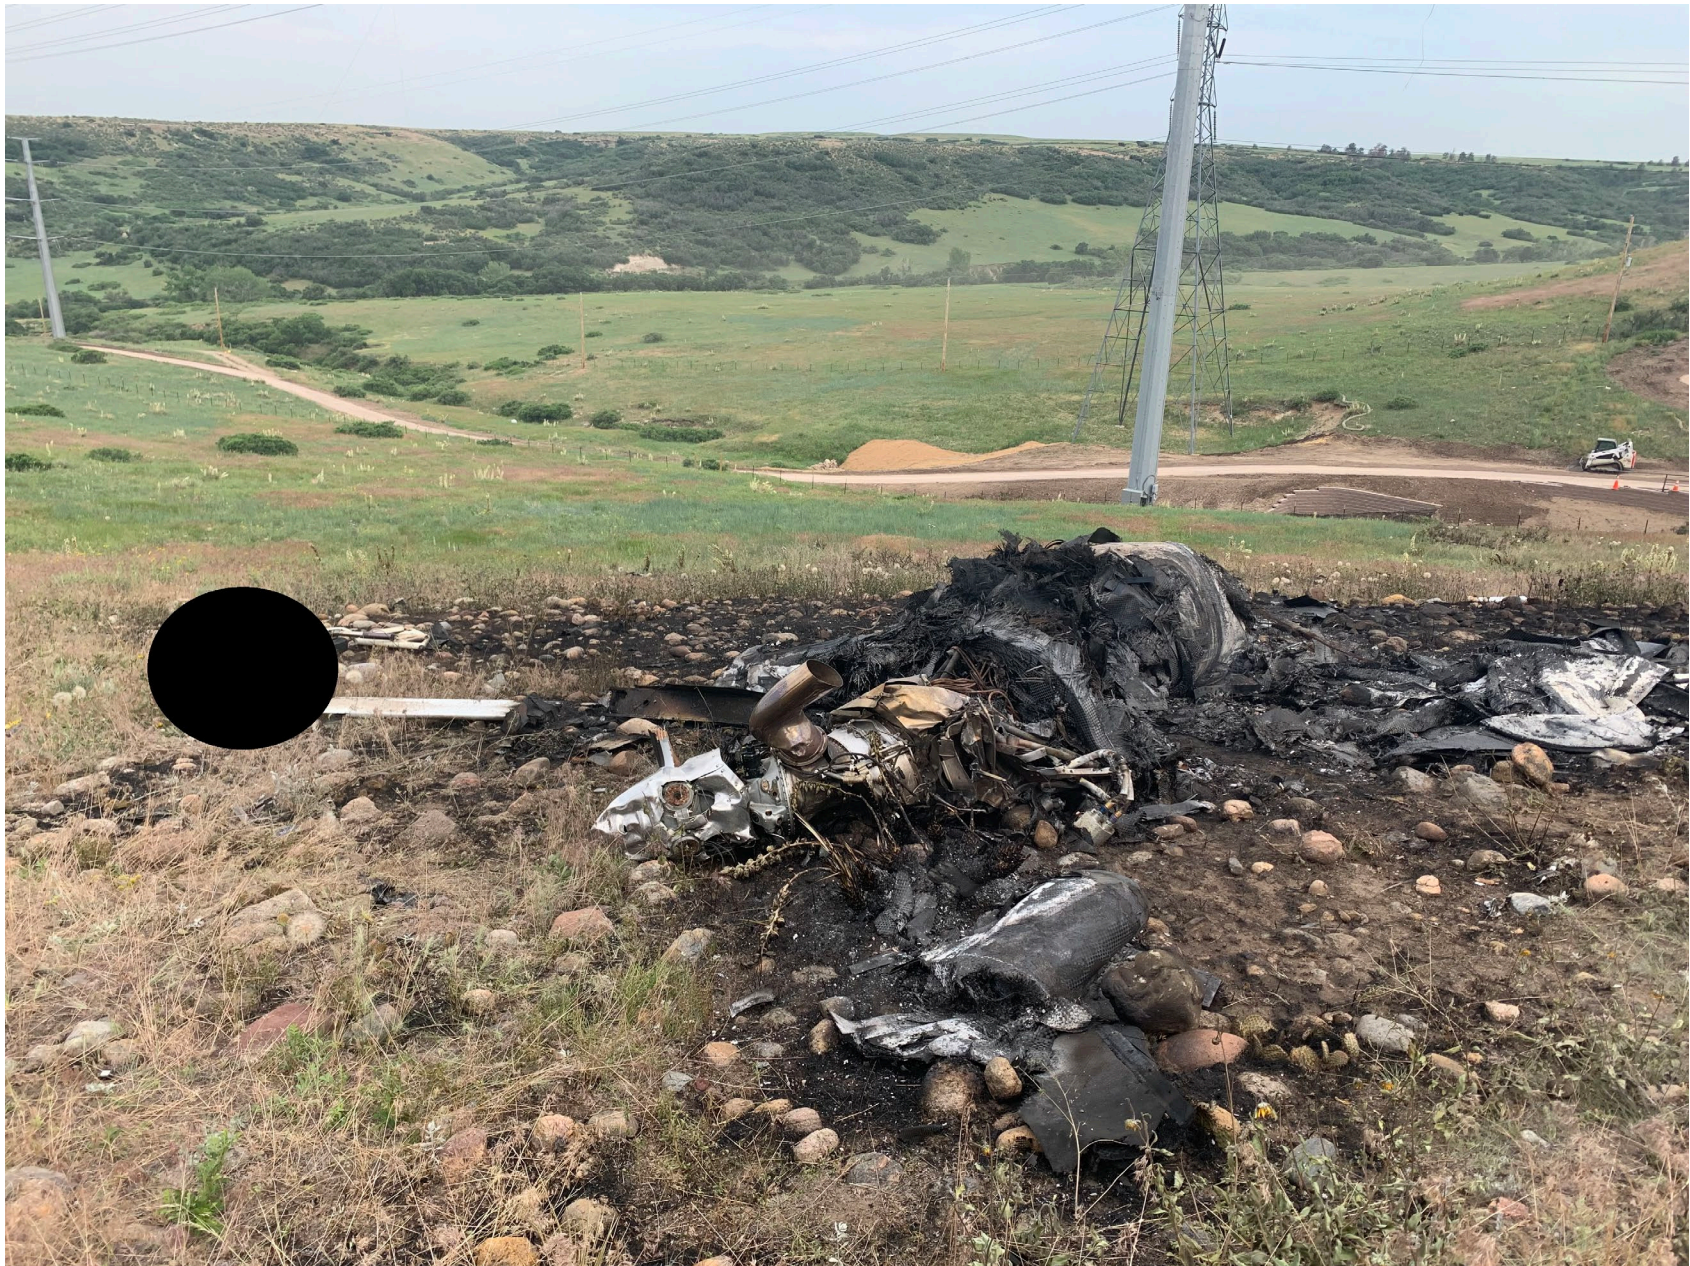
**Photo 4 – View of the wreckage looking to the south.**

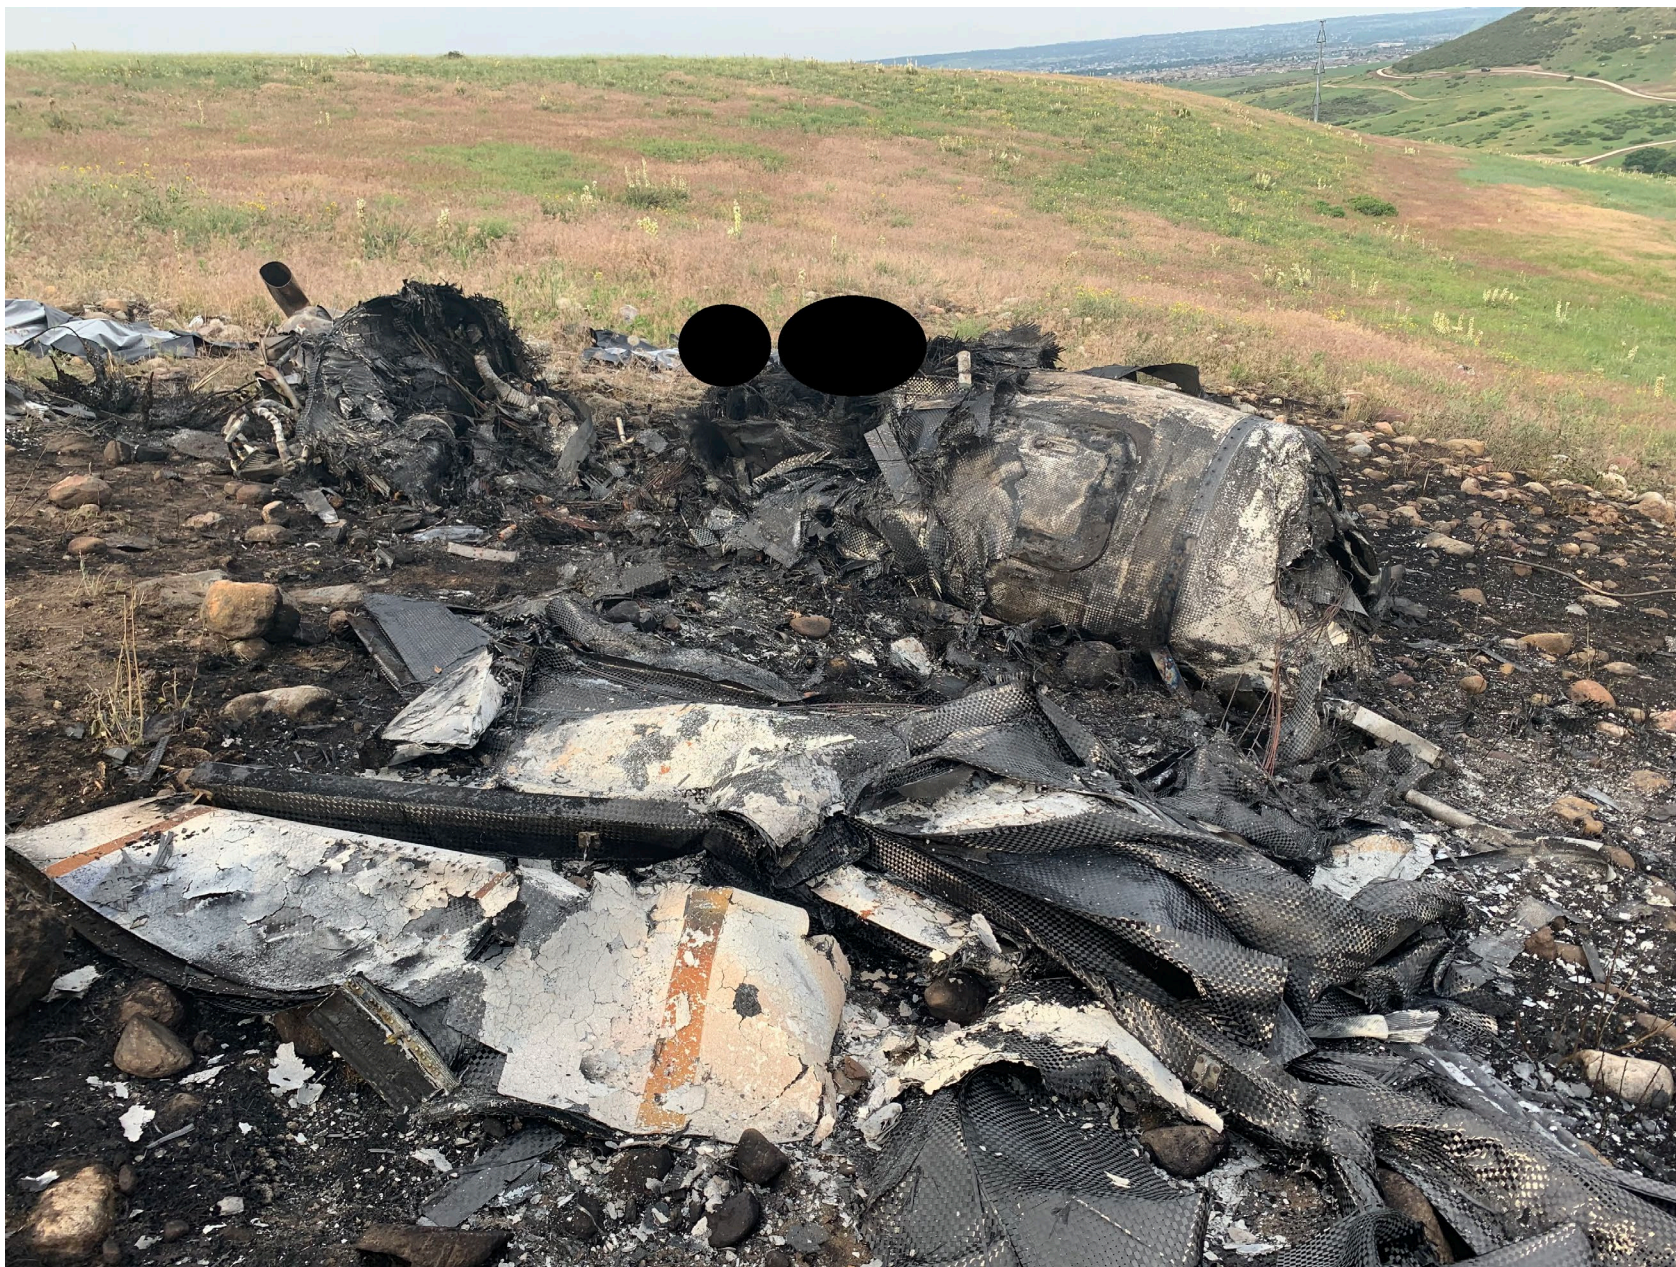
**Photo 5 – View of the wreckage looking to the east.**

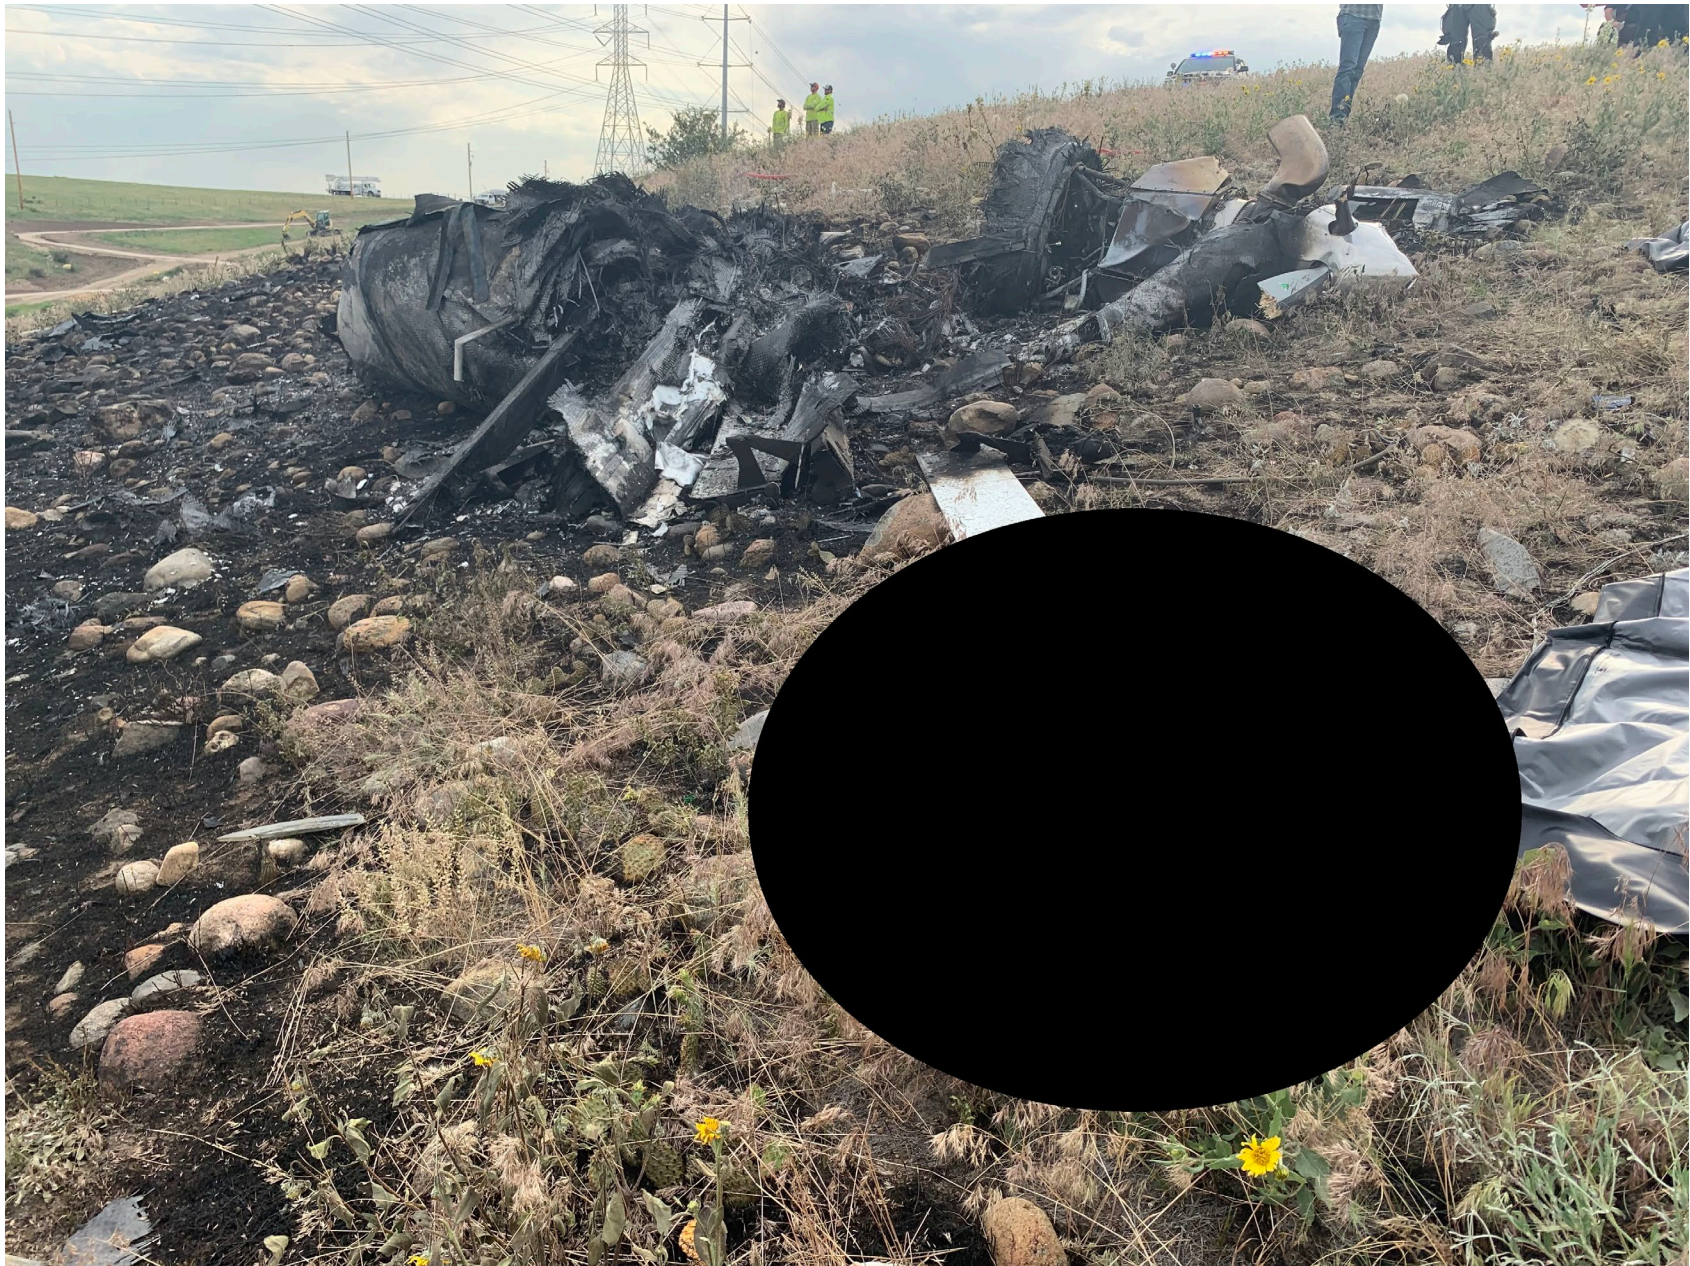
**Photo 6 – View of the wreckage looking to the west.**

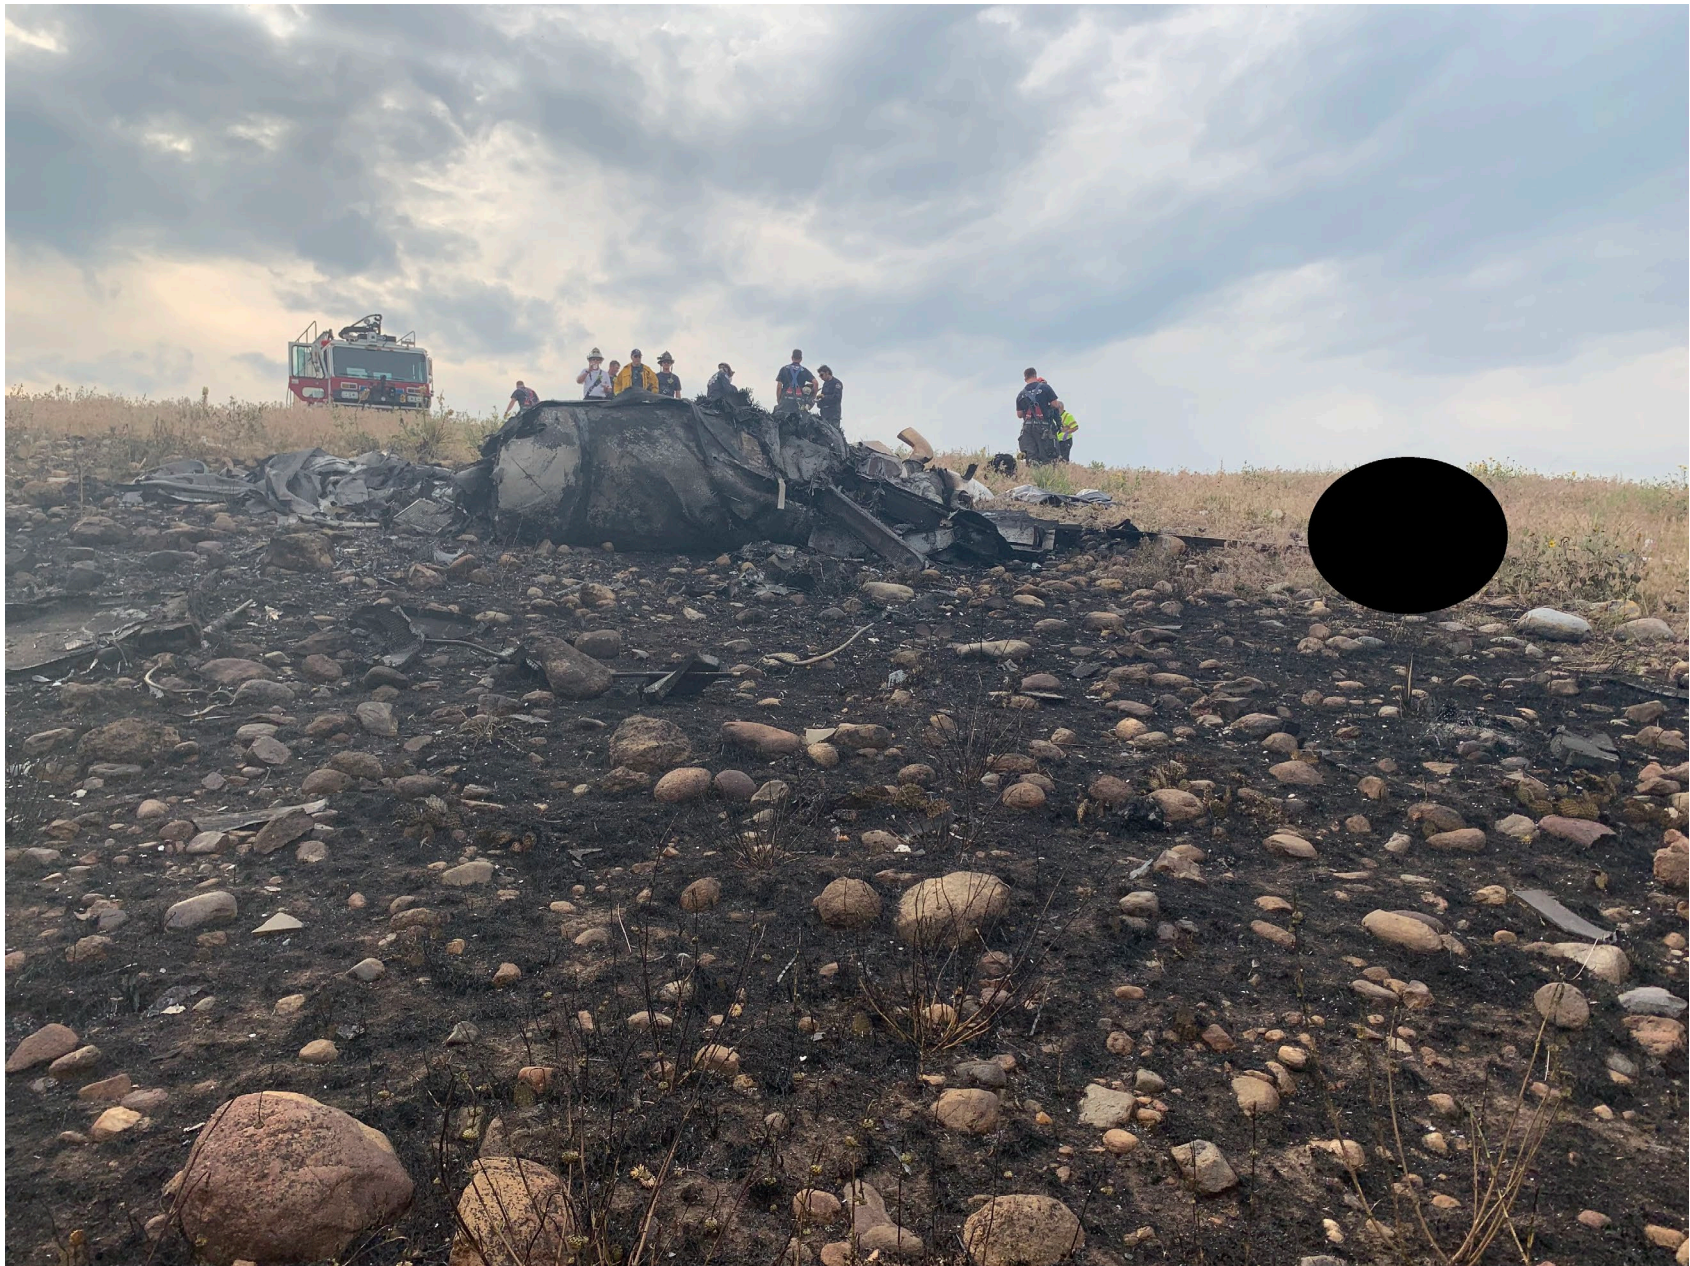
**Photo 7 – View of the wreckage looking to the north.**

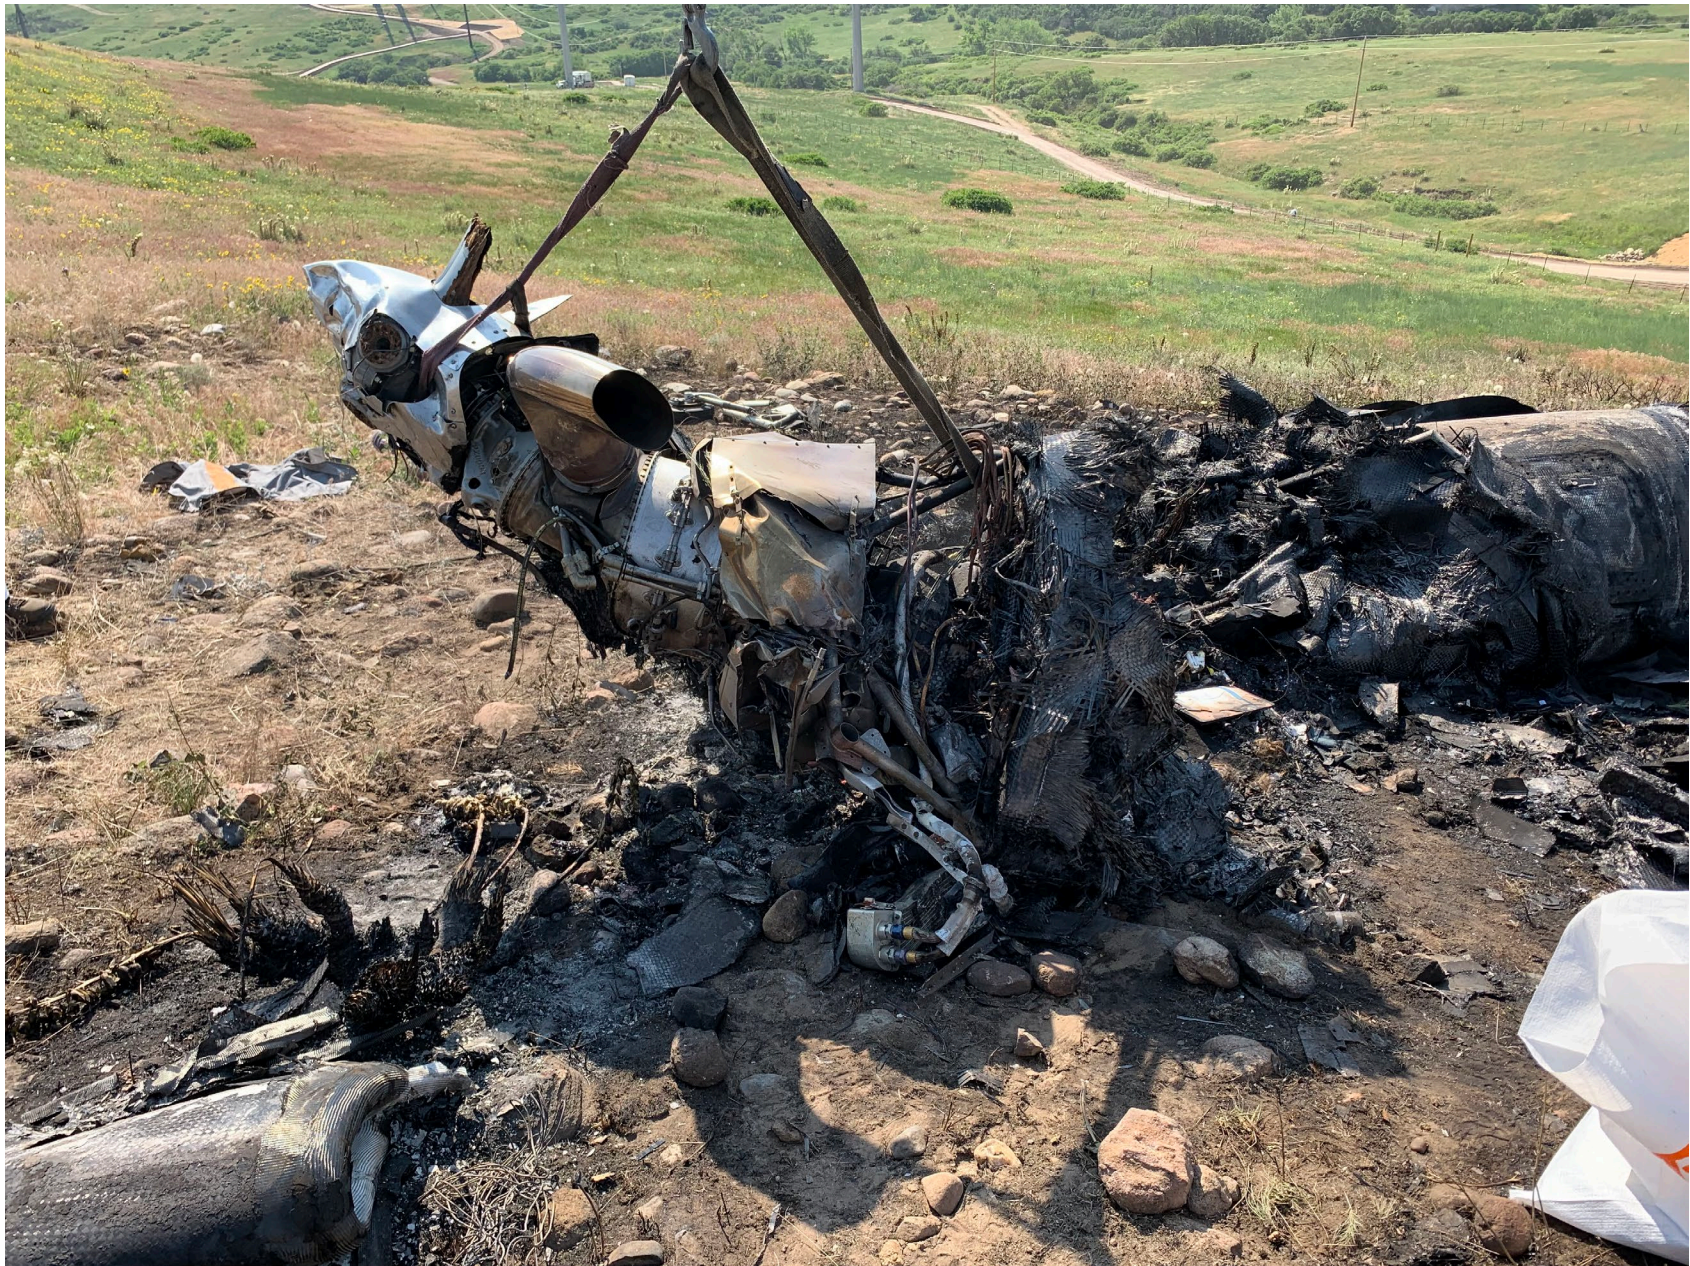
**Photo 8 – View of the propeller and the engine.**

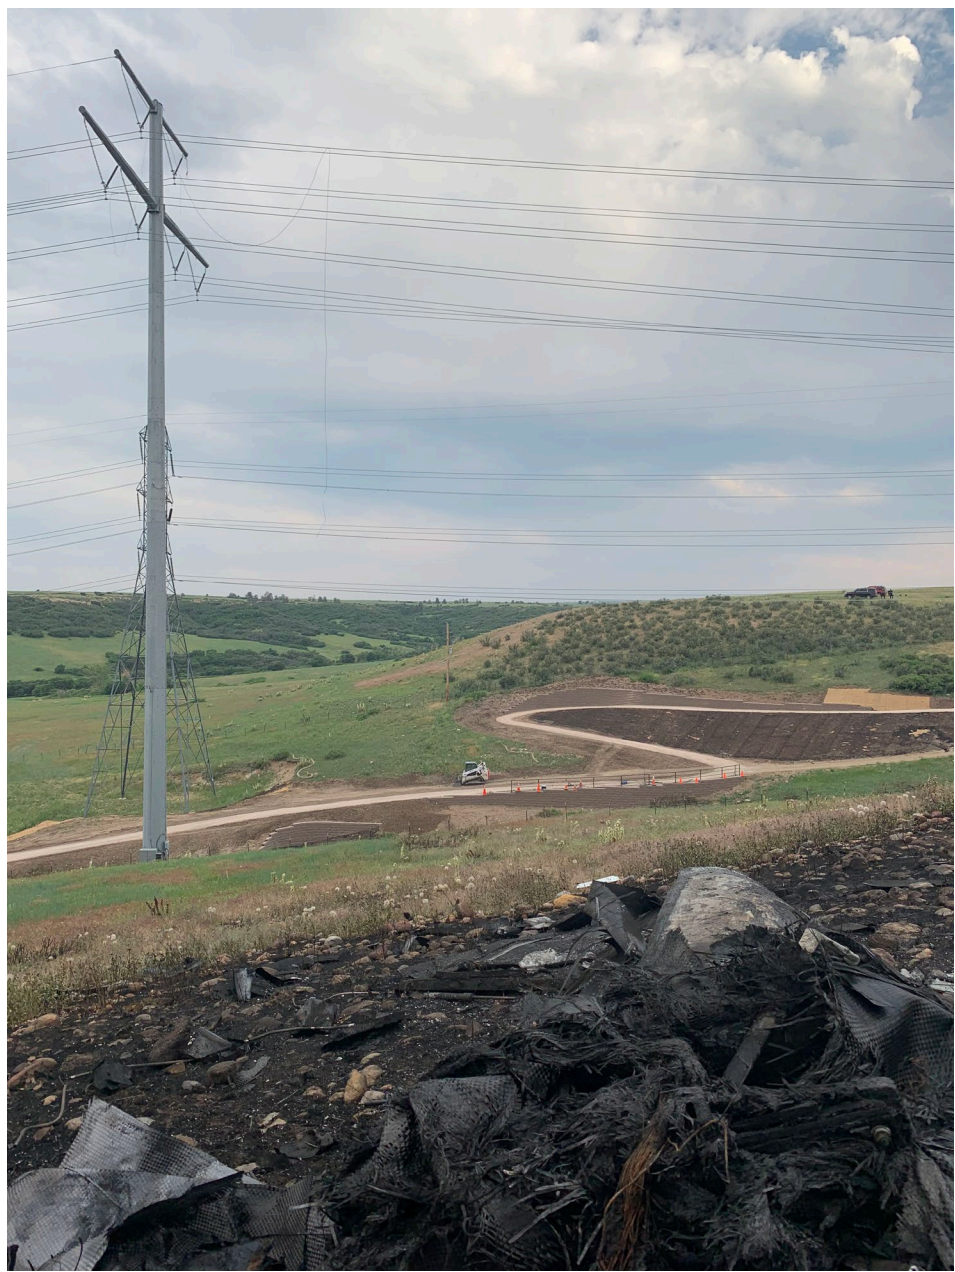
**Photo 9 – View of the transmission static lines from the accident site.**

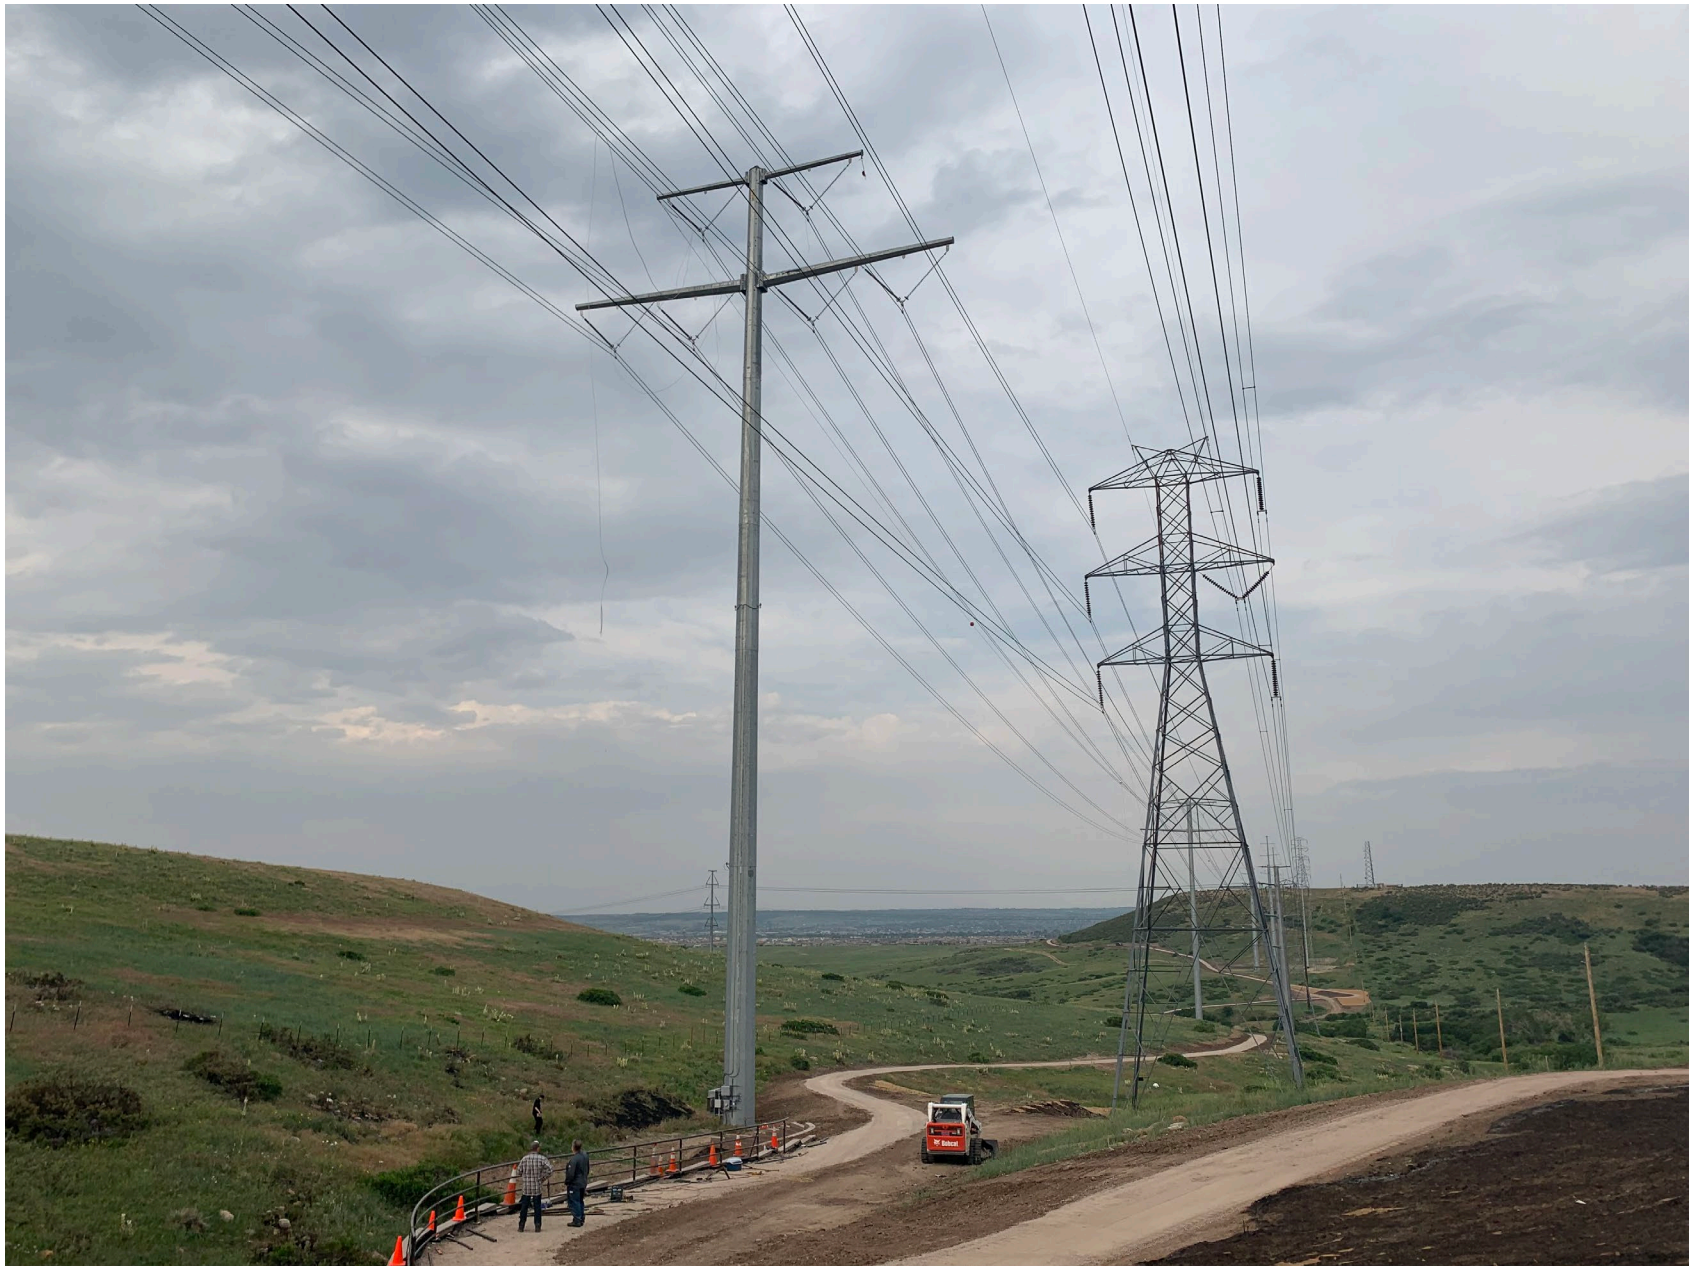
**Photo 10 – View from underneath the transmission static lines.**

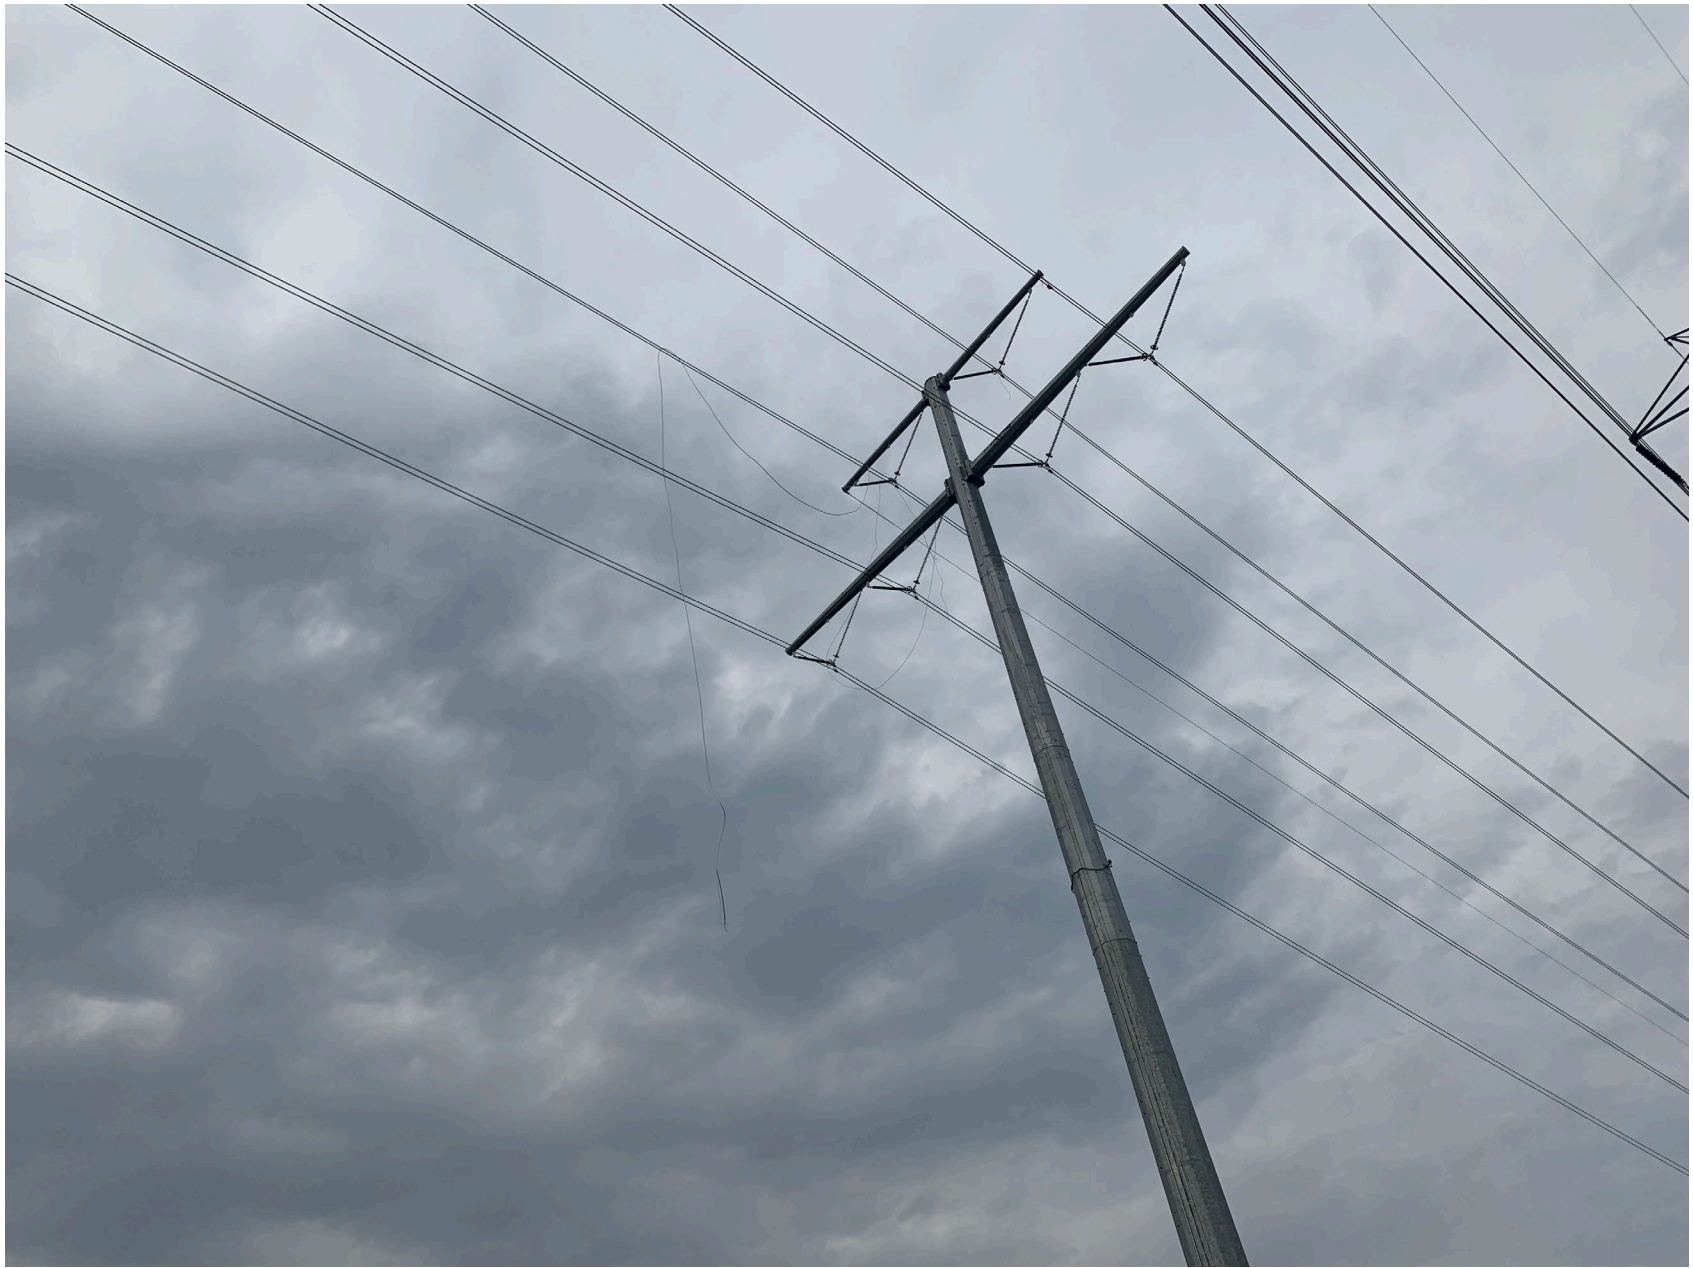
**Photo 11 – View from underneath the transmission static lines, showing a transmission static line that was impacted by the airplane.**
