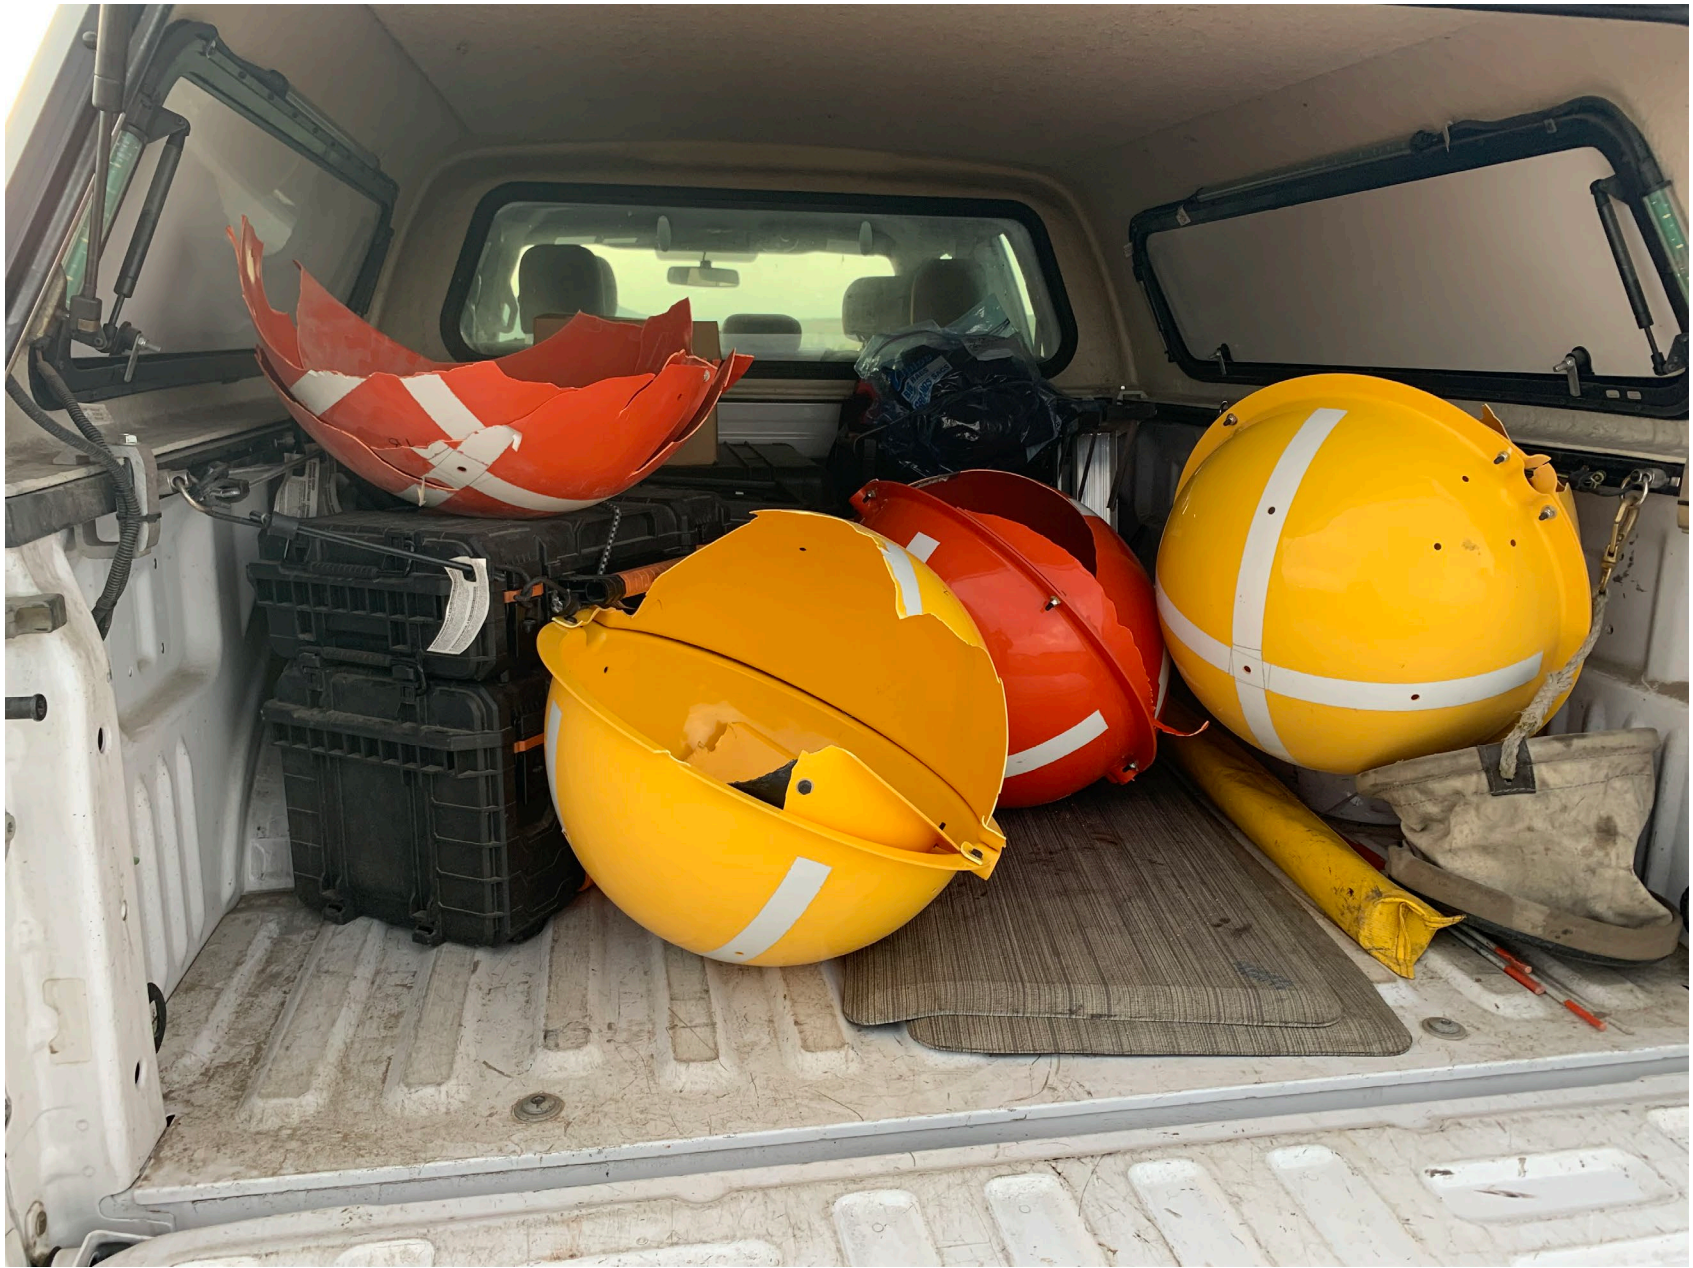
**Photo 12 – View of the various recovered marker balls that were installed on the transmission static lines.**

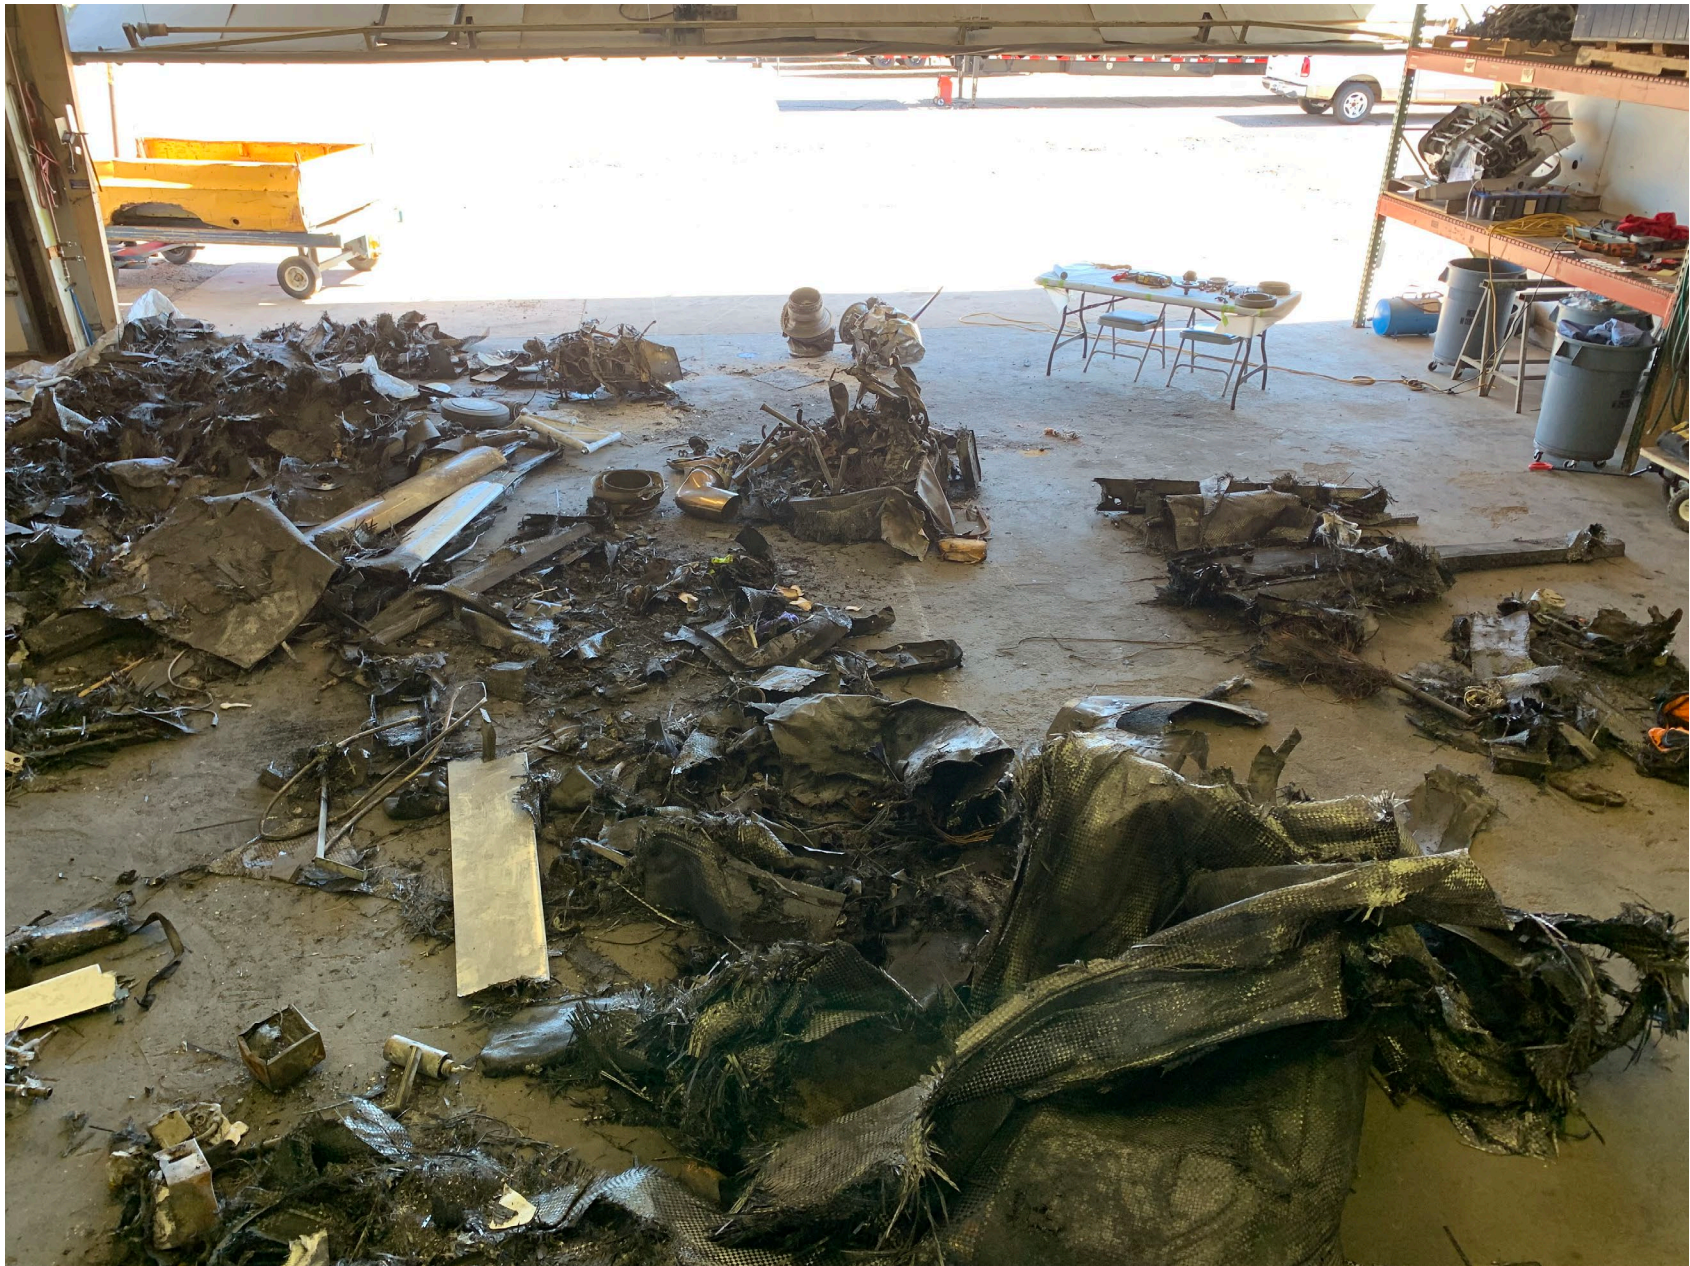
**Photo 13 – View of the wreckage layout.**

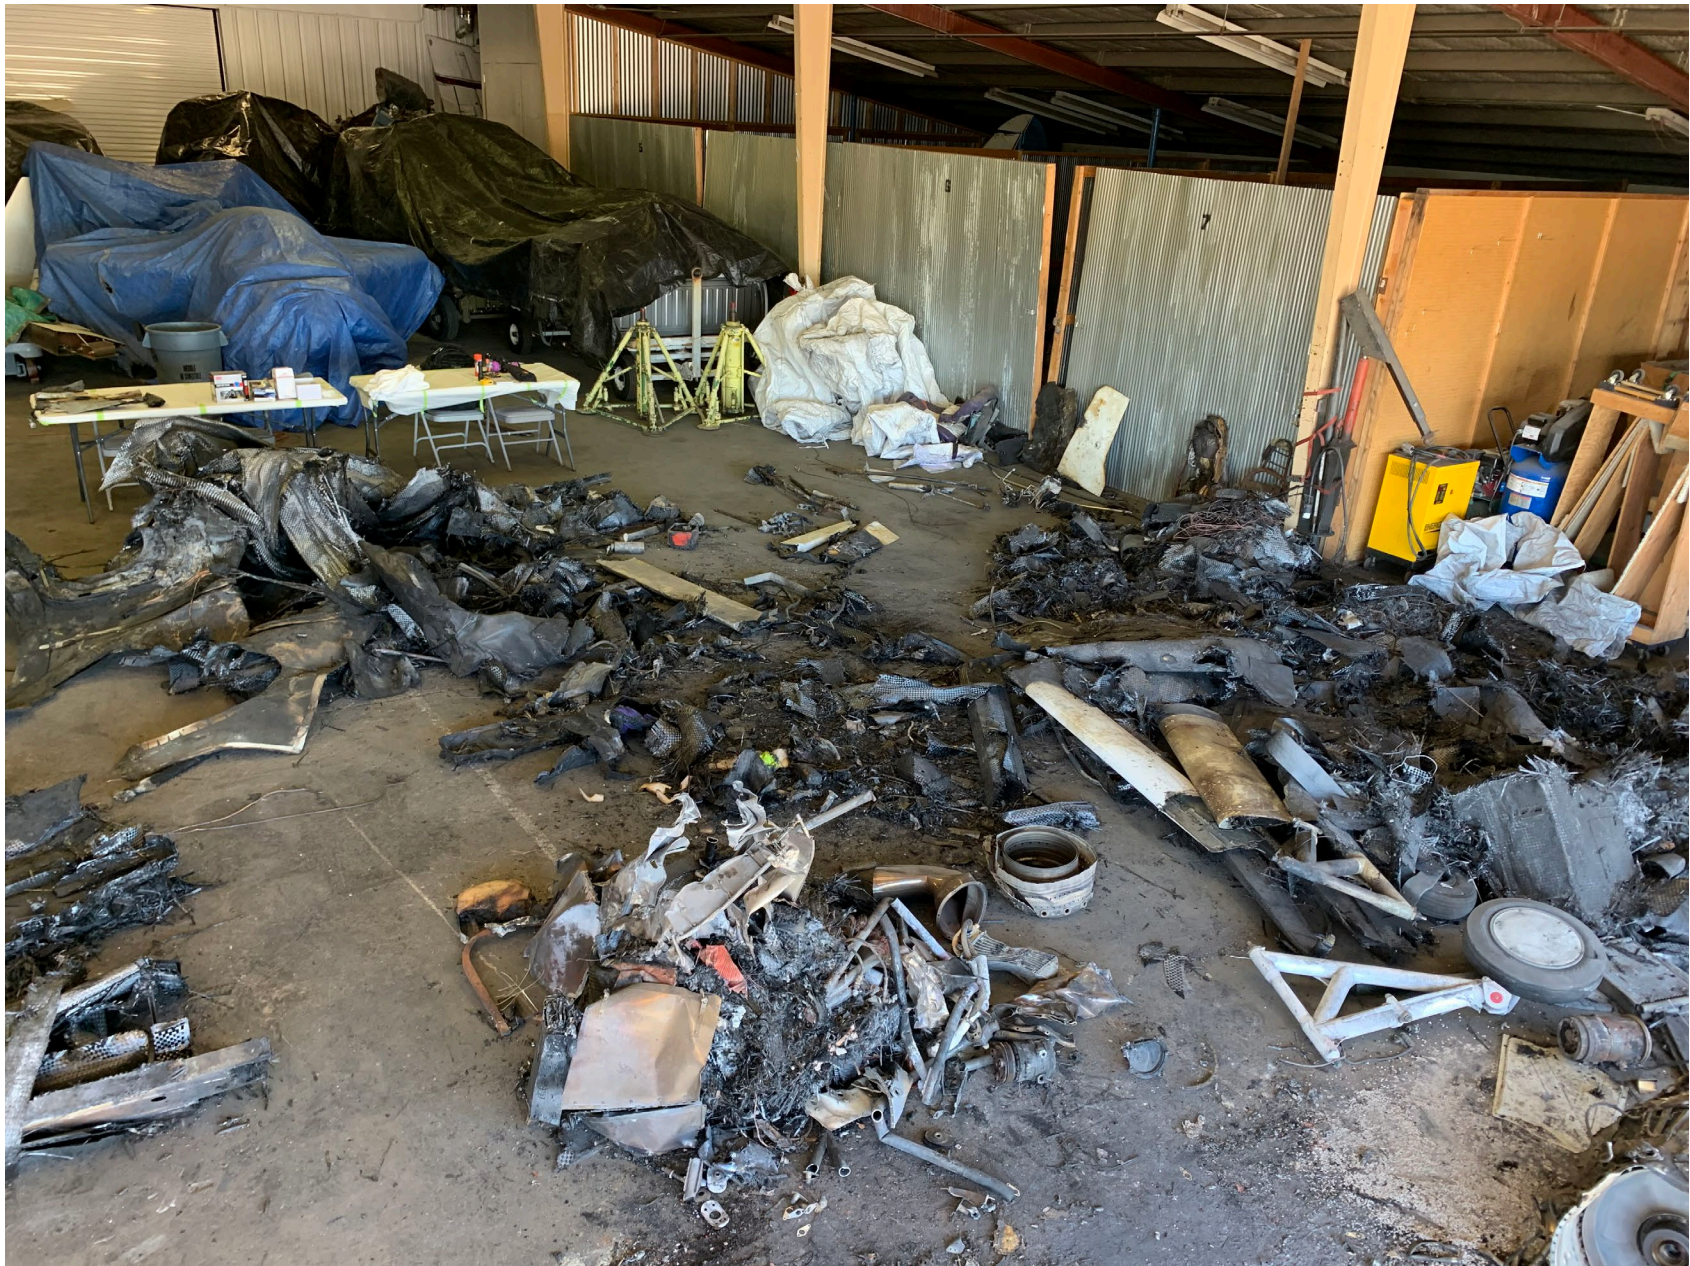
**Photo 14 – View of the wreckage layout.**

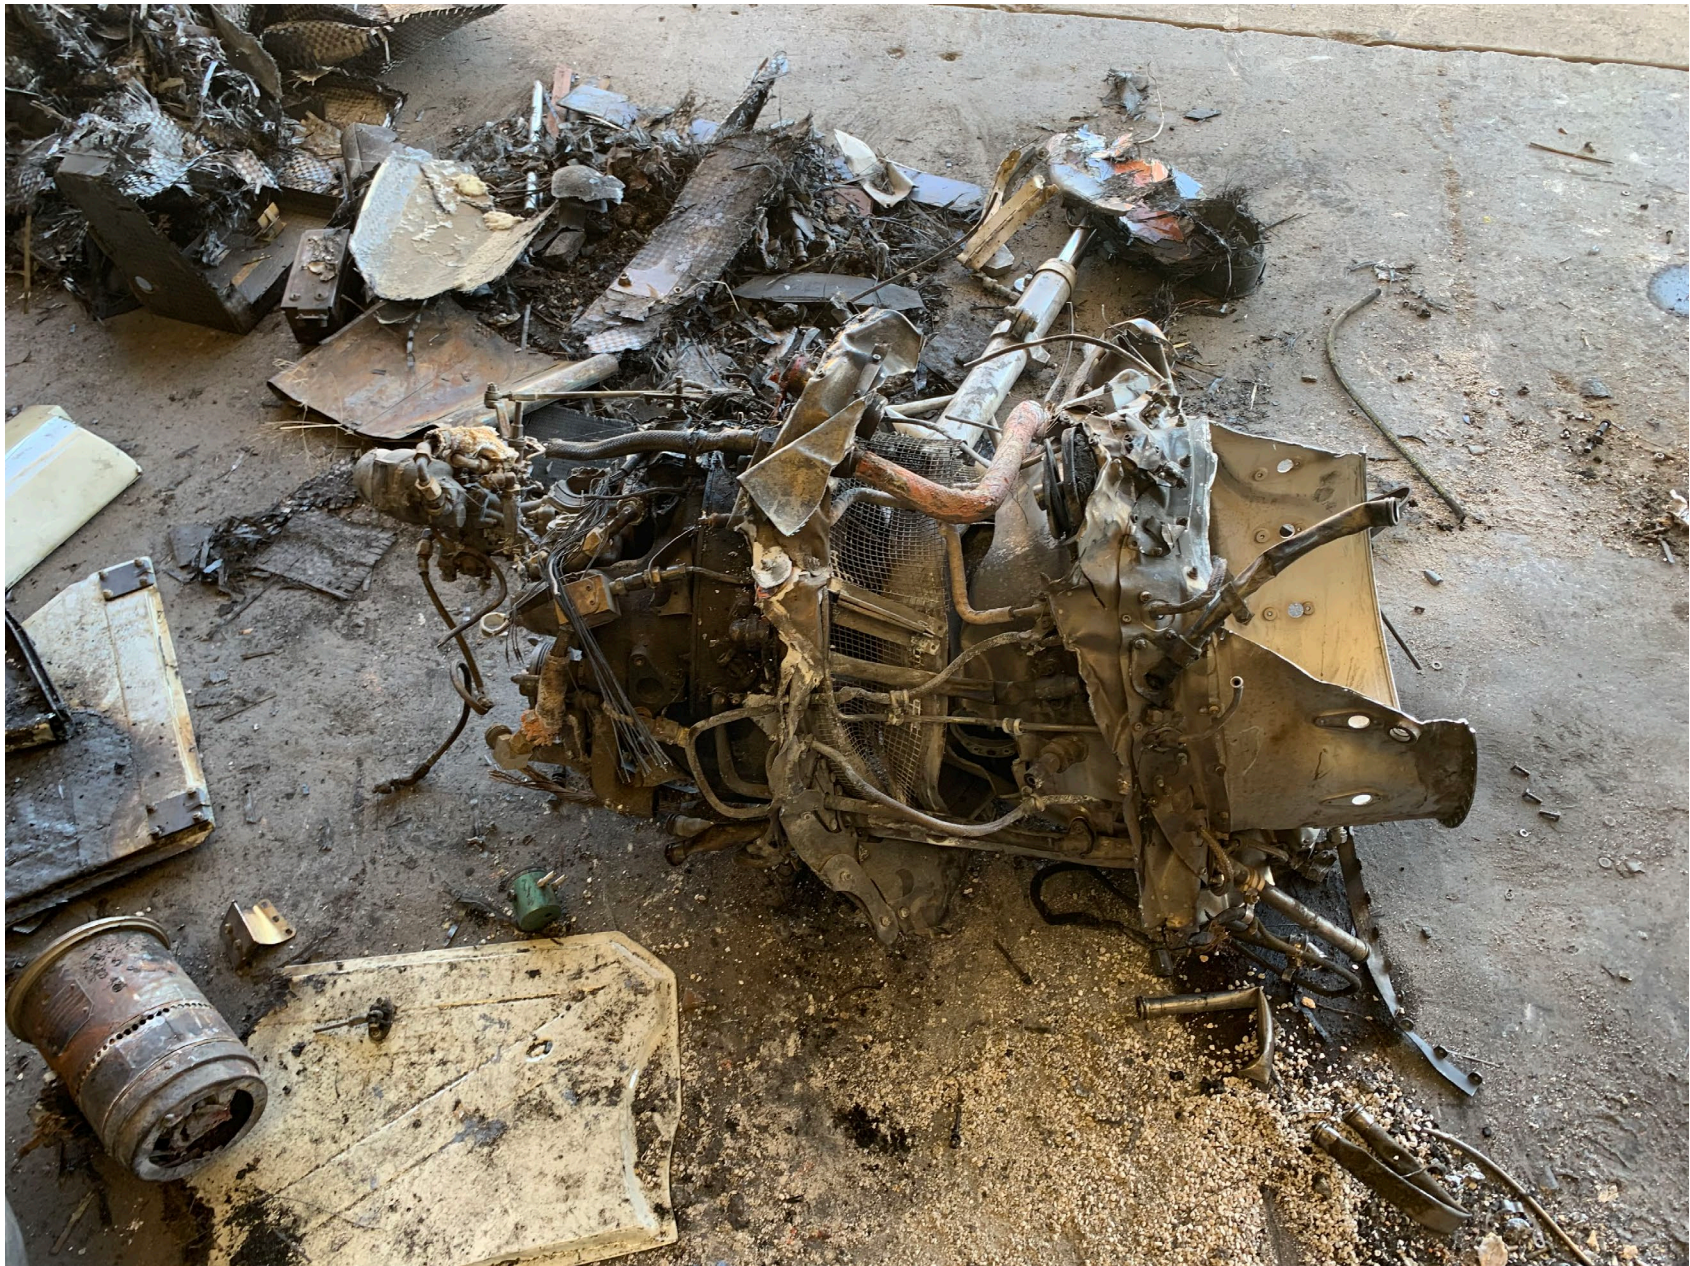
**Photo 15 – View of the engine during the examination.**

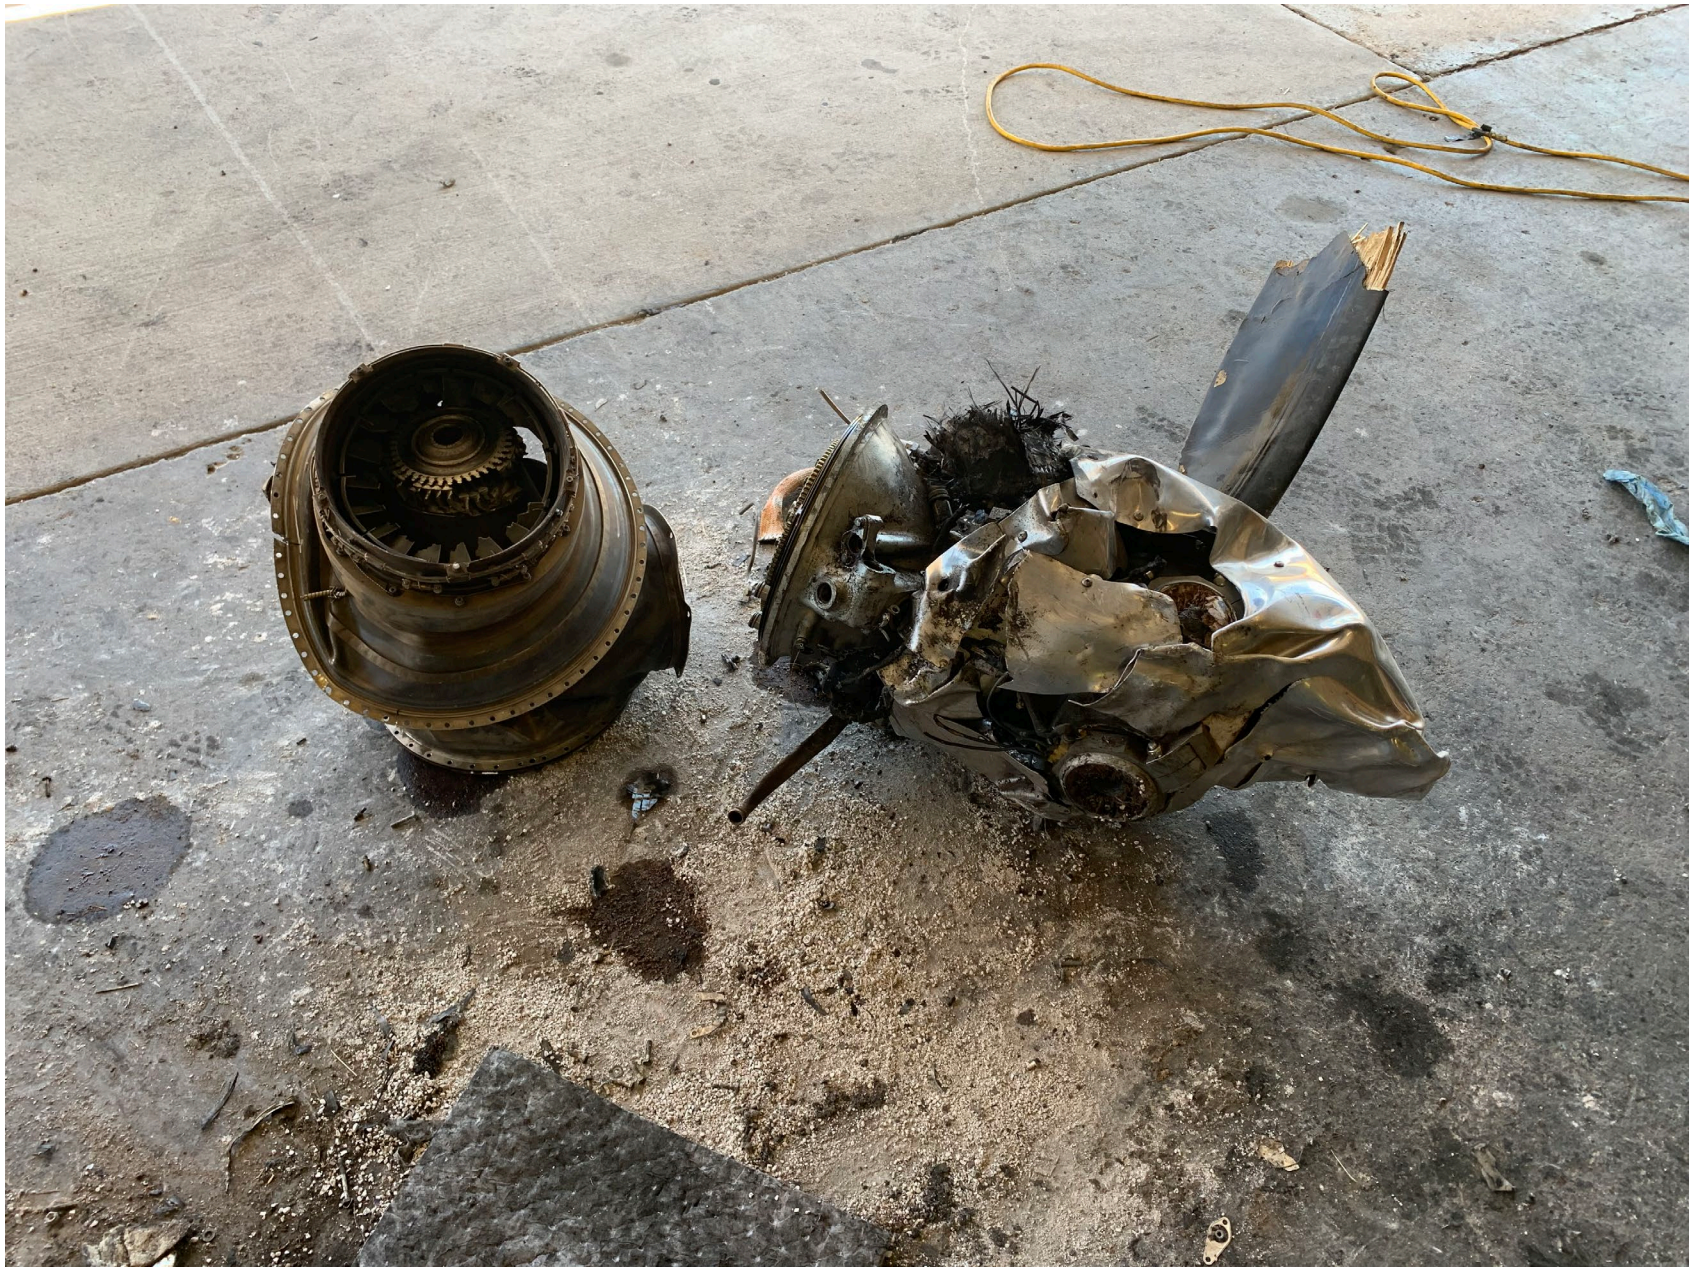
**Photo 16 – View of the propeller during the examination.**
