# National Transportation Safety Board

CEN21FA297

## **WRECKAGE EXAMINATION SUMMARY**

Location: Curtiss, Wisconsin  
Date: June 30, 2021  
Time: 0450 central daylight time (0950 UTC)  
Airplane: Earthstar Aircraft Gull 2000, Registration No. N1712L

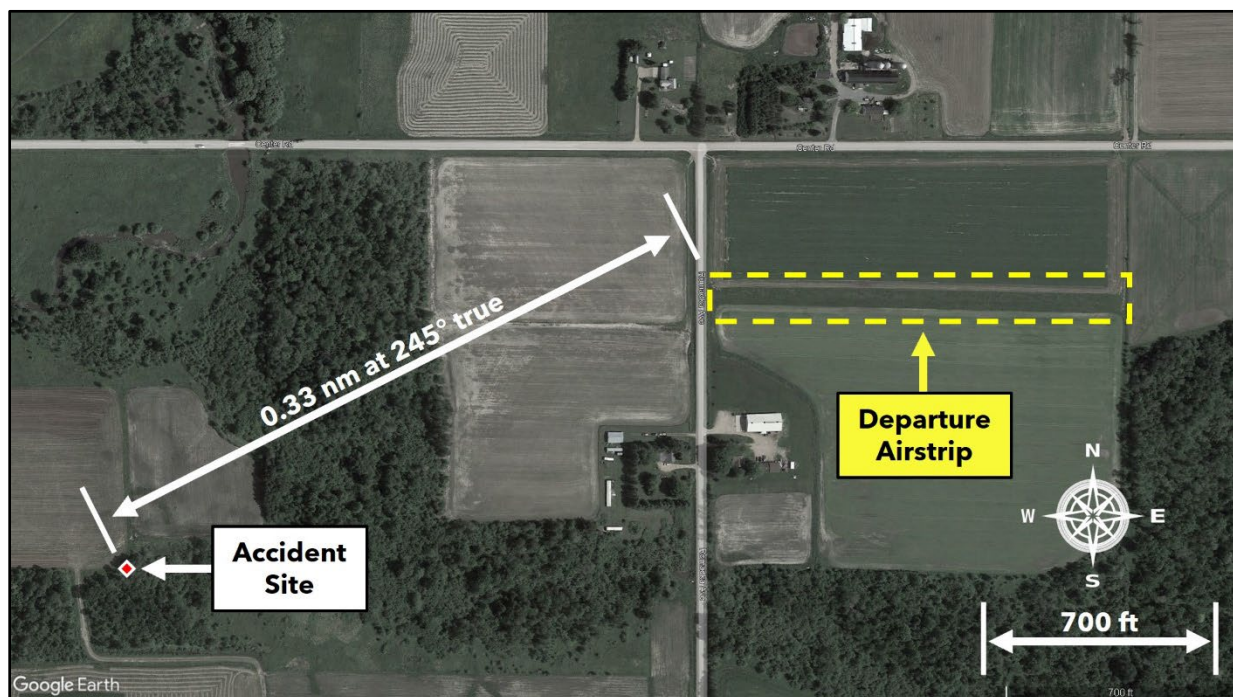
**Figure 1** - Accident Site Overview

The main wreckage was in a wooded area at the edge of a cornfield located south of Center Road and west of Romadka Avenue, near Curtiss, Wisconsin. The accident site location was 44.984025° north latitude, 90.461475° west longitude, at 1,313 ft mean sea level (msl). The accident site was about 0.33 nm southwest of the west end of the grass airstrip (1,275 ft long by 60 ft wide) that the pilot used for takeoff, as depicted in figure 1.

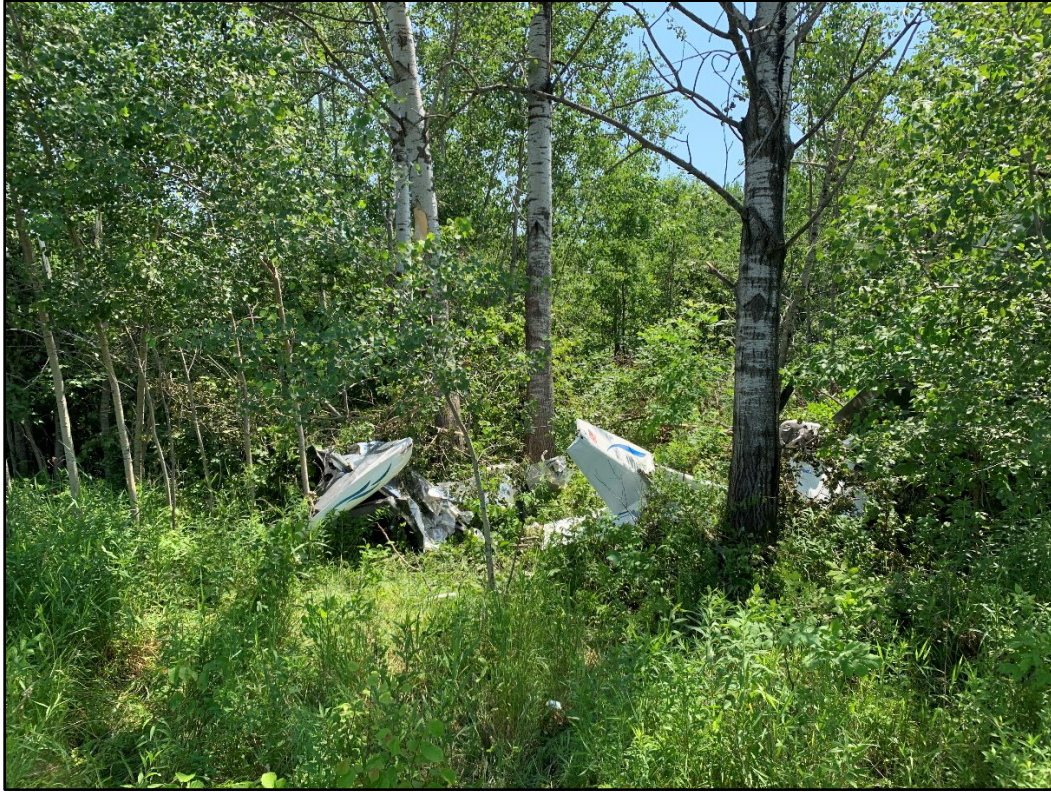
**Figure 2** - Main Wreckage

All structural components and flight control surfaces were located at the accident site, as shown in figure 2. The main wreckage consisted of the fuselage, tailboom, right wing, engine, and propeller. The right wing was intact with the aileron and flap attached, as shown in figure 3. The left wing and left flap separated from the fuselage during the impact sequence with the trees, as shown in figure 4. The empennage remained attached to the aft section of the tailboom, as shown in figure 5.

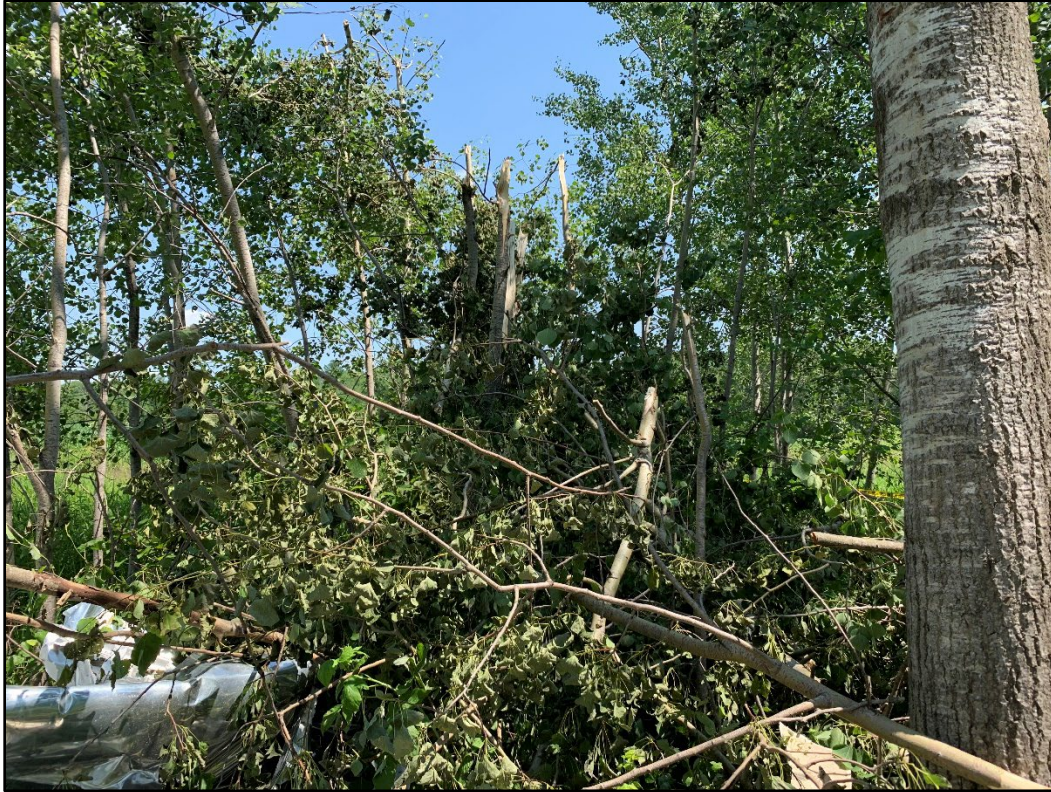
**Figure 6** - Airplane's Descent Path Through Trees

Based on damage to trees at the accident site, the airplane was traveling to the south as it descended into the trees in an approximately 30° nose-down flight path angle, as shown in figure 6.

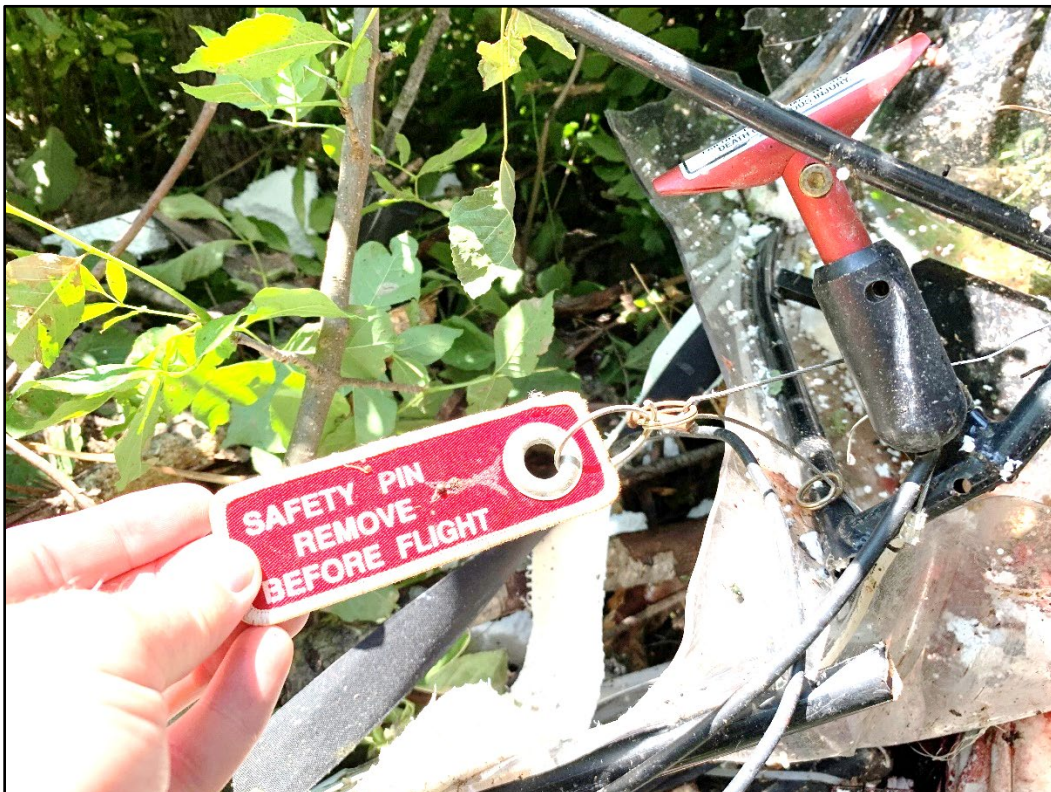
**Figure 7** - Airframe Ballistic Recovery Parachute Activation Handle and Safety Pin

The airframe parachute rocket deployed due to impact forces. The activation handle was stowed with the safety pin removed, as shown in figure 7.

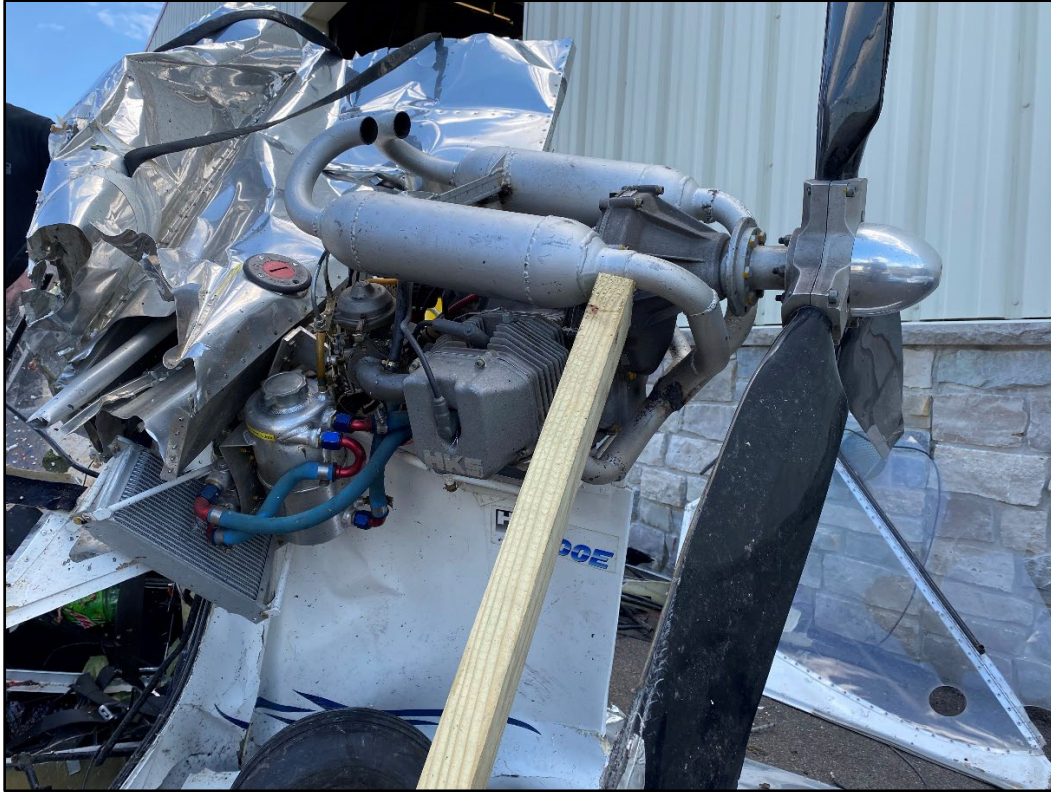
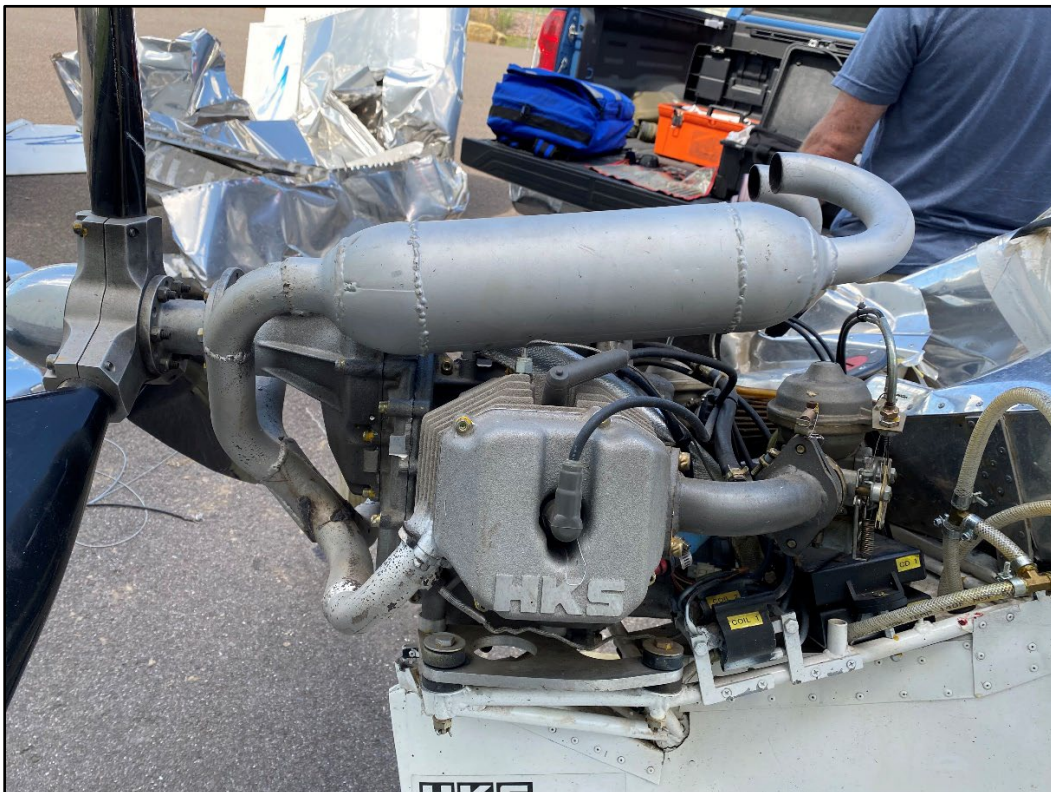
The aft-facing engine remained mounted at the rear of the fuselage, as shown in figure 8 and figure 9. The propeller remained attached to the engine crankshaft and all three propeller blades remained attached in the propeller hub, as shown in figure 10. The propeller blades exhibited minor leading-edge damage and light chordwise burnishing of the blade surfaces consistent with the propeller rotating at the time of the accident.

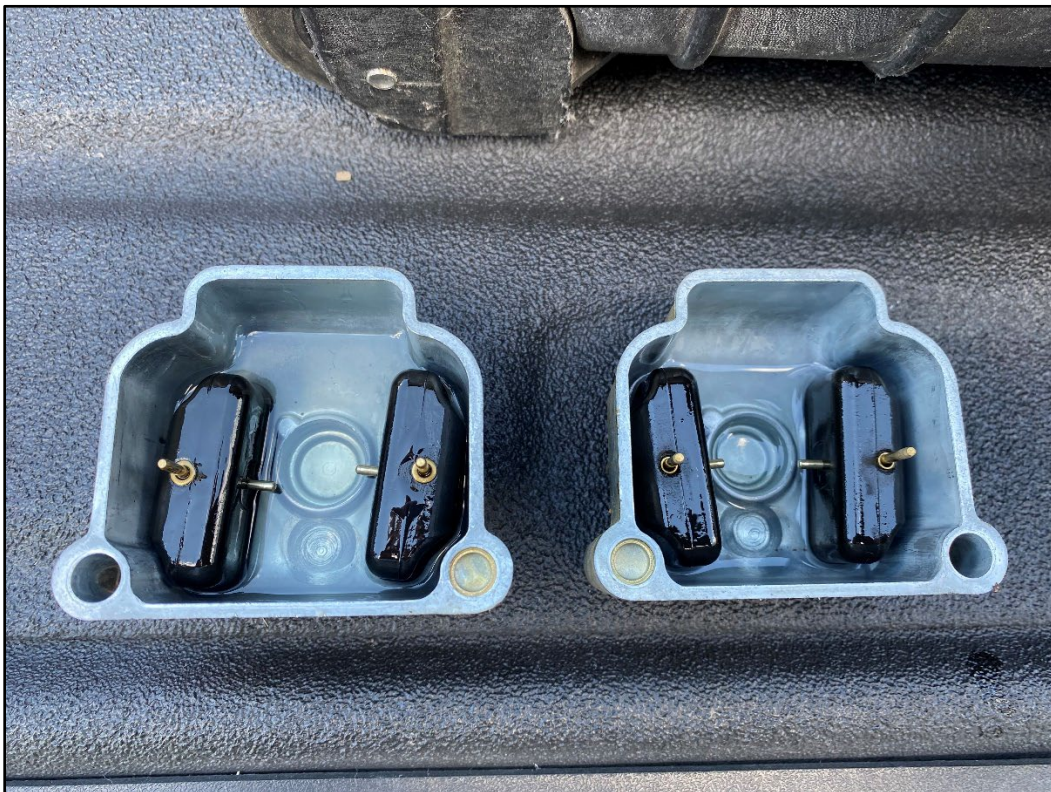
**Figure 11** - Carburetor Fuel Bowls

Examination of the engine's crankcase did not exhibit any holes or cracks. There was no evidence of an oil leak and the engine contained oil. The exhaust and intake pipes remained attached to both cylinders. Both carburetors contained uncontaminated fuel, as shown in figure 11. The spark plugs were removed and exhibited features consistent with normal engine operation, as shown in figure 12.
