## **NATIONAL TRANSPORTATION SAFETY BOARD**

### **ON SCENE OBSERVATIONS**

**CEN21FA300**

Location: Roff, Oklahoma  
Date: July 2, 2021  
Aircraft: Beech 35-33, Registration N302Z  
NTSB IIC: Samantha Link

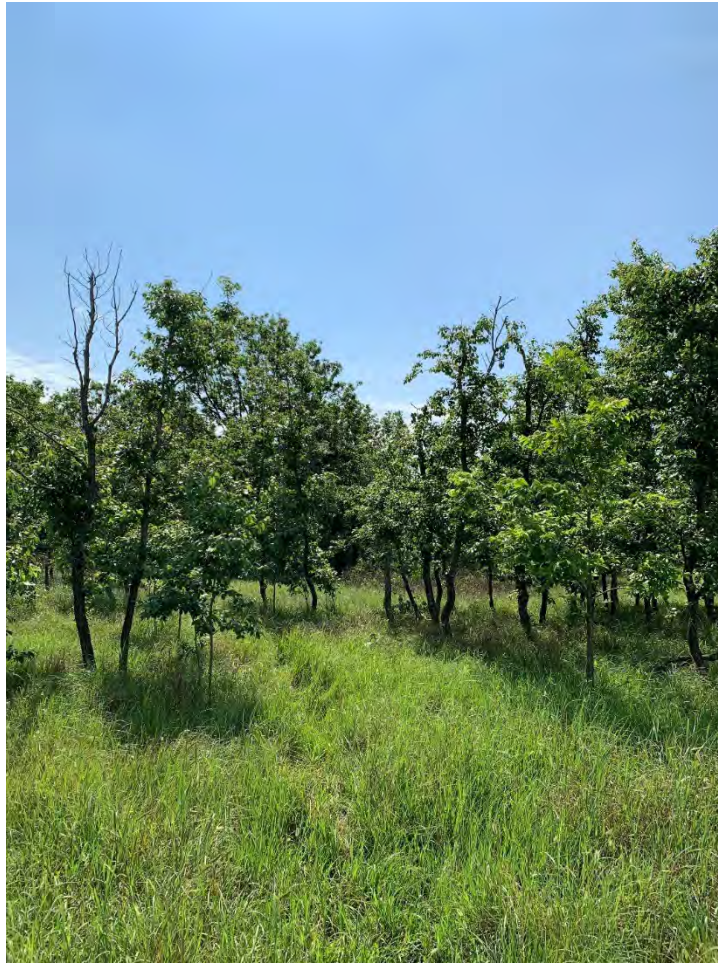
Figure 1: View from the Start of the Debris Path

The debris field was about 70 yards long, along a heading of about 110 degrees (East Southeast). The airplane first impacted small trees, then entered a patch of medium sized trees. The first identified piece of airplane debris was the left wingtip. Followed by left aileron and a small portion of the left-wing leading edge. Next was a large narrow ground scar along the dirt with the pitot tube inside.

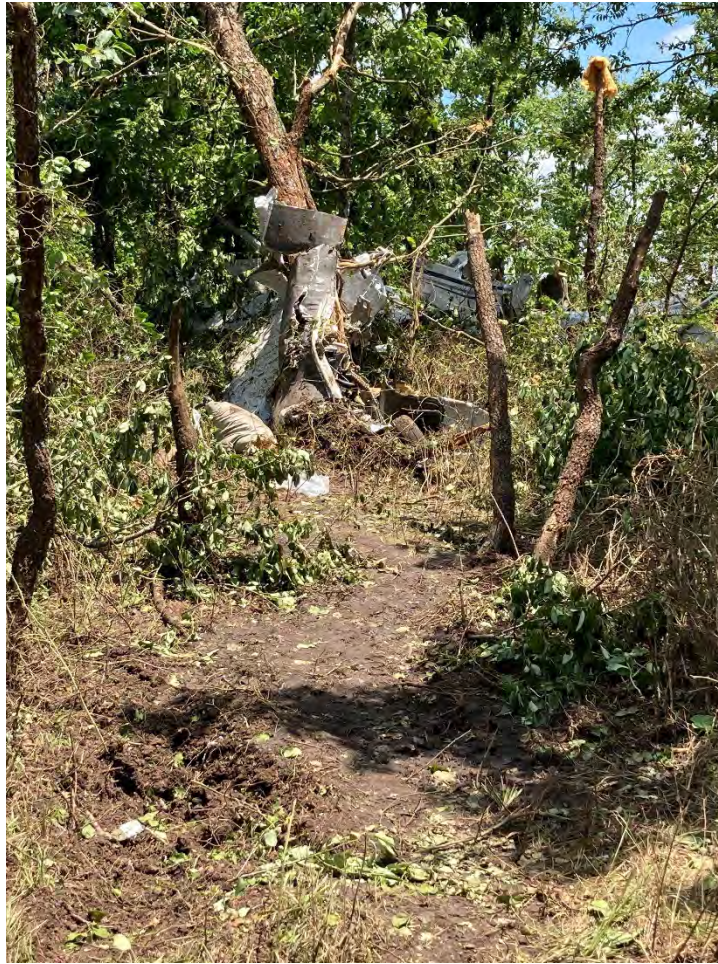
Figure 4: Ground Scar, Right Wing and Main Wreckage

The next major pieces of debris were the right wing, right side front passenger seat, and the airplane door. The right wing was fracture separated from the fuselage at the wing root. The wing came to rest leading edge down with the root of the wing wrapped around a medium sized tree. The tree was bent and damaged consistent with the direction of the debris path. A portion of the left wing, with the inboard left aileron attached, was also located near the right wing.

The main wreckage was about 4 yards beyond the right wing. It consisted of the cabin area, aft fuselage, and inboard left wing. About 6 feet beyond the main wreckage was the engine. The engine was fracture separated

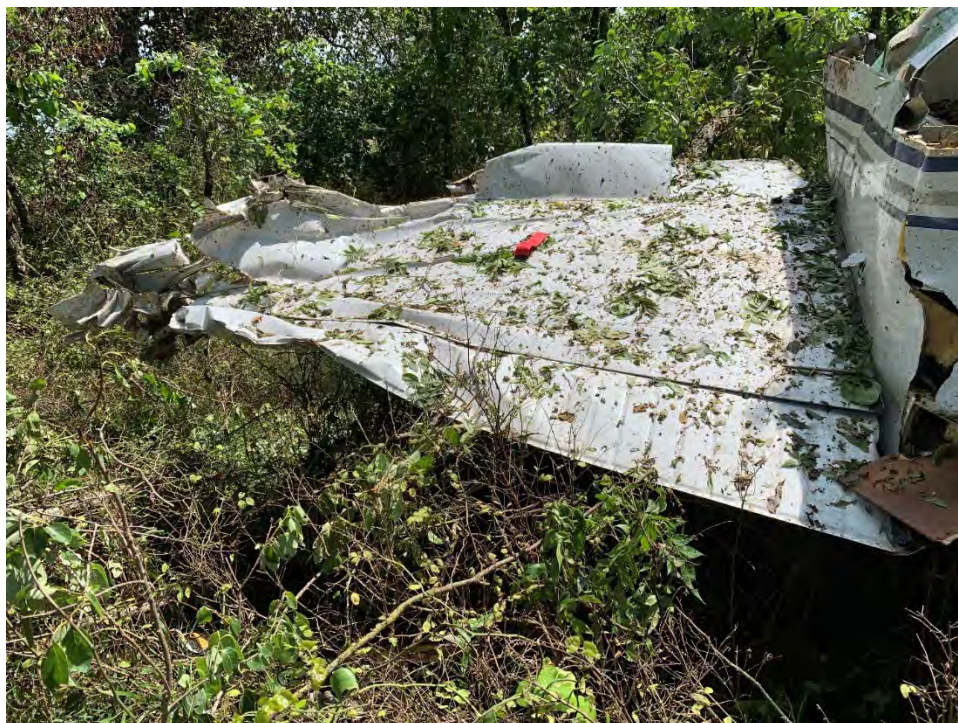
Figure 8: The Left Wing

- The left wing remained attached at the wing root and was fracture separated about midspan.
  - The inboard portion of the fracture exhibited up and aft crush damage.

- The left main landing gear was in the down and locked position.
  - The fuel filler cap remained in place and there was no evidence of fuel staining or leaking on the wing surface.

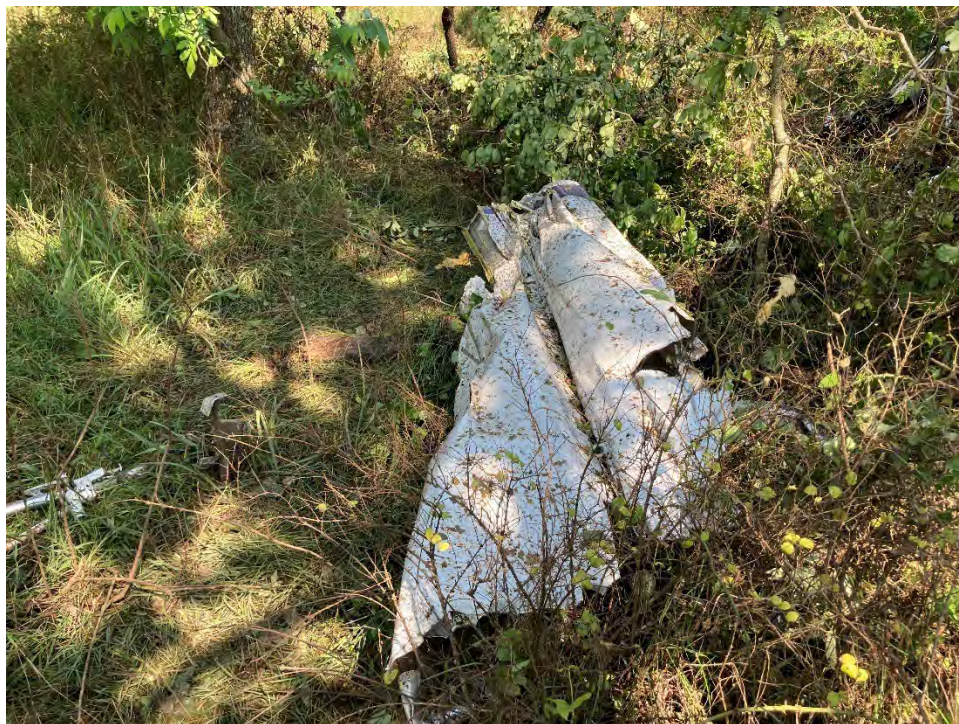
Figure 10: Fragment of Left Wing (Inboard Aileron)

- The cap was removed, and fuel was observed inside of the tank. It smelled consistent with 100LL.
- The inboard portion of the left aileron and a fragment of the left wing were fracture separated and exhibited extensive aft crush damage.

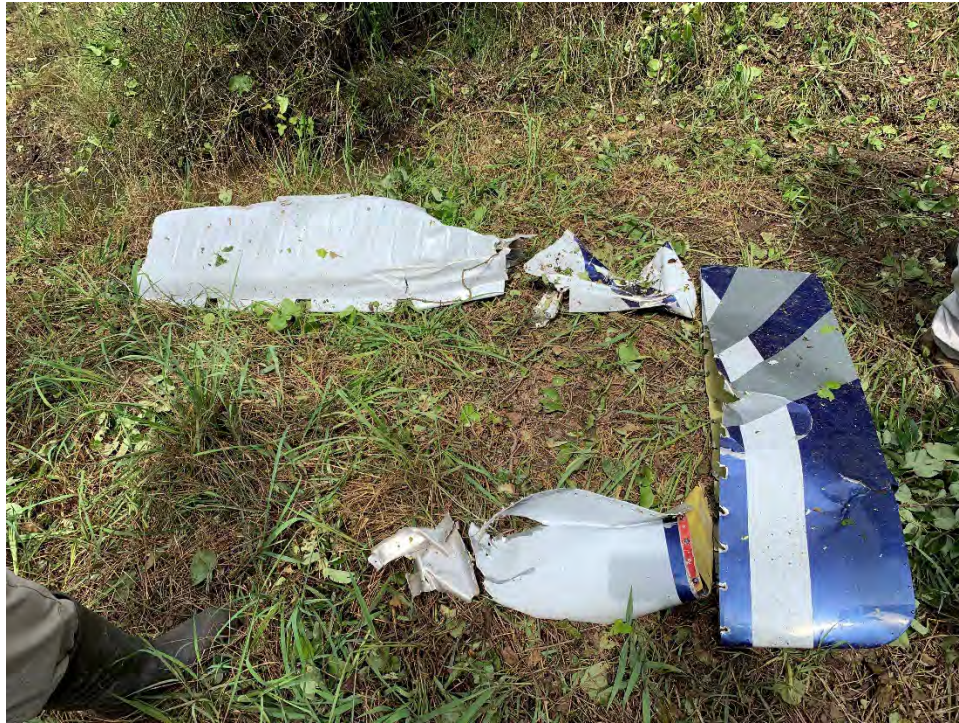
Figure 11: Left Outer Wing Fragments

- The left-wing wingtip, outboard left aileron, and a small portion of the leading edge were fracture separated and located early in the debris path.
- The right wing remained whole and was fracture separated at the wing root. The right wing came to rest leading edge down with the underside of the wing facing toward the end of the debris path.

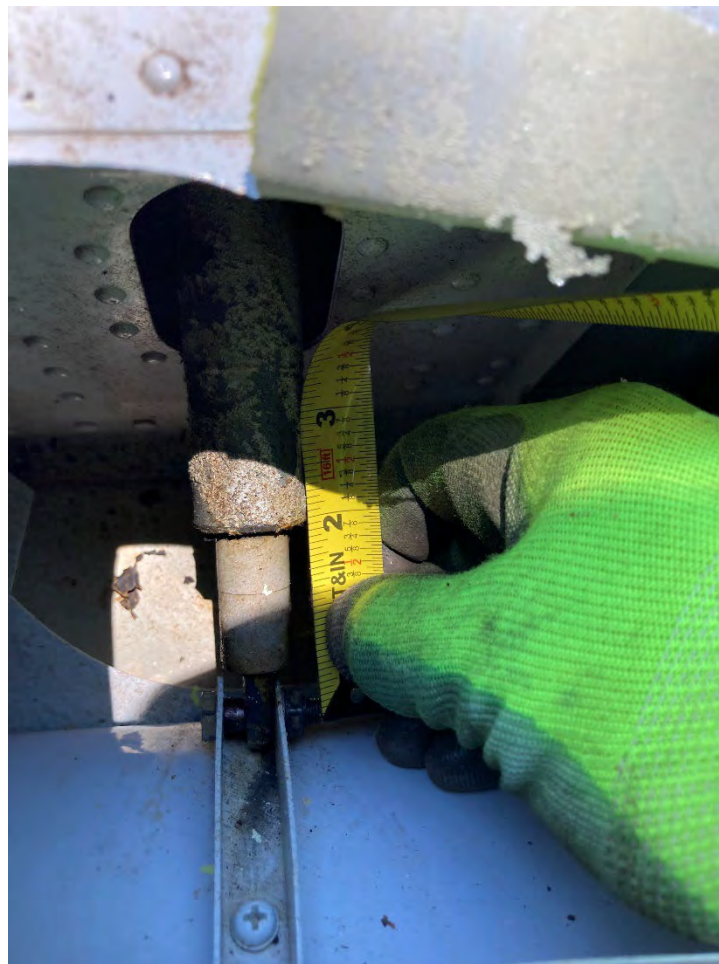
Figure 12: Left-side Flap Actuator

- The left-side actuator was measured about 2 inches, which is consistent with the “up” position.
- The aft fuselage was bent and mostly fractured just aft of the cabin.

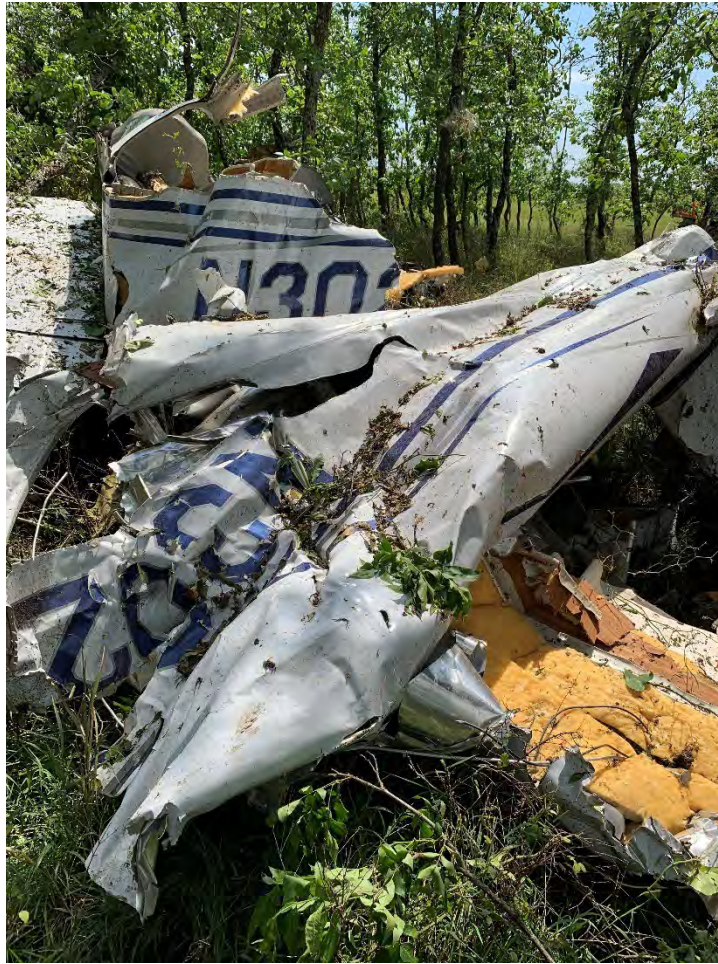
Figure 13: The Aft Fuselage

- It exhibited crush and crumple damage throughout.
  - There was a large horizontal tear along the right side.
- The ELT was located and found in the “armed” position.

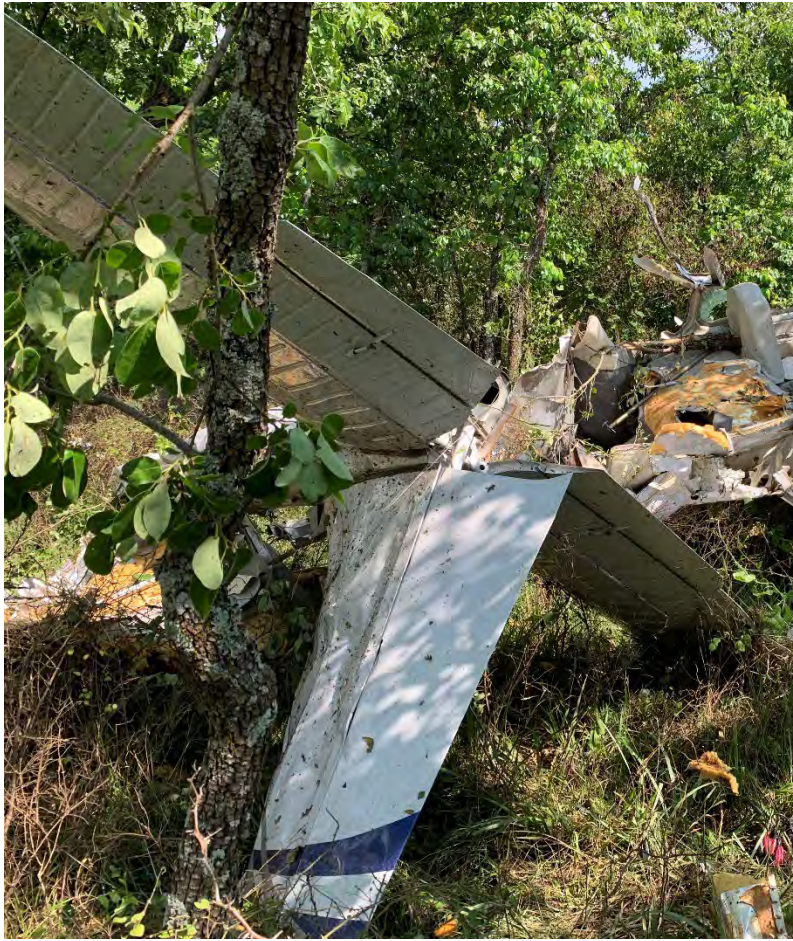
Figure 14: Empennage

- The empennage remained mostly whole:
  - The horizontal stabilizer exhibited some crush damage.
  - The elevators and rudder remained attached.
    - The elevator trim was about neutral.

- The vertical leading edge exhibited crush damage.

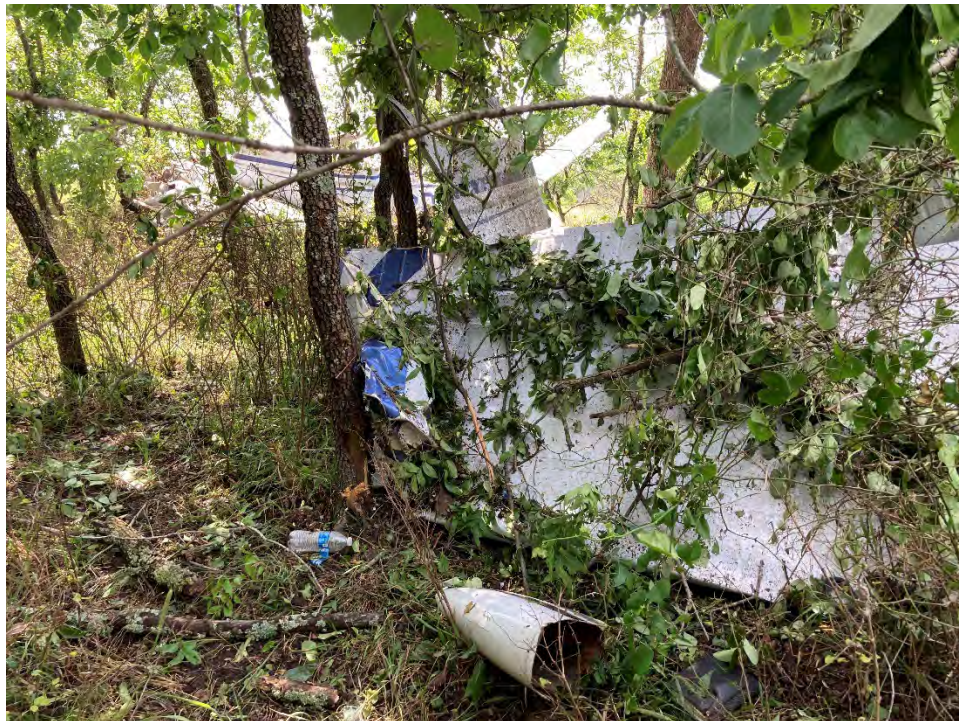
Figure 15: Top of Right Wing

- The right main landing gear was fracture separated and was located nearby.
  - The right-wing fuel tank remained intact, and the fuel cap remained secured to the wing.

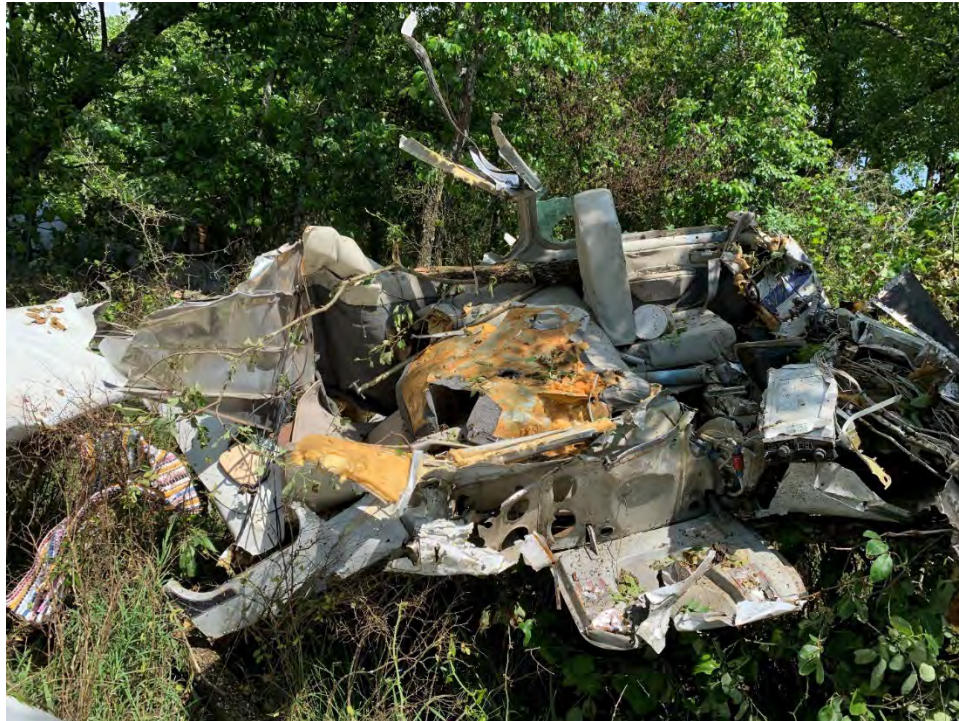
Figure 16: The Cabin Area

- The cabin area exhibited extensive damage.
  - The roof and right side of the cabin were mostly fracture separated.
  - The forward left seat remained attached and secured to the airframe.

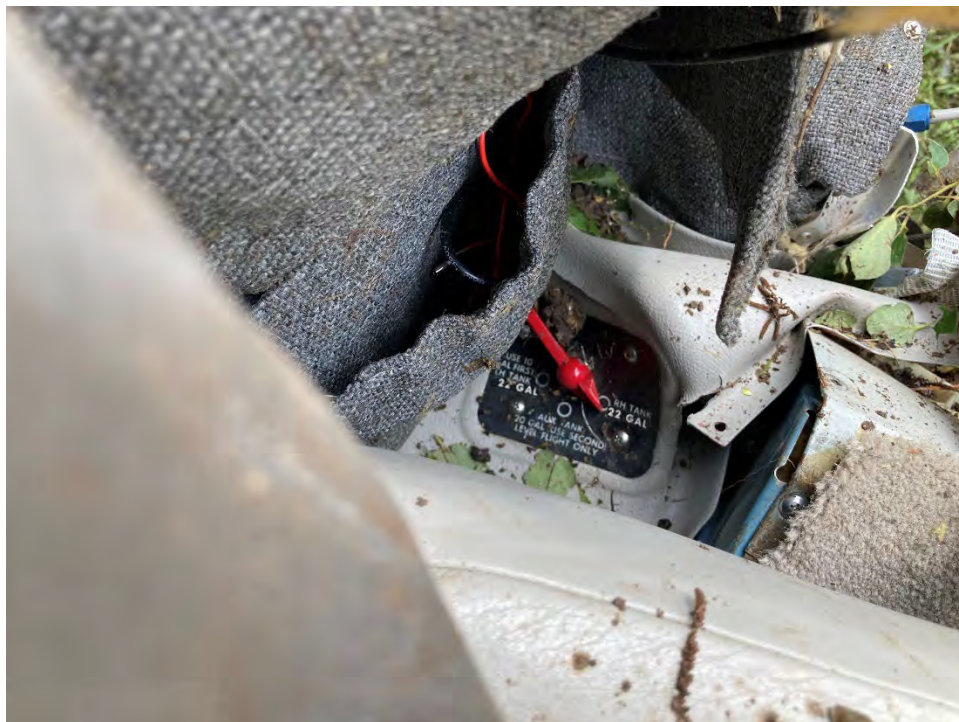
Figure 17: Fuel Selector Valve

- The instrument panel was heavily fragmented. The recovered instruments and radios exhibited crush damage and were unremarkable.
  - The fuel selector was positioned on the right-wing fuel tank.

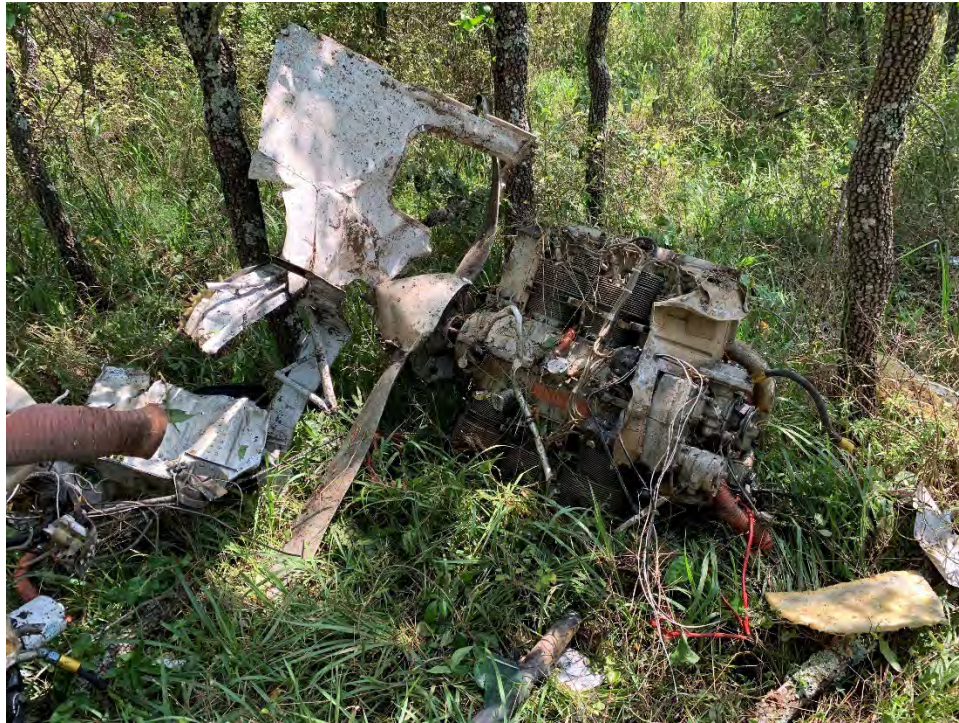
Figure 20: The Engine

- Visual examination did not reveal any indications of catastrophic failure.
- The engine came to rest on its left side against two smaller trees.
- The propeller hub was rotated, and it moved freely in the allowable space.

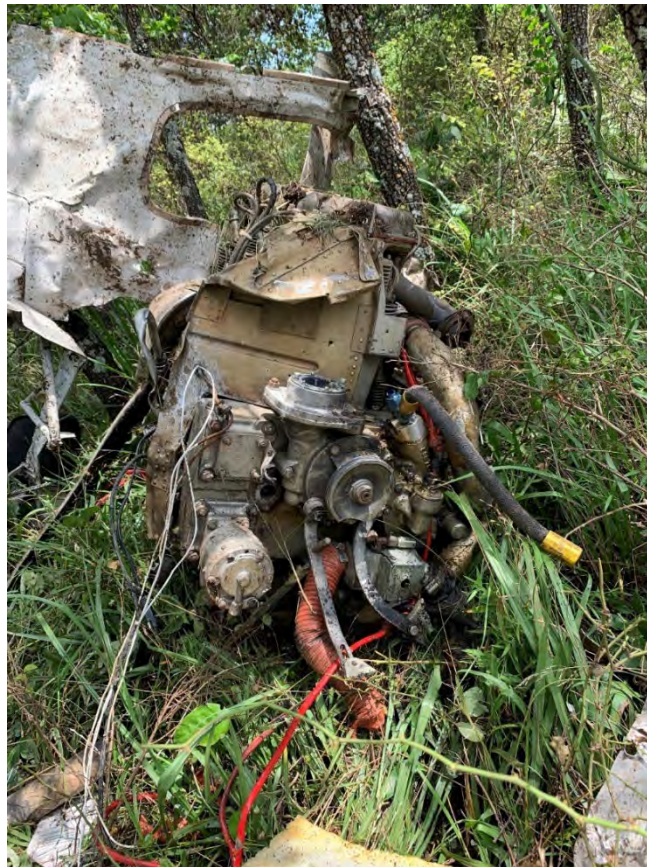
Figure 21: The Accessory Section of the Engine

- Corresponding rotation was observed on the accessory side of the engine.
  - The crankshaft was bent just aft of the propeller hub.
- The right-side spark plugs were removed, and all were consistent with normal operations.

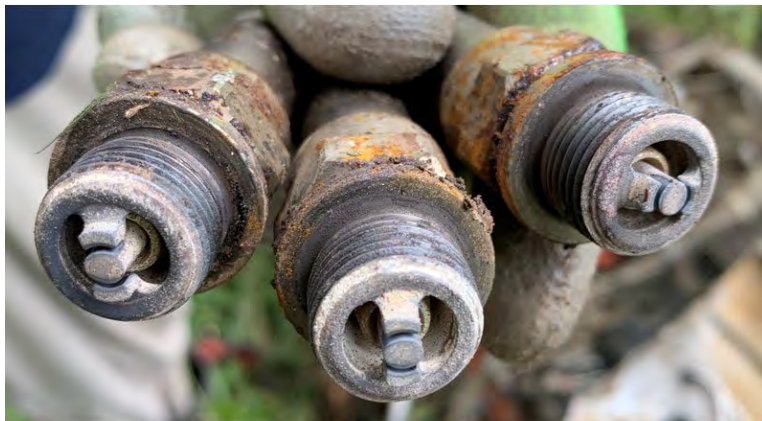
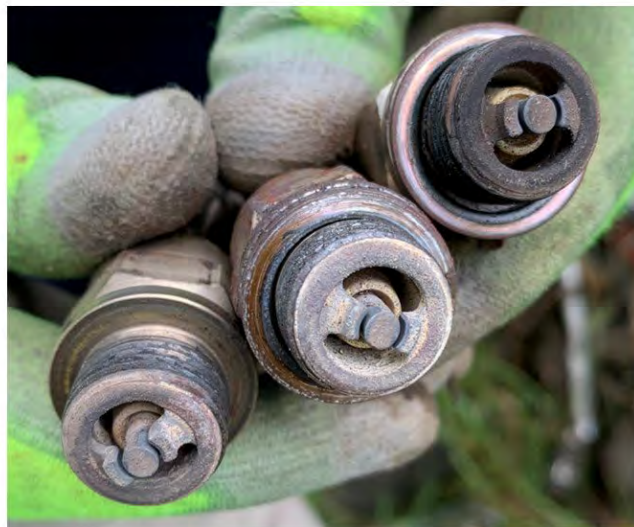
Figure 23: Right Side Upper and Lower Spark Plugs

- The center electrodes were more circular than oval.
- The rocker covers were removed, and all valve assemblies were consistent with normal operations.

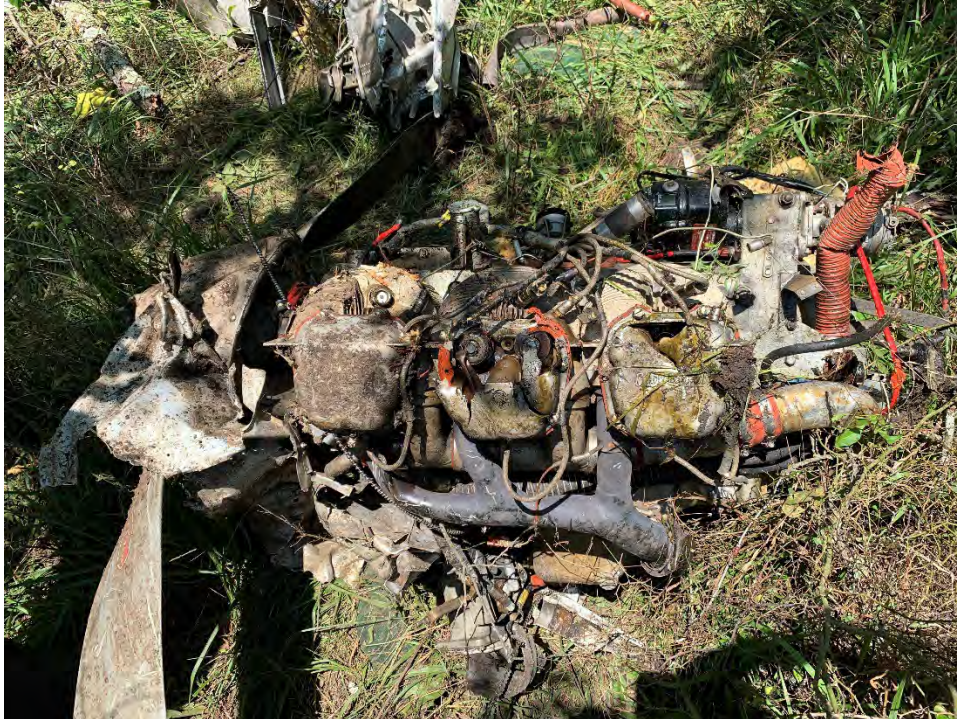
Figure 24: Left side of Engine

- Fuel was noted within the manifold.
- The left side of the engine exhibited more impact damage than the right side.
  - The #4 and #2 cylinder rocker covers exhibited impact damage and the valves were exposed.

- The #4 cylinder head exhibited fracture damage and the cooling fins were bent.
- The left side spark plugs were removed with the exception of the #4 and #6 lower spark plugs, which were inaccessible due to exhaust stack deformation.

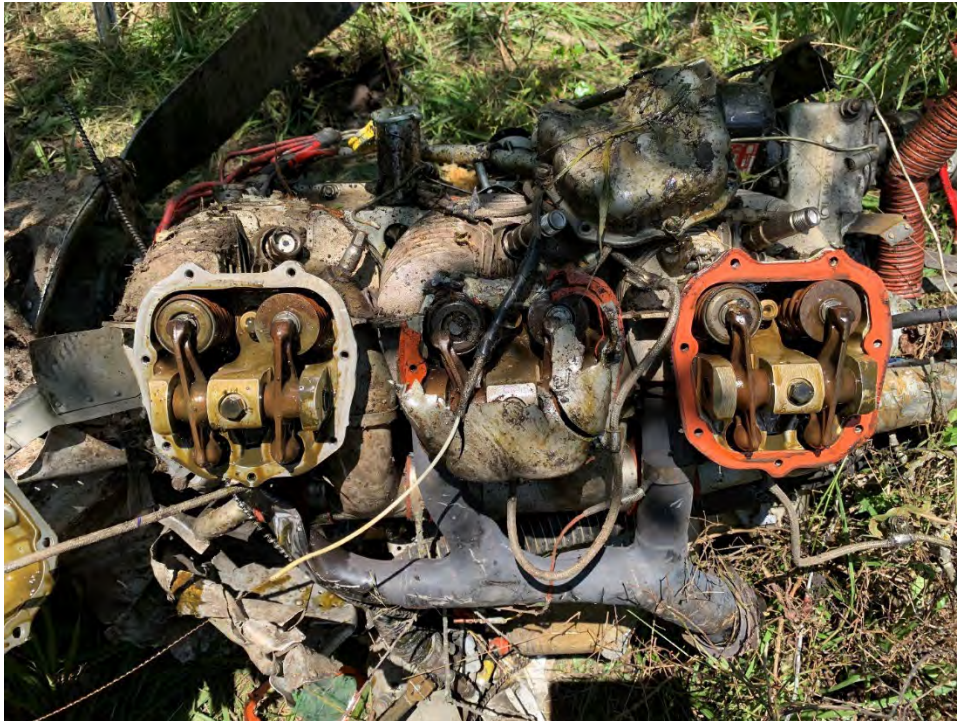
Figure 25: Left Side Valve Assemblies

- The left side rocker covers were removed.
  - The valves were oily, consistent with how the engine came to rest.
- The ignition harness was mostly intact.

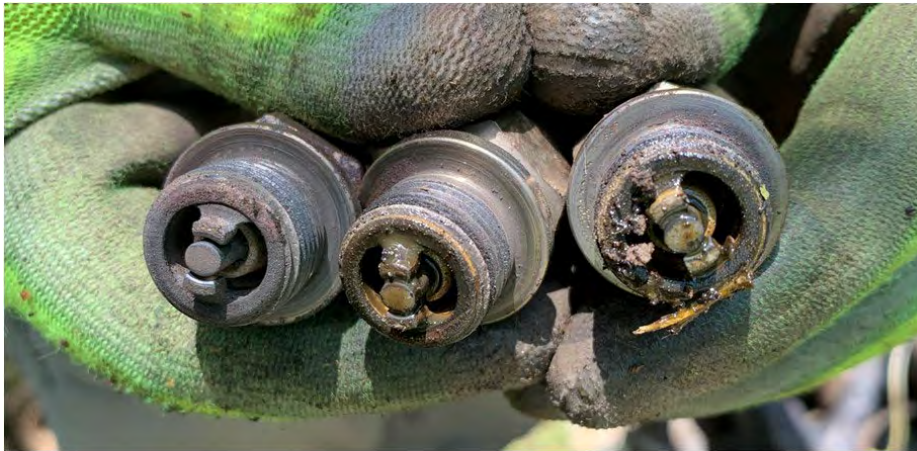
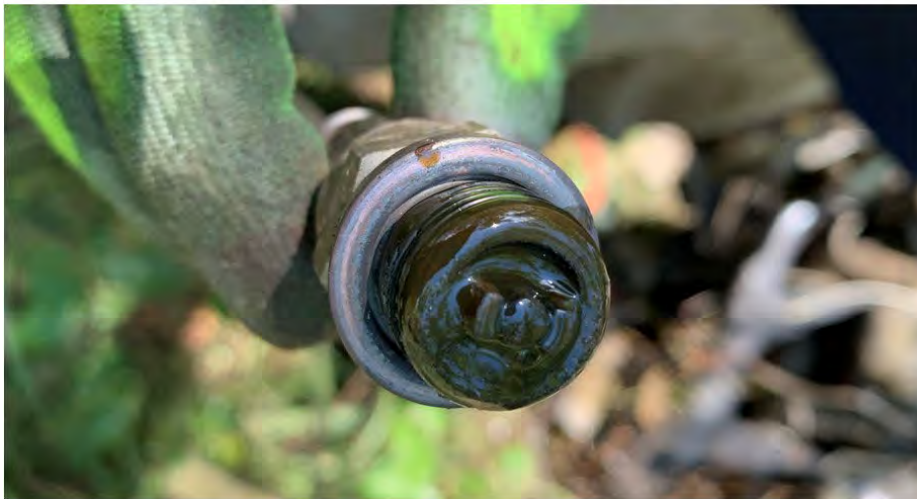
Figure 26: Left Side Spark Plugs

- All removed spark plugs were consistent with normal operations.
    - They were covered in oil consistent with how the engine had been resting.
  - The upper portion and lead of the #6 cylinder upper spark plug were fracture separated.

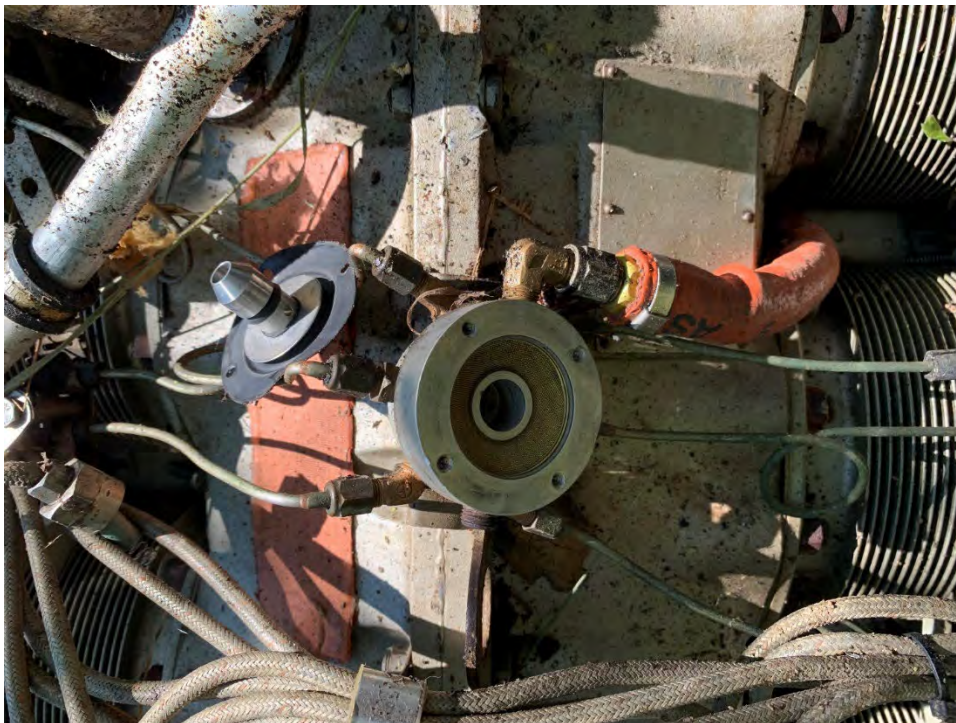
Figure 27: The Fuel Manifold

- The fuel manifold was disassembled, and no anomalies were noted with its internal components.
  - The diaphragm was palpable, and the screen was clear of debris.

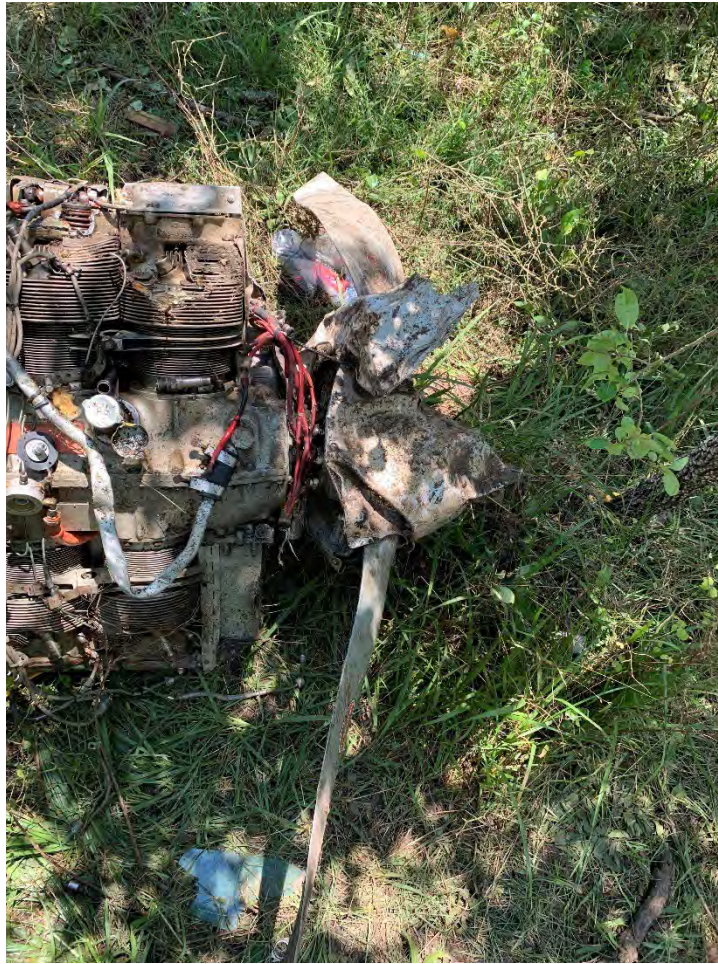
**Figure 29: Propeller Blade Assembly**

- Corresponding motion was observed on the butterfly valve.
- The spinner remained attached to the propeller hub and exhibited crush damage.
- The two propeller blades remained attached at the hub. Both blades rotated freely within the hub.

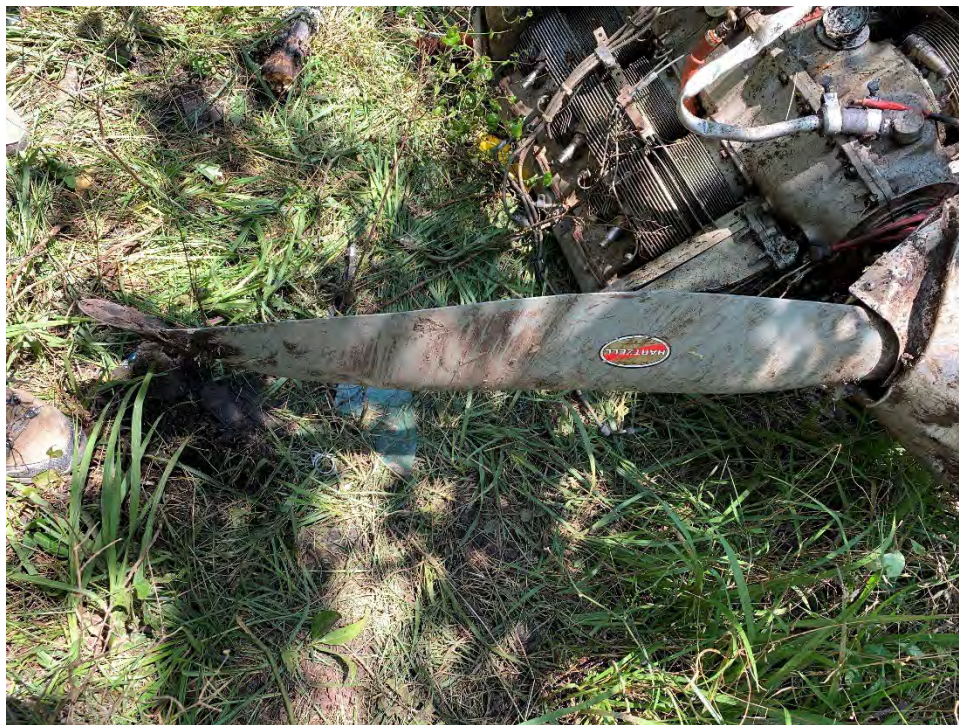
Figure 30: One Propeller Blade

- One blade was flattened, and the outboard tip was curled aft.
    - Chordwise diagonal dirt score marks were noted along the chamber side of the blade.

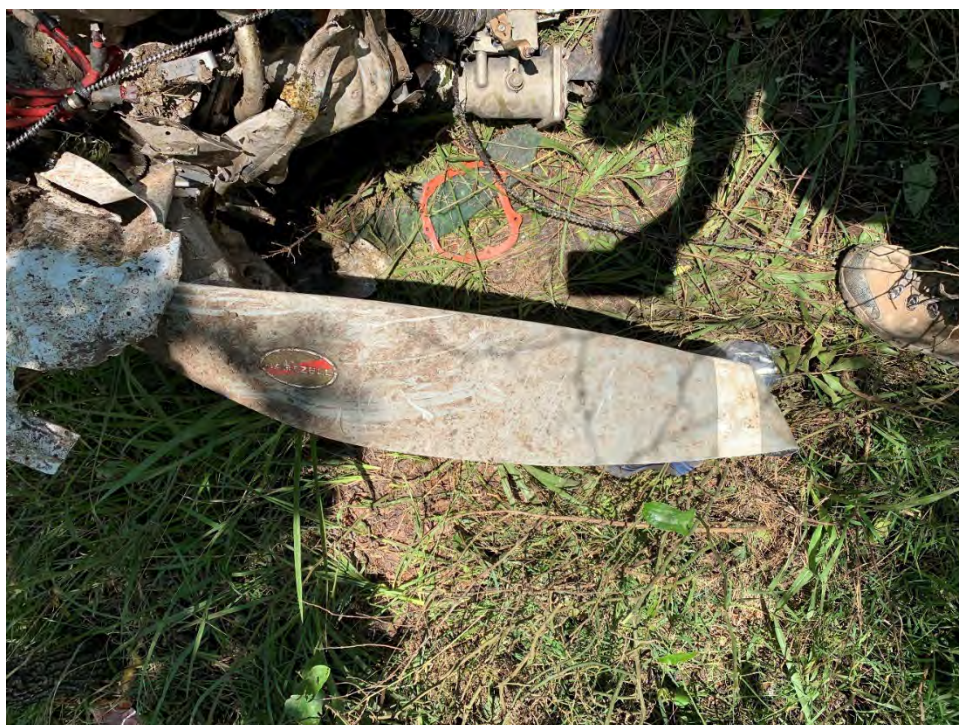
Figure 31: The Second Propeller Blade

- The second blade was bent aft about midspan and the outboard tip was curled aft.
    - Both spanwise and chordwise scoring was noted on the chamber side of the propeller blade.
