# National Transportation Safety Board

CEN21FA304

## **MATERIALS LABORATORY**

Factual Report 22-079

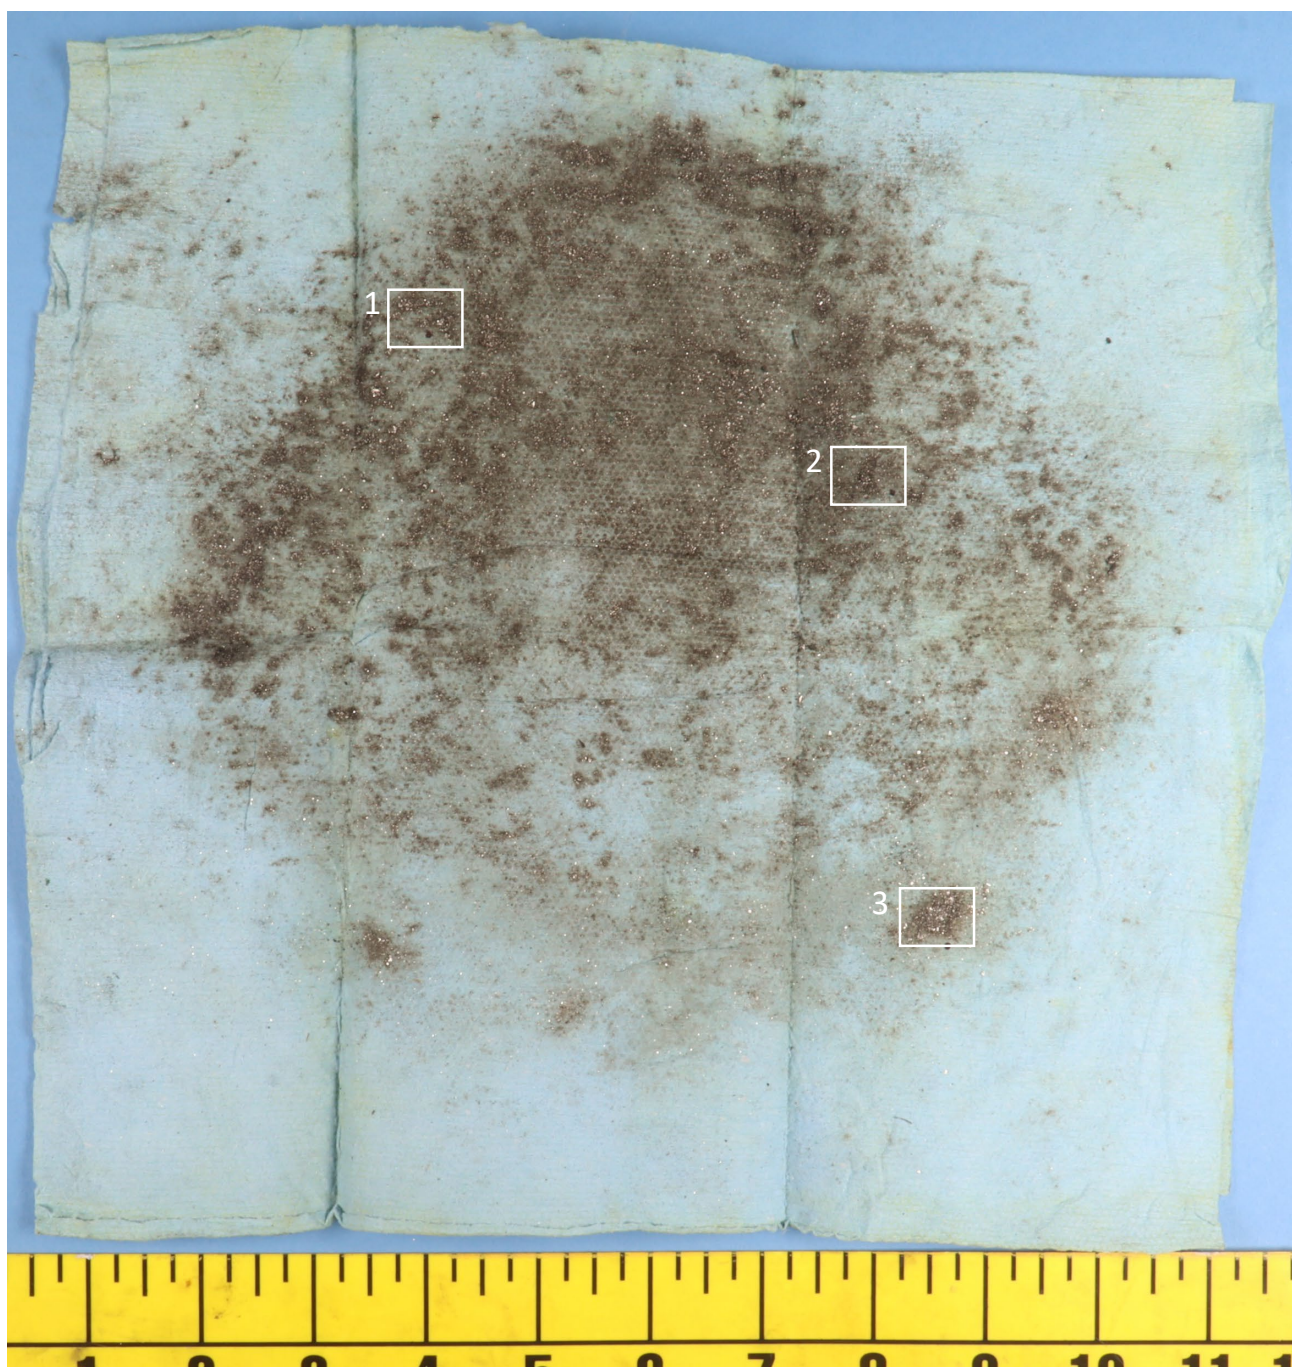
The submitted shop cloth with particulate debris collected from a filter screen is shown in Figure 1. Three representative areas, labeled 1, 2, and 3 in the figure were examined and photodocumented using a digital microscope (see Figures 2-4). In general, the particles had a consistent appearance and size distribution at areas 1, 2, and 3. The particle morphology ranged from flat plate-like to ovoid and the major dimension of the particles ranged from 0.01 inch to less than 0.001 inch. Compositional analysis of the particles was performed on a sample from area 1 (see Figure 2). A piece of the shop cloth containing the particles was cut from area 1. The shop cloth particle sample was then mounted on a beryllium stub and examined using a field emission scanning electron microscope (SEM) with an energy dispersive spectrometer (EDS) (using standardless semiquantitative analysis). A scanning electron micrograph of the field of view examined is shown in Figure 5. False colors are used to identify the predominate elemental composition of the particles. A key to

**Figure 1.** Image of the shop cloth with screen filter particulate.

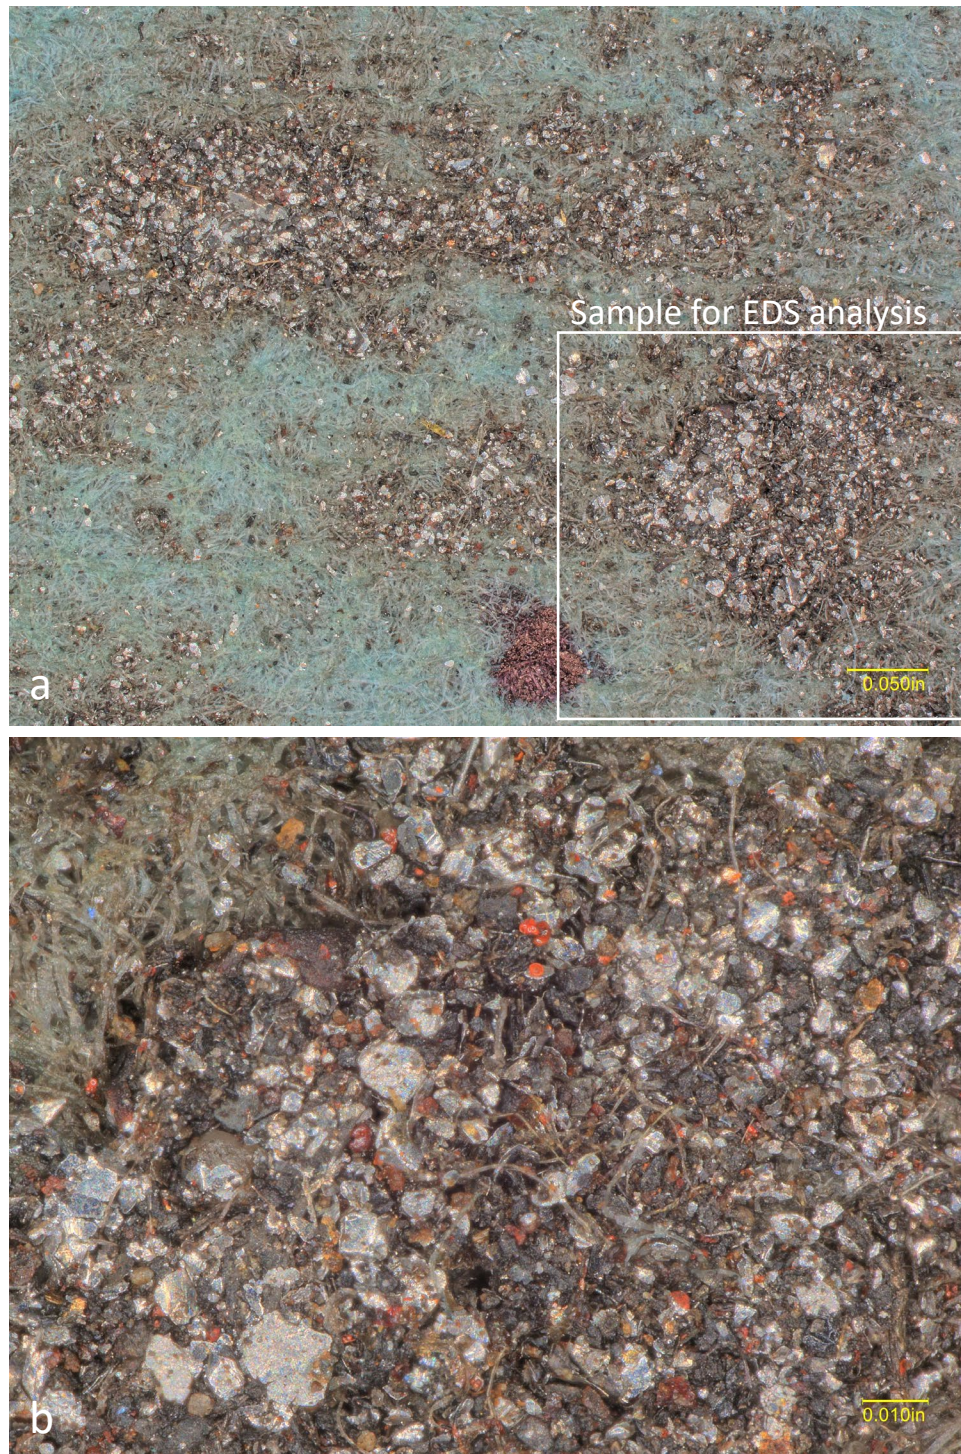
**Figure 2.** Close views of the filter particles at location 1 (See Figure 1). Compositional analysis by EDS was performed on the particles within the area labeled “sample for EDS analysis” in view a.

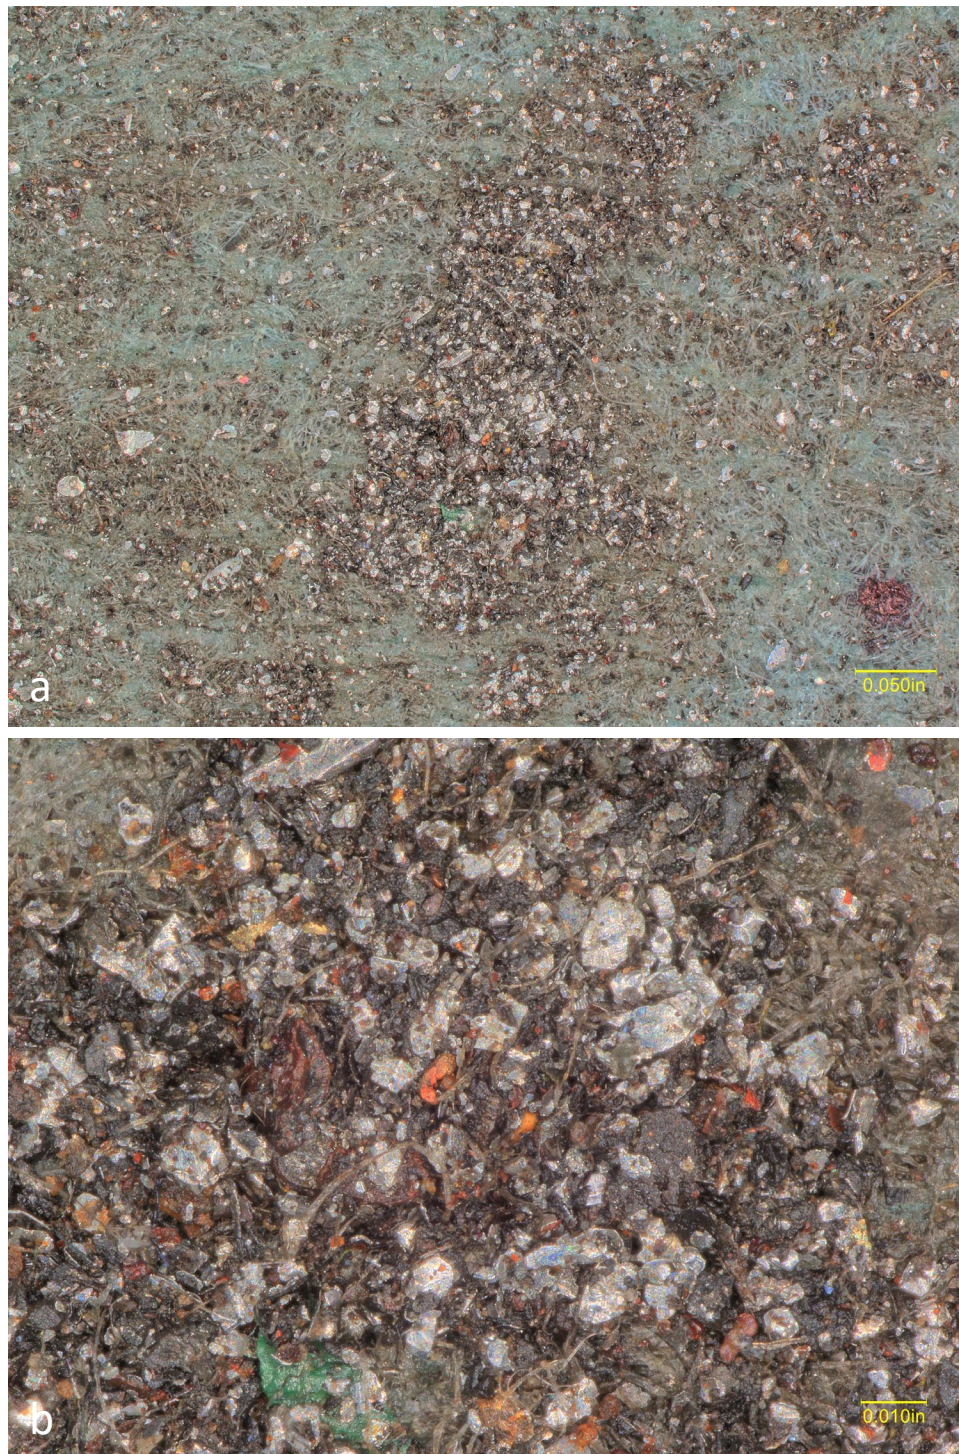
**Figure 3.** Close views of the filter particles at location 2 (See Figure 1).

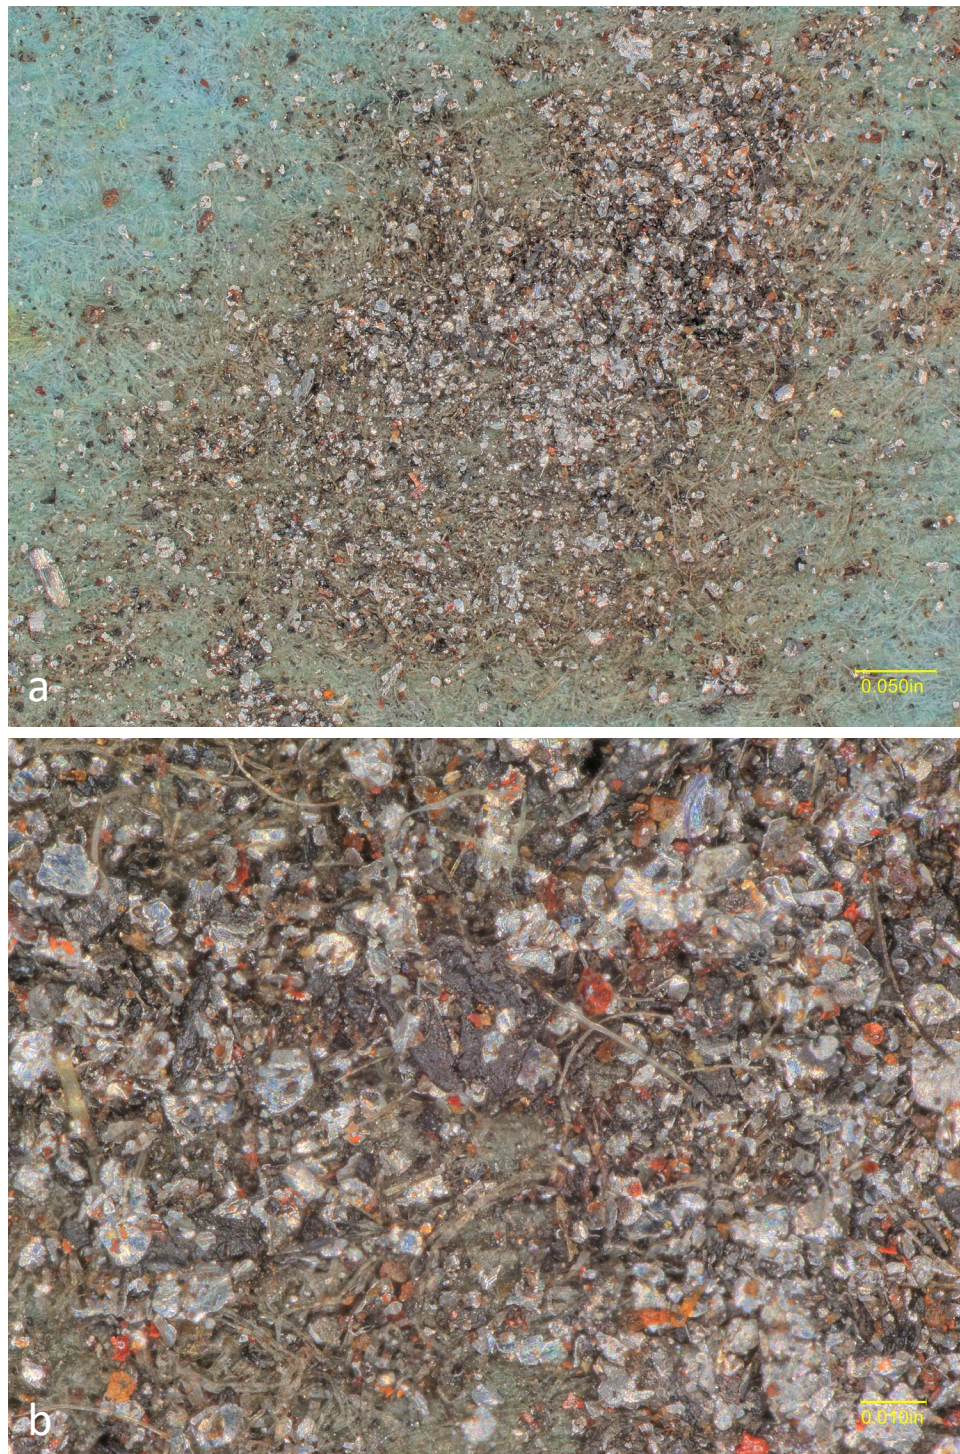
**Figure 4.** Close views of the filter particles at location 3 (See Figure 1)

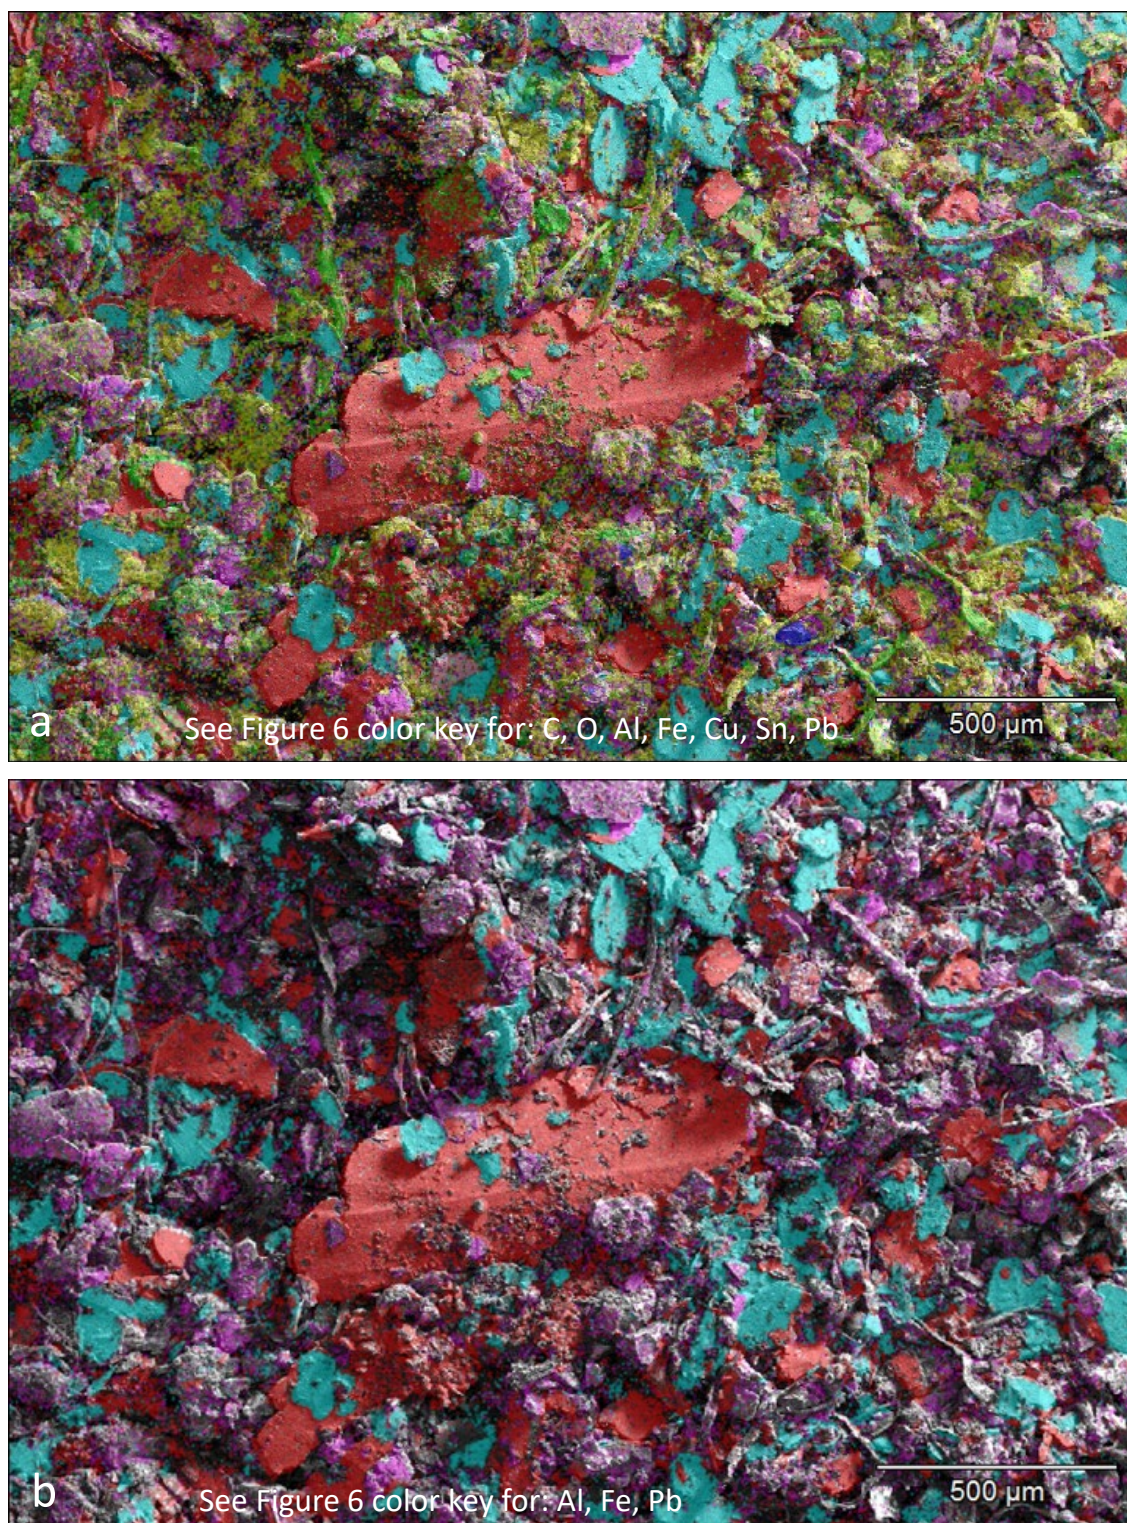
the false colors is shown in Figure 6. Overall, the EDS analysis revealed the following primary elements: C, O, Al, Fe, Cu, and Pb.

**Figure 5.** Scanning electron microscope images of a region within the Figure 2a inset area, shown with false colors to represent the primary elemental composition of the particles. A key to the colors is shown in Figure 6.

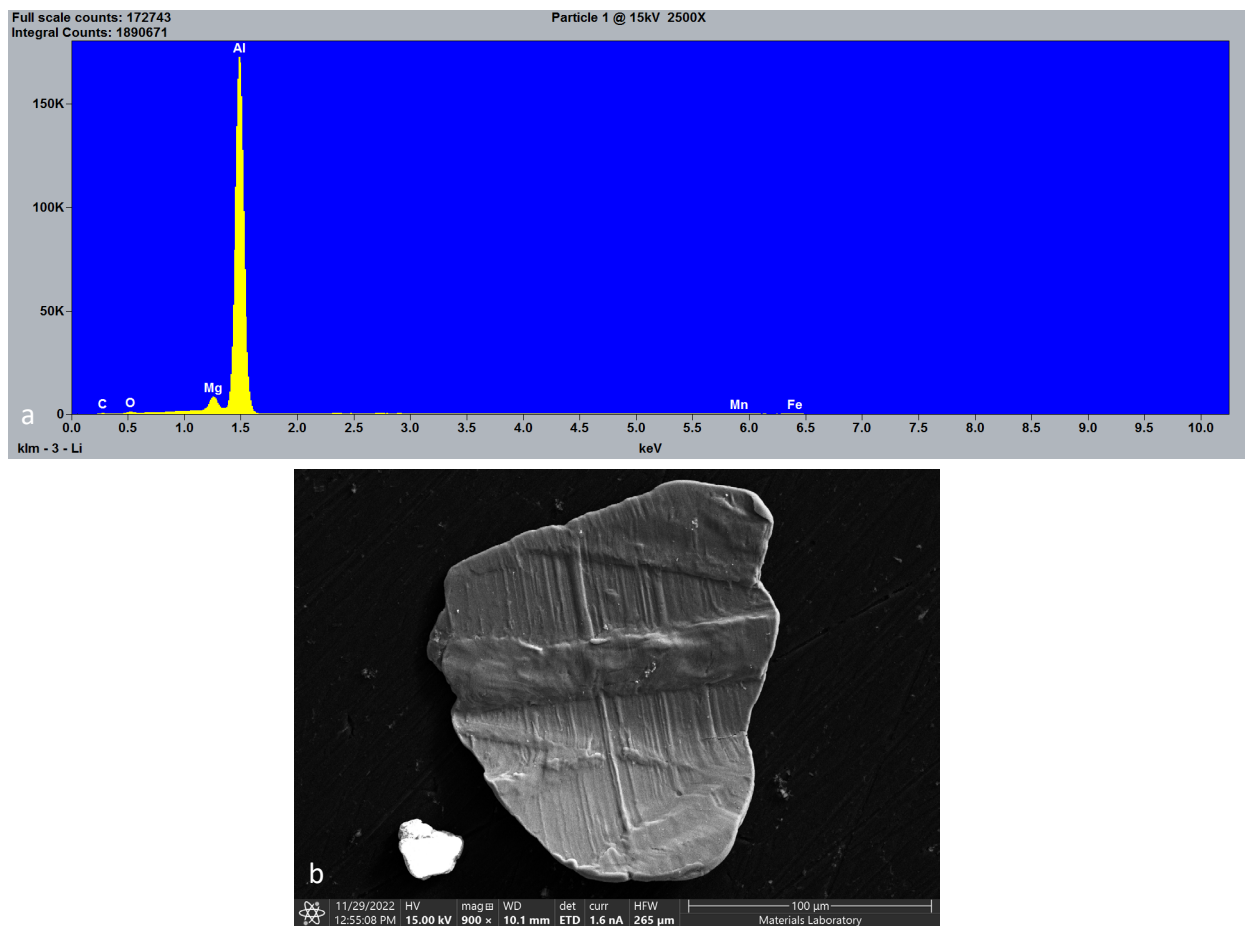
The shop cloth sample with particles was then immersed in acetone under ultrasonic agitation to disperse the particles in the liquid. The acetone with particles was then vacuum filtered onto filter paper, dried, and the particles were deposited onto a beryllium stub. Isolated particles were then surveyed using an SEM with EDS. Figures 7 through 11 show images of the isolated particles and their respective compositional spectra. In general, the aluminum and iron particles are flat or platelike consistent with removal via skiving or milling action. The composition of the iron particle (Figure 8) is consistent with a chromium or chromium and molybdenum steel (the counterweights are fabricated from a chromium and molybdenum steel). Particles with high concentrations of lead and bromine are vestiges of the fuel additives in 100 octane low lead fuel (contains tetraethyllead and ethylene dibromide). The composition of the aluminum particle is consistent with an aluminum alloy with minor amounts of magnesium.

**Figure 7.** Spectrum and scanning electron microscope image (view b) of the larger particle comprising predominantly aluminum and magnesium.

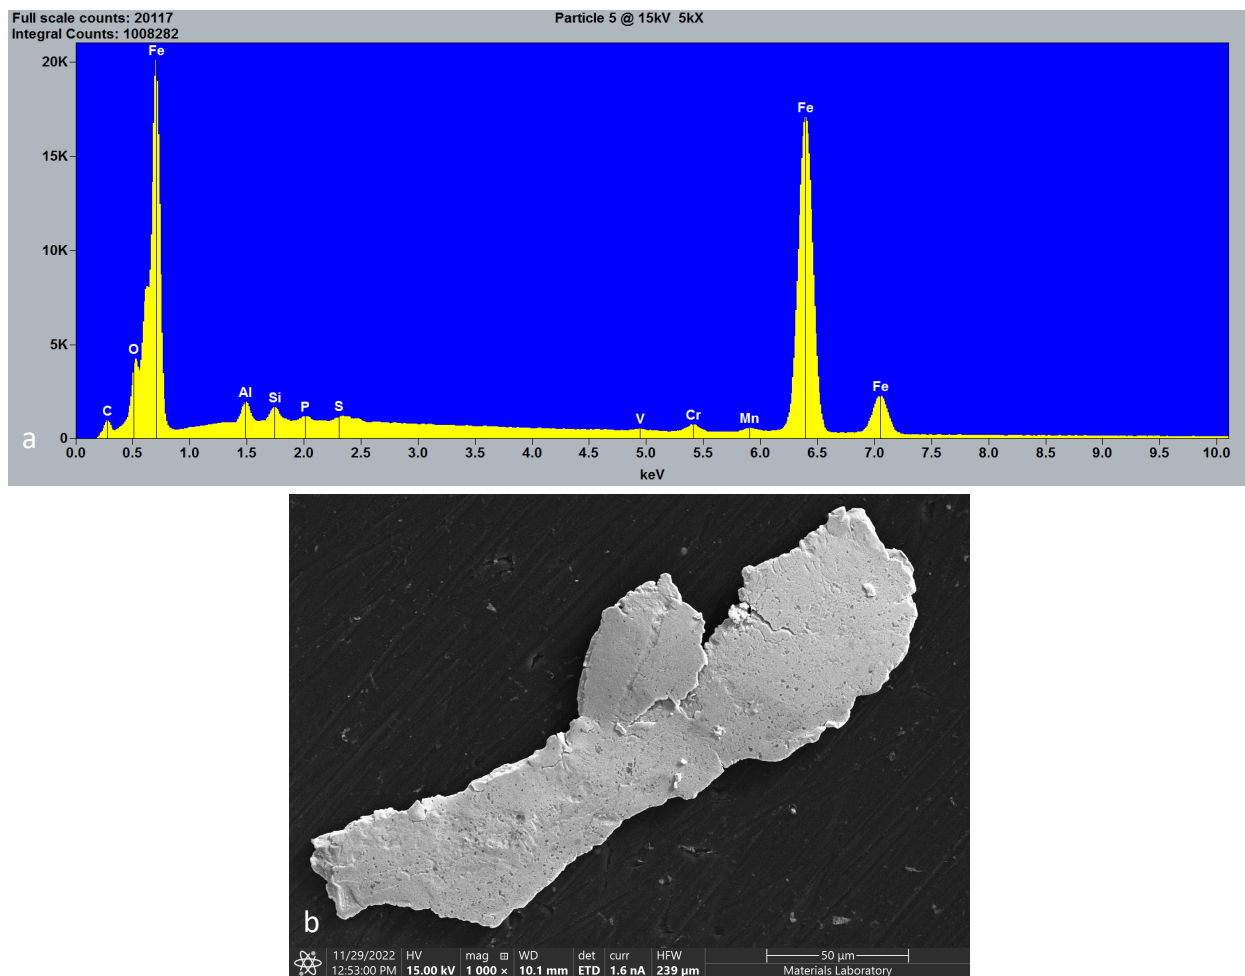
**Figure 8.** Spectrum and scanning electron microscope image (view b) of a particle comprising iron, aluminum, silicon, oxygen, carbon, chromium, phosphorous, sulfur, manganese, and vanadium.

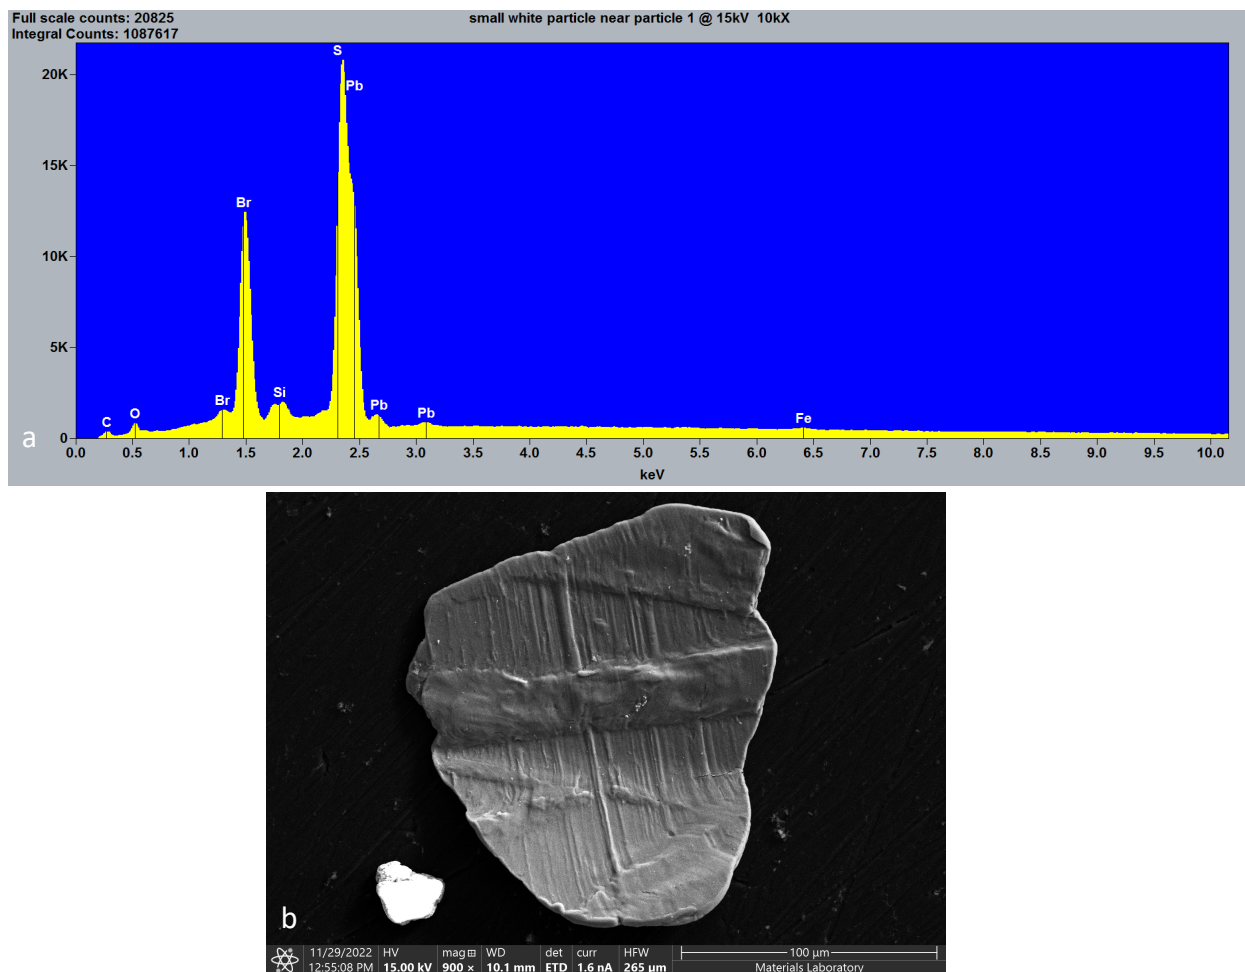
**Figure 9.** Spectrum and scanning electron microscope image (view b—bottom right smaller particle) of a particle comprising carbon, oxygen, silicon, bromine, lead, and trace iron.

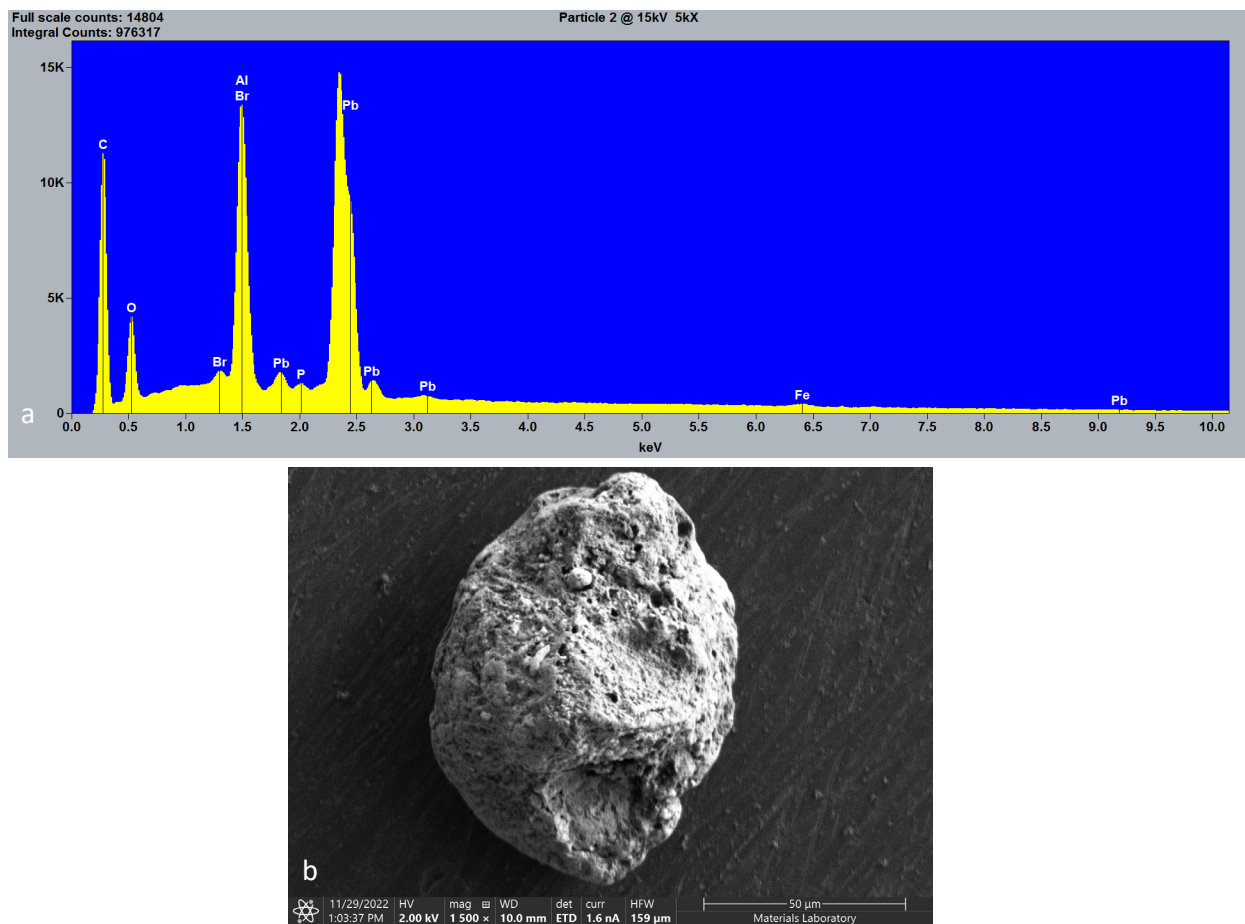
**Figure 10.** Spectrum and scanning electron microscope image (view b) of a particle comprising carbon, oxygen, bromine, lead, and trace iron.

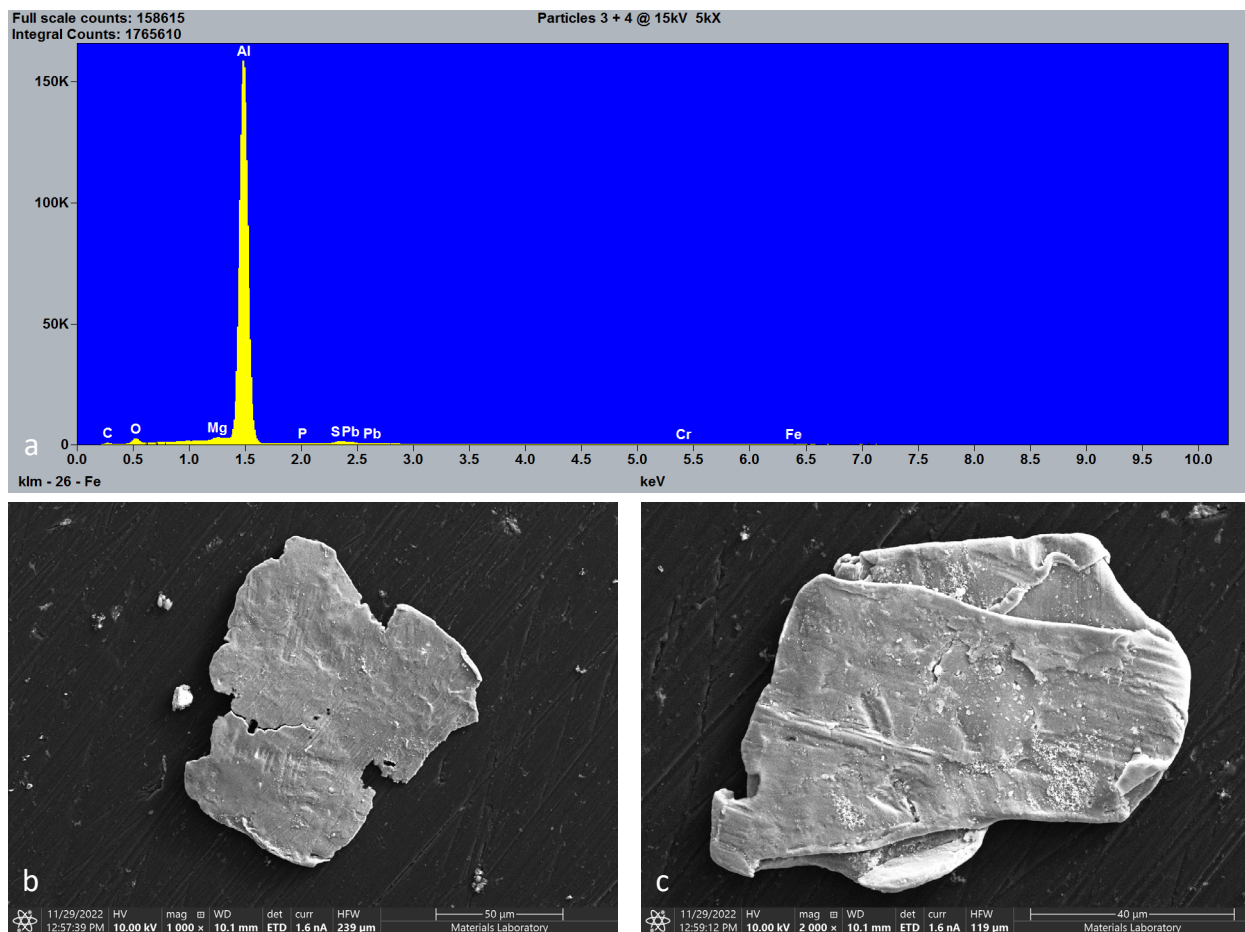
**Figure 11.** Spectrum and scanning electron microscope images (views b and c) of predominantly aluminum particles.

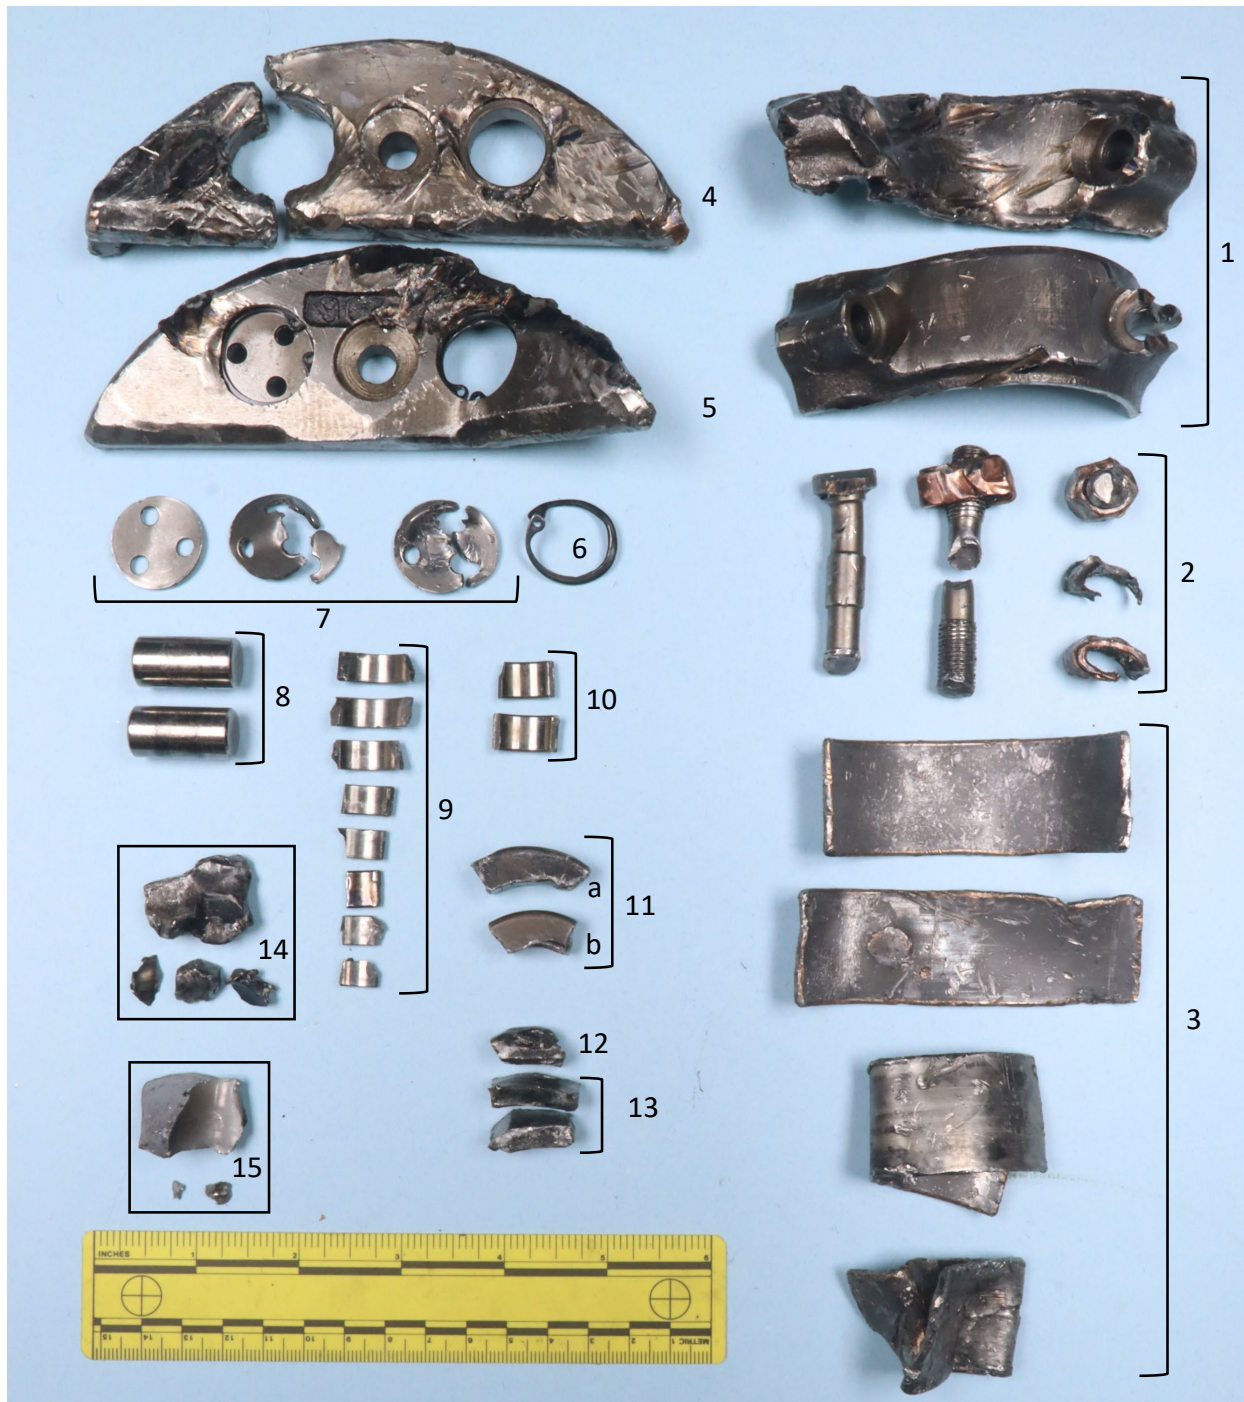
The pieces recovered from inside the crankcase are shown in Figure 12. Descriptions of the pieces and corresponding examination observations are listed in Table 1. Three pieces, shown in Figures 13, 16, and 19 exhibited curved surfaces and case cracking. The composition of the pieces was evaluated using a hand-held x-ray fluorescence spectrometer. All three pieces exhibited minor concentrations of nickel, chromium and molybdenum and major iron concentration (consistent with type 4340 steel alloy used for crankshafts). The case cracking is consistent with nitrided steel (crankshafts are fabricated from nitrided type 4340 steel). The curved surfaces are consistent with the geometrical features of a counterweight lug on the crankshaft (see Figure 22)

| Item | Description | Observations |
|---|---|---|
| 1 | Pieces of connecting rod caps | Pieces exhibited gross plastic deformation and batter. |
| 2 | Pieces of connecting rod cap bolts and nuts | Pieces exhibited gross plastic deformation and batter. Remaining fracture surfaces exhibited overstress fracture features. |
| 3 | Pieces of connecting rod bearings | Pieces exhibited gross plastic deformation and batter. |
| 4 | Pieces of crankshaft counterweight (two pieces) | Pieces exhibited gross plastic deformation and batter. Full counterweight has been fractured into pieces. Bushing remains in the intact hole. The remaining fracture surfaces exhibited overstress fracture features. Composition consistent with type 4140 steel (via handheld x-ray fluorescence spectrometer). |
| 5 | Pieces of crankshaft counterweight | Pieces exhibited gross plastic deformation and batter. Full counterweight has been fractured into pieces. Bushing, retaining ring, and plate remain in one hole. Retaining ring remains in the other hole. Composition consistent with type 4140 steel (via handheld x-ray fluorescence spectrometer). |
| 6 | Internal retaining ring | Piece exhibited gross plastic deformation. |
| 7 | Pieces of washer | Pieces exhibited gross plastic deformation. Two of the washers exhibited overstress fracture features. |
| 8 | Counterweight rollers | Roller surfaces exhibited features consistent with batter. |
| 9 | Counterweight bushing pieces (0.29 inch wide) | Pieces exhibited deformation and batter, and fracture features consistent with overstress fracture. |
| 10 | Counterweight bushing pieces (0.34 inch wide) | Pieces exhibited deformation and batter. The fracture features are consistent with overstress fracture. |
| 13 | Unknown, consistent with the web between the two halves of the counterweight (Figure 22) | Pieces exhibited deformation and batter. Composition consistent with type 4140 steel (via handheld x-ray fluorescence spectrometer). |
| 14 | Unknown, ferrous alloy pieces | Pieces exhibited batter and deformation. No remaining features to identify source of the pieces. |
| 15 | Unknown, aluminum alloy pieces | The large piece exhibited overstress fracture features. Composition of the large piece: aluminum alloy with Si, Cu, and Mg (via handheld x-ray fluorescence spectrometer). |

**Figure 12.** Image showing the pieces recovered from the engine after teardown. The pieces are approximately grouped according to their function. Table 1 provides a description of the pieces.

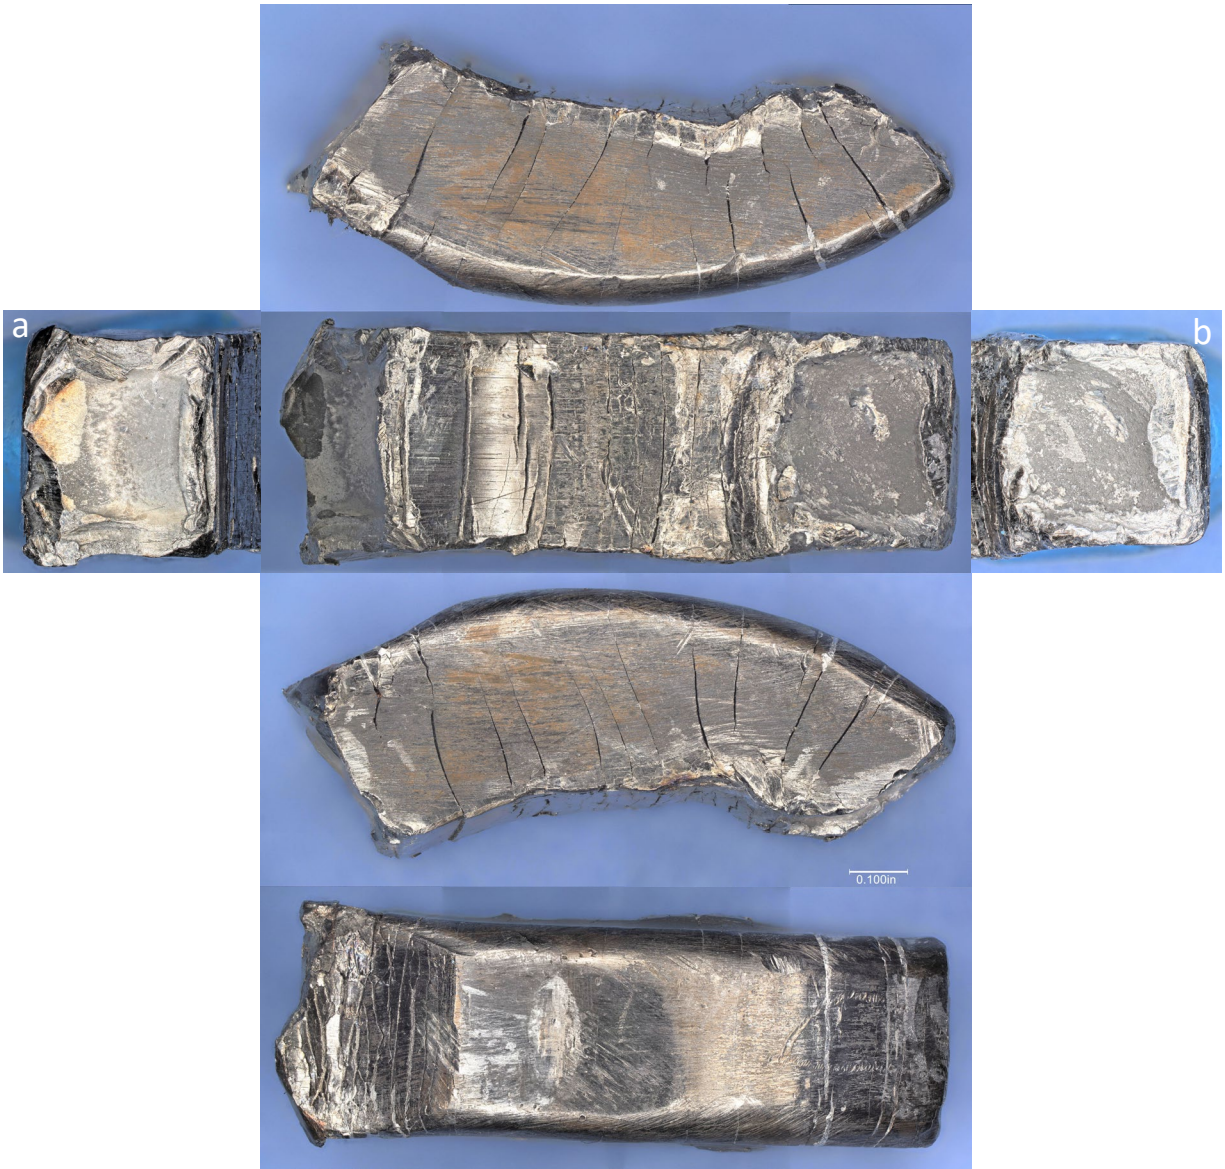
The crankshaft counterweight lug piece in Figure 13 (item 11a in Table 1) exhibited overstress fracture features on the left side of the piece (Figure 14) and progressive fracture features on the right side of the piece (Figure 15).

| Item | Description | Observations |
|---|---|---|
| 11a,b | Pieces from a crankshaft counterweight lug (Figure 22) | Pieces exhibited deformation and batter. The ends exhibited partial fracture features. 11a exhibited overstress fracture features on both ends and evidence of nitride case cracking on the machined surfaces. 11b exhibited progressive fracture features on both ends and evidence of nitride case cracking on the machined surfaces. Composition consistent with type 4340 steel (via handheld x-ray fluorescence spectrometer). |

**Figure 13.** Close digital microscope images of item 11a in Figure 12. Left and right fracture faces are shown in views a and b, respectively.

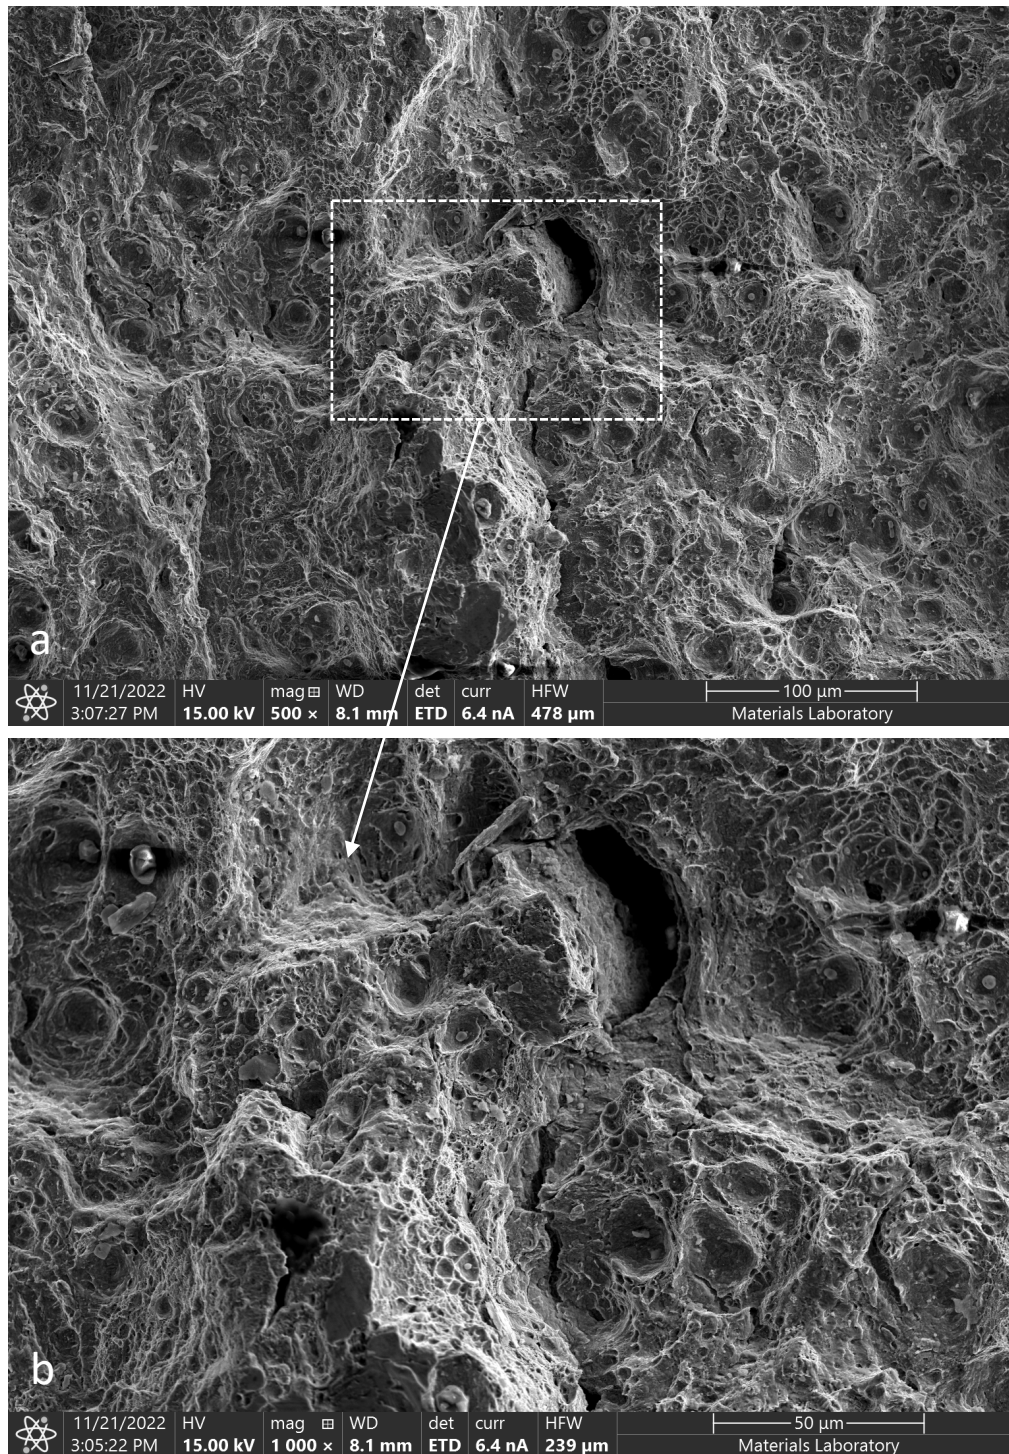
**Figure 14.** Secondary scanning electron fractograph of the fracture face on the left side of item 11a shown in Figure 13a. Dimpled rupture fracture features are observed.

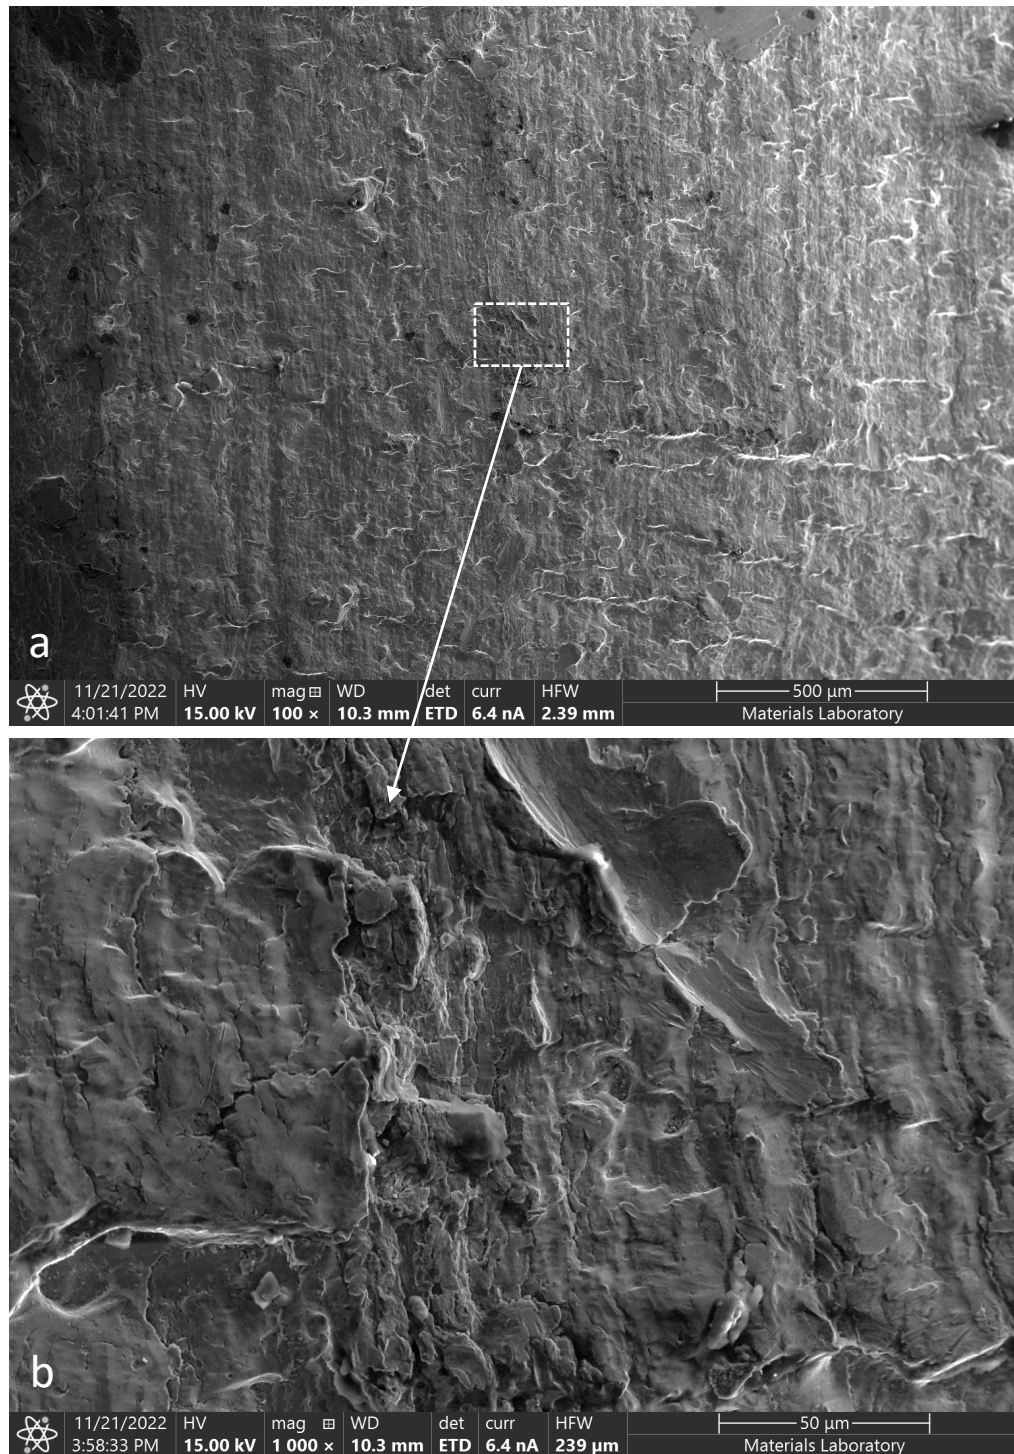
**Figure 15.** Secondary scanning electron fractograph of the fracture face on the right side of item 11a shown in Figure 13b. Progressive fracture features are observed.
