# National Transportation Safety Board

CEN21FA304

## **MATERIALS LABORATORY**

Factual Report 22-079

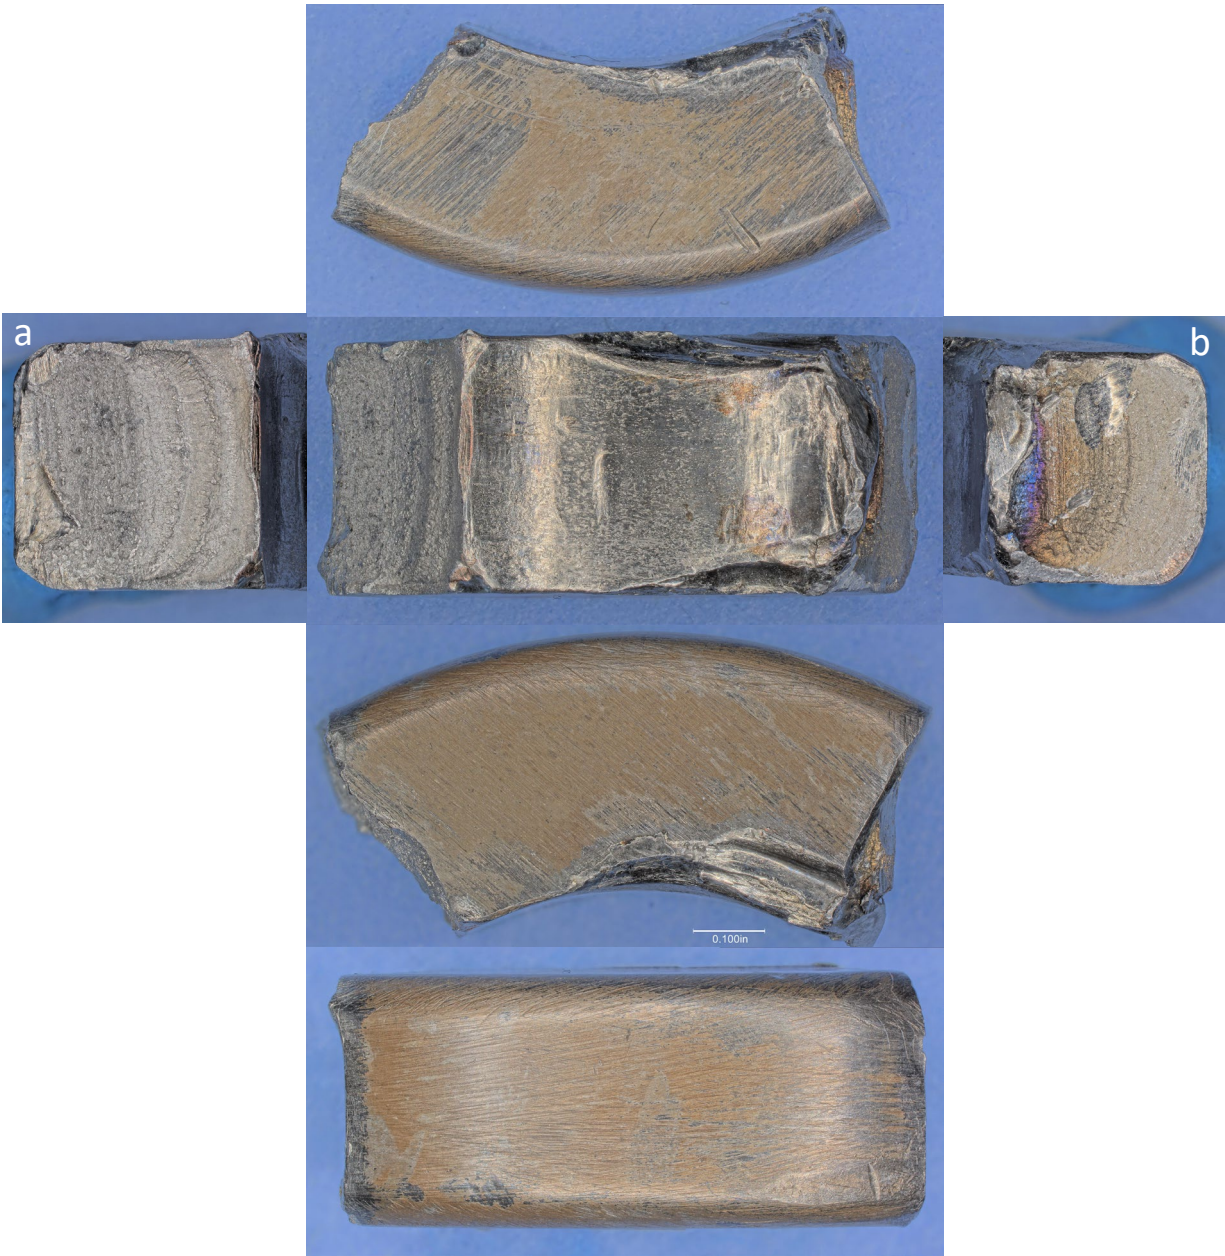
The crankshaft counterweight lug piece in Figure 16 (item 11b in Table 1) exhibited progressive fracture features on both the left and right side of the piece (Figure 17 and 18).

**Figure 16.** Close digital microscope images of item 11b in Figure 12. Left and right fracture faces are shown in views a and b, respectively.

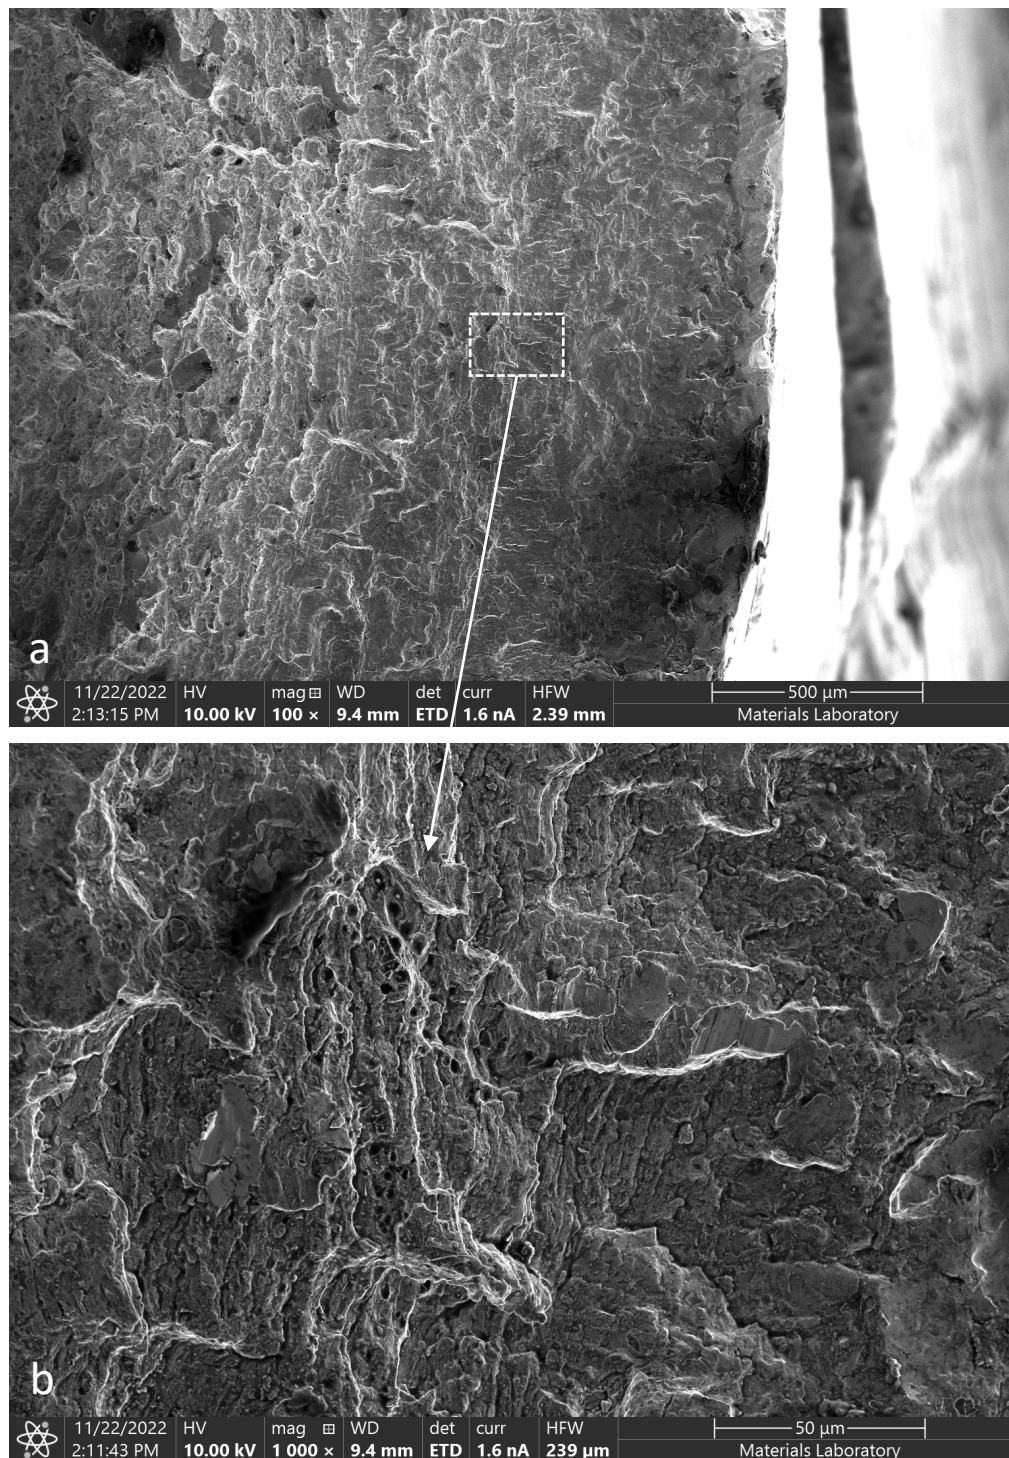
**Figure 17.** Secondary scanning electron fractograph of the fracture face on the left side of item 11b shown in Figure 16a. Progressive fracture features are observed.

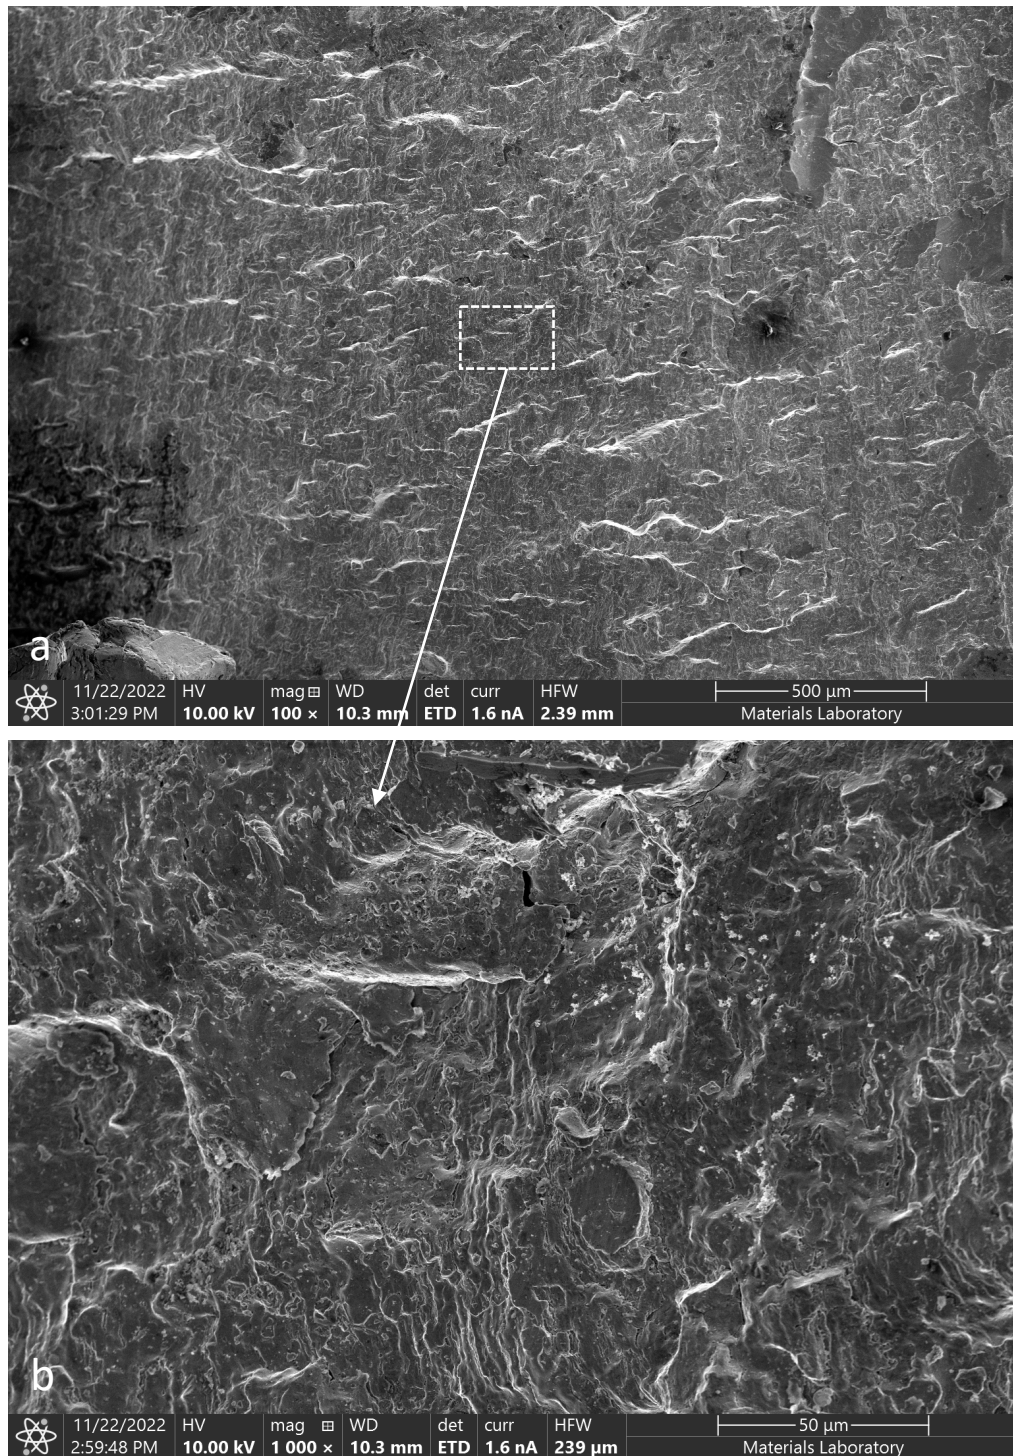
**Figure 18.** Secondary scanning electron fractograph of the fracture face on the right side of item 11b shown in Figure 16b. Progressive fracture features are observed.

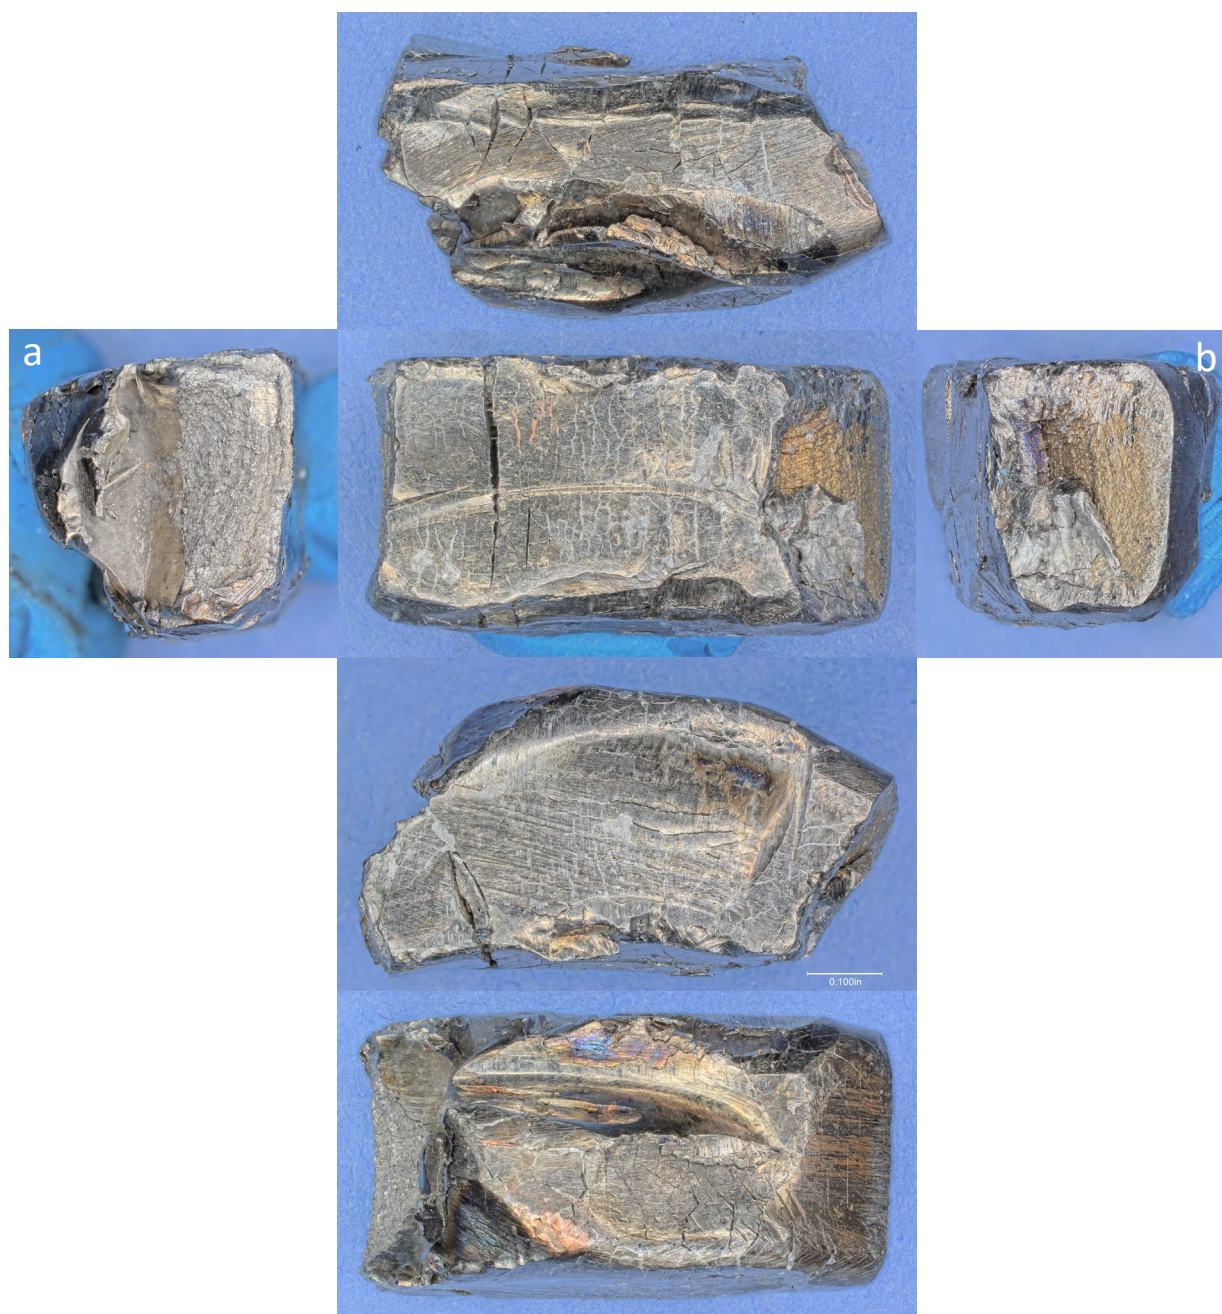
The crankshaft counterweight lug piece in Figure 19 (item 12 in Table 1) exhibited progressive fracture features on both the left and right side of the piece (Figure 20 and 21).

| Item | Description | Observations |
|---|---|---|
| 12 | Piece consistent with a crankshaft counterweight lug (Figure 22) | Piece exhibited deformation and batter. Progressive fracture features are present on both ends and evidence of nitride case cracking on the machined surfaces. Composition consistent with type 4340 steel (via handheld x-ray fluorescence spectrometer). |

**Figure 19.** Close digital microscope images of item 12 in Figure 12. Left and right fracture faces are shown in views a and b, respectively.

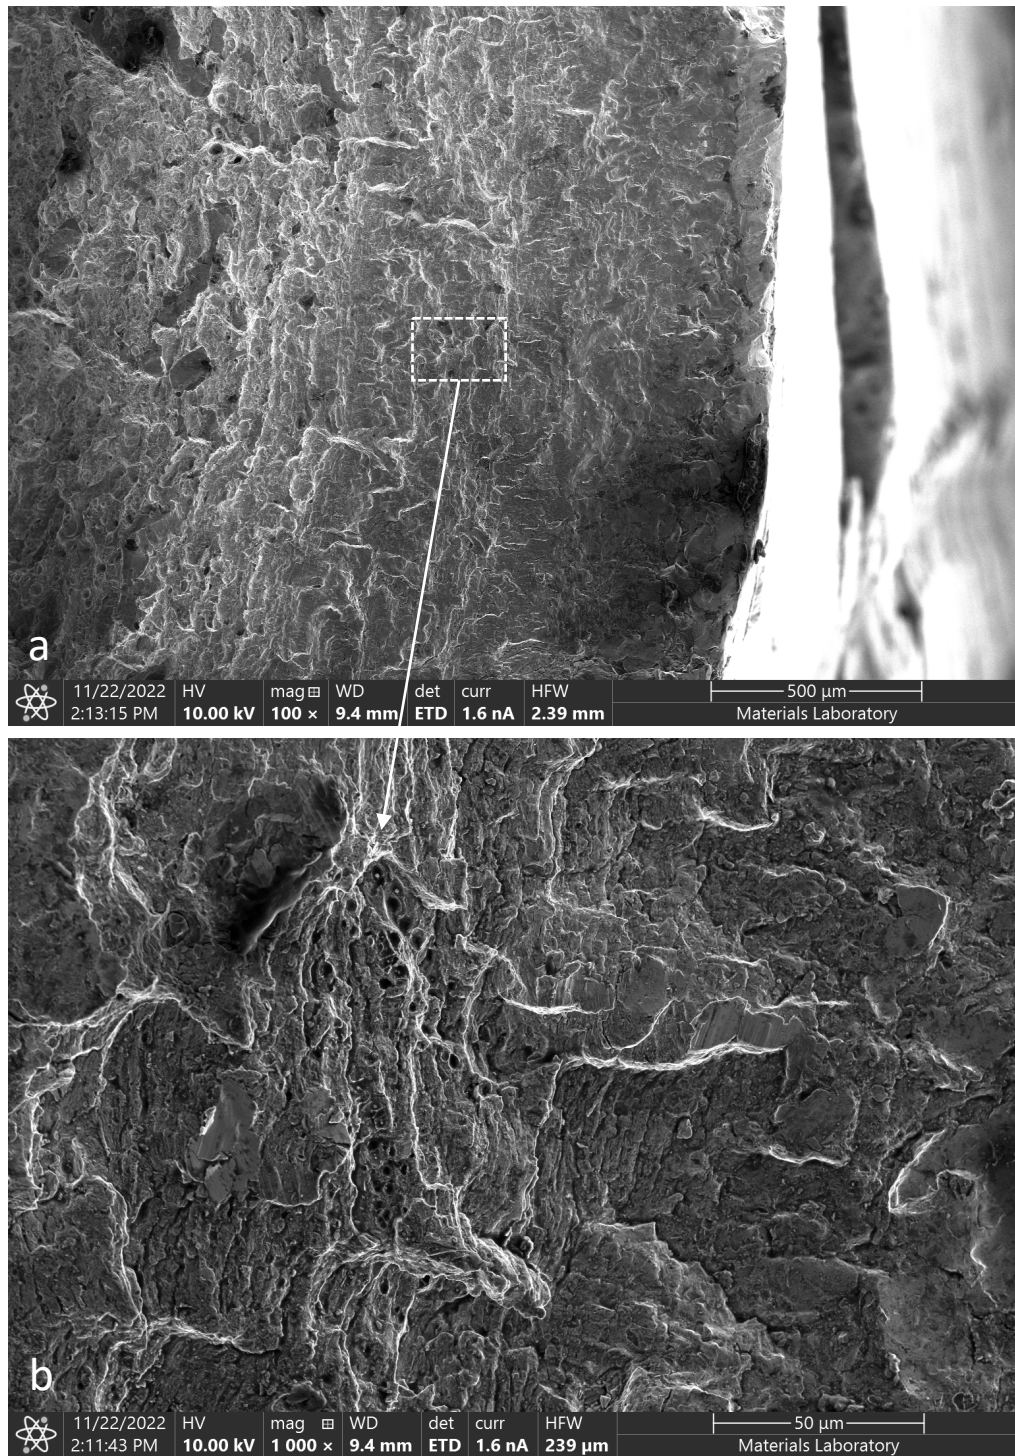
**Figure 20.** Secondary scanning electron fractograph of the fracture face on the left side of item 12 shown in Figure 19a. Progressive fracture features are observed.

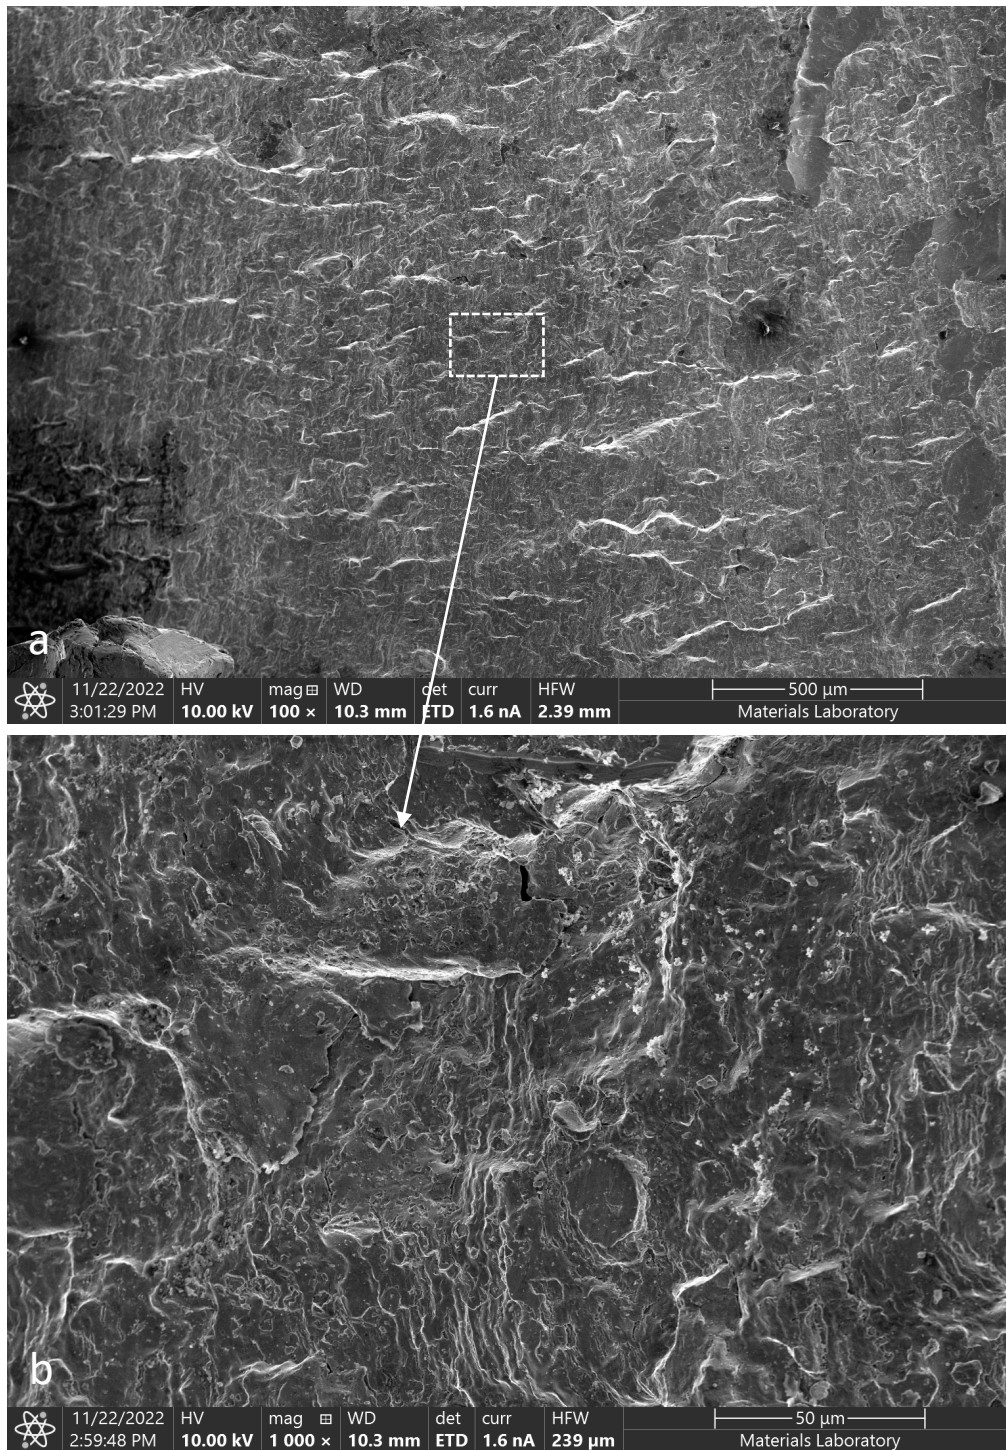
**Figure 21.** Secondary scanning electron fractograph of the fracture face on the right side of item 12 shown in Figure 19b. Progressive fracture features are observed.
