# National Transportation Safety Board

CEN21FA304

## **WRECKAGE EXAMINATION SUMMARY**

Location: Killeen, Texas  
Date: July 4, 2021  
Time: 1722 central daylight time (2222 UTC)  
Airplane: Focke-Wulf FWP-149D, Registration No. N9145

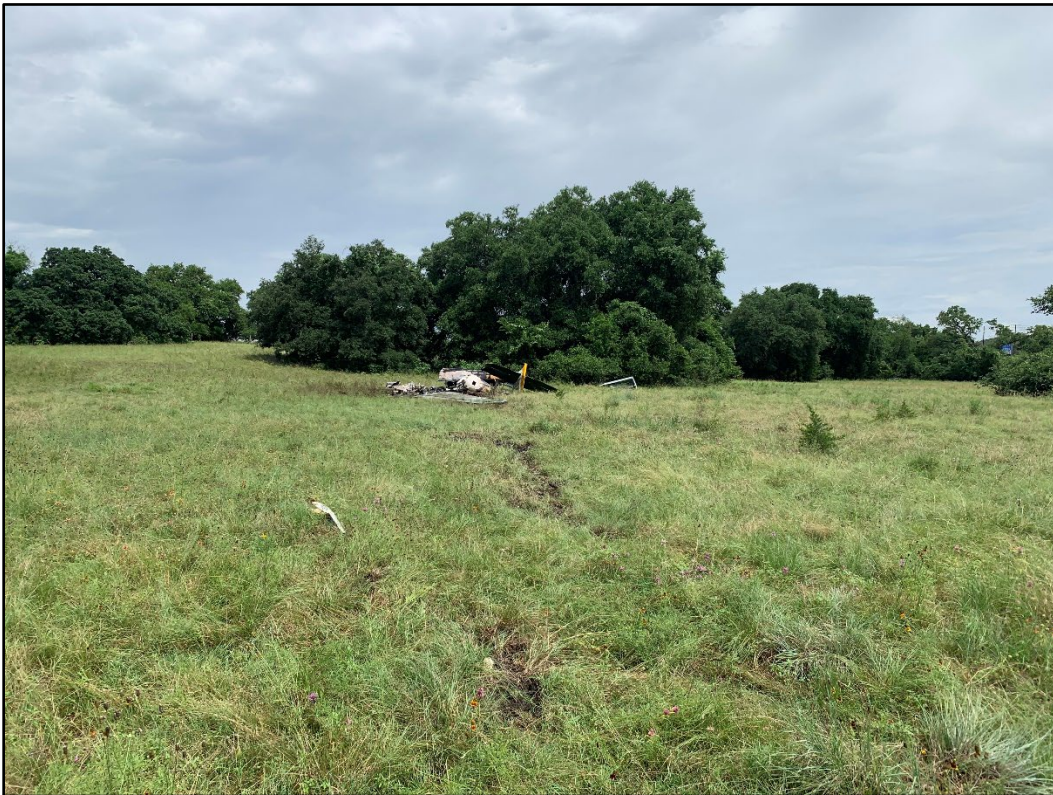
The main wreckage was in a level grass field with several grouping of trees, as shown in figure 2, about 0.2 miles south-southwest of the intersection of East Stagecoach Road and East Trimmier Road, in Killeen, Texas.

**Figure 2** - Accident site overview

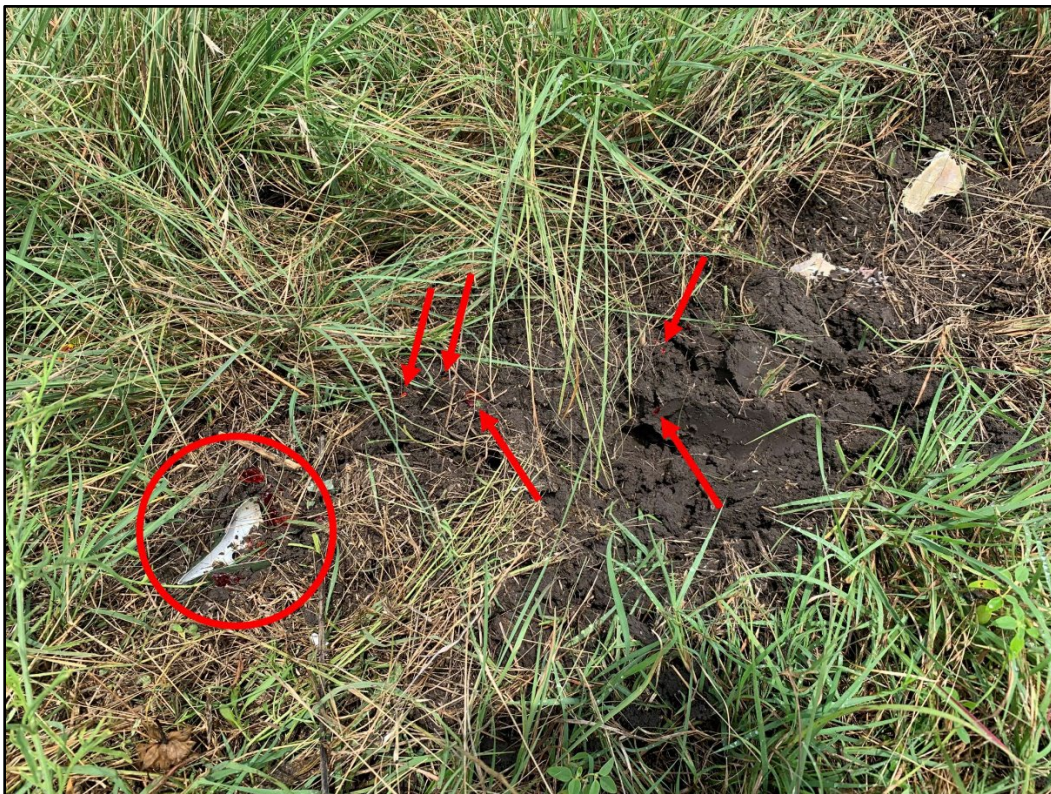
The airplane's initial impact point was a ground scar containing fragments of red navigation light lens material, as shown in figure 5, consistent with the airplane in a left-wing-low attitude at impact. The wreckage debris path was oriented on a 319° true heading and measured about 135 ft long.

**Figure 5** - Initial impact point with red navigation lens material from left wingtip

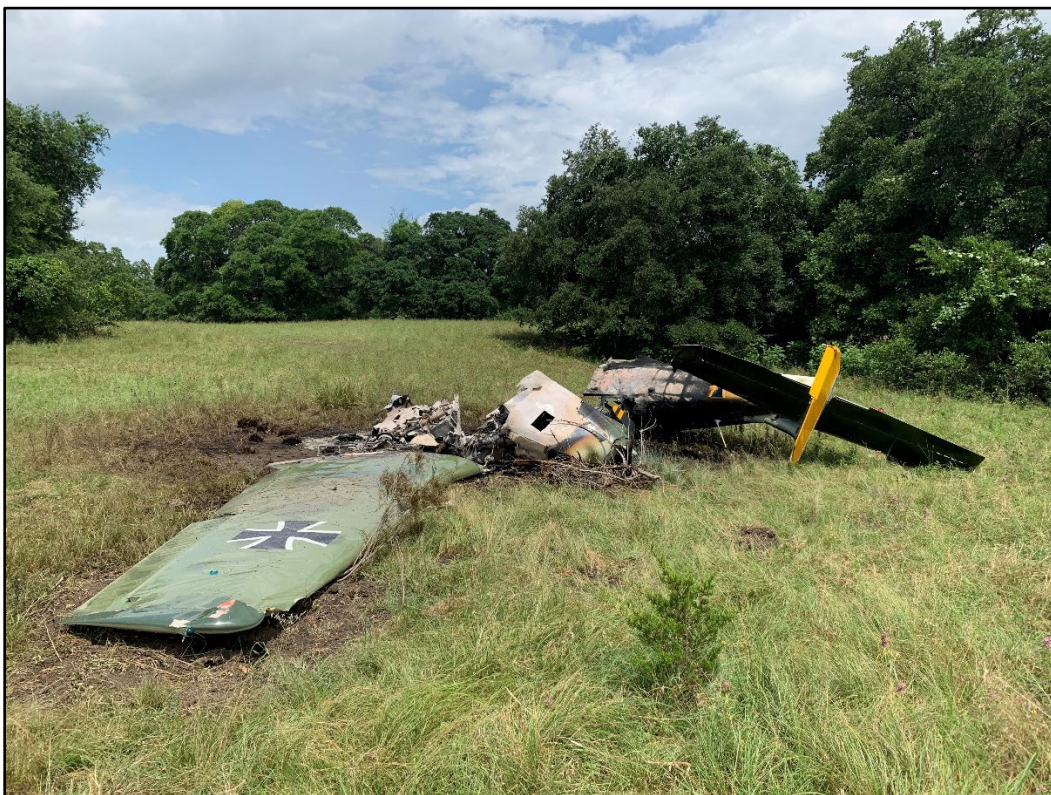
The main wreckage consisted of the cabin and cockpit, right wing, aft fuselage, engine, and propeller, as shown in figure 6. The main cabin and cockpit were destroyed by impact forces and the postimpact fire, as shown in figure 7. The aft fuselage with empennage separated from the remaining fuselage and was resting inverted in front of the cabin, as shown in figure 8 and figure 9. The nose landing gear was found retracted inside the engine compartment. The right wing remained intact, as shown in figure 10, and the right main landing gear and right flap were found retracted. The left wing was found in multiple sections, and the inboard half of the wing was destroyed by impact and fire damage, as shown in figure 11. The left main landing gear was found in the extended position, as shown in figure 12. The left aileron and left wingtip separated from the wing, as shown in figure 13 and figure 14.

**Figure 6** - Main wreckage at the accident site

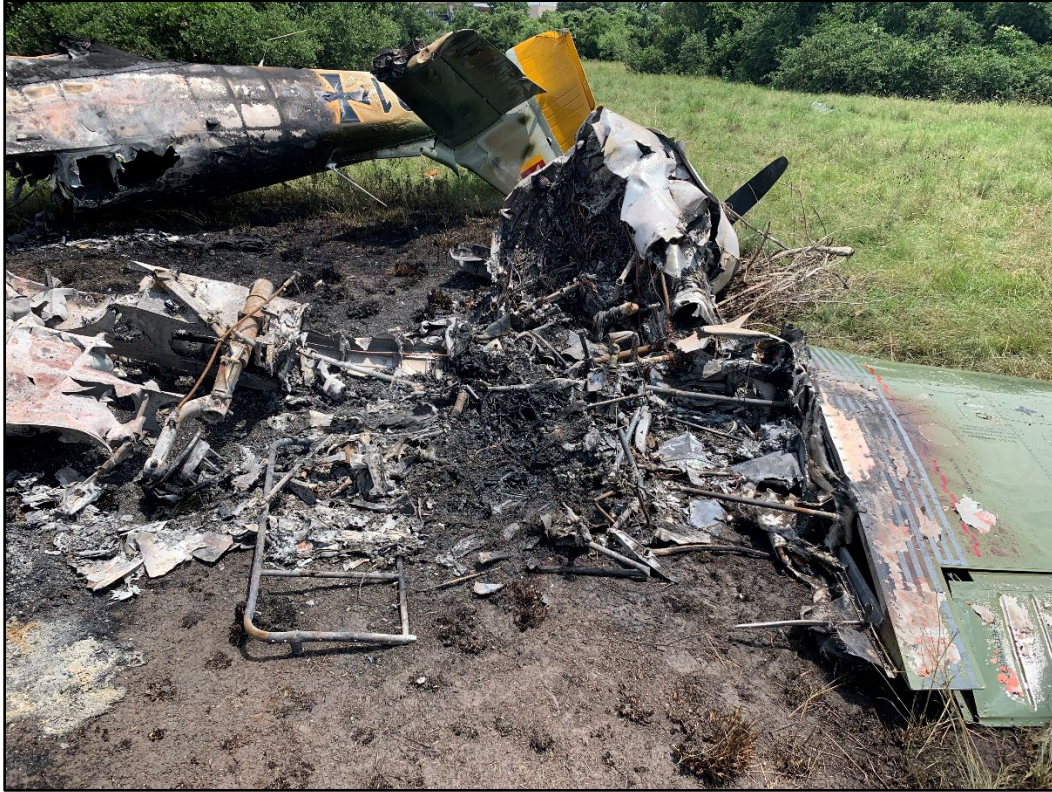
**Figure 7** - Cabin, cockpit, and instrument panel

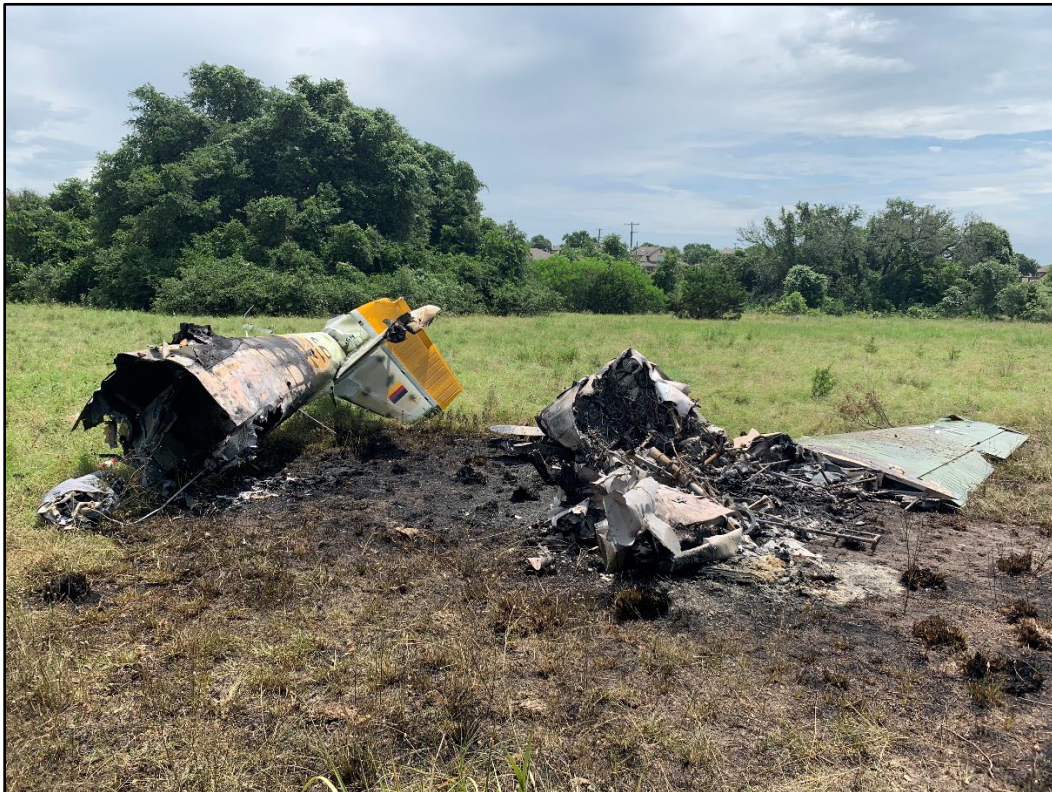
**Figure 8** - Main wreckage, aft fuselage, and empennage

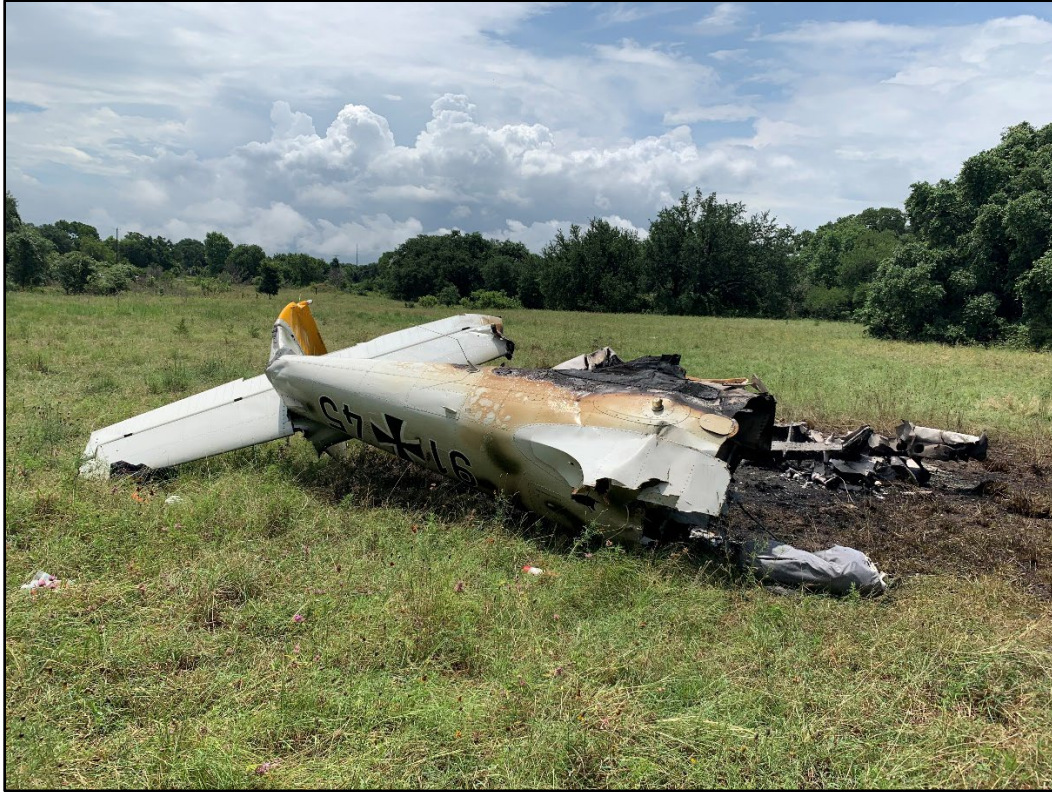
**Figure 9** - Aft fuselage and empennage

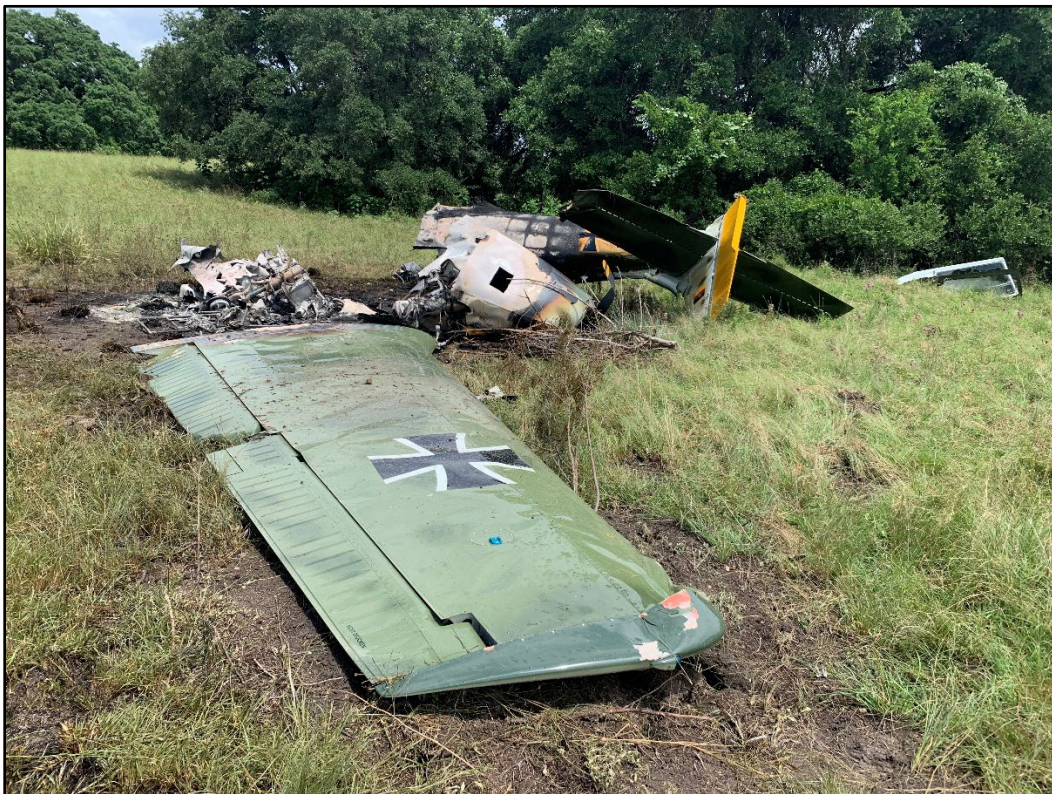
**Figure 10** - Right wing, right aileron, and right flap

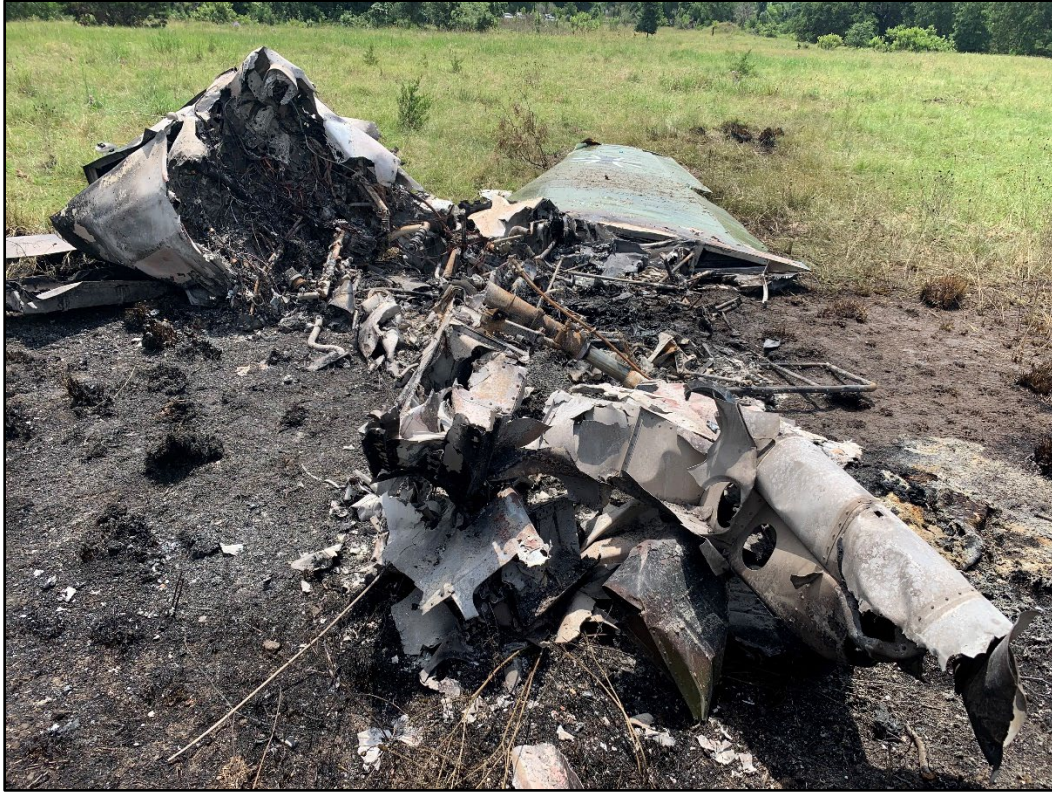
**Figure 11** - Left wing and cabin

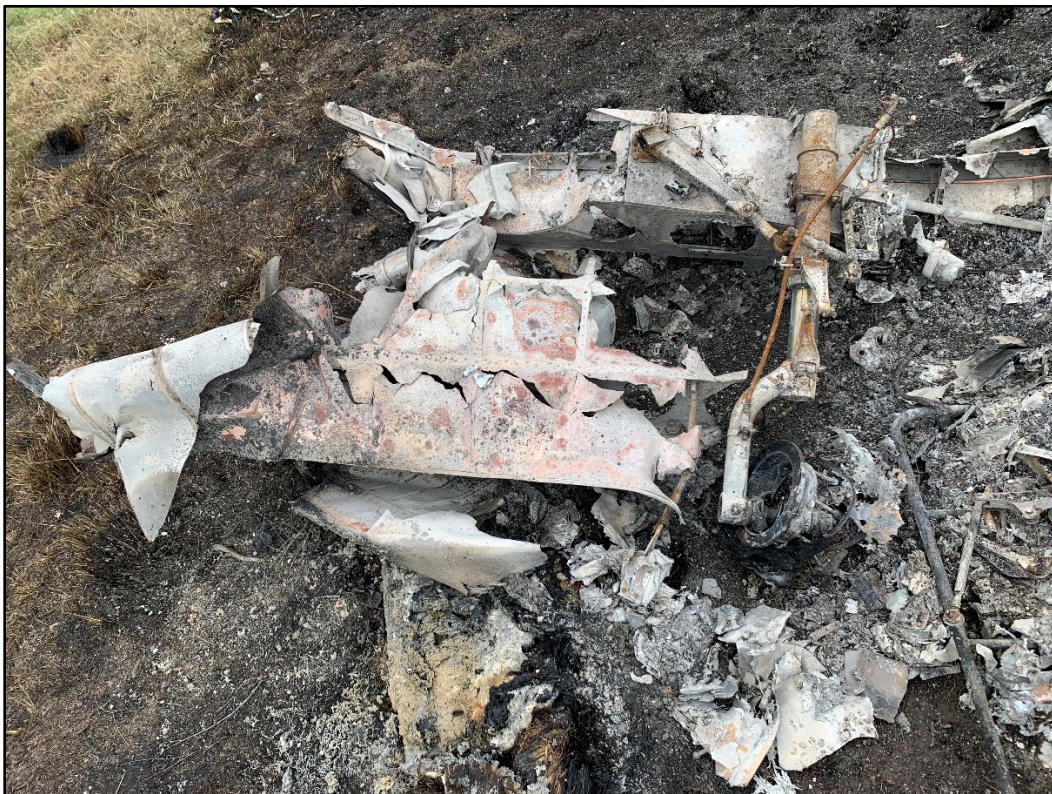
**Figure 12** - Left wing spar, left flap, and left main landing gear

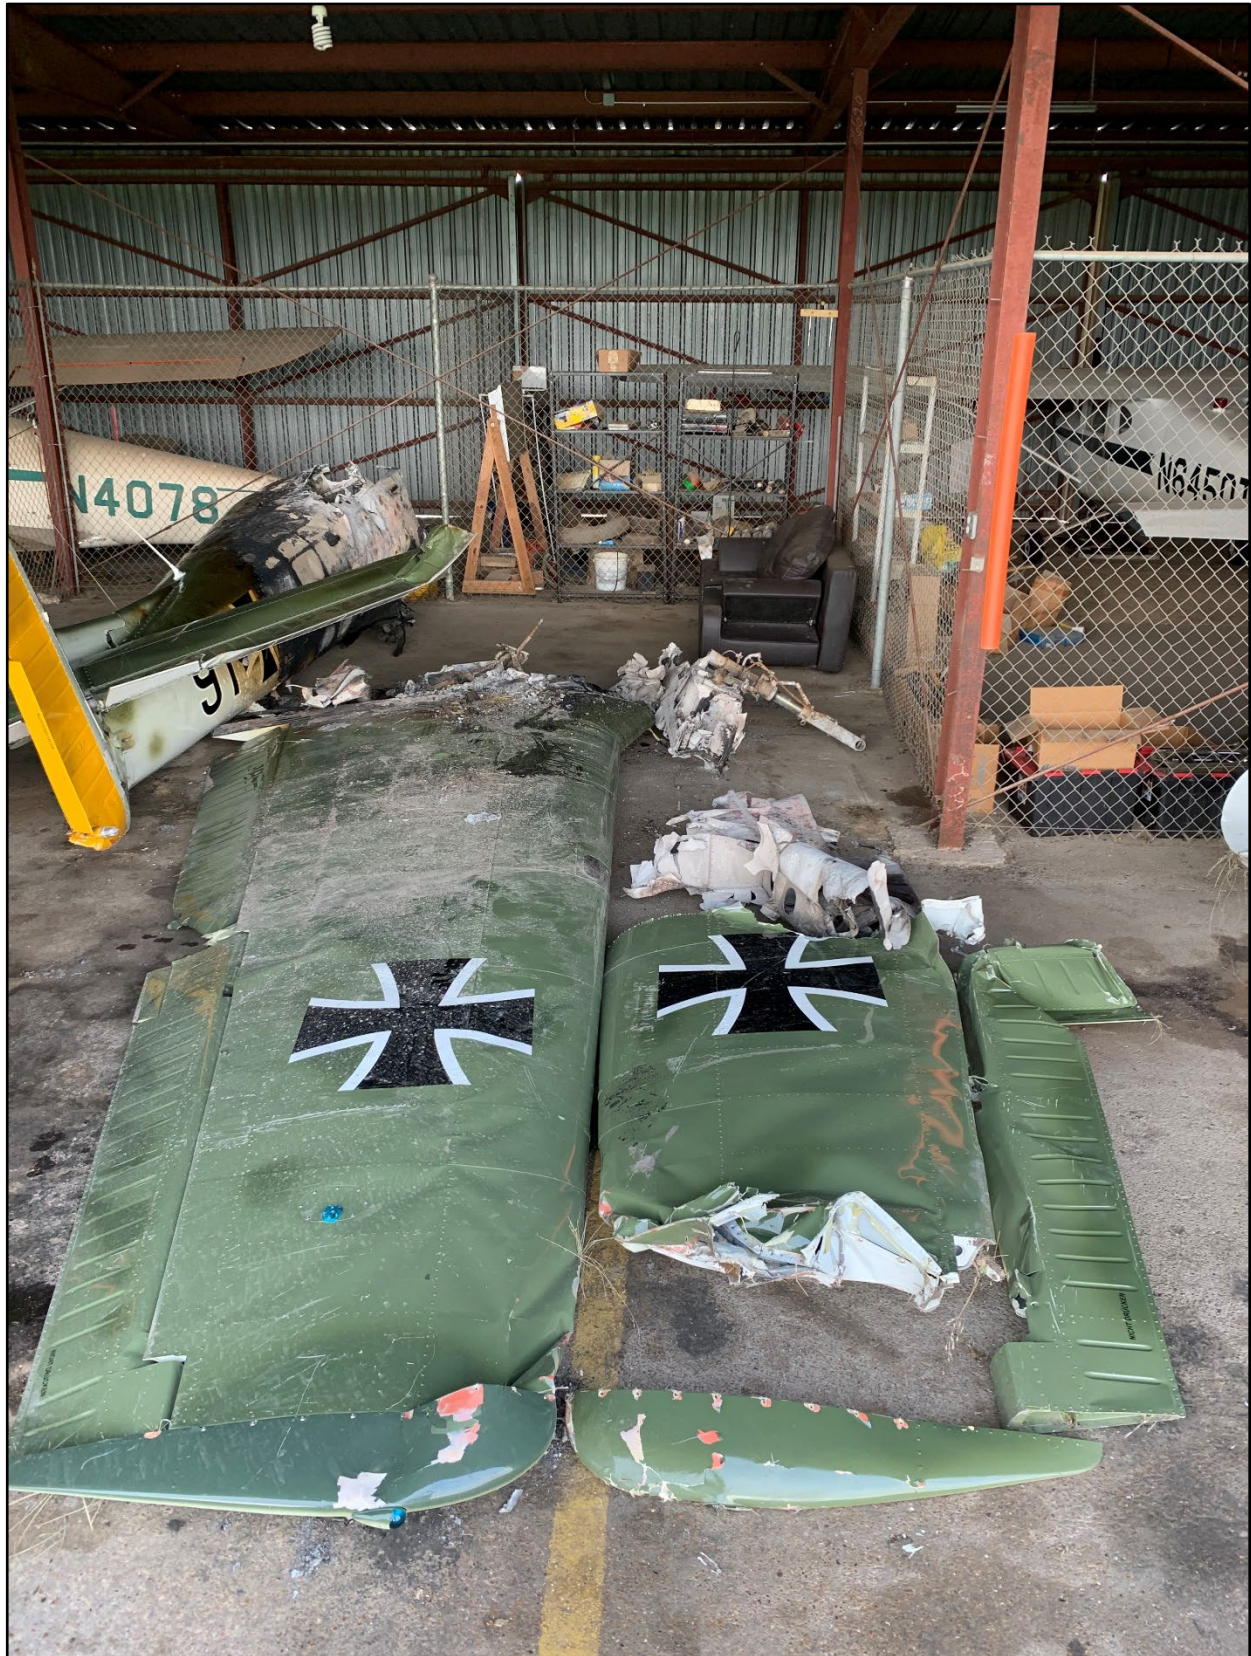
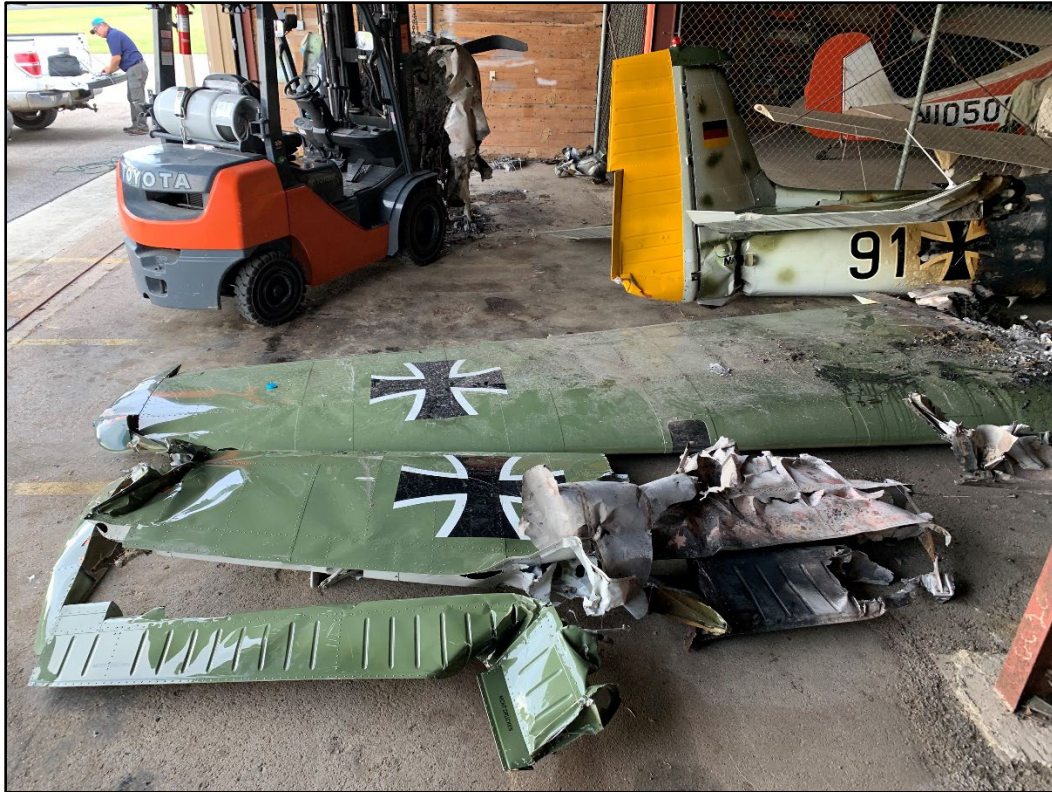
**Figure 13** - Left and right wings after recovery from accident site

**Figure 14** - Left and right wings after recovery from accident site

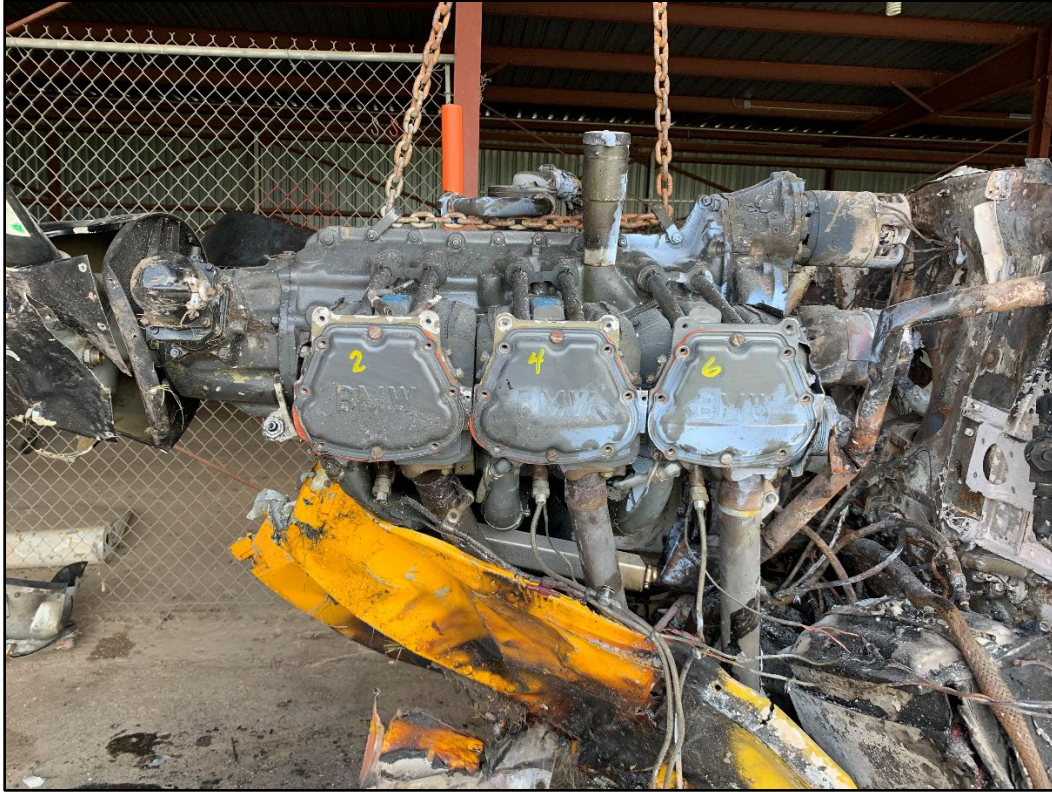
The engine remained attached to the fuselage through the engine mounts, as shown in figure 15. The engine had sustained significant thermal damage at the rear section encompassing the engine driven accessories, wiring, plumbing, and firewall. The propeller hub and two propeller blades remained attached to the engine, as shown in figure 16. The third propeller blade, as shown in figure 17, separated from the hub during impact and was recovered from an impact crater along the wreckage debris path. The propeller blades were relatively straight and did not exhibit damage typically observed with the absorption of rotational energy at impact.

**Figure 15** - Engine after recovery from accident site

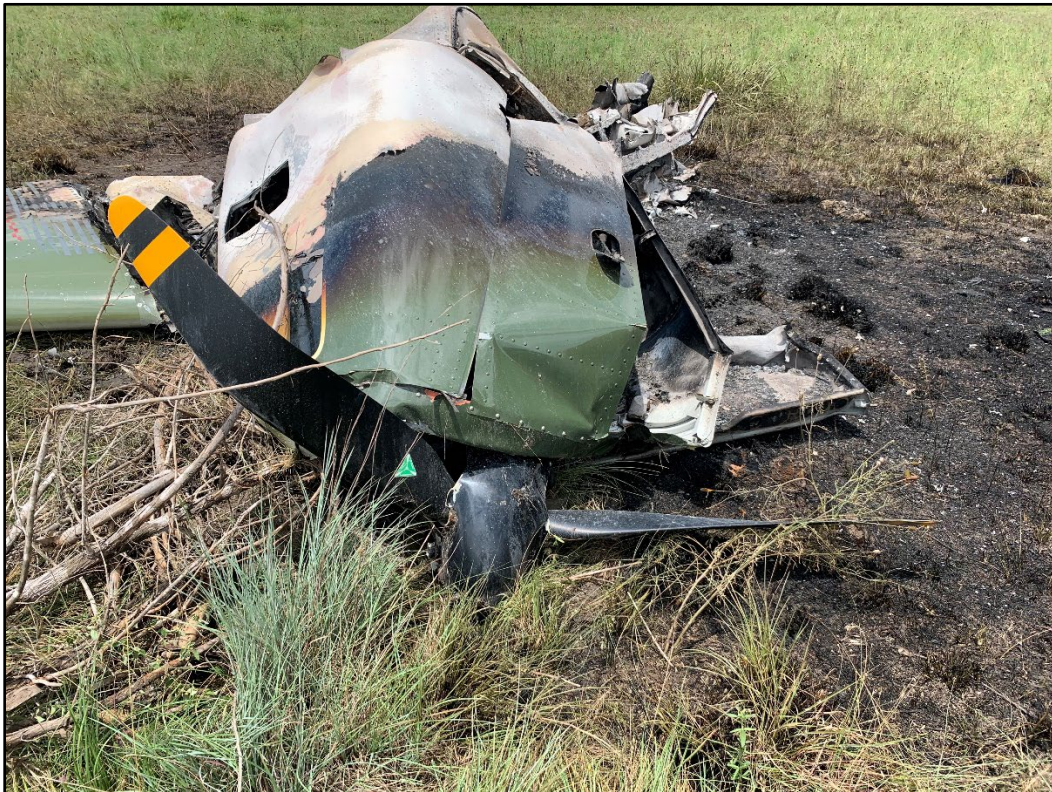
**Figure 16** - Propeller at accident site

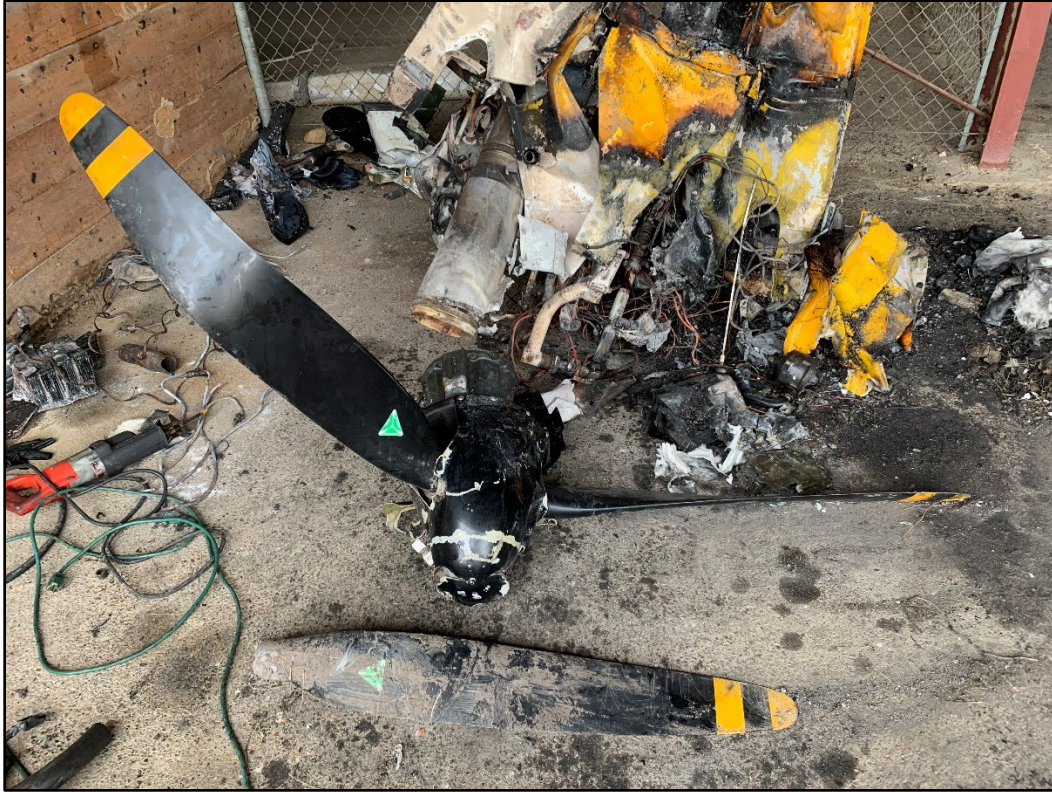
**Figure 17** - Propeller after recovery from accident site

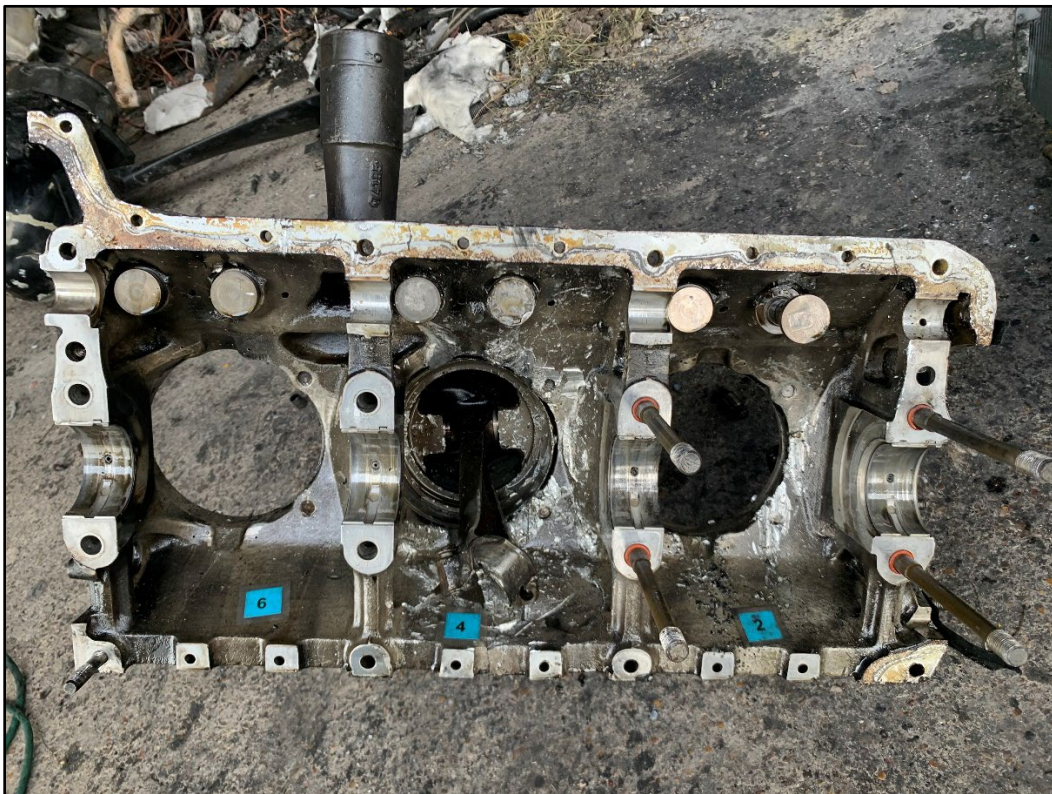
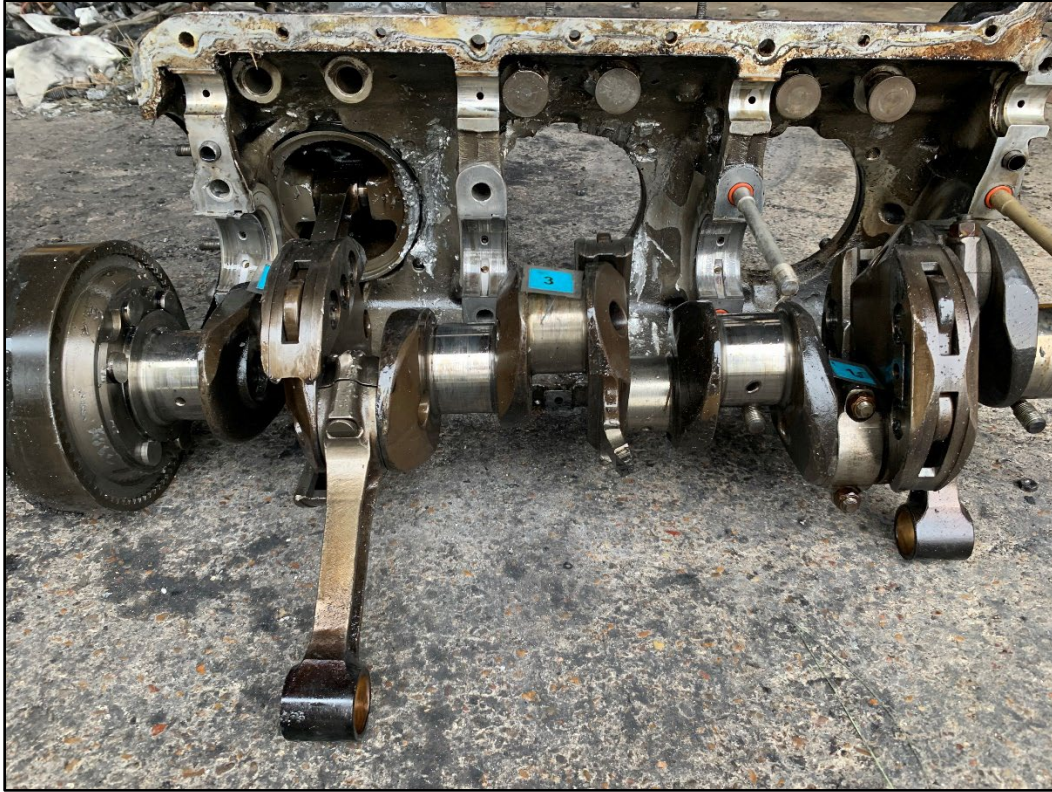
The engine could not be rotated through the reduction gearbox using the attached propeller. Disassembly of the engine revealed the Nos. 3 and 4 connecting rods separated from their respective crankshaft journals. The No. 3 and No. 4 connecting rod beams were bent, twisted, and deformed. There was significant damage to the internal cavities of the engine crankcase, particularly along the rotational plane of the Nos. 3 and 4 connecting rods and associated rotating crankshaft components, as shown in figure 18 and figure 19.

**Figure 18** - Crankcase (left side)

**Figure 19** - Crankshaft and crankcase (right side)

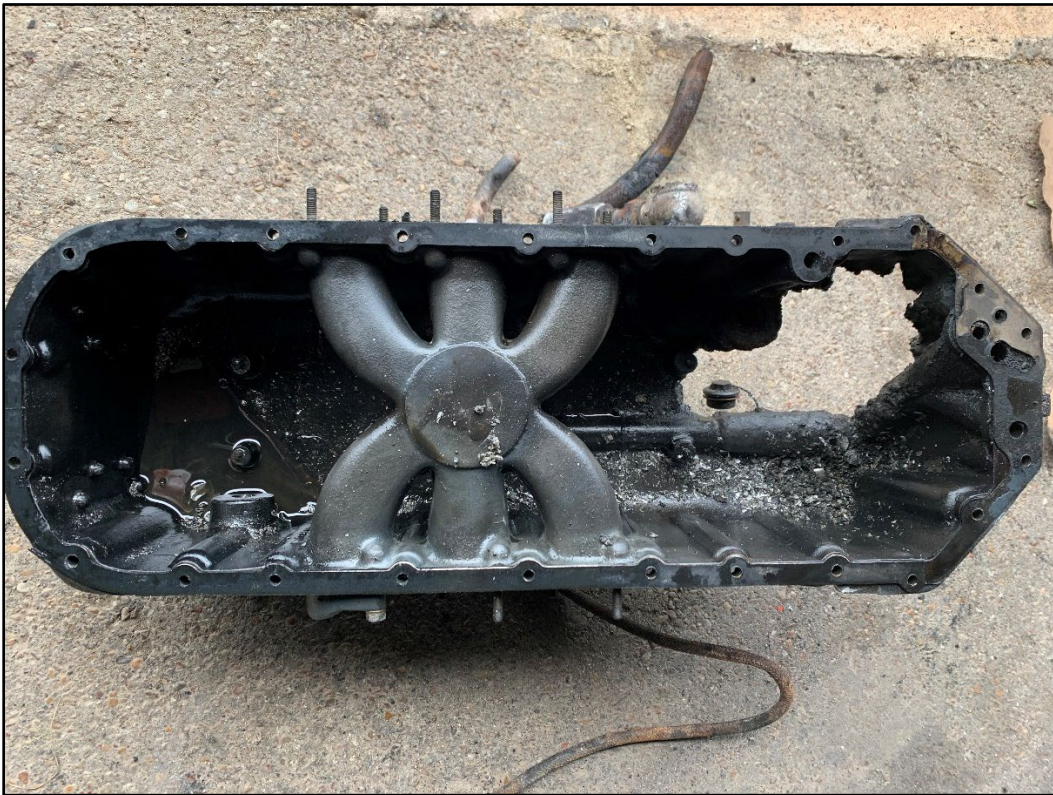
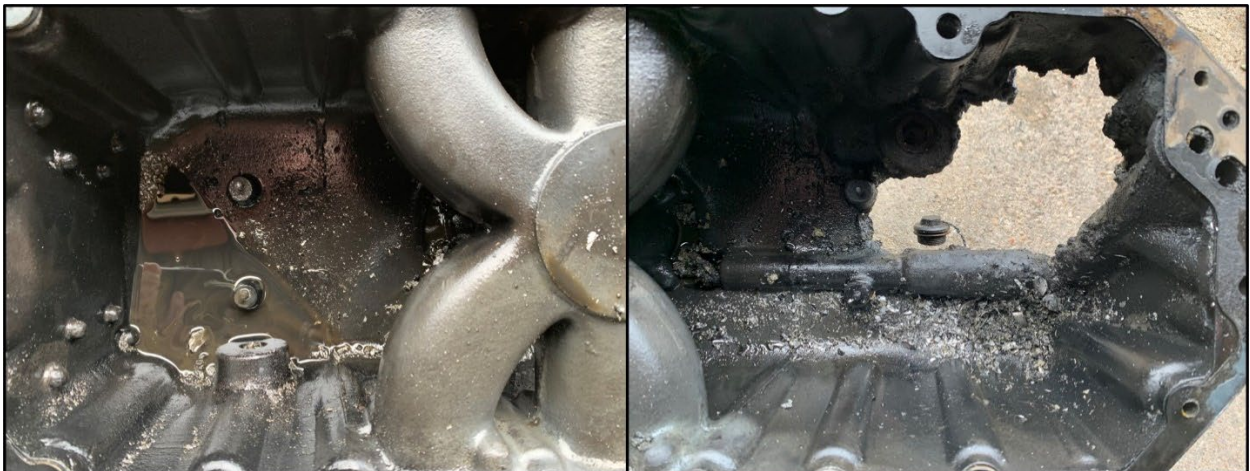
There was no evidence of heat distress or a lack of lubrication to the internal engine drivetrain components. The cylinder combustion chambers remained mechanically undamaged, with no evidence of foreign object ingestion or detonation. The propeller reduction gearbox remained intact and free of impact energy damage, and the internal gear assemblies remained free of damage, lubrication deprivation or heat distress signatures. The oil sump exhibited thermal damage that included a large hole, as shown in figure 20 and figure 21.

**Figure 20** - Engine oil sump

**Figure 21** - Metal contamination found in the engine oil sump

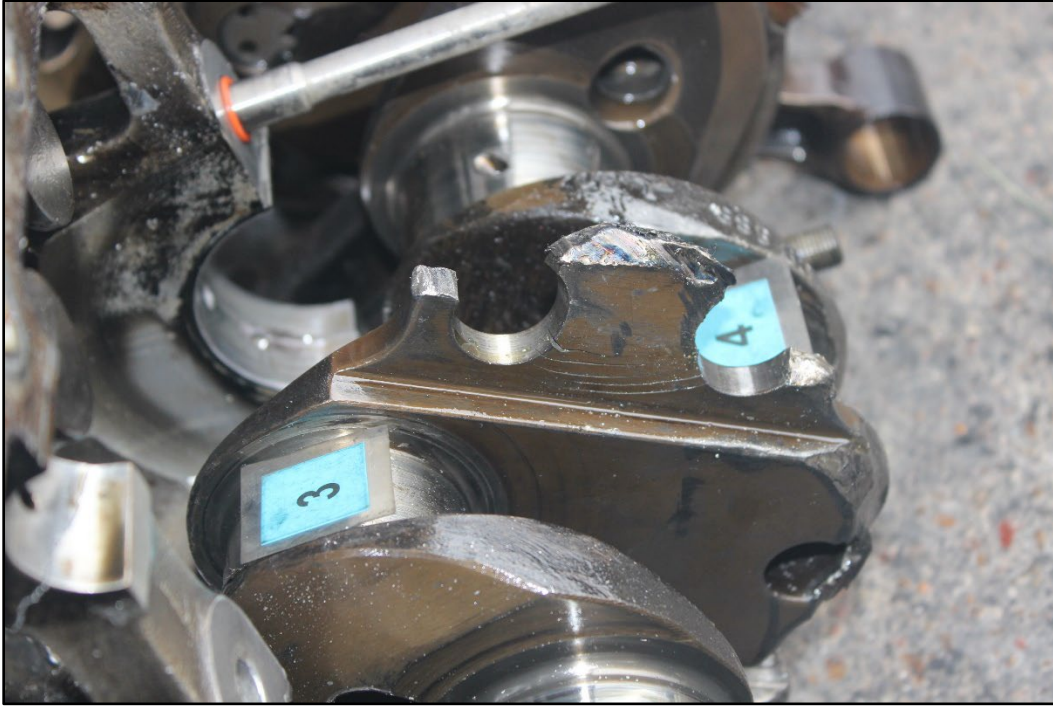
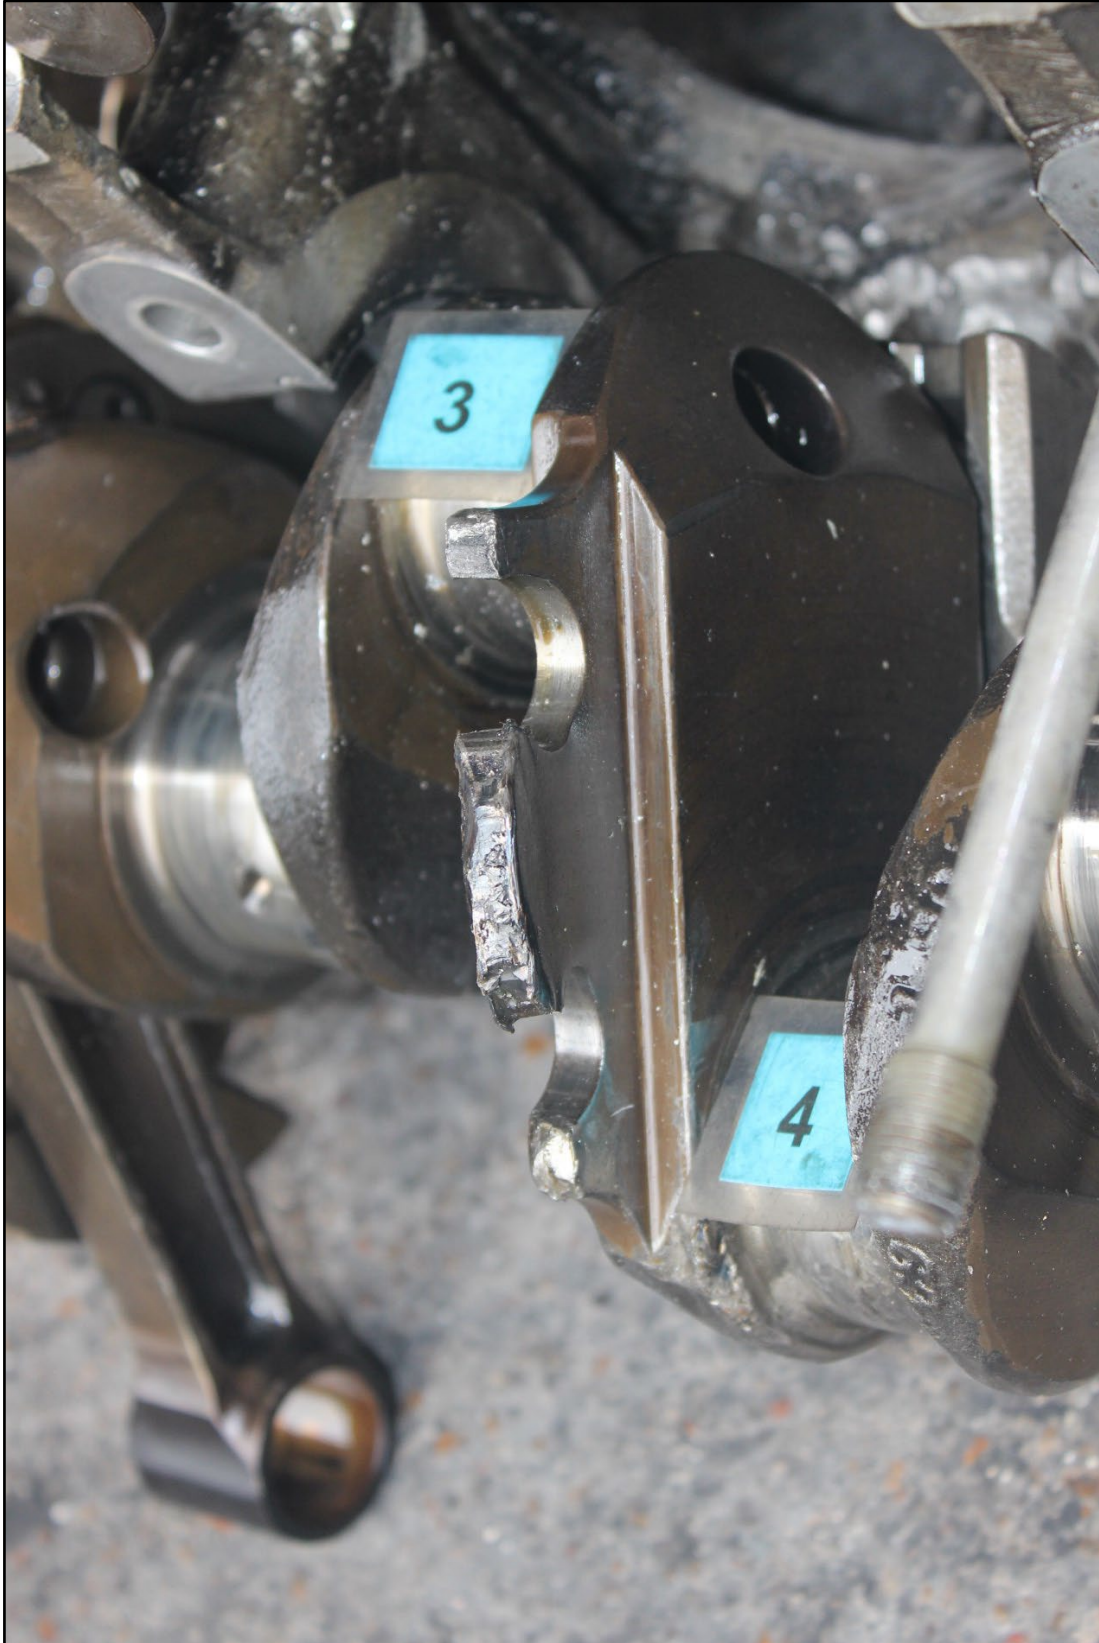
One of the two crankshaft dynamic counterweights separated from its respective crankshaft counterweight mounting lobe at position No. 3. The crankshaft counterweight mounting lobe at position No. 3 exhibited elongated bores and a tearing/bending appearance, as shown in figure 22 and figure 23.

**Figure 22** - Crankshaft counterweight mounting lobe at position No. 3  
(Lycoming Photo)

**Figure 23** - Crankshaft counterweight mounting lobe at position No. 3  
(Lycoming Photo)

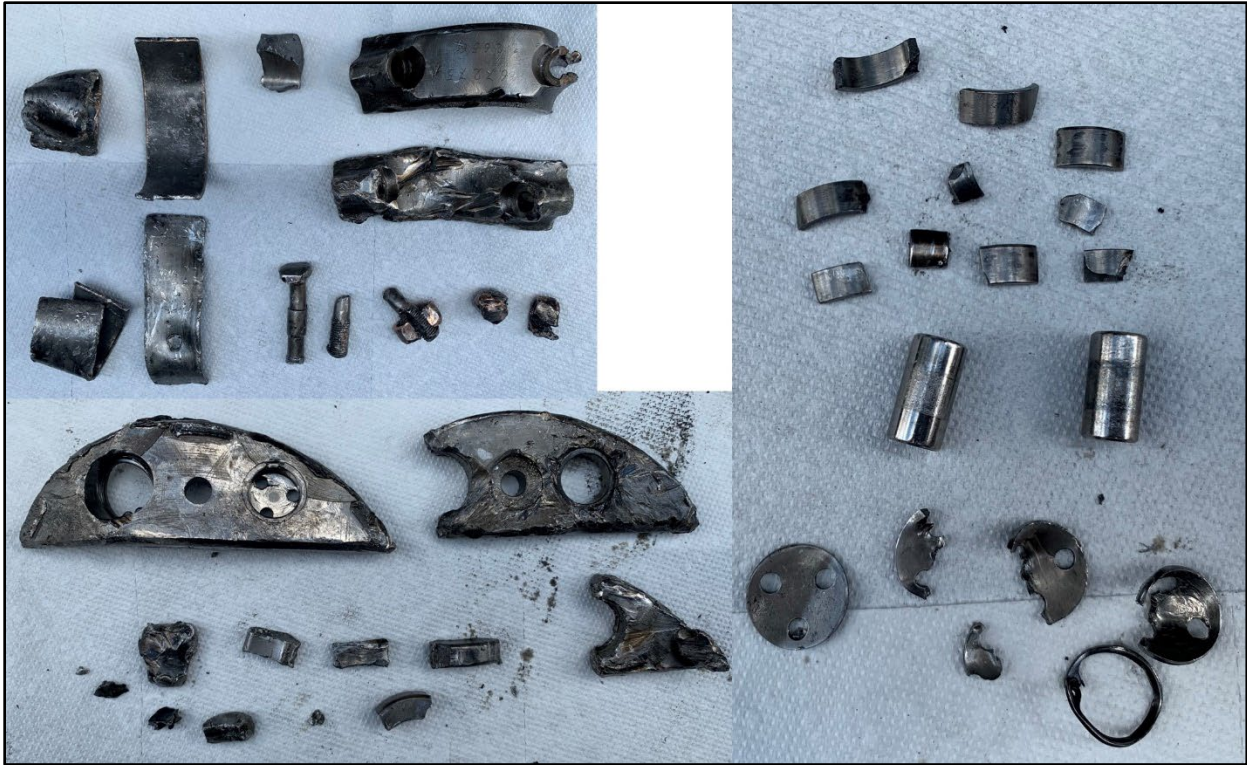
Several fractured metal items were recovered from inside the crankcase, cylinders Nos. 3 and 4, and the oil sump. The recovered items included pieces of connecting caps, bolts, nuts, bearings, counterweights, counterweight mounting lobes, rollers, bushings, snap rings, and washers, as shown in figure 24. The recovered counterweight rollers, p/n 69433, exhibited fretting/galling signatures at the center bushing (crankshaft) surfaces.

**Figure 24** - Metal items recovered from inside engine during the examination

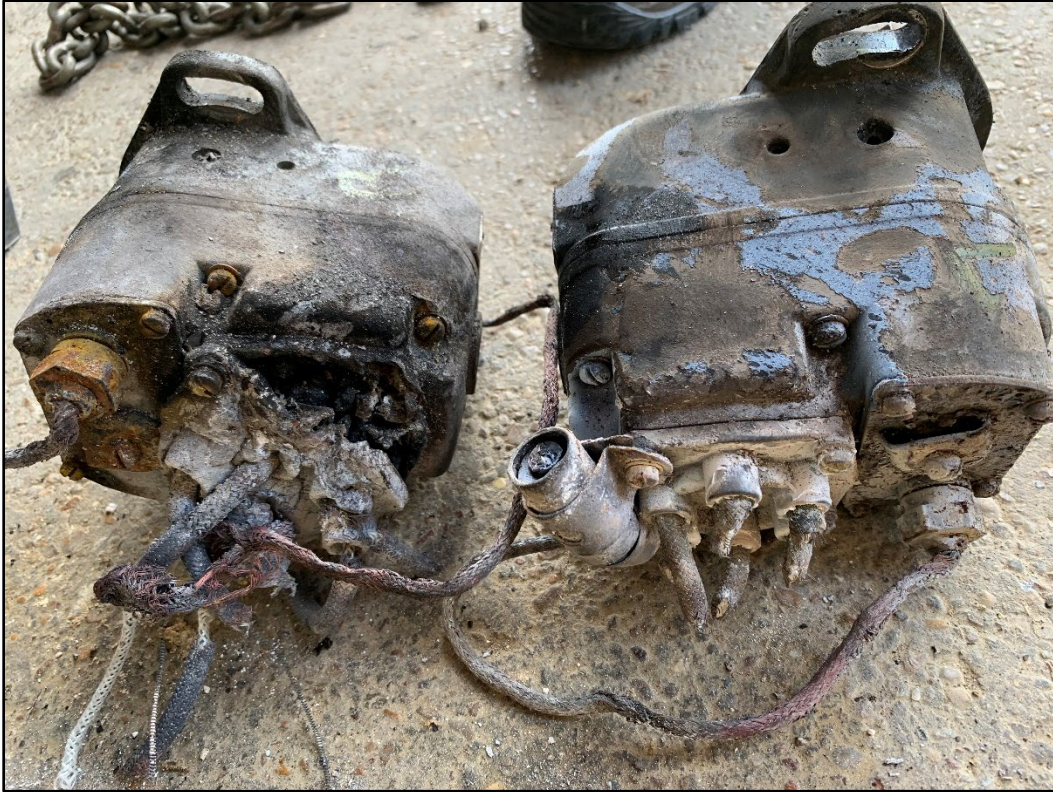
The magnetos remained secured to their respective mounting pad and exhibited varying degrees of thermal damage from the postimpact fire, as shown in figure 25. Neither magneto could be functioned tested due to damage. Magneto-to-engine timing could not be ascertained. The ignition harness remained attached to the magnetos and each spark plug, and exhibited significant thermal damage from the postimpact fire.

**Figure 25** - Magnetos

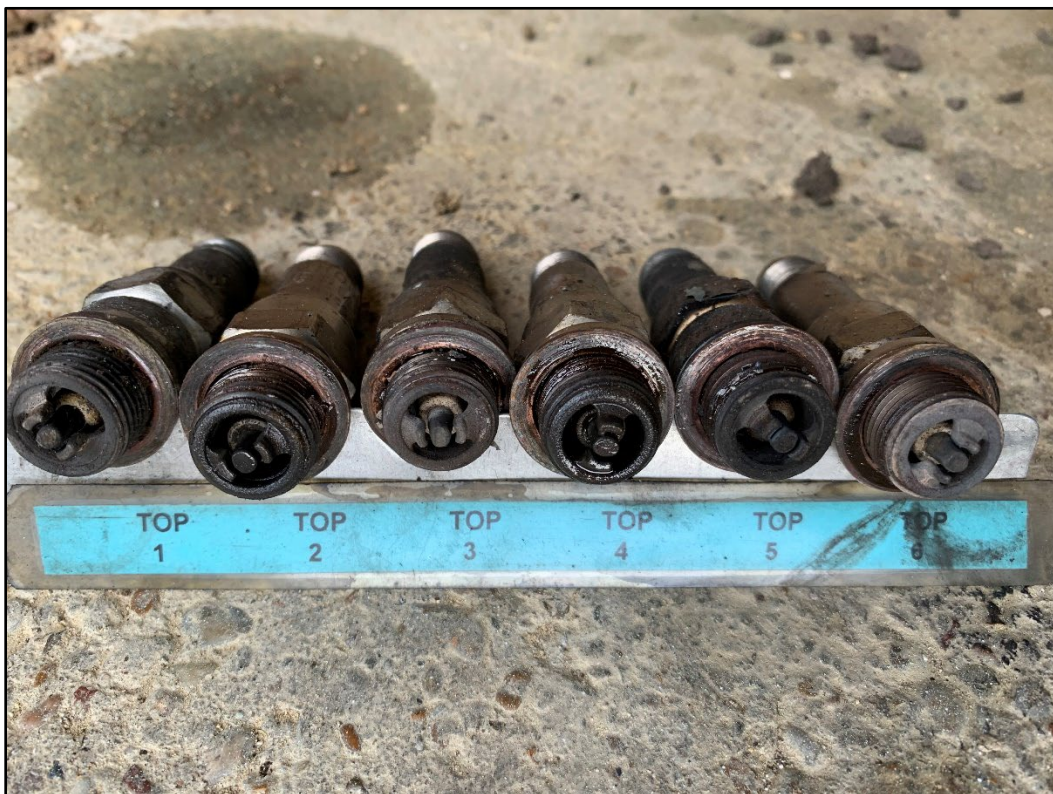
The spark plugs remained installed at each cylinder with their respective spark plug lead attached. The top spark plugs electrodes appeared mechanically undamaged and according to the Champion Spark Plugs "Check-A-Plug" Chart AV-27, and their electrodes displayed coloration consistent with normal operation, as shown in figure 26. Several spark plugs exhibited static oil soaking that was attributed to the engine positioning at the mishap site and post recovery.

**Figure 26** - Top spark plugs
