# National Transportation Safety Board

CEN21FA304

## **WRECKAGE EXAMINATION SUMMARY**

Location: Killeen, Texas  
Date: July 4, 2021  
Time: 1722 central daylight time (2222 UTC)  
Airplane: Focke-Wulf FWP-149D, Registration No. N9145

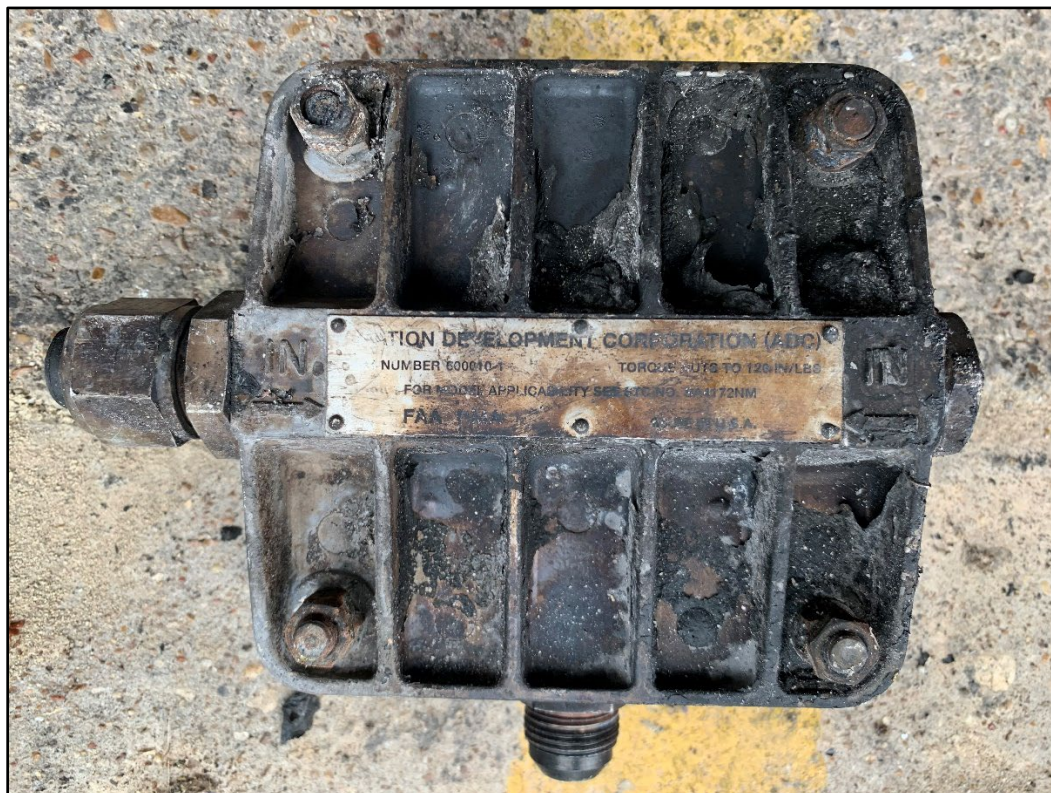
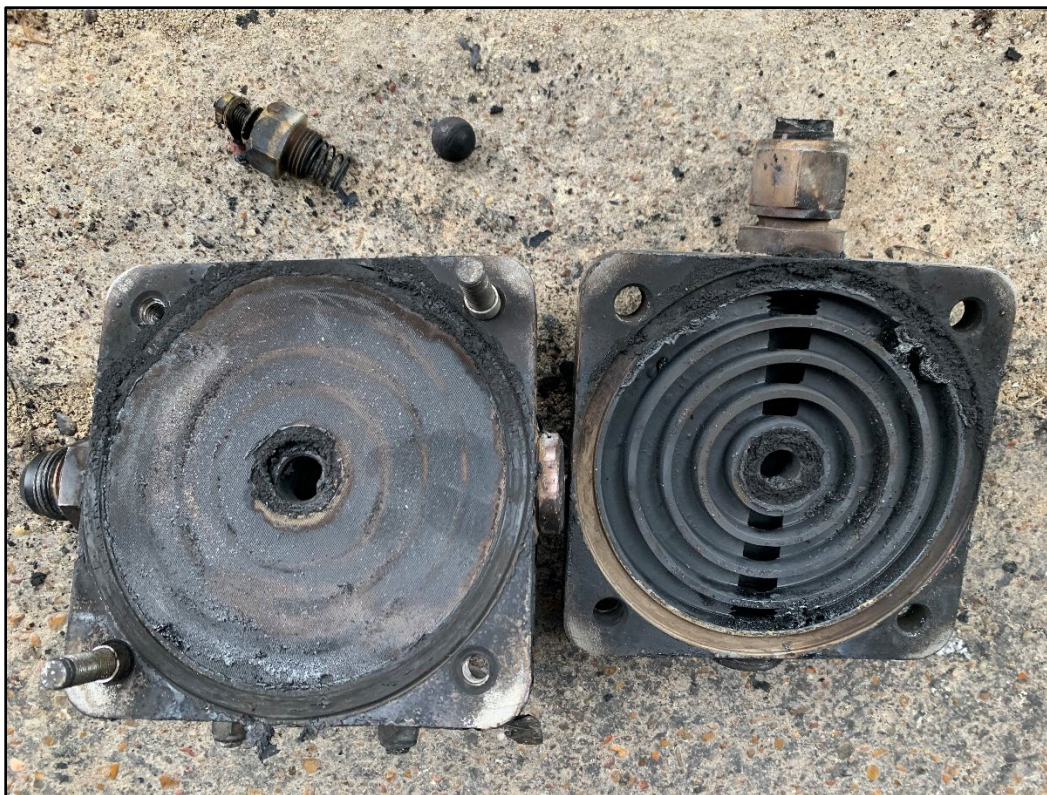
The airplane was equipped with an Aviation Development Corporation (ADC) oil filtration system, p/n 600010-1, as shown in figure 27 and figure 28. A review of product literature revealed that the oil filtration system was equipped with a ball-and-spring "bypass" switch, which when wired to a cockpit warning light offers a visual indication of when the filtration system is bypassing engine oil instead of flowing through the filter screen.

**Figure 27** - Engine oil filtration assembly, p/n 600010-1

**Figure 28** - Engine oil filtration assembly disassembled

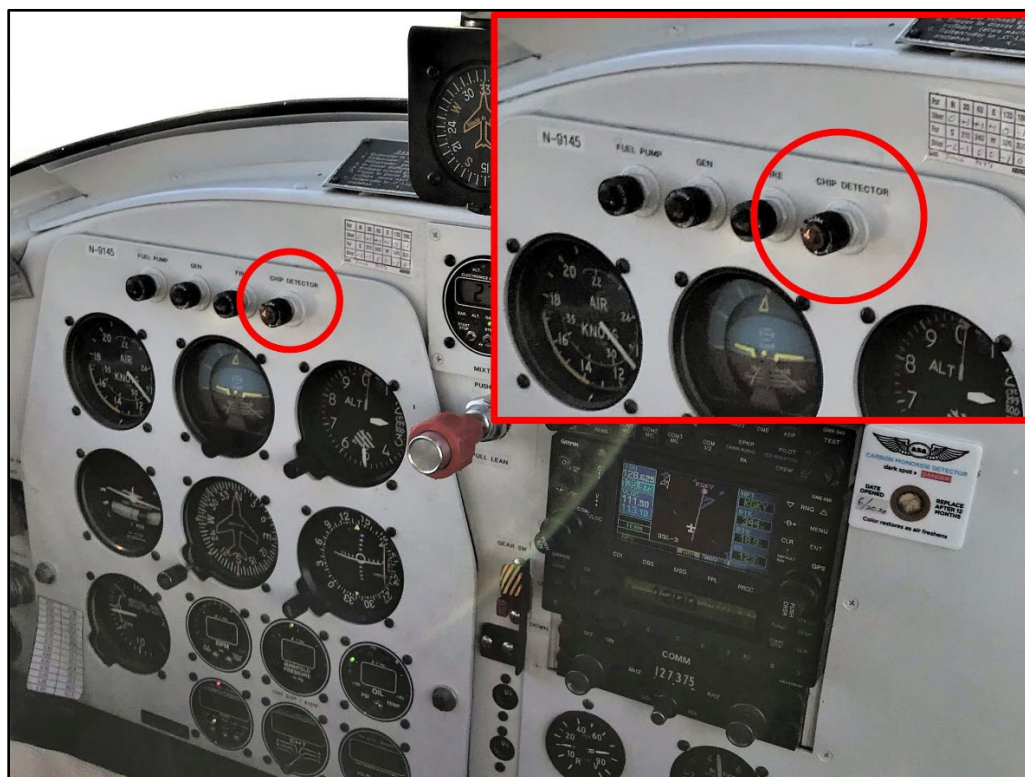
A separate magnetic chip detector was offered as an optional feature for the oil filtration system; however, postaccident examination of the oil filtration system confirmed that the optional chip detector was not installed. As such, the amber warning light installed in the instrument panel was mislabeled "chip detector", as shown in figure 29. The light was a visual indication that the oil filtration system was restricted and, as result, operating in bypass.

**Figure 29** - Instrument panel warning light mislabeled “chip detector” (original photo provided by pilot’s family; cropped and annotated by NTSB)

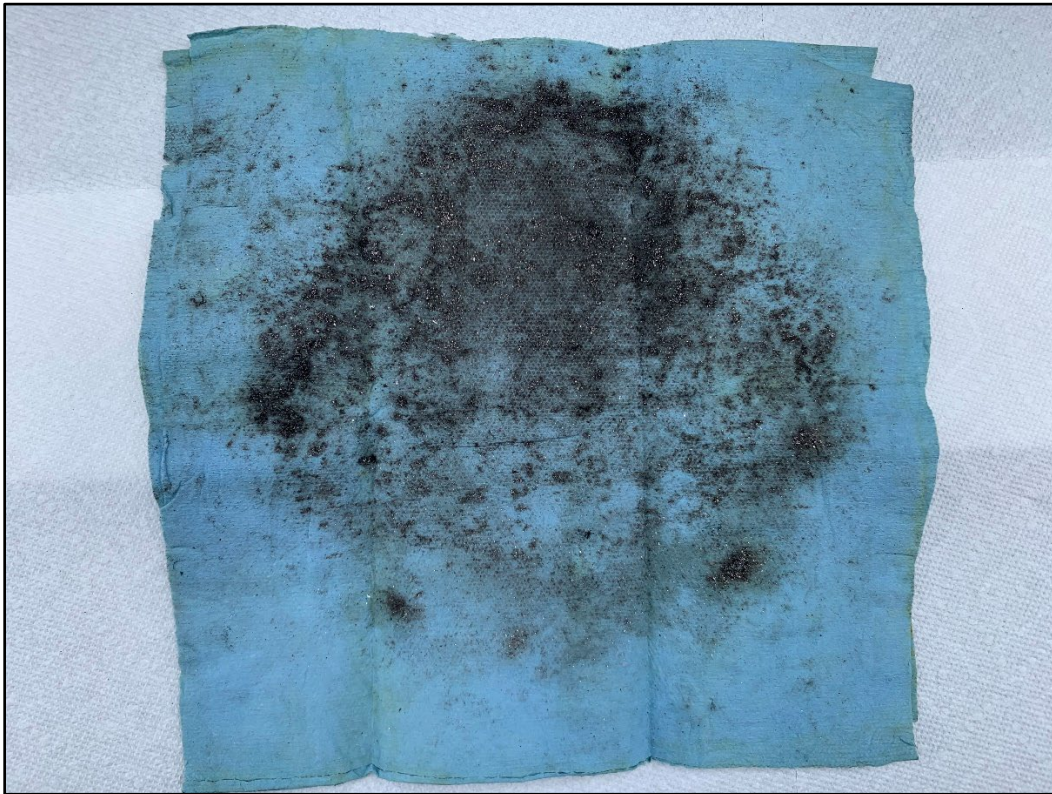
The mechanic reported that during the engine run the amber-colored "chip detector" warning light in the cockpit's instrument panel illuminated. He shut down the engine, drained the engine oil into a clean bucket, and followed the wiring associated with the "chip detector" warning light to the oil filtration system housing. Disassembly of the oil filtration device revealed metal contamination inside the filter housing and on the filtration screen.

The contamination collected from the oil filtration system by the mechanic on July 2, 2021, as shown in figure 30, was submitted to the NTSB Materials Laboratory for identification.

**Figure 30** - Contamination collected from oil filtration screen 2 days before accident
