# NATIONAL TRANSPORTATION SAFETY BOARD

## MATERIALS LABORATORY FACTUAL REPORT

Report No. 21-054

Place : Seiling, Oklahoma  
Date : 07/12/2021  
Vehicle : WSK PZL Mielec M-18A Dromader (N9310R)  
NTSB No. : CEN21FA314  
Investigator : Tim Sorenson

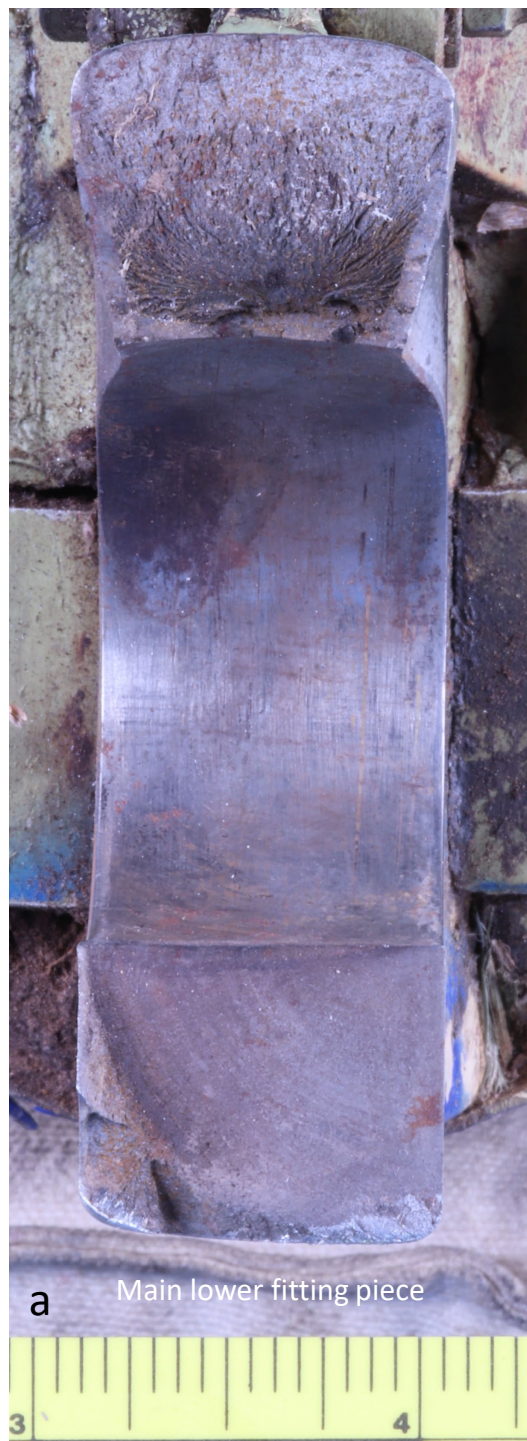
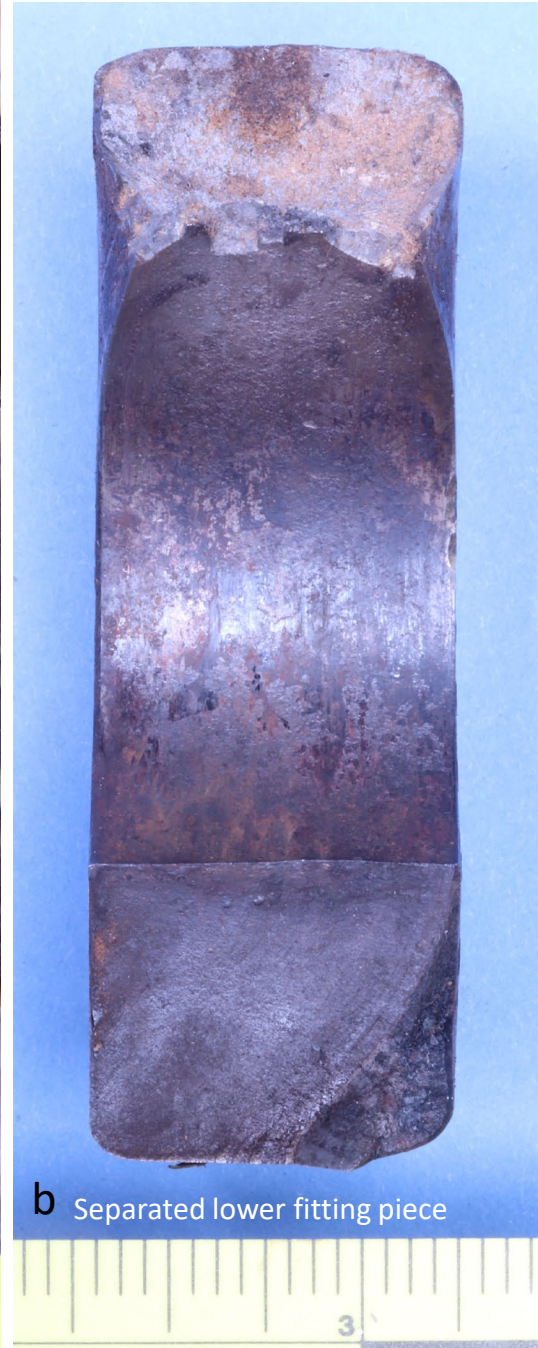
A side-by-side comparison of the fracture surfaces from the main lower attachment fitting piece and the separated lug piece is shown in Figure 11 in the as-received condition. The upper and lower attachment fitting lug fractures are identified in the figure.

Close views of the upper lug fracture surfaces on the main and separated lower attachment fitting pieces are shown in Figure 11 (see also Figure 10 for reference). These fractures occurred under Mode 1 (with minor levels of Mode 2) due to upward bending of the inboard portion of the lug after the fatigue crack in the lower lug grew to a critical size and the remaining ligament fractured via ductile overstress (see Figure 10 for annotation

Figure 11 Close views of the as-received fracture faces and bore surfaces on the lower attachment fitting and the separated lug piece. Corrosion product deposits are evident on the bore surface of the separated lower fitting piece.

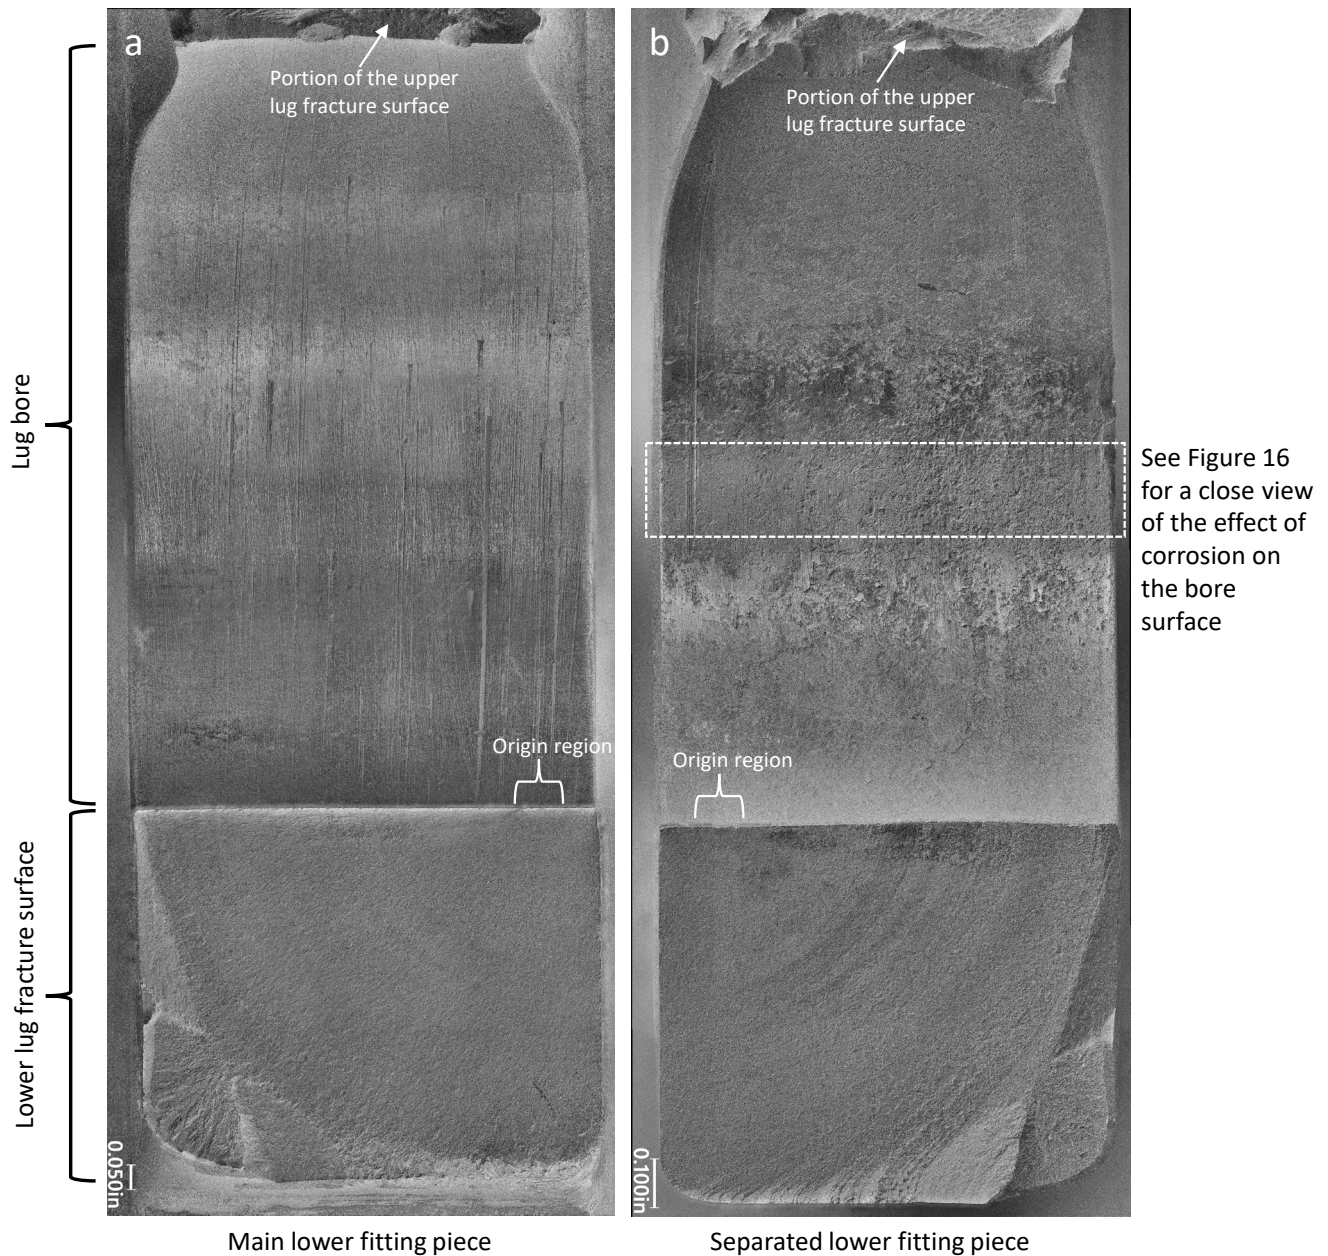
Figure 15 shows both halves of the lug bore and lower lug fracture faces imaged using a Keyence VHX-7000 digital microscope. Numerous circumferential scratches are present of varying length and depth on the bore surface of the main lower attachment fitting piece. No scratches or marks were observed across the width of the bore on either lower attachment fitting piece. The bore surface on the separated lower attachment fitting piece exhibited a dark and rough surface consistent with corrosion product deposits. A higher magnification image is shown in Figure 16. Macrofractographs of the fracture surfaces on both halves of the lower lug are shown in Figures 17-20. Using a digital microscope with HDR imaging and oblique lighting, the macrofractographs in Figure 17 were taken<sup>2</sup>. Key fracture features are annotated in Figure 18a on the same images as Figure 17a. Fractographic features such as crack progression marks and ratchet marks reveal that a fatigue crack developed at an origin on the bore surface centered about 0.12 inch from the forward side of the lower lug. At its longest length, the fatigue crack propagated about 0.80 inch (see Figure 36) before the remaining ligament fractured in ductile overstress. The ratchet marks at the origin region were associated with corrosion pits on the bore surface.

Figure 15 Digital microscope monochromatic images of the lug bore and lower lug fracture surfaces for both halves of the fractured lower attachment fitting. The lower lug fracture surfaces exhibit crack progression marks and a fine thumbnail region at the fracture origin. The surface of the bore on the separated lower fitting piece exhibited corrosion product scale and pits (a higher magnification view is shown in Figure 16).

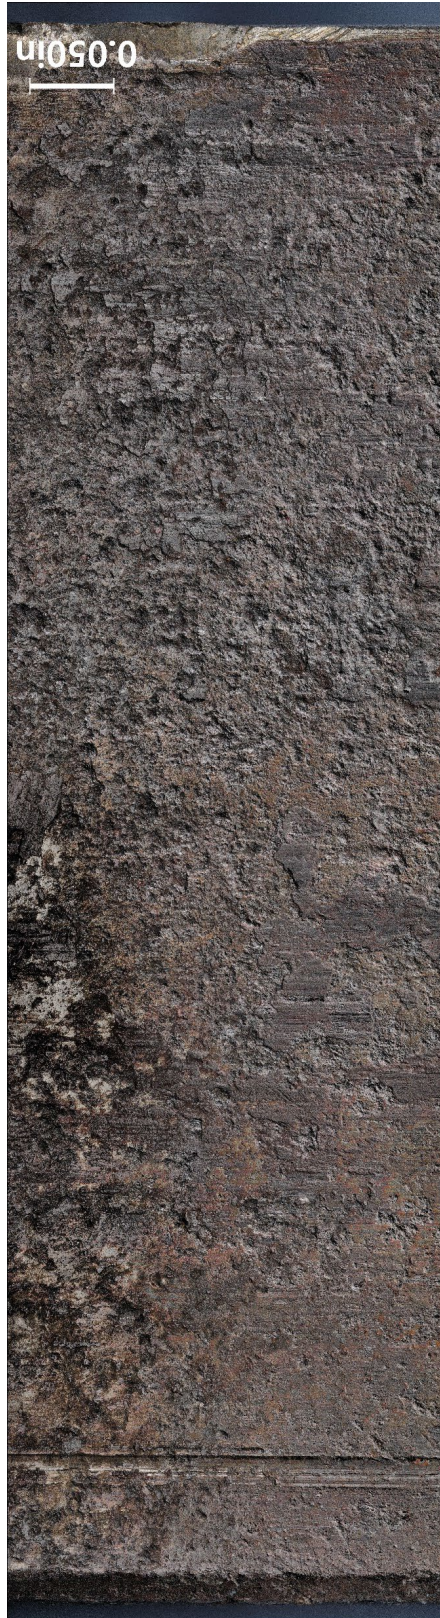
Figure 16 Digital microscope view across with width of the lug bore for the separated lower fitting piece (see Figure 15 for location) revealing corrosion product scale and pits. A circumferential score mark is also present.

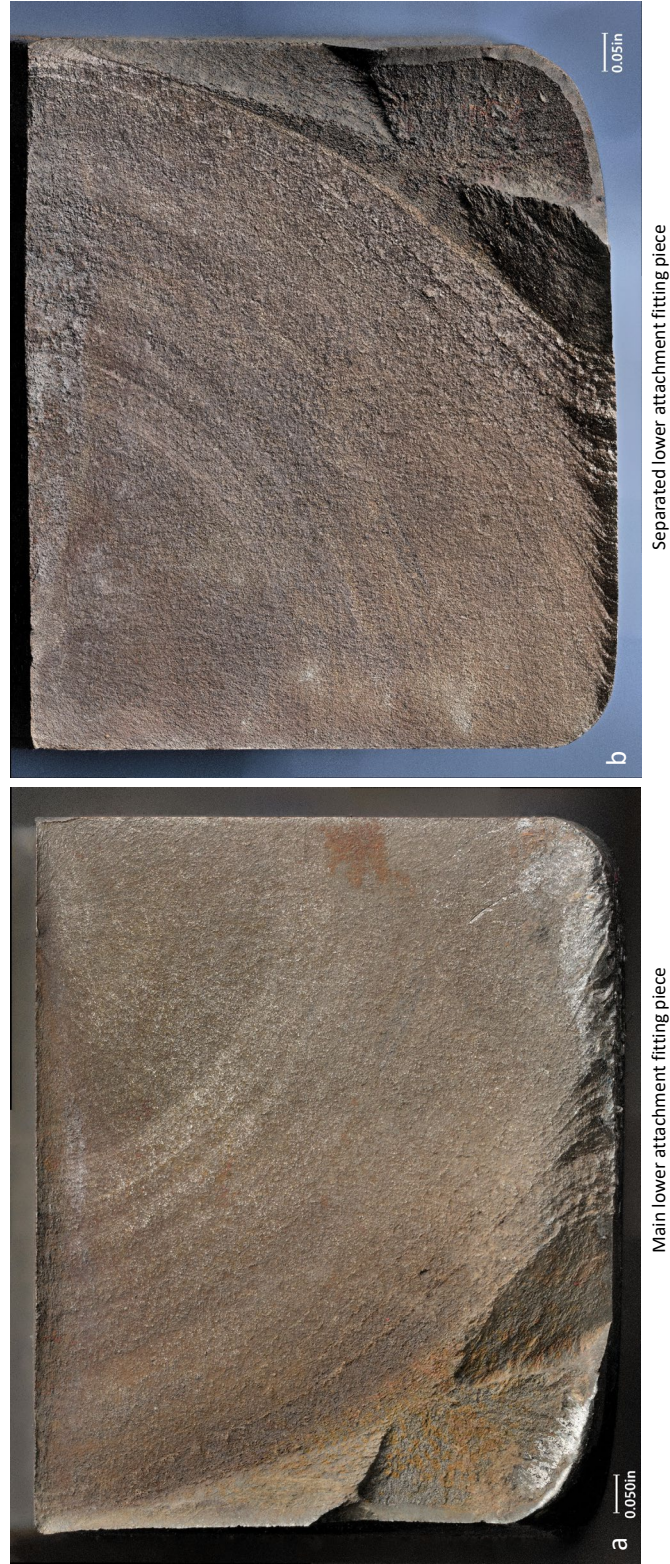
Figure 17 Digital microscope images of both halves of the lower lug fracture surfaces (see Figure 18 for the same images with annotations). The images were acquired under HDR imaging conditions with oblique lighting.

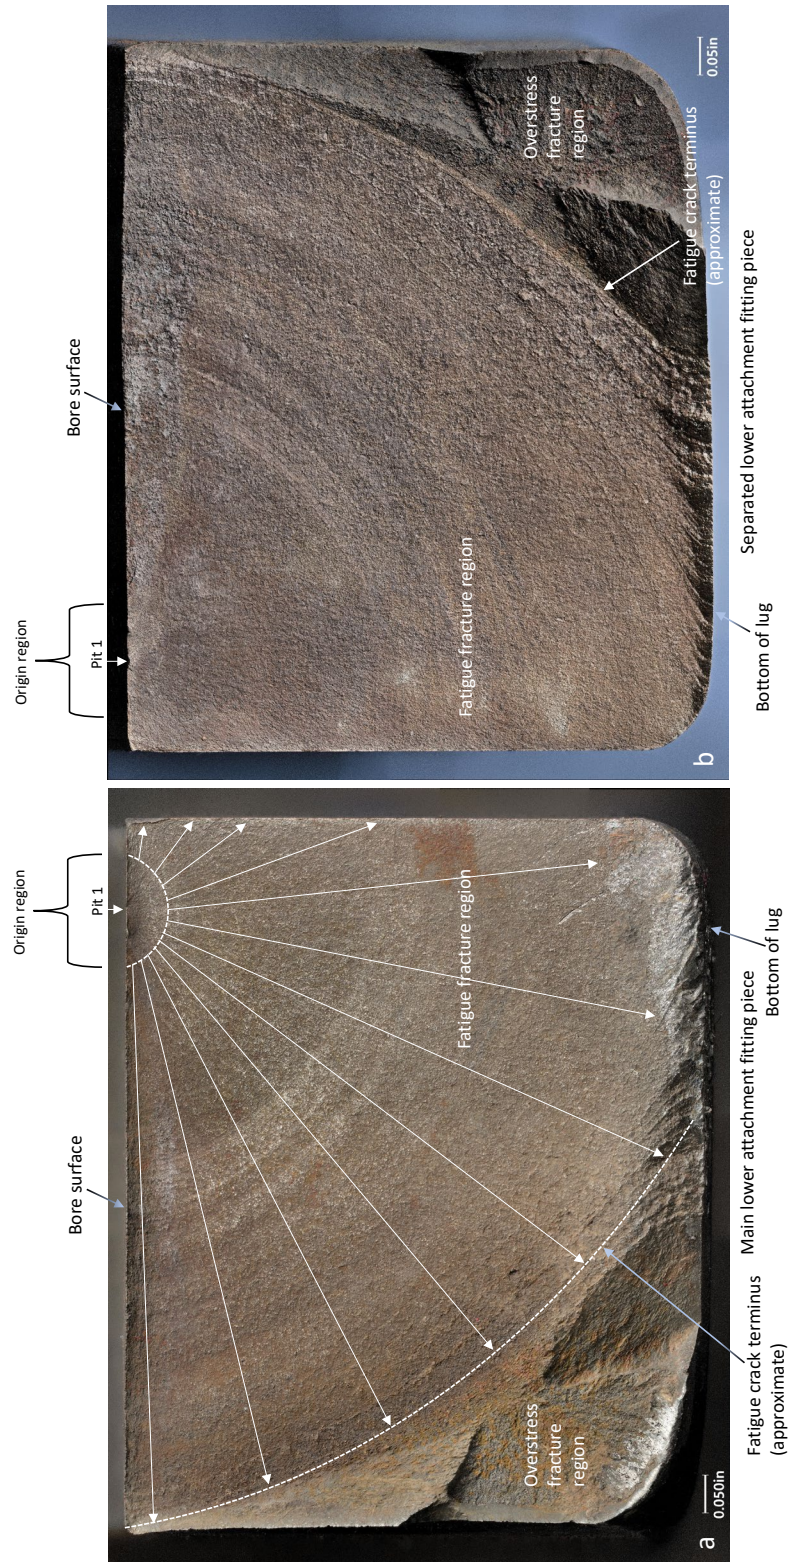
Figure 18 Digital microscope images of both halves of the lower lug fracture surfaces with annotations to identify key features on the fracture surfaces (same images as Figure 17 but with annotations). The images were acquired under HDR imaging conditions with oblique lighting.

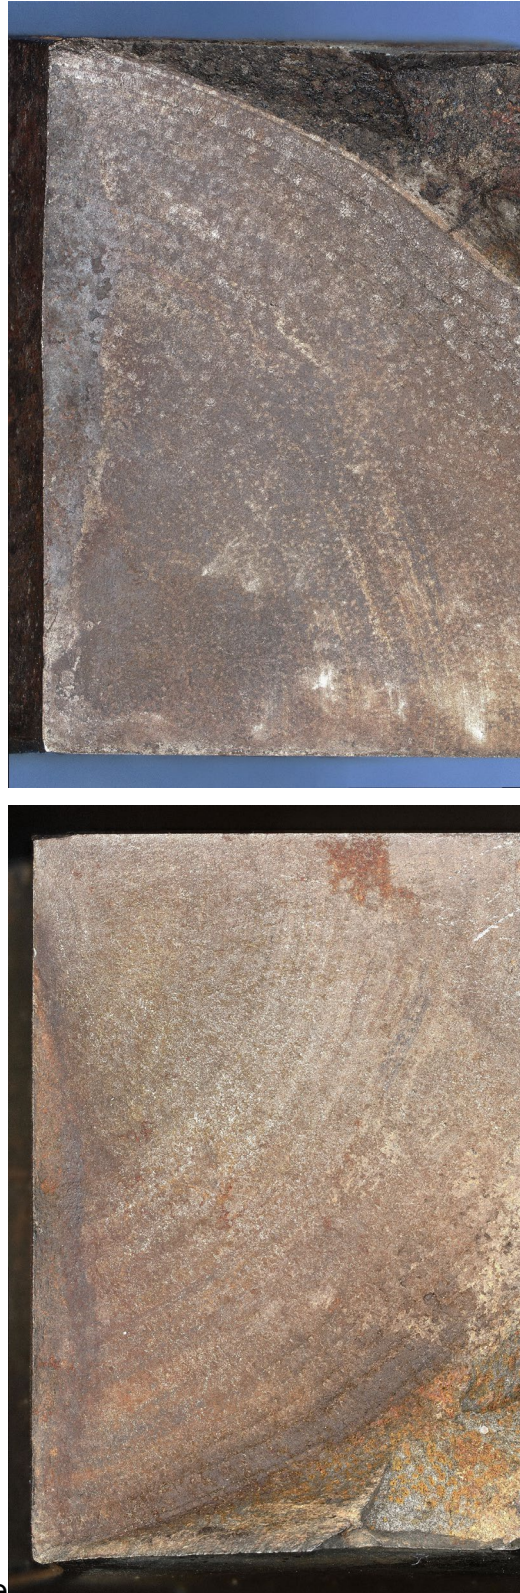
Using a digital microscope in the normal imaging mode, the macrofractographs in Figure 19 were acquired on both halves of the lower lug fractures. The images reveal stains on the fracture surfaces immediately below and parallel to the surface of the bore (see Figure 20 for annotations on the image in Figure 19). An area within the stain was evaluated on the separated lower attachment fitting piece (after acetone cleaning) using a scanning electron microscope (SEM) with an energy dispersive spectrometer (EDS). Features associated with the stain on the fracture surface are documented in Figures 20b through 23. The stain comprises continuous and flake-like deposits that occlude the fracture features. Exemplar flakes or clumps are identified in Figure 23 and the associated EDS spectra are shown in Figure 24. The composition of the clump deposits is consistent with ferrous corrosion product. In Figure 25, an SEM fractograph just outside the stained area (see Figure 20b for location) reveals fractographic features covered with a thin, continuous deposit consistent with ferrous corrosion products.

Figure 19 Digital microscope images of both halves of the lower lug fracture surfaces showing a stained region just below the bore (see Figure 20 for the same images with annotations). The images were acquired under normal imaging conditions with oblique lighting.

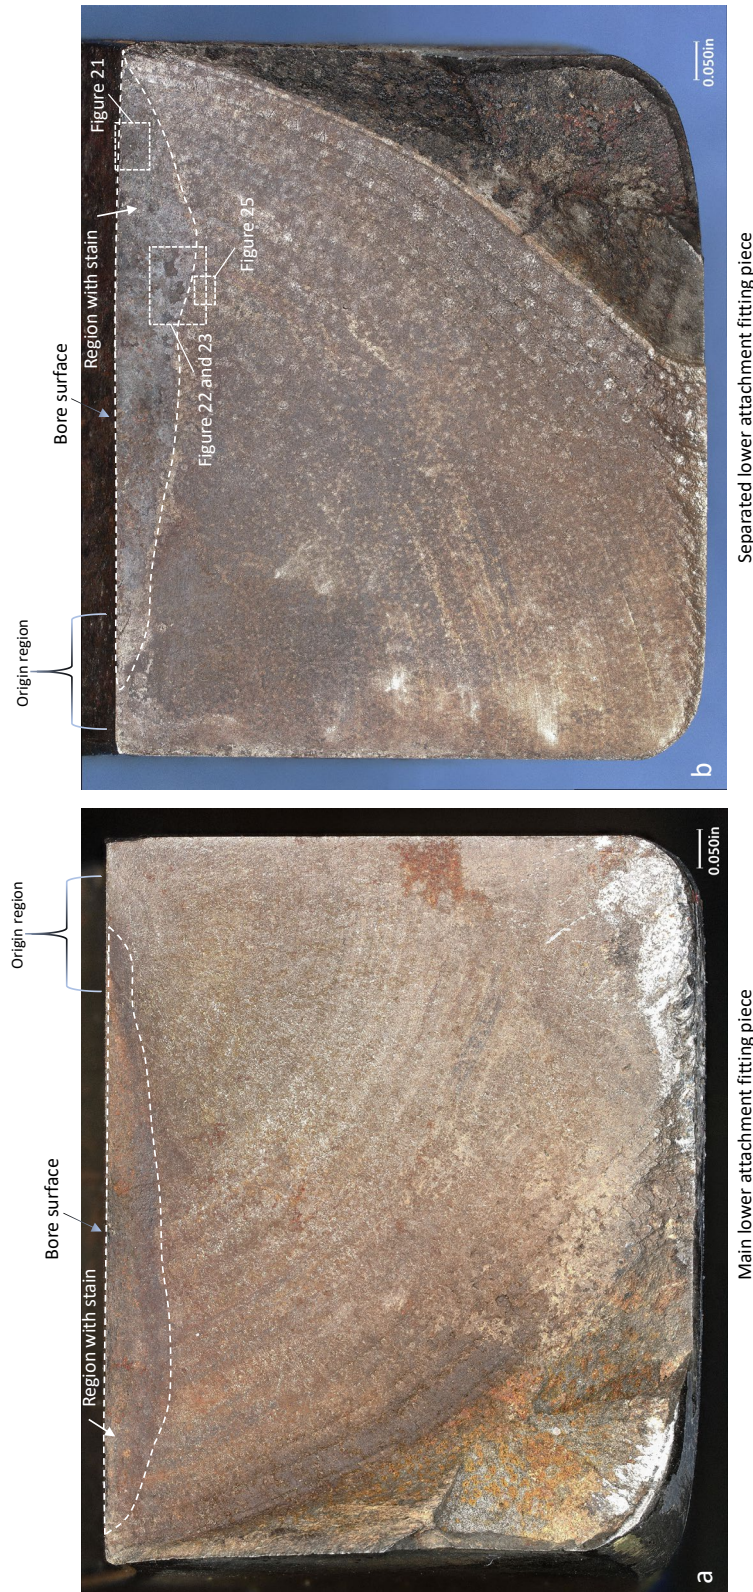
Figure 20 Digital microscope images of both halves of the lower lug fracture surfaces showing a stained region just below the bore with annotations (same images as Figure 19 but with annotations). The images were acquired under normal imaging conditions with oblique lighting.

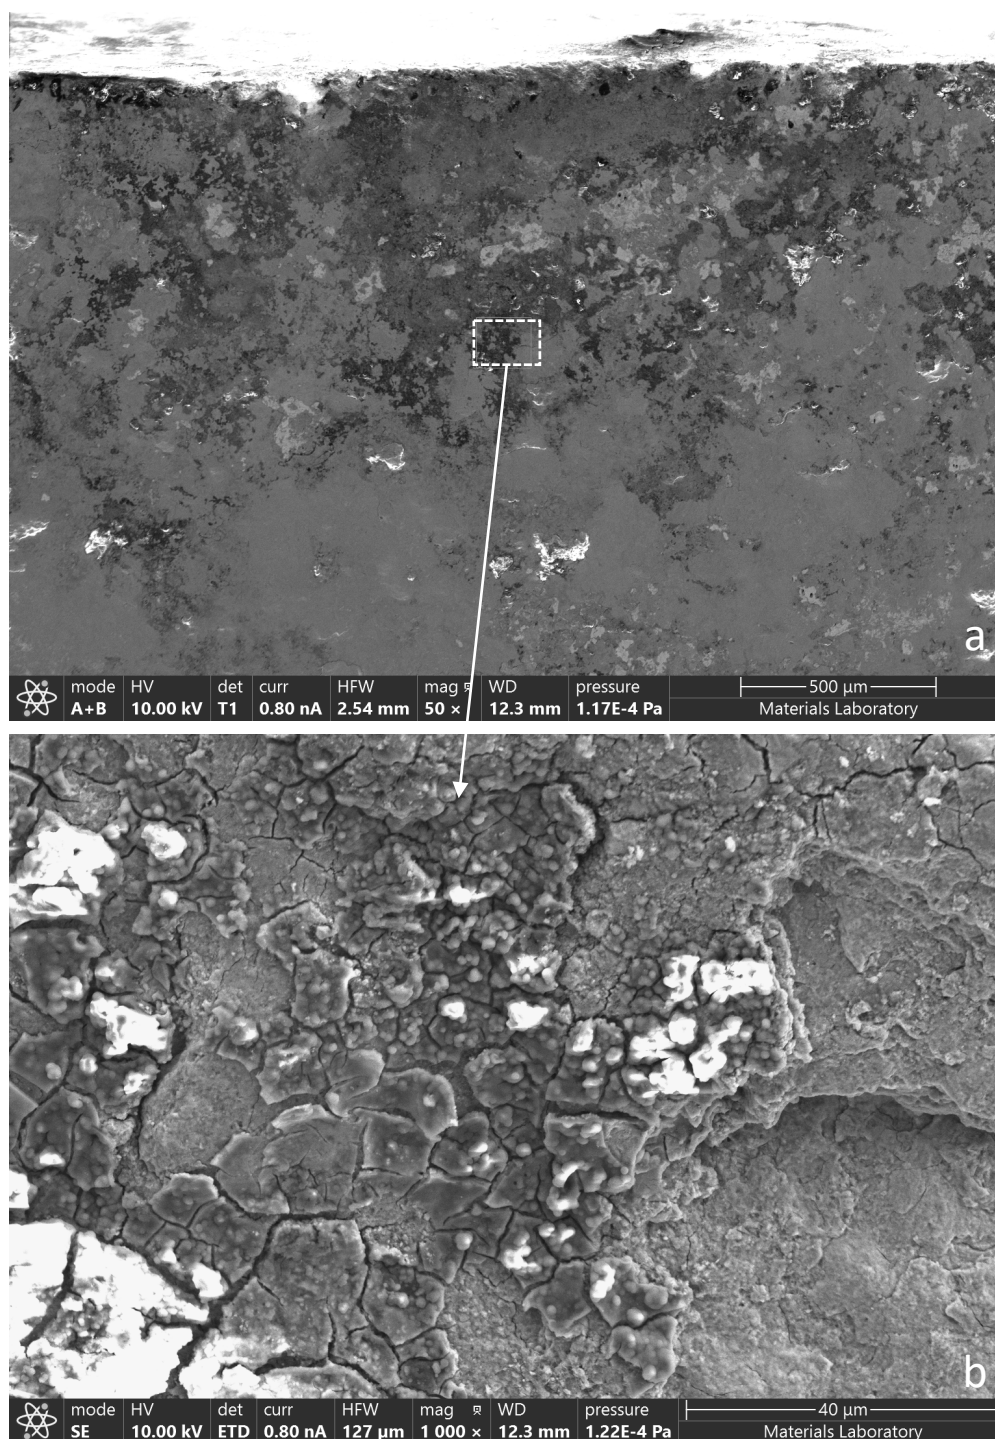
Figure 21 SEM images of the stained region on the fracture surface (see Figure 20 for location). View a is a lower magnification image showing the general morphology of the corrosion product scale. View b is a higher magnification image that shows the corrosion product scale morphology. The thickness of the scale occludes the fine fractographic features on the fracture surface.

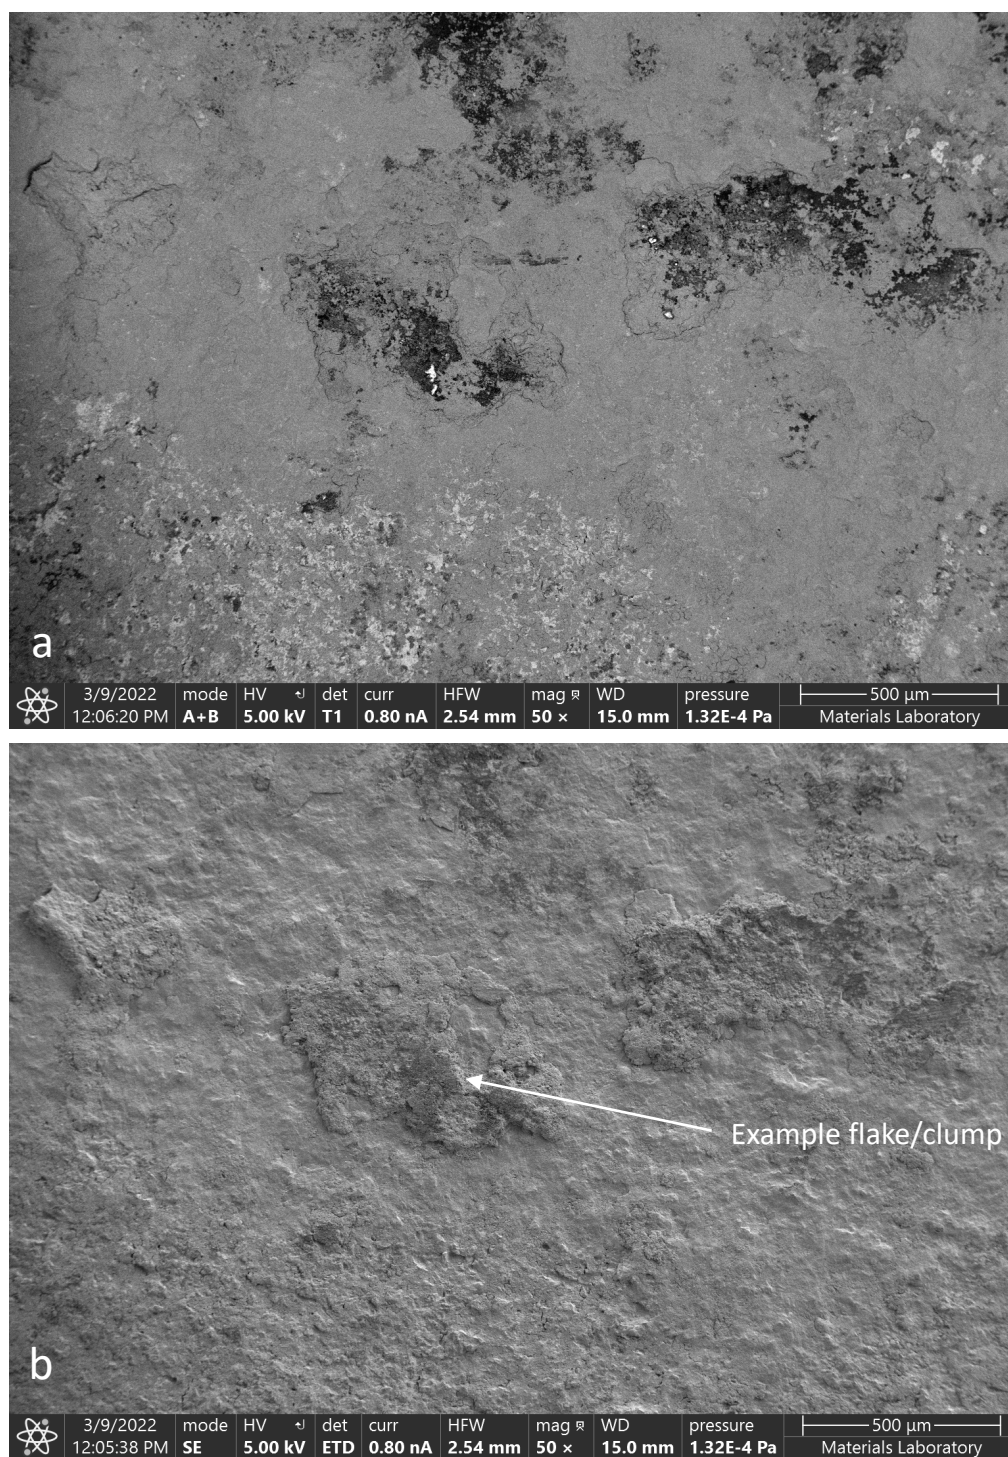
Figure 22 General SEM image of corrosion product with a thick clump or flake morphology. EDS analysis was performed on the central clump as documented in Figures 23 and 24.

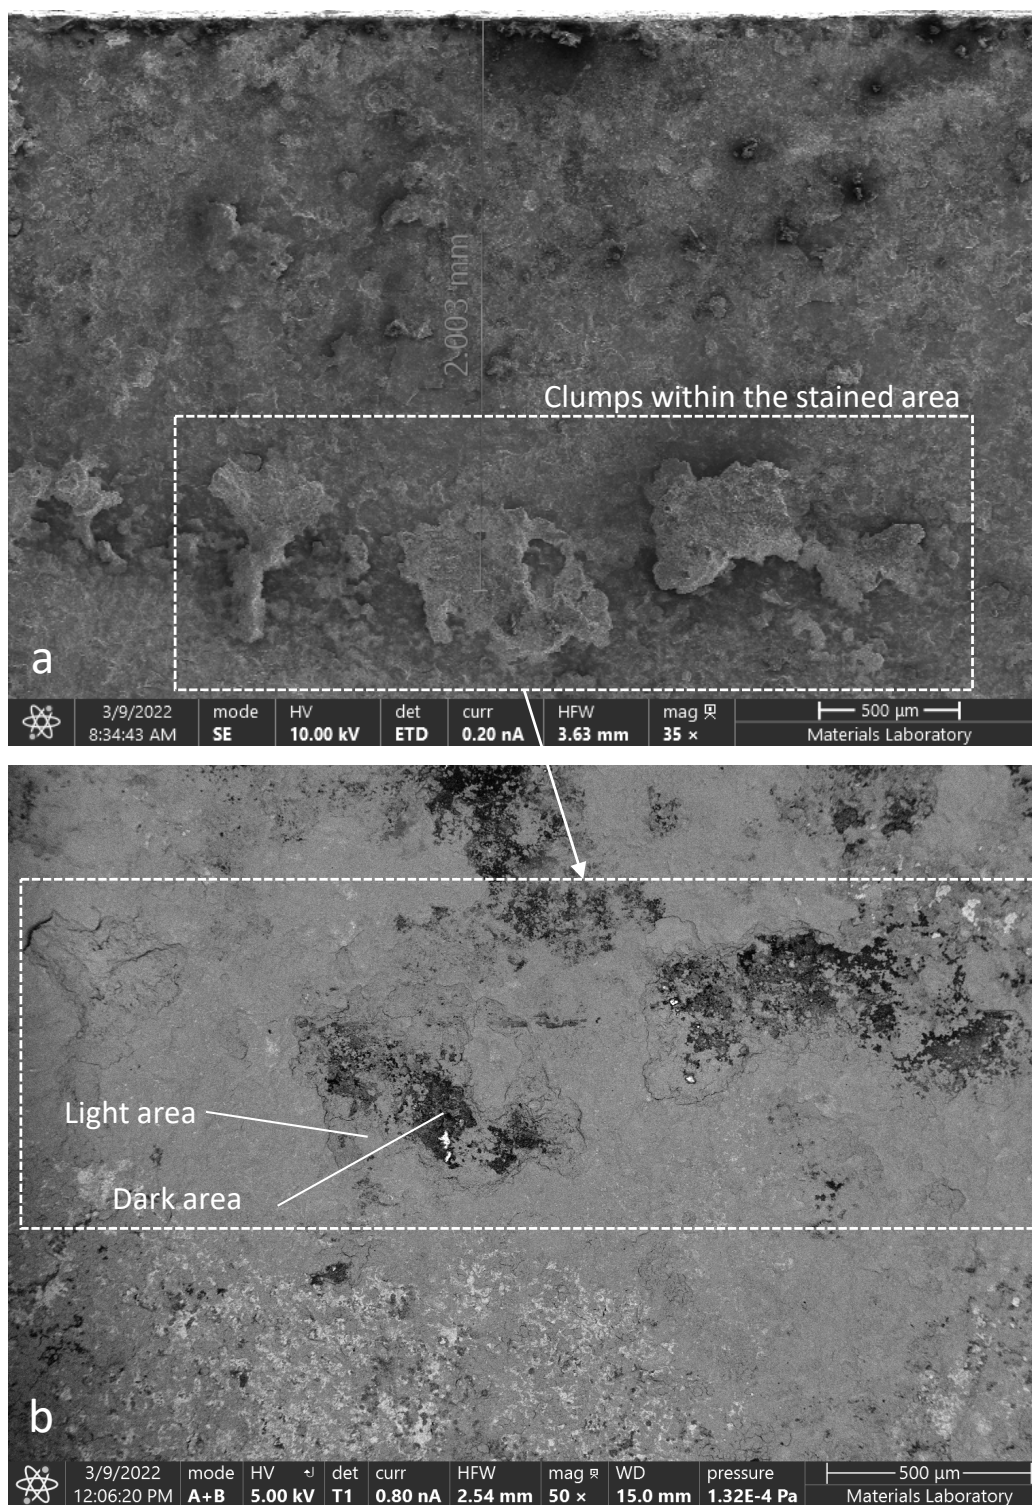
Figure 23 SEM images of the exemplar flakes or clump corrosion product deposits identified in Figure 22. View a is a secondary electron image and view b a mixed backscattered electron image. EDS spectra for the areas identified in view b are shown in Figure 24.

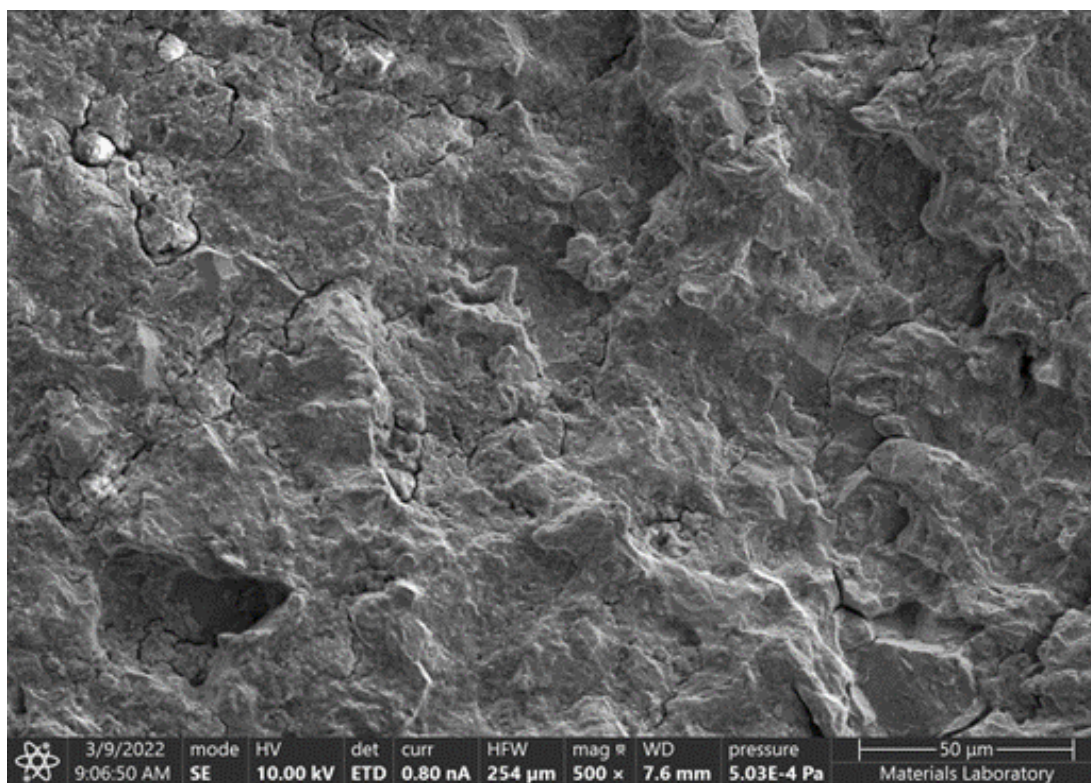
Figure 25 Close SEM view of the as-received fracture surface (after cleaning in acetone) for the area identified in Figure 20b. This fractograph, which is immediately below the stained region identified in Figure 20b, reveals a thin layer or deposit that occludes fine fractographic features.

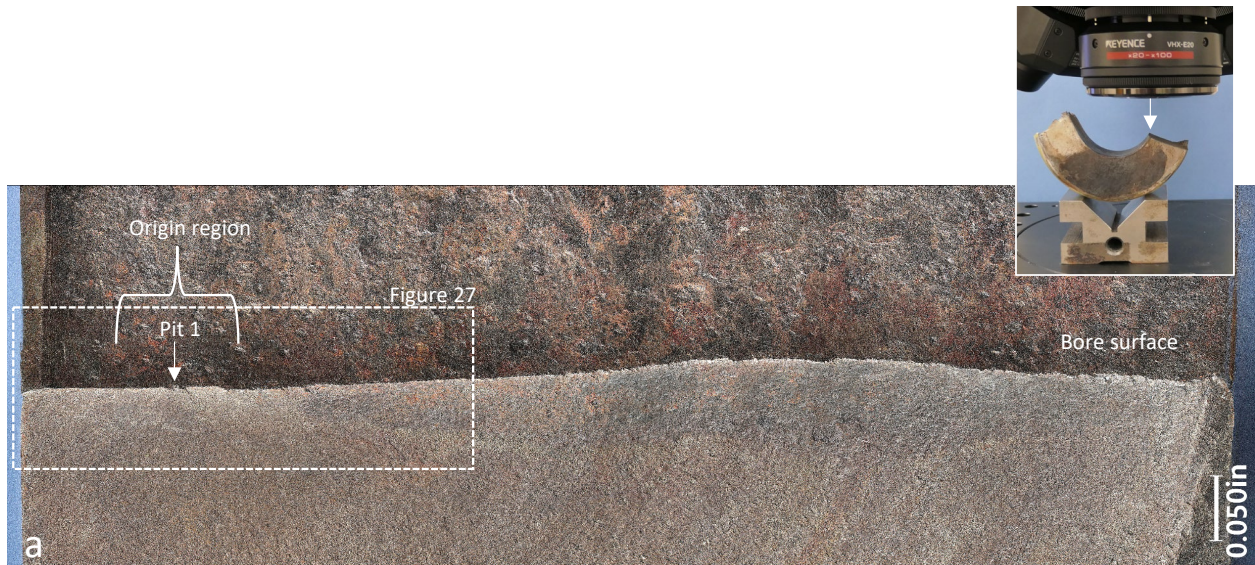
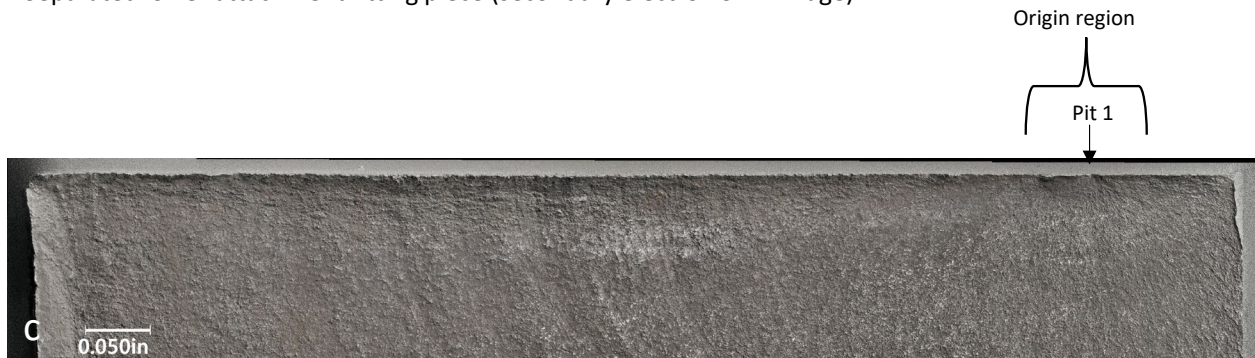
Macrofractographs of the fatigue fracture origin region on the lower lugs are shown in Figures 26 and 27 (the separated lower attachment fitting piece has been acetone-cleaned). As indicated in the figure, ratchet marks at pits in the bore surface are in the origin region. An SEM image of the fatigue crack origin region on the separated lower attachment fitting piece is shown in Figure 28. Three observed pits near the origin region are identified as Pit 1, Pit 2, and Pit 3. As will be documented later in the report, the fracture origin is at Pit 1. Higher magnification SEM images of the pits are shown in Figures 29-31. Pit 1 was examined using EDS and its elemental composition was compared with the elemental composition of an exemplar spot on the main fracture

Figure 26 Close images of both halves of the fracture surfaces just below the lug bore (full width of the lug in the as-received acetone-cleaned condition). Observations of pits and ratchet marks at the fatigue crack origin region are identified in the images. Crack progression marks are present in the images. Closer images of the origin region for the separated lower fitting piece are shown in Figure 27.

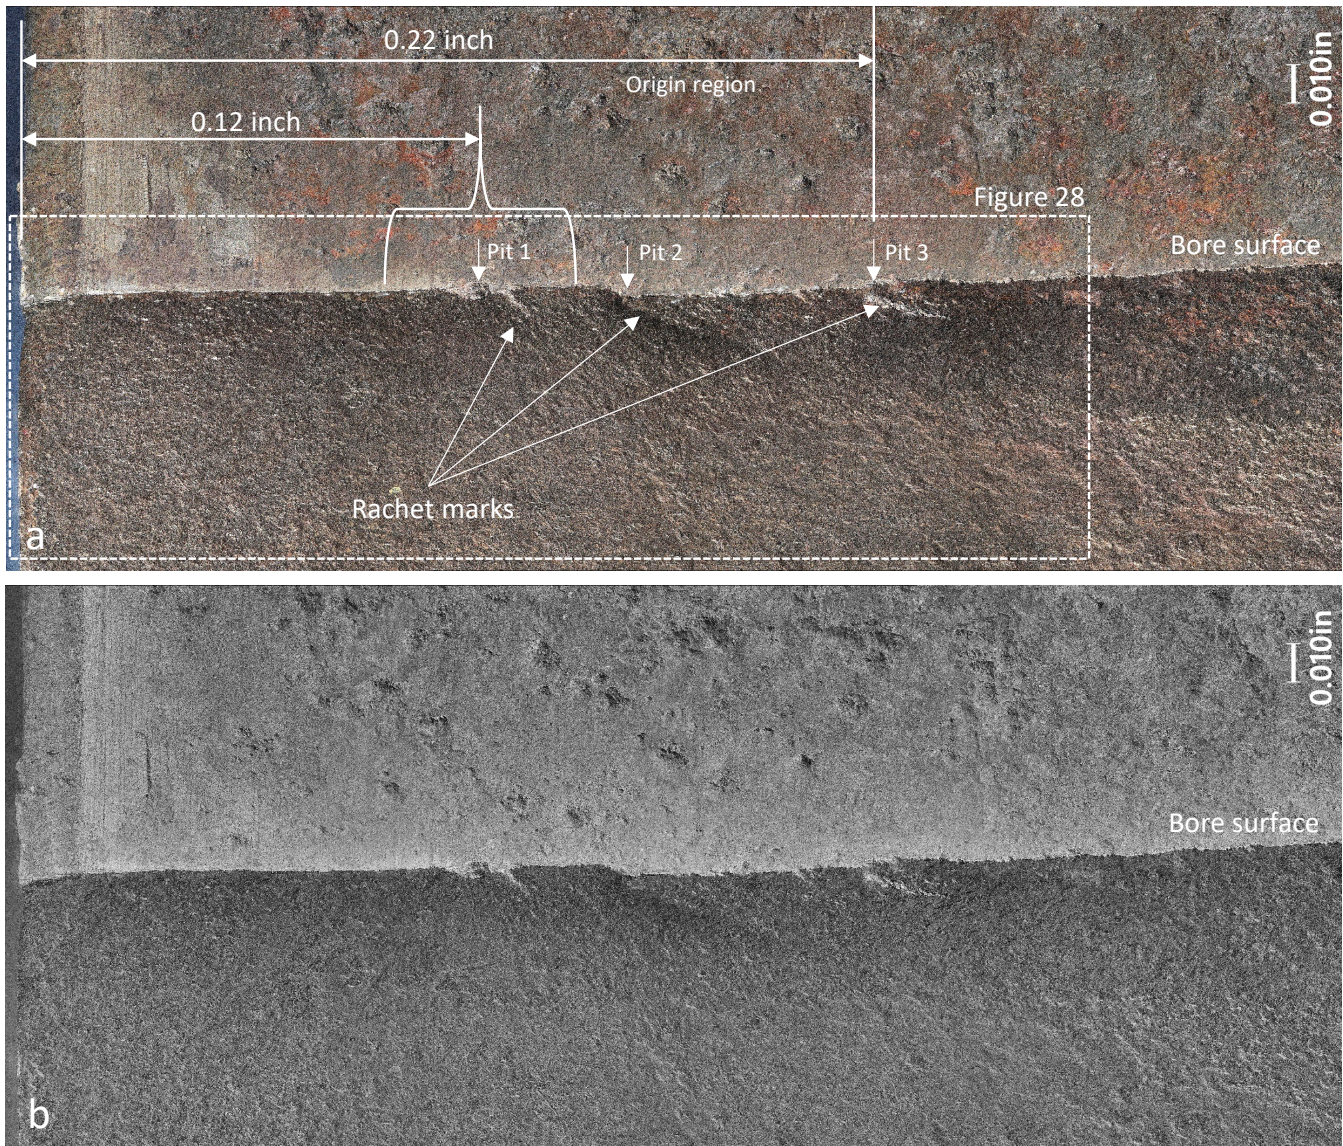
Figure 27 Higher magnification digital microscope images of the of the fatigue crack origin region on the separated lower attachment fitting piece (as-received acetone-cleaned condition). In view a, the location of several pits and associated ratchet marks are indicated (image taken under HDR with oblique lighting). View b is the same image as view a but under monochromatic conditions.

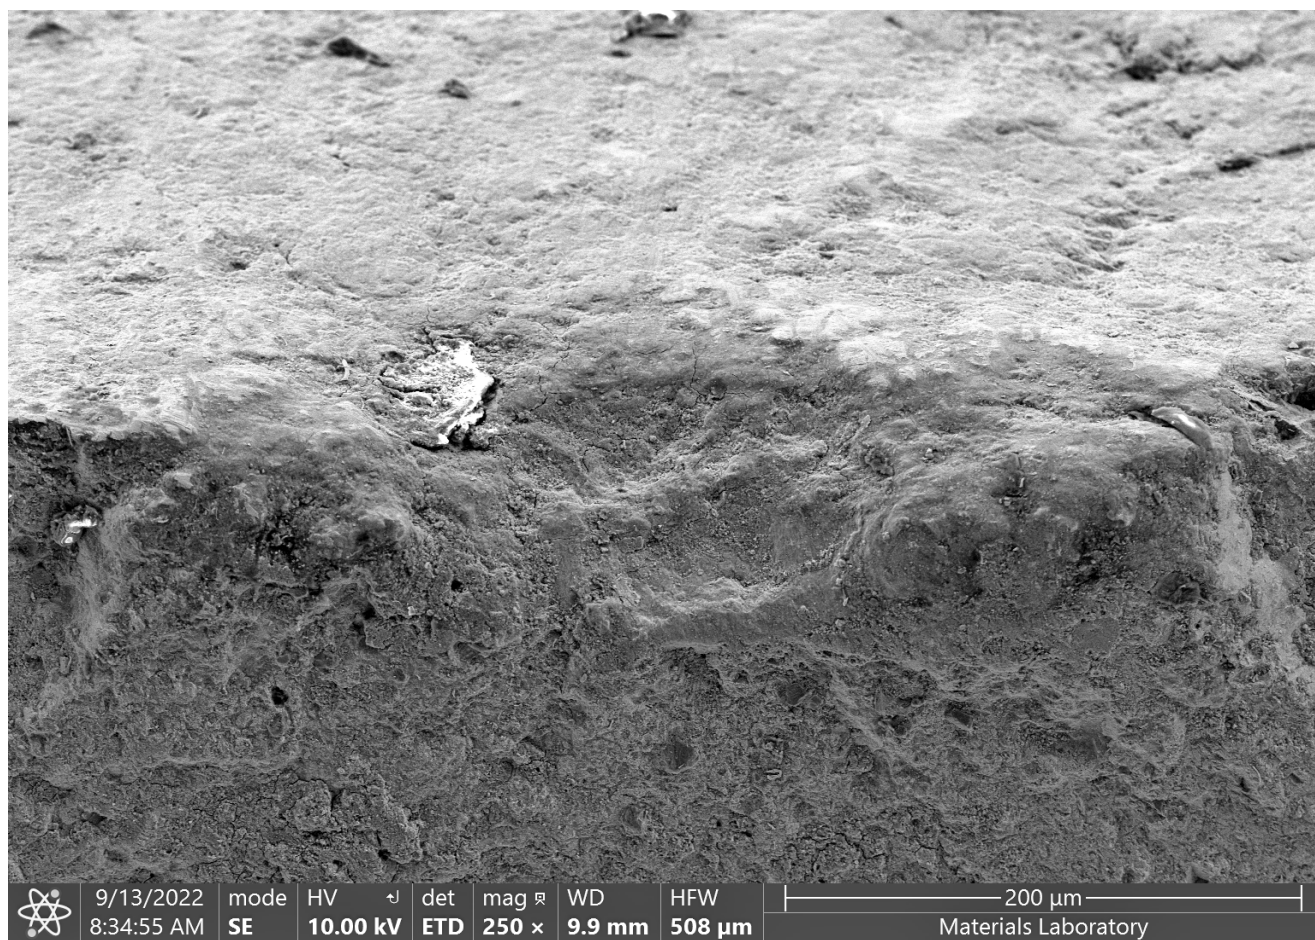
Figure 29 Secondary electron SEM micrograph of Pit 1 (see Figure 28) after cleaning in acetone. Corrosion product is present on all the surfaces, occluding the underlying surface features.

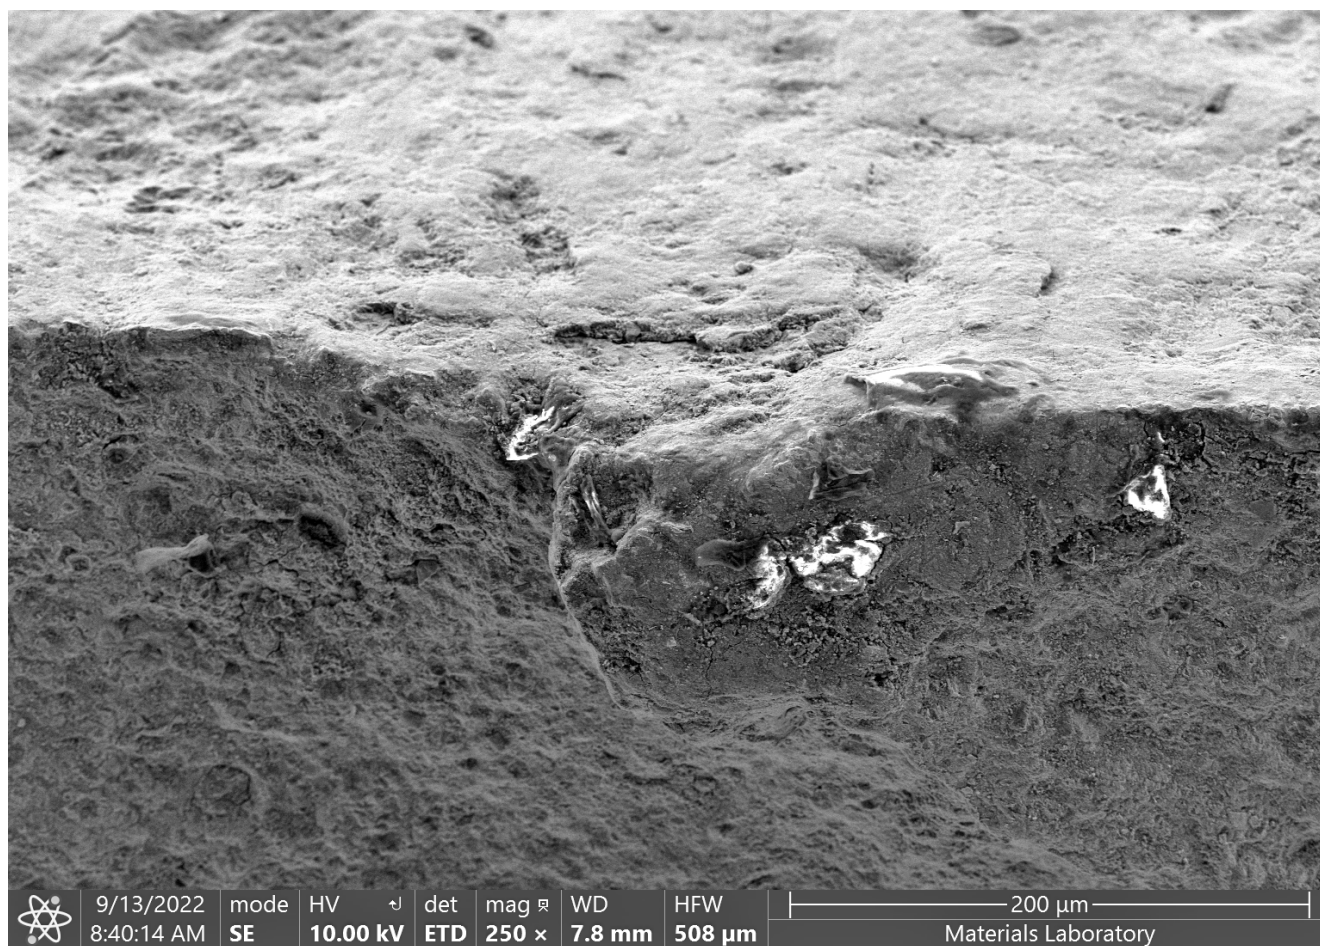
Figure 30 Secondary electron SEM micrograph of Pit 2 (see Figure 28) after cleaning in acetone. Corrosion product is present on all the surfaces, occluding the underlying surface features.

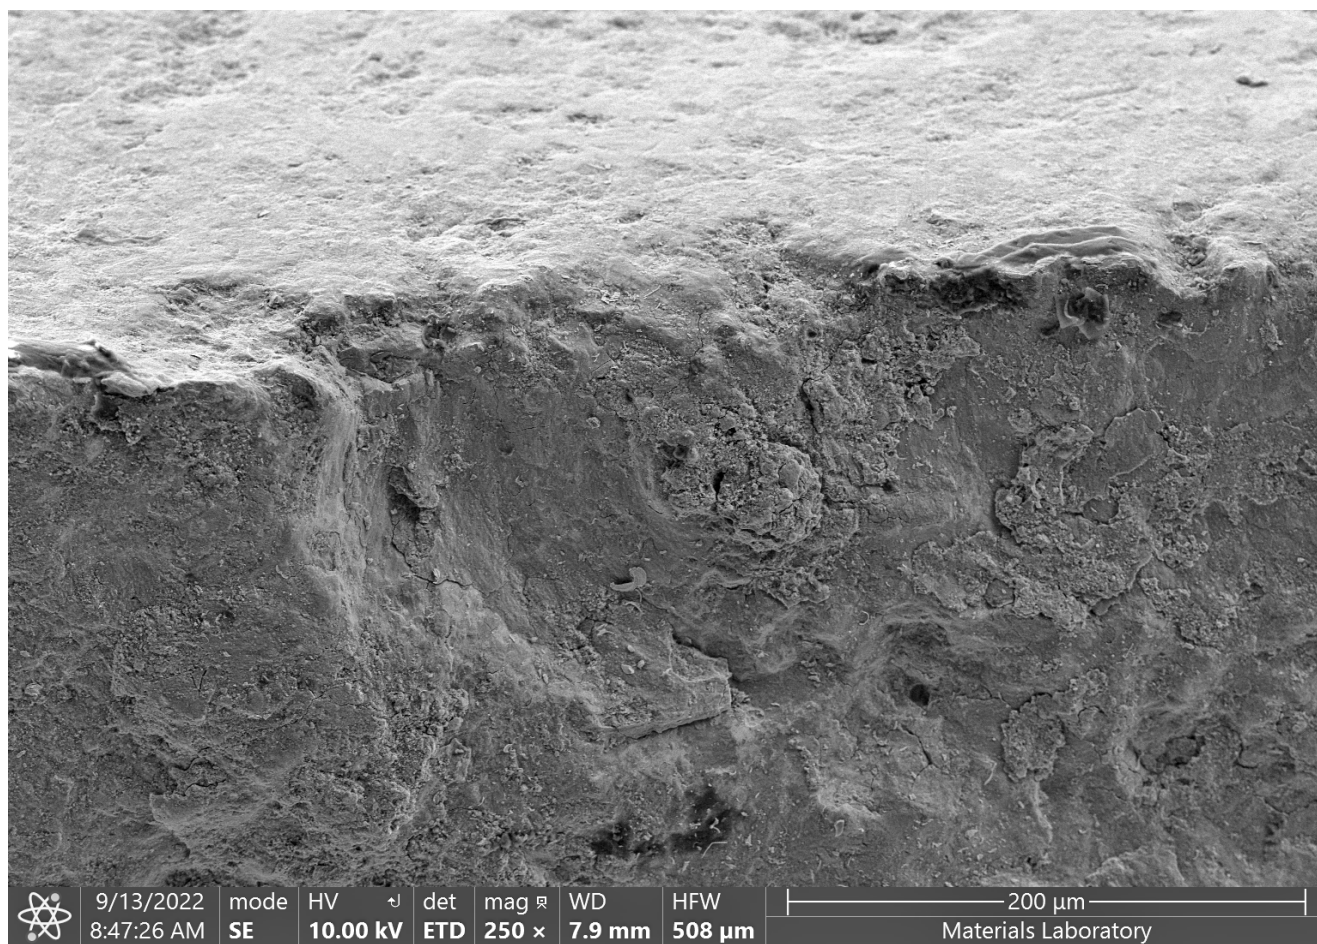
Figure 31 Secondary electron SEM micrograph of Pit 3 (see Figure 28) after cleaning in acetone. Corrosion product is present on all the surfaces, occluding the underlying surface features.
