# NATIONAL TRANSPORTATION SAFETY BOARD

## MATERIALS LABORATORY FACTUAL REPORT

Report No. 21-054

Place : Seiling, Oklahoma  
Date : 07/12/2021  
Vehicle : WSK PZL Mielec M-18A Dromader (N9310R)  
NTSB No. : CEN21FA314  
Investigator : Tim Sorenson

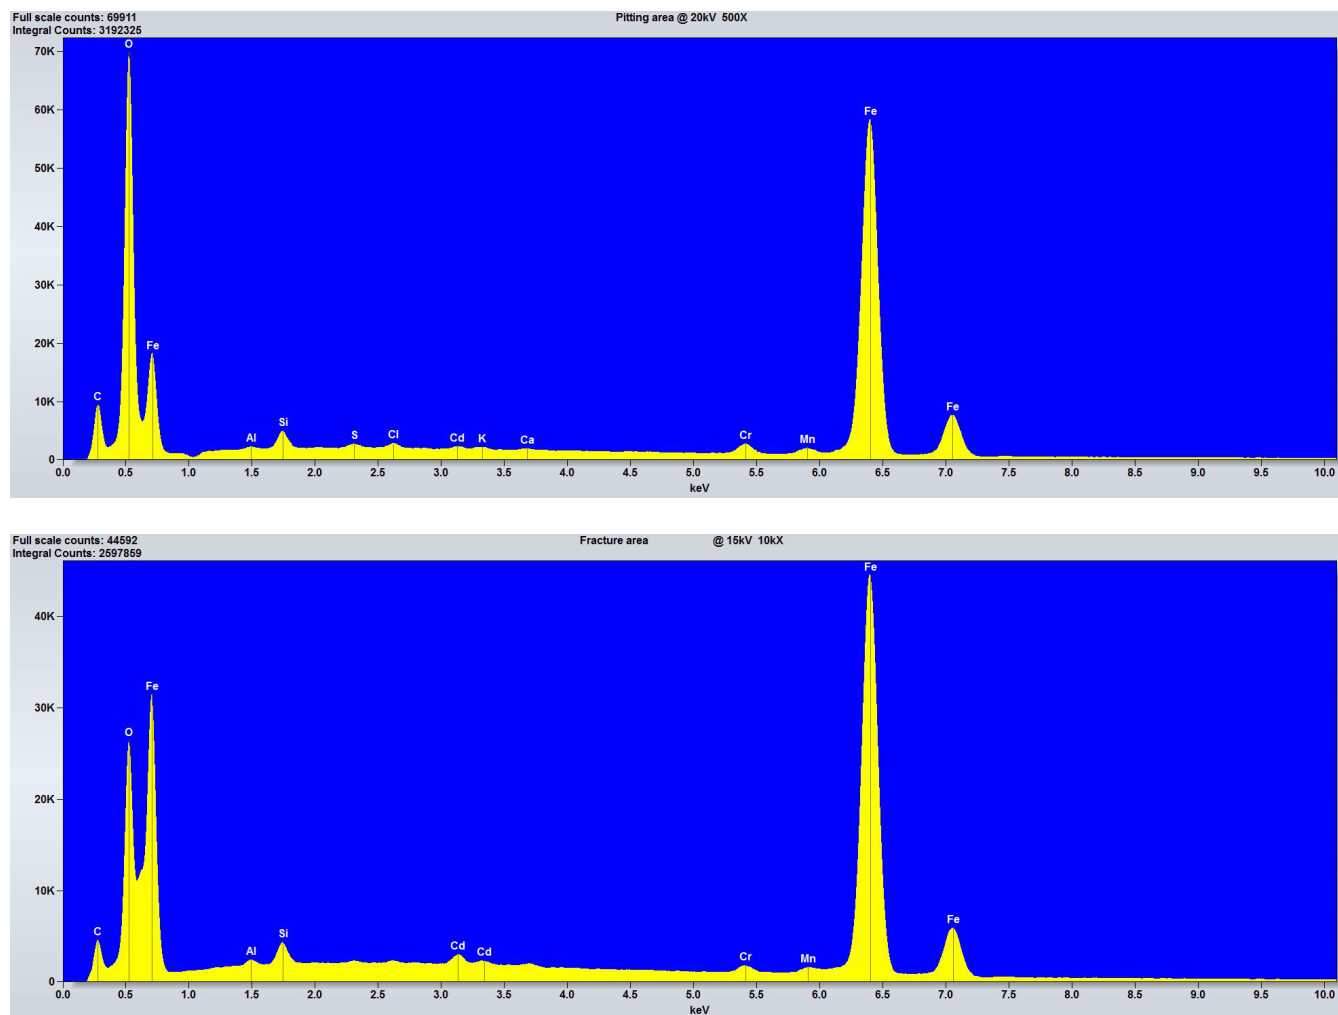
surface. The spectra are shown in Figure 32 and summarized in Table 1. The composition of deposits in the pit and on the fracture surface are consistent with steel corrosion products. The observed iron, manganese, silicon, and chromium are constituents in the attachment fitting base metal and cadmium is used as an external protective coating. The sulfur, chlorine, potassium, calcium, and aluminum in the pit are from exogenous sources but are consistent with salts or compounds encountered in crop dusting environments. The elevated oxygen and iron concentrations in the pit and on the fracture surface are consistent with iron corrosion product. Carbon may be present in both sample areas as it is present in the base metal and may be present due to its adventitious nature.

Figure 32 EDS spectra acquired from a sample area within Pit 1 and on the fracture surface of the as-received separated lower attachment fitting piece.

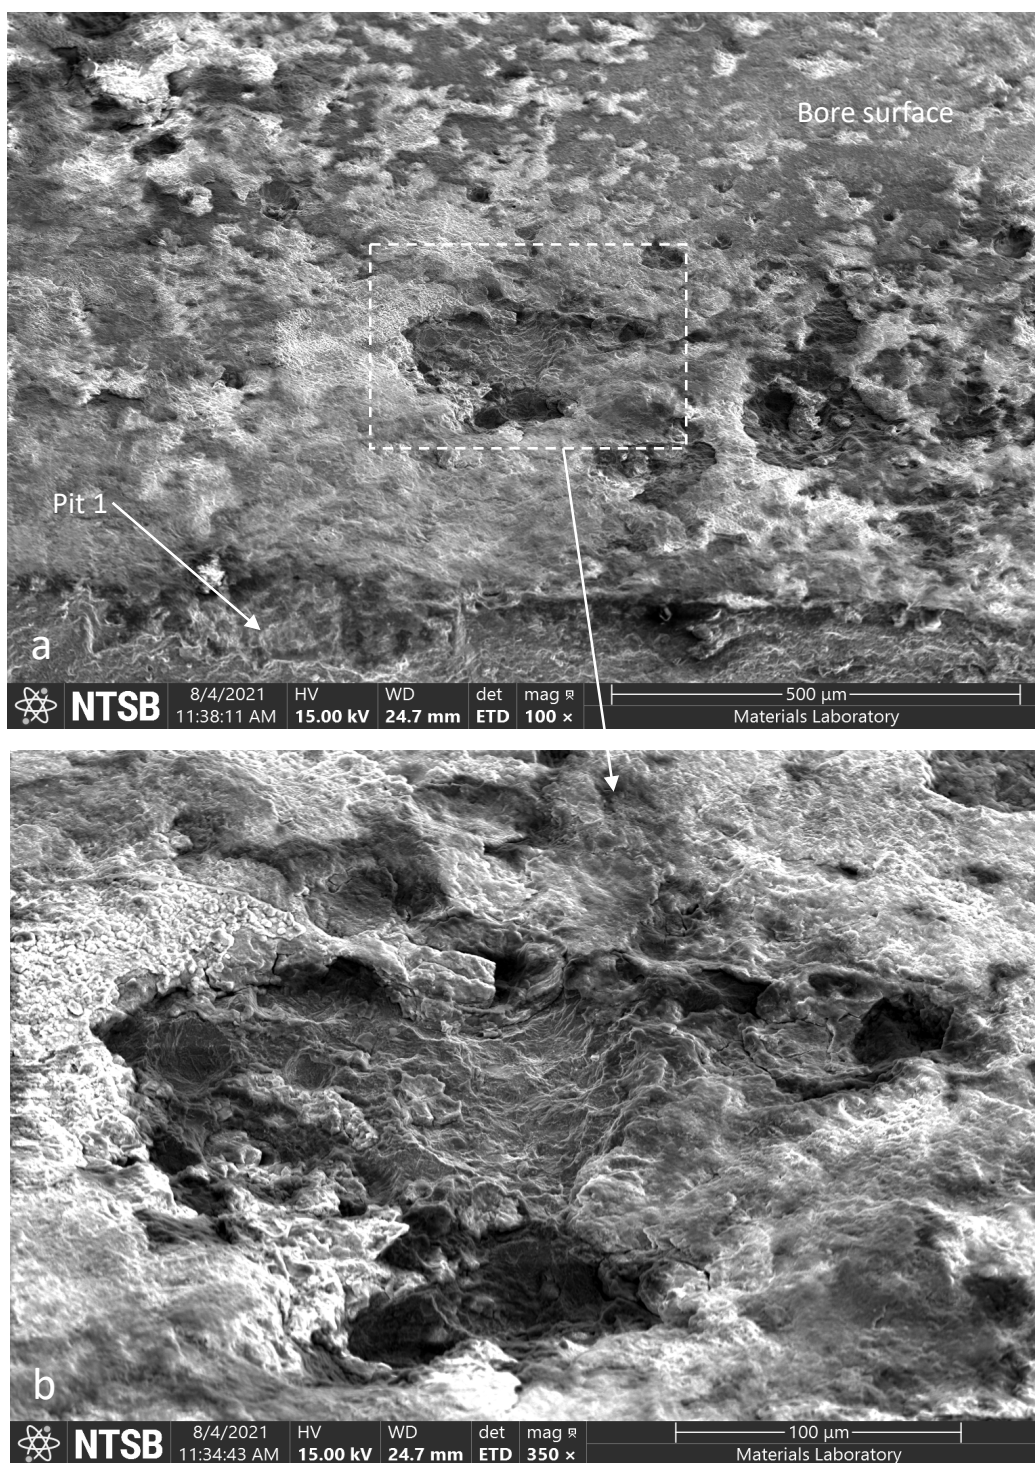
Figure 33 documents the as-received surface of the bore on the lower lug of the separated lower attachment fitting piece, just adjacent to the fracture origin pit, Pit 1. As revealed in the SEM micrographs, the bore has a deposit on the surface consistent with corrosion product. A void in the deposit reveals an underlying pit (View b in Figure 33).

Figure 33 Secondary electron SEM micrographs of the bore surface adjacent to the fracture origin region on the separated lower attachment fitting piece (as-received condition, acetone cleaned). View a shows corrosion product and pits in the general region. Views b shows an example pit at higher magnification.

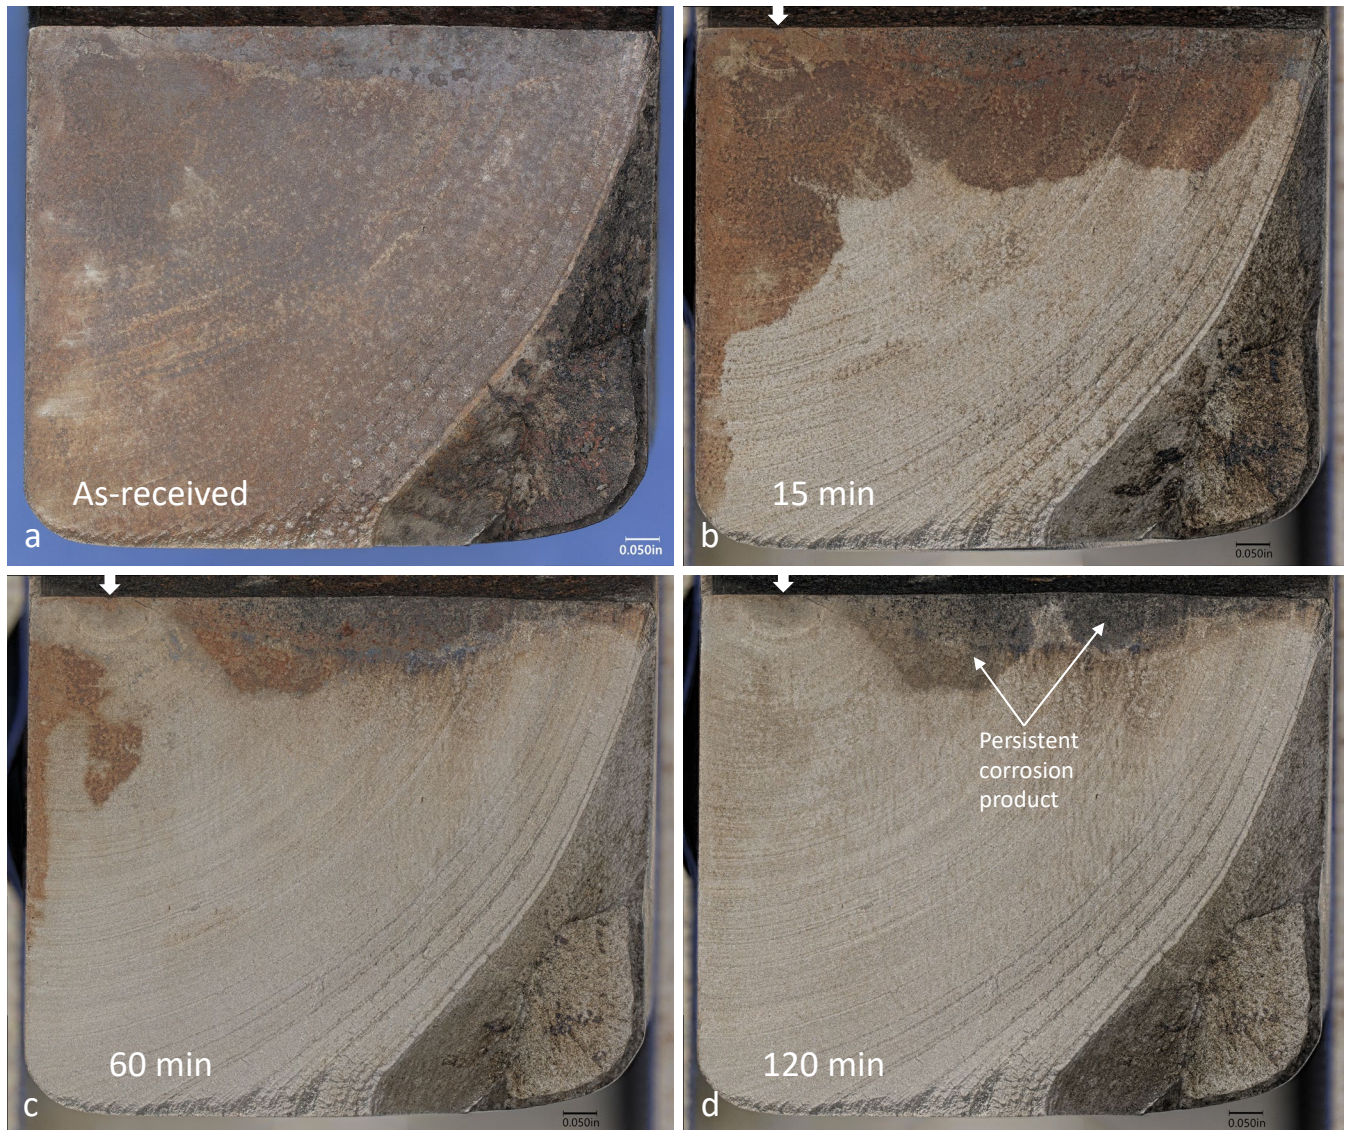
Figure 35 Digital microscope images in HDR revealing the temporal effects of cleaning in Evapo-Rust at different time intervals. View d shows that after 120 minutes of immersion in Evapo-Rust, a persistent corrosion product deposit remained on the fracture surface just below the bore surface.

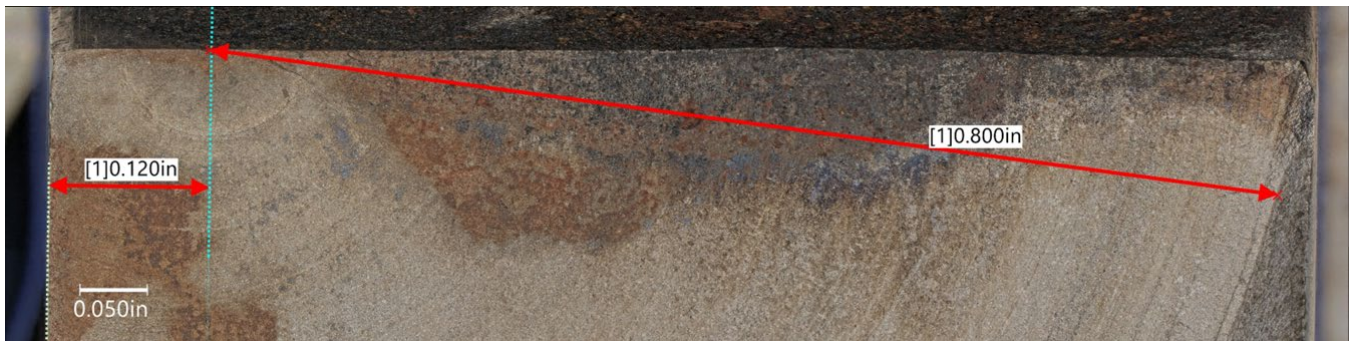
Figure 36 Digital microscope image (HDR) showing the location of the initiating pit feature relative to the edge of the lug. The overall length of the fatigue crack was also measured from the origin (Pit 1) to the approximate terminus. Image taken after 60 minutes immersion in Evapo-Rust.

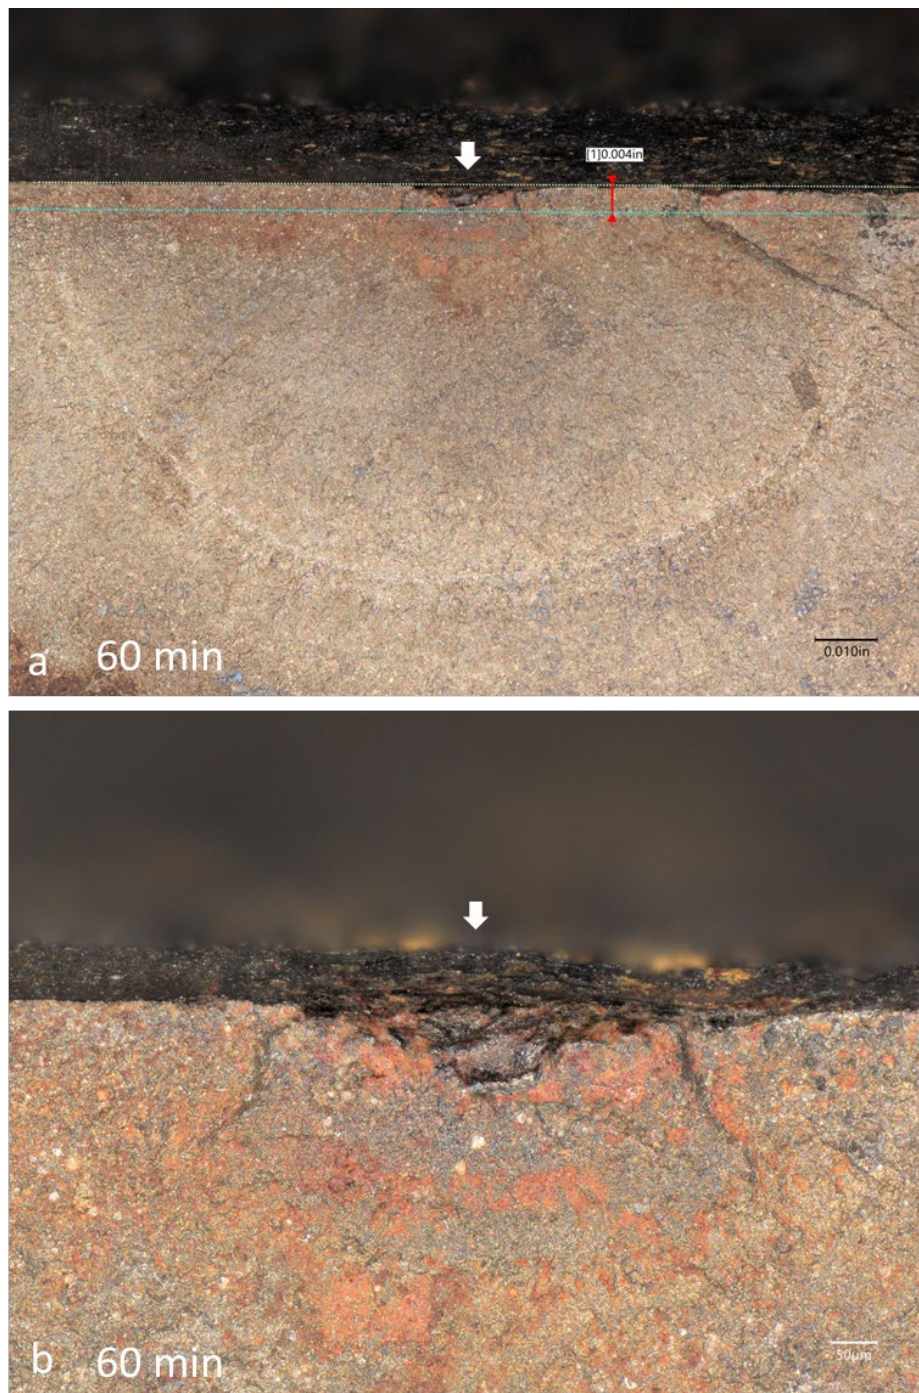
Figure 37 Close digital microscope images (HDR) of the origin region at Pit 1 (unmarked white arrow) after cleaning the fracture in Evapo-Rust for 60 minutes. View a shows the depth of the pit as well as the first semicircular crack progression mark (or thumbnail feature). In view b, ratchet marks are revealed on both sides of Pit 1.

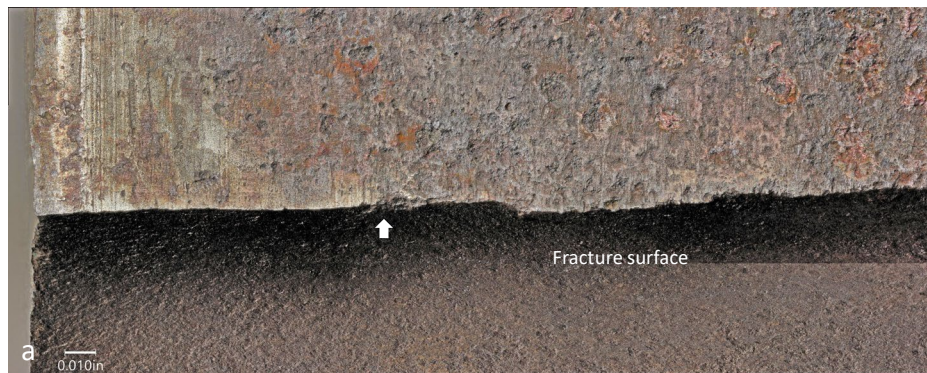
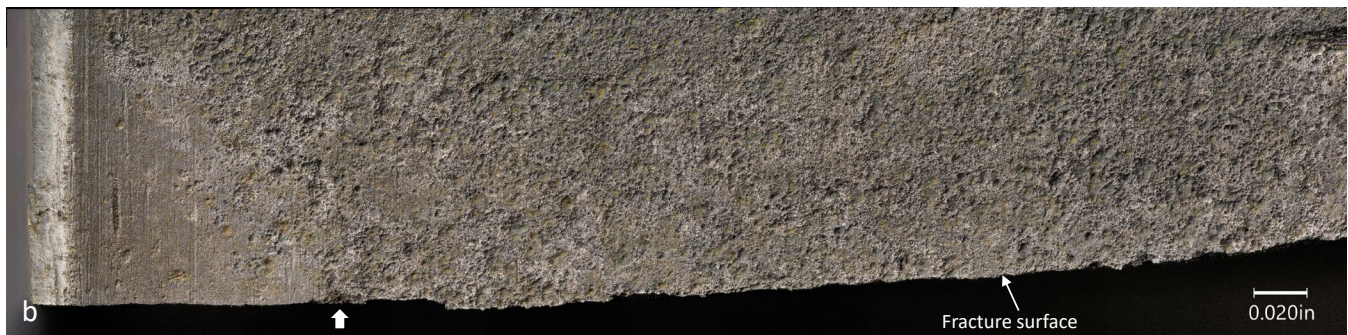
Figure 39 Closer digital microscope images (HDR) of those in Figure 38. View a is in the as-received acetone-cleaned condition. View b is the surface after 240 minutes of Evapo-Rust immersion followed by brush cleaning to remove corrosion product deposits on the surface. Under the corrosion product layer, material loss by corrosion is evident. Pit 1 is marked with an unlabeled white arrow.

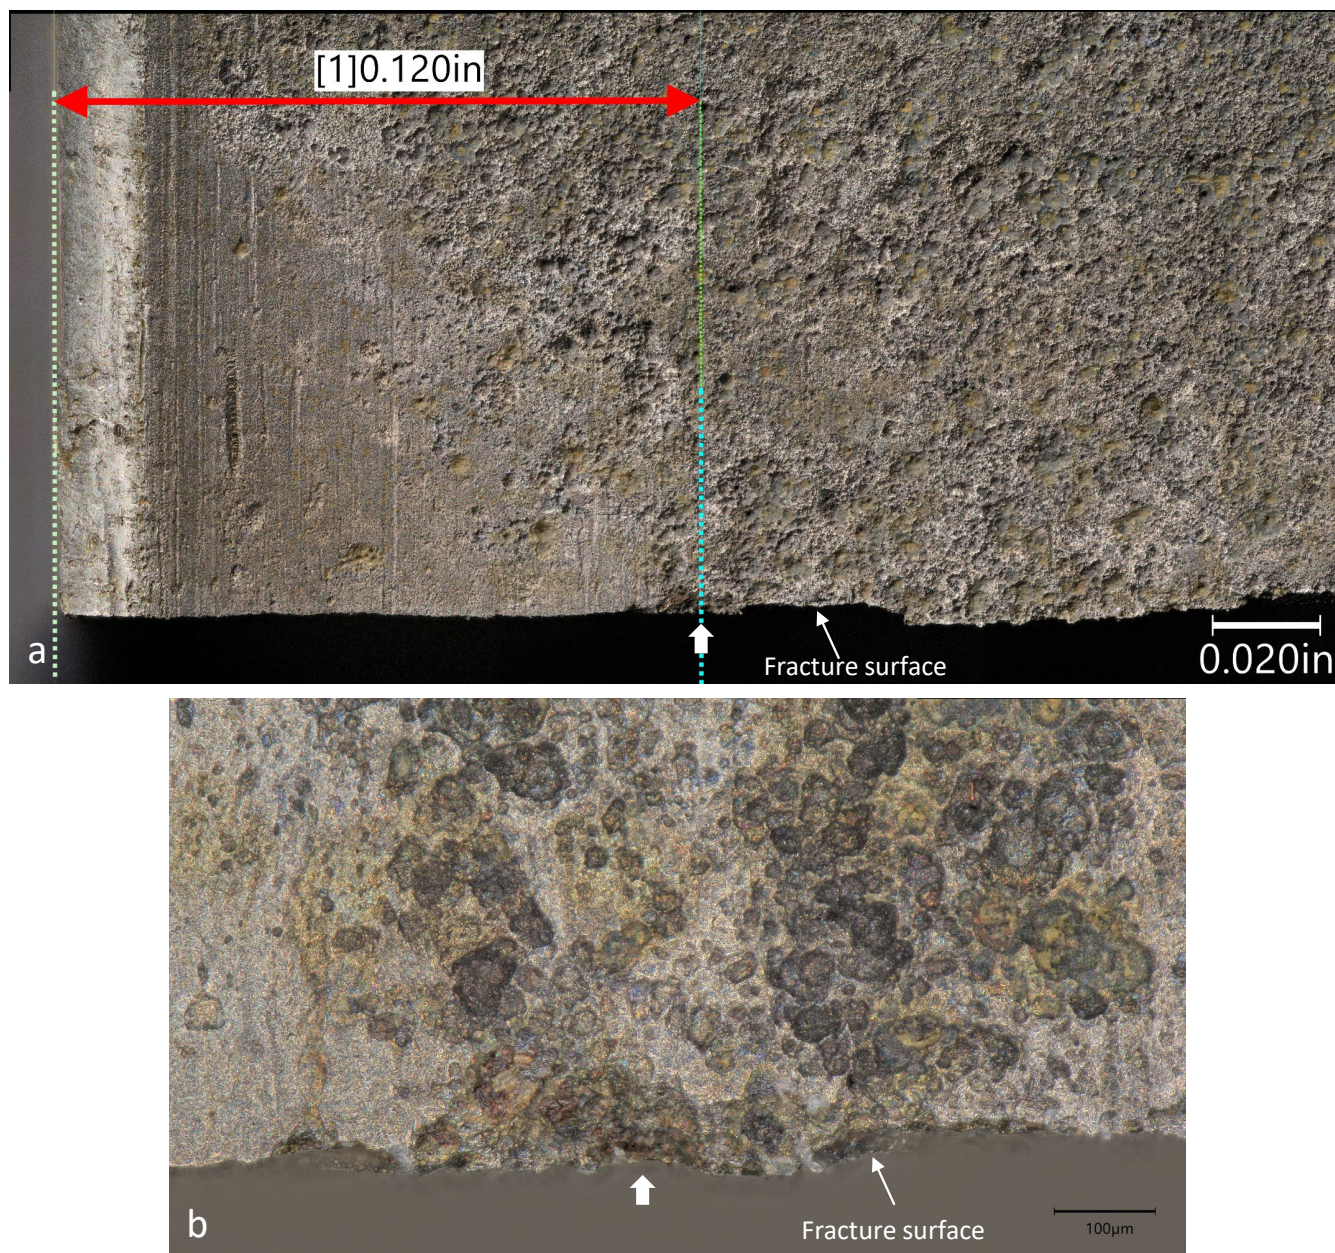
Figure 40 Closer digital microscope images (HDR) of the bore surface in Figure 39b after 240 minutes of Evapo-Rust immersion followed by brush cleaning to remove corrosion product deposits on the surface. Under the corrosion product layer, material loss by corrosion is evident and pits cover the surface. Pit 1 is marked with an unlabeled white arrow.

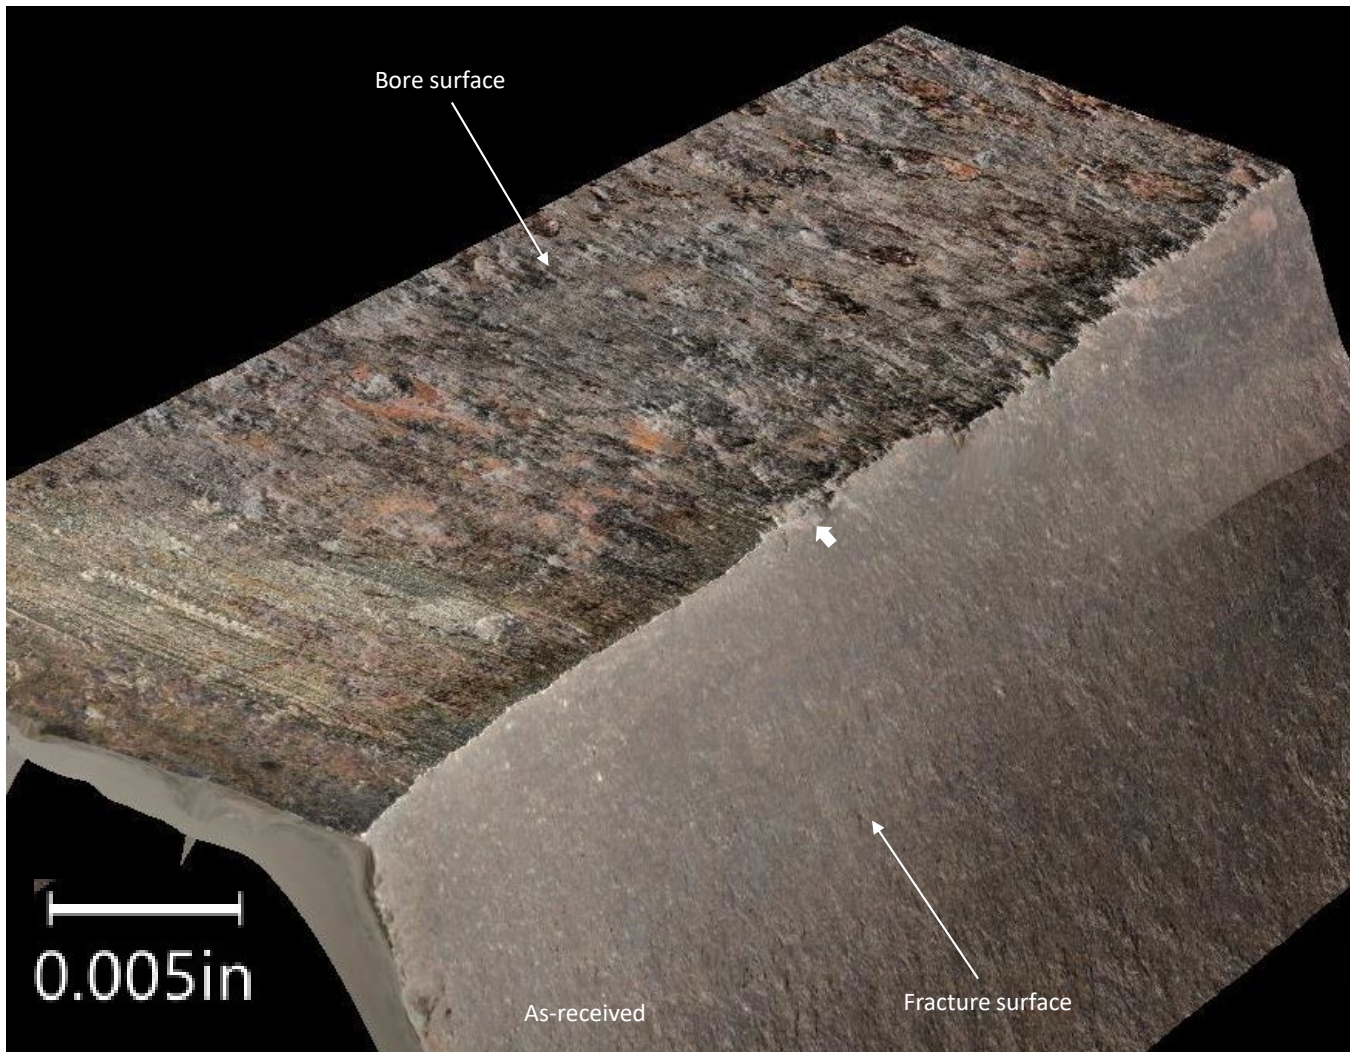
Figure 41 Oblique view of the bore surface in the as-received acetone-cleaned condition. Corrosion product deposits obscure the underlying features in the bore surface. Image taken with a digital microscope under HDR conditions. Pit 1 is marked with an unlabeled white arrow.

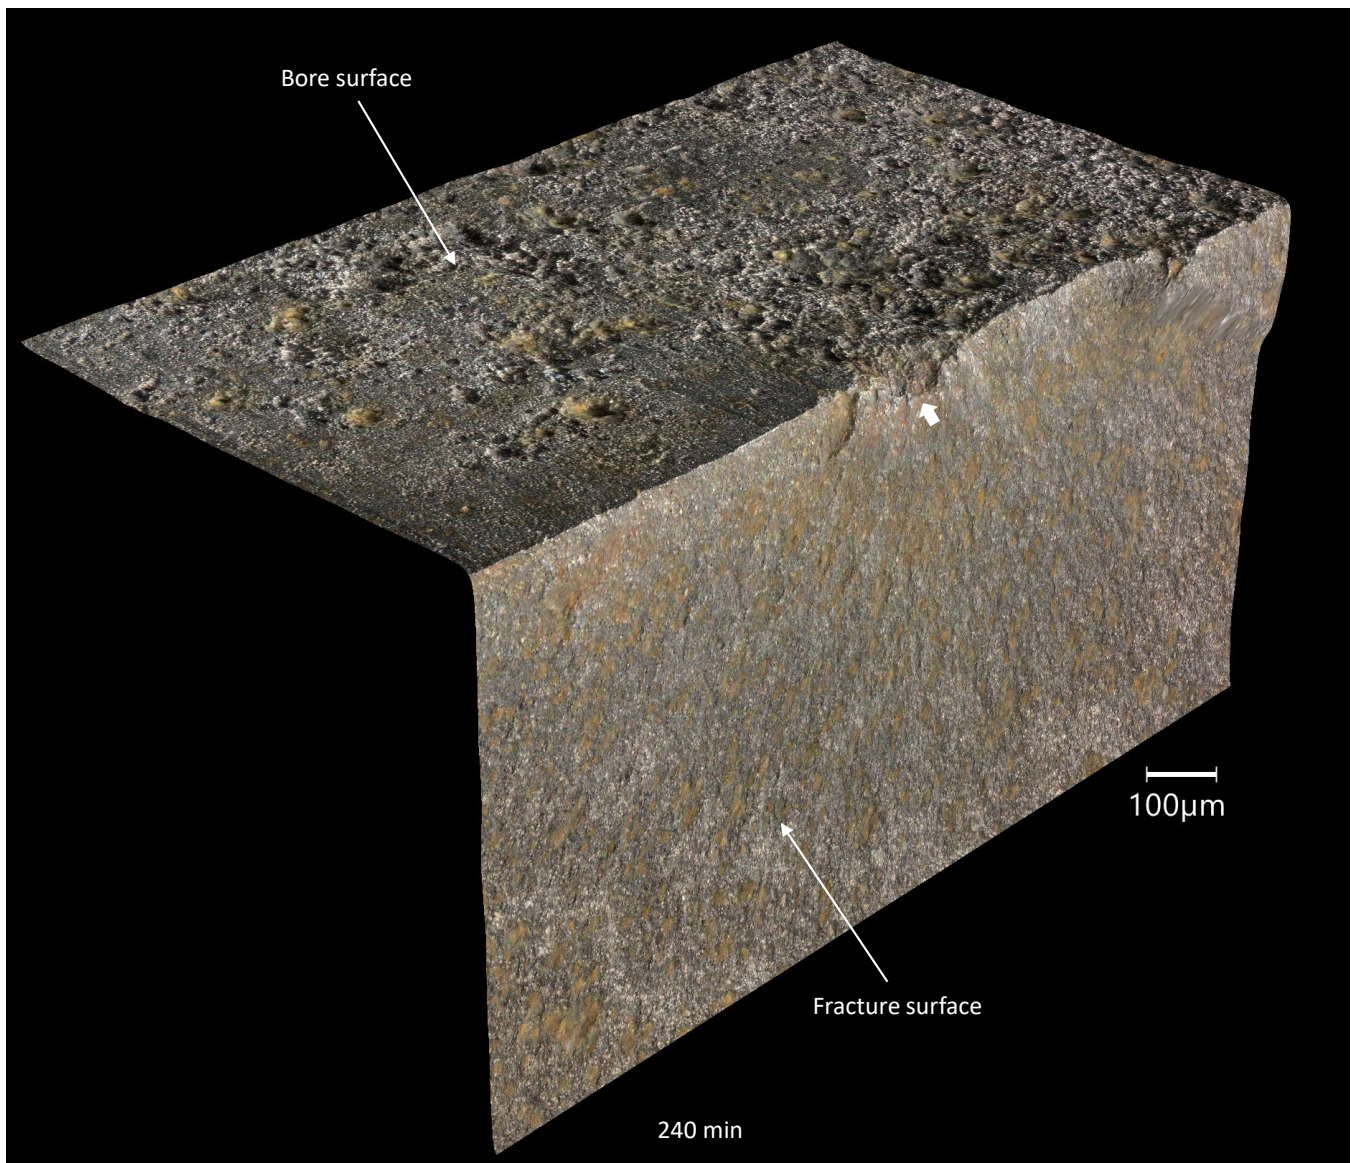
Figure 42 Oblique view of the bore surface after 240 minutes of Evapo-Rust immersion followed by brush cleaning to remove corrosion product deposits on the surface. Pitting on the surface reveals material loss due to corrosion. Image taken with a digital microscope under HDR conditions. Pit 1 is marked with an unlabeled white arrow.

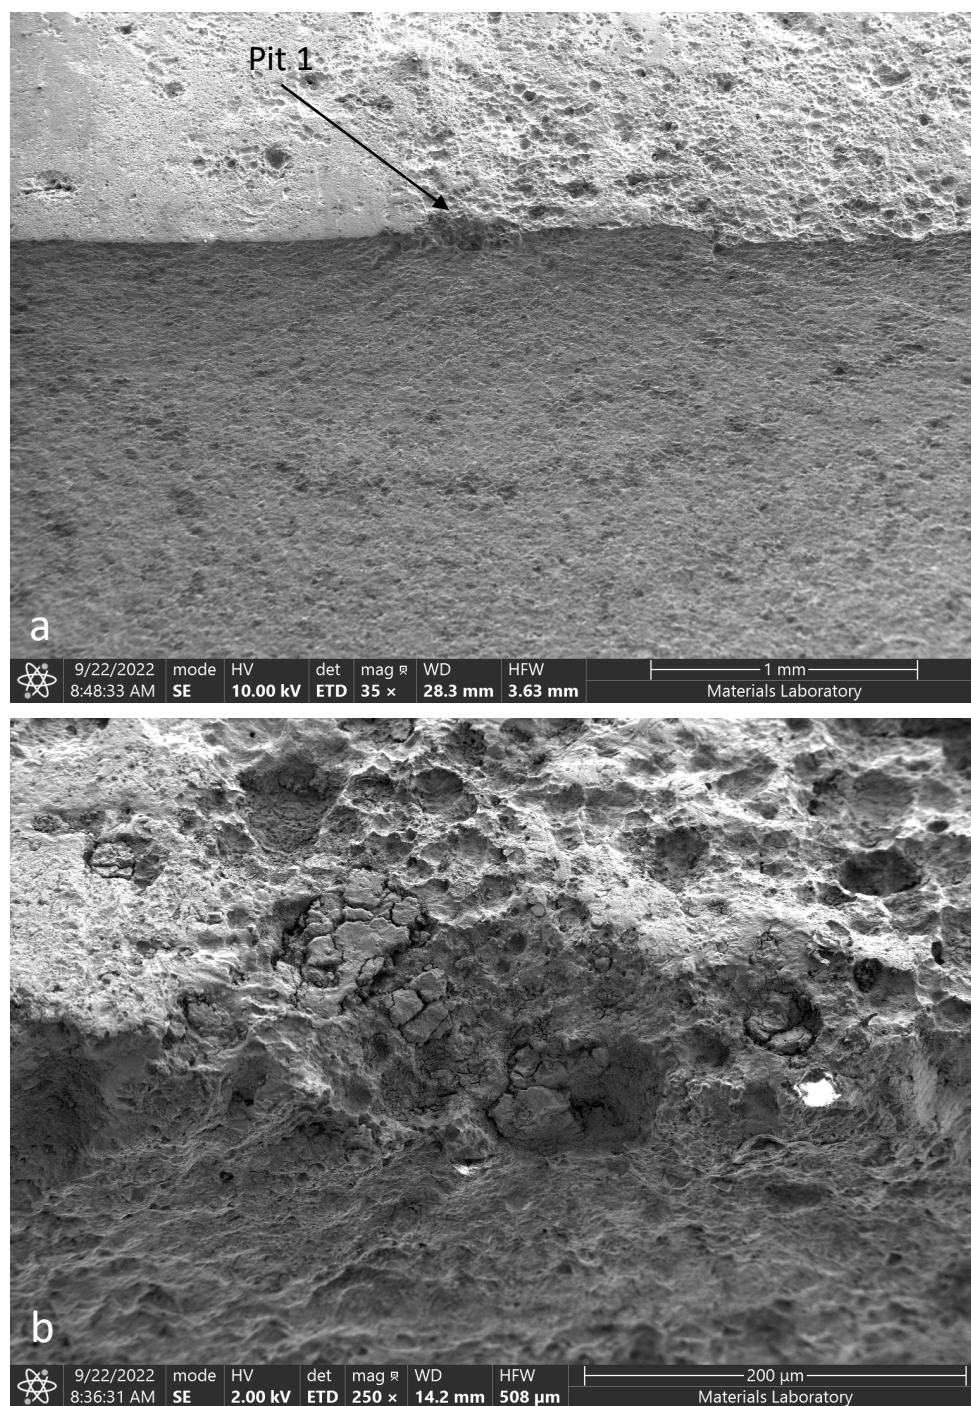
Close SEM micrographs of Pit 1 are shown in Figure 43 after the fracture sample was cleaned in Evapo-Rust for a total of 240 minutes and then the bore surface was cleaned with Alconox and a fine, but stiff bristle brush. The higher magnification micrograph in Figure 43b shows some remaining corrosion product within Pit 1. The depth of Pit 1 was measured on an SEM micrograph as shown in Figure 44, consistent with digital microscope measurements. Figures 45-47 show SEM fractographs of the fracture surface at various locations. In areas with more significant corrosion (see Figure 35b) corrosion product and corrosion damage affected the ability to observe fatigue striation features.

Figure 43 Secondary electron SEM micrographs of Pit 1 after 240 minutes of Evapo-Rust immersion (oblique view). View a shows Pit 1 flanked on both sides by ratchet marks as well as the first observable semicircular crack progression mark (or thumb nail feature) View b is a closer micrograph revealing vestiges of corrosion product deposits.

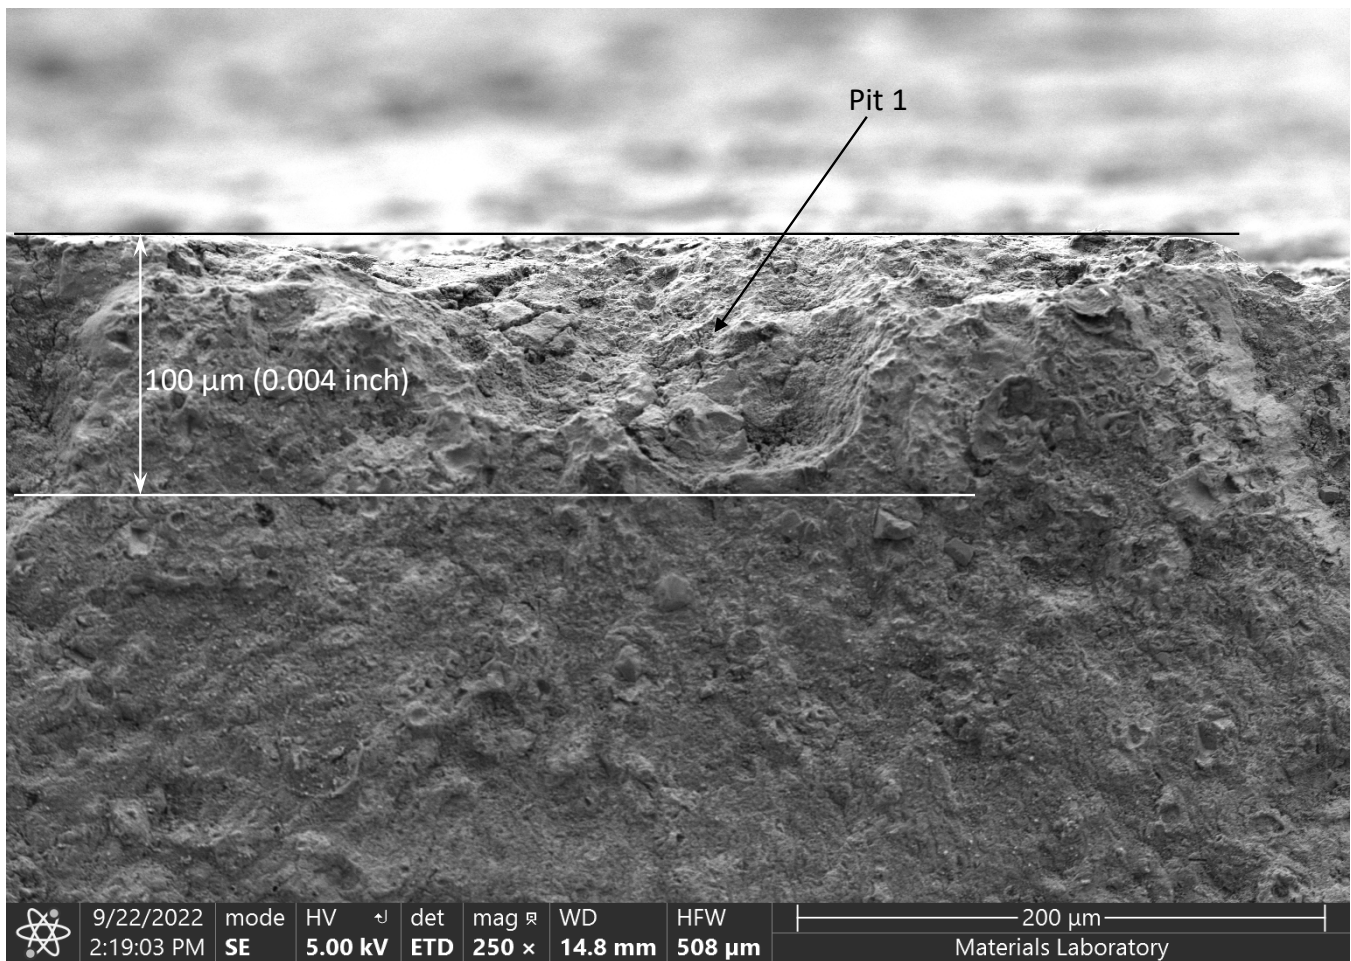
Figure 44 Secondary electron SEM images of Pit 1 after 240 minutes of Evapo-Rust immersion. Pit 1 depth is approximately 0.004 inch.

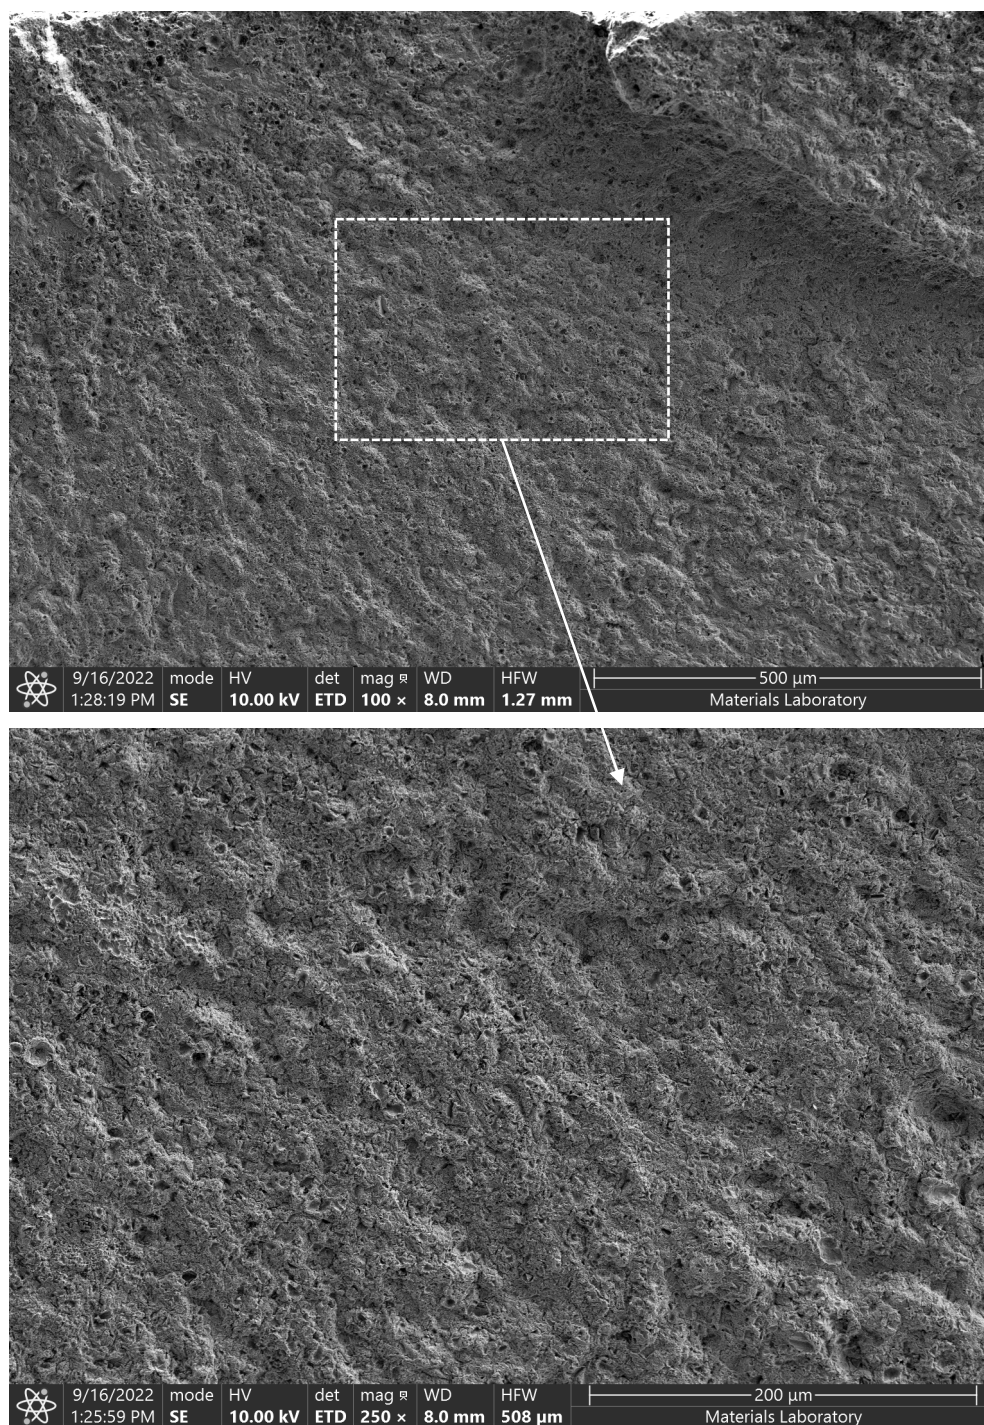
Figure 45 Secondary electron SEM fractographs of the fracture surface adjacent to the origin pit and within the first crack progression mark at the origin (see Figure 37a) after immersion for 120 minutes in Evapo-Rust. Fatigue striation features are not discernable due to corrosion and persistent corrosion product deposits.

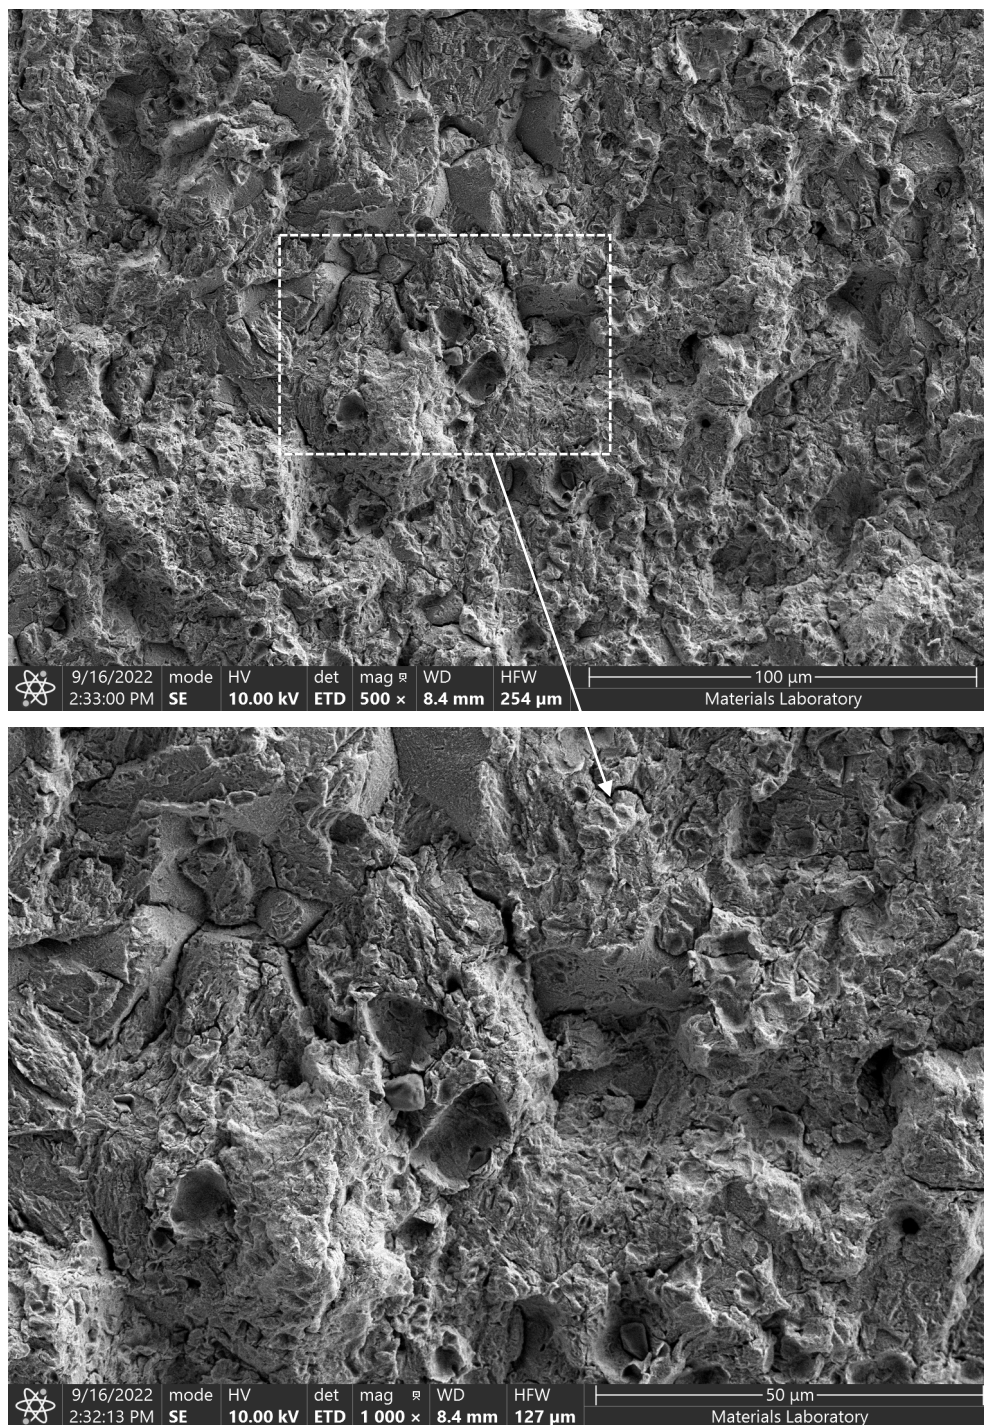
Figure 46 Secondary electron SEM fractographs of the fracture surface near the first crack progression mark at the origin (see Figure 37a) after immersion for 120 minutes in Evapo-Rust. Fatigue striation features are not discernable due to material loss by corrosion and persistent corrosion product deposits.

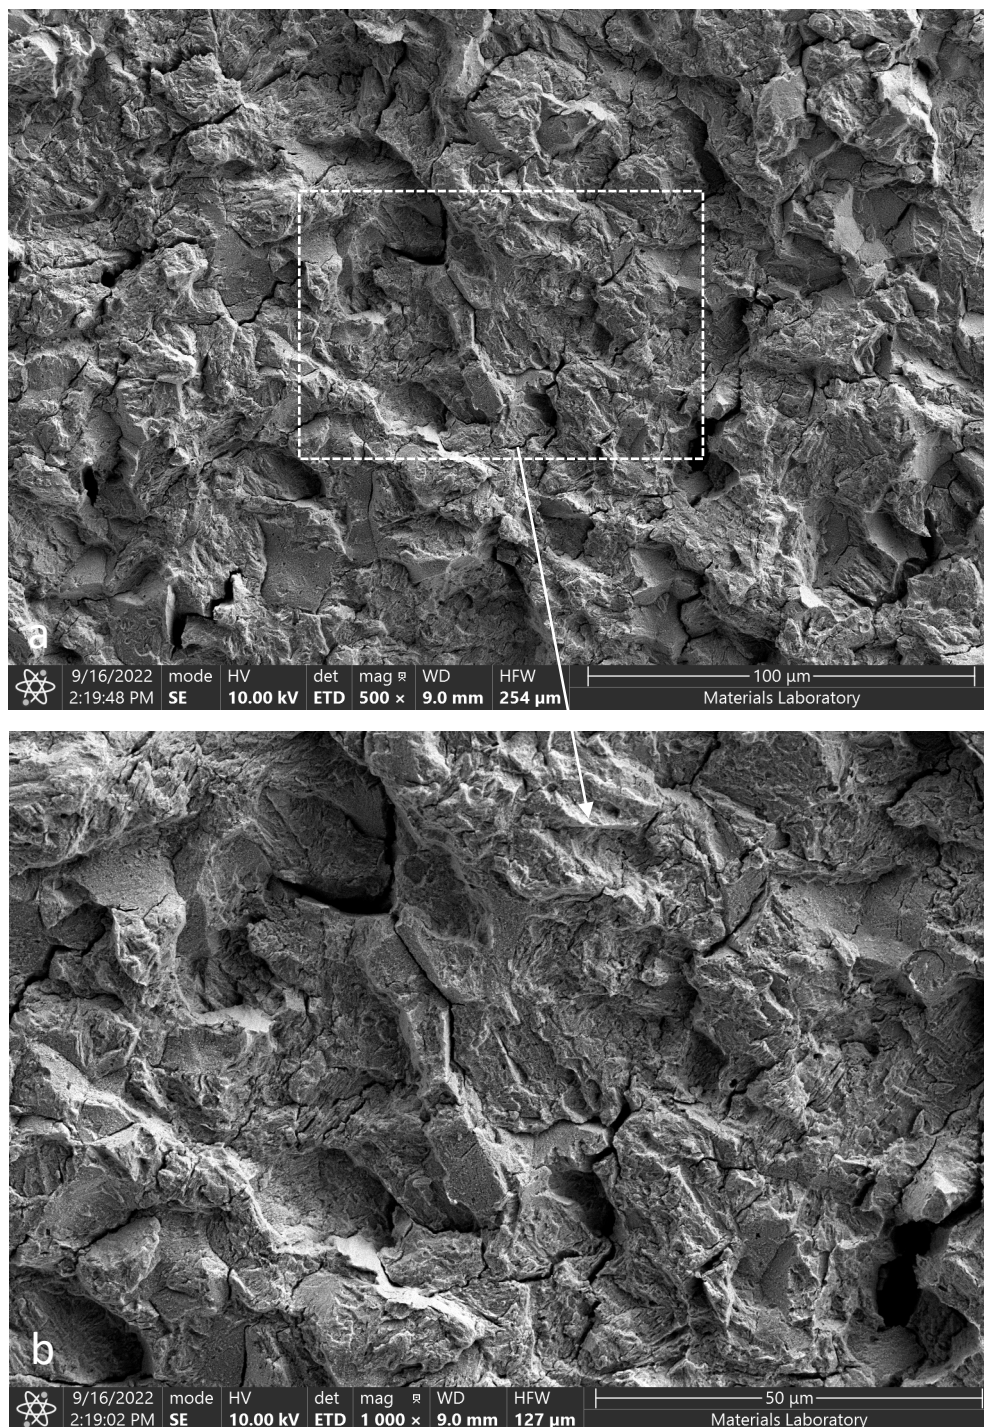
Figure 47 Secondary electron SEM fractographs of the fracture surface in the geometric middle of the lug fracture face after immersion for 120 minutes in Evapo-Rust. Fatigue striation features are discernable as well is evidence of intergranular fracture.

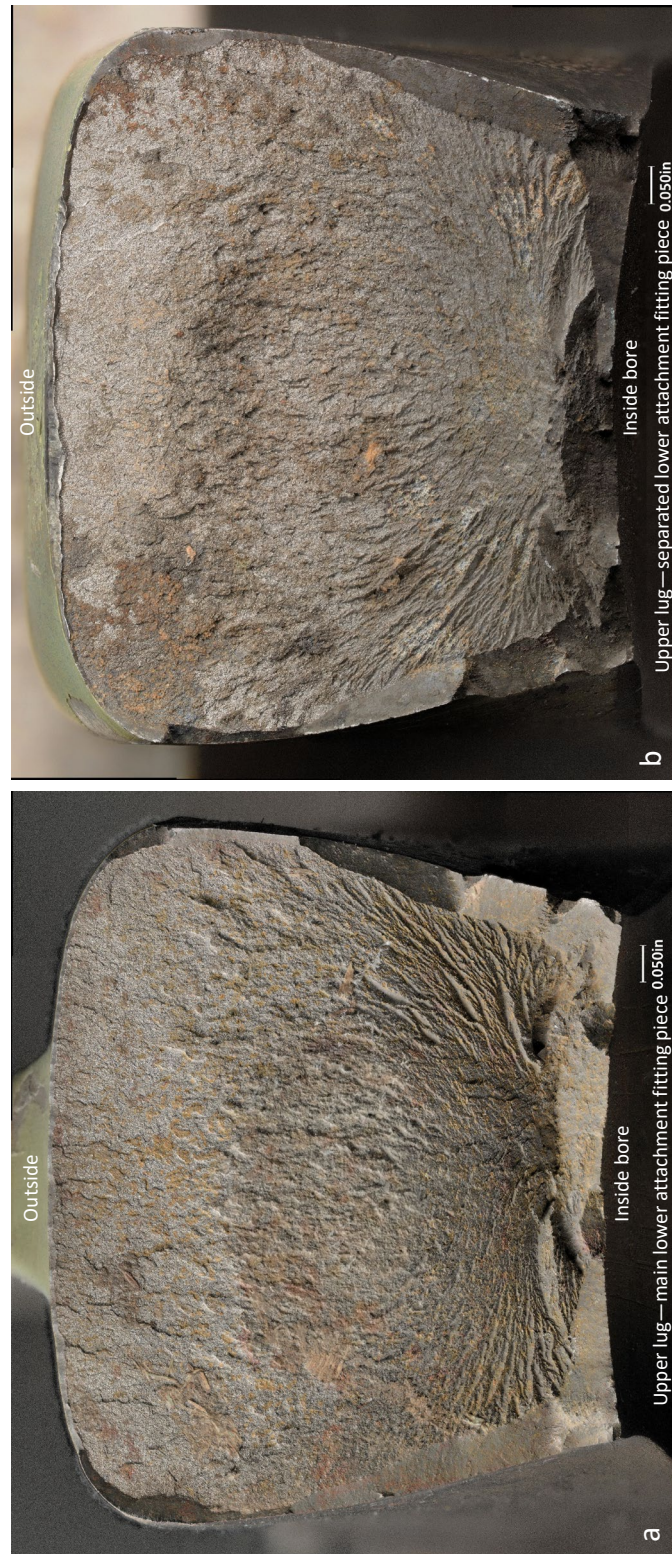
of the bending moment on the lug after the lower fracture occurs)<sup>5</sup>. Fractographs by HDR digital microscopy of the fracture surfaces in the upper lug pieces are shown in Figures 48 and 49. The upper lug fracture surfaces exhibited shear lips at the perimeter of the section and rougher fracture surfaces in the core with river patterns. Based on the river pattern fracture features, the direction of crack propagation is shown using the white arrow annotations in Figure 49. The attributes in the figure are indicative of overstress fracture associated with gross plastic deformation as evidenced by the lateral contraction along the lug width at the internal bore.

Figure 48 Fractographs by HDR digital microscopy of the fracture surfaces on the upper lug of the lower attachment fitting pieces (as-received condition). Key fractographic features are annotated in Figure 49.

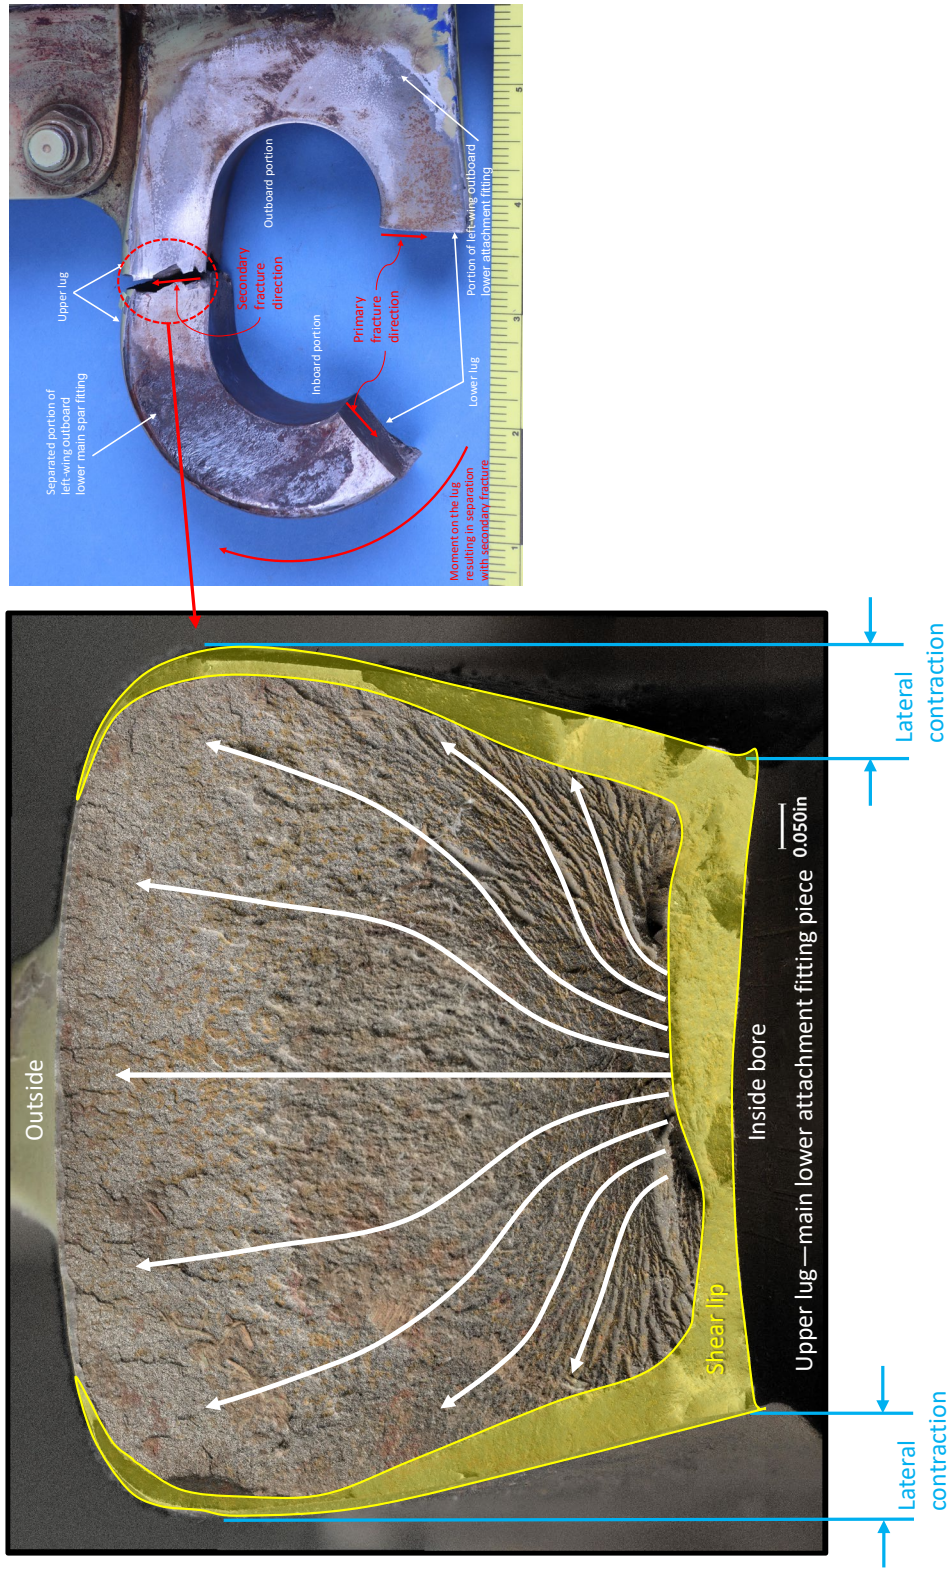
Figure 49 Fractograph by HDR digital microscopy of view a in Figure 48. The upper lug fracture surfaces exhibited shear lips (in yellow) at the perimeter of the section and rougher fracture surfaces in the core with river pattern features. The width at the inner bore exhibits lateral contraction. The direction of crack propagation is shown via the white arrow annotations. Such attributes are indicative of overstress fracture with gross plastic deformation.
