# NATIONAL TRANSPORTATION SAFETY BOARD

## MATERIALS LABORATORY FACTUAL REPORT

Report No. 21-054

Place : Seiling, Oklahoma  
Date : 07/12/2021  
Vehicle : WSK PZL Mielec M-18A Dromader (N9310R)  
NTSB No. : CEN21FA314  
Investigator : Tim Sorenson

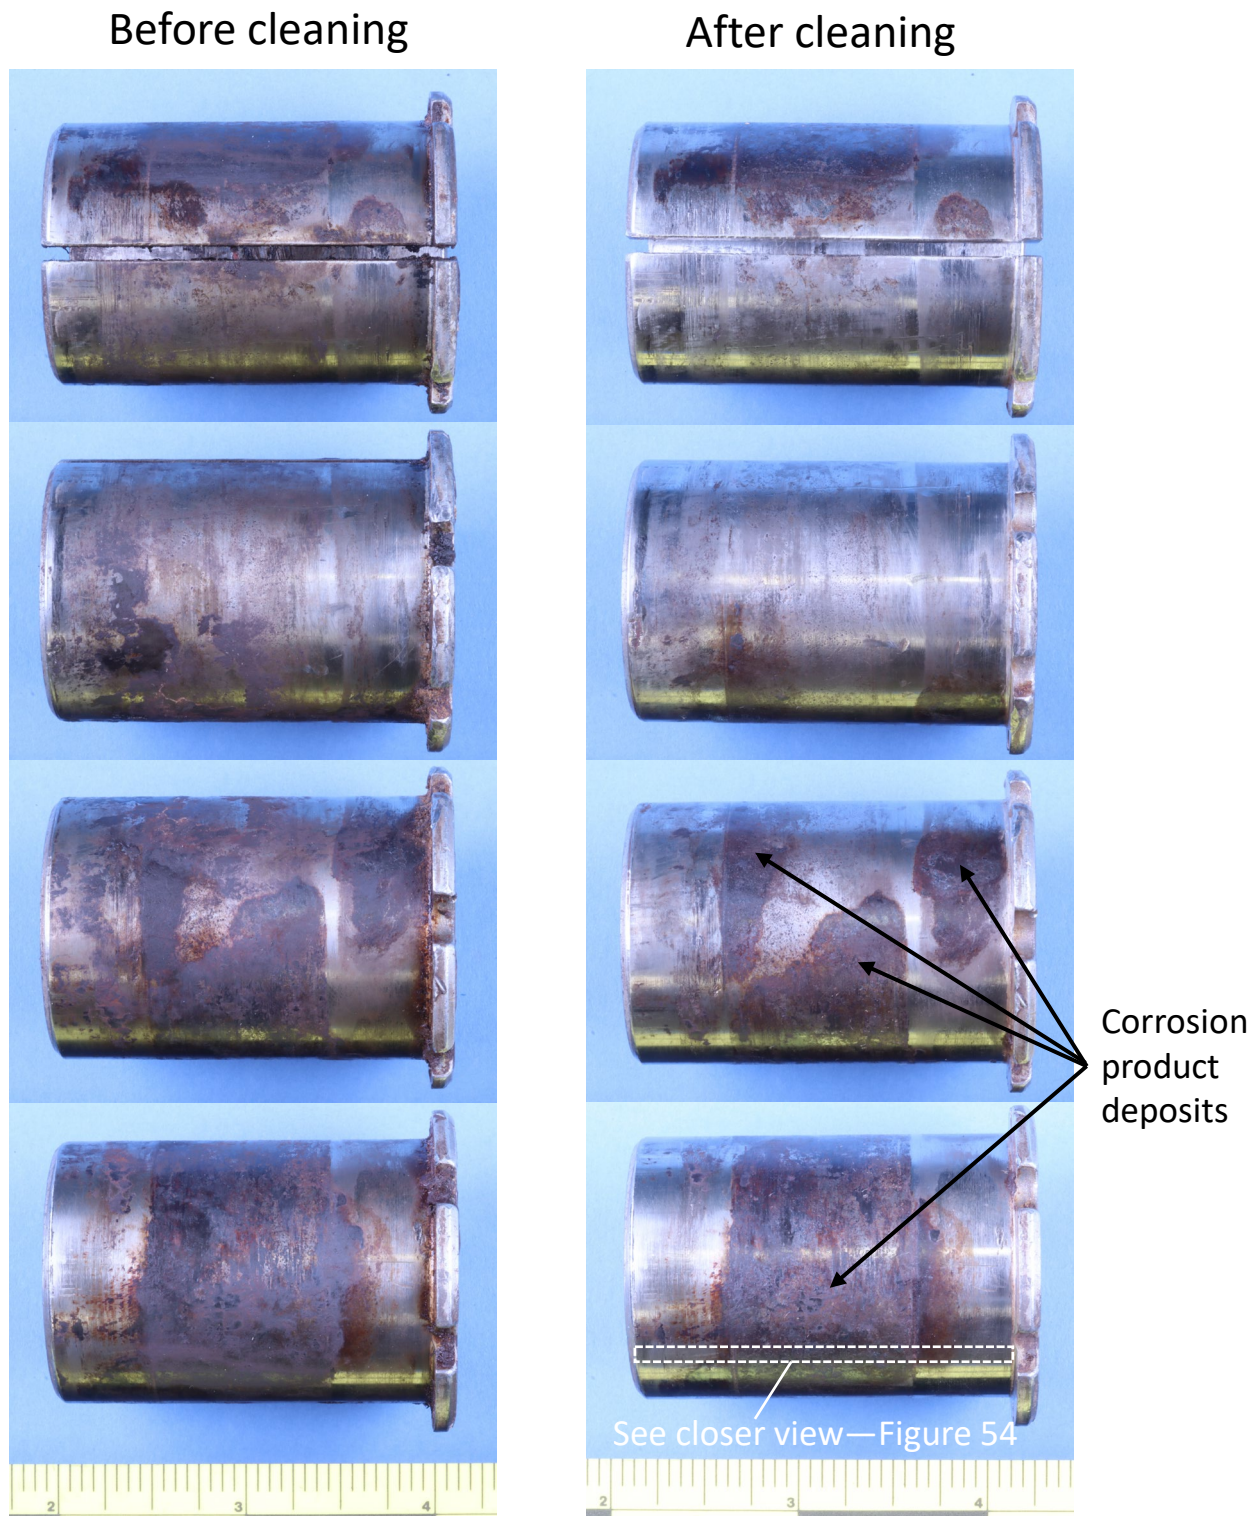
Detailed images of the split mandrel at 90° intervals about the main axis are shown in Figure 53. Some areas on the outside diameter (OD) of the mandrel exhibited corrosion deposits as indicated in the figure. Corrosion deposits were prevalent on the portion of the mandrel OD that contacted the outboard lower main attachment fitting bore. A closer view of the mandrel surface exhibiting corrosion deposits is shown in Figure 54.

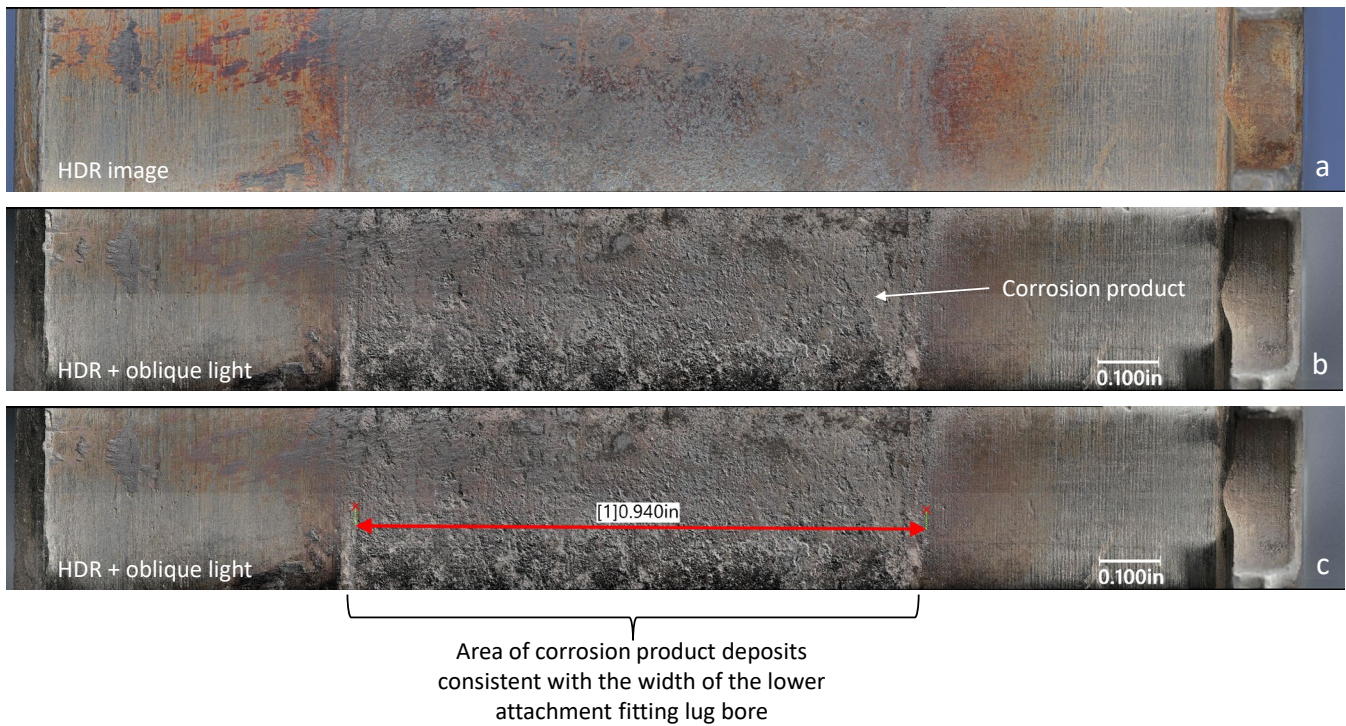
Figure 54 Digital microscope images of the surface of the split mandrel (see Figure 53 for the location). Under oblique lighting conditions corrosion deposits revealed by a rougher surface texture correspond to the location of the outboard lower attachment fitting.

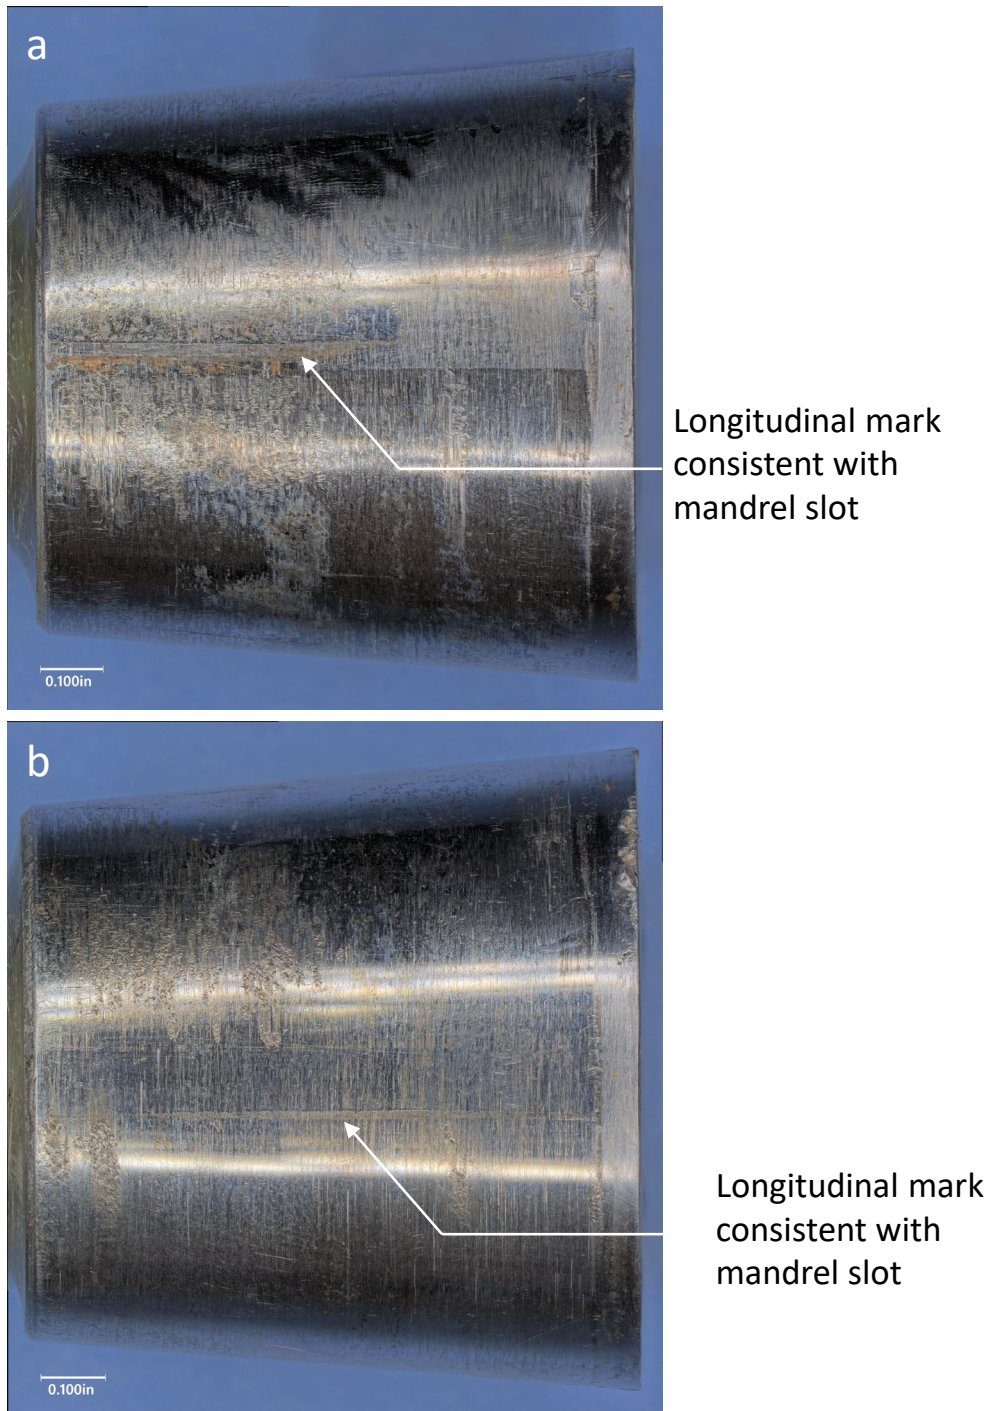
Figure 56 Close digital microscope images of the surface of the tapered portion of the retention bolt. The annotations indicate two longitudinal marks on the surface consistent with contact with the edge of the slot in the split mandrel.

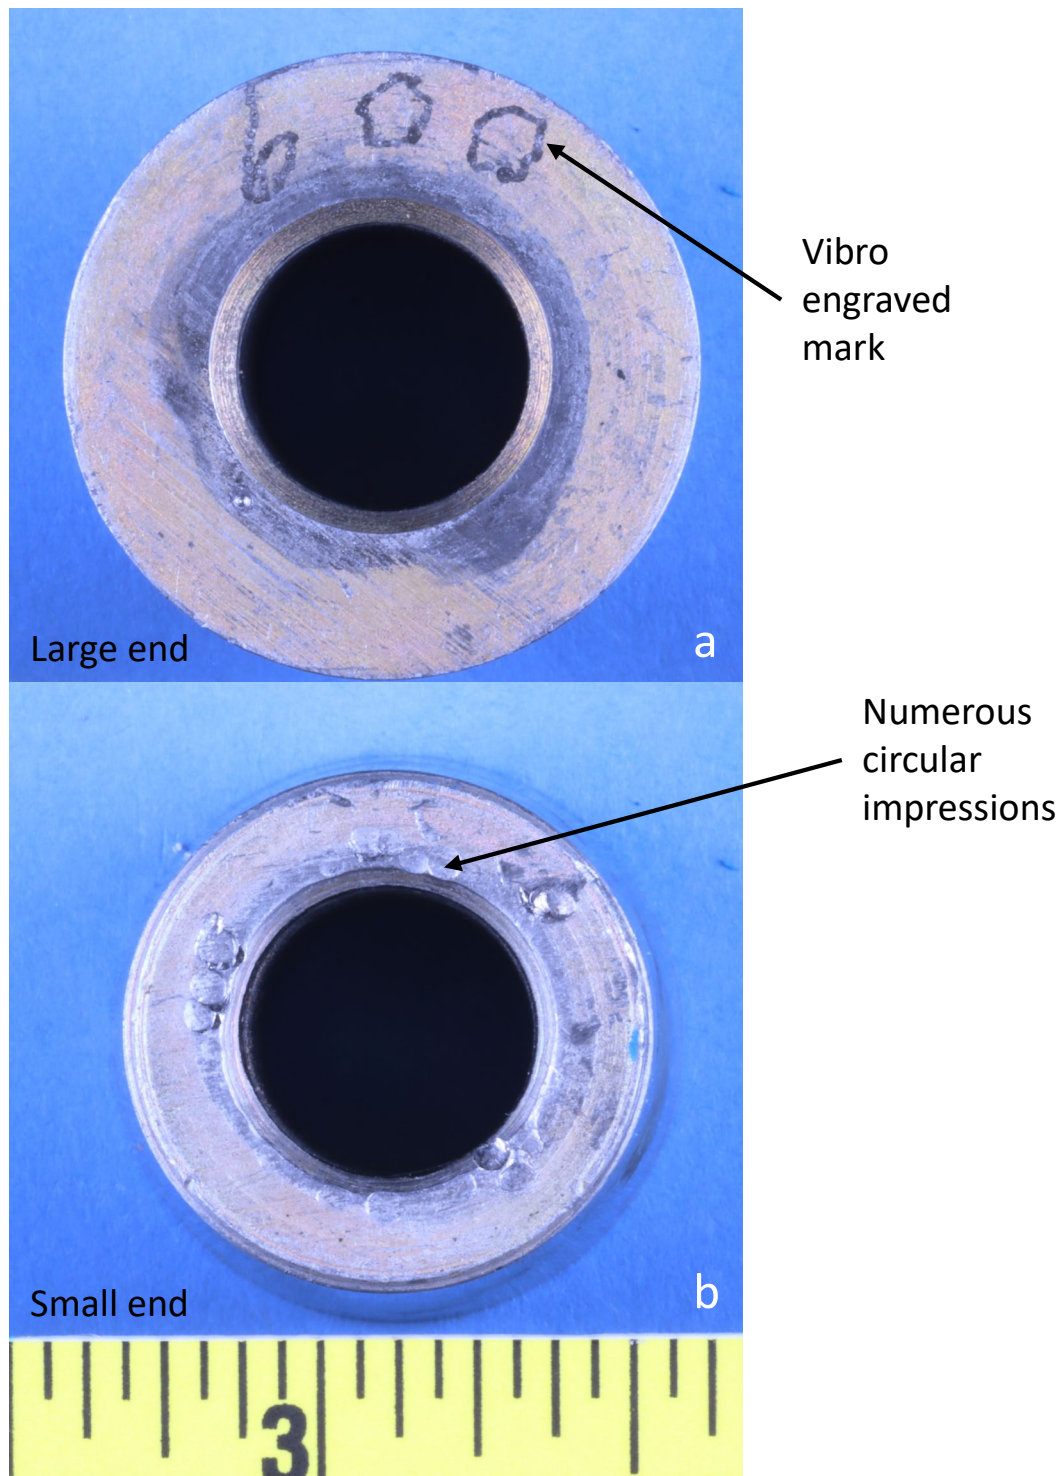
shown in Figure 60a. Small circular impressions were observed at the small end of the tapered plug as indicated in Figure 60b.

Figure 60 Image showing the small end of the tapered plug. Numerous circular impressions are present, consistent with contact marks from a drift pin.

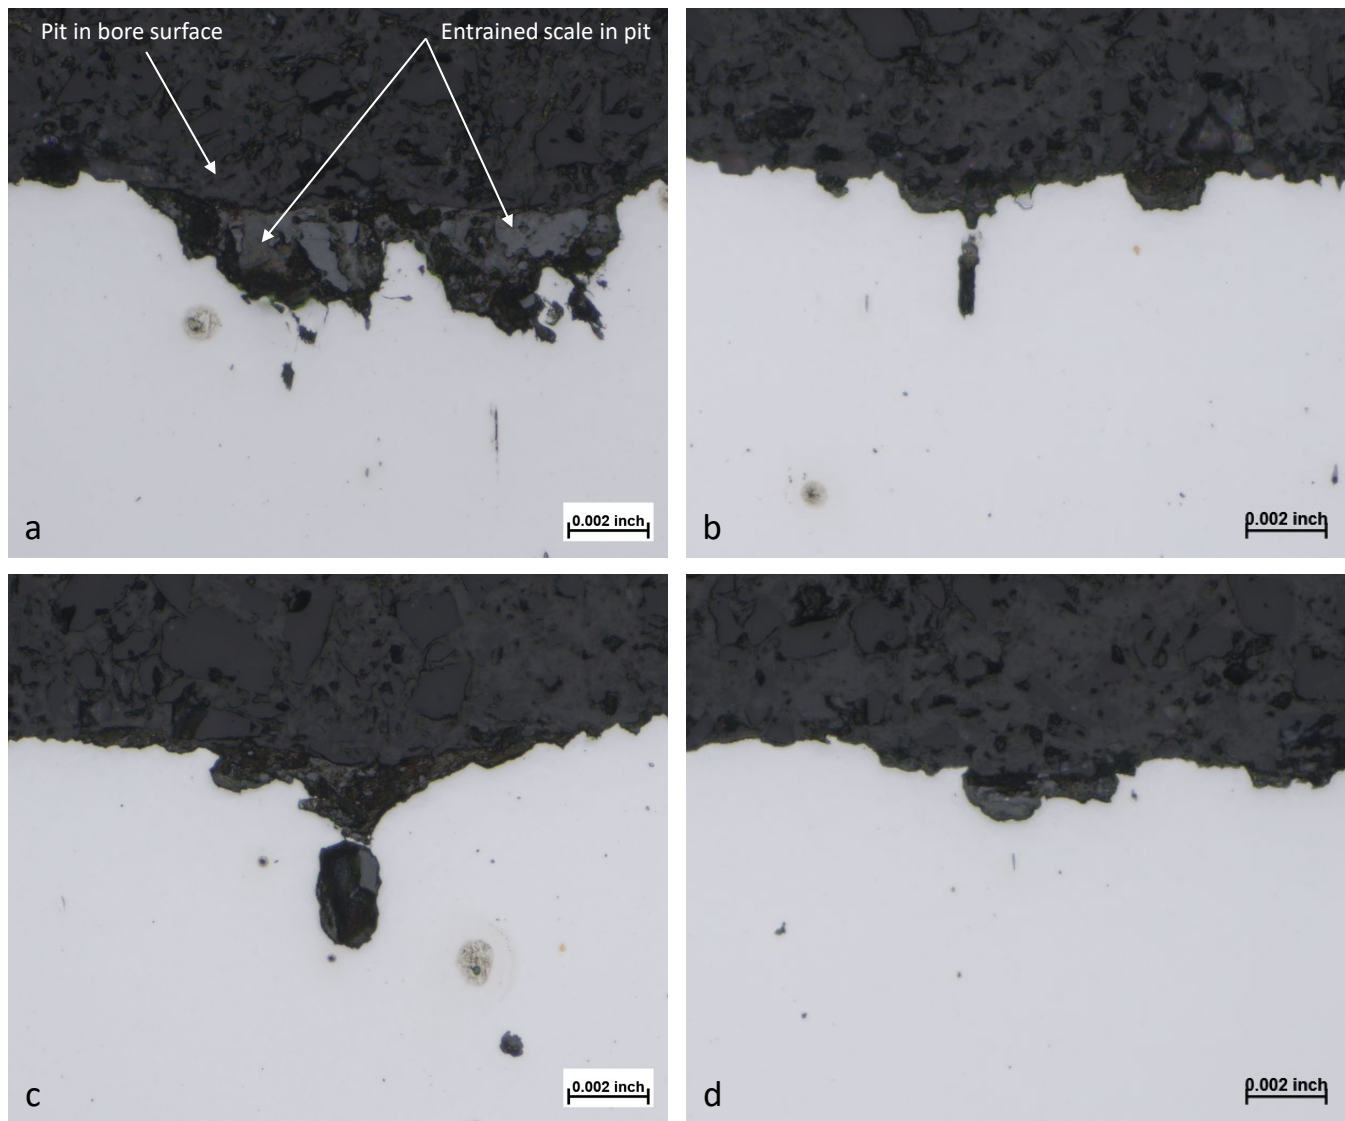
Figure 64 Bright-field optical micrographs of a cross section through the lower lug bore surface (See Figure 34 for sample location) revealing pit features in the surface of the bore as well as corrosion product scale entrained within the pits. (Unetched, 500X original magnification.)

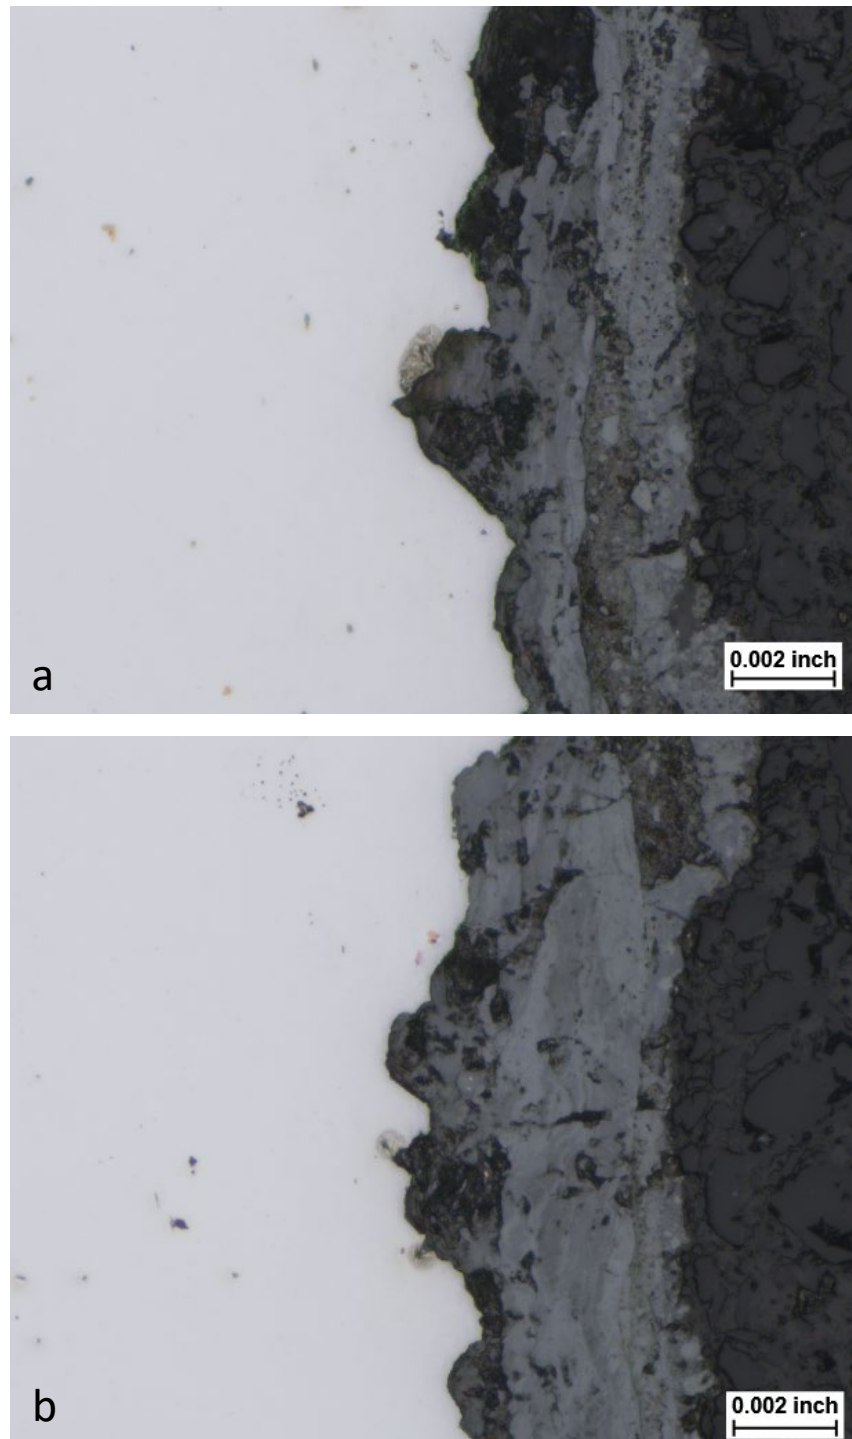
Figure 65 Bright-field optical micrographs of a cross section through the lower lug forward side surface (See Figure 34 for sample location) revealing pit features in the surface as well as corrosion product scale entrained within the pits. (Unetched, 500X original magnification)

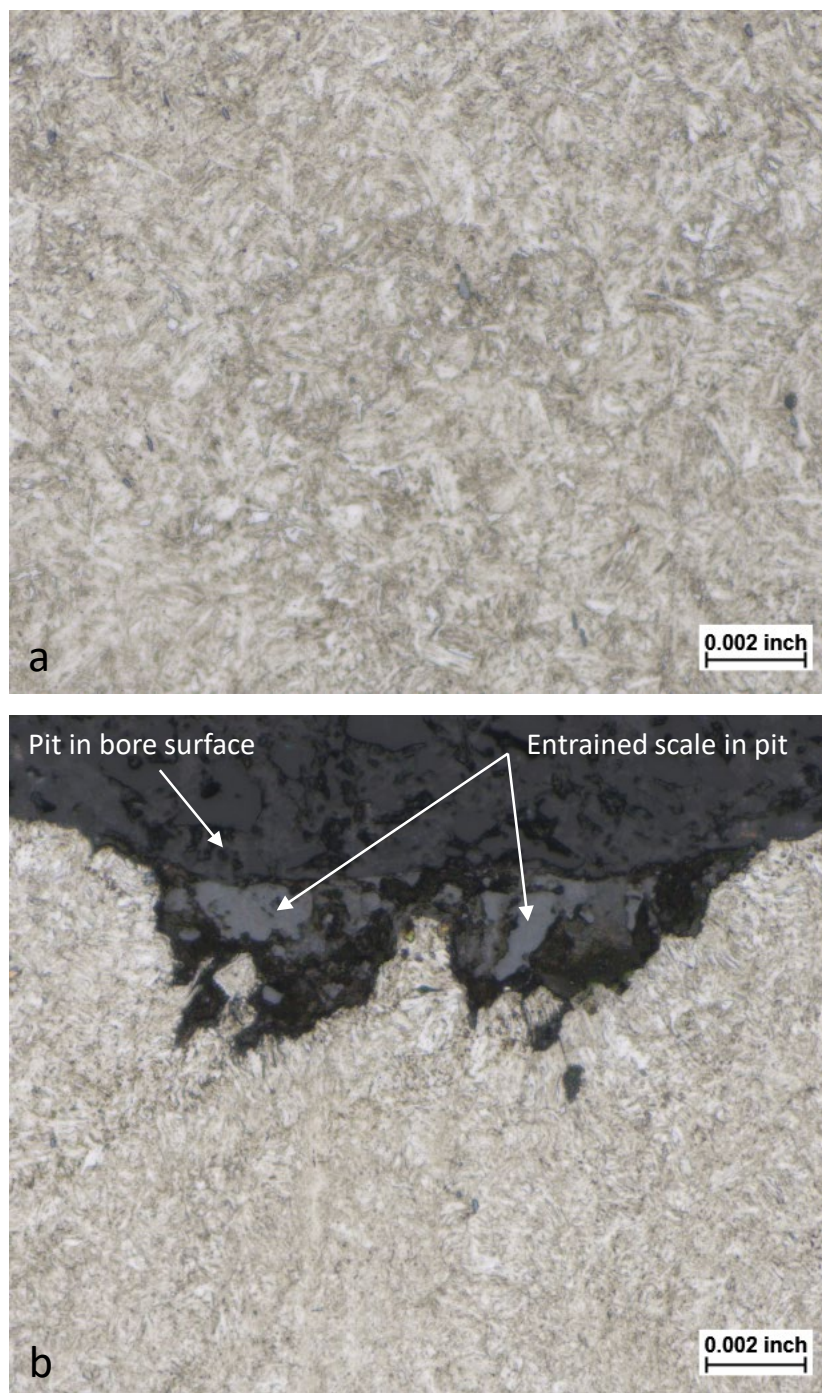
A cross sectional sample piece was cut from the separated piece of the lower attachment fitting lug. The sample was metallurgically mounted for microstructural examination and hardness. The cross section revealed numerous pits in the bore surface and the forward side of the lower lug, consistent with corrosion. Typical pits with corrosion product are shown in Figure 64. The side of the lower lug exhibited corrosion pitting and corrosion product scale as demonstrated in Figure 65. The microstructure was uniformly tempered martensite as shown in Figure 66.

Figure 66 Bright-field optical photomicrographs of the microstructure of the lower attachment fitting taken from the lower lug portion of the separated fitting piece. View a shows a tempered martensitic core. View b shows a martensitic surface at a pit in the bore surface. (2% nital etched, 500X original magnification)
