# NATIONAL TRANSPORTATION SAFETY BOARD

## MATERIALS LABORATORY FACTUAL REPORT

Report No. 22-072

Place : Seiling, Oklahoma  
Date : 07/12/2021  
Vehicle : WSK PZL Mielec M-18A Dromader (N9310R)  
NTSB No. : CEN21FA314  
Investigator : Tim Sorenson

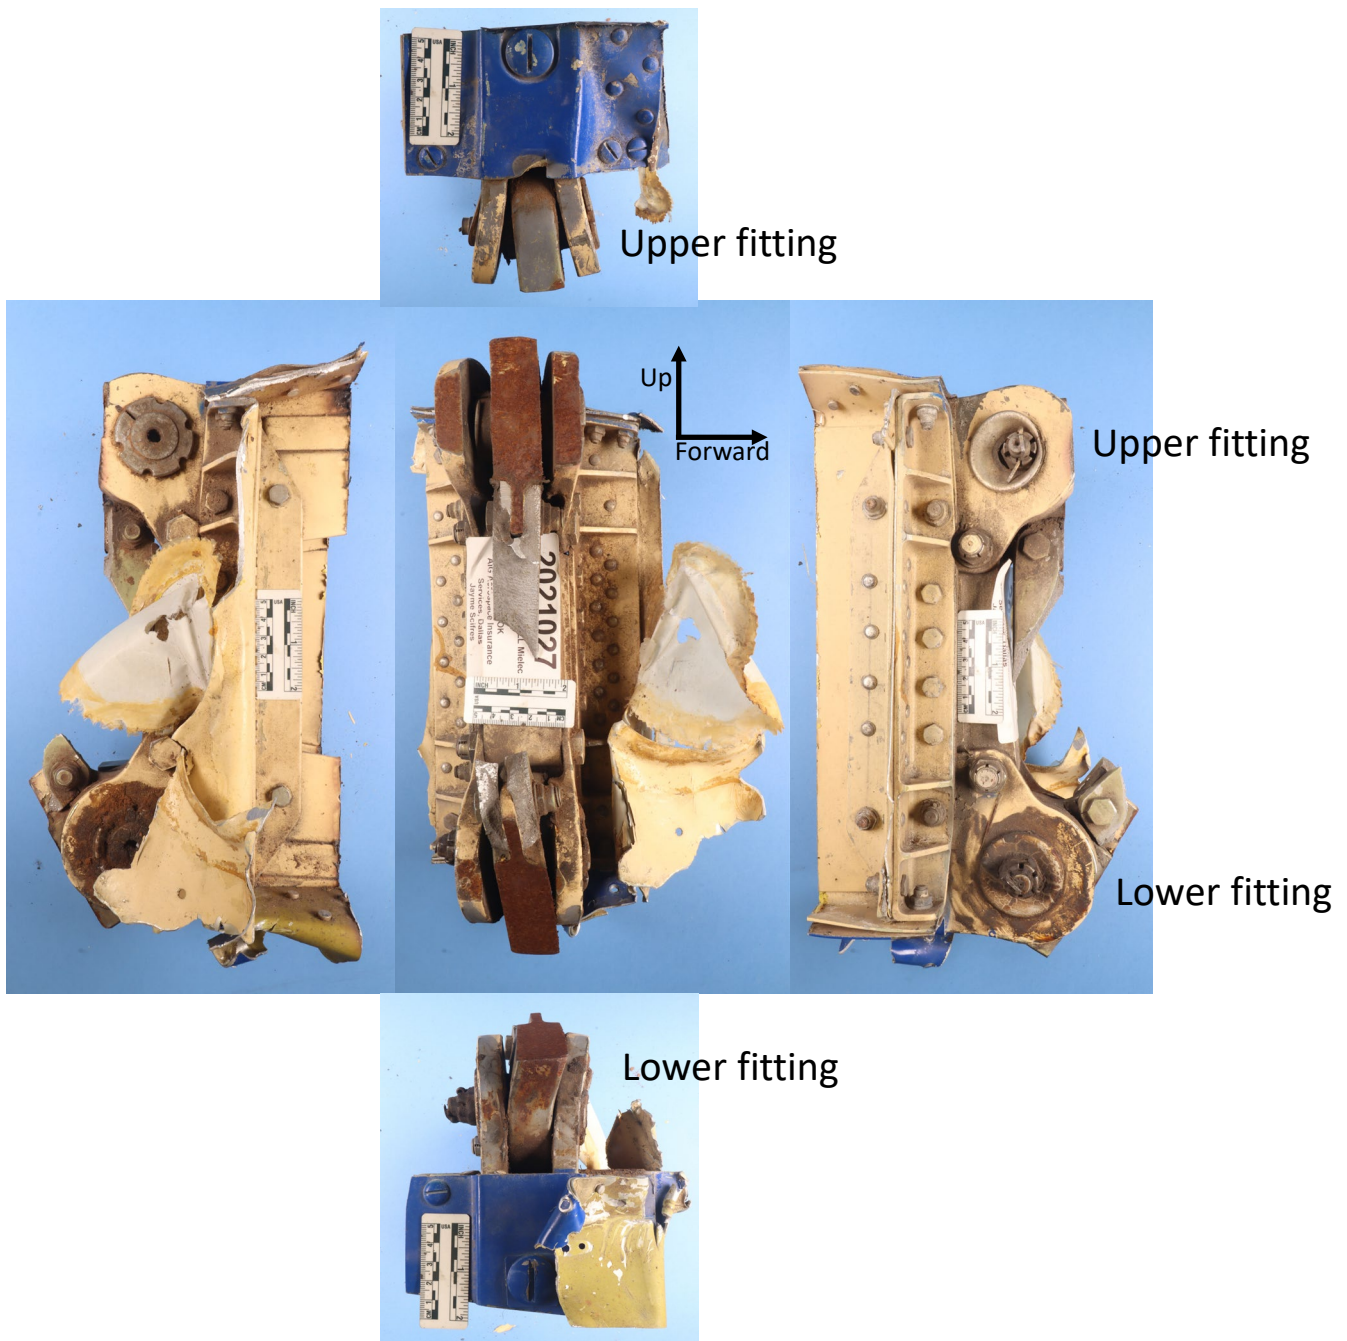
Multiple views of the as-received evidence are shown in Figure 1 with the upper and lower attachment fittings identified. As received, the attachment fitting areas were examined under UV light using an UltraLite ALS inspection system with UV head at 400 nm/250 mW to identify the presence of any deposits from a fluorescent magnetic particle inspection. No positive indications of fluorescent deposits were observed on the lug portions of the upper and lower attachment fittings (see Figure 2 for example images).

Figure 1 Orthogonal views of the right center wing spar piece with right wing attachment yokes and portions of the wing attachment fittings.

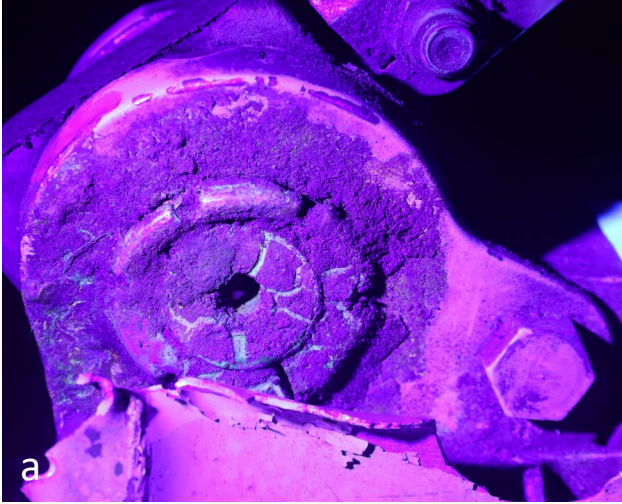
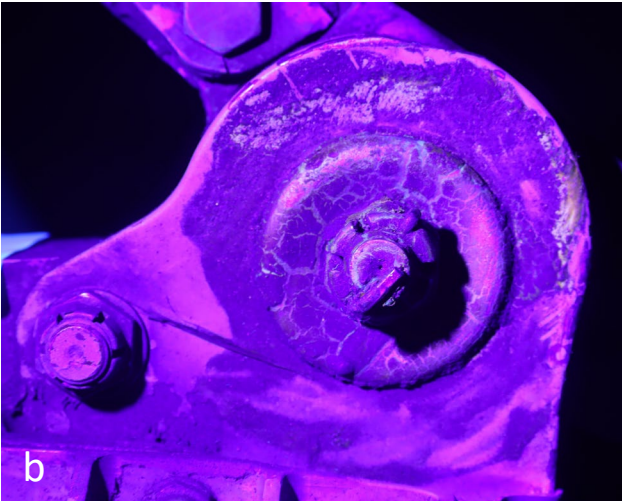
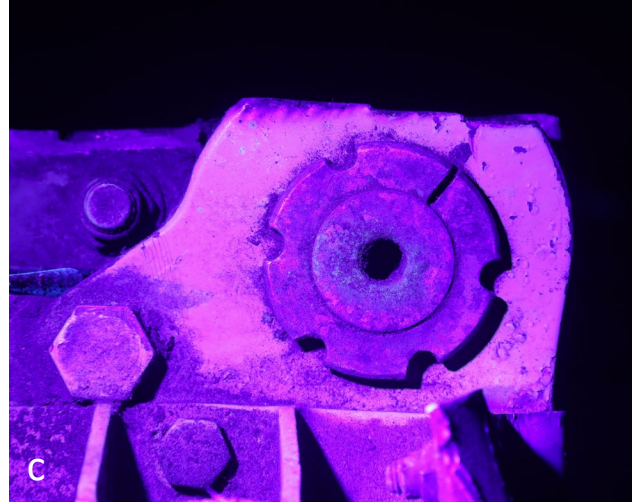
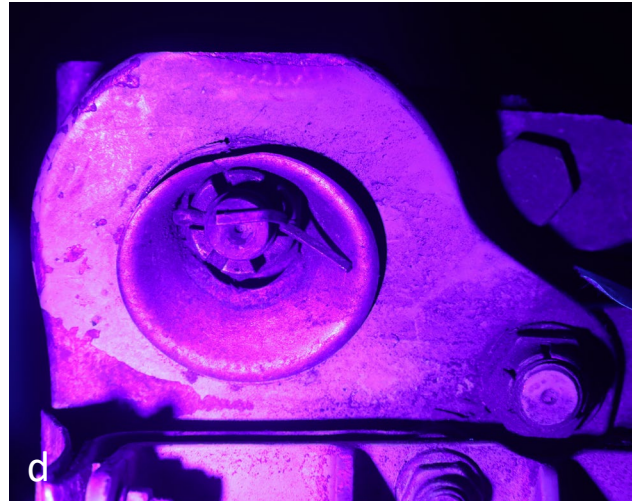
Figure 2 Side views of the attachment yokes under UV lighting conditions.

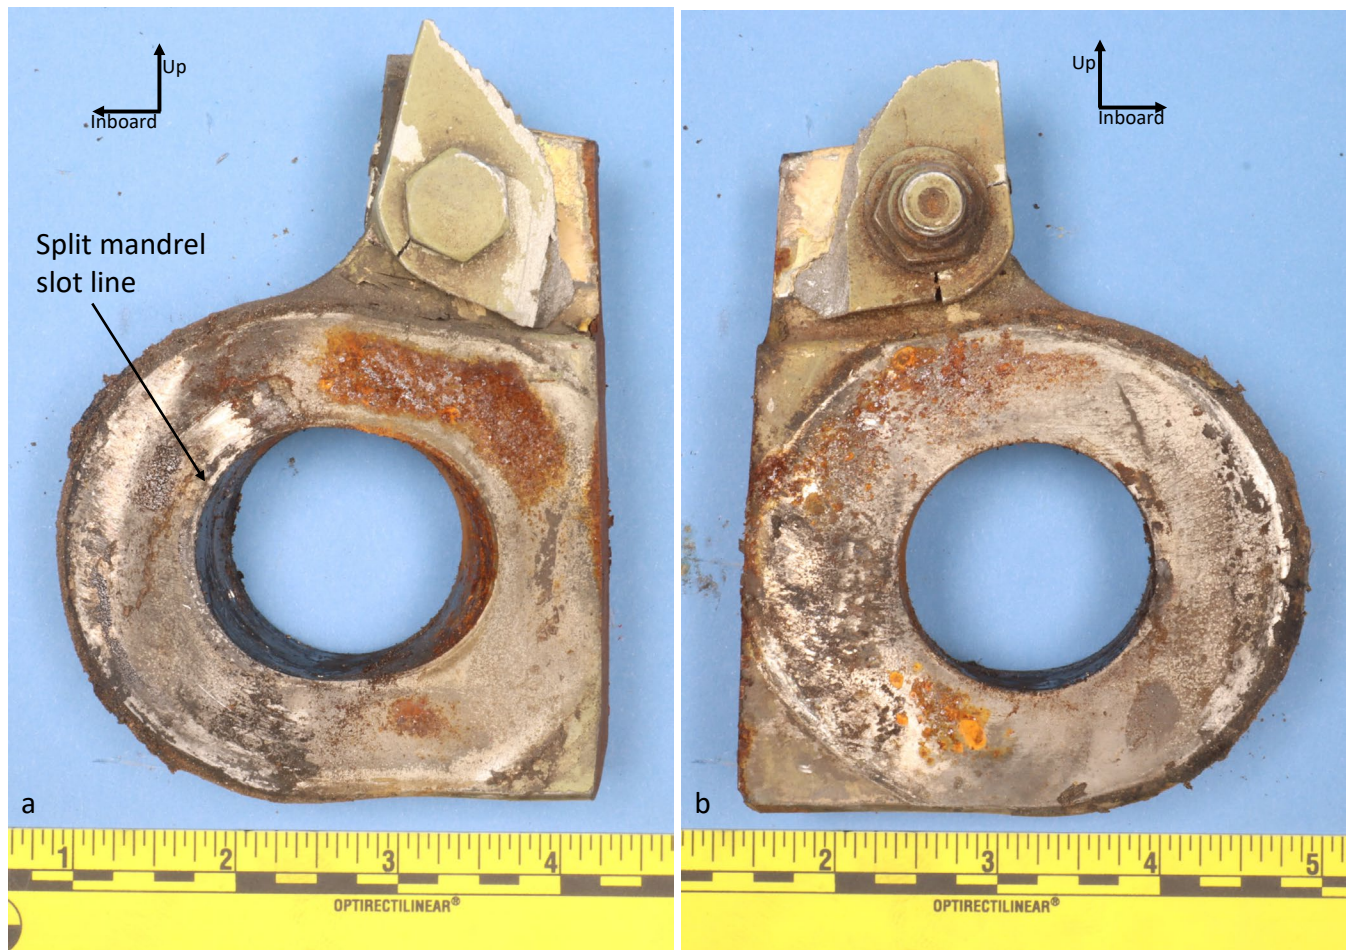
The right lower attachment fitting piece was removed from the lower yoke by disassembling the lower expansion mandrel assembly (cotter pin, castellated nut, washer, retention bolt, and tapered plug) and tapping out the split mandrel with a 1/8 inch diameter drift punch. Figure 3 shows the disassembled pieces in an exploded-view fashion. Side views of the lug portion of the right lower attachment fitting are shown in Figure 4 in the as-disassembled condition. The location of the slot in the split mandrel is annotated on

Figure 4 Images of the right outboard lower attachment fitting after disassembly from the lower yoke showing the aft (view a) and forward (view b) sides.

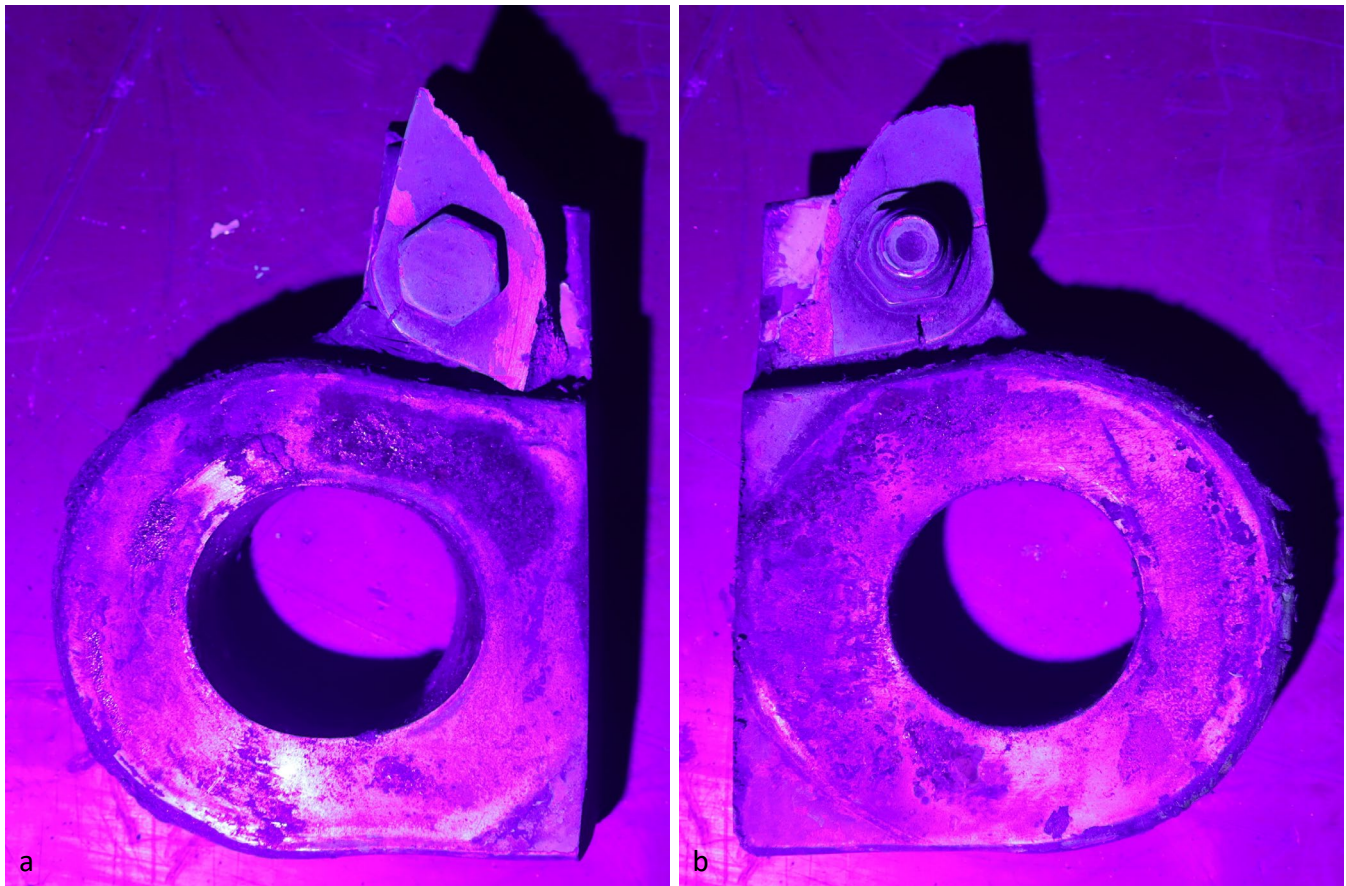
the image (Figure 4a) and on a closer oblique image in Figure 6. The lower attachment fitting piece was inspected under UV light using an UltraLite ALS inspection system with UV head at 400 nm/250 mW to identify the presence of any deposits from a fluorescent magnetic particle inspection. No positive indications of fluorescent deposits were observed on the lug (see Figure 5 for example images).

Figure 5 Images of the right outboard lower attachment fitting under UV lighting after disassembly from the lower yoke showing the aft (view a) and forward (view b) sides.

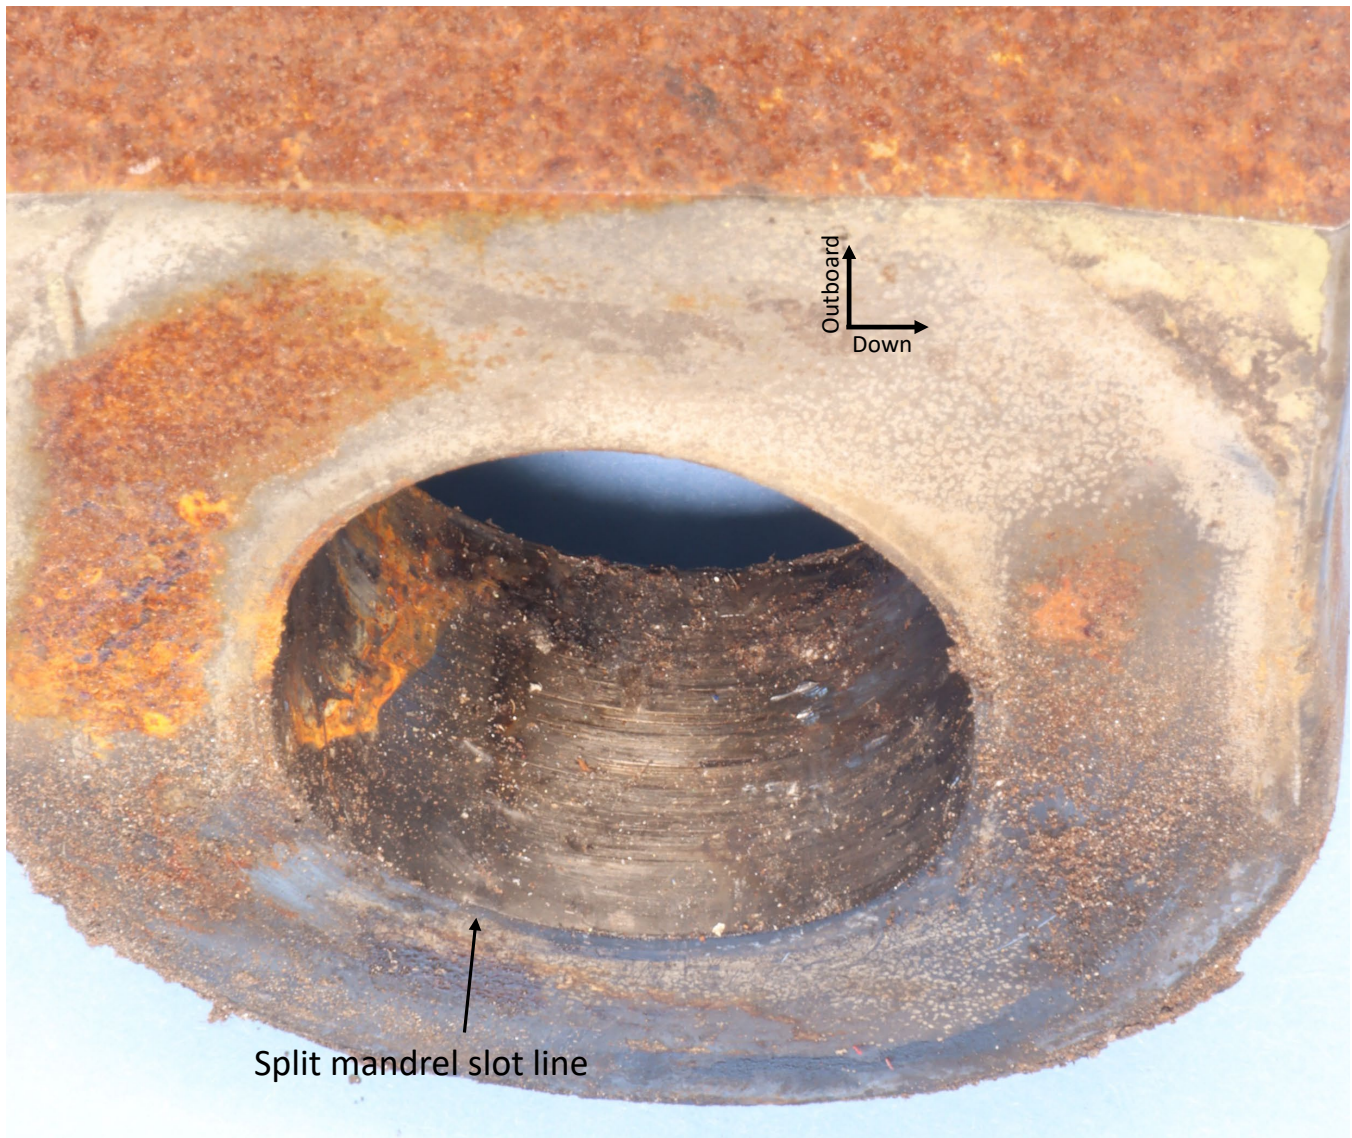
Figure 6 View of the right lower attachment fitting bore showing a witness line from the slot in the expansion mandrel.

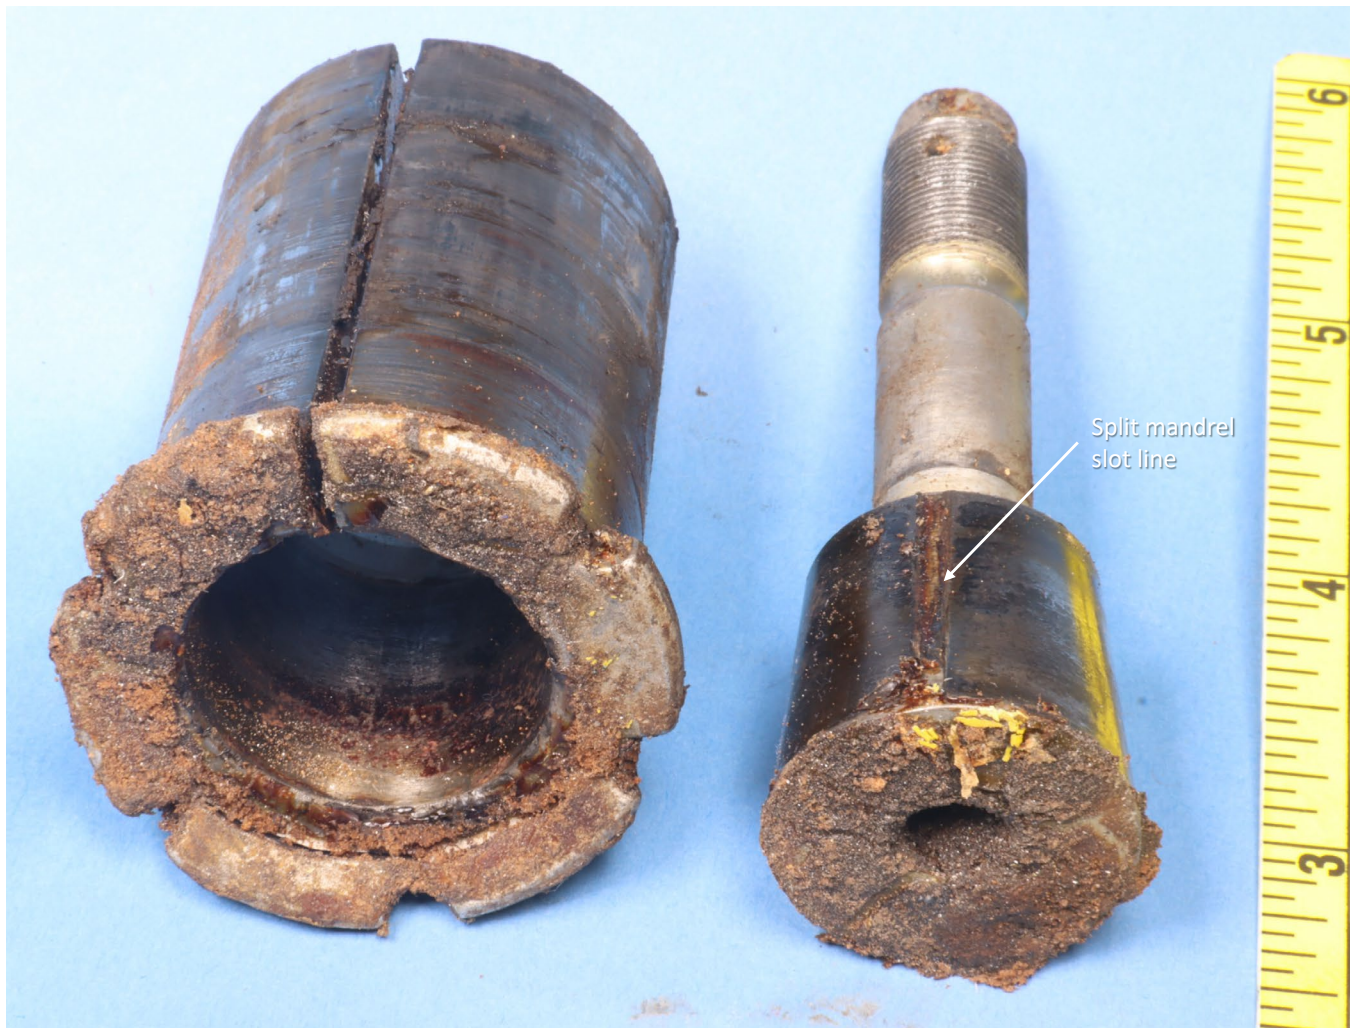
Detailed images of the as-disassembled split mandrel, tapered plug, and retention bolt are shown in Figures 7-9. As observed in Figures 7 and 8, the expansion mandrel components had a brittle and crumbling brown coating, consistent with an aged or degraded corrosion inhibitor coating such as DINITROL AV-30 or ADROX AV 30. Normally such corrosion inhibitor coatings are non-hardening and pliable as shown in an exemplar in Figure 10. Figures 7 and 8 show a line with residue where the slot in the split mandrel was present on the tapered plug and retention bolt. Faint marks were present on the tapered plug and retention bolt about 180° from the residue line.

Figure 7 Image of the split mandrel and the retention bolt. A deposit of brittle coating is present on the ends of the parts. A witness mark on the tapered portion of the retention bolt is from the slot in the split mandrel.

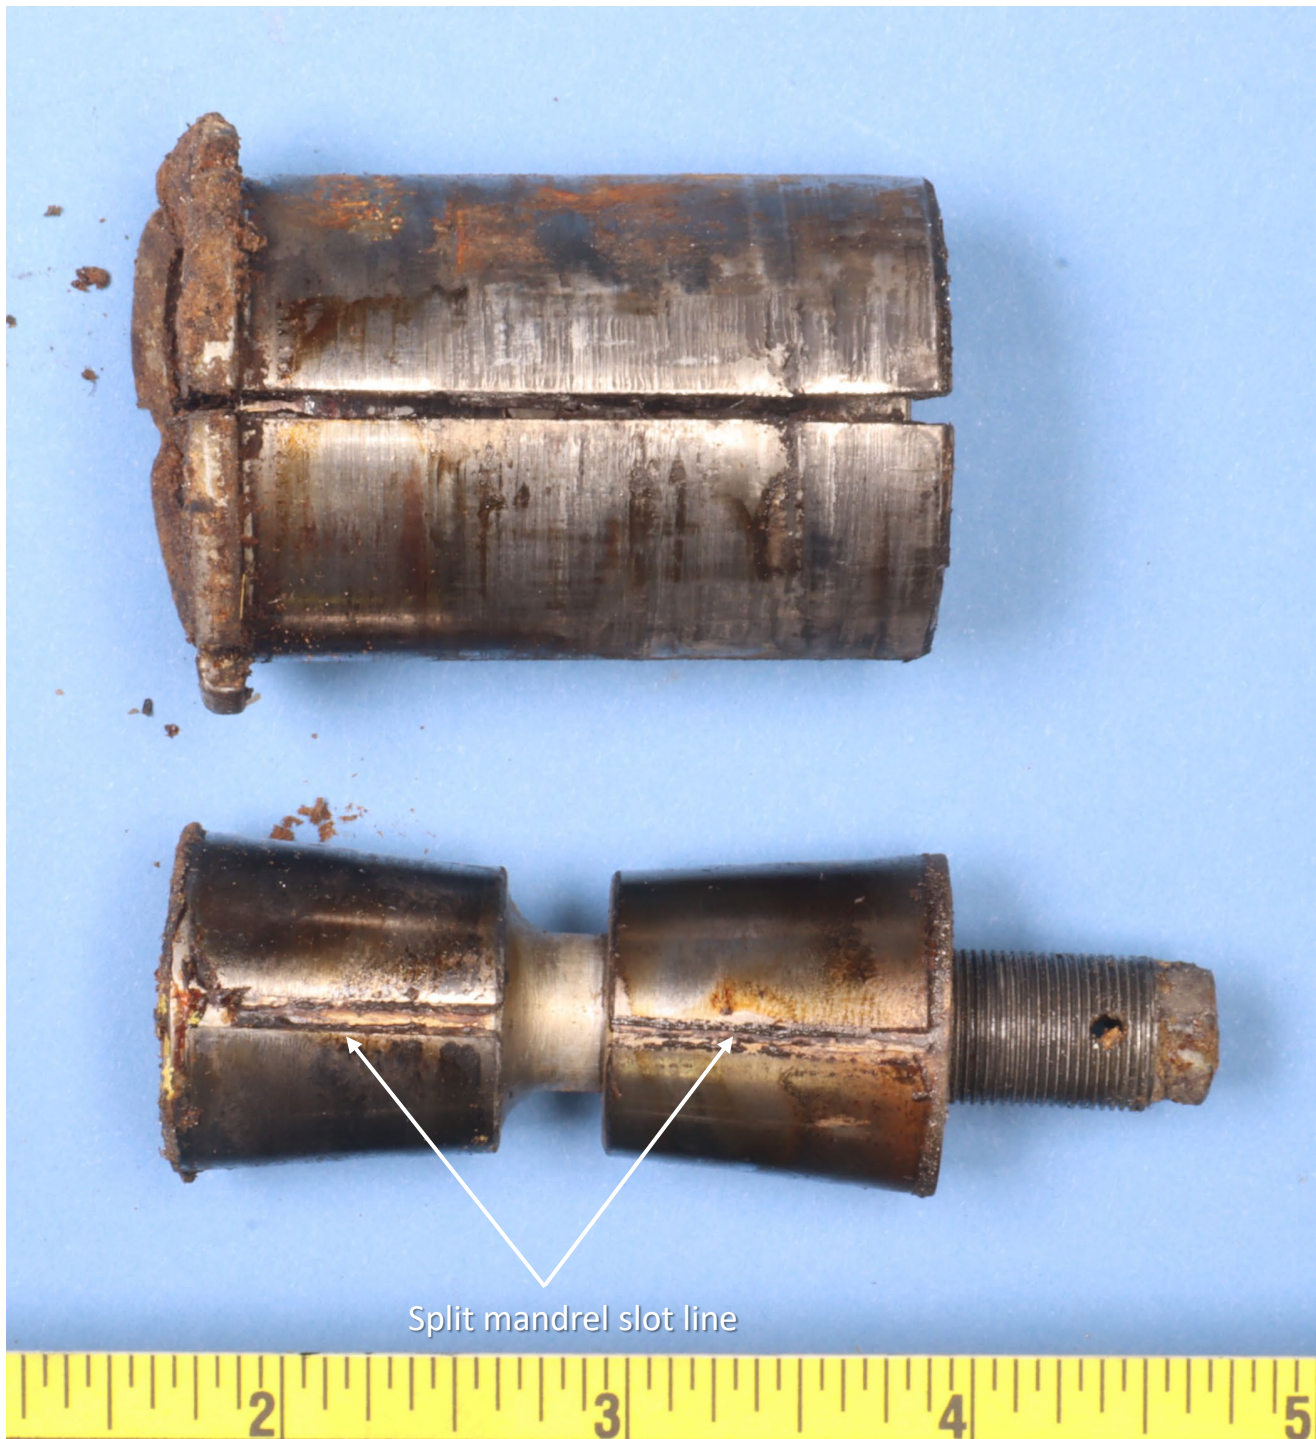
Figure 8 Image of the split mandrel, the retention bolt and tapered plug. A deposit of brittle coating is present on the ends of the parts. Witness marks on the tapered portion of the retention bolt and the tapered plug is from the slot in the split mandrel.

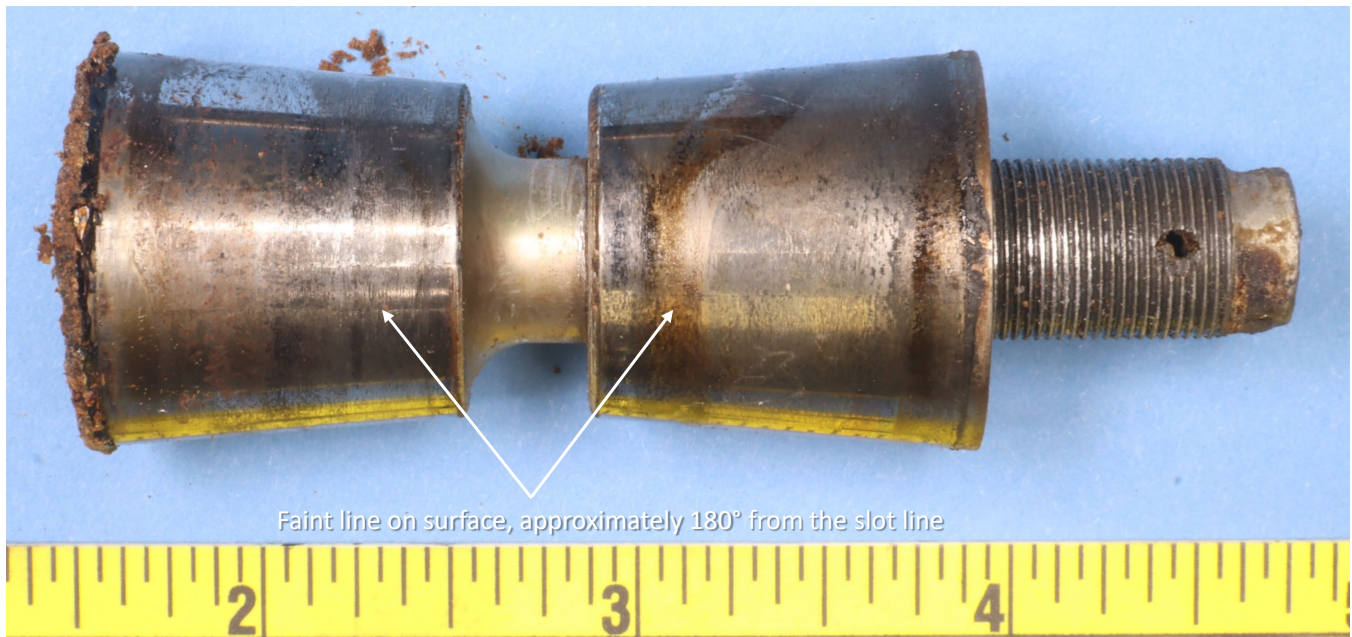
Figure 9 Image showing faint witness marks on the tapered portion of the retention bolt and the tapered plug.

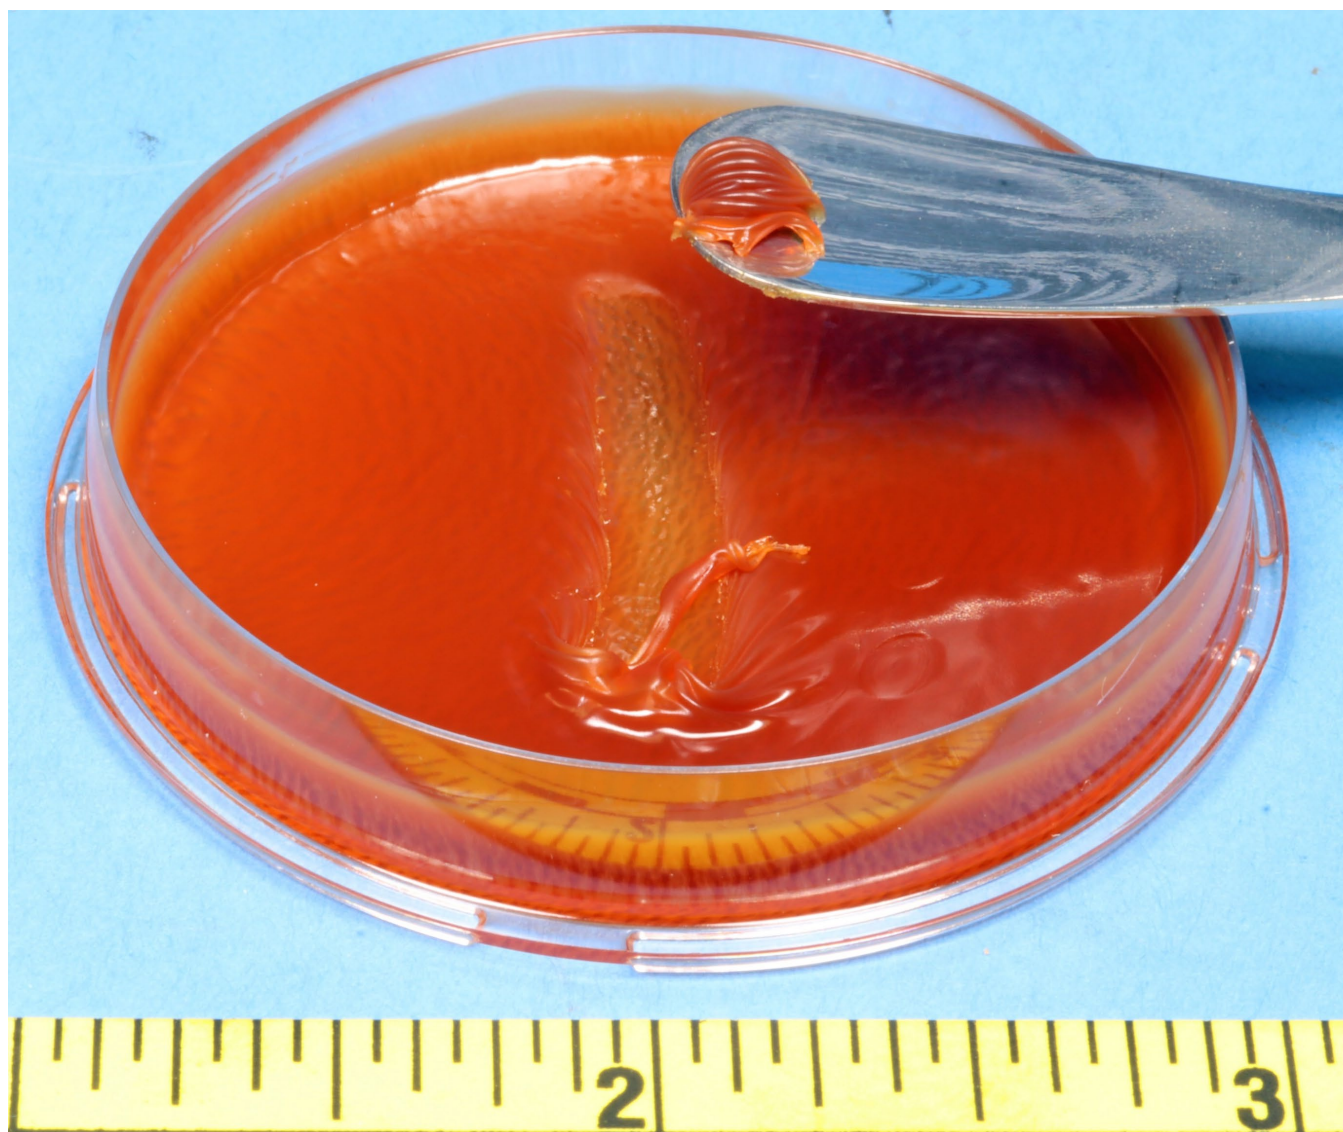
Figure 10 Image of a dish with a thick layer of dried ADROX AV 30 showing its non-hardening and pliable characteristics.

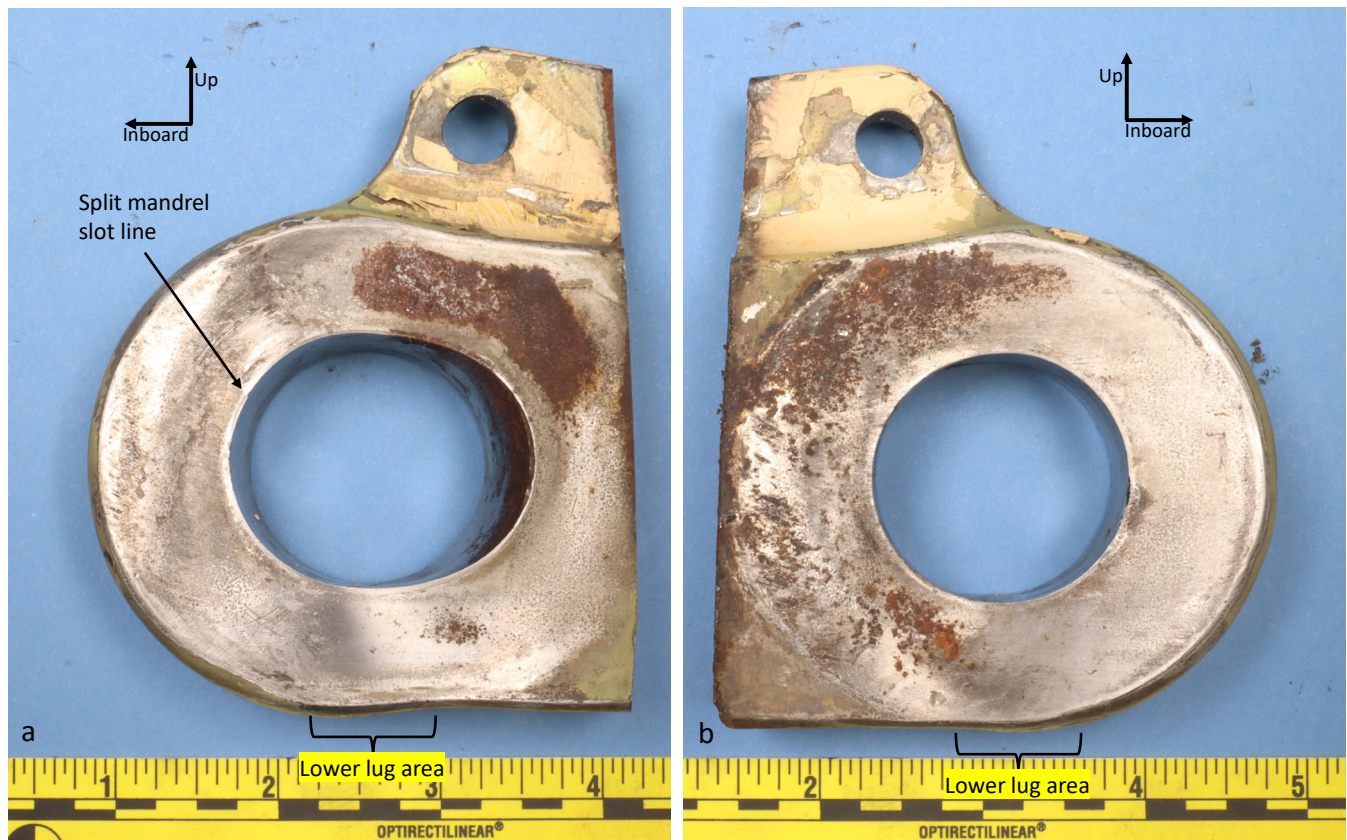
Side views of the lug portion of the right lower attachment fitting are shown in Figure 11 in the acetone-cleaned condition. The location of the slot in the split mandrel is annotated on the image (Figure 11a). Using a 5X to 50X stereo-zoom microscope the surface of the lug bore was examined for indications of corrosion, pitting, and cracks. Close views of the bore surface along the lower lug are shown in Figures 12-13. Pitting indications are shown in Figure 13. No crack indications were observed.

Figure 11 Images of the right outboard lower attachment fitting after cleaning in acetone showing the aft (view a) and forward (view b) sides.

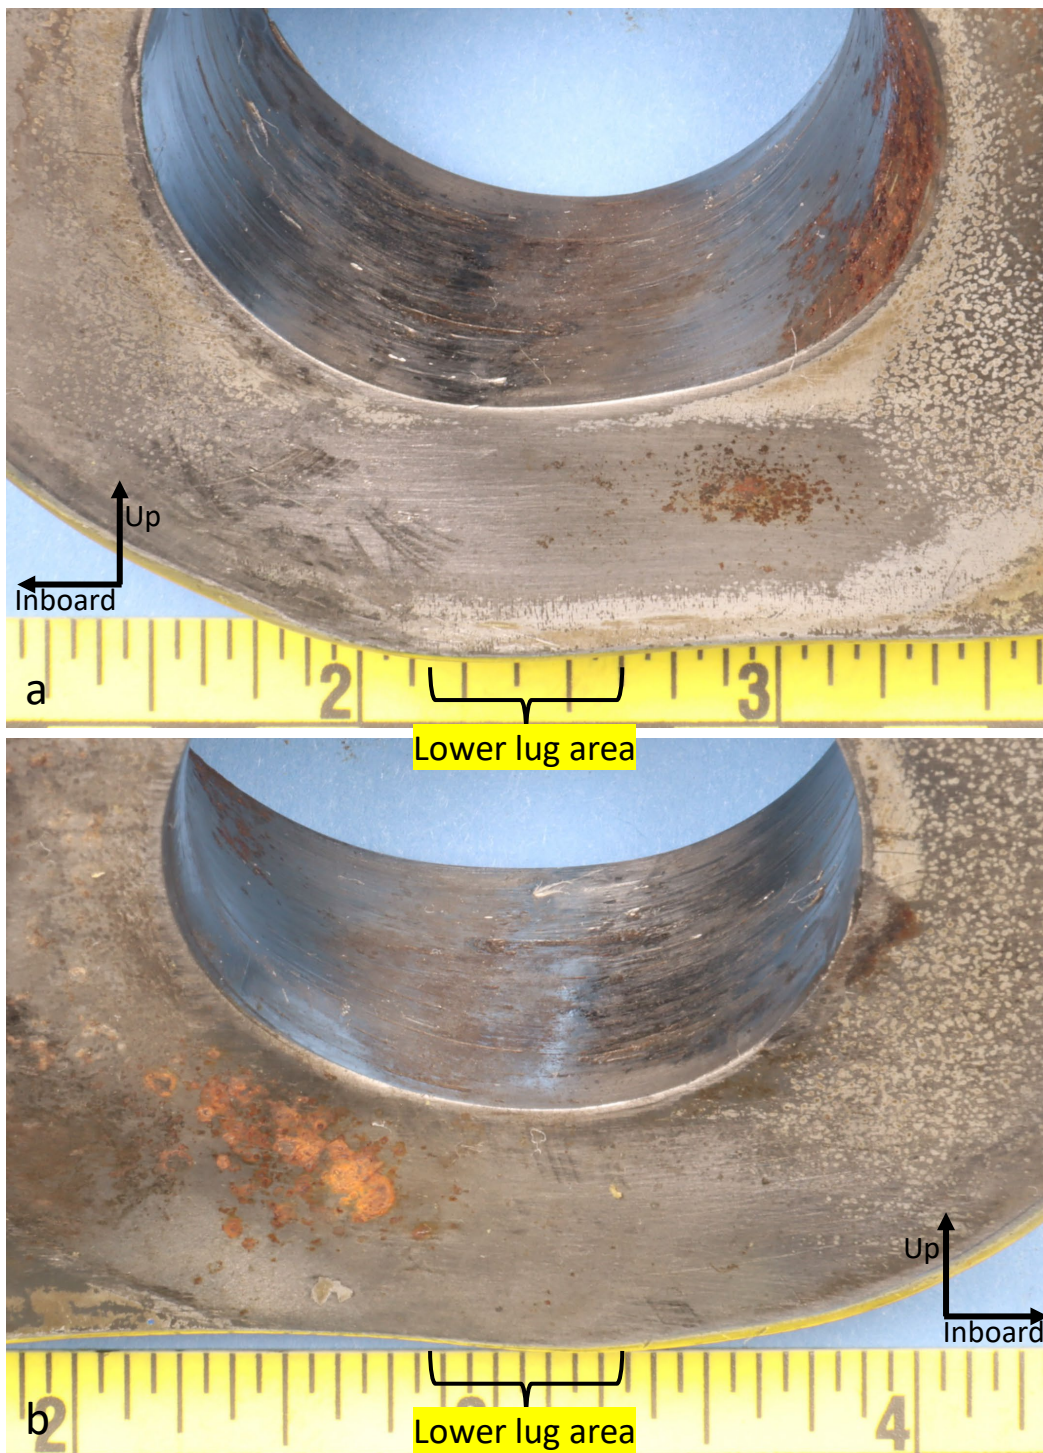
Figure 12 Views of the right lower attachment fitting bore at the lower lug. View a is an image of the lower lug bore area looking forward. View b is an image of the lower lug bore area looking aft. A closer image is shown in Figure 13.

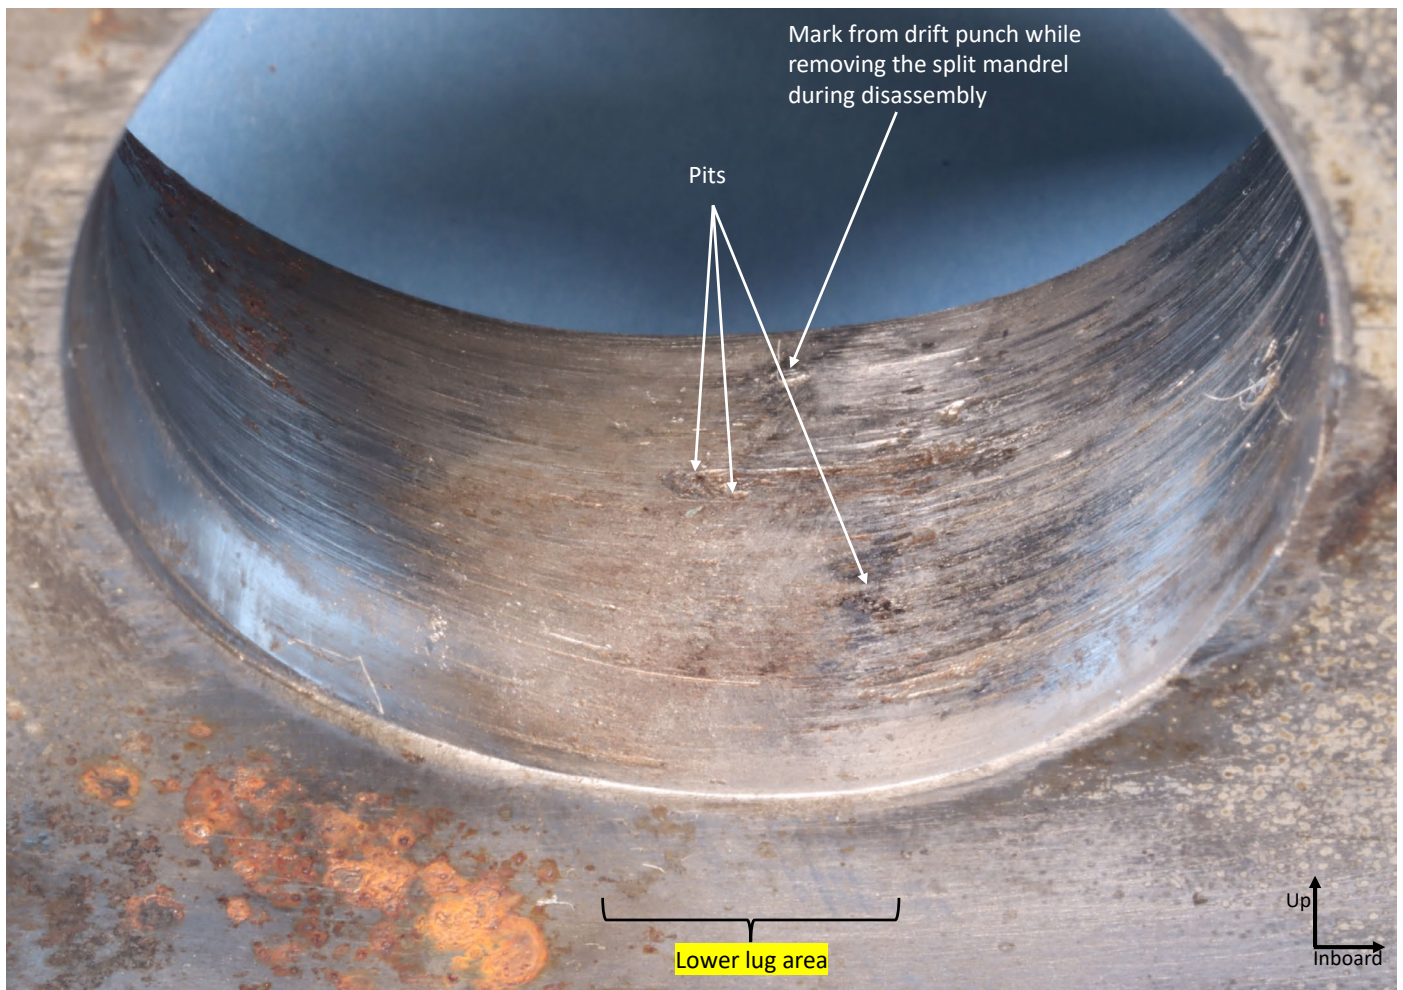
Figure 13 View of the right lower attachment fitting bore at the lower lug (see Figure 12b). Deep pits are present along with numerous circumferential marks or scratches.
