**CEN21FA320  
PIPER PA28-180  
N2801T  
Muscatine, IA  
July 14, 2021**

## **GRYOSCOPIC INSTRUMENT EXAMINATION NOTES**

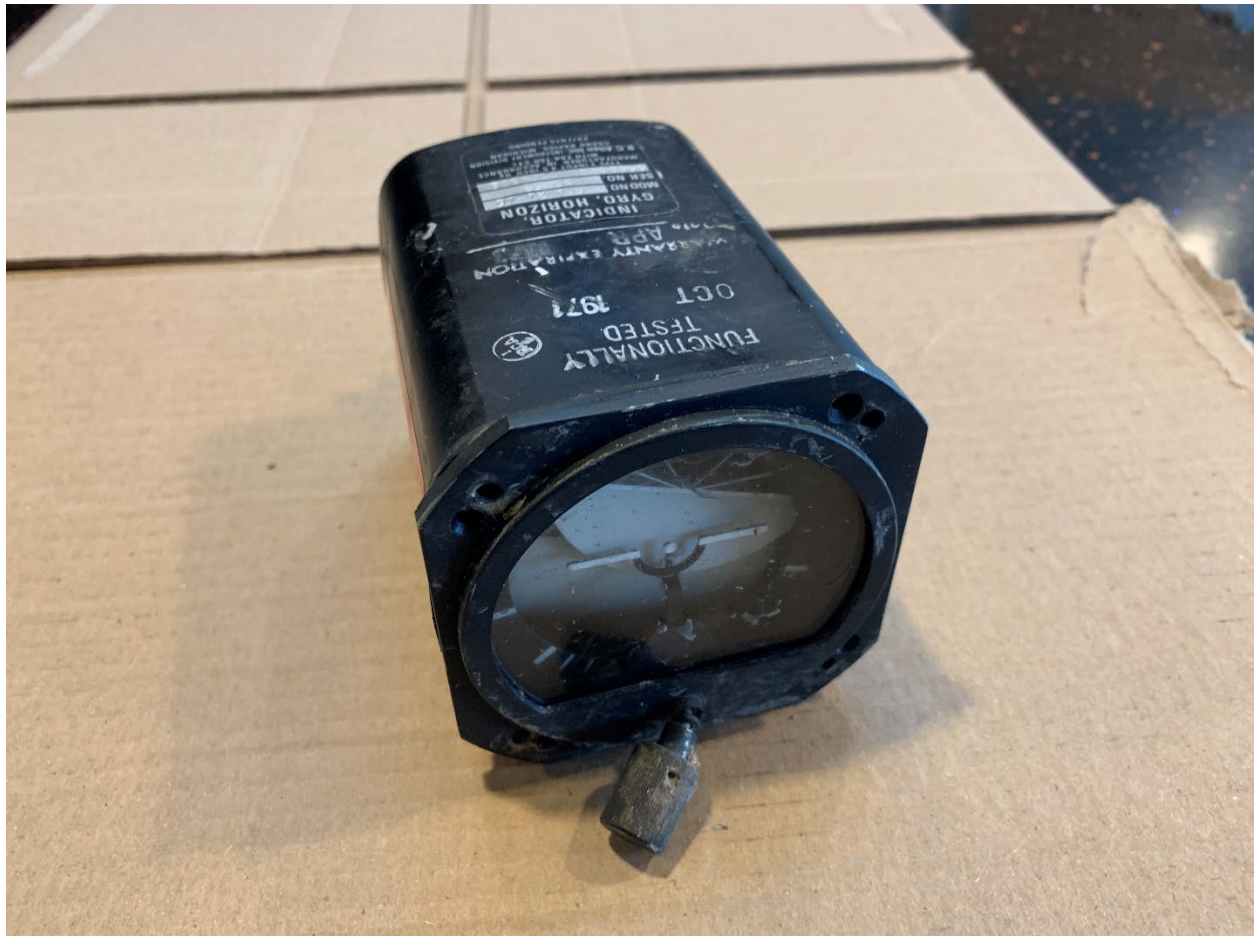
The Artificial horizon, shown in the figure above, was predominately intact with external damage to the setting knob on the front of the instrument.

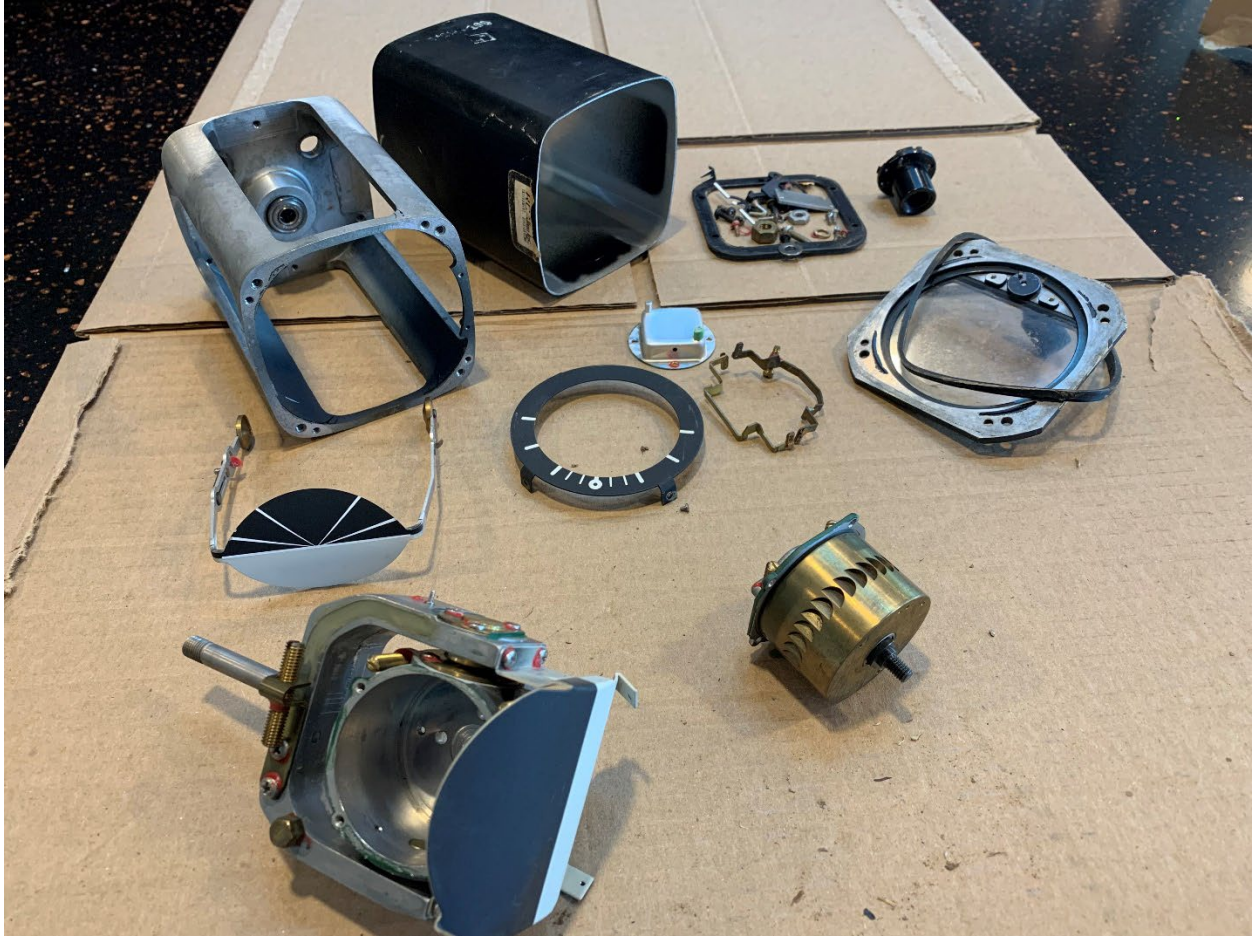
The instrument was disassembled, as shown above, to determine if any witness marks were present to indicate operation. During disassembly, all parts moved freely and no defects were noted regarding any linkages or hinge points. The brass gyroscope core was still mounted in its housing and all mounting points and bearings were intact. The bearings rotated freely.

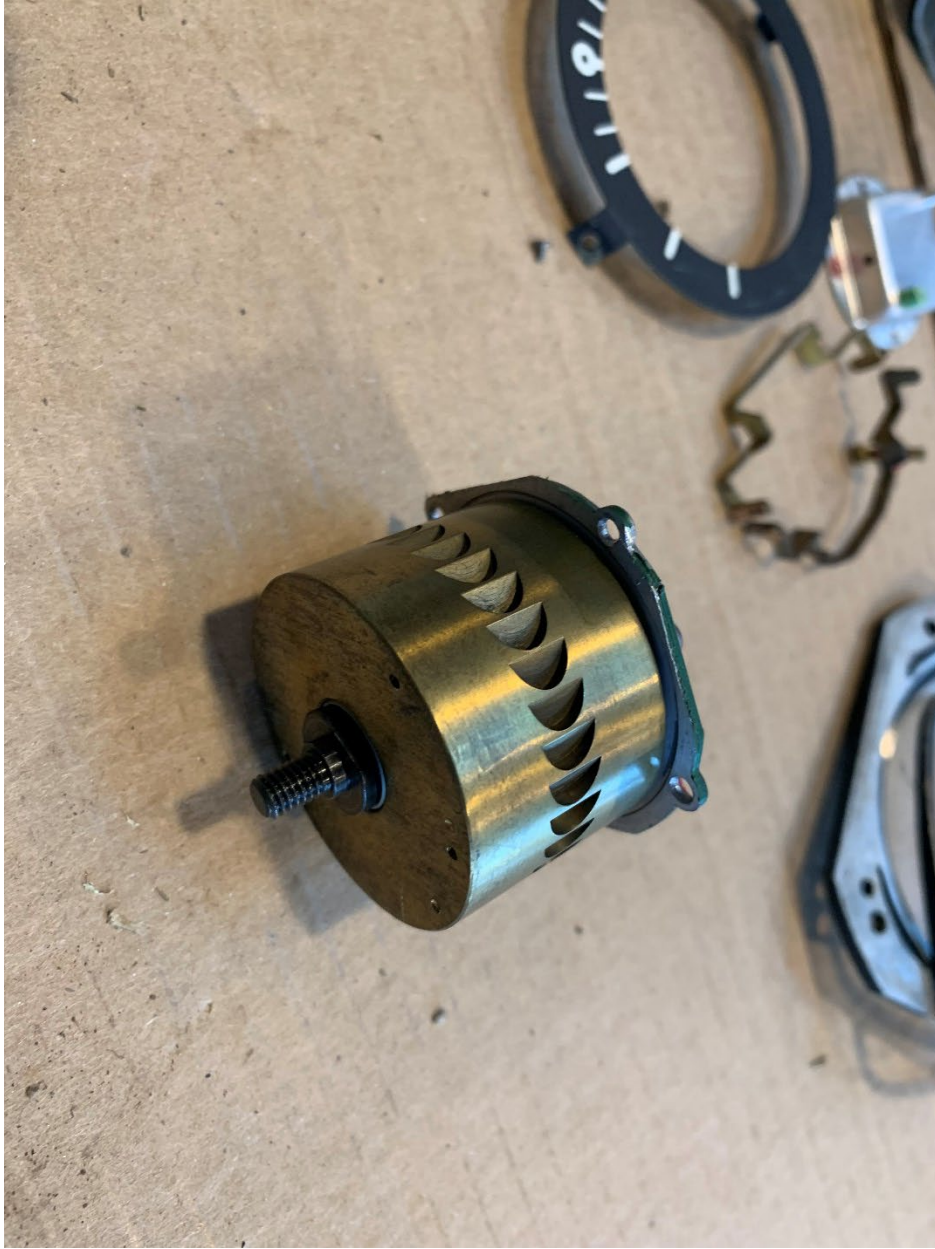
There was no damage to the rotor, bearings, shaft, mounting points or the housing which contained the gyroscope core and there were no witness marks on either the core or the housing that contained it. No preimpact defects were found that would have prevented operation.

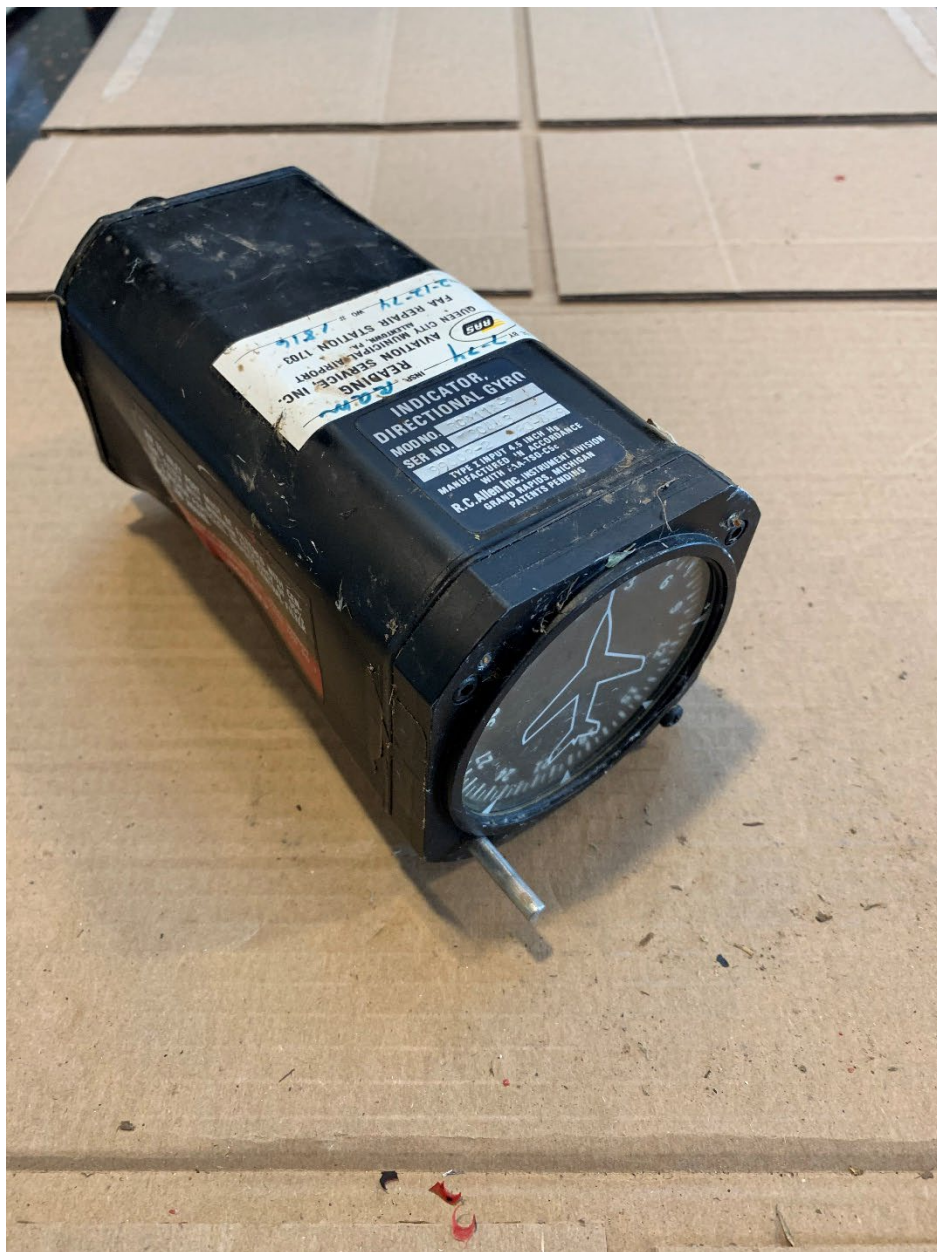
The Directional gyro was predominately intact but did have damage to the external case. Before disassembly, rotation of the setting shaft (knob missing) resulted in rotation of the compass card inside the unit as expected.

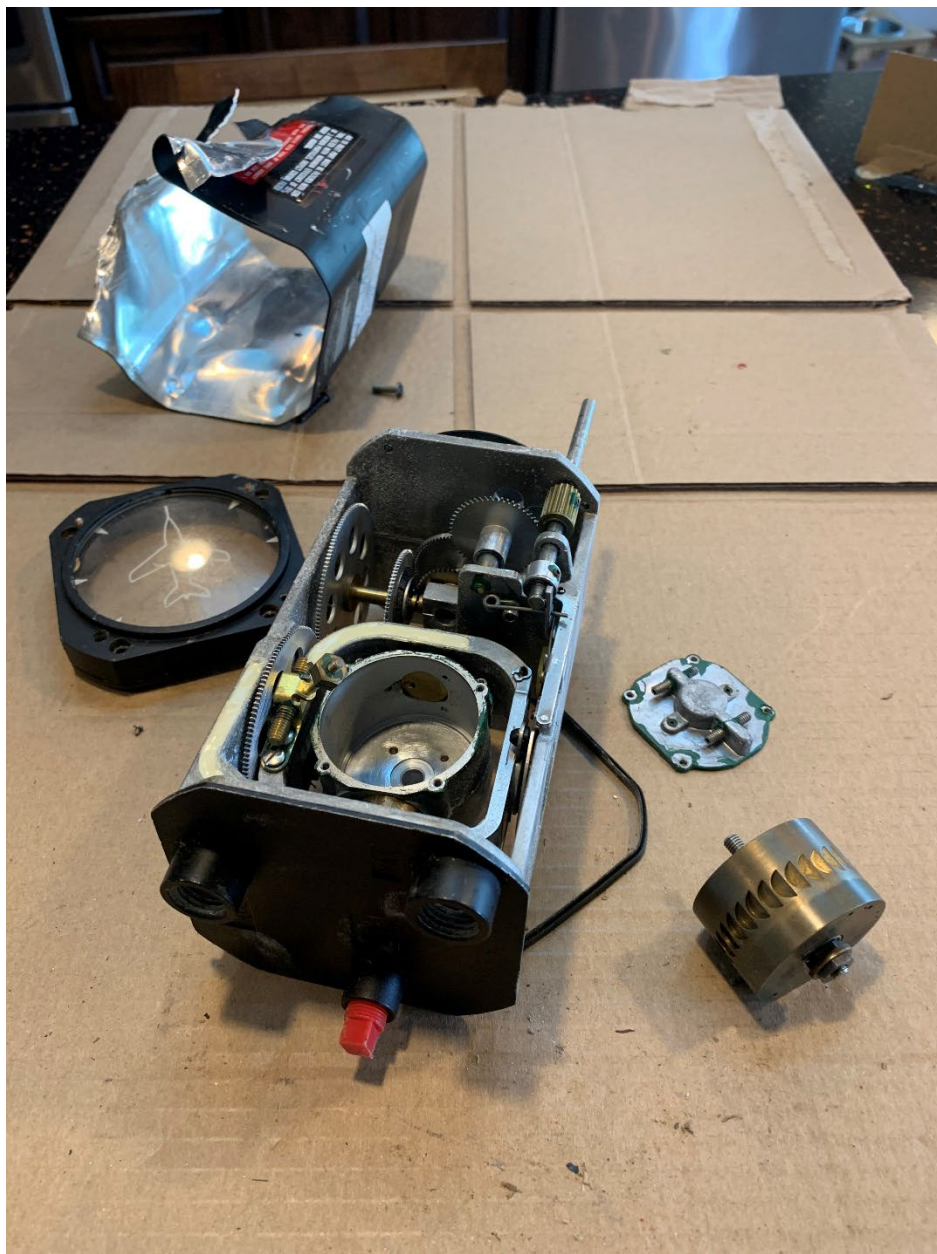
Disassembly of the directional gyro required cutting of the outer housing to facilitate removal. Examination of the internal components of the gyro did not reveal any anomalies. Removal of the gyroscope core revealed that the core, shaft, bearings, and core housing were not damaged. The bearings rotated freely.

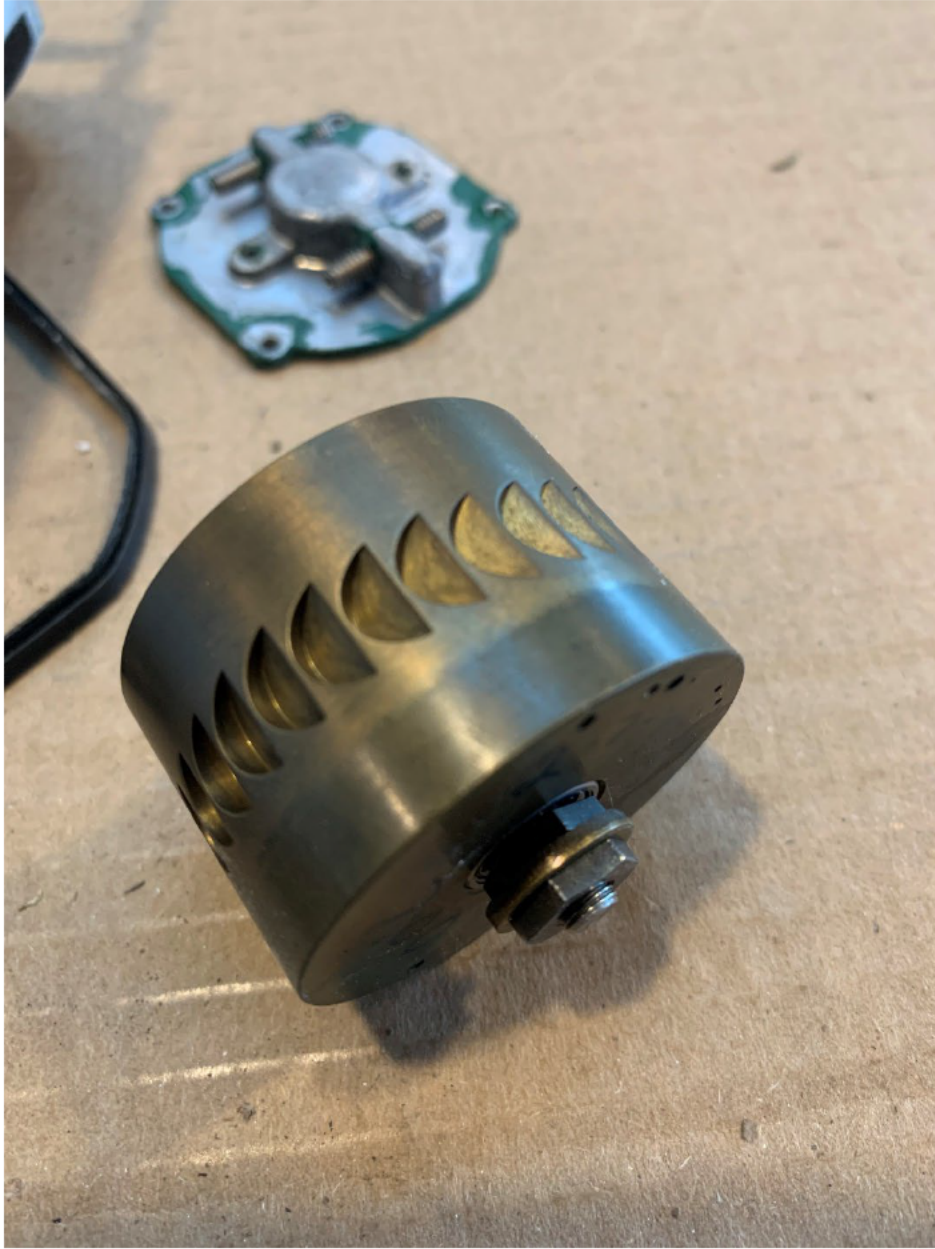
There were no rotational witness marks on the gyro core or the housing that contained it. No preimpact defects were found that would have prevented operation.
