NATIONAL TRANSPORTATION SAFETY BOARD  
Vehicle Recorder Division  
Washington, D.C. 20594

## Handheld Global Positioning System (GPS)

Specialist's Factual Report  
By W. Deven Chen

Location: Comstock, Texas  
Date: July 17, 2021  
Aircraft: Luscombe 8F  
Registration: N2054B  
Operator: Private  
NTSB Number: CEN21FA327

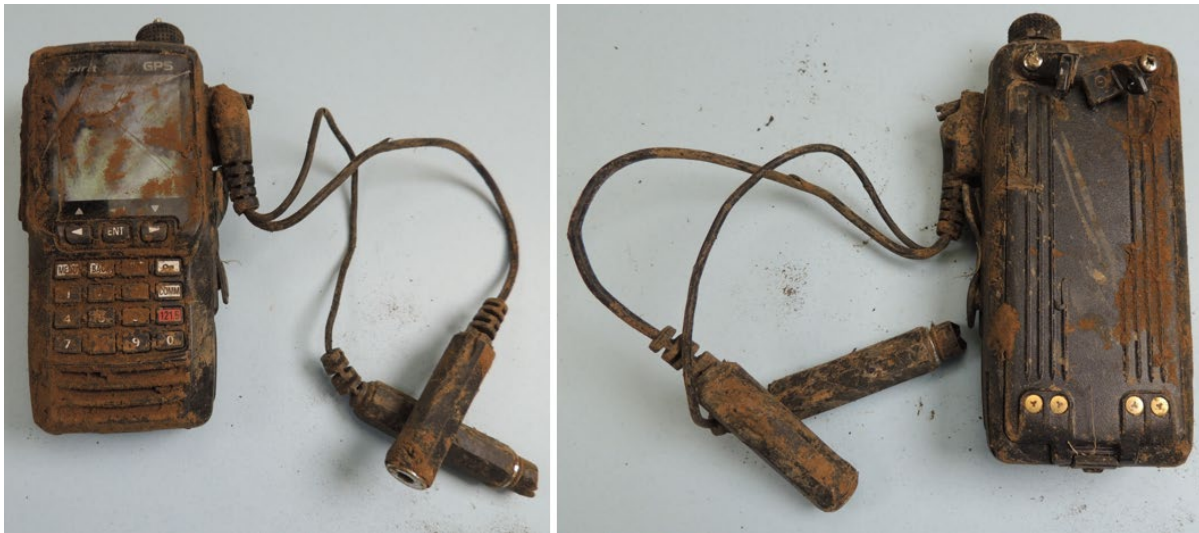
Upon arrival at the Vehicle Recorder Division, an exterior examination revealed that the device had sustained severe impact damage, as shown in Figure 1. The circuit boards were removed from the device and found to have sustained minor damage. The circuit

Figure 1. Front and back of the YAESU handheld GPS as received.

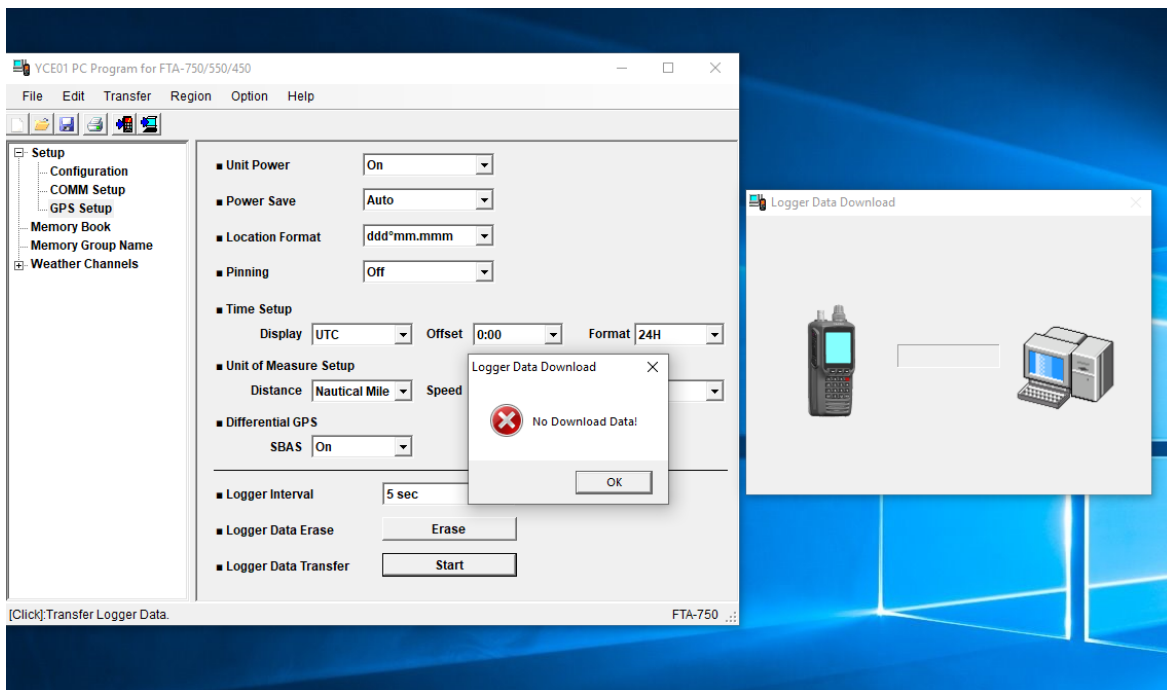
boards were cleaned and placed into a surrogate device, but it did not power on. The device was then sent to the manufacturer for technical support. After further examination, the manufacturer stated that the device would require a memory module transplant for data recovery due to its damage; however, due to technical challenges, the manufacturer could not perform the procedure at its facility. The device was returned to the Vehicle Recorder Division where a memory module transplant was attempted by hand with hot-air and soldering tools. The device turned on normally after the procedure and was connected to the manufacturer's software. The device communicated normally with the software; however, it showed there were no data on the device to be downloaded, as shown in Figure 2. Thus, there were no data recovered from this device.

Figure 2. Manufacturer's software indicating no data on the device to be downloaded.
