# National Transportation Safety Board

CEN21FA330

## **WRECKAGE EXAMINATION SUMMARY**

Location: Elgin, Minnesota  
Date: July 19, 2021  
Time: 1600 central daylight time (2000 UTC)  
Airplane: Robinson R44 II, Registration No. N44BJ

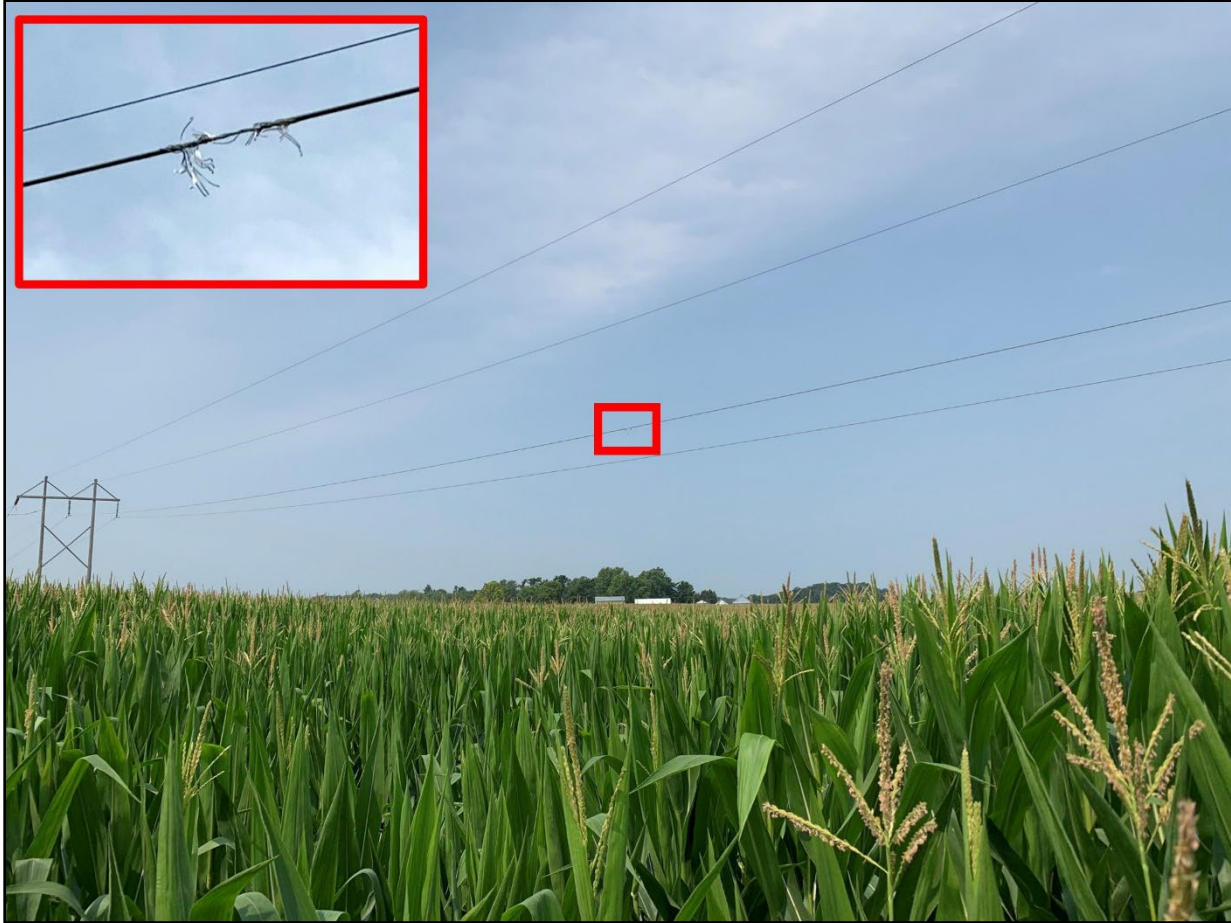
The initial impact location was a multi-phase power transmission line, as shown in figure 2. The western line remained intact, the center line exhibited fraying, and the eastern line was severed. The transmission lines consisted of 3 (477ACSR type) 24 aluminum conducting strands over 7 steel strands. The GPS elevation below the transmission lines was 1,080 ft. The frayed transmission line at the point of damage was about 28 ft above the ground. The height of the corn crop under the transmission lines was 8-10 ft tall. Portions of the swashplate yoke, a blade droop tusk, pilot's headset, sunglasses and ballcap, and plexiglass fragments were located under and immediately east of the power transmission lines.

**Figure 2.** Power lines above the cornfield with a red rectangle identifying the center power line that was damaged during the accident. A separate closeup photo shows the frayed center power line in more detail.

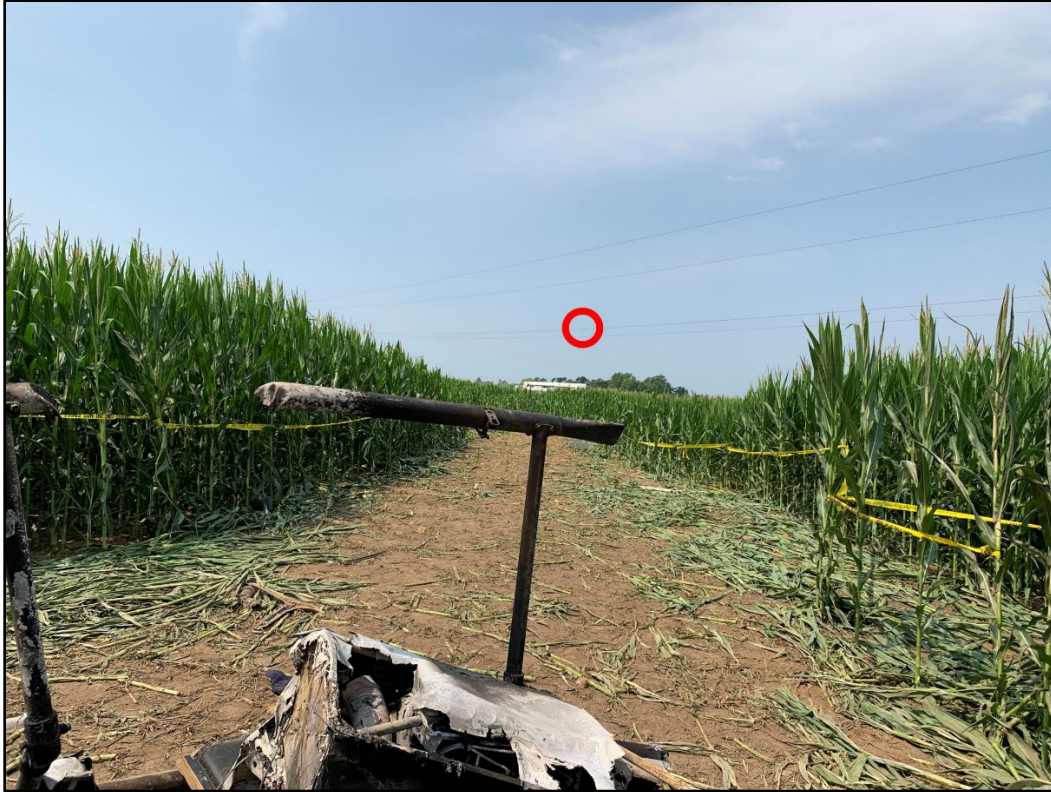
The wreckage debris path measured 292 ft between the power transmission lines and the main wreckage, as shown in figure 3. The wreckage debris path through the cornfield was on a 090° heading. The helicopter impacted terrain in a 15° descent angle, as shown by the severed corn crop. Fractured portions of the spray booms, cabin door, and plexiglass were scattered along the wreckage debris path.

**Figure 3.** Wreckage debris path with red circle showing the location of wire strike

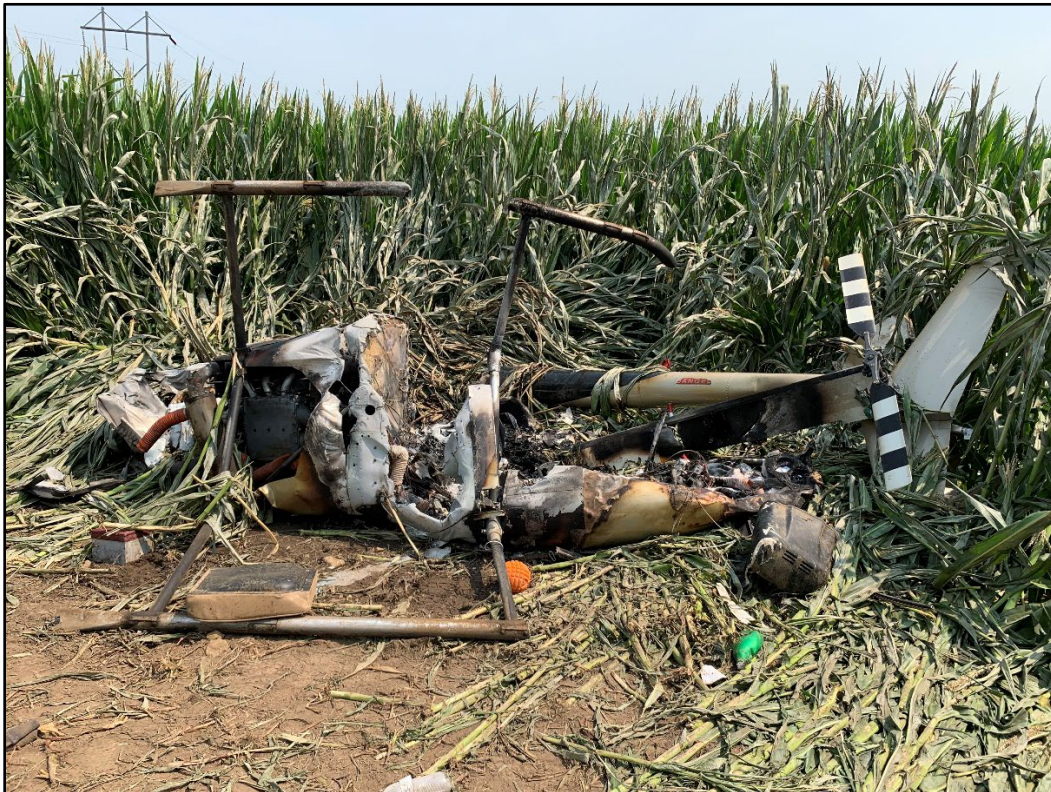
The main wreckage, as shown in figure 4, included remnants of the cabin, landing skids, cockpit, engine, main rotor transmission, main rotor head, main rotor blades, aft fuselage, sheaves, tail rotor drive shaft, tailboom, tail rotor gear box, and tail rotor blades. The relatively intact product tank and its support frame was located about 15 ft north of the main wreckage.

**Figure 4.** Main wreckage at the accident site

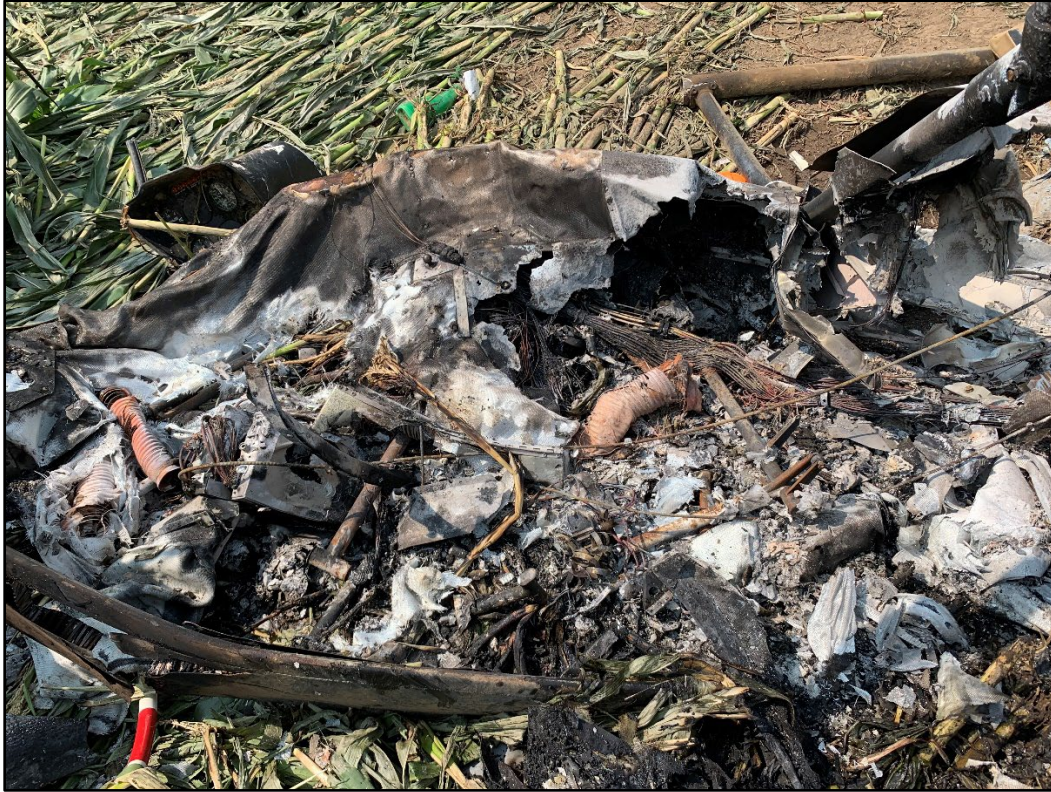
Most of the cabin and cockpit were destroyed by the postimpact fire, as shown in figure 5. Flight control continuity could not be established due to extensive damage sustained during impact and postimpact fire. The firewall remained intact with the engine partially attached to the mounts. The upper and lower instrument panel remained attached through electrical wires.

**Figure 5.** Main cabin and cockpit

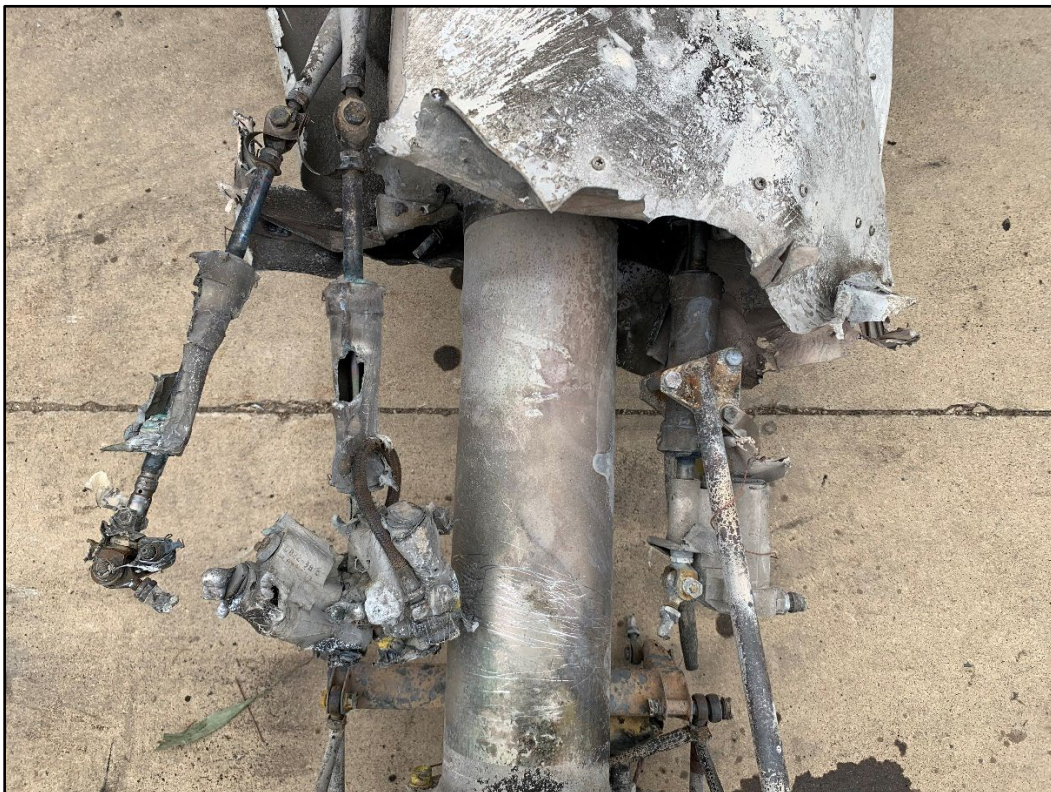
The main rotor transmission remained attached to its structural airframe mounts. The three hydraulic flight control actuators exhibited extensive thermal damage from the postimpact fire and could not be tested, as shown in figure 6. The lower connections of each hydraulic actuator exhibited impact related separations. The control tubes were bent within the main rotor mast housing but remained attached at the non-rotating portion (lower) swashplate. The rotating portion (upper) swashplate exhibited significant damage and the main rotor pitch control links were fractured. The upper portion of the main rotor mast above the swash plate was bent about 15°. Main rotor transmission continuity was established as the main rotor head was rotated by hand.

**Figure 6.** Hydraulic flight control actuators

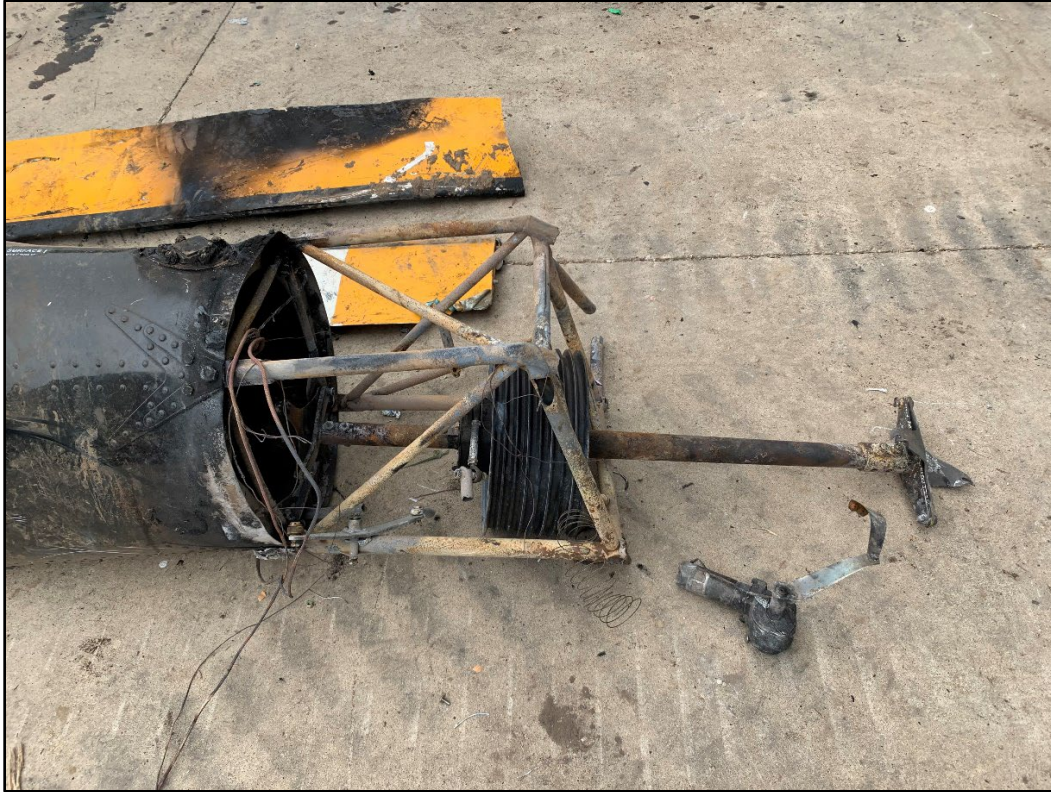
The tailboom separated into two sections. The forward section of the tailboom remained mostly attached to the fuselage support structure and contained a portion of the tail rotor drive shaft and upper sheave with sprag clutch, as shown in figure 7. The vertical stabilizer, horizontal stabilizer, stinger, tail rotor gearbox, remained attached to the remaining tailboom, as shown in figure 8. The tail rotor blades remained attached to the tail rotor gear box output shaft. The tail rotor blade pitch change links remained intact and moved freely. Rotation of the tail rotor blades established continuity through the tail rotor gear box. The tail rotor drive shaft and tail rotor blade pitch control tube exhibited bending overstress fractures, as shown in figure 9.

**Figure 7.** Forward section of tailboom

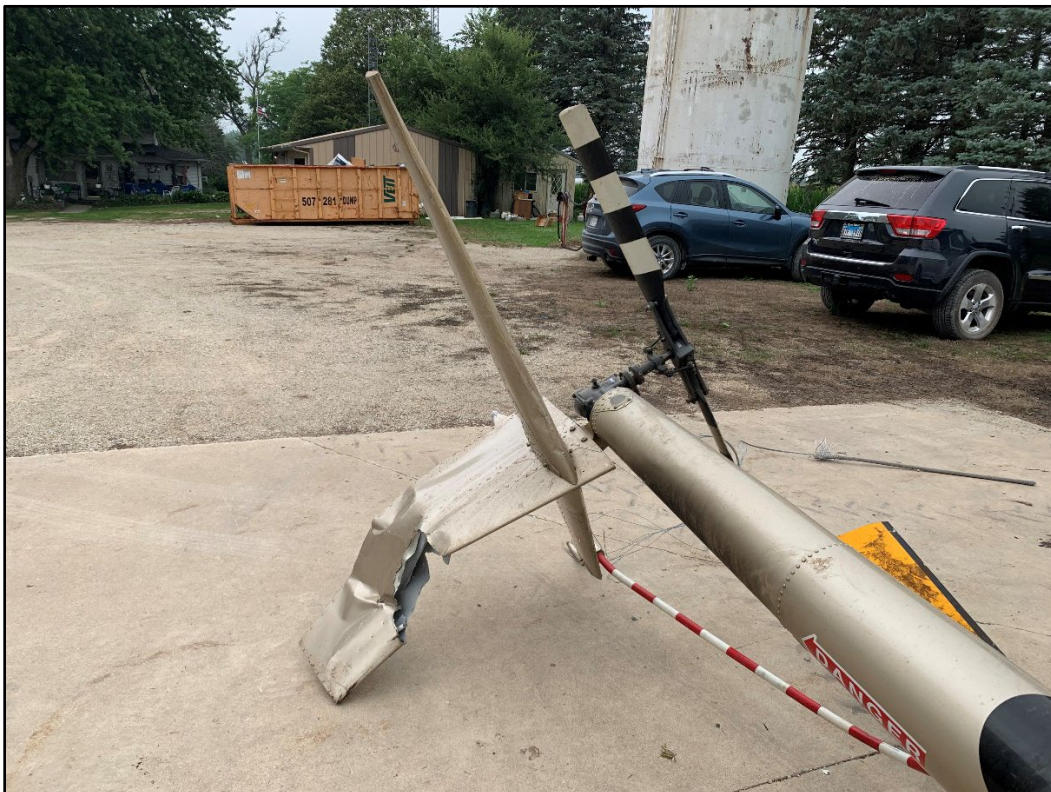
**Figure 8.** Aft section of tailboom

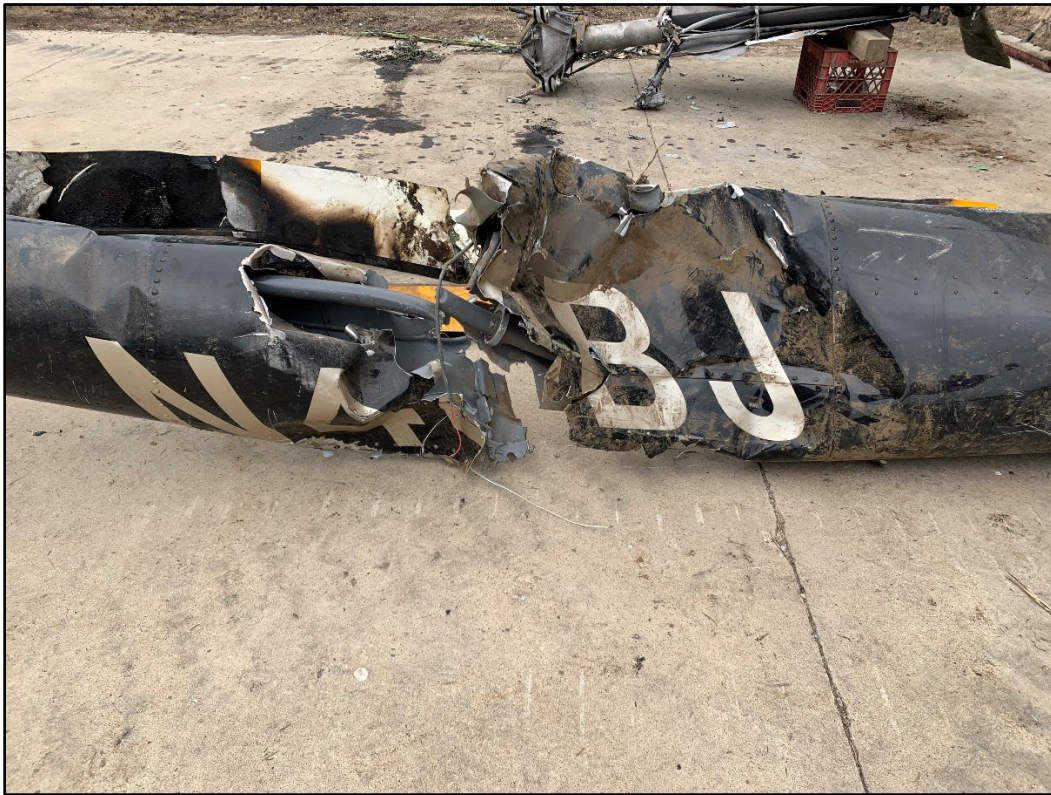
**Figure 9.** Tailboom boom separation about midspan

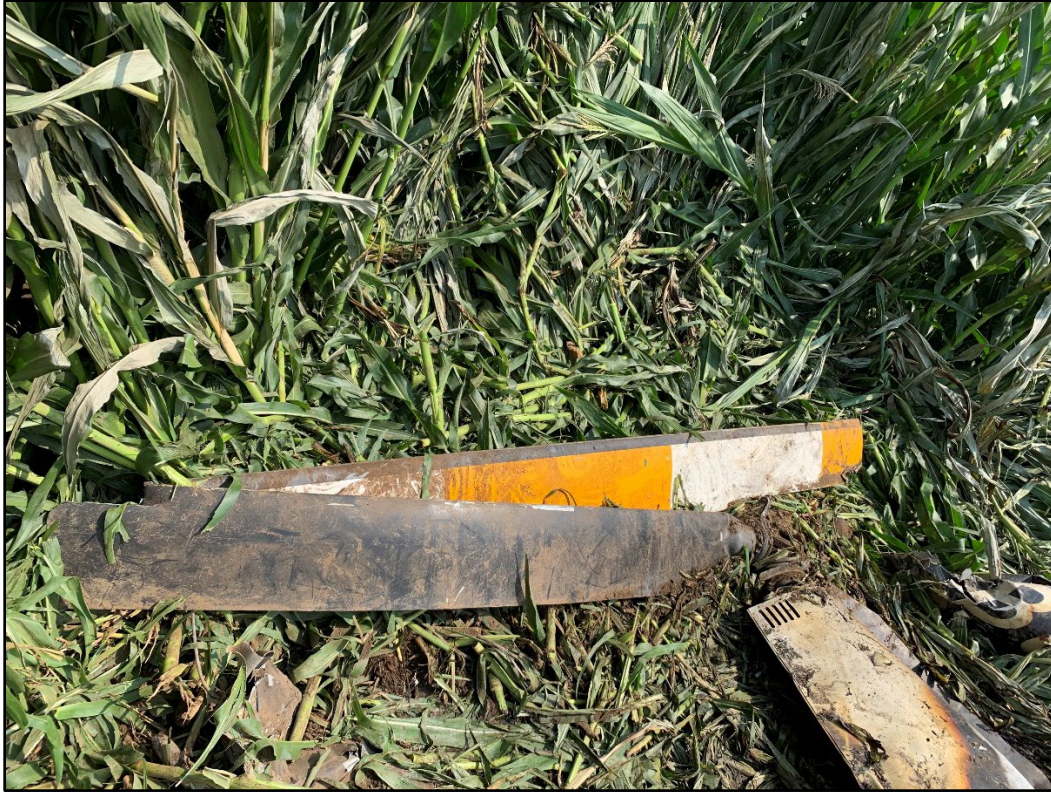
Both main rotor blades were cut about 18 inches from the main rotor head to facilitate wreckage recovery. One of the two main rotor blades remained intact but folded in half during impact, as shown in figure 10. The outboard 3 ft of the other main rotor blade was not located during the on-scene investigation. The blade fracture exhibited damage consistent with impact with a power transmission line, as shown in figure 11. On October 5, 2021, the missing outboard 3 ft of the main rotor blade was located by a farmer during harvest. The outboard 3 ft blade section, as shown in figure 12, was located about 465 ft south of where the helicopter impacted the power transmission line.

**Figure 10.** Main rotor blade

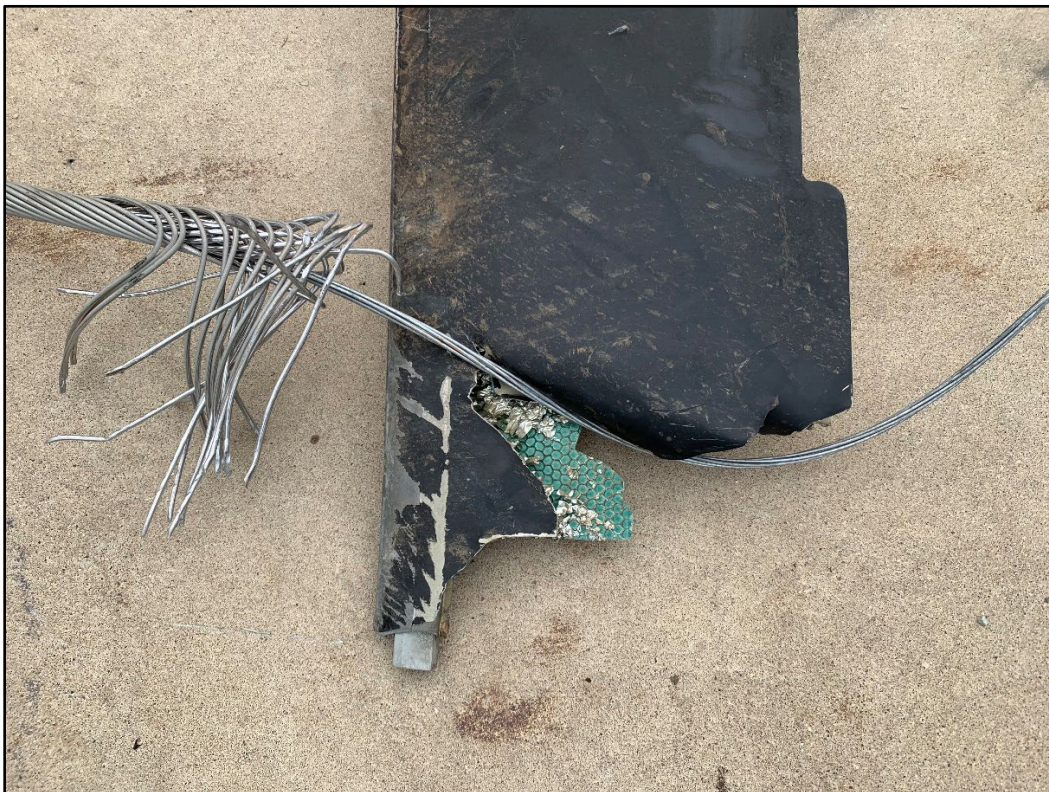
**Figure 11.** Main rotor blade fracture with the severed power transmission line

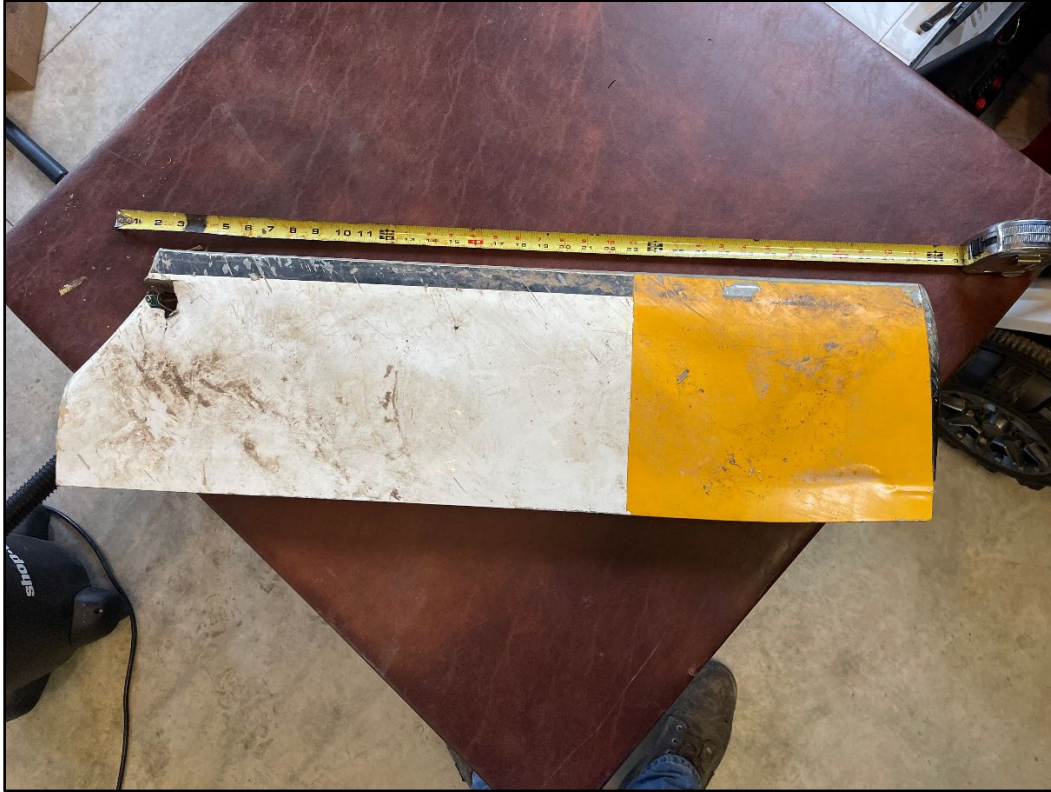
**Figure 12.** Outboard 3 ft of main rotor blade found on October 5, 2021 (photo provided by helicopter operator)

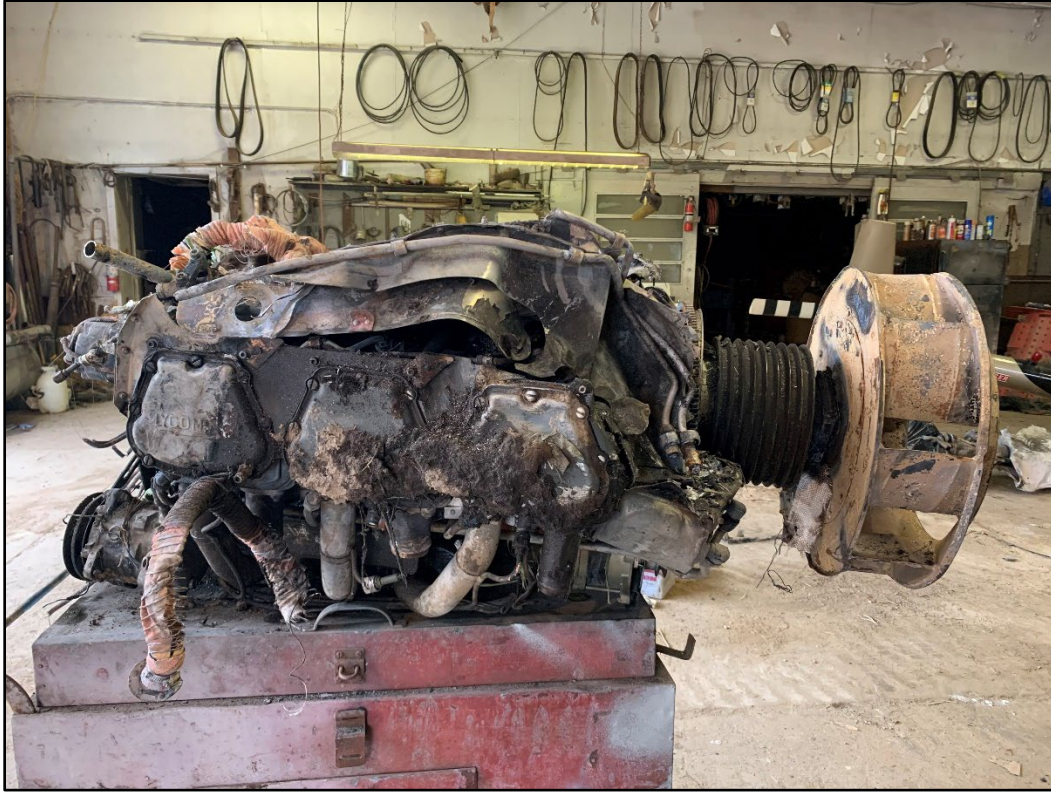
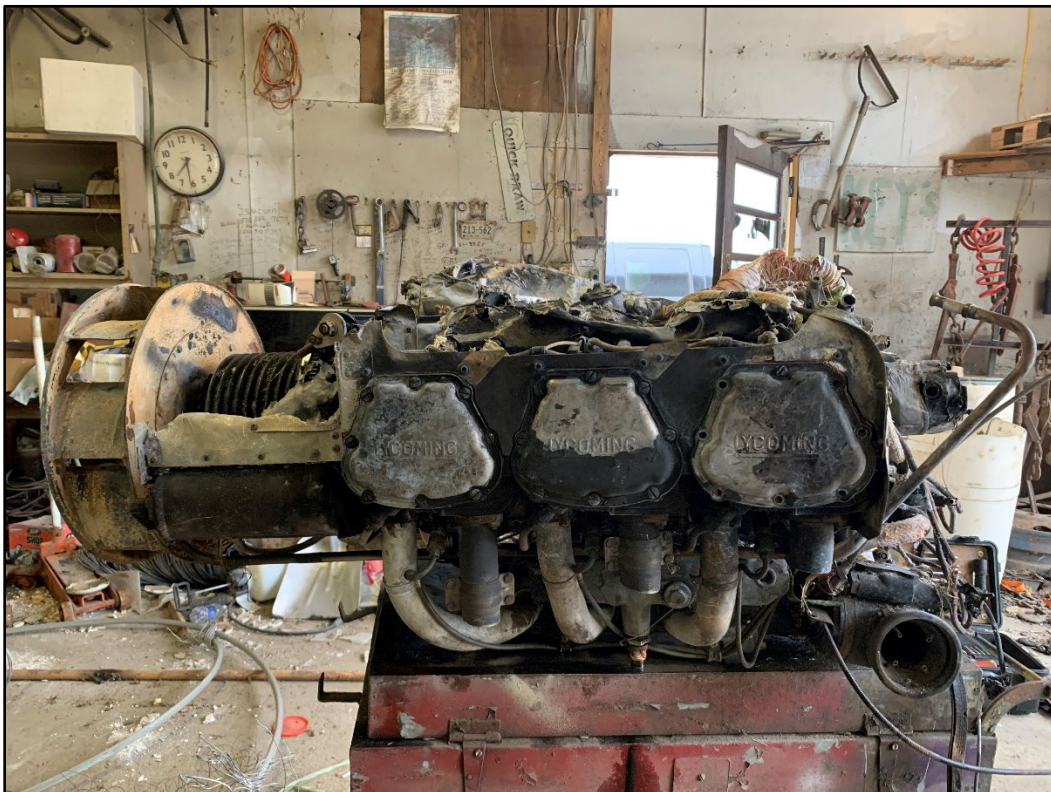
The engine remained partially attached to the engine mounts, which were cut at the accident site to facilitate engine recovery. The engine then was placed on a steel cart for the examination, as shown in figure 13 and figure 14. An external examination of the engine case and accessory section revealed significant thermal damage due to prolonged exposure to the postimpact fire, as shown in figure 15. The oil filter had separated from the rear accessory case. The throttle linkages forward of the firewall were destroyed during the postimpact fire. The throttle linkages on the engine-side of the firewall remained intact and connected to the fuel servo. Mixture control cable continuity was established from the cockpit control knob to the fuel servo mixture control arm.

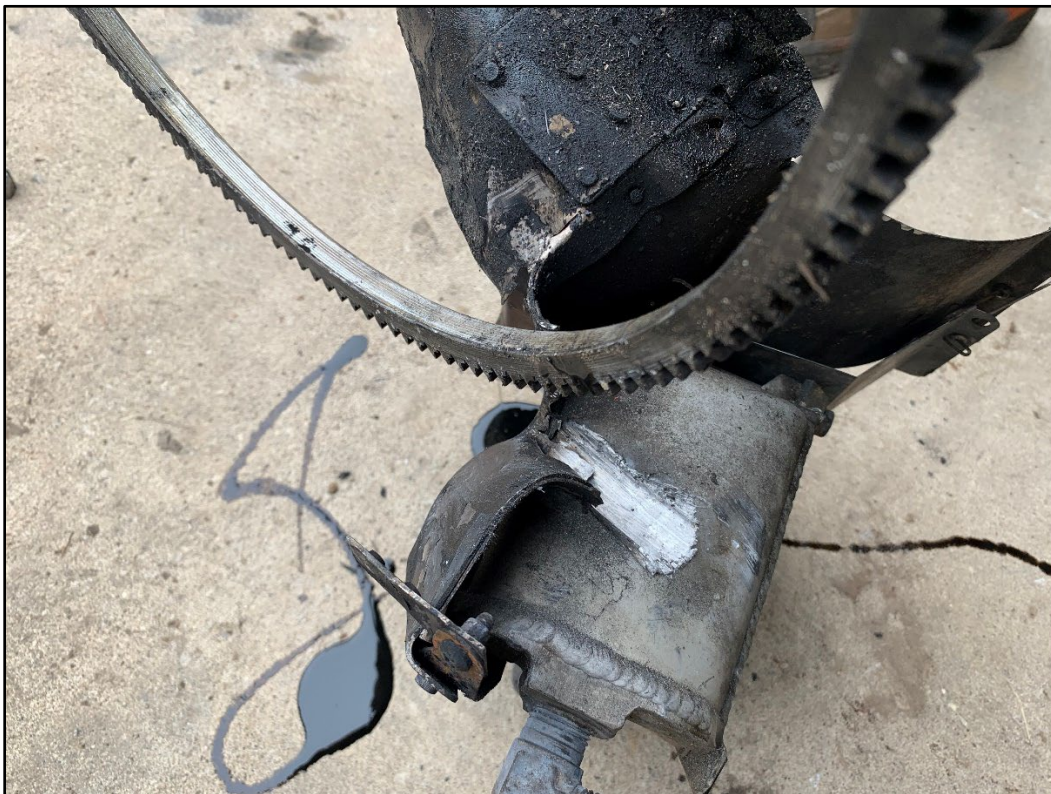
The starter ring gear had dislodged from the flywheel. The starter ring gear left a significant gouge on the oil cooler body consistent with engine operation at impact, as shown in figure 16.

**Figure 16.** Starter ring gear gouge on the oil cooler body

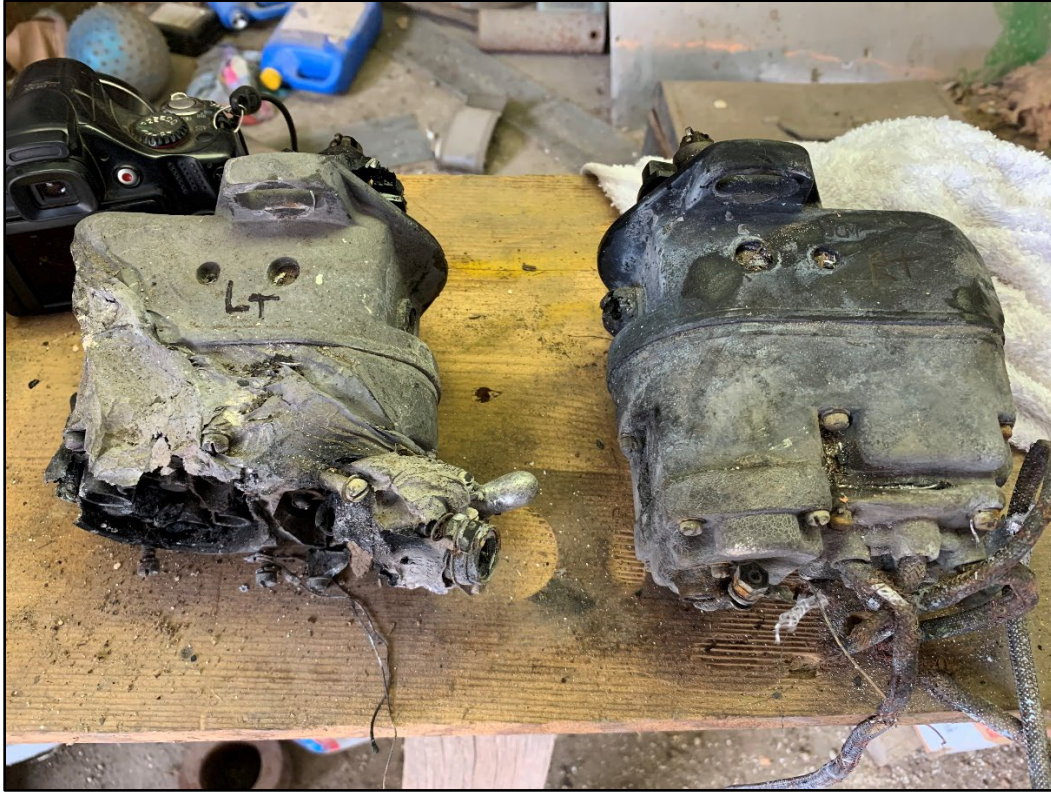
The engine was equipped with two magnetos that exhibited significant thermal damage from the postimpact fire and could not be tested, as shown in figure 17. The upper spark plugs were removed and exhibited features consistent with normal engine operation. The ignition harness exhibited significant thermal damage from the postimpact fire.

**Figure 17.** Magnetos
