**SUMMARY OF AIRPLANE EXAMINATION**

-- CEN21FA345 --

Location: Hartford, Wisconsin  
Date: July 31, 2021  
Time: 1130 cdt  
Airplane: Piper J3C-65

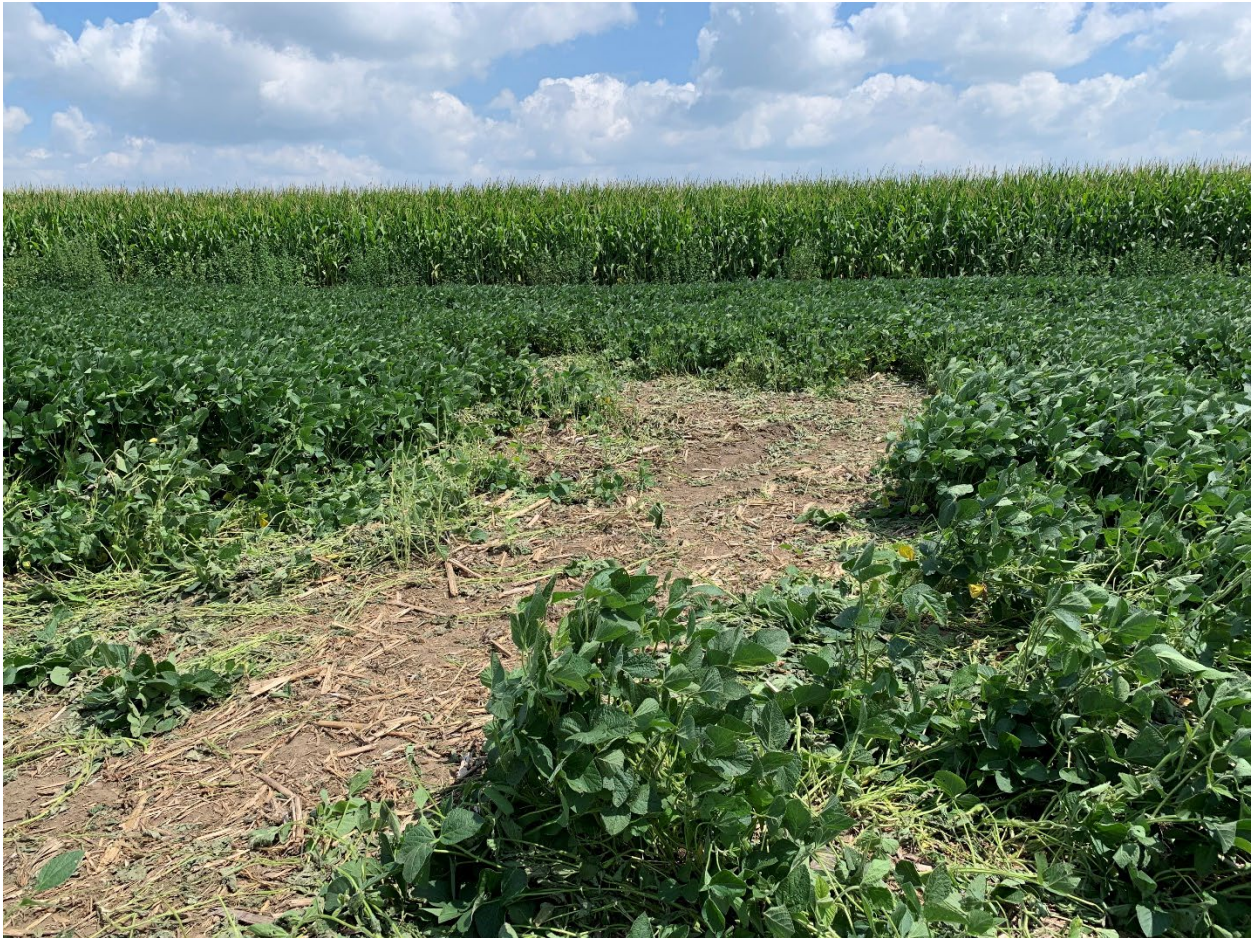
The airplane impacted an agricultural bean field about 1,100 ft west of the departure end of runway 27 at Hartford Municipal Airport (HFX). The NTSB IIC was not present for the recovery of the airplane from the accident site. The airplane had been moved from the site to a hangar on HFX. It was reported by the FAA Inspector that was on-scene that the airplane came to rest in the field in an upright position with evidence of a nose-low impact with the ground.

Figure 1. Photograph of the accident site (NTSB Photo)

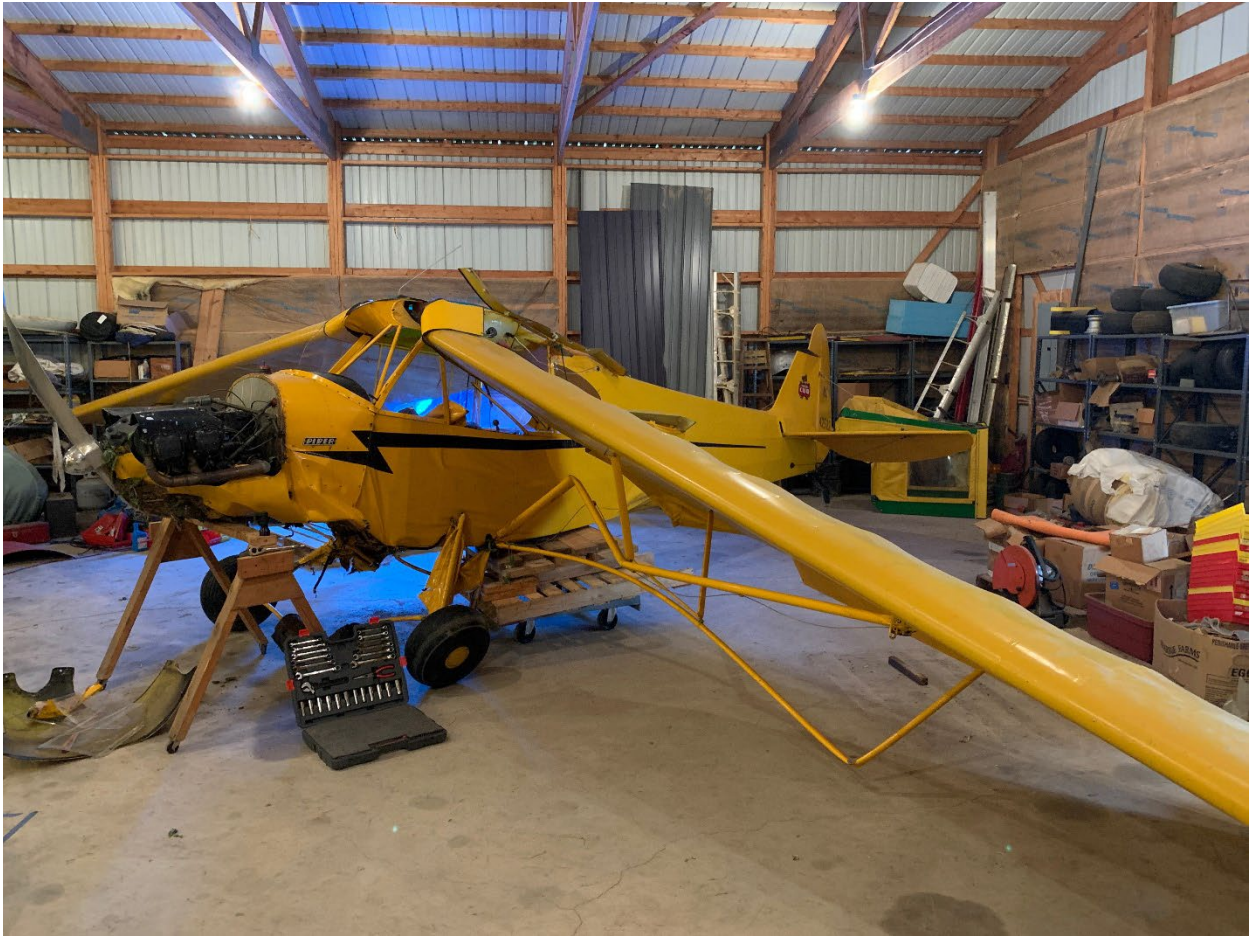
Figure 2. Airplane during examination viewed from front left (NTSB Photo).

The forward fuselage was crushed aft into the front seat pilot cockpit area. The deformation was limited to the area where the front pilot rudder pedals were and where the front pilot feet would be positioned. The airplane did not have shoulder harnesses installed. Only lap belts were present. The top of the instrument panel was bent forward.

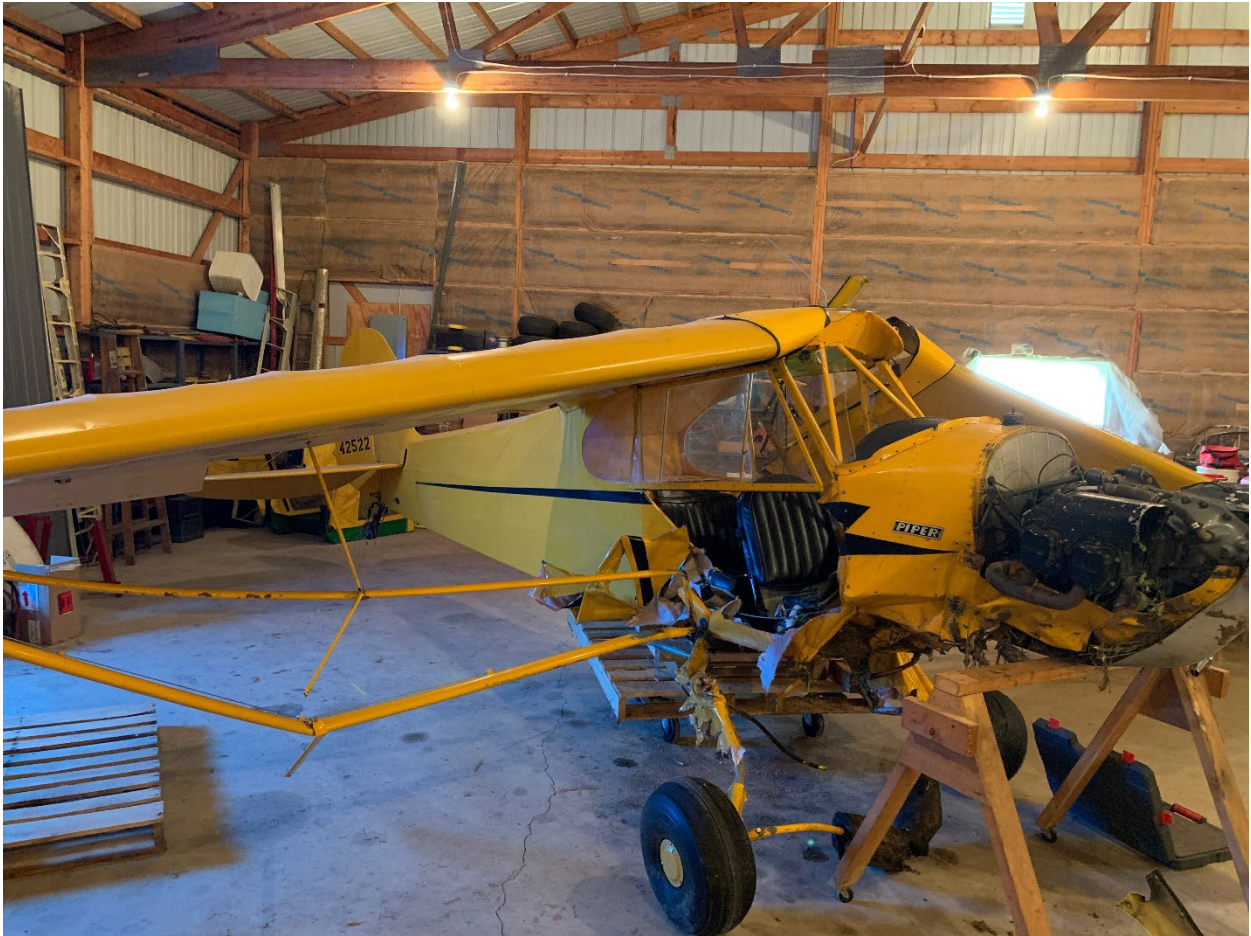
Figure 3. Airplane during examination viewed from front right. (NTSB Photo)

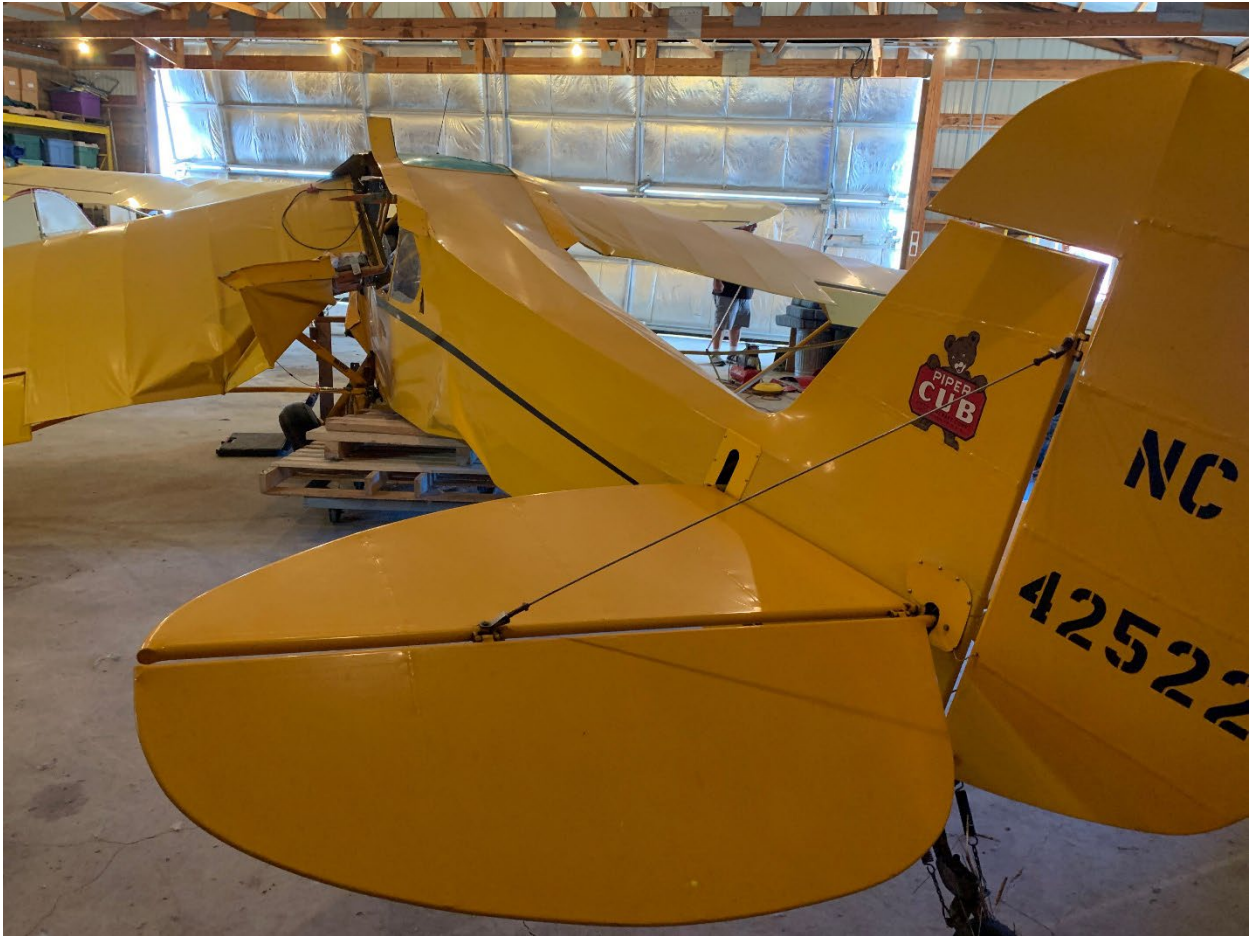
The fuselage of the airplane was predominately intact. The tail surfaces remained attached to the fuselage and were undamaged. The right fuselage side aft of the cockpit was undamaged. The left fuselage side had a bent lower longeron about 2 feet aft of the rear window of the airplane. But was otherwise undamaged. The forward fuselage was crushed rearward and upward with additional deformation in the cabin section of the fuselage. The cabin door area of the fuselage exhibited cuts made by first responders for extrication of the occupants. The landing gear was partially separated from the fuselage and both right and left gear legs remained attached by the rear attachment points.

Figure 4. Aft fuselage of airplane and tail viewed from rear left. (NTSB Photo)

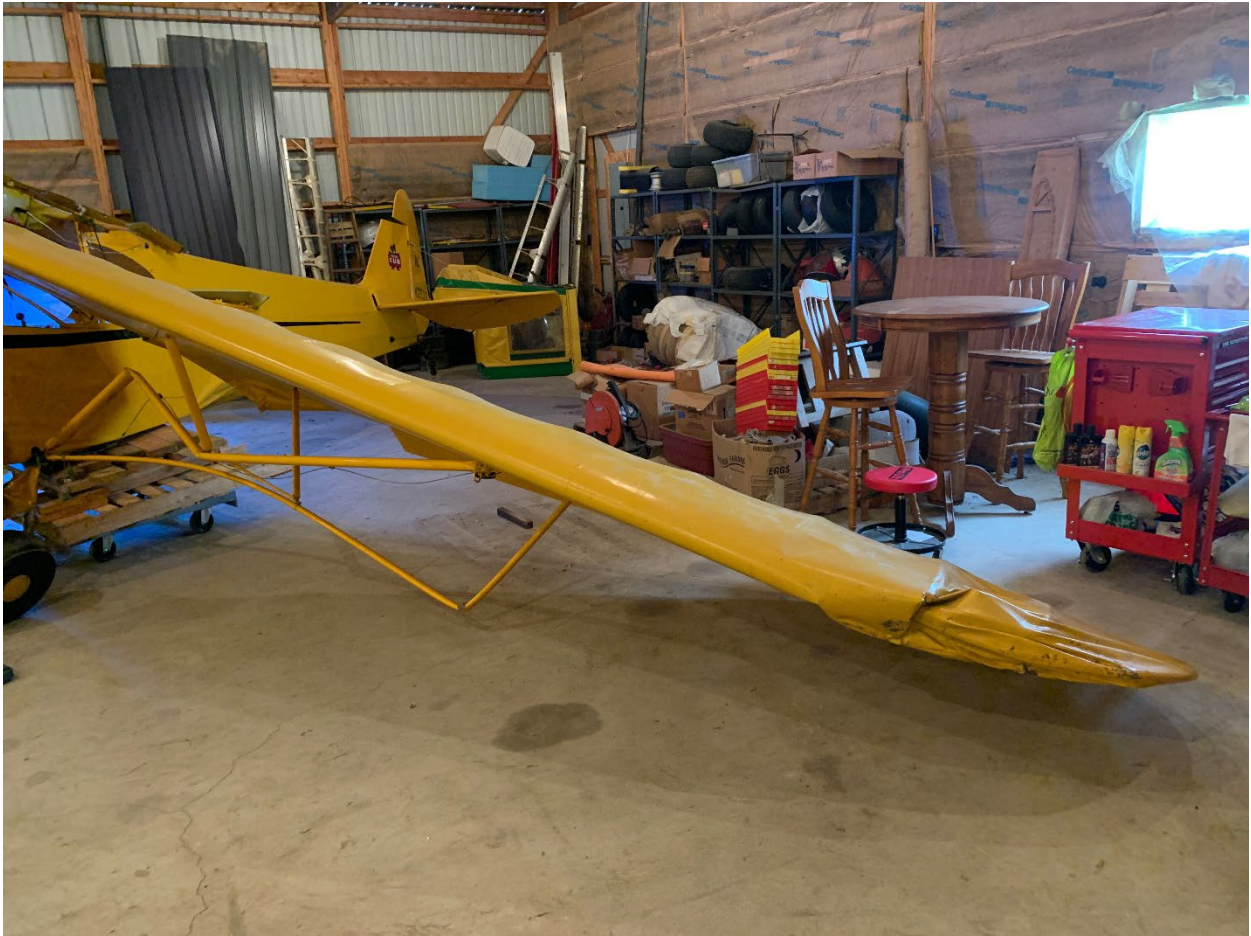
The left wing was still attached to the fuselage by non-structural fairings. The front and rear spars were torn from the fuselage mounts. The left-wing leading edge was crushed aft at the tip. Both struts were bent due to impact. The aileron remained attached with all hinges intact and the aileron was not damaged.

Figure 5. Left wing showing tip damage. (NTSB Photo)

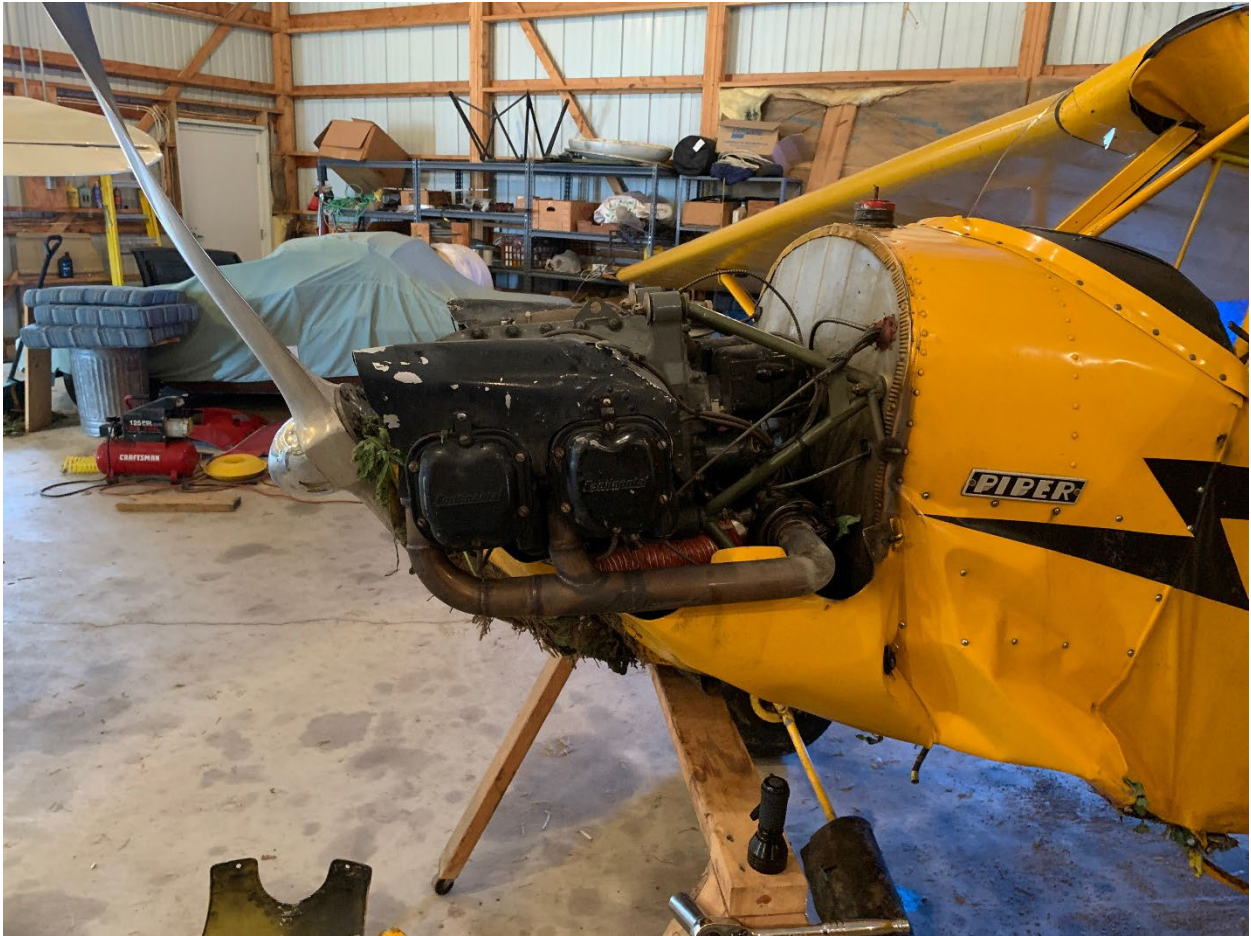
The engine was still attached to the engine mount and was bent downward relative to the firewall. The engine crankshaft flange was bent downward, and the propeller was still attached to the crankshaft flange. The propeller was removed to facilitate engine examination. With the propeller and upper set of spark plugs removed, the engine crankshaft could be rotated by the crankshaft flange. Valve train continuity was established by removing the rocker covers and observing valve motion during crankshaft rotation.

Figure 6. Engine during examination. (NTSB Photo)

The spark plug leads were removed and the crankshaft rotated to check spark. Both magnetos produced spark from all leads.

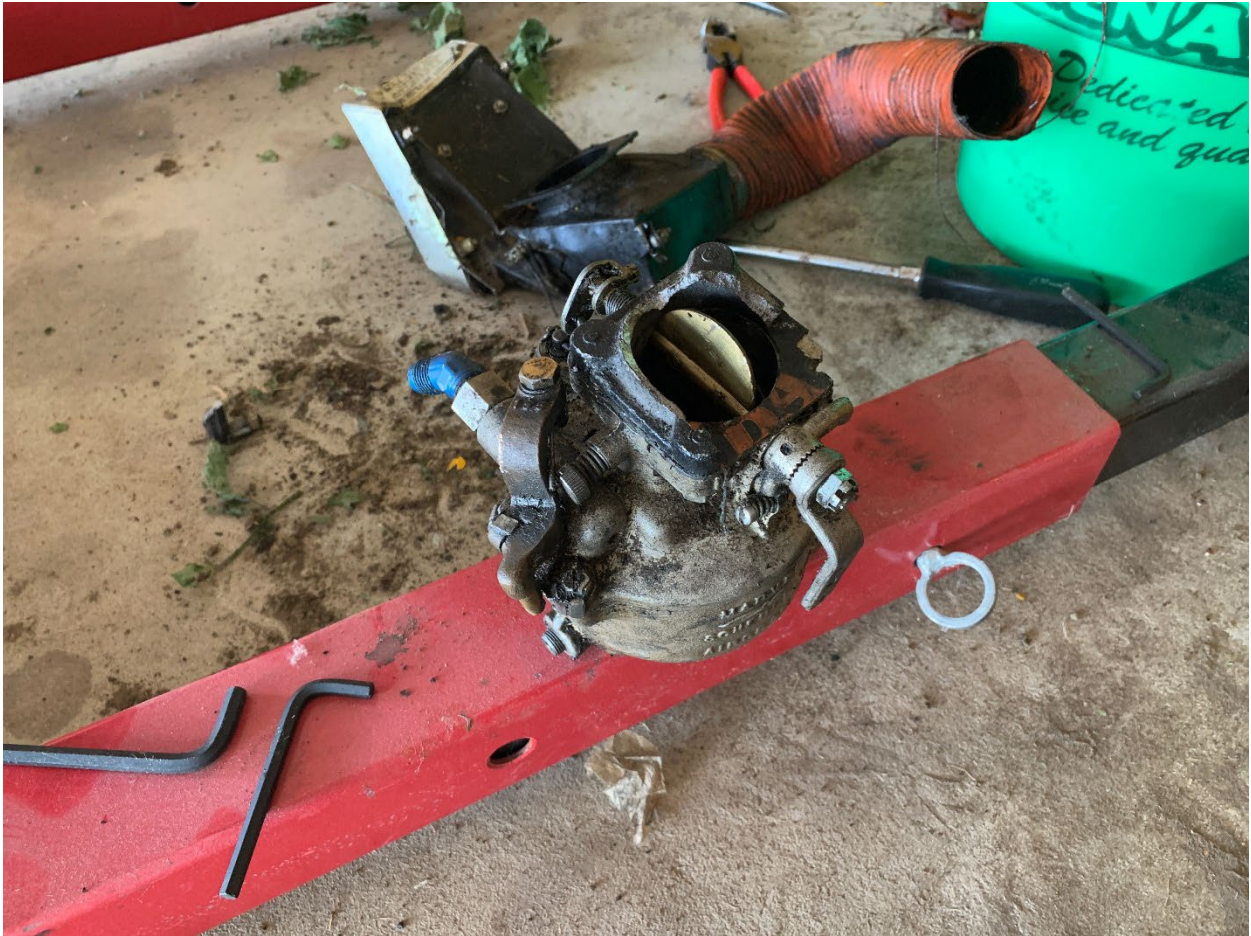
The carburetor attachment flange portion of the intake was broken off with the flange remaining attached to the carburetor. The carburetor was disassembled, and no anomalies were noted. The fuel bowl was clean, and the floats were intact.

Figure 7. Carburetor during examination. (NTSB Photo)
