## **NATIONAL TRANSPORTATION SAFETY BOARD**

### **ON SCENE OBSERVATIONS**

**CEN21FA380**

Location: Adrian, MO  
Date: August 22, 2021  
Aircraft: Piper J3C-65, Registration N70643, Serial #17661  
NTSB IIC: Samantha Link

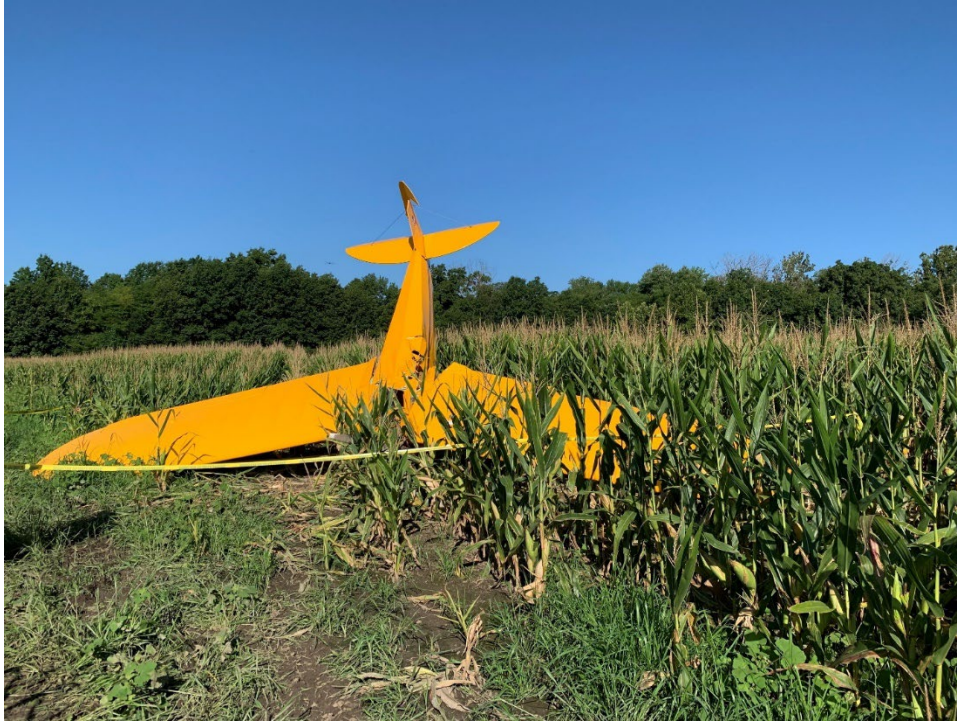
Figure 1: Overview of Accident Site

The airplane was found in a cornfield about 300 yards northwest of the private grass runway. The airplane was mostly whole and was positioned along a heading of about 135-degrees. The airplane came to rest nose down in the dirt. The aft fuselage and empennage extended upward into the air; it remained intact and mostly undamaged. Both wings were bent downward at the forward wing spar; and the aft wing attachment points were fracture separated. The wingtips exhibited aft crush damage and came to rest touching the dirt.

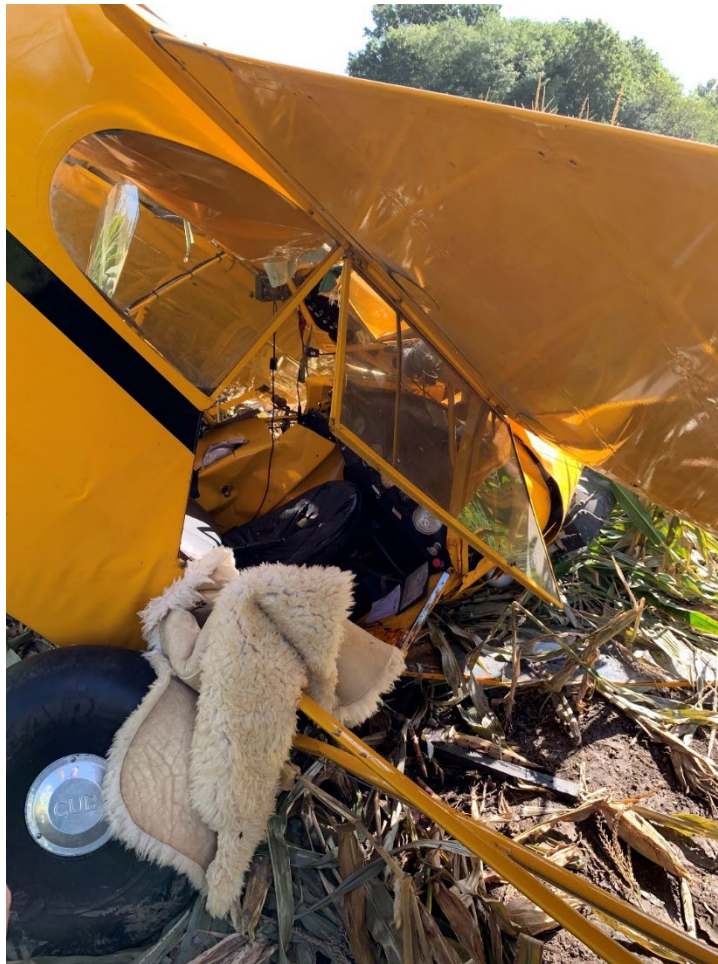
Figure 3: Cabin Area

The cabin area exhibited extensive aft crush damage throughout. The instrument panel was pushed aft into the front seat area. The front seat was pushed into the aft control stick, and it was unable to be manipulated. The fabric on the left side of the fuselage was torn away consistent with impact damage exposing a crushed fuselage frame and the fuel selector valve.

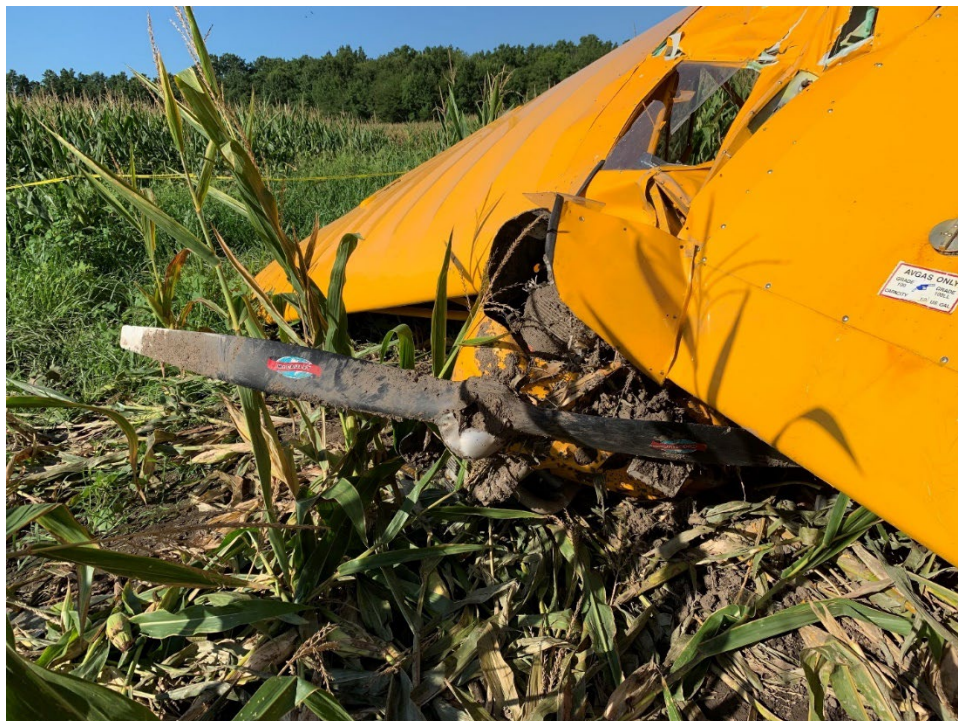
Figure 5: Forward Fuselage

The engine and firewall were pushed aft and up toward the left. The left side of the engine was wedged between the wing spar and the left-wing leading edge. The lower cowlings were compressed into the bottom of the engine.

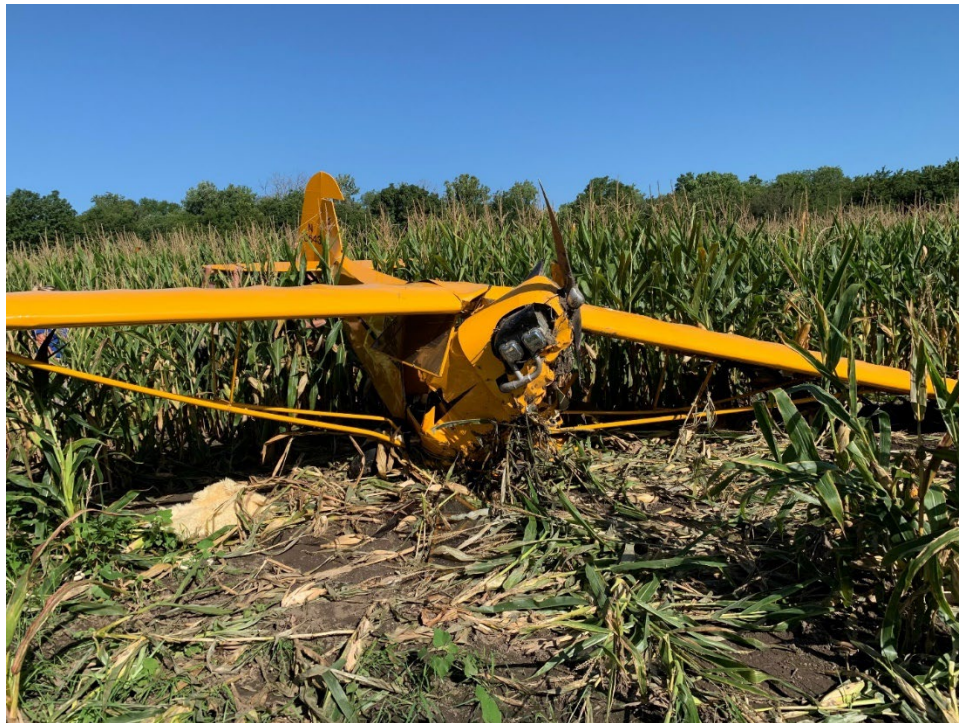
Figure 6: Overall Crush damage to Forward Fuselage and Engine

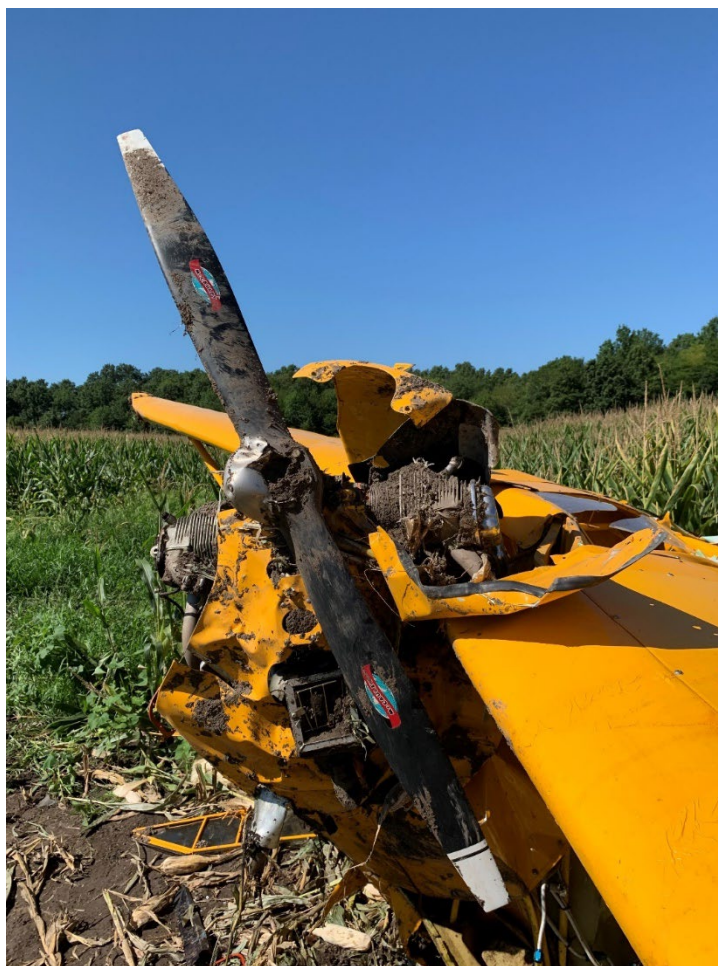
Figure 7: Propeller

The propeller remained attached at the hub, and the crankshaft was bent just aft of the attachment flange. Both propeller blades were mostly straight. One blade exhibited some chordwise dirt marks and a slight aft bend about midspan. The other blade was mostly undamaged. The spinner was pushed aft into the hub and was cracked; it did not exhibit rotational damage.

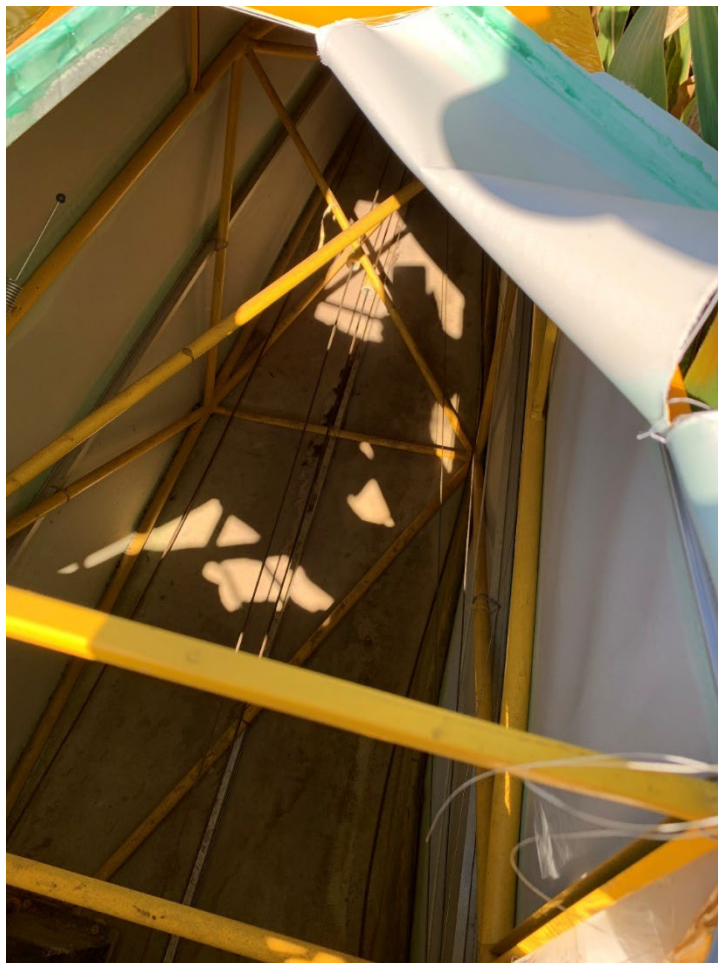
**Figure 10: Elevator and Rudder Controls**

- The elevator and rudder control surfaces were manipulated by hand and corresponding motion was observed at the pilot seat.
    - The rudder control cables were not visible underneath the pilot seat, however, the control cables remained attached at the rudder pedals.

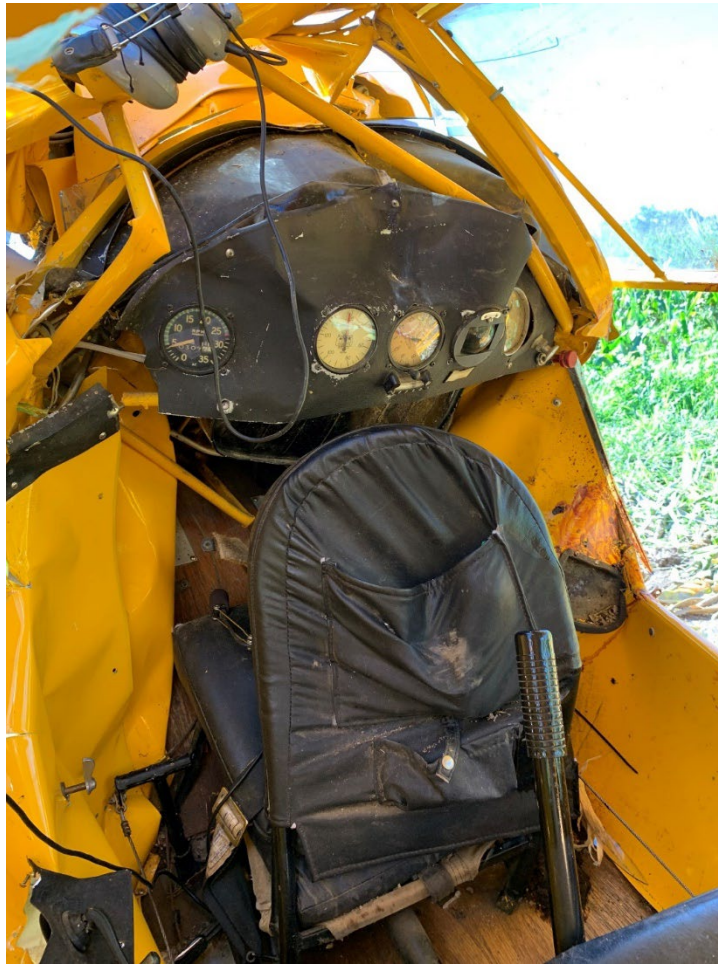
**Figure 11: Instrument Panel**

- The instruments remained within the instrument panel and were unremarkable.
- The fuel selector valve was not marked, and the handle was positioned up.

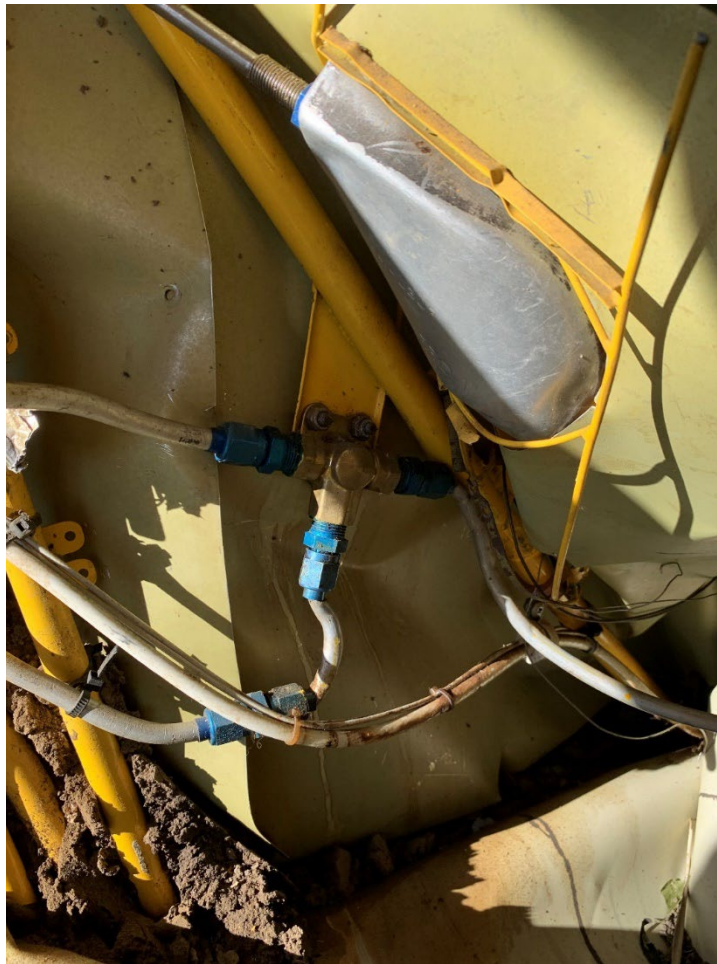
Figure 12: Fuel Selector Valve

- The valve was removed from the airframe. The valve was open between the header fuel tank and the engine.
    - The valve was closed to the left-wing fuel tank.

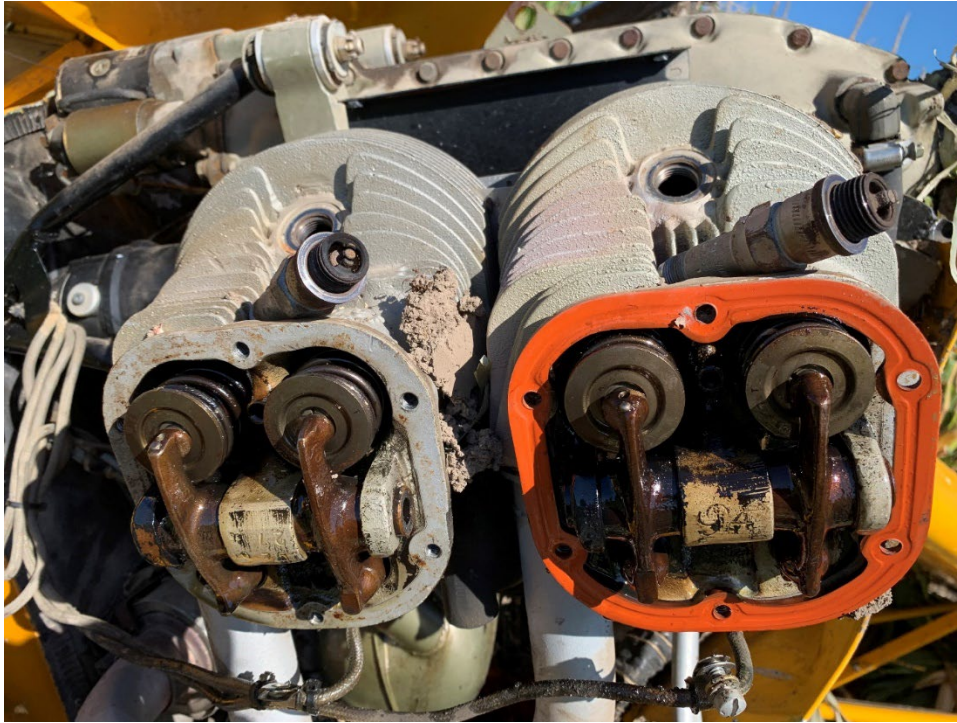
- The spark plugs exhibited rust on the outside.
- All spark plugs, with the exception of the lower left side plugs, were removed from the engine.
  - The upper spark plugs exhibited normal operating signatures given the automotive gas.

Figure 13: Right Side of Engine and Upper Spark Plugs

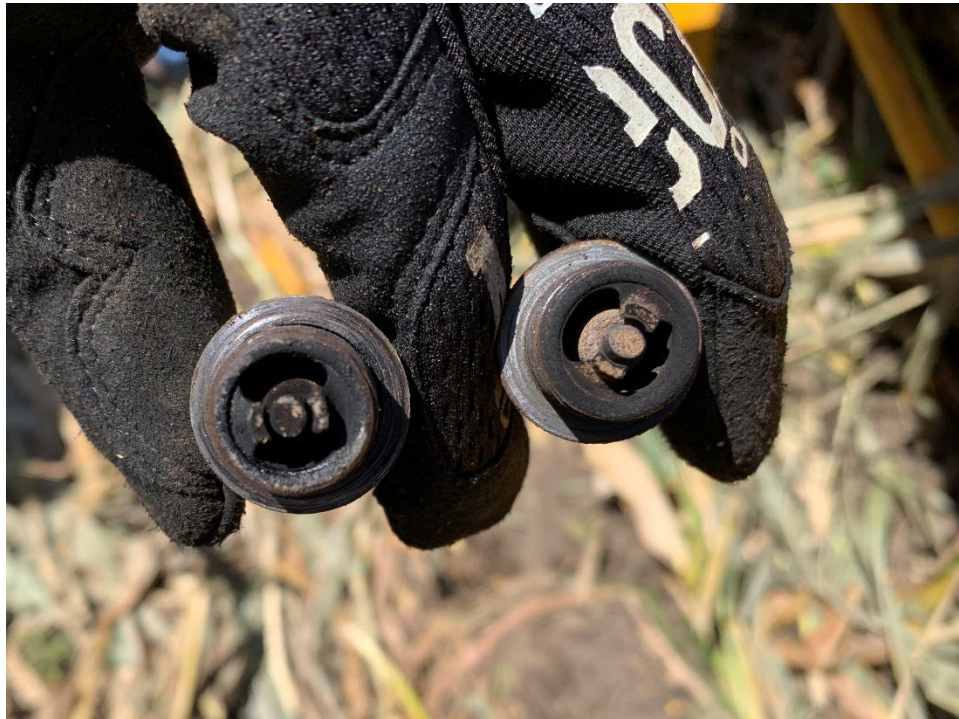
Figure 15: Left Side Upper Spark Plugs

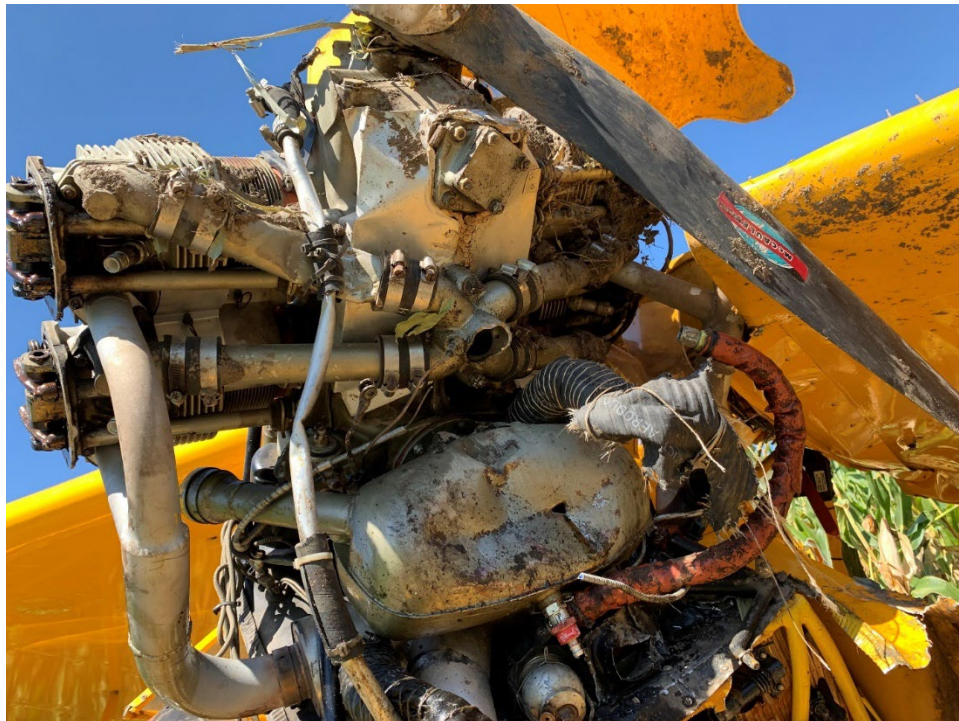
Figure 16: Underside of Engine

- The oil sump was breached, and oil leaked from the engine and was present below the engine.
- The exhaust system was mostly intact and exhibited some crush damage.

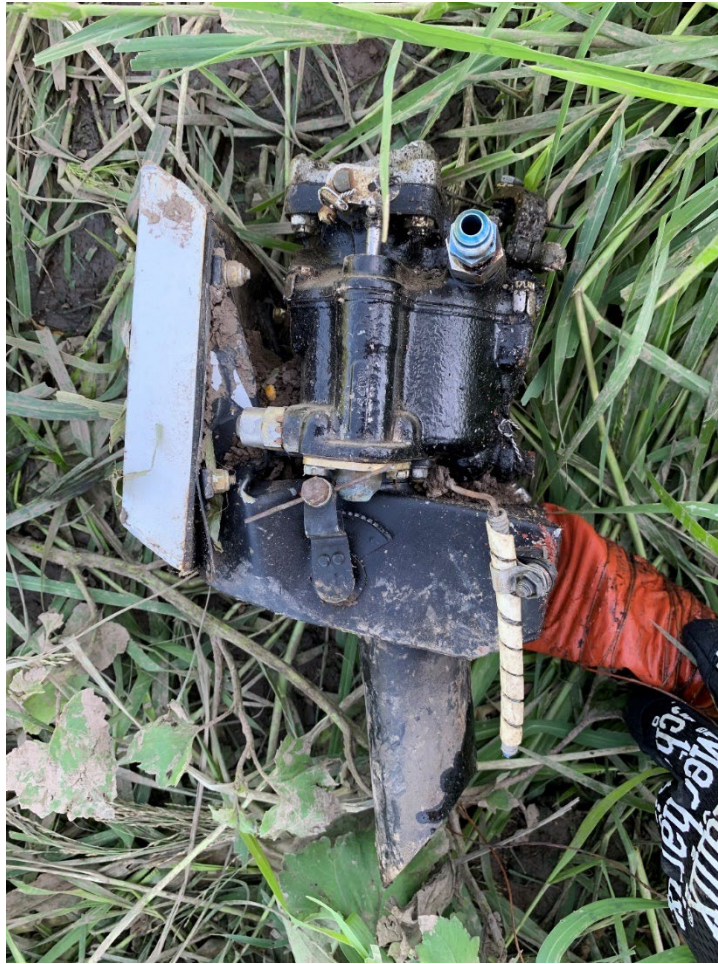
Figure 17: Carburetor

- The carburetor was fracture separated from the engine and covered in dirt. The throttle and mixture controls remained attached to their respective levers.

- The engine controls were disconnected, and the carburetor was disassembled.
  - When the throttle arm was moved, the butterfly valve moved accordingly, and fuel was observed exiting the accelerator pump.

- The fuel was consistent with automotive gas
    - The remaining fuel was drained from the carburetor and debris was noted. However, it was unable to be determined if that was from inside of the carburetor or dirt from the outside.

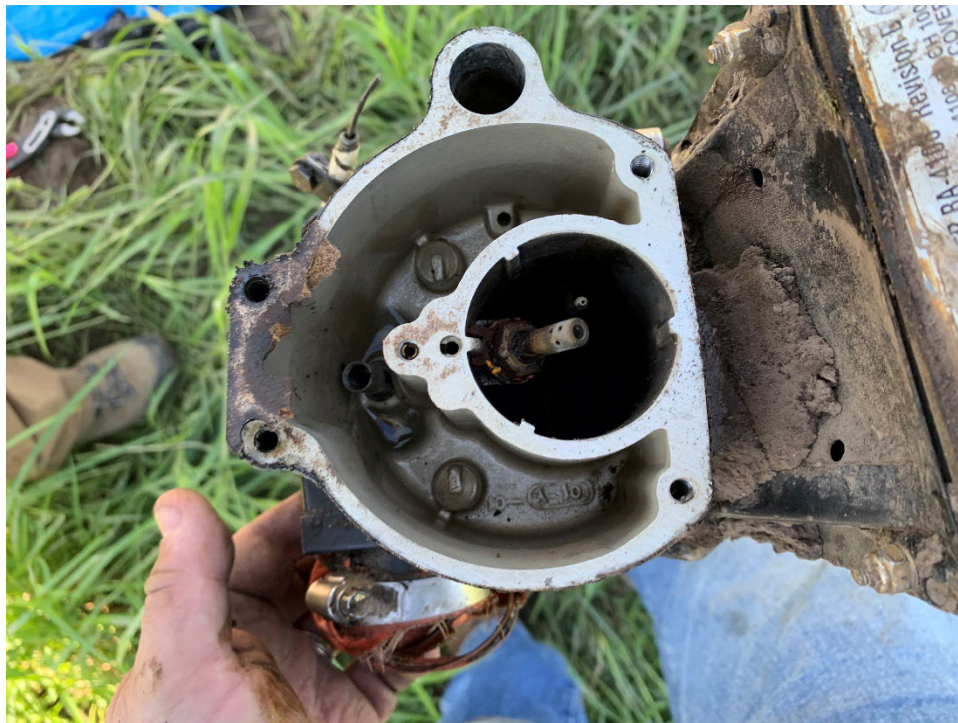
Figure 18: Carburetor Bowl

- The carburetor bowl was removed
      - Some debris was noted on the bottom of the bowl.
    - The floats were metal and unremarkable.
    - The needle valve manipulated easily.

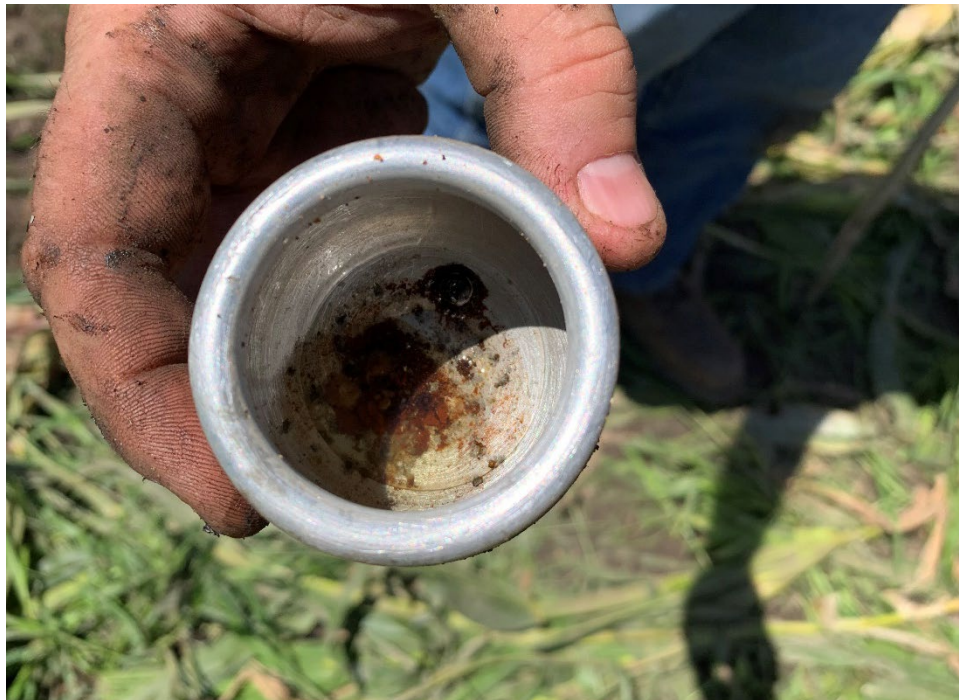
Figure 20: Fuel Strainer

- The fuel inlet screen was removed and was clear of debris.
- The fuel strainer was removed from the airplane.
  - It was full of automotive fuel and debris was noted on the bottom of the bowl.
