# **NATIONAL TRANSPORTATION SAFETY BOARD**

## **Attachment 1 – Pratt & Whitney Canada Accessories Accident Report**

**CEN21LA004**

## ACCESSORIES ACCIDENT REPORT

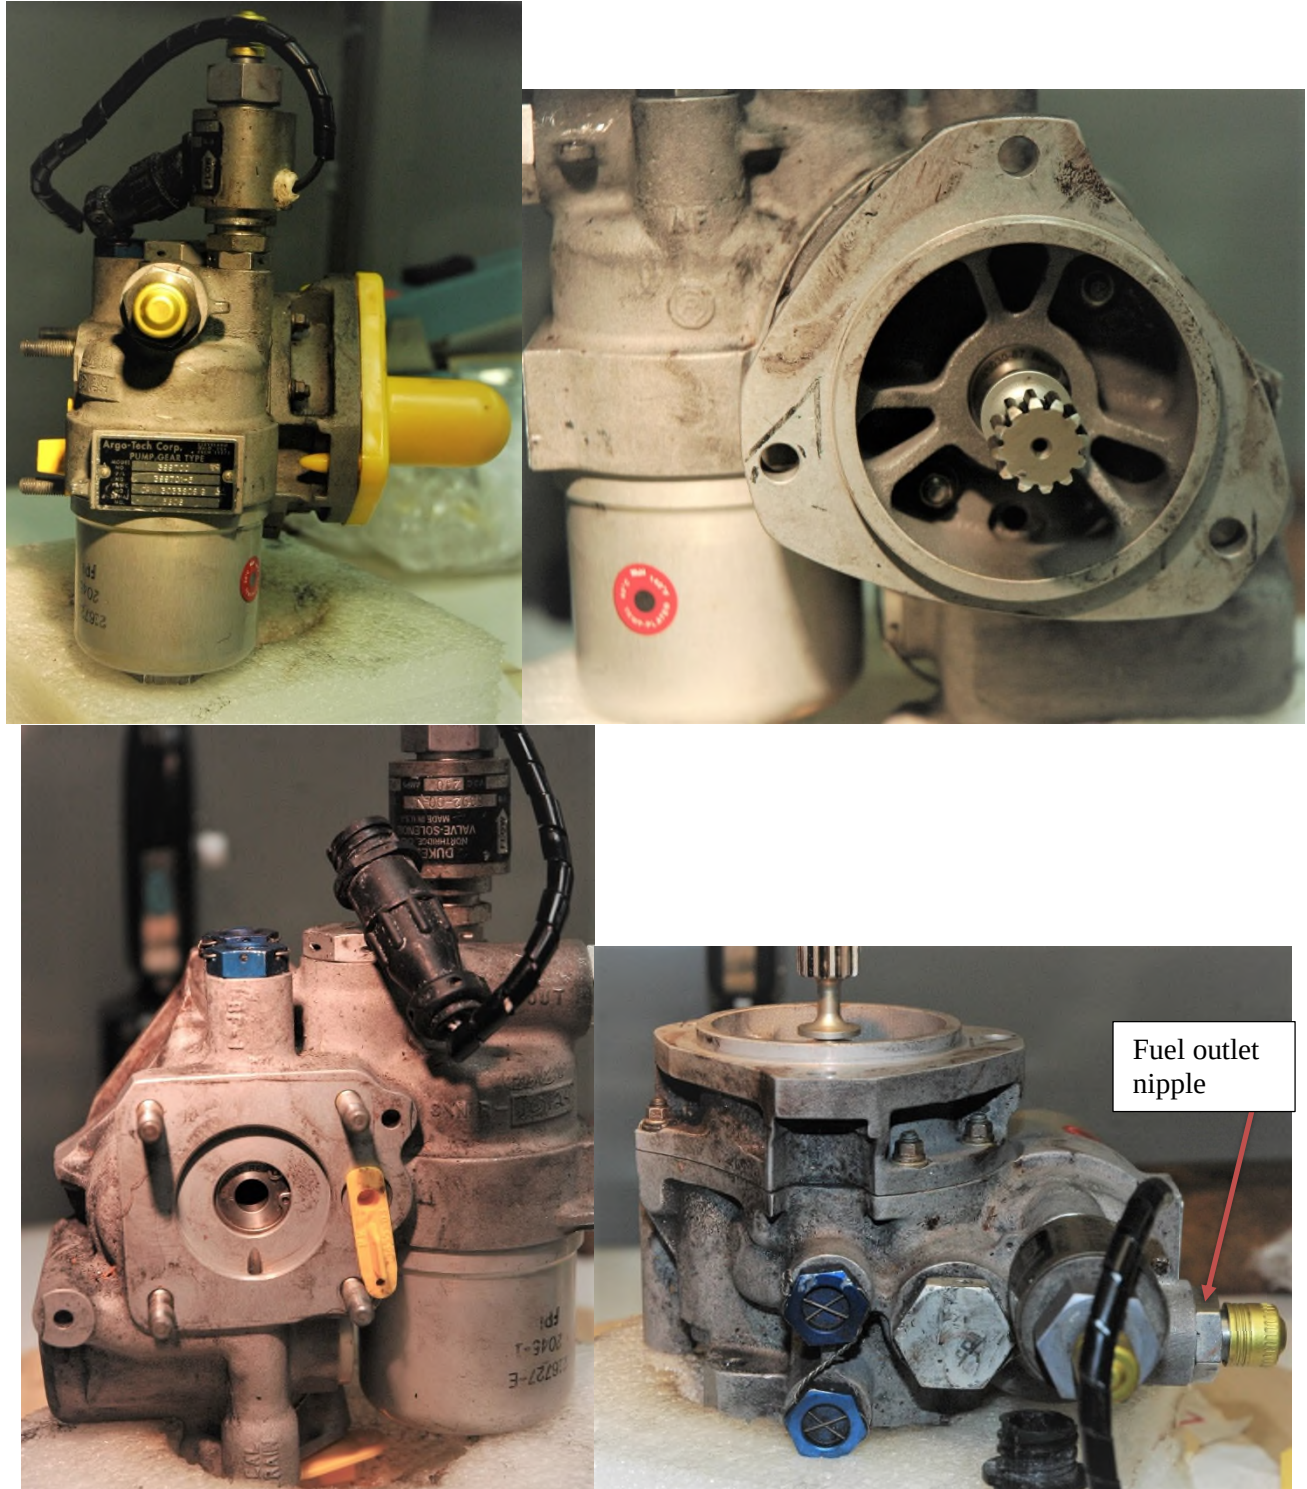
The fuel pump (figure 1) was received packed with a fuel sample bottle. There was no evidence of water in the fuel sample. A solenoid valve was attached to the fuel pump motive-flow port. The exterior of the fuel pump was lightly soiled. The driveshaft turned with normal resistance. There was no evidence of bearing grease dilution at the fuel control unit mounting flange. There was a temperature sticker on the outlet filter bowl. Lockwire was missing from the fuel pump outlet filter-bowl, but the bowl could not be removed by hand. Lockwire was present at all other locations.

Figure 1  
Fuel pump as received

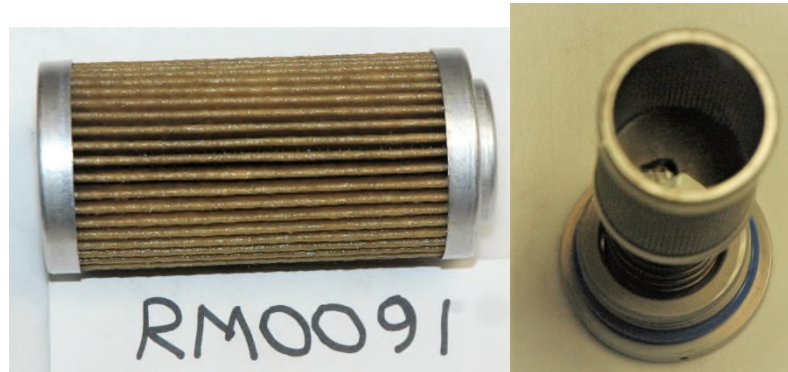
Figure 2

Prior to testing the fuel pump, the outlet filter and inlet screen were removed for inspection (figure 2). No significant debris was present in the outlet filter, outlet filter bowl, inlet-screen, or inlet screen cavity. With the fuel pump installed on the test stand a leak was observed at the fuel outlet nipple. The nipple was replaced with a slave and the fuel pump was tested in accordance with Eaton overhaul manual 73-10-12 rev. 2. The test was satisfactory.

Fuel pump outlet filter (left) and inlet screen (right) prior to testing

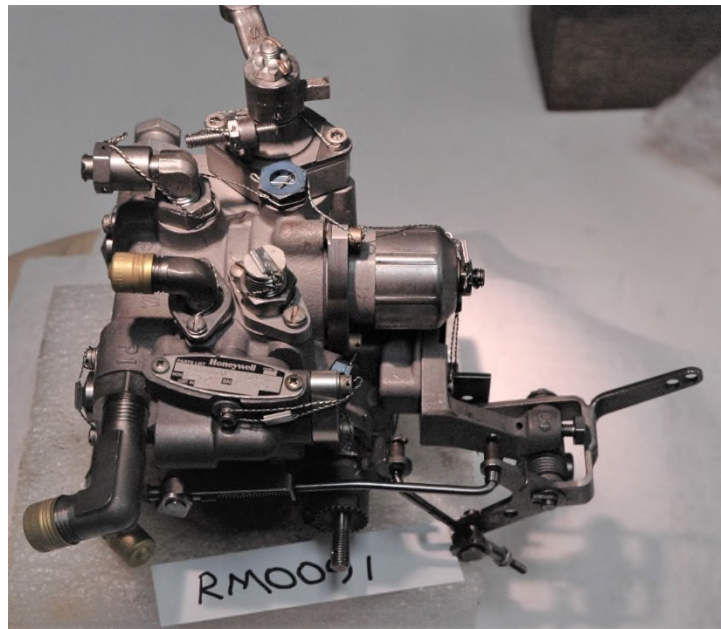
Figure 3

The exterior of the fuel control unit (FCU) was lightly soiled (figure 3). The plastic drive-coupling (figure 4) was attached to the mounting pad by a tie-wrap. The driveshaft turned freely. The throttle lever/cut-off lever linkage moved freely over the full range. The part-power trim stop was in the stowed (flight) position. The index mark of the Sg dome was in-line with the datum line on the bypass valve collar. The manual override lever moved freely over the full range. Lockwire was present at all locations. There were no identification marks on the lockwire seals.

Fuel control unit (FCU) as received

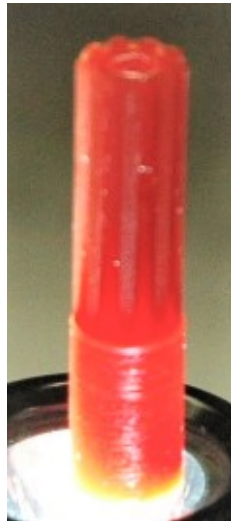
Figure 4  
FCU plastic drive-coupling

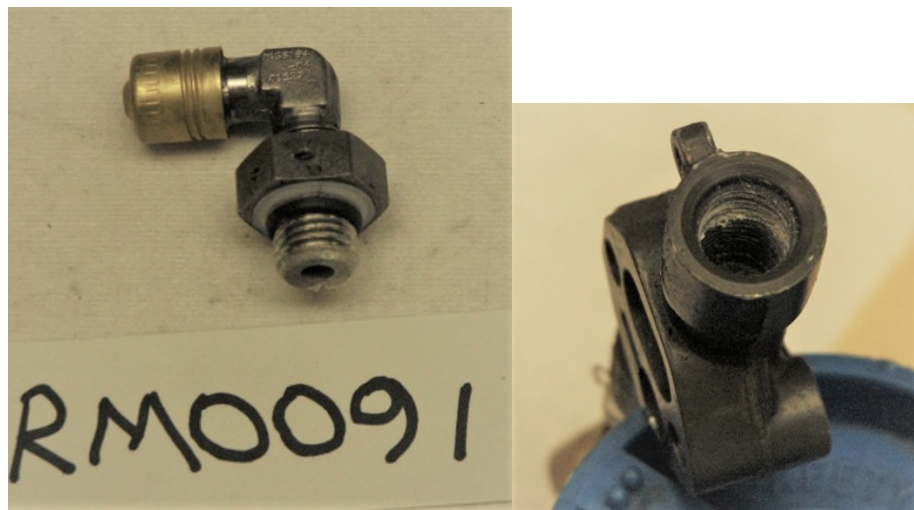
Prior to testing the FCU the P3 air inlet fitting, Py air outlet fitting, and air adapter were removed for inspection. The P3 inlet fitting was intact with no obstruction present in the Px restrictor. There was galvanic corrosion present on the Py outlet fitting and in the corresponding threads of the air adapter (figure 5). There was no obstruction present in the Pa bleed, Py bleed or Py restrictor. With the FCU installed on the test stand air was applied to the pneumatic system and a leak-test solution was applied to the air system fittings and flanges. Acceptable slow bubbling was observed at the drive-body/flow body flange and the air adapter flange. No other air leaks were observed. The FCU was operated at fixed speed, fixed P3 air pressure and fixed throttle lever position for 5 minutes while monitoring the fuel outlet flow for a decrease, as could be anticipated if the acceleration bellows was leaking, or an increase, as could be anticipated if the governing bellows was leaking. No significant change in fuel outlet flow was observed during the monitoring period. The FCU was tested in accordance with Honeywell CMM 73-20-35 Rev. 1. The following observations were recorded:

Figure 5  
FCU Py outlet elbow and P3 air adapter galvanic corrosion residue

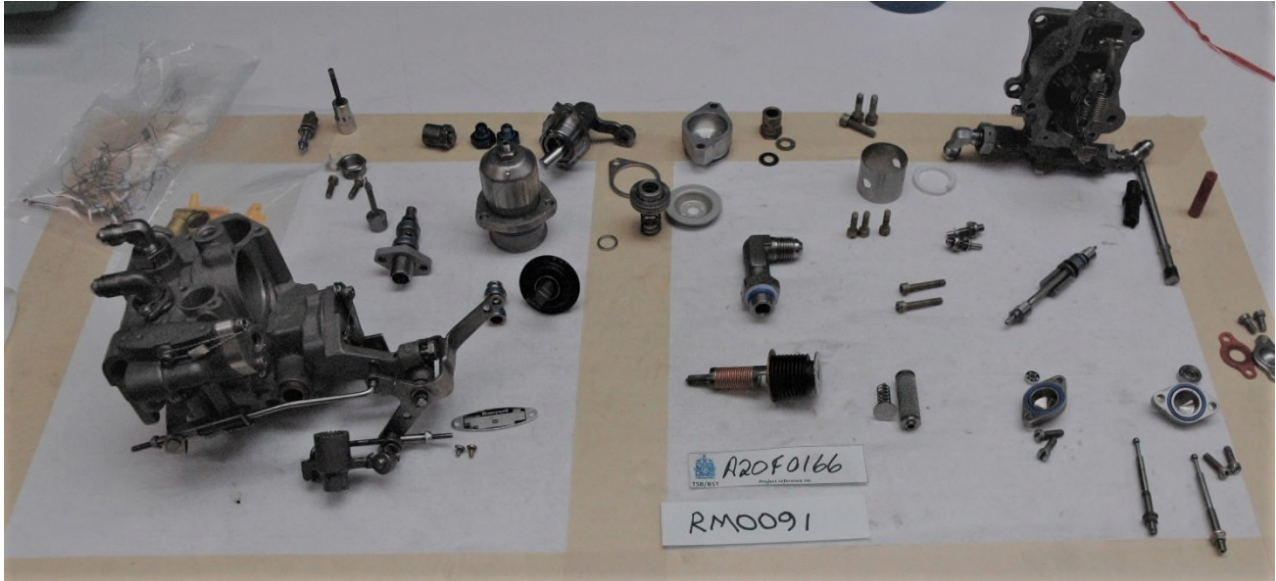
The FCU was partially disassembled (figure 6). The throttle lever shaft was straight. The bypass valve diaphragm was marked 4Q10 indicating that it was manufactured in the 4<sup>th</sup> quarter of 2010 and was not within the 6-year life limit recommended by Honeywell at the time of the event (figure 7). The rubber of the diaphragm was pliable, blistering was present on the underside of the diaphragm and there was no evidence of leaks. There was no debris or broken wires in the fuel inlet screen. There were no burrs or obstructions in the bypass valve sleeve. There was no obstruction in the metering valve and the metering valve fell freely in the sleeve. The torque-tube was tested and confirmed to have no leaks. The ratio levers were straight, and the bronze insert was present in the metering valve ratio lever. The length of the acceleration bellows was within 0.007in of the length marked on the end plate confirming that the acceleration bellows was not leaking. The governing bellows was tested and confirmed to have no leaks. There was no marking on the back of the identification plate.

Figure 6  
FCU partially disassembled

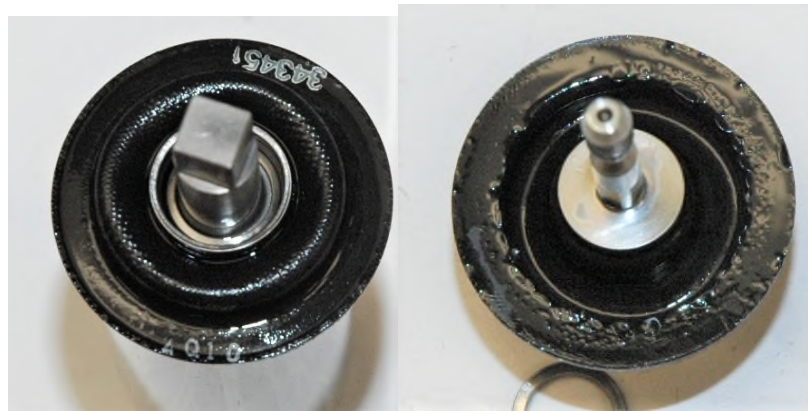
Figure 7  
FCU bypass valve diaphragm

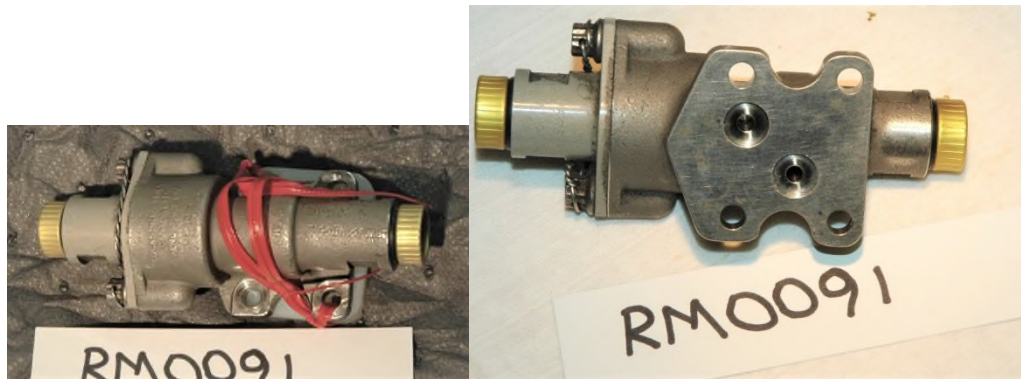
Figure 8

The exterior of the flow divider valve (FDV) was generally clean (figure 8). There were no significant scratches on the fuel manifold inlet adapter mating face. There were no leak-paths visible in the packing grooves and no packings in the grooves. Lockwire was present at all locations.

Flow divider valve (FDV) as received

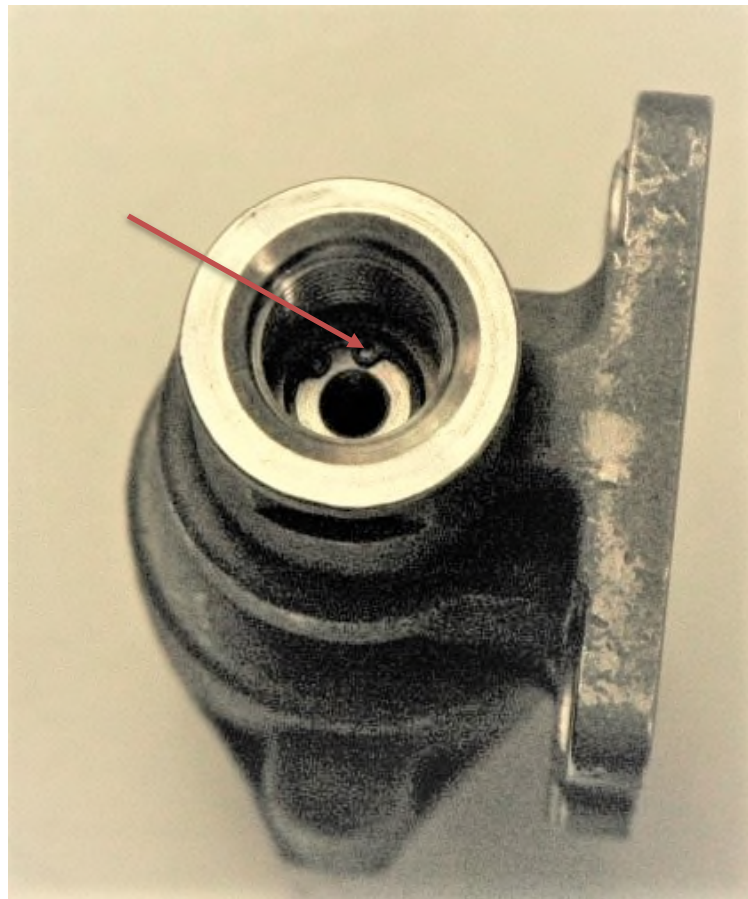
Figure 9

The FDV was tested in accordance with Triumph overhaul manual 73-10-01 Rev. 7. The test was satisfactory. During set up for testing it was observed that the primary transfer valve retaining clip was not in the clip groove (figure 9). This had no detrimental effect on the function of the FDV during testing.

FDV primary transfer valve retaining clip (arrowed)

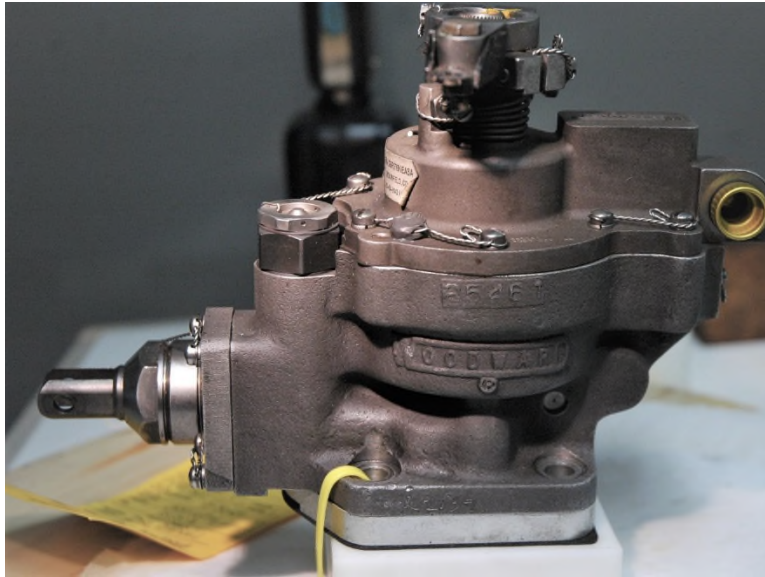
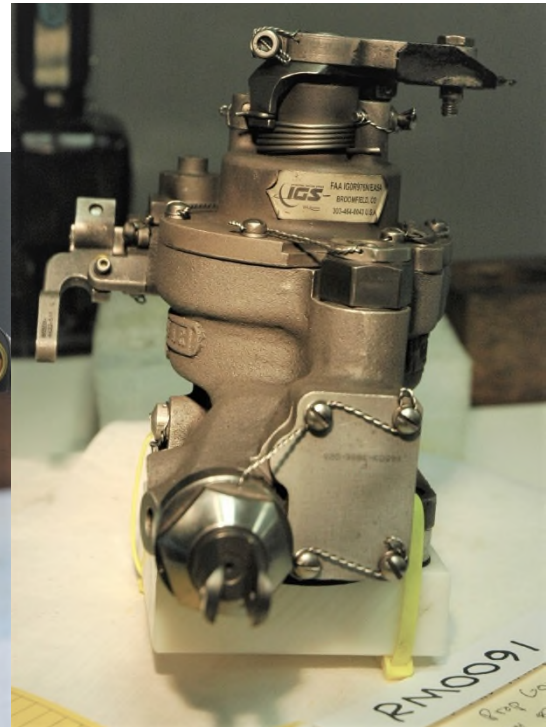
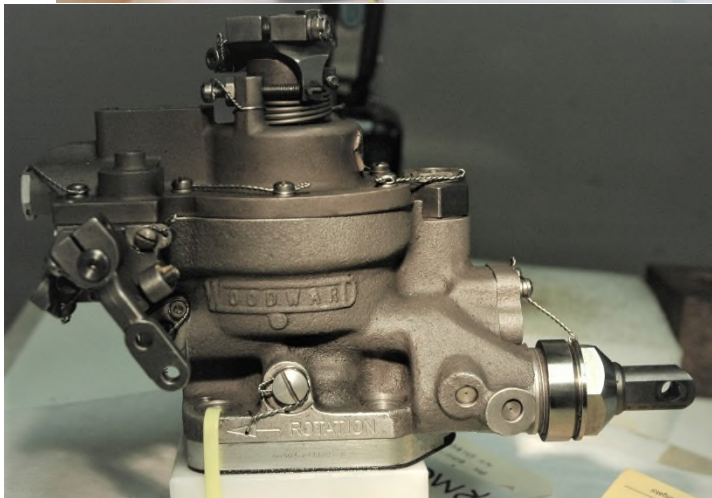
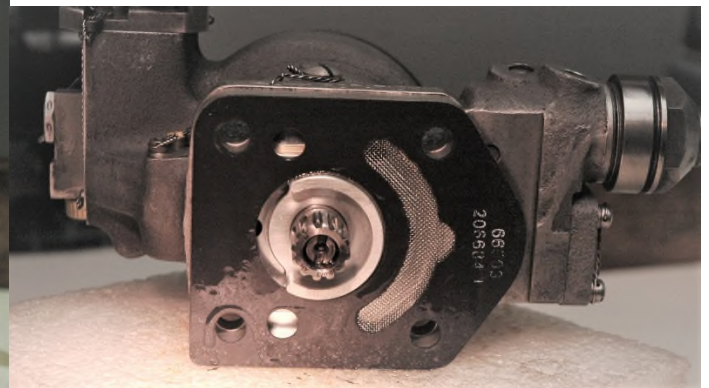
The exterior of the propeller governor (CSU) was generally clean (figure 10). The speed setting lever moved freely over the full range and returned under the influence of its spring. There was un-broken yellow anti-tamper paint on the pilot-valve/speed setting lever. The reset arm moved freely over the full range and returned under the influence of its spring. There was un-broken yellow anti-tamper paint in the reset arm stop screw. There was un-broken yellow anti-tamper paint on the minimum governor adjustment. The driveshaft turned freely and there was no debris in the mounting pad gasket screen. There was an International Governor service-label on the cover. The data plate was marked 01/2015 indicating that the CSU had been serviced in January 2015. Lockwire was present at all locations. The lockwire seal was marked IGS (International Governor).

Figure 10  
Propeller governor (CSU) as received

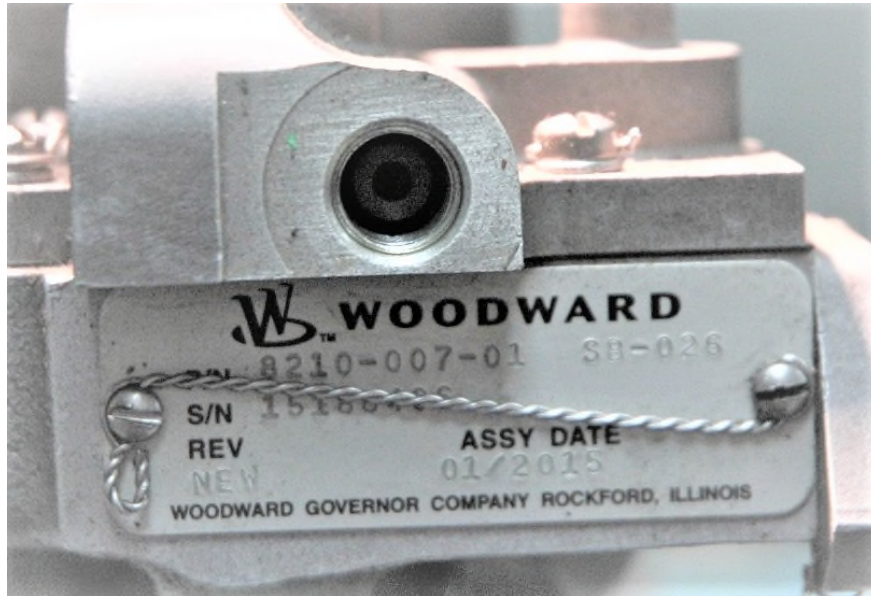
Prior to shipping the CSU to Woodward, the plug was removed from the Py bleed port to check the port for contamination (figure 11). No contamination was observed. The CSU was forwarded to Woodward (the manufacturer) for investigation in the presence of a representative from the National Transportation Safety Board (NTSB). Their investigation conclusion was as follows:

Figure 11  
CSU Py port

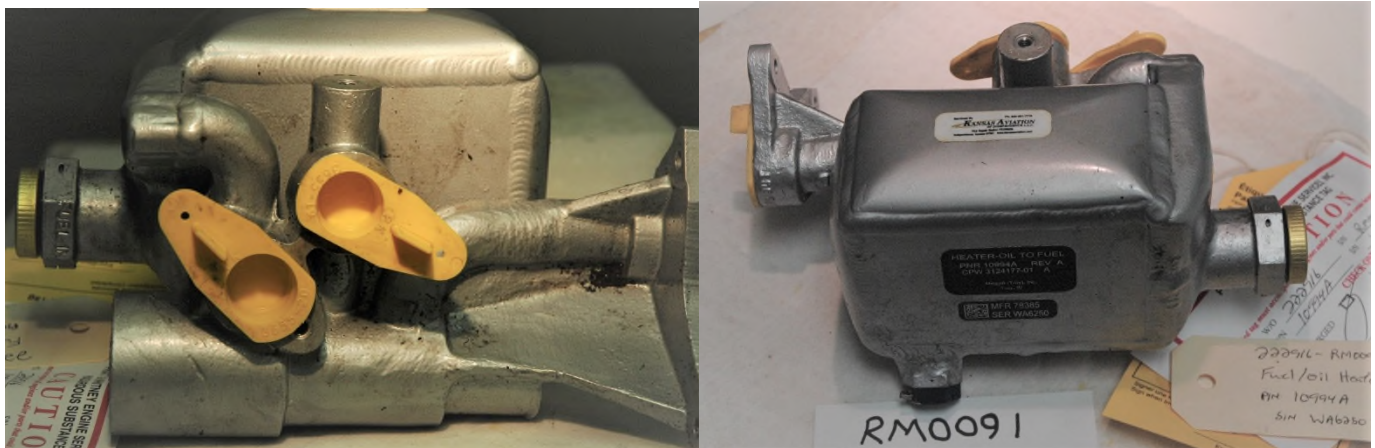
The exterior of the fuel oil heat exchanger was lightly soiled (figure 12). There was a Kansas Aviation service label on the top of the tank. Lockwire was present at the thermal element cap and the flushing plug. A low-pressure air source was attached to the FOHE fuel inlet port, the fuel outlet port was sealed, and the unit was pressurized while submerged in a water-bath to check for leakage across the fuel and oil matrices. No leakage was observed. The thermal element was removed (figure 13) and tested in accordance with Meggitt CMM 73-10-20. The thermal element was confirmed to be functioning.

Figure 12  
Fuel oil heat exchanger (FOHE) as received

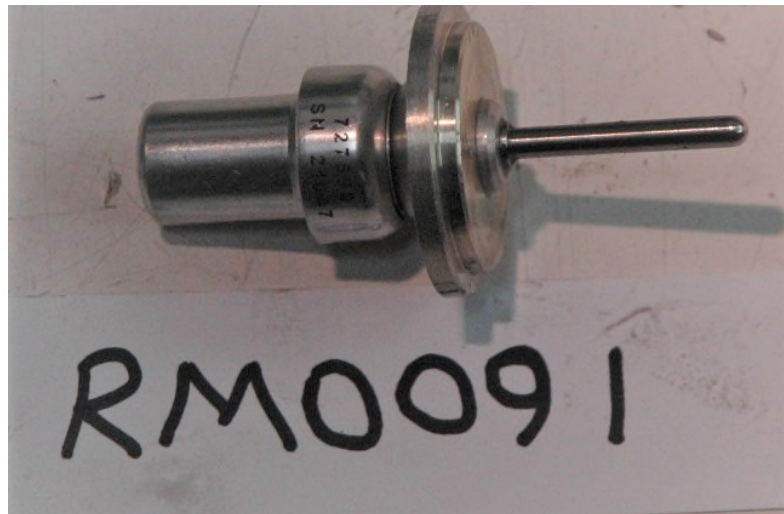
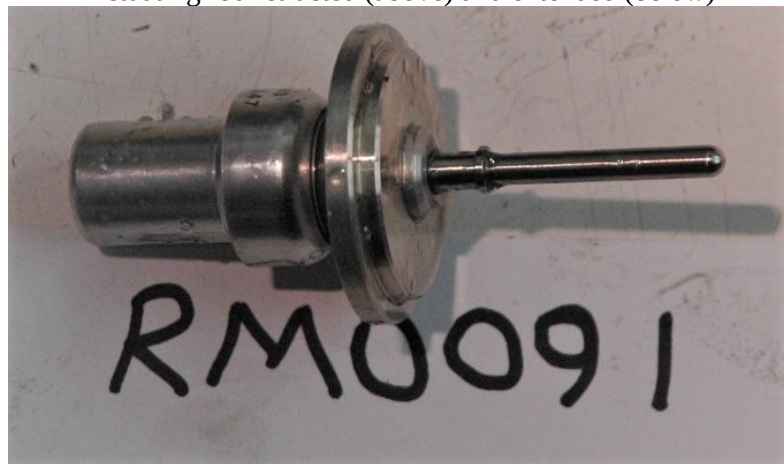
Actuating rod retracted (above) and extended (below)

Figure 13  
FOHE thermal element
