**NATIONAL TRANSPORTATION SAFETY BOARD**  
**Office of Aviation Safety**  
**Washington, D.C. 20594**

**POWERPLANT GROUP CHAIRMAN'S FACTUAL REPORT**

**NTSB No: CEN21LA004**

Aircraft: Piper PA-46-500TP, registration number N62ZM

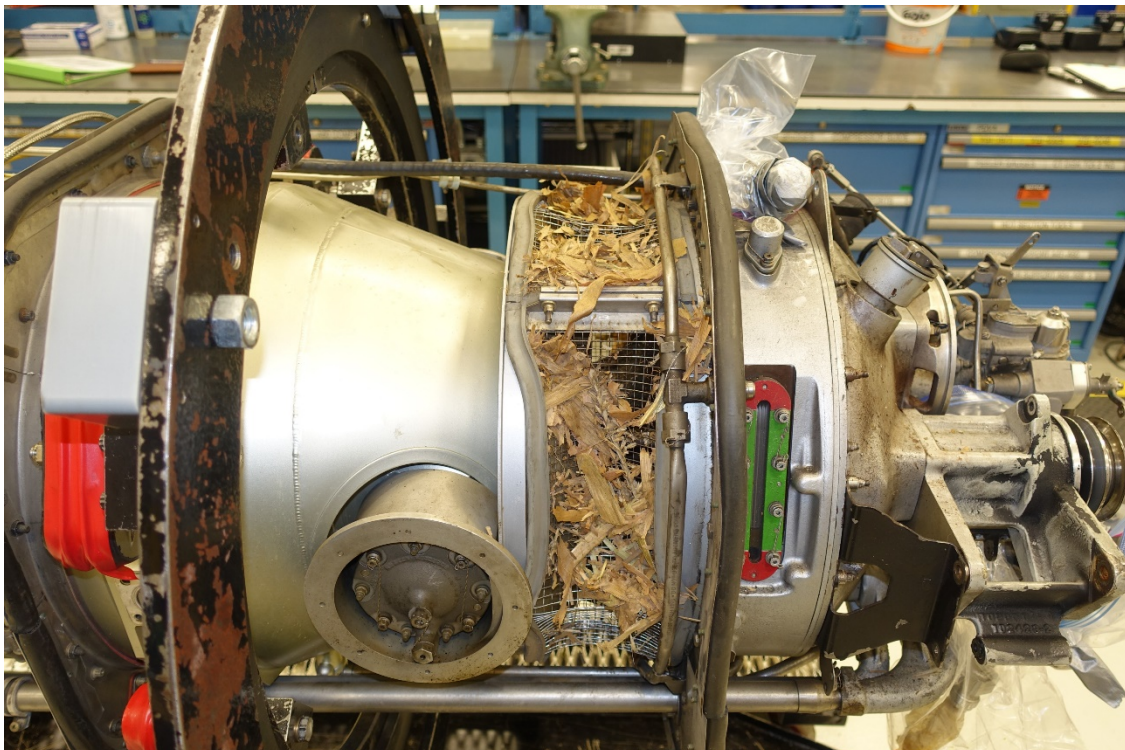
**Photo 5- Corn Stalk Material Collected on the Inlet Screen**

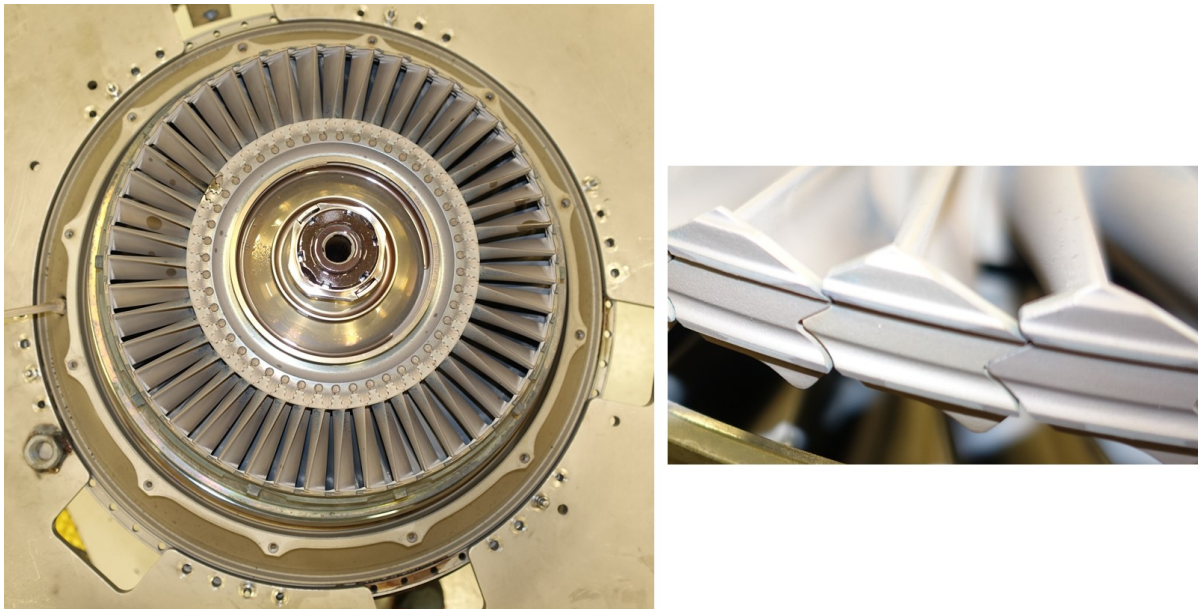
The 1<sup>st</sup> and 2<sup>nd</sup> stage power turbine rotors and nozzles were both in good condition and unremarkable (**Photos 7 and 8**).

**Photo 7- (L) 1<sup>st</sup> Stage Power Turbine Rotor Disk and (R) Blade Tip Platforms**

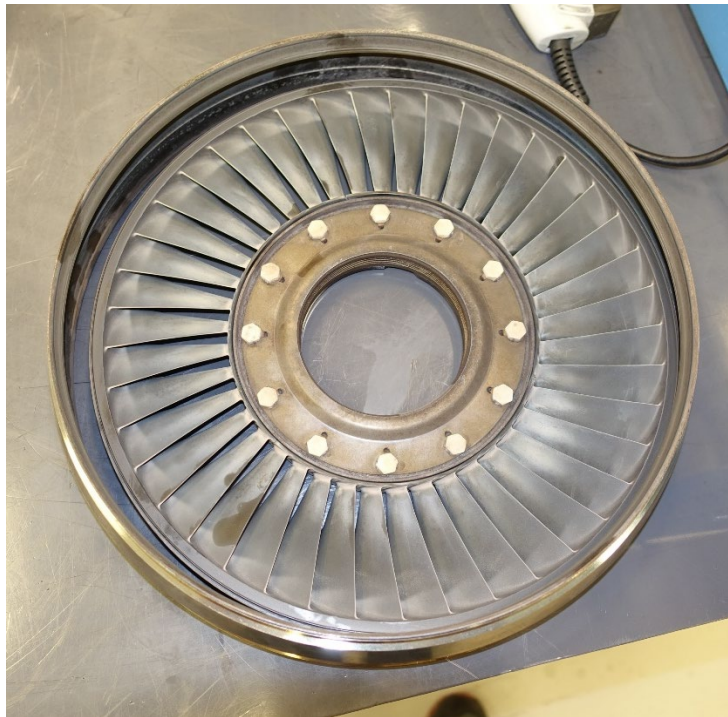
**Photo 8- 2<sup>nd</sup> Stage Power Turbine Nozzle**

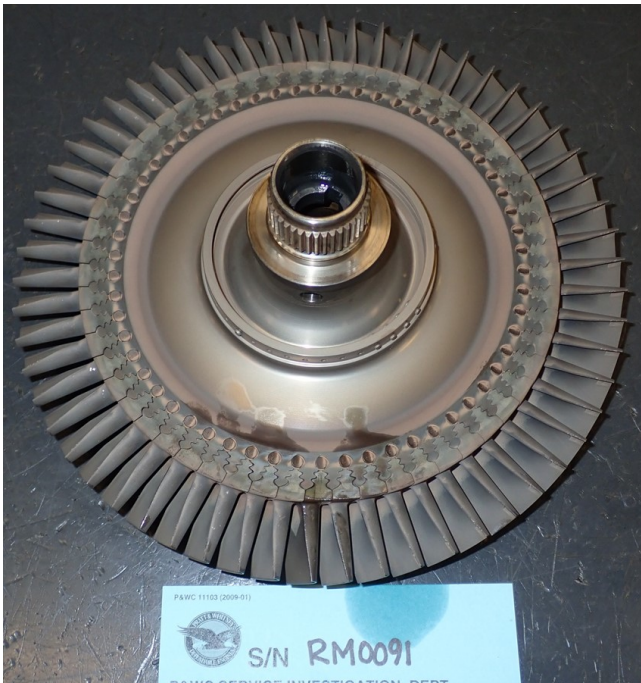
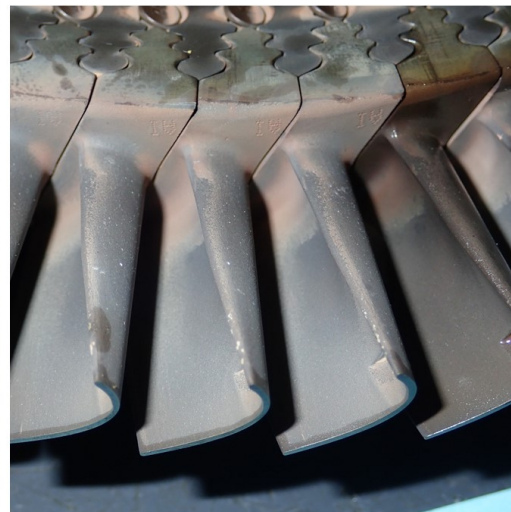
The compressor turbine (CT) rotor disk and nozzle were in good condition. The CT rotor blades had light superficial impact damage along the leading edge (**Photo 9**).

**Photo 9- (L) Compressor Turbine Rotor Disk, (R) Compressor Turbine Blade Leading Edge**

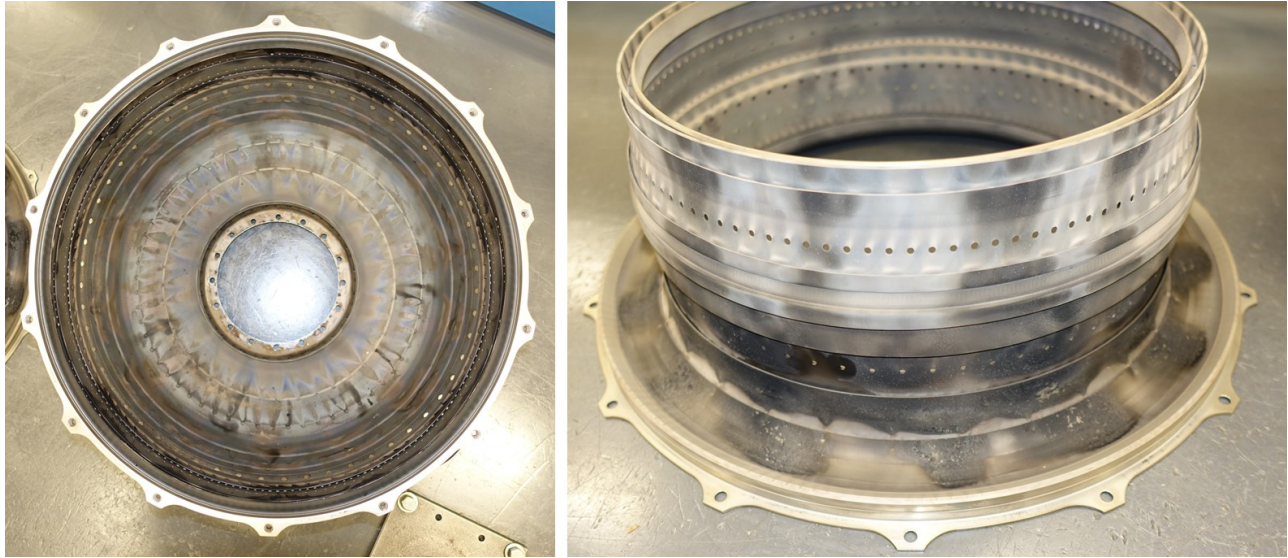
The combustor assembly was intact and did not exhibit indications of thermal damage, fuel nozzle streaking, or uneven wear (**Photo 10**). The fuel nozzles were individually removed and visually examined with no anomalies noted.

**Photo 10- Combustion Liner**

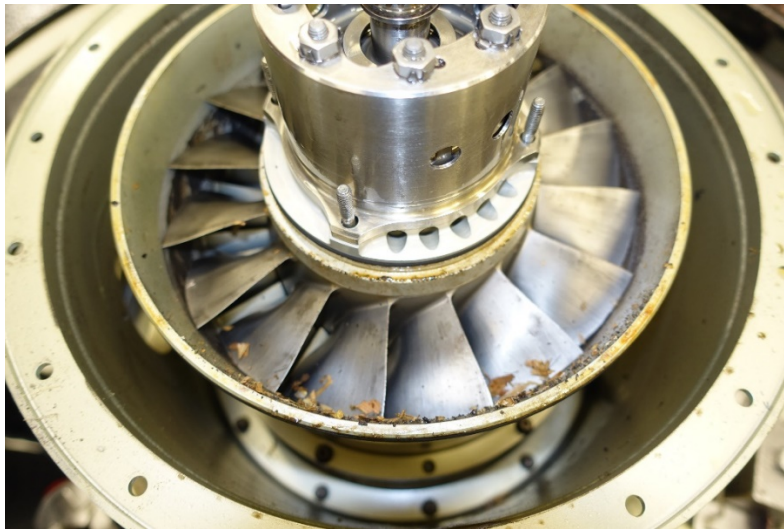
Loose corn stalk debris was visible through the compressor, from the 1<sup>st</sup> stage axial rotor to the centrifugal impeller (**Photos 11 and 12**). A dark sticky residue was adhered to interior stator case surfaces, stator vanes, and compressor rotor blades. The residue was most concentrated on the stator case along the 1<sup>st</sup> stage compressor rotor blade tip path. The stator case had a light rub coincident with the 1<sup>st</sup> stage blade path between the 5 and 7 o'clock positions (**Photo 13**). The No. 1 and No. 2 bearings were oil wetted and in good condition. The compressor bleed valves were removed and functionally tested. Both bleed valve pistons actuated smoothly and there was no evidence of damage that would have prevented normal operation.

**Photo 11- Compressor 1st Stage Rotor**

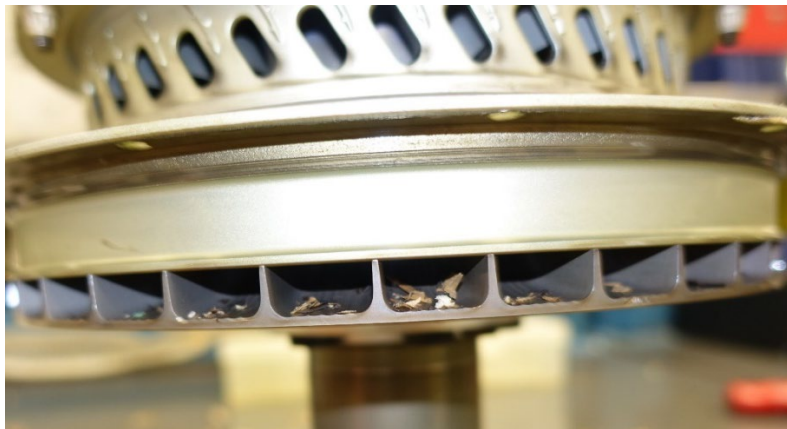
**Photo 12- Centrifugal Compressor Exducer Debris Accumulation**

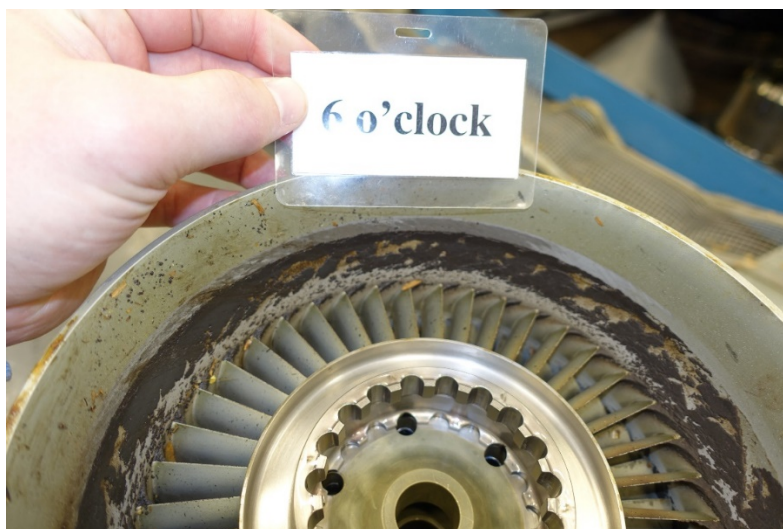
**Photo 13- Axial Compressor Stator Case Debris Buildup and Rub Marks**

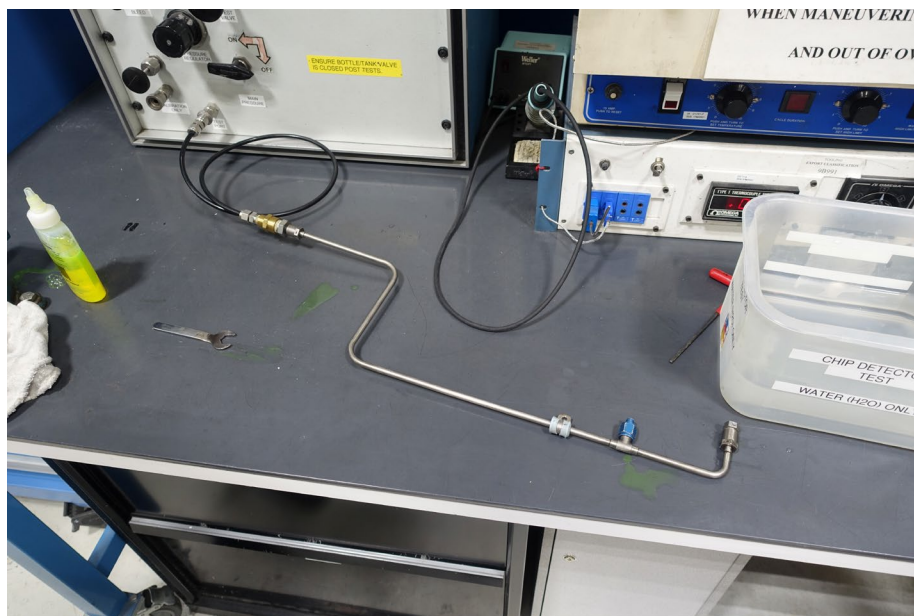
The air pressure sense lines were disconnected from the FCU and turboprop governor. The ferrule and/or braze joints on each line were pressure leak checked with air at 20 pounds per square inch (psi) in a water bath or by spraying the tube and connections with soap solution with no leaks detected (**Photo 14**). The fuel filter was removed and was in good condition with no debris accumulation.

**Photo 14- Turboprop Governor Py, Air Pressure Sense Line Leak Check**

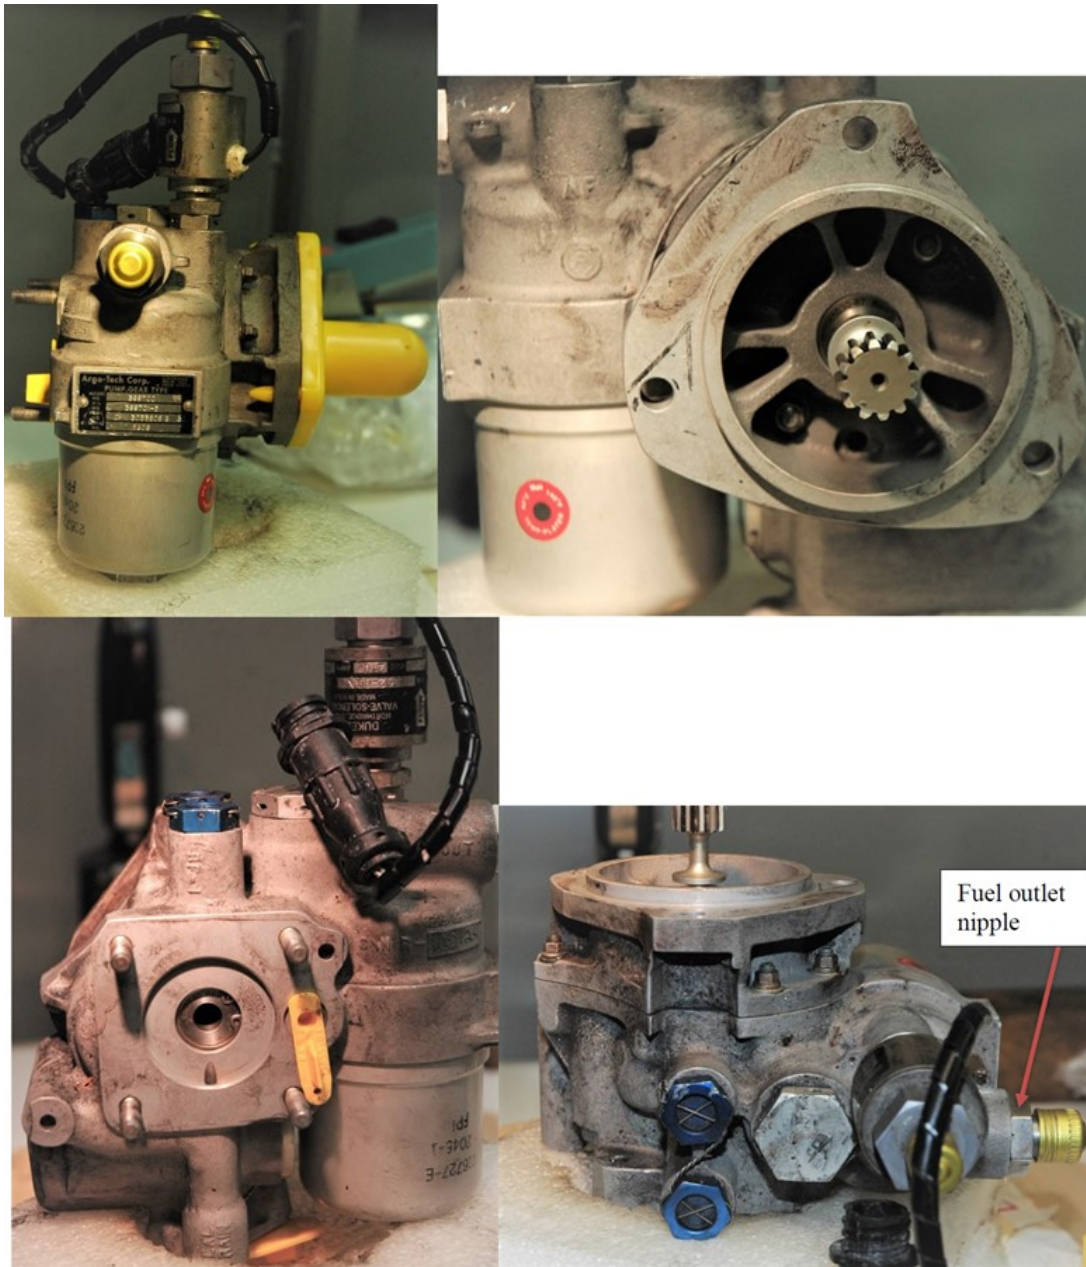
**Photo 15- Fuel Pump, as Received (Photos Courtesy of PWC)**

screen cavity. The fuel pump was installed on the test stand and a leak was observed originating at the fuel outlet nipple. A visual examination of the fuel pump outlet nipple revealed damage and it was replaced with a spare. The fuel pump was tested in accordance with Eaton overhaul manual 73-10-12 revision 2<sup>2</sup>. The fuel pump performance met specification and no anomalies were noted during the test.

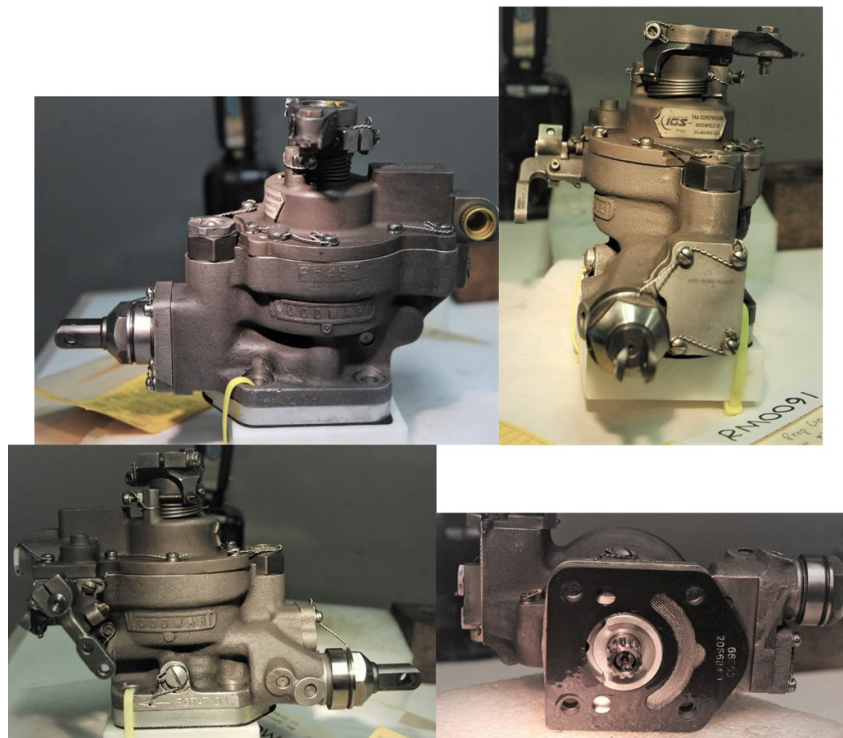
**Photo 18- Turboprop Governor, as Received at Woodward**

The turboprop governor, P/N 3074158-01, S/N 1516404, was manufactured by Woodward. The governor was bench tested in accordance with test specification procedure (TSP)-1527, revision 1. The maximum speed and control arm location test points were slightly above maximum limit. According to Woodward engineering, the readings were consistent with customer field adjustment and would not have affected performance during the accident flight.
