# NATIONAL TRANSPORTATION SAFETY BOARD

## MATERIALS LABORATORY FACTUAL REPORT

Report No. 21-037

Place : Mount Vernon, Indiana  
Date : October 6, 2020  
Vehicle : Quicksilver, N2942A  
NTSB No. : CEN21LA008  
Investigator : Steven Williams, AS-CEN

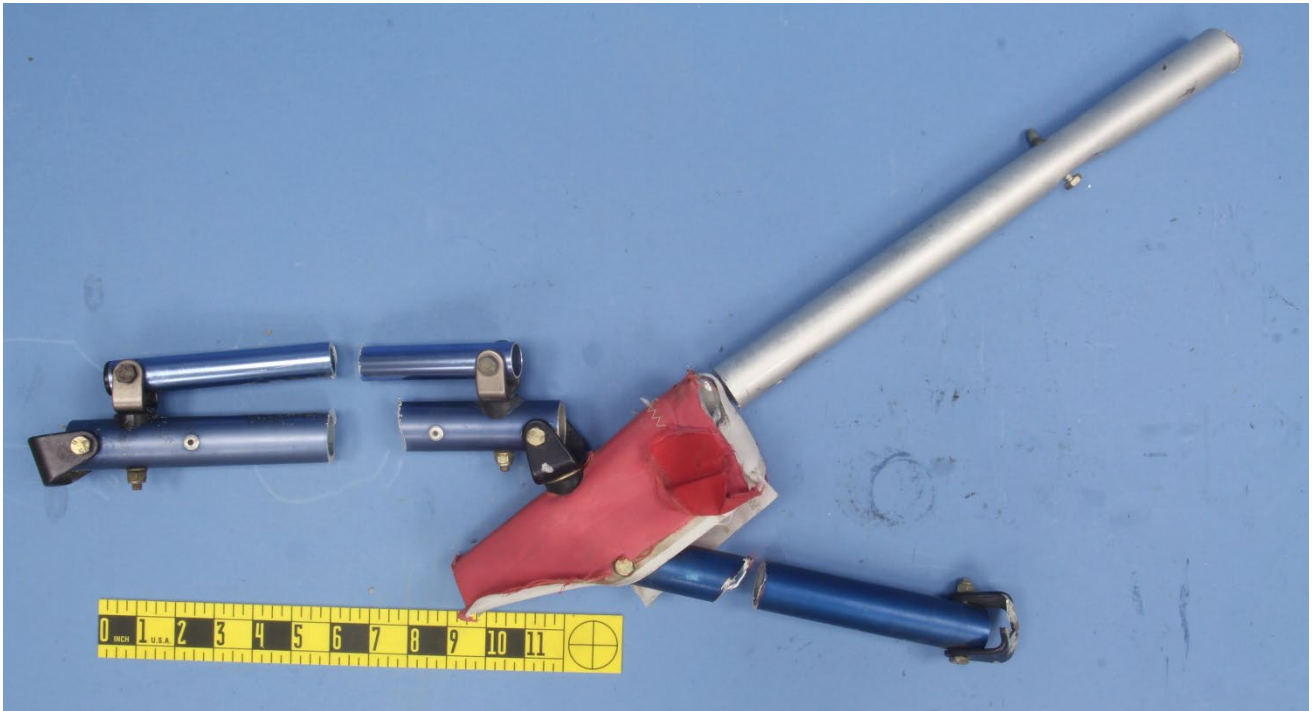
Several pieces of the structure from the airplane were received by the NTSB Materials Laboratory, as illustrated in Figure 1. These consisted mainly of tubular supports that were bolted together, which had been sectioned prior to receipt. The color, nonmagnetic properties, and relatively low density were consistent with these tubes being composed of anodized aluminum. The blue color exhibited by some of the supports was typical of aluminum anodized with blue dye and seal. The positions shown in Figure 1 do not necessarily correspond with the support positions on the aircraft prior to sectioning.

Figure 1 – The fractured structural support sectioned components, as received.

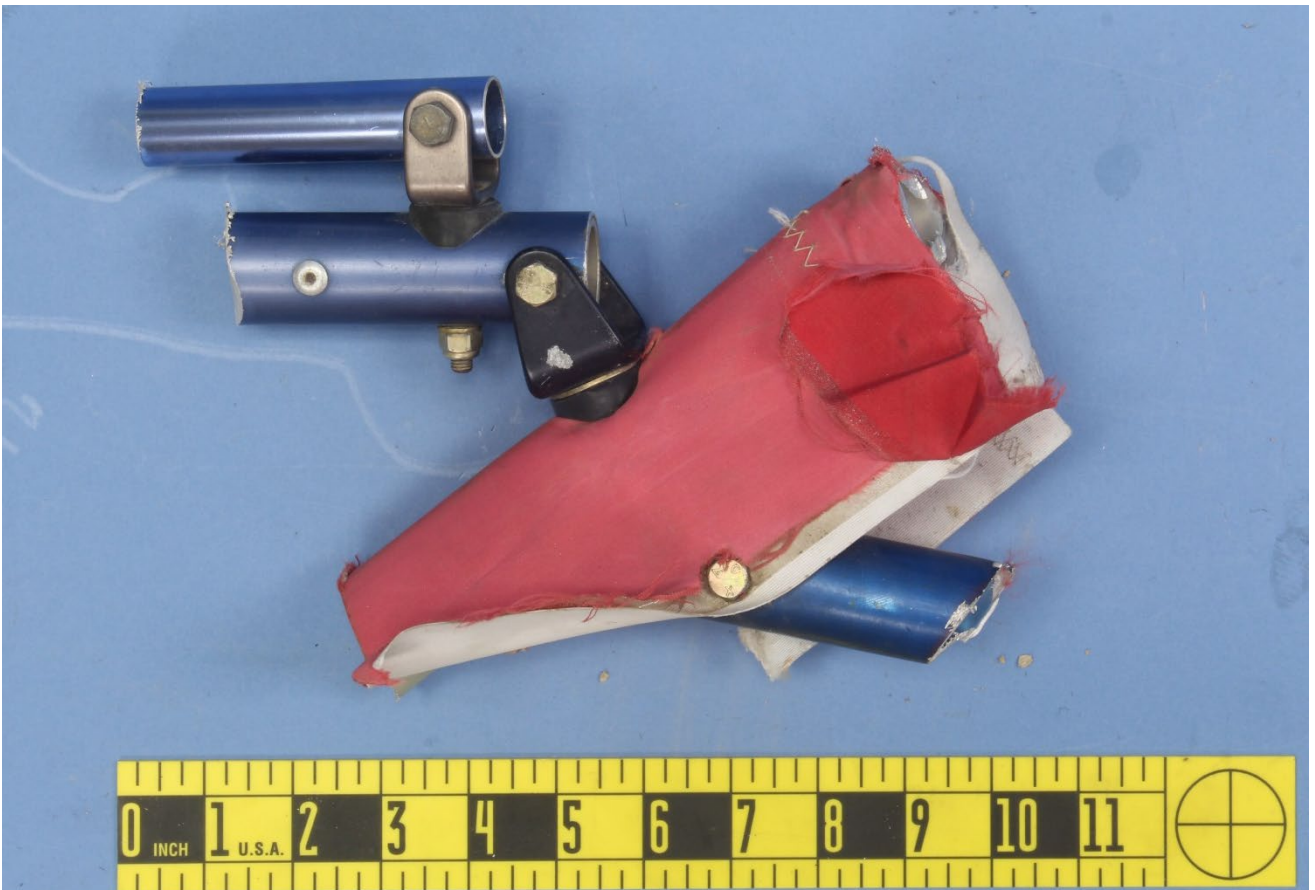
Figure 2 shows one of the sectioned support assemblies, as received. This assembly remnant consisted of three sectioned tubes joined by two Y-shaped clevis brackets that had been bolted through the supports. A remnant of red and white multilayer polyester fiber cloth was still attached through a bolted connection. The cloth exhibited loose short fiber filaments consistent with having been torn along a seam. All the support sections exhibited reflective, jagged features where sectioned, along with no indications

of macroscopic plastic deformation. These features were consistent with sectioning after the accident rather than having fractured.

Figure 2 – Three of the sectioned supports, as received.

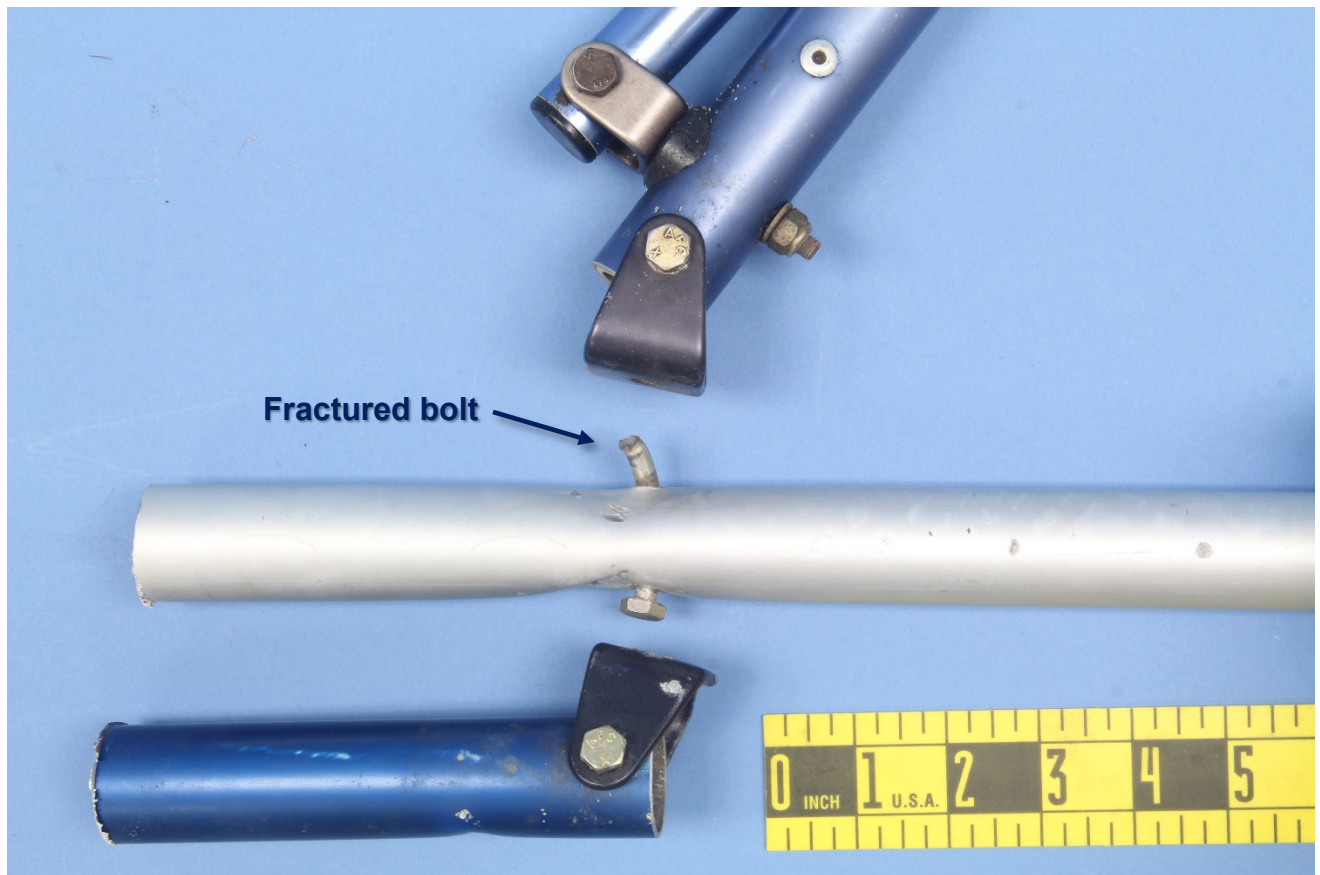
Figure 3 shows three of the assembly remnants, positioned as they had been assembled prior to fracture. These consisted of the two-support assembly section from the left in Figure 1 with a bracket, a single sectioned support with a bolted bracket, and a longer metallic-colored support tube with a fractured bolt remnant through a hole in the center.

Figure 3 – Several of the sectioned components, repositioned to show the location of a fractured bolt (arrow).

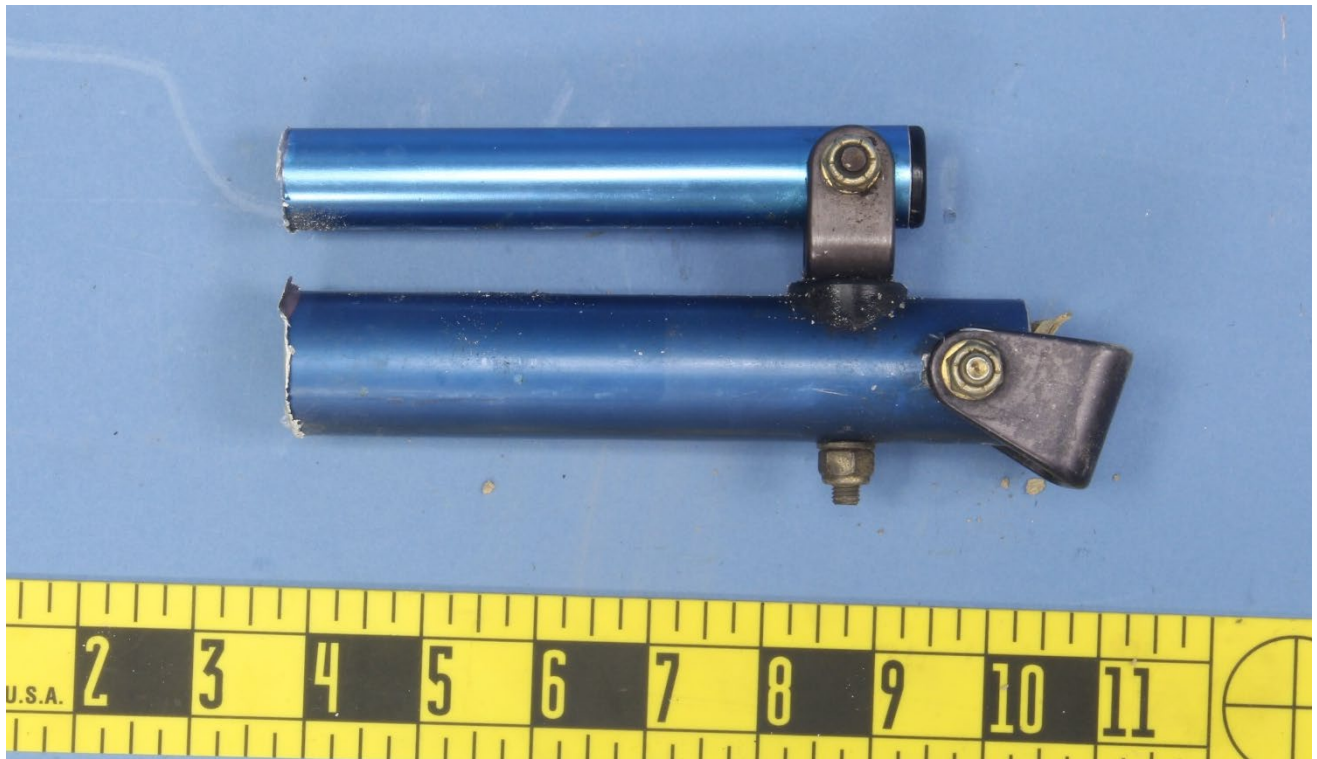
Figure 4 shows the upper assembly remnant from Figure 3, viewed from the side. This assembly remnant consisted of two anodized support tubes bolted together with a Y-shaped clevis. The bottom support section in the figure also had a U-shaped bracket bolted to its end. This bracket had been attached to the middle support section in Figure 3 with the threaded section of the fractured bolt and a nut (not received).

Figure 4 – The sectioned support assembly from Figure 4, viewed from the side.

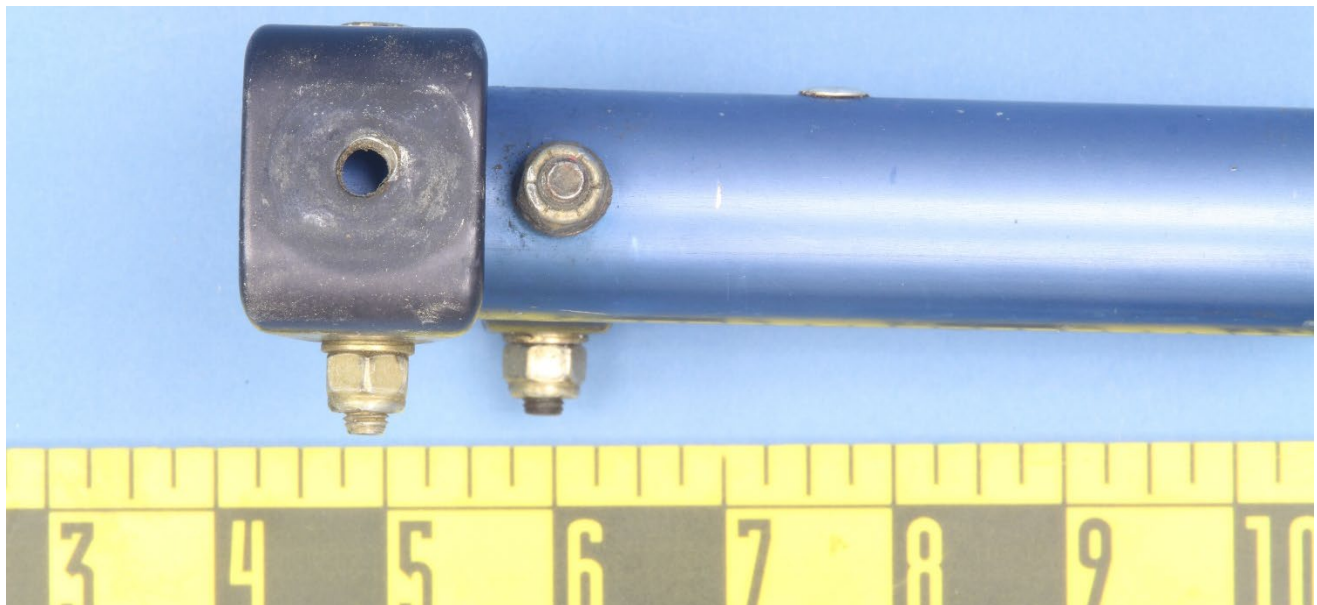
Of note on this assembly remnant was the bolt hole on the bracket, shown in Figure 5 facing the reader. This bolt hole exhibited plastic deformation along one side of the periphery. Figure 6 shows a microscopic view of the hole deformation. The hole exhibited elongation towards the lower right side of the figure, with material deformed upward and back over the bracket surface. These features were consistent with a mating component (the fractured bolt) having been forced toward the direction of deformation in this bracket.

Figure 5 – View of a second bracket, showing the bolt hole.

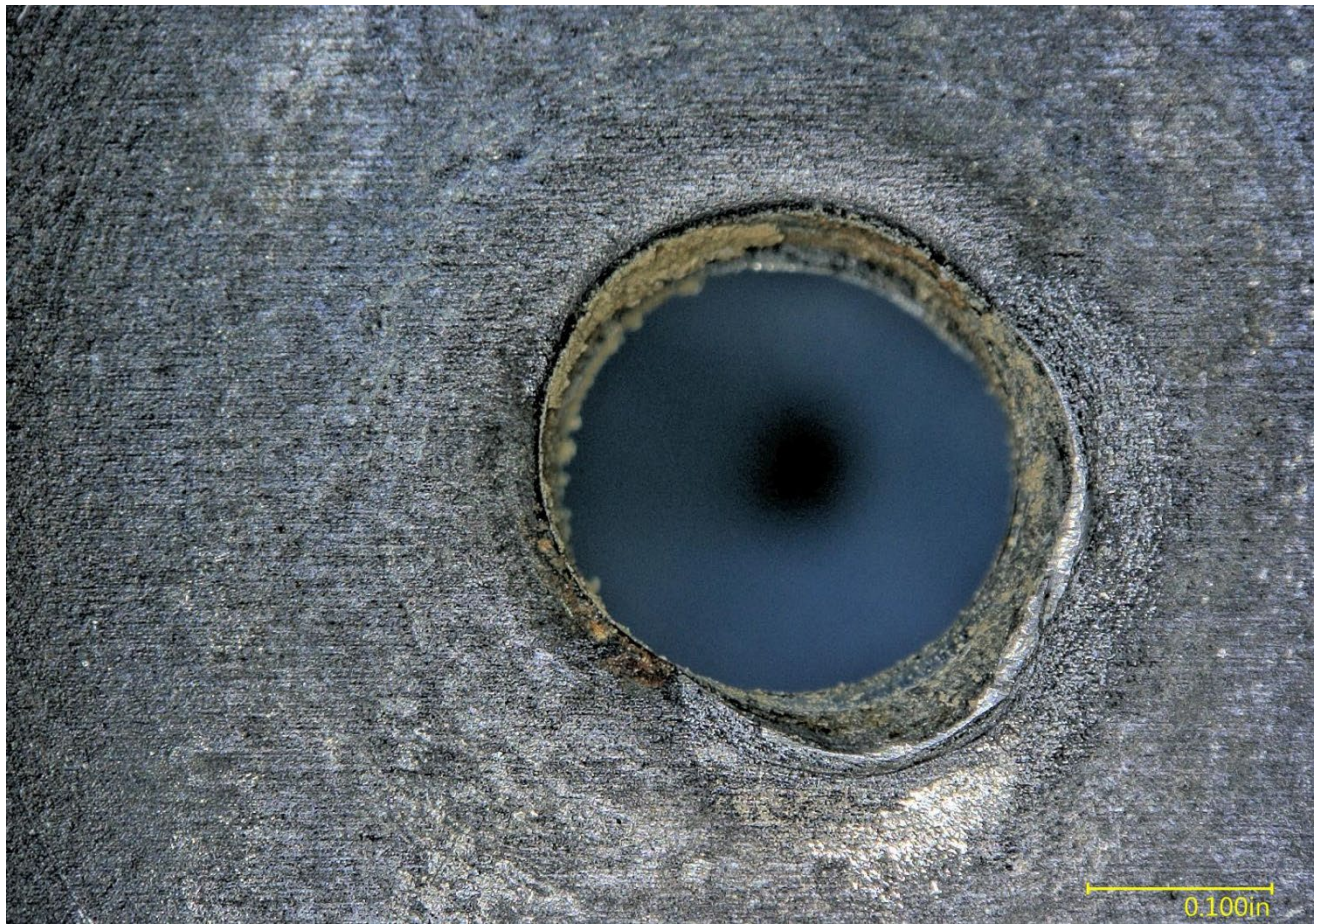
Figure 6 – Closer view of the bolt hole in the bracket in Figure 5, showing outward deformation (towards lower right in figure).

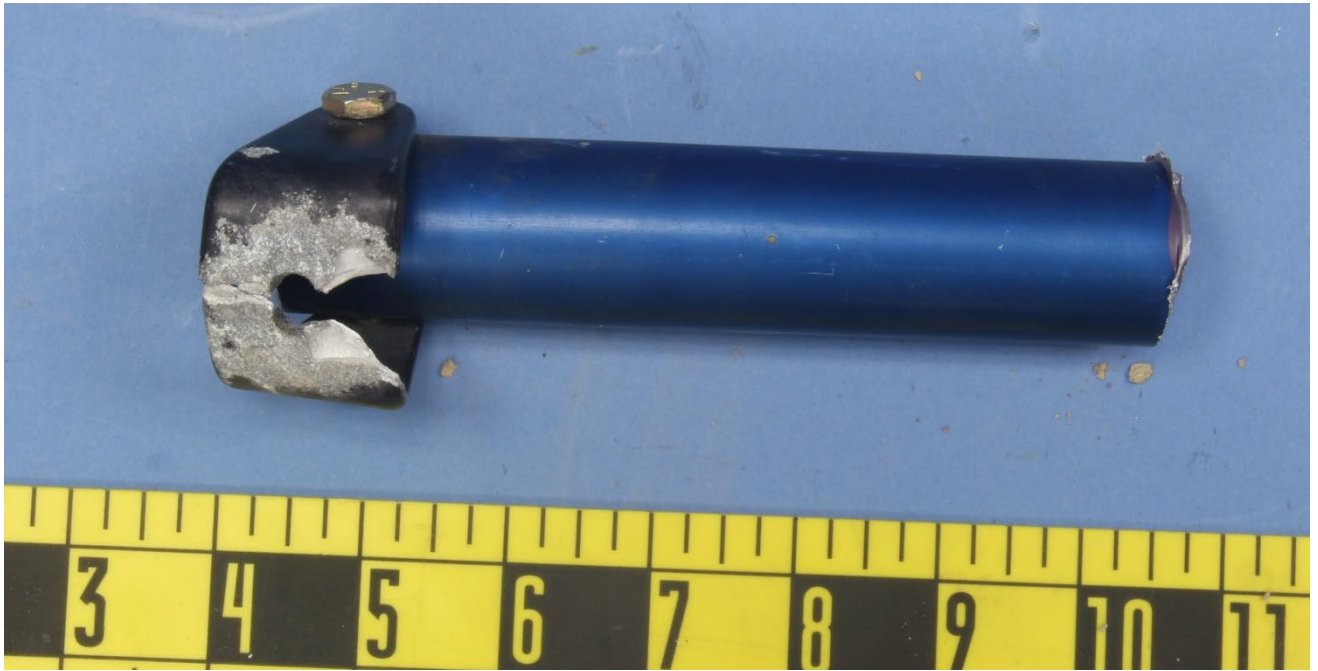
Figure 7 shows the sectioned anodized support tube from the bottom of Figure 3, viewed with the U-shaped bracket facing the reader. This bracket had been connected to the middle tube in Figure 3 from the fractured bolt. In this case, the black-painted bracket exhibited bare metal and missing material, consistent with having fractured. Moreover, the bracket had fractured along the middle, parallel to the sectioned support. The fracture of the bracket of the left side of the bolt hole in the figure consisted of a straight profile parallel to the support direction. To the right of the bolt hole in the figure, the fracture was angled outward (a V-shape), consistent with the fracture branching, generating a small piece of missing material.

Figure 7 – Planar view of the fractured bracket attached to the sectioned support in Figure 7.

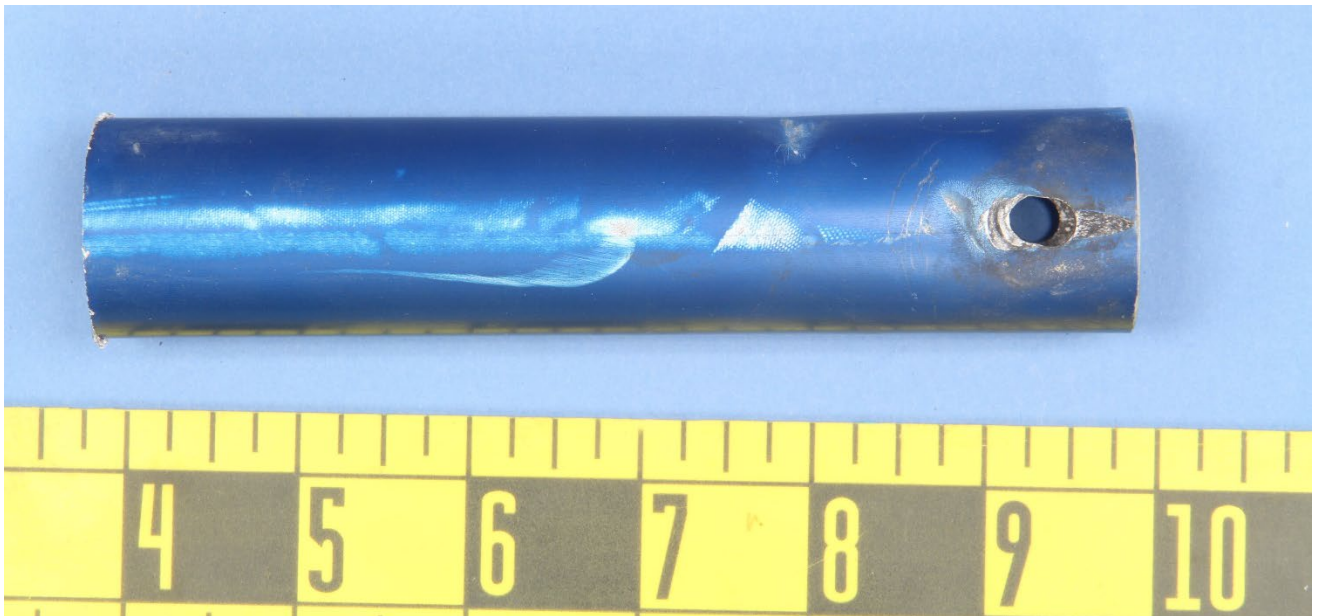
The fractured bracket was removed by disassembling the bolted connection. Figure 8 shows the remaining sectioned support tube, without the bolt or bracket remnants. The surface of the support shows an array of witness marks, consistent with impact against adjacent components. The bolt hole exhibited plastic deformation consistent with elongation parallel to the support direction. This deformation was consistent with the bolt that connected to the bracket being forced along the hole in the direction of the support (towards the right in Figure 8).

Figure 8 – View of a sectioned support, showing a bolt hole elongated in both directions along the longitudinal direction.

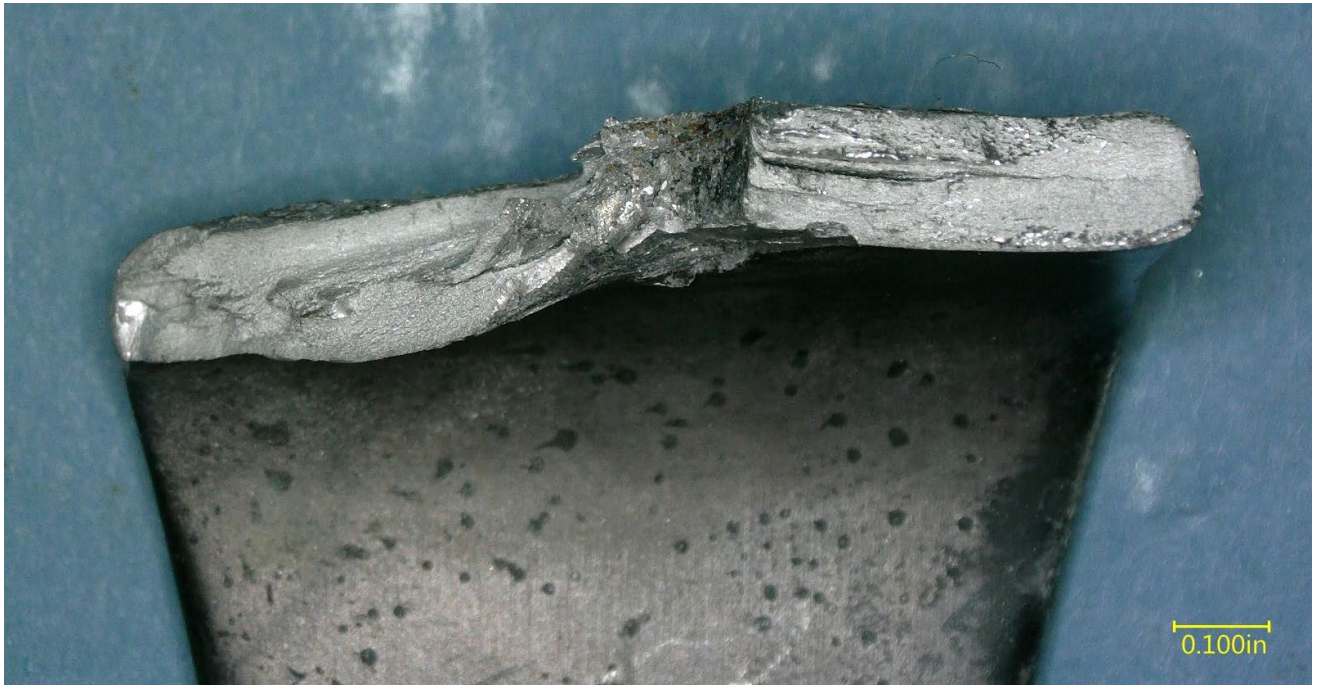
Figure 9 shows the fractured support bracket from one of the mating fracture surfaces. The right side of the figure shows the flatter or straight portion of the bracket fracture surface, whereas the left side shows the outward angled portion. Both areas of the fracture surface generally exhibited a rough, fibrous surface with a dull gray luster. There were also sporadic areas that were flatter and reflective—these regions were consistent with smearing and other types of post-fracture damage.

Figure 9 – View of one of the mating faces of the fractured bracket.

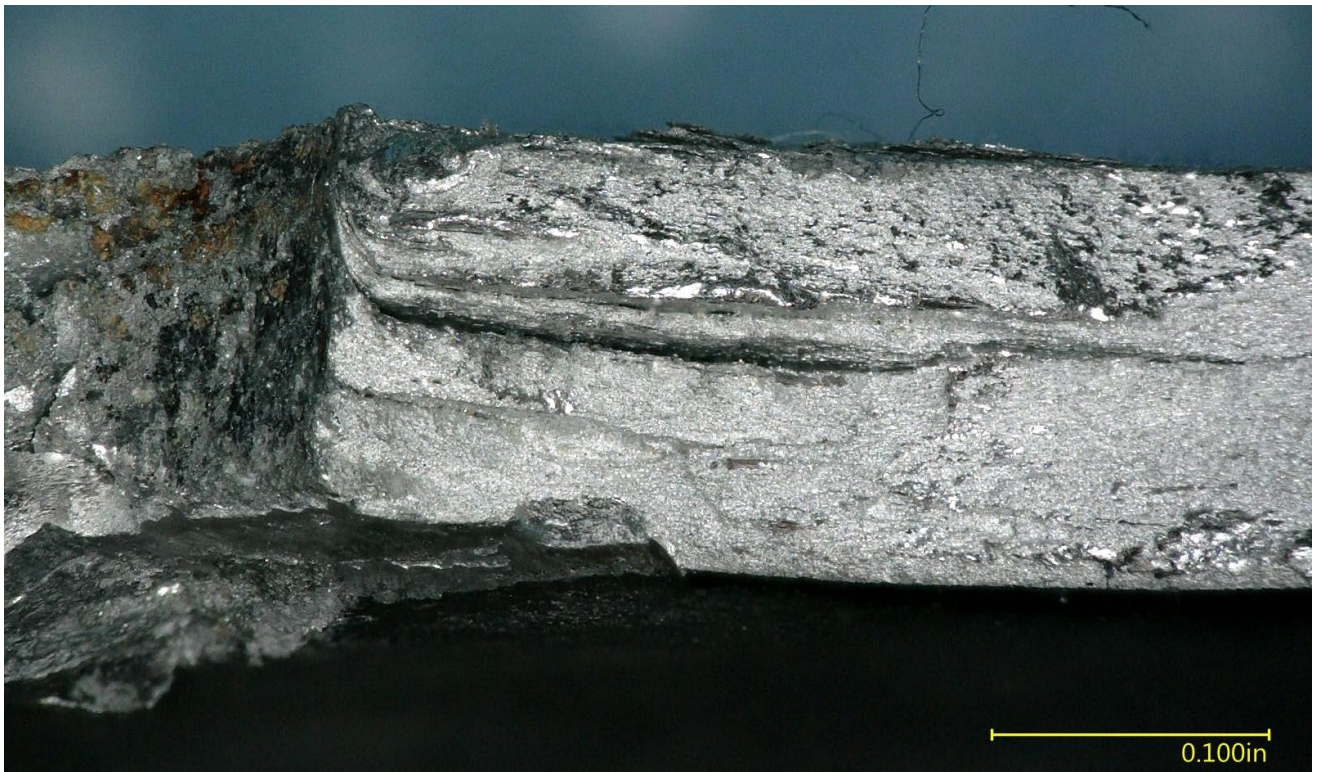
Figure 10 shows a closer view of the flatter area of the fracture surface, adjacent to the bolt hole. The material adjacent to the hole exhibited a curved morphology, oriented upward parallel to the hole surface in the figure. This was consistent with deformation outward of the bracket along the hole. This portion of the fracture surface also exhibited secondary cracks. These cracks were oriented parallel to the rolling or forging direction of the bracket, and were consistent with secondary fracture along the elongated grain boundaries.

Figure 10 – View of part of the bracket fracture surface near the bolt hole, showing outward deformation.

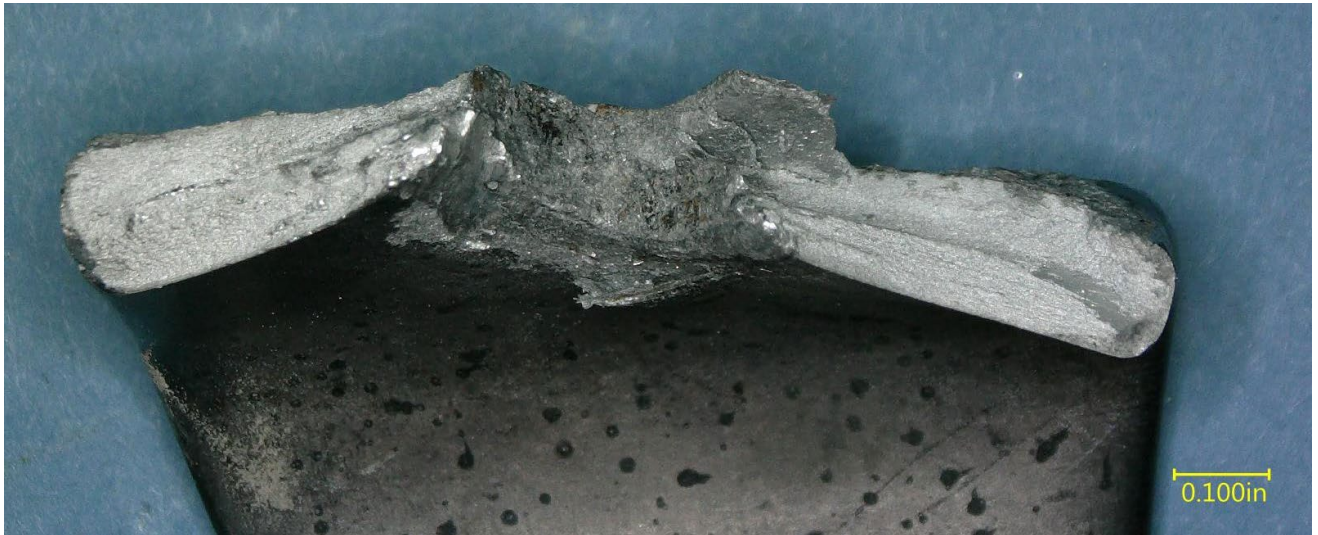
Figure 11 shows the mating (opposite) fracture surface of the bracket. In this view, the straighter or flatter fracture surface is on the left, and the angled area of the fracture surface is on the right. In both areas, the surfaces exhibited a rough, fibrous surface texture with a dull gray luster. The areas along both sides of the bolt hole exhibited plastic deformation. This deformation was upward in the figure, which was towards the outward face of the bracket. The outward surface edge on the angled area of the fracture surface (right side in Figure 11) exhibited a stratified angled protrusion.

Figure 11 – View of the mating bracket fracture surface opposite that shown in Figure 9.

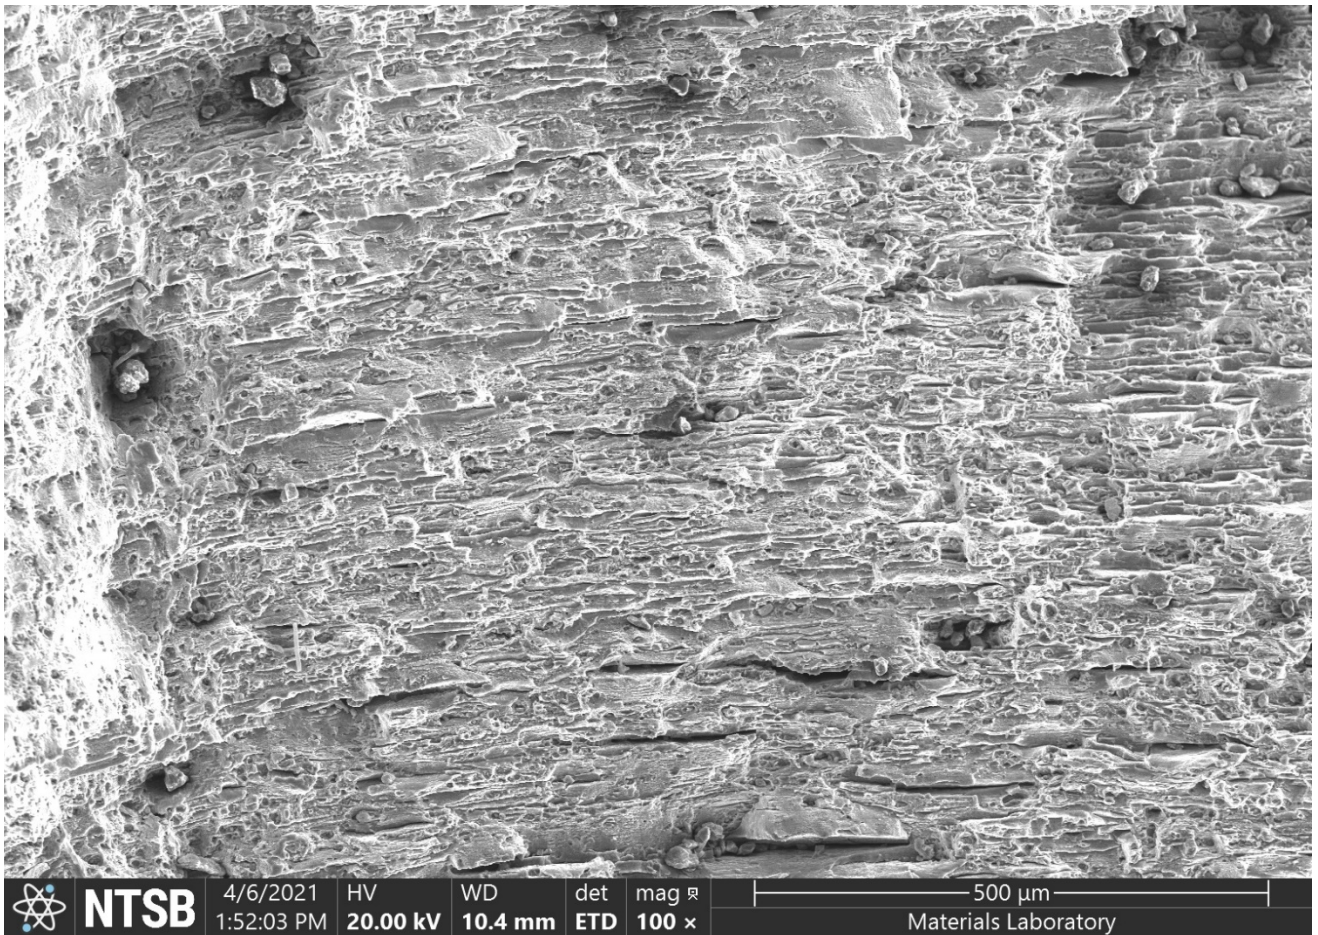
The bracket fracture surface was cleaned ultrasonically using acetone and then examined using a scanning electron microscope (SEM). Figure 12 shows a typical area of the bracket fracture surface near the bolt hole. The features were relatively uniform, showing a rough layered appearance, consistent with having fractured transverse to the elongated grain direction of the bracket. A closer view of the fracture surface in Figure 13 and Figure 14 revealed dimpled rupture, consistent with overstress fracture. The features illustrated in these figures were typical of the entirety of the bracket fracture surface examined. There were no other features observed consistent with other fracture modes or pre-existing defects such as cracks.

Figure 12 – Secondary electron (SE) micrograph of the bracket fracture surface.

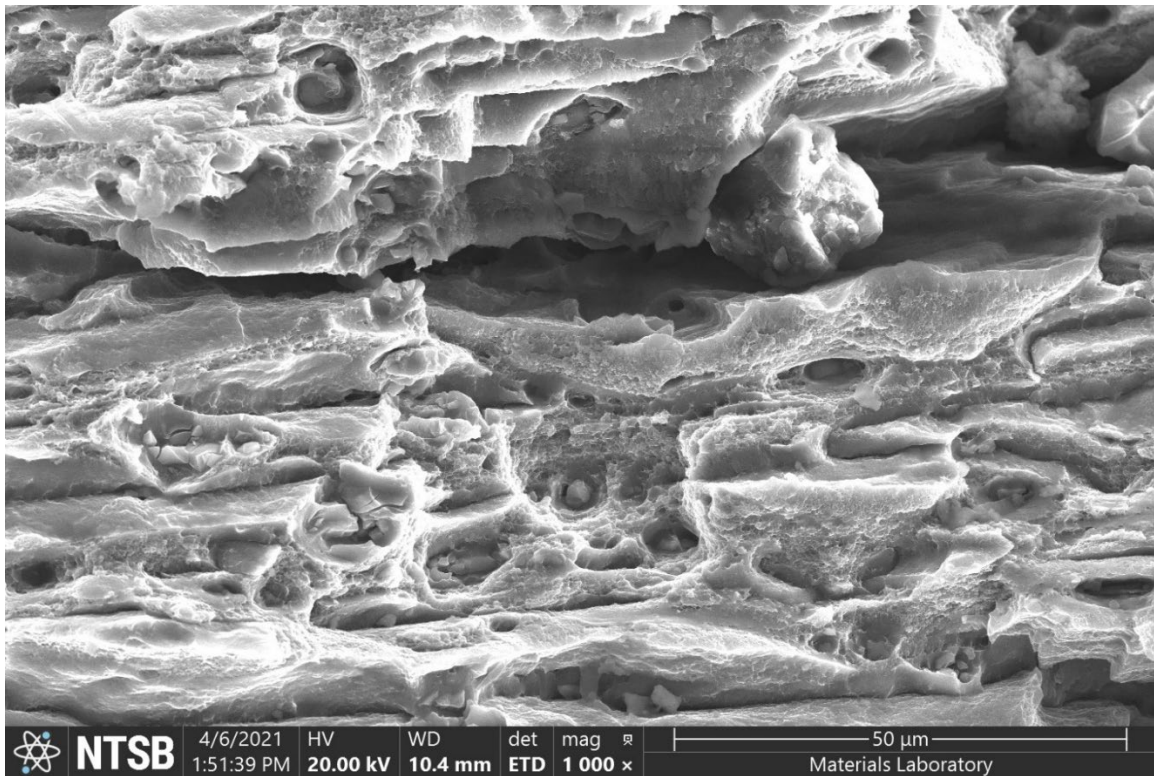
Figure 13 – SE micrograph of a closer view of the fracture surface in Figure 12, showing dimpled rupture.

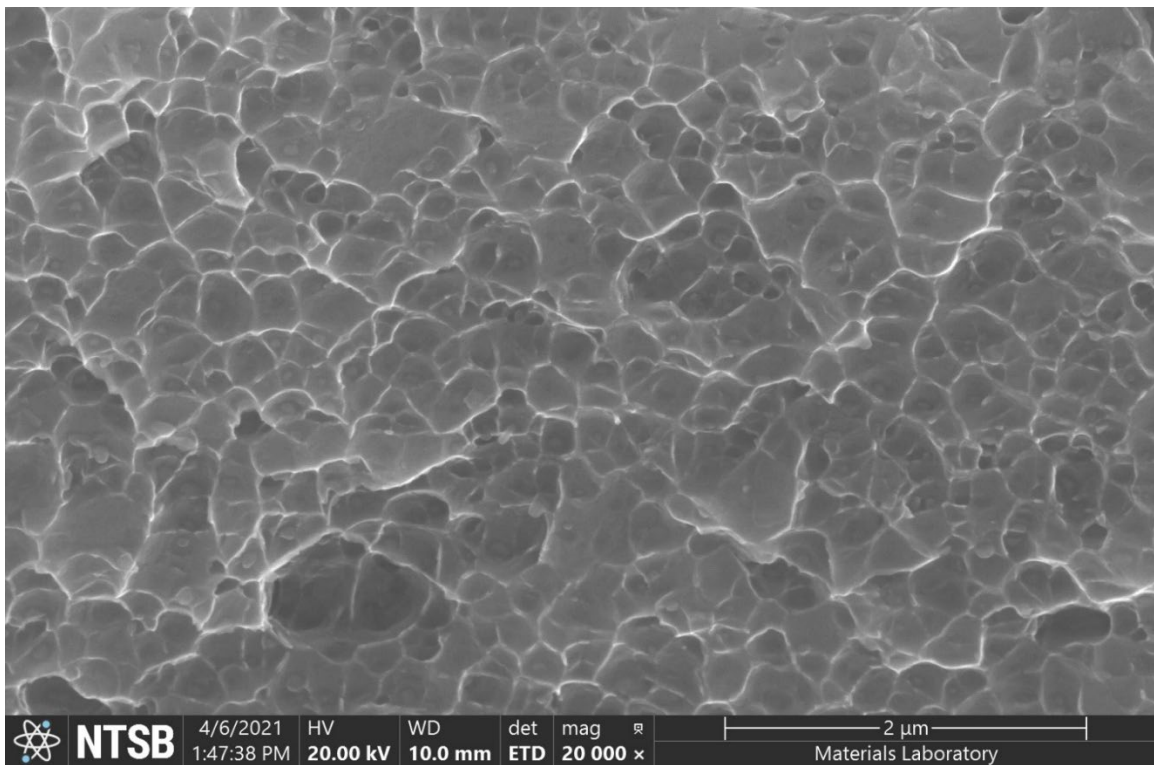
Figure 14 – SE micrograph of dimpled rupture on the fracture surface in Figure 13.

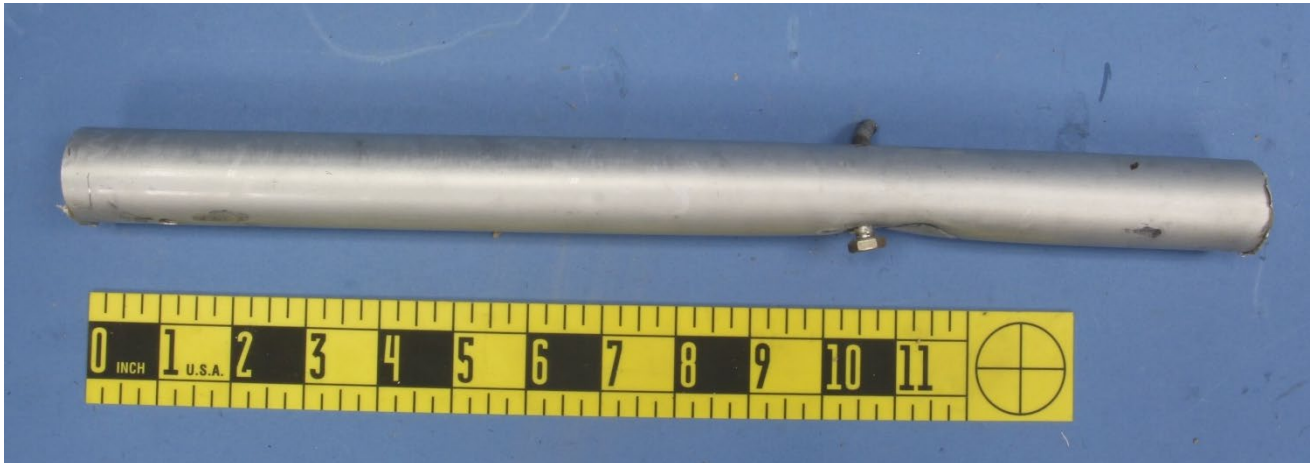
Figure 15 shows the middle support tube from Figure 3 with the fractured bolt in the bolt hole. The support tube exhibited inward deformation at the location of the bolt hole, particularly on the side with the head of the fractured bolt. The opposite side of the tube exhibited outward deformation along with periphery of the bolt hole, and nearby inward deformation located towards the right of the hole in Figure 16. These features were consistent with inward buckling from compression of the support around the bolt, and tension on the bolt and surrounding bolt hole walls.

The fractured bolt had been deformed into a C-shape (see Figure 15). The bolt had fractured along the threaded portion of the shaft, as illustrated in Figure 16. This side corresponded with the outward deformation of the adjacent support material around the bolt hole wall.

Figure 15 – View of the support section with the fracture bolt.

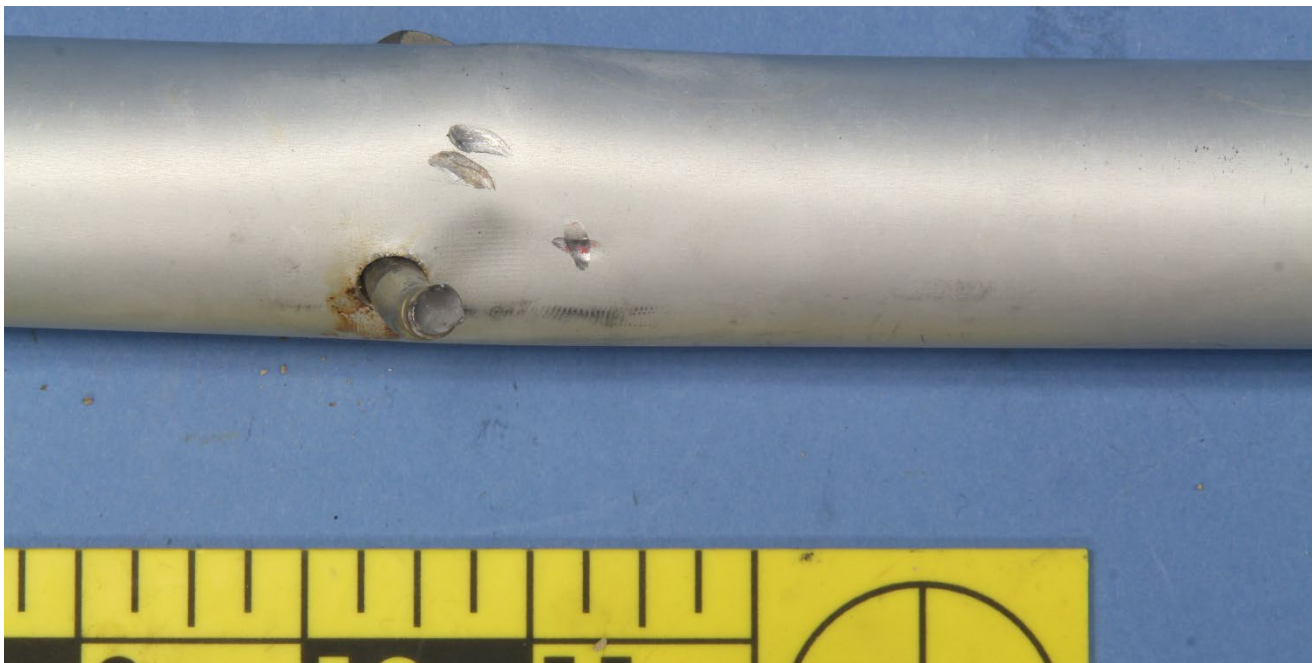
Figure 16 – Closer view of the sectioned support in Figure 15, showing the fracture surface of the bolt, and witness marks on the outer surface of the support.

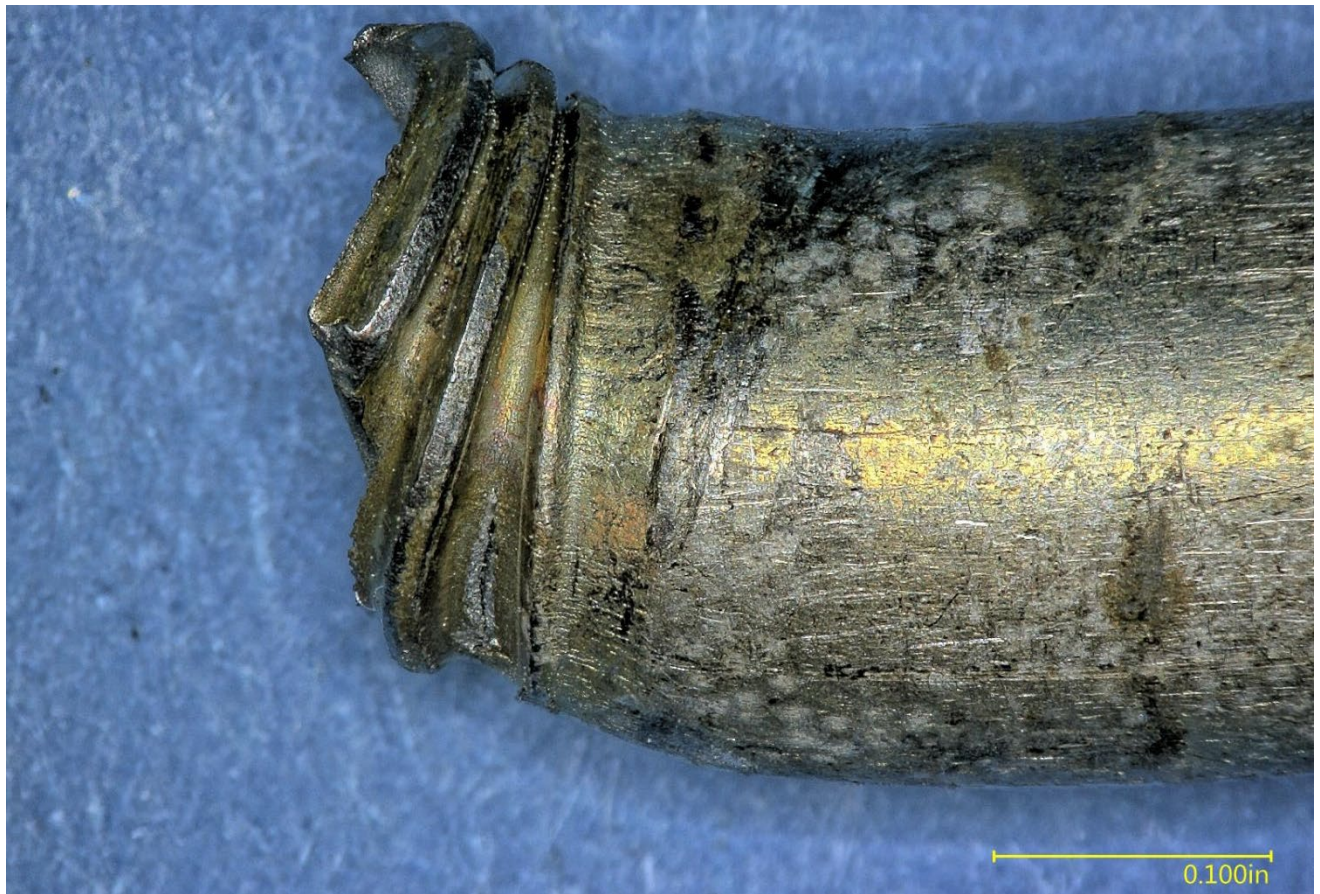
The fractured bolt was removed from the middle support section. A side view of the fractured portion along the threaded area is displayed in Figure 17. This fracture surface

was positioned so that the shaft of the bolt was horizontal, demonstrating the upward bending deformation in the threaded region. Several of the bolt thread crests exhibited smearing marks in the direction of deformation, and outward-oriented streaks were present along the transition of the shaft to the initial threads. These streaks were consistent with sliding across adjacent metal surfaces. There were two parallel cracks along the thread valleys below the lowest thread that had fractured, visible on the bottom of Figure 17.

Figure 17 – View of the fractured bolt, from the side.

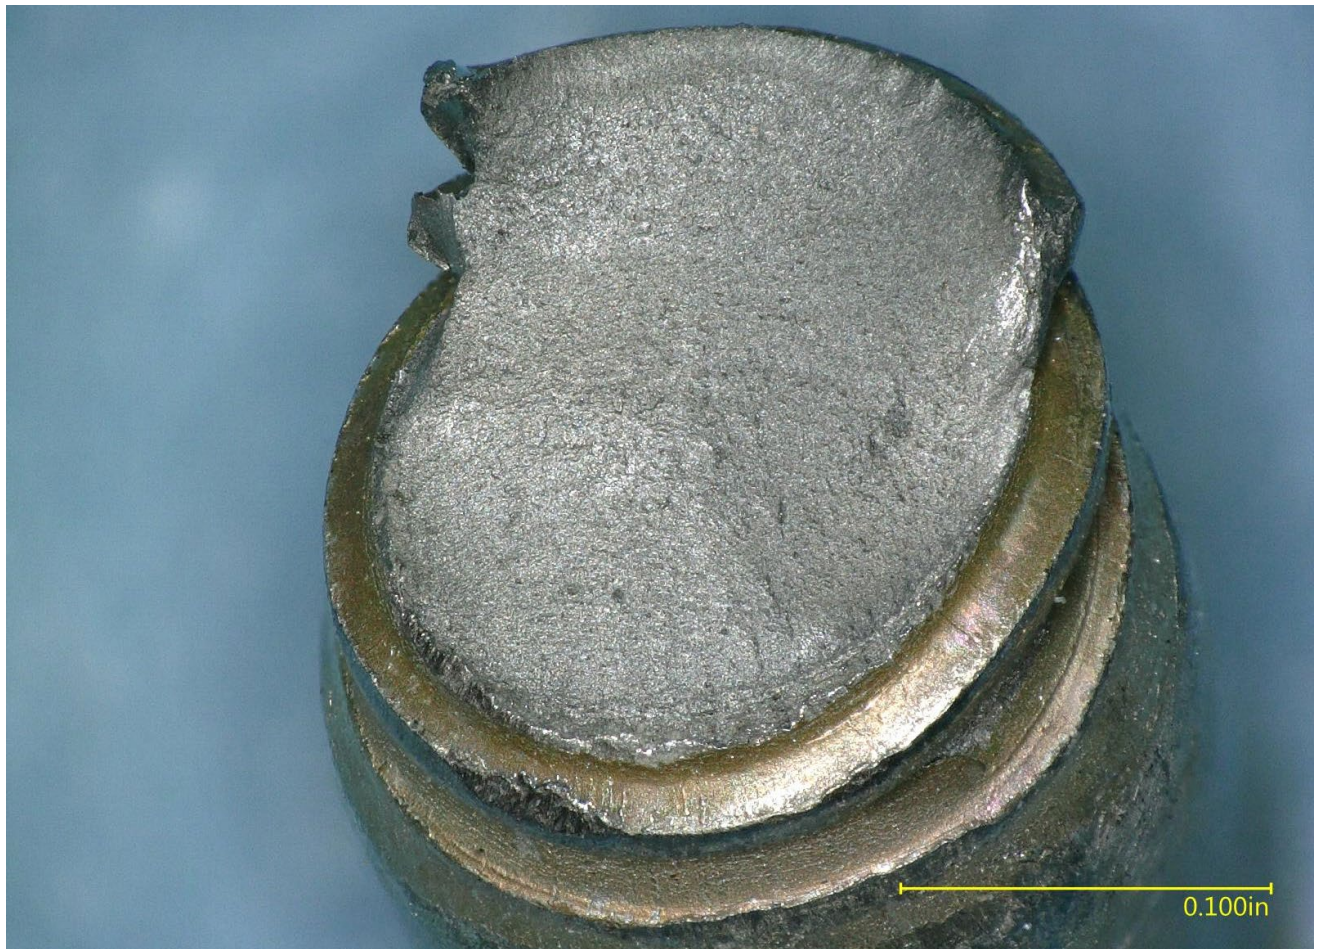
Figure 18 shows a planar view of the fracture surface. As also shown in Figure 17, the fracture transited several bolt threads, rather than being oriented solely along the crest of one thread. The fracture surface was oriented at an approximately 45° angle. As shown in Figure 18, the fracture surface exhibited a dull gray luster with a rough, fibrous surface texture. The river patterns and visual features of the bolt fracture surface were consistent with fracture starting on the bottom of Figure 18 and ending at the top of the figure.

Figure 18 – The bolt fracture surface.

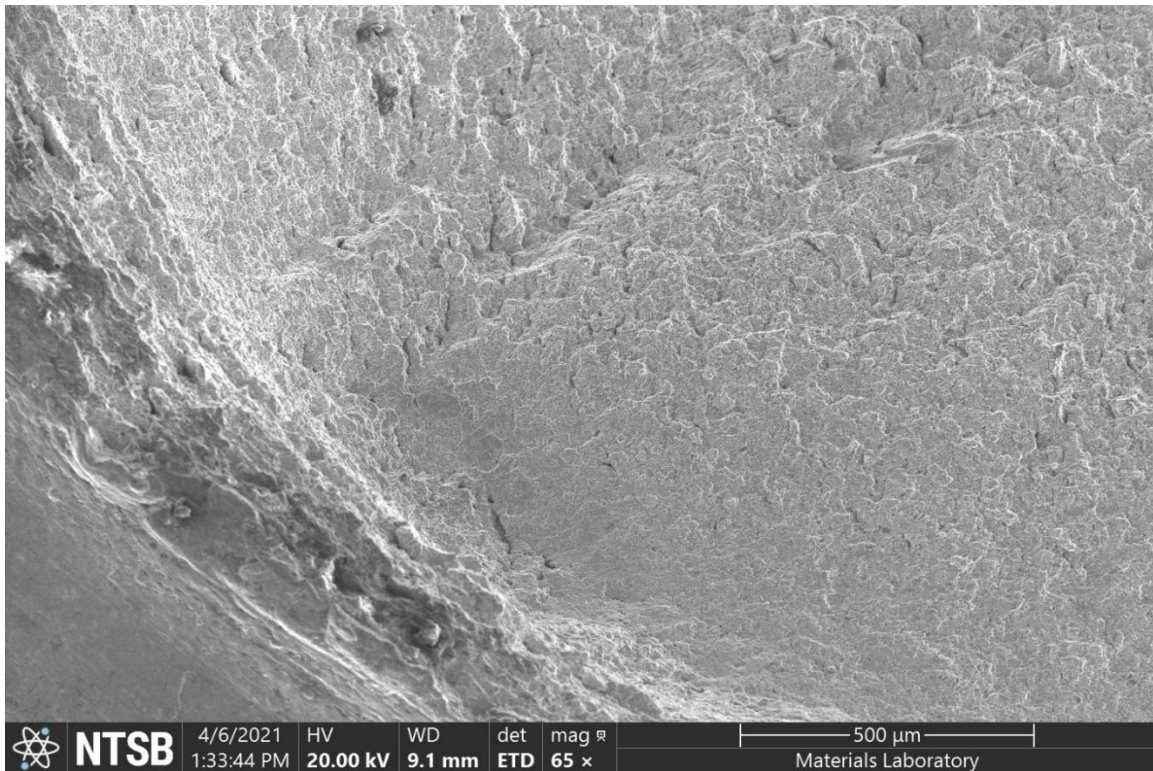
The fractured bolt was examined using a SEM. Figure 19 shows the area where the fracture began on the bolt. This region showed flow lines and river patterns emanating from the depressed area near the thread surface. Figure 20 shows a closer view of this area. The fracture surface exhibited rupture consistent with overstress fracture. No other features consistent with other failure modes such as pre-existing cracking were observed.

Figure 19 – SE micrograph of the fracture initiation area of the bolt fracture.

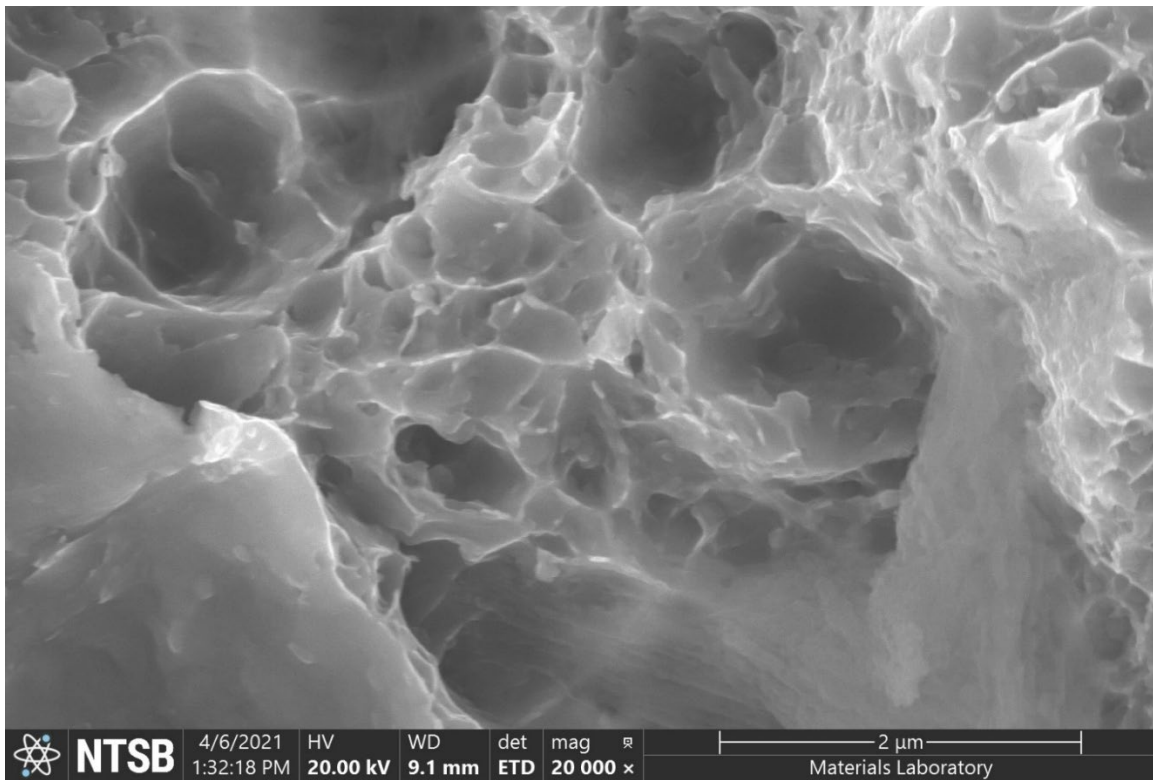
Figure 20 – SE micrograph of dimpled rupture near the initiation area of the bolt fracture.
