# NATIONAL TRANSPORTATION SAFETY BOARD

## MATERIALS LABORATORY FACTUAL REPORT

Report No. 21-037

Place : Mount Vernon, Indiana  
Date : October 6, 2020  
Vehicle : Quicksilver, N2942A  
NTSB No. : CEN21LA008  
Investigator : Steven Williams, AS-CEN

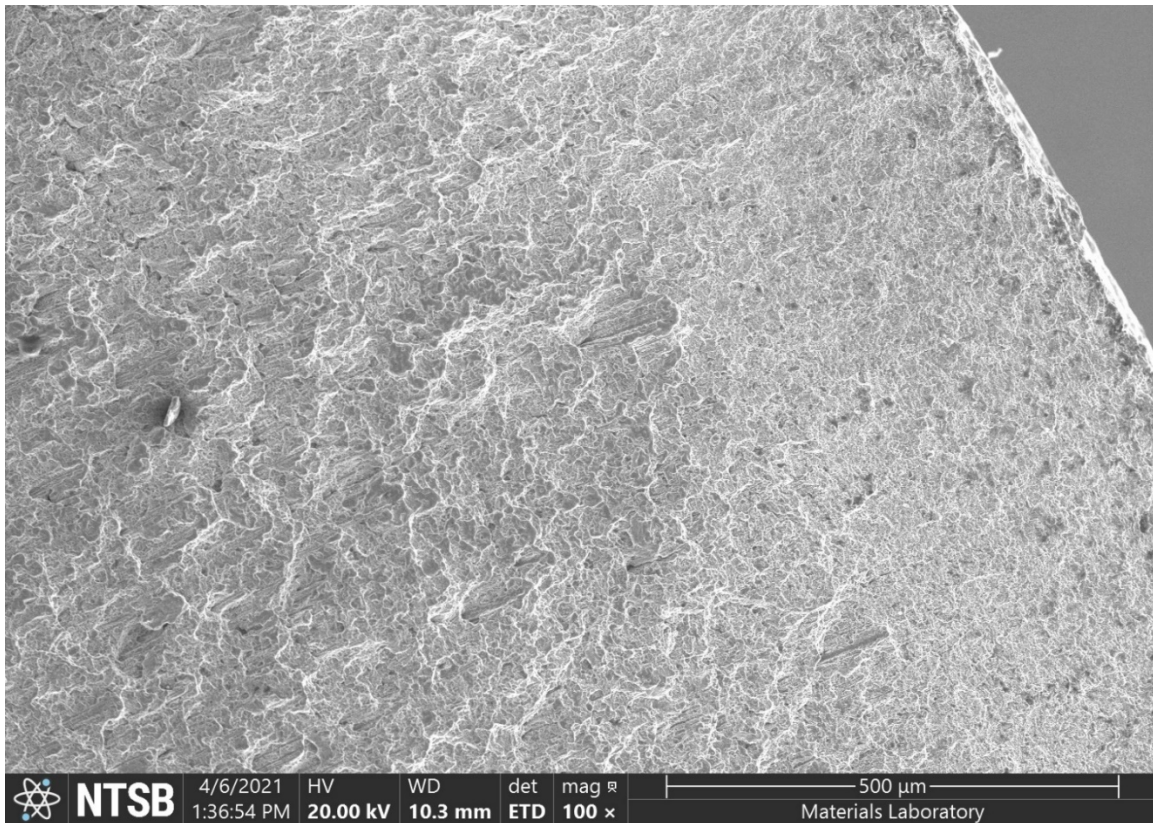
Figure 21 shows the opposite side of the bolt fracture surface, where the fracture would have terminated. These features were comparable to those at the initial area of the bolt fracture surface. A closer view of this region revealed slanted dimpled rupture, consistent with overstress in a shearing direction.

Figure 21 – SE micrograph of the opposite (terminal) side of the bolt fracture.

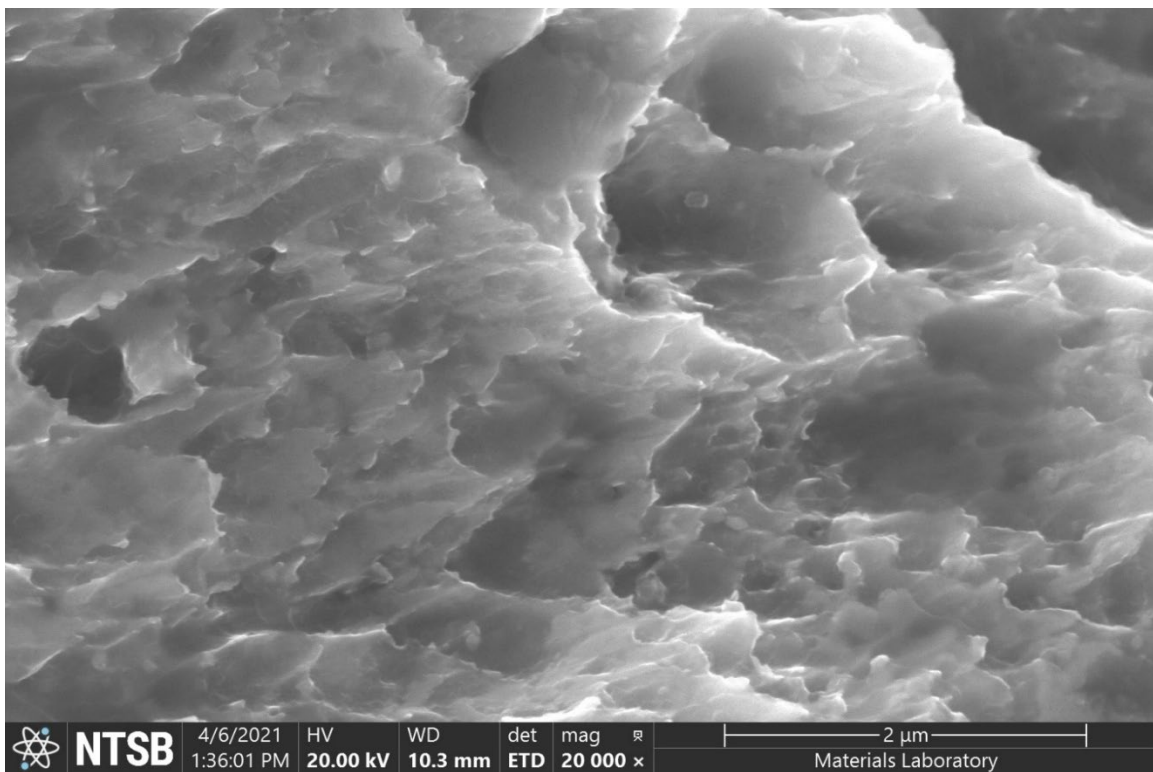
Figure 22 – SE micrograph of shear dimpled rupture from the area in Figure 21.
