**Photo 2 – N5910A inverted at the accident site (Ian Alumbaugh photo)**

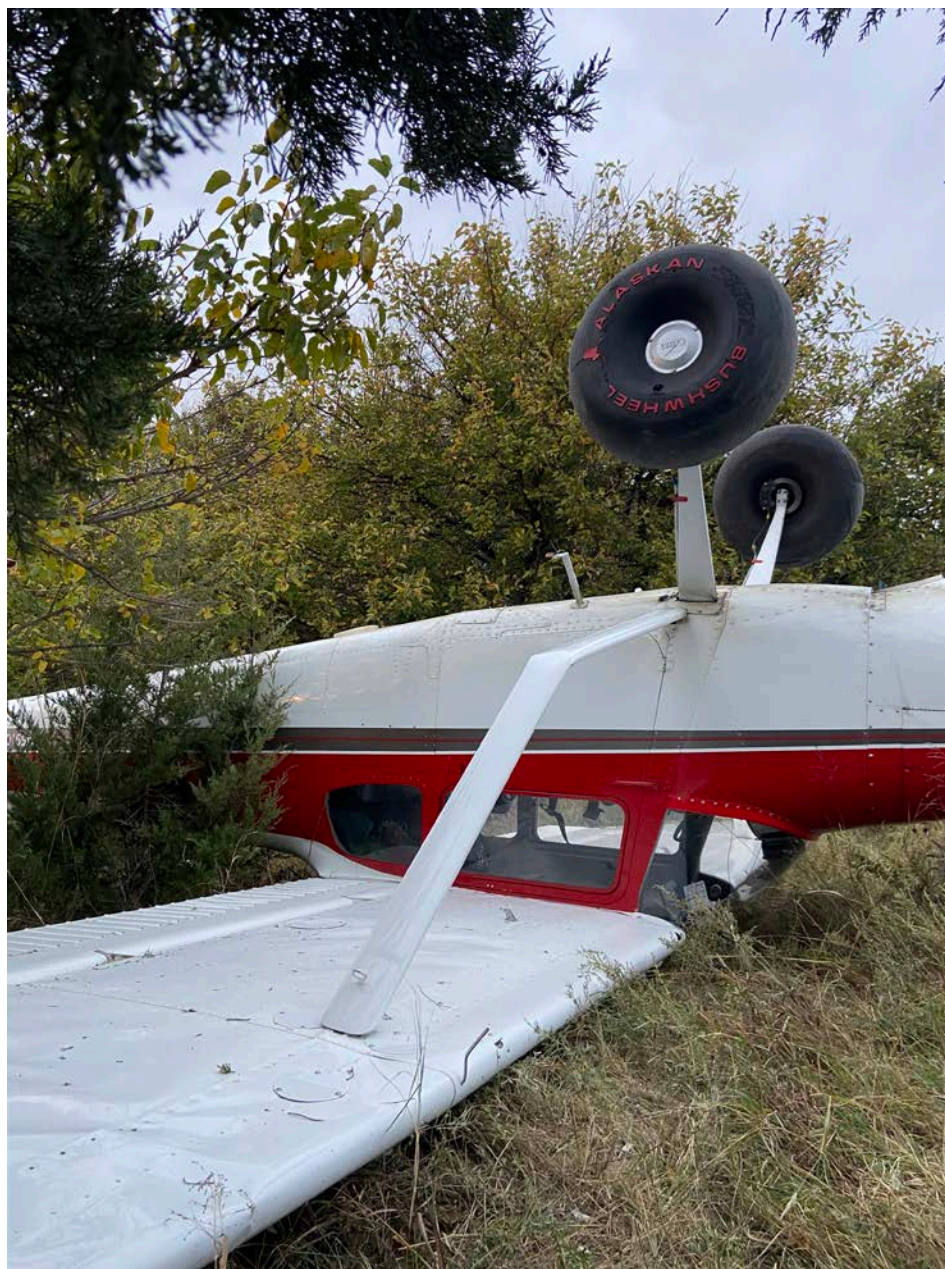
**Photo 3 – Inverted N5910A. Note bent wing strut and buckled skin underneath left wing (Ian Alumbaugh photo)**

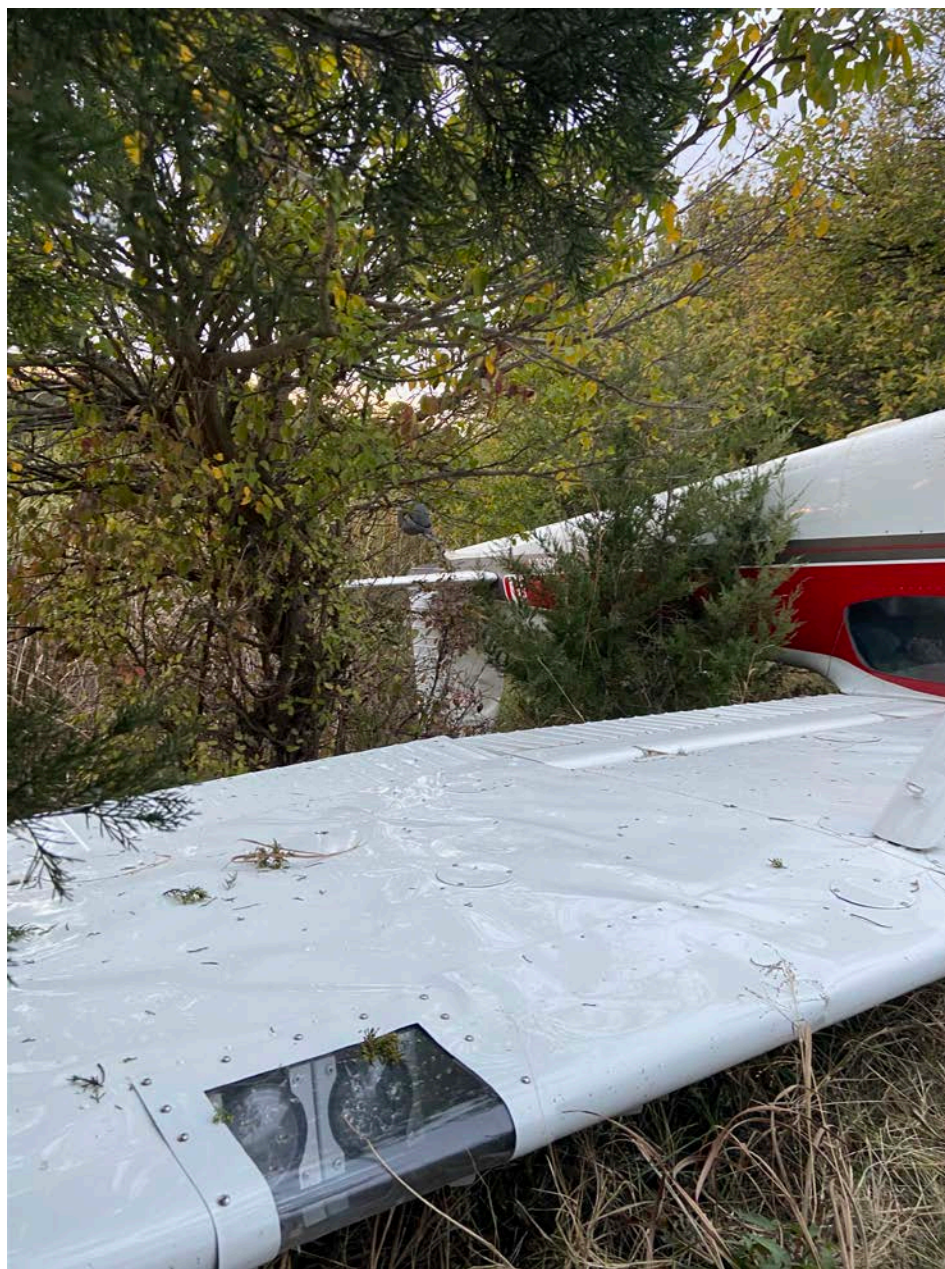
**Photo 4 – Closer view of left wing's buckled skin (Ian Alumbaugh photo)**

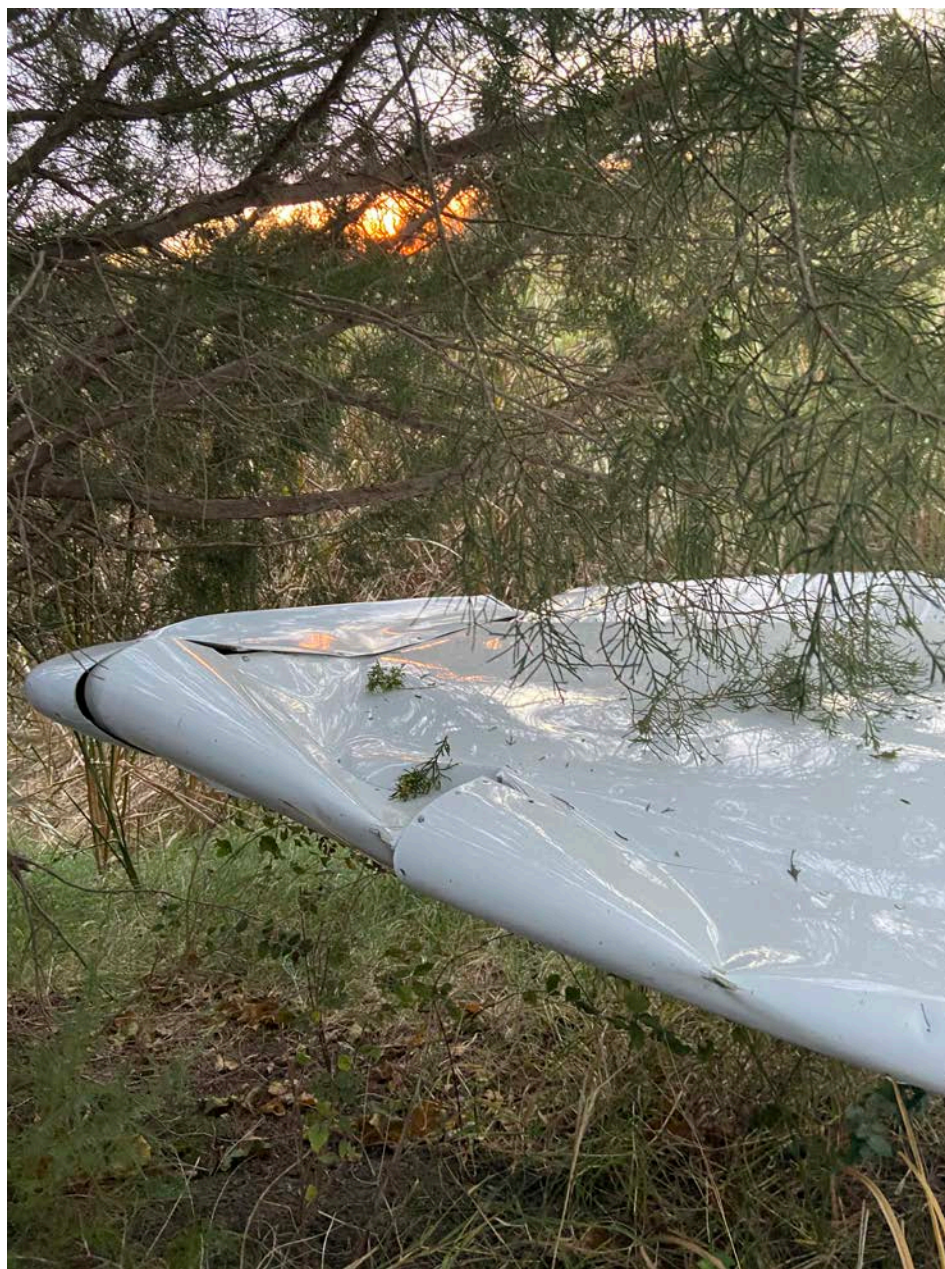
**Photo 5 – Damage to left wing tip and leading edge (Ian Alumbaugh photo)**

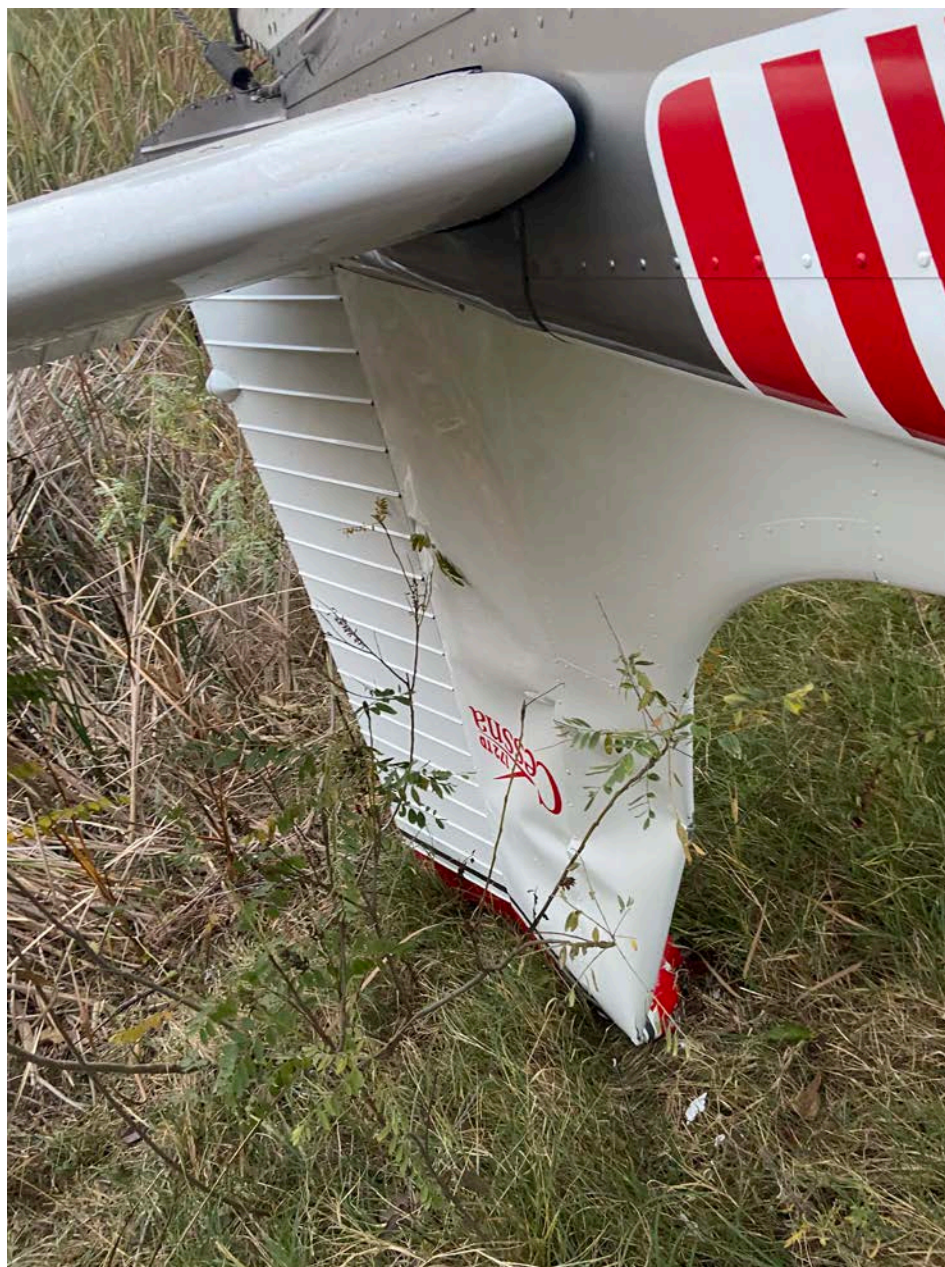
**Photo 6 – Crushed and buckled vertical stabilizer (Ian Alumbaugh photo)**
