## Air Safety Investigations Aircraft Incident/Accident Technical Report

| Aircraft Incident/<br>Accident Information | Year: 1960 | Make: Cessna | Model: 210 |
| | Serial number: 57422 | | Registration: N9622T |
| Air Safety Investigator: Casey J. Love | | Report #: ASI-20-CM-T | Report date: 03-25-21 |

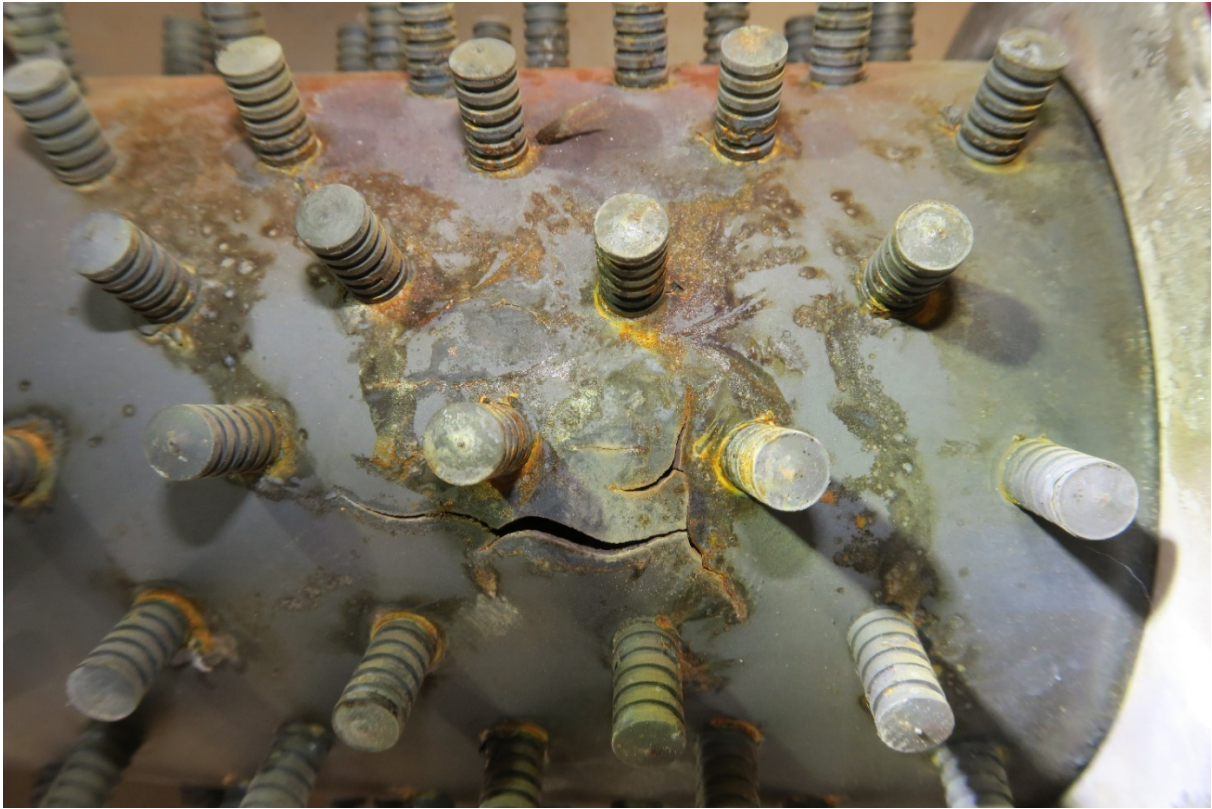
The engine was separated from the mounts and remained attached to the fuselage by the engine control cables. There was no evidence of preimpact abnormalities to the engine cylinders or crank case. The oil sump was crushed on impact. The mufflers were separated from the exhaust stacks. The stacks sustained crush damage but remained attached to the cylinder heads. The induction tubes and fuel control were separated from the engine. The fuel control sustained fire damage. The cabin heat muffler heat exchanger exhibited numerous cracks in an approximate two inch area where a bulge protruded outward from the muffler. The engine data tag was unreadable.

(ASI-20-CM-060) Muffler Crack)

The muffler heat exchanger was in the custody of the FAA inspector for possible future examination.

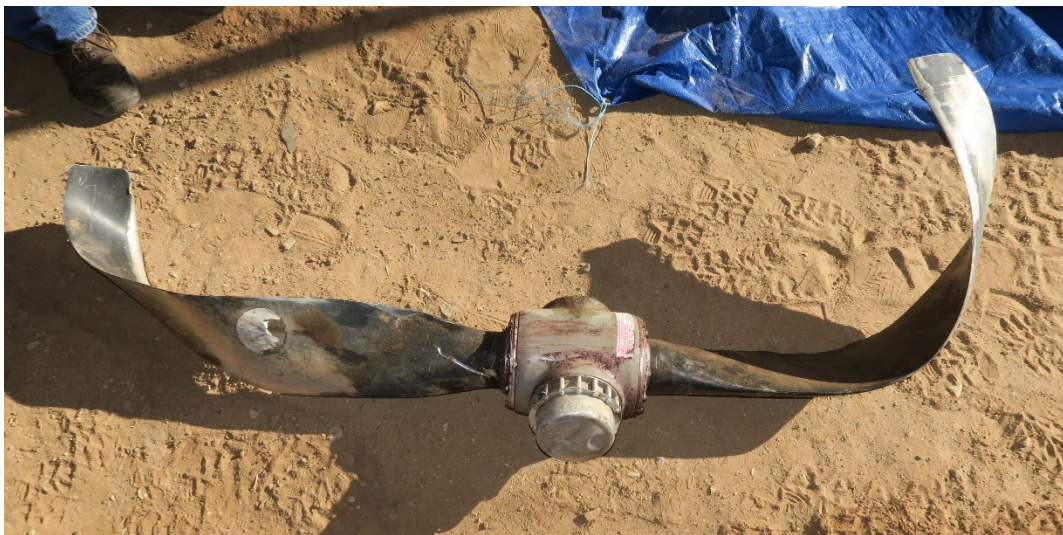
The propeller was impact separated from the crankshaft at the prop flange. Blade A and B exhibited similar damage. They were bent aft midspan and twisted. The blade tips were curled aft. The face of each blade exhibited polishing. The leading edges were gouged in a similar pattern approximately 4 inches inboard from the tip.

ASI-20-101 (cropped) (propeller damage)
