# NATIONAL TRANSPORTATION SAFETY BOARD

## MATERIALS LABORATORY FACTUAL REPORT

Report No. 21-046

Place : Lubbock, TX  
Date : 10/26/2020  
Vehicle : Cessna 210, N9622T  
NTSB No. : CEN21LA030  
Investigator : Josh Lindberg

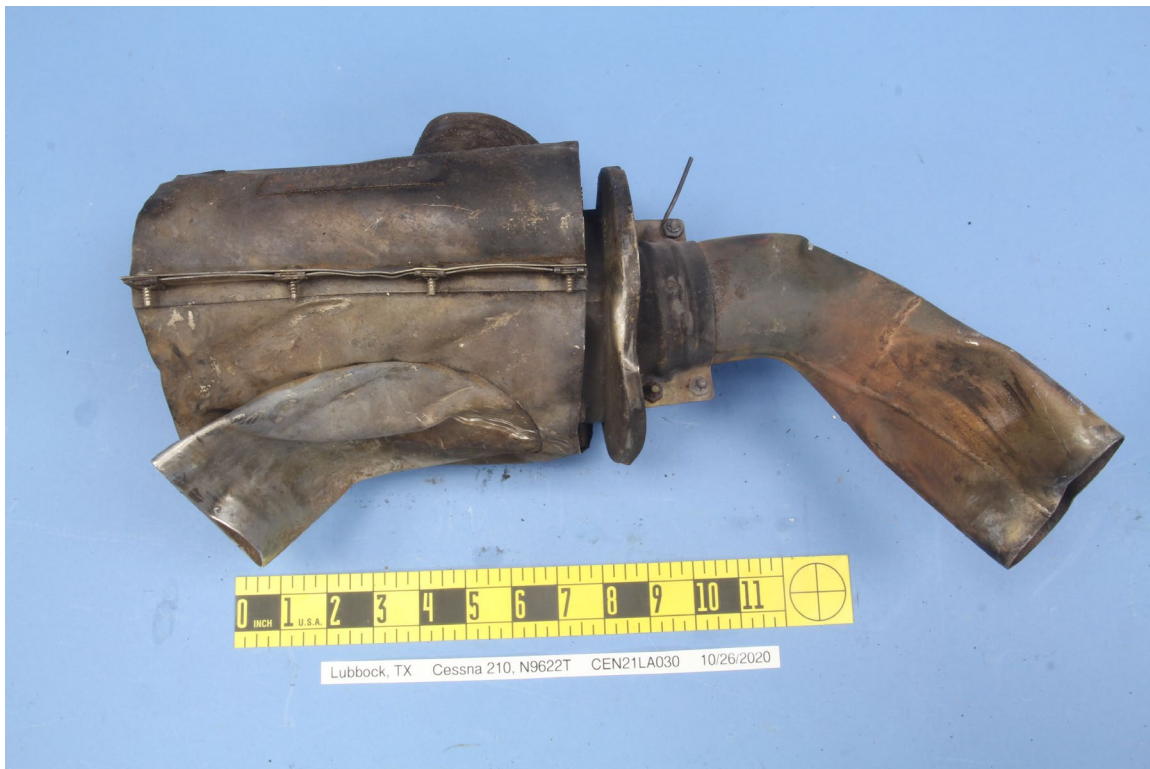
Figure 1: Portion of heat exchanger as received.

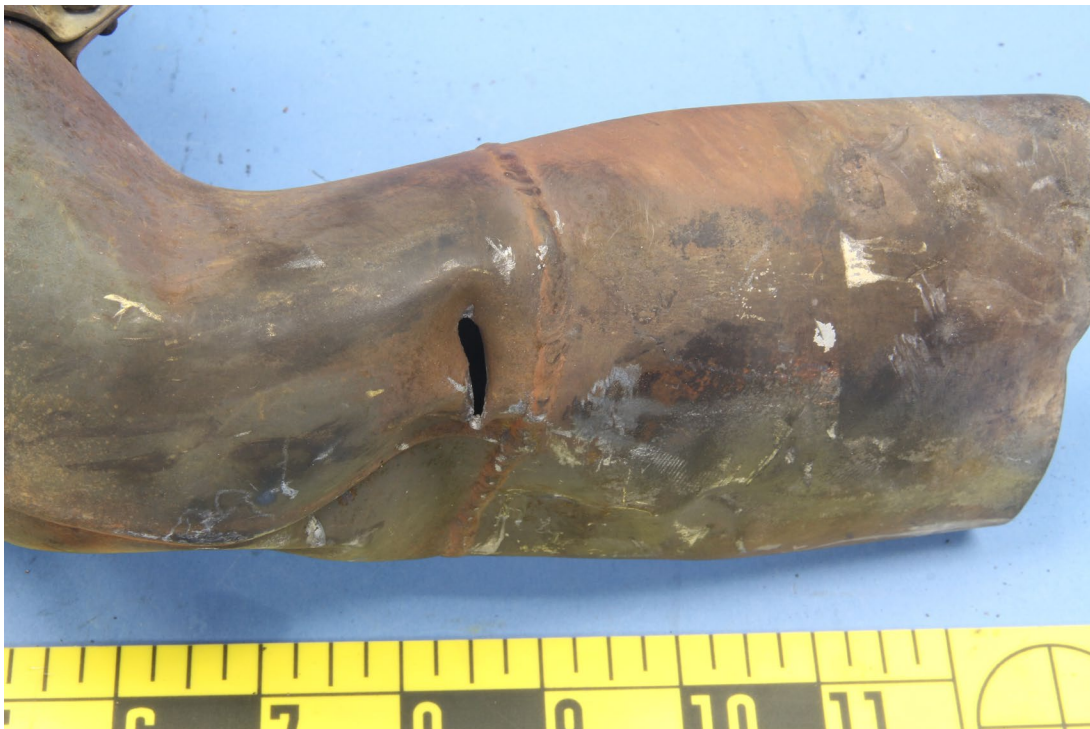
A portion of a cabin air heat exchanger made by the Hanlon & Wilson company, model 1250200-1, was examined. This heat exchanger used exhaust gasses through an interior volume to heat cabin air on an exterior volume. A section of pipe associated with the exhaust gas exhibited a crack approximately .5 inch long (figure 2). Close examination of the crack revealed deformation of the pipe towards the interior and the fracture faces exhibited shiny corrosion free surfaces (figure 3). This crack was consistent with a puncture due to mechanical force likely incurred during the accident.

Figure 2: Crack on exhaust gas pipe

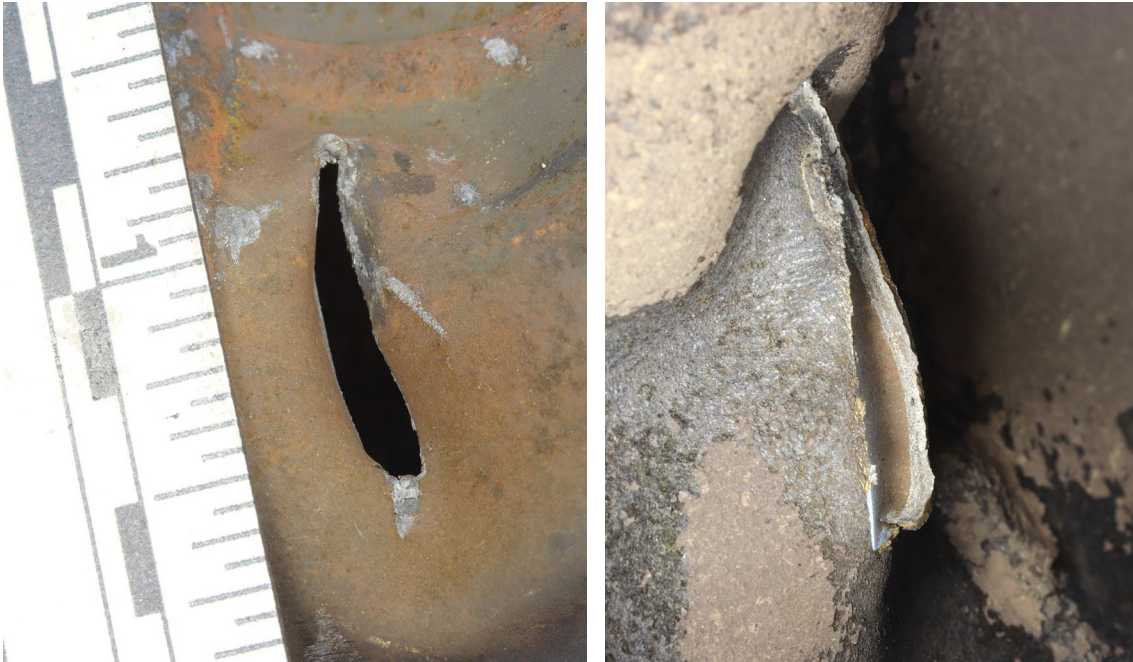
Figure 3: External and internal views of the crack on the exhaust gas pipe.

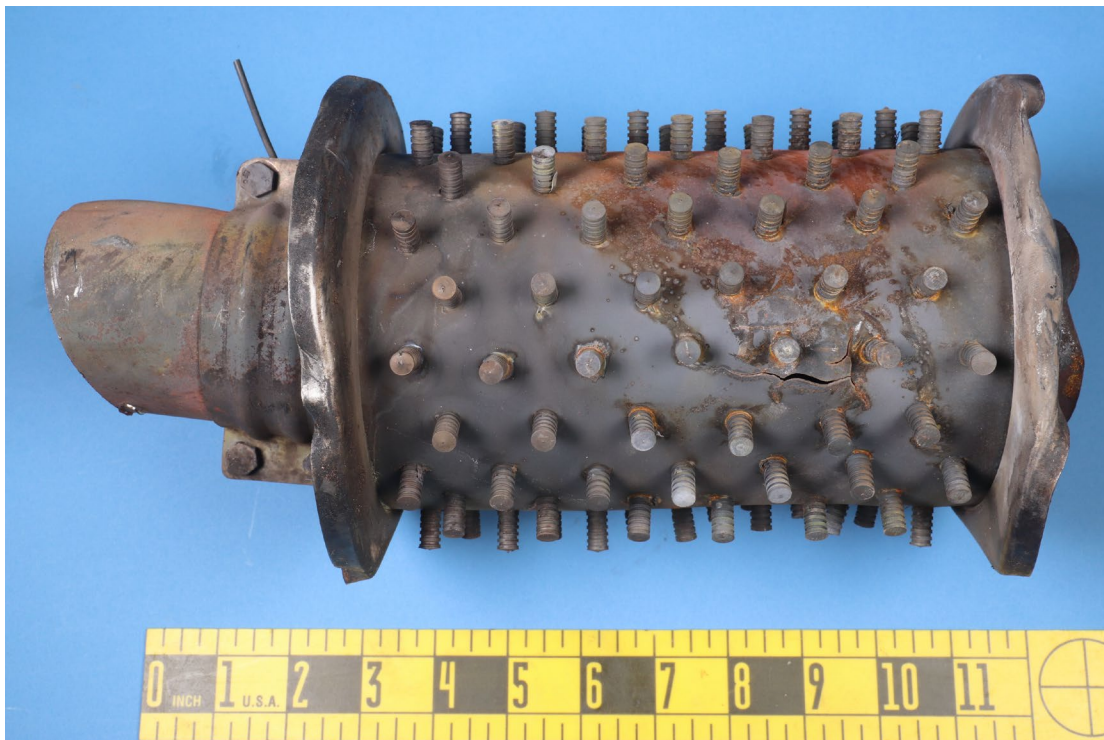
Figure 4: Heat exchanger with cover removed exposing the barrier between the exhaust gas and cabin air.

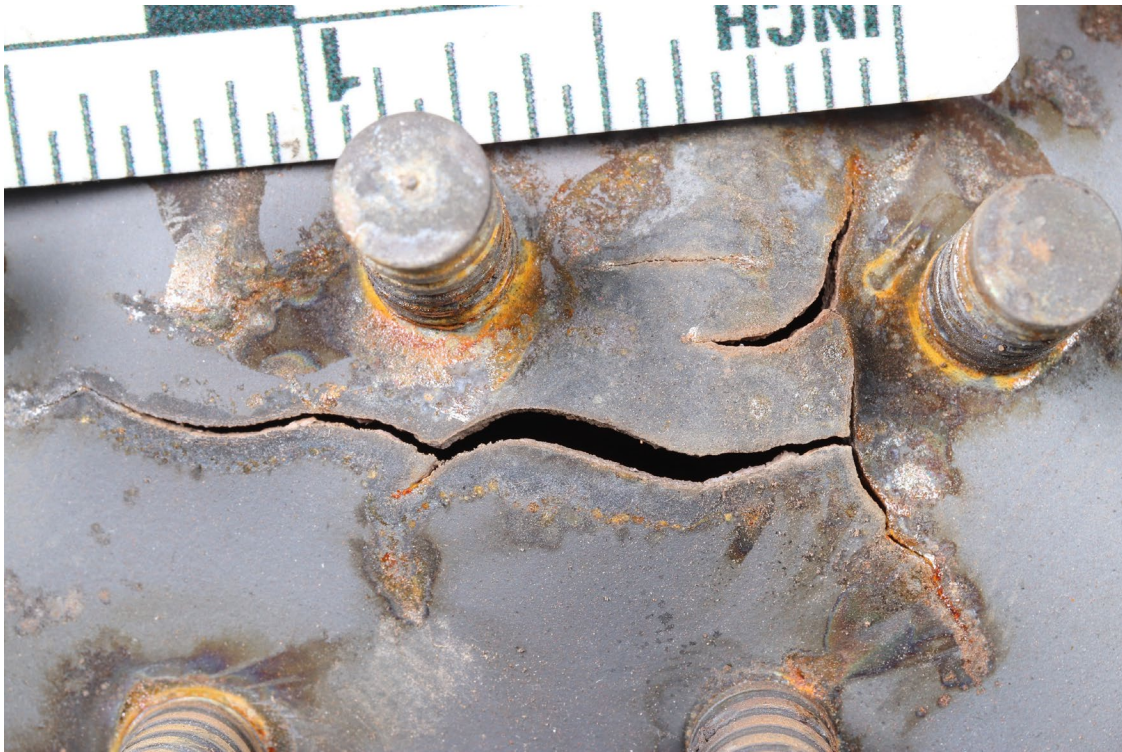
After disassembly of the external cover the space where the cabin air would circulate was revealed (figure 4). The sheet metal barrier between the exhaust gas and the cabin air exhibited a region with branching cracks (figure 5). The branching cracks exhibited fracture faces with corrosion and deposits on the surface consistent with the cracks being preexisting to the accident. These cracks had the appearance of having been caused by thermal cycles resulting in thermal fatigue of the sheet metal. The largest continuous crack was approximately 1 inch long with a maximum width of approximately 0.05 inch (figure 6). This crack would have allowed exhaust gasses to mix with the cabin air.

Figure 5: Branching cracks on the barrier between exhaust gas and cabin air.

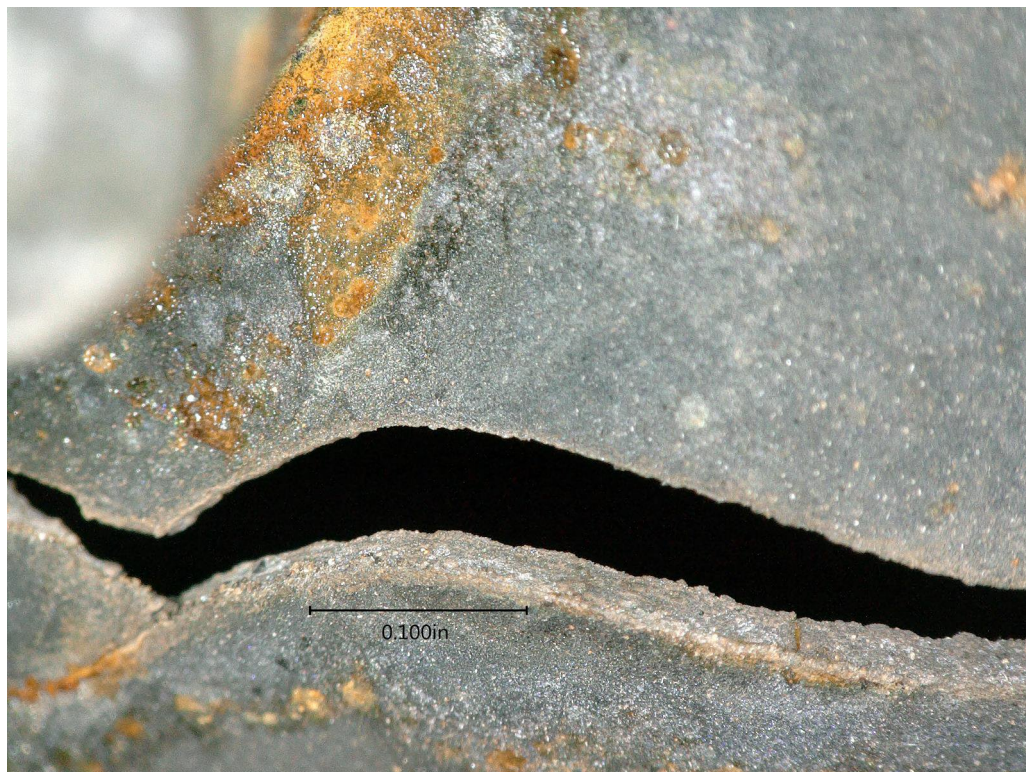
Figure 6: Crack fracture face exhibiting corrosion on the surface.
