**From:** [Baker Daniel](#)  
**To:** [Baker Daniel](#)  
**Subject:** FW: Request for Information/Support - CEN21LA034, N3537C (C182T)  
**Date:** Friday, January 29, 2021 10:24:08 AM

**From:** Enders, Ryan [REDACTED]  
**Sent:** Monday, November 2, 2020 2:17 PM  
**To:** Baker Daniel [REDACTED] Welch, W Buck [REDACTED]  
**Subject:** RE: Request for Information/Support - CEN21LA034, N3537C (C182T)

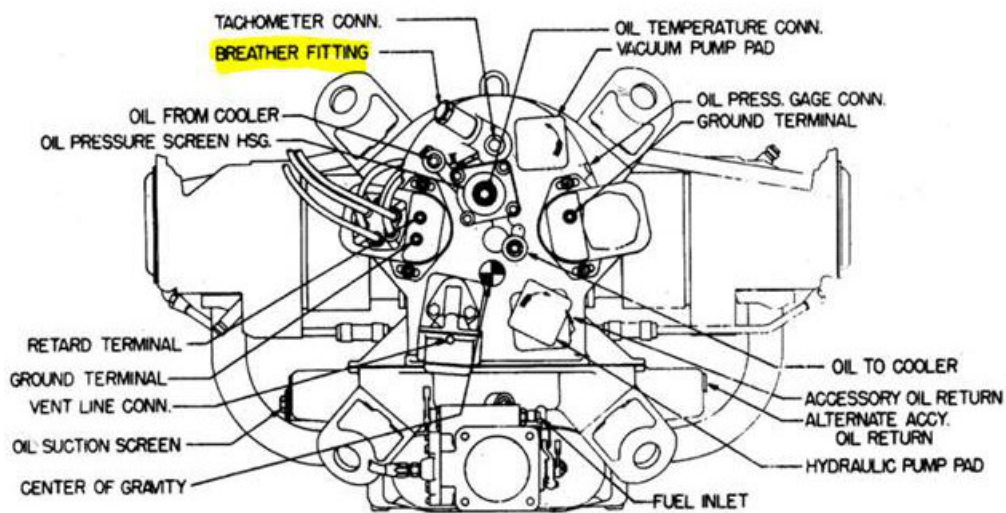
That is the crankcase breather. Below is a diagram of the accessory housing and the oil system diagram you wanted.

The breather port that is clogged so crankcase pressure cannot vent. Since the pressure cannot vent out of the engine, it builds inside of the engine. The nose seal (crankcase seal) would then be the next location to vent pressure.

From what you've sent/described, it appears that the clogged breather port forced the pressures to push out the seal. Once that seal is out, oil will exit the engine via the front of the crankcase.

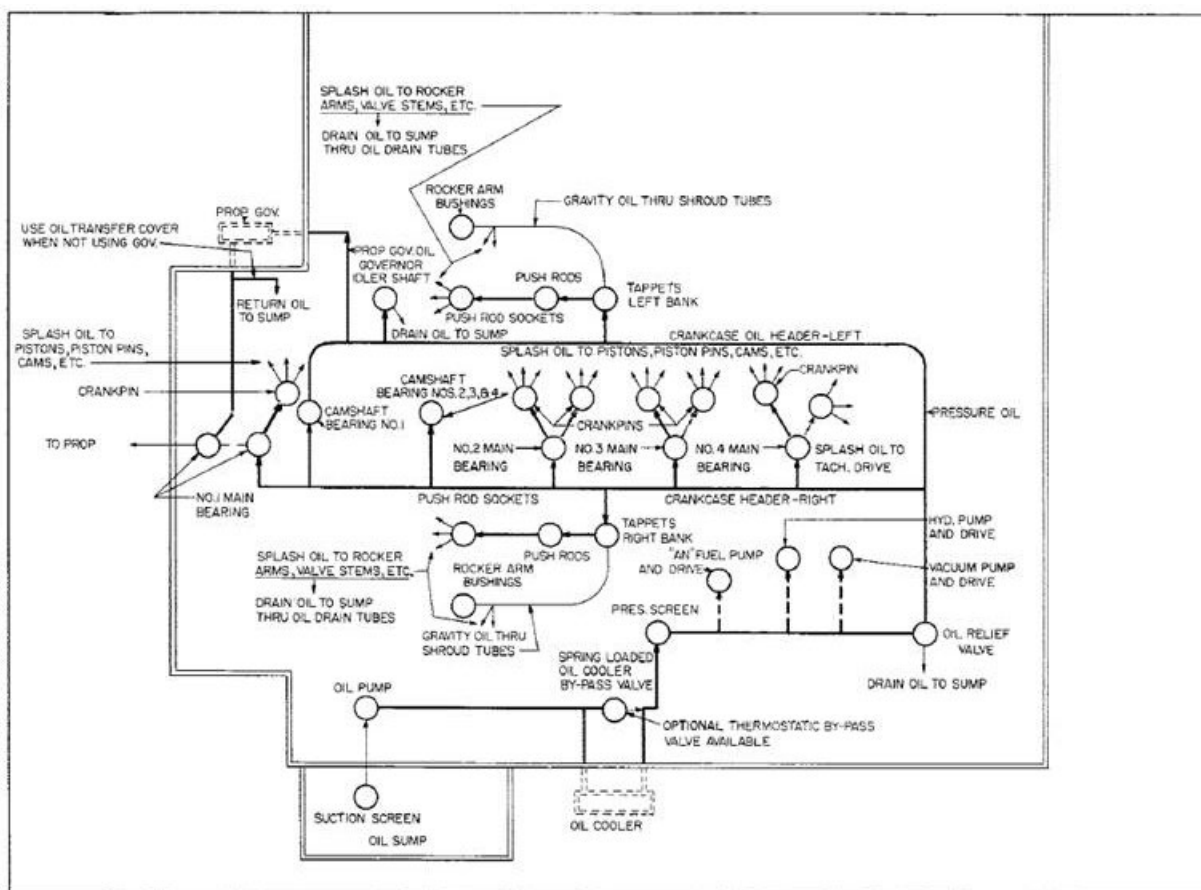
**Figure 2-4. Lubrication Diagram - 6 Cylinder Engines**

The oil system itself really doesn't play apart of the breather system. It is possible to have excessive crankcase pressure that pumps oil out of the engine breather, but that would be a totally different thing than this.
