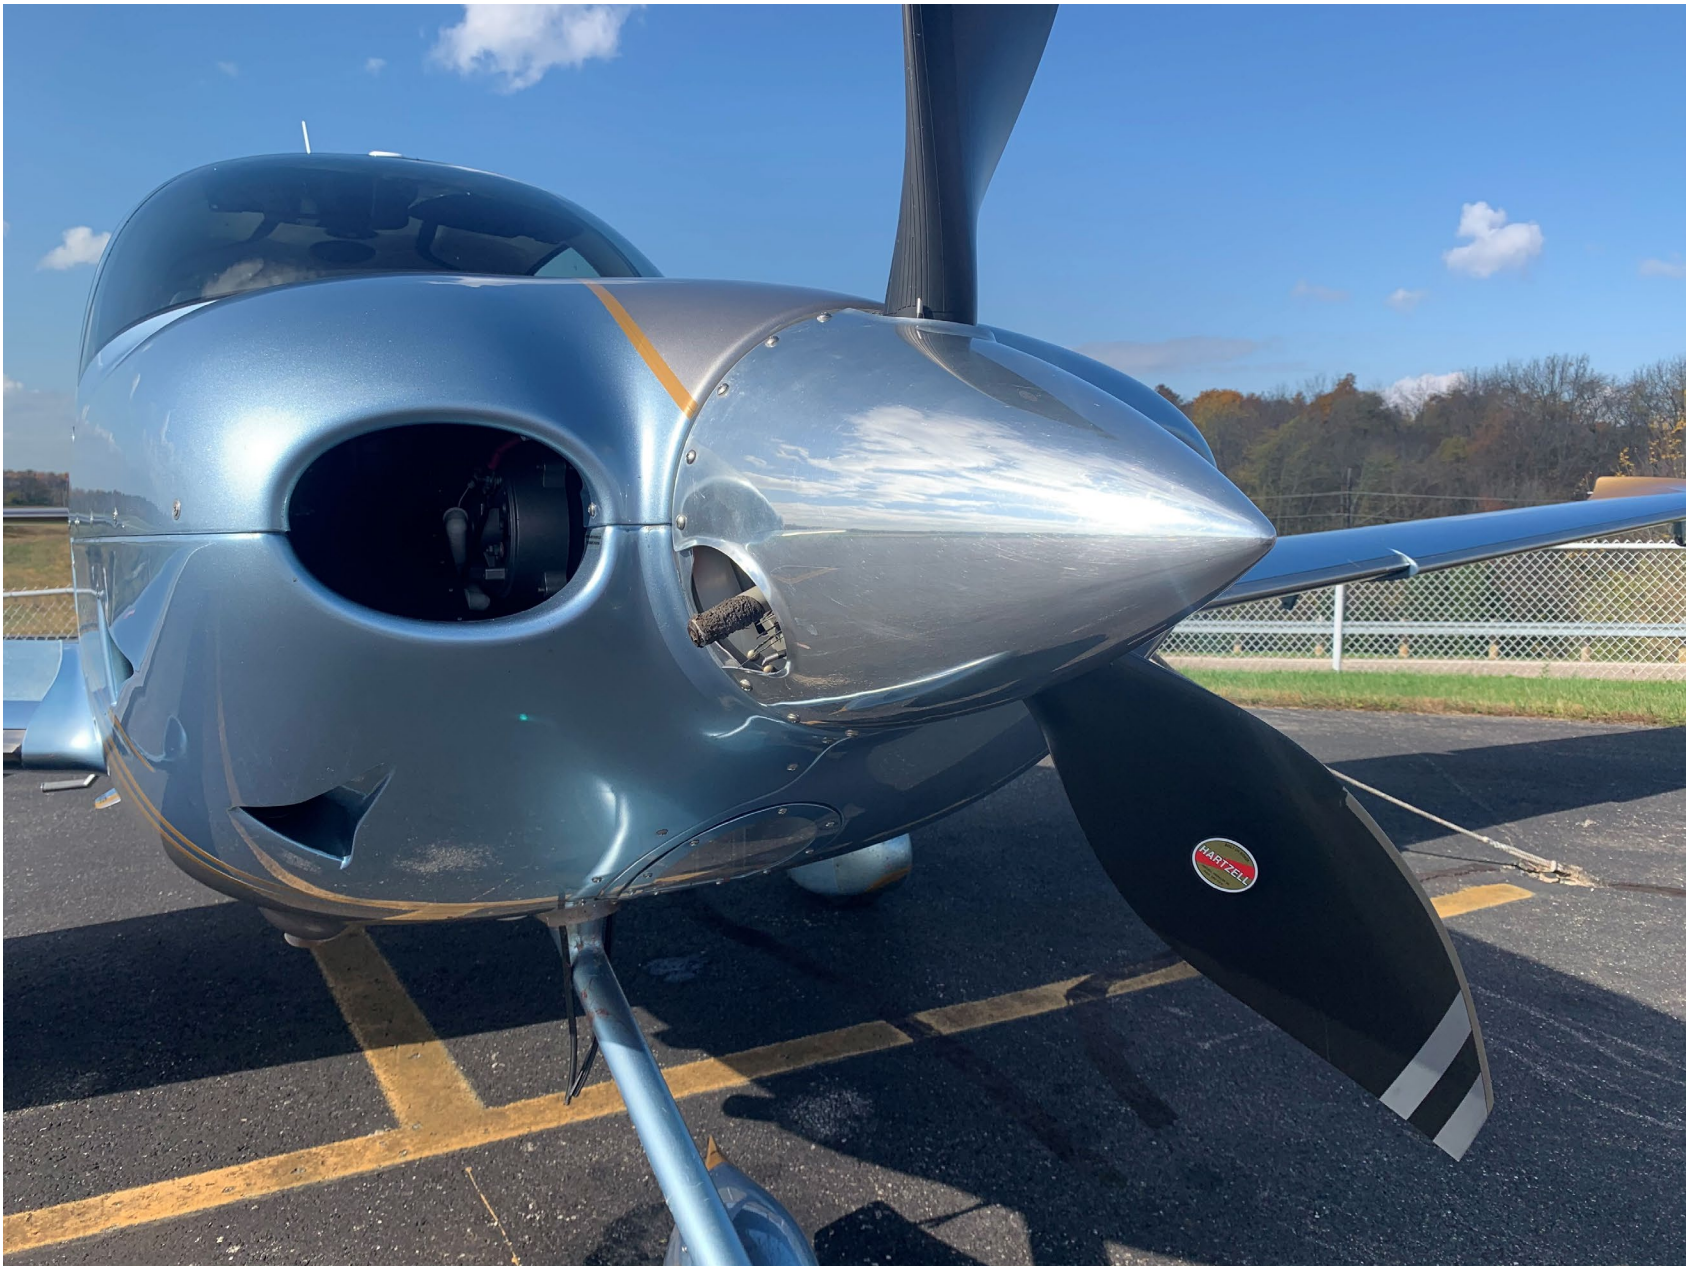
**Photo 1 – View of the separated propeller blade (courtesy of the Federal Aviation Administration).**

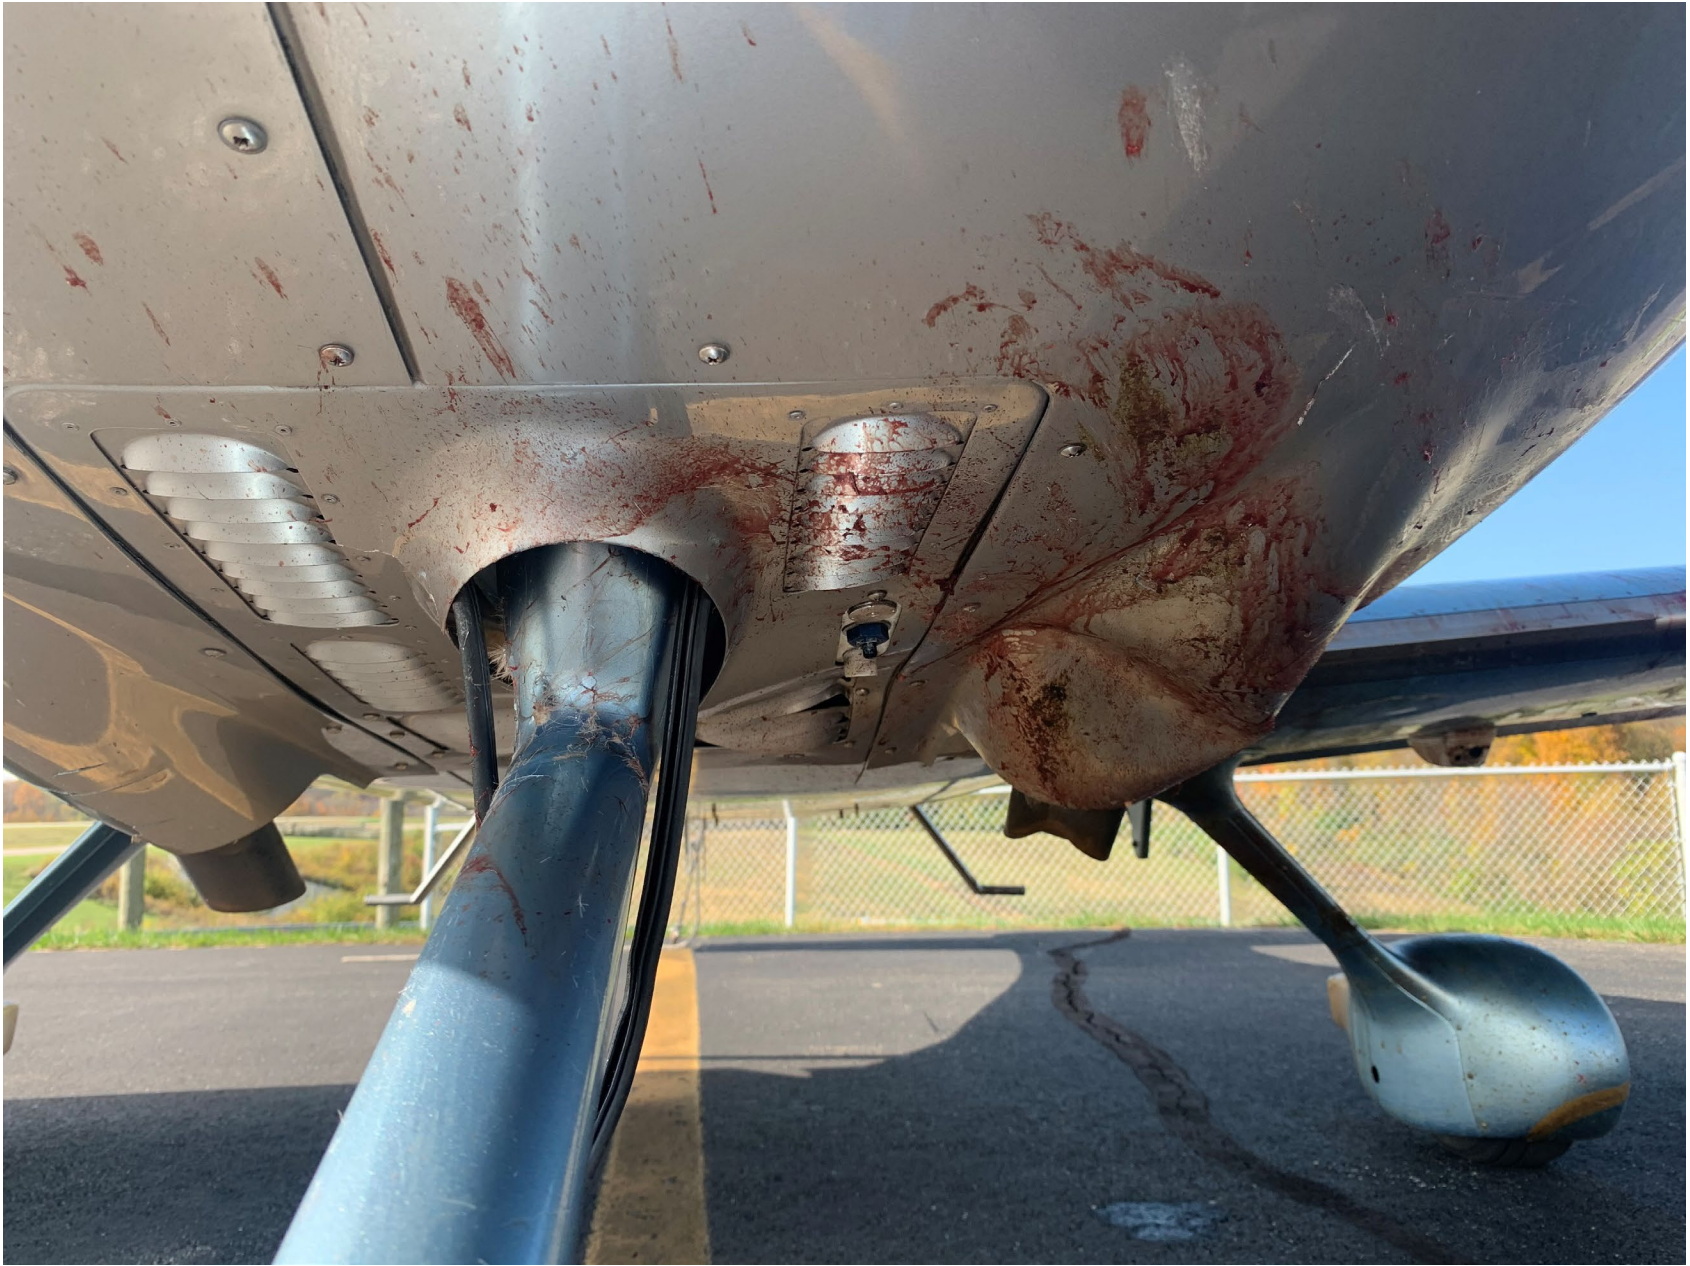
**Photo 2 – View of the damaged main landing gear and the underside of the fuselage (courtesy of the Federal Aviation Administration).**

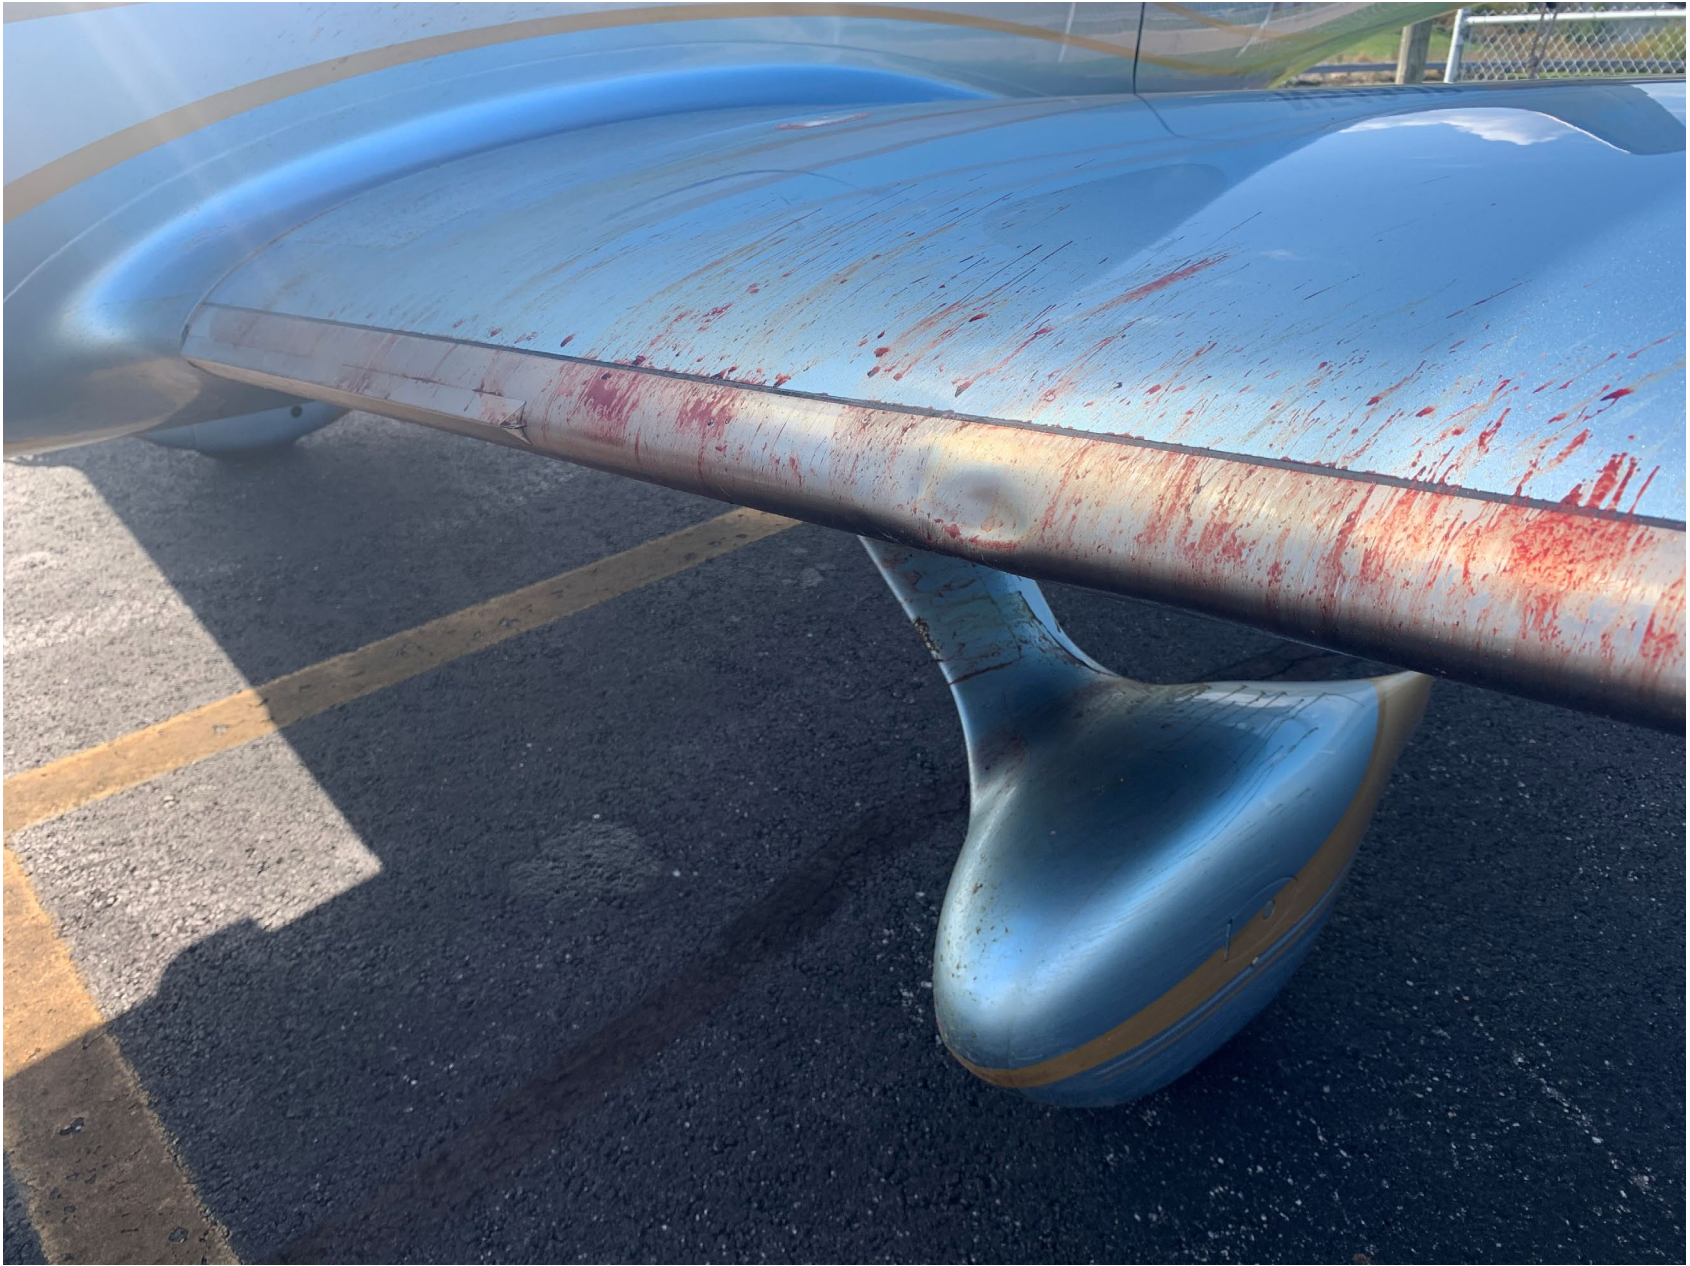
**Photo 3 – View of the damaged left wing leading edge (courtesy of the Federal Aviation Administration).**

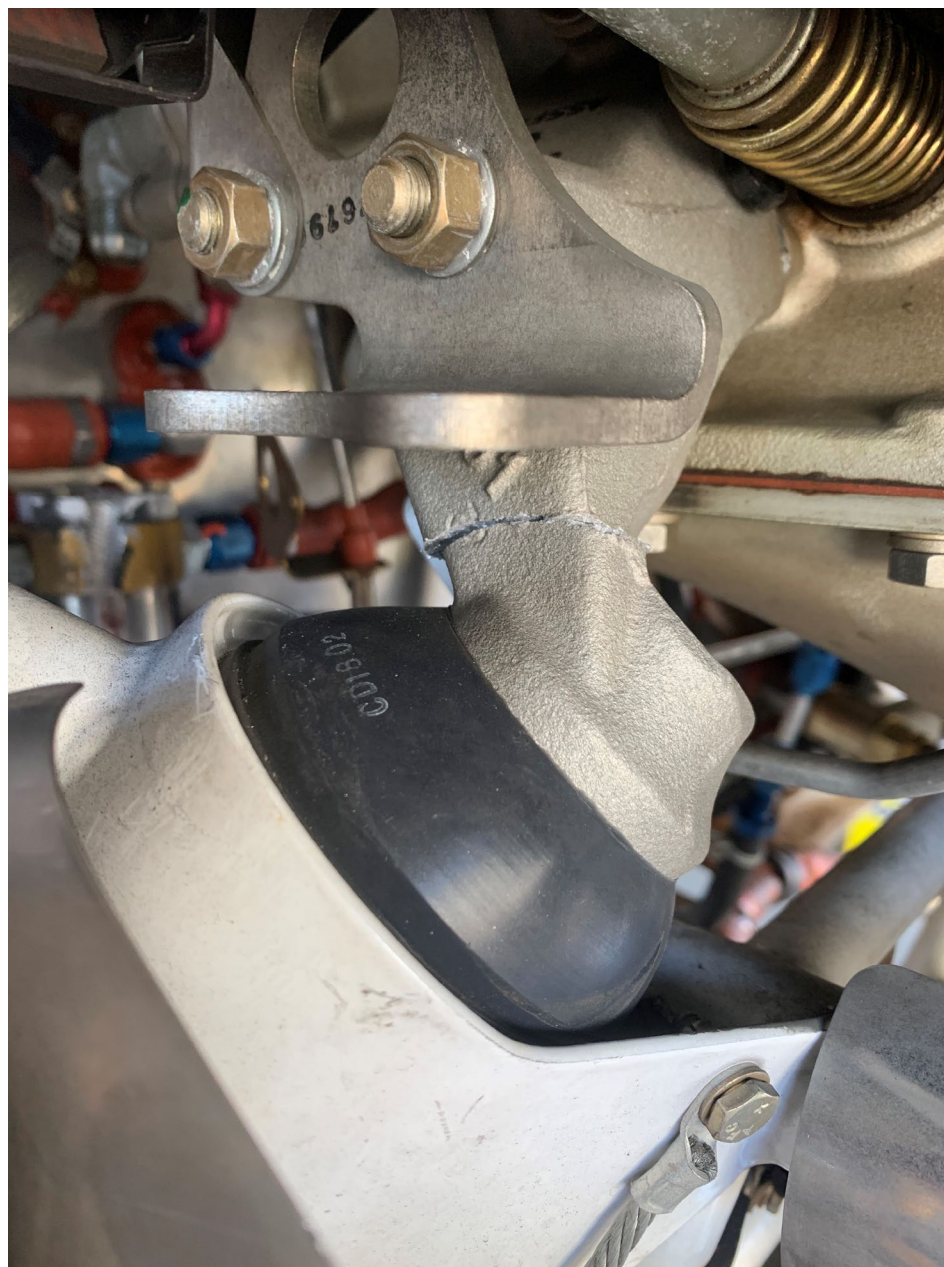
**Photo 4 – View of the damaged engine mount (courtesy of the Federal Aviation Administration).**
