# National Transportation Safety Board

CEN21LA067

## **WRECKAGE EXAMINATION SUMMARY**

Location: Telluride, Colorado  
Date: November 26, 2020  
Time: 1259 mountain standard time  
Airplane: Vans RV4, Registration No. N87LW  
Latitude: 37.94909 North Latitude  
Longitude: 107.88862 West Longitude  
Elevation: 8,877 ft msl

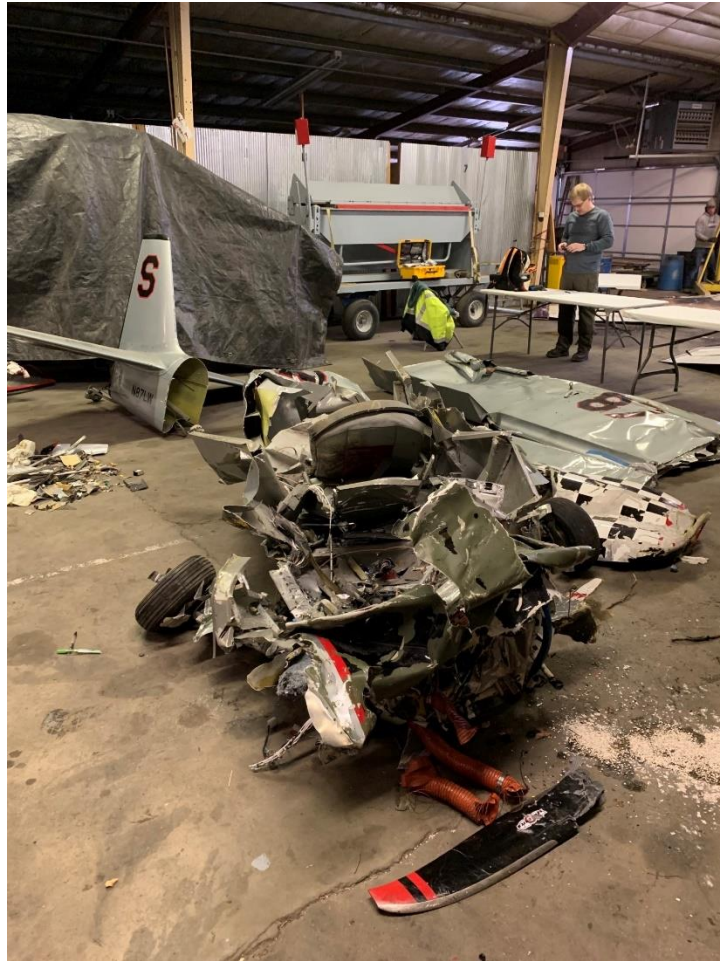
Figure 2 - Airplane Layout

The airplane was laid out in a Beegles Aircraft Service's hangar. The left and right wings were separated from the fuselage during recovery. The cockpit forward on the aft fuselage, main landing gear, engine, and propeller hub were attached. The fuselage aft of the cockpit was separated and the empennage was cut from the fuselage forward of the vertical and horizontal stabilizers. The main landing gear struts and wheels were broken aft. The tailwheel was present.

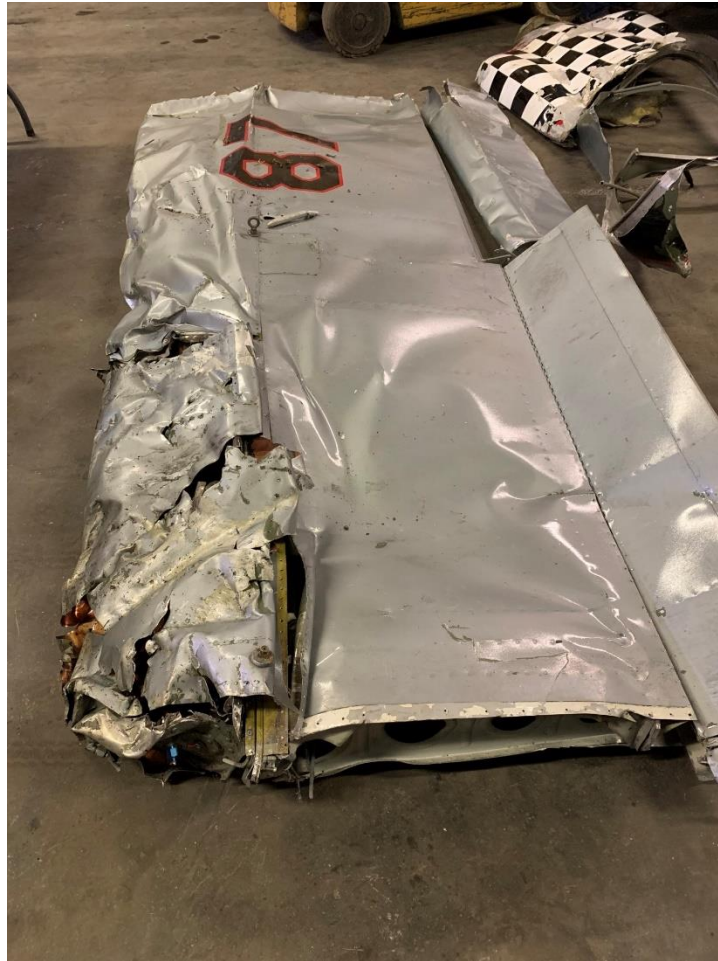
Figure 3 - Left Wing (Bottom Facing)

The airplane's left wing had been cut at the root. The wing was crushed aft along the leading edge to the spar, from the wing tip to the root. The wing tip was broken aft. The fuel tank cap was secure. Examination showed the cap intact and the seal in good condition. The cap depicted the tank quantity as 16.3 US gallons and the type of aviation fuel as 100 low lead. The fuel tank was broken open and no fuel was present.

The left aileron push tubes and linkages were located. The push-pull tube into the wing was compressed and cut. The aileron was separated and broken at the hinges and actuator horn. The aileron surface itself was dent and buckled. Manipulation of the aileron horn showed the mechanism was intact and moved freely. The corresponding push-pull tube was in the fuselage, left front cockpit area. Manipulation of the forward and aft cockpit control sticks laterally moved the tube at the fuselage.

The left flap was connected to the wing, intact, and broken forward. The actuator arm was separated at the wing root. The inboard flap surface was bent inward along the length of the hinge and buckled at midspan. The electric flap switch was in the front cockpit along the left wall forward of the throttle and mixture control. The flap switch was broken in its housing.

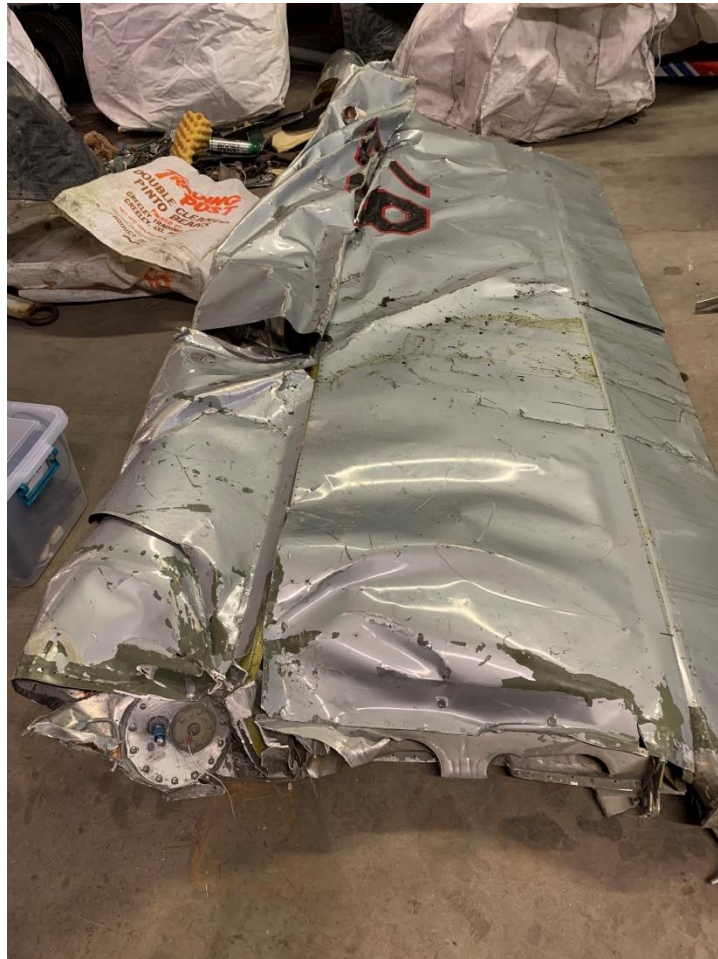
Figure 4 - Right Wing (Bottom Facing)

The airplane's right wing had been cut at the root. The wing was crushed aft along the leading edge to the spar, from the wing tip to the root. The wing tip was broken aft. The fuel tank cap was secure. Examination showed the cap intact and the seal in good condition. The cap depicted the tank quantity as 16.3 US gallons and the type of aviation fuel as 100 low lead. The fuel tank was broken open and no fuel was present.

The right aileron push tubes and linkages were located. The push-pull tube into the wing was cut. Manipulation of the aileron showed the mechanism was intact and moved freely. The aileron itself was buckled slightly. The corresponding push-pull tube was in the fuselage, front cockpit area. Manipulation of the forward and aft cockpit control sticks laterally moved the tube at the fuselage.

The right flap was connected, intact, and slightly extended. The actuator arm was separated at the wing root. The inboard flap surface was bent up and aft.

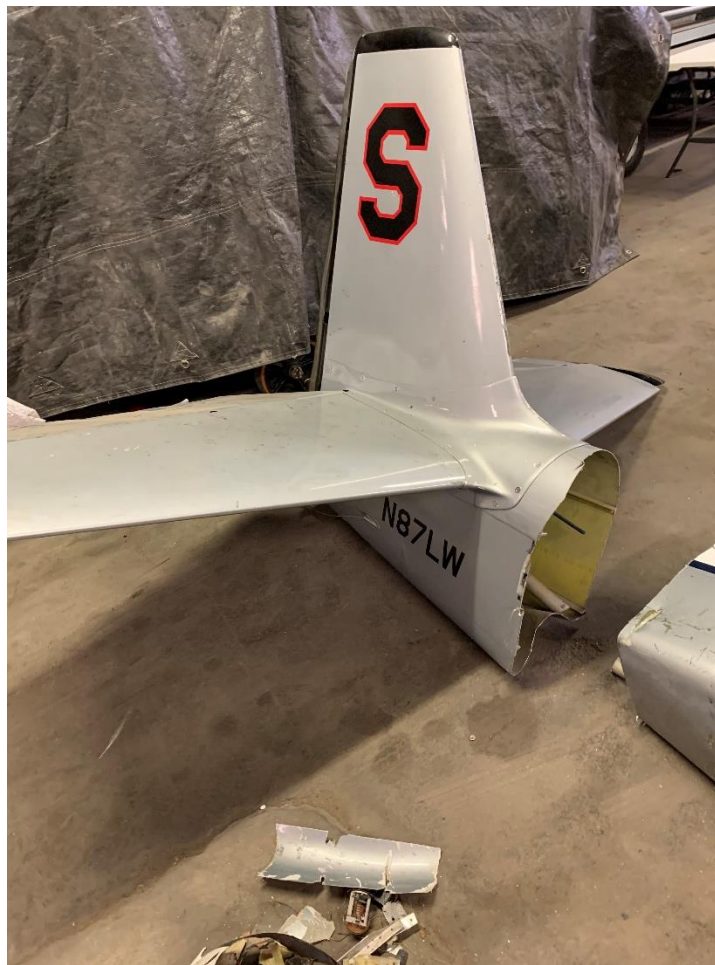
Figure 5 – Empennage

The empennage was intact. The horizontal stabilizers and showed minor damage. The left elevator was buckled at midspan outboard. The trailing edge toward the tip was torn in several places and the trailing edge corner was bent upward. The right elevator trailing edge corner was also bent upward and the right elevator tip was separated along the seam. The push-pull tube to the elevator was cut forward of the

vertical stabilizer. Manipulation of the tube freely moved the elevator. The elevator trim tab was in a nose up position. The trim cable was broken at the empennage separation. Manipulation of the cable moved the trim tab. The remainder of the trim cable was traced to the cockpit through to the trip actuator lever. The trim lever was at mid-range. The vertical stabilizer showed no damage. The rudder was crushed upward slightly at the base. The rudder cables were found separated and frayed. Pulling on the cables moved the rudder and tailwheel through their entire range. The cable separations were in the floor of the aft cockpit just under the rear pilot seat and corresponded with the separations found at the empennage. The cables were traced through the floor to the rudder pedals showing continuity through the rear and front cockpits.

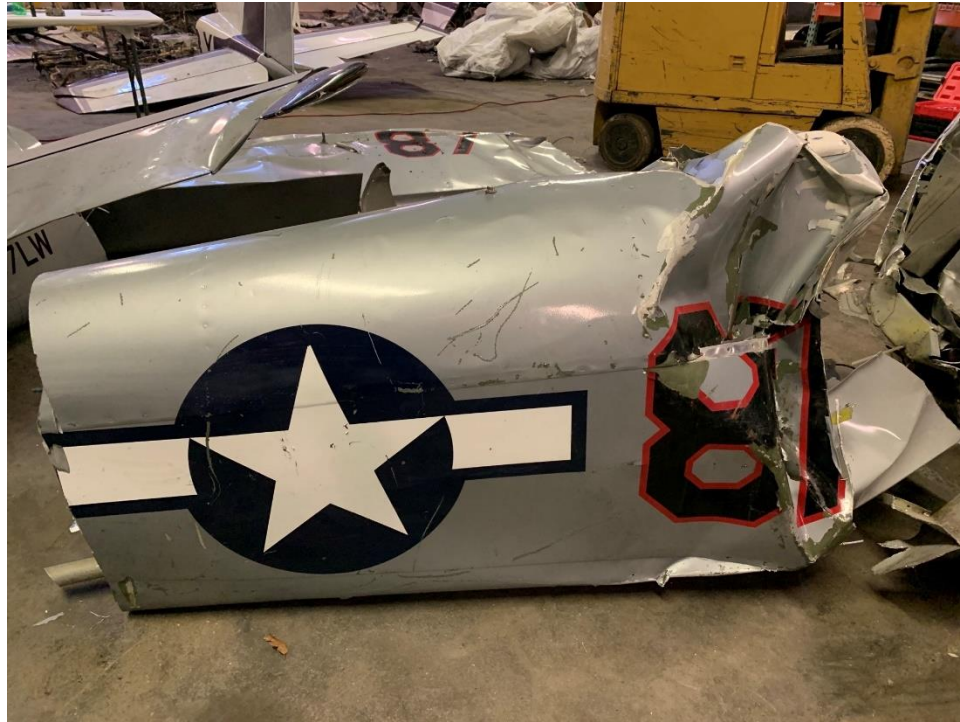
Figure 6 - Aft fuselage

The fuselage, aft of the rear cockpit, was bent inward on the right side, broken upward, and separated. The elevator push-pull tube was cut at the aft portion of the

fuselage separation where the empennage had been cut. It was traced to the balance weight just behind the baggage bulkhead. The bottom of the fuselage in that area was crushed upward.

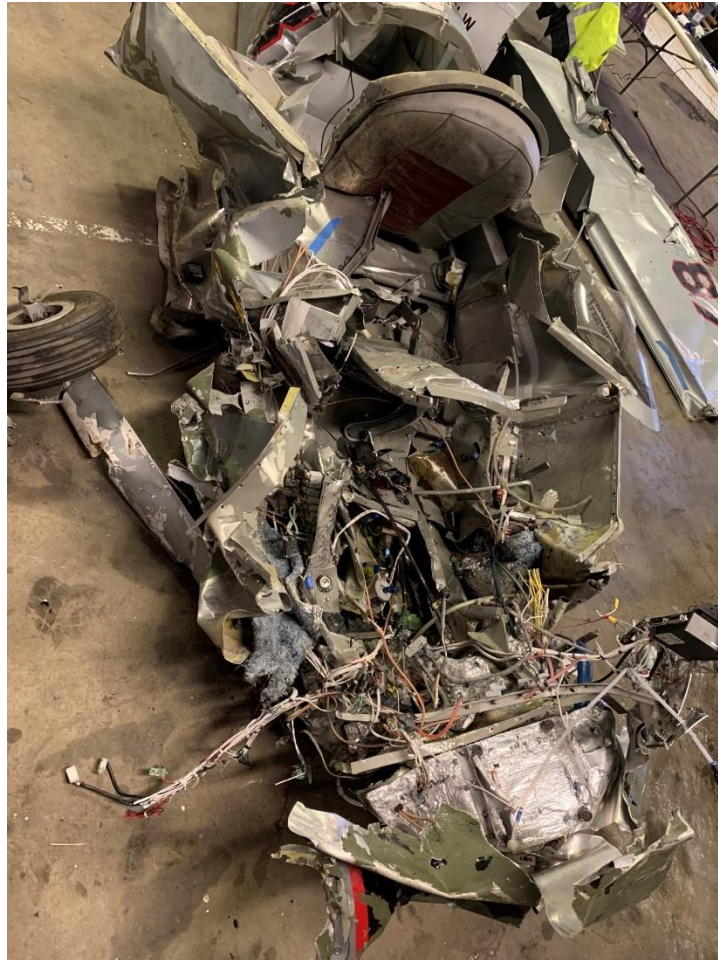
Figure 7 - Cockpit

The instrument panel was broken forward and fragmented. The radios, flight, and navigation instruments were broken out. The front and rear seats were also broken forward and the cockpit floor was crushed upward. The cockpit walls were bent, buckled, and broken forward. The canopy was separated and most of the front plexiglass was broken out.

The throttle and mixture control handles were found full forward. The fuel selector was on the left tank. The fuel gauges on each side of the fuel selector switch were broken and the needles indicated the left and right fuel tanks were full. The ignition switch was in the both position. The key was broken at the switch.

The front and aft cockpits were equipped with lap belts. The right front seat lap belt had been cut. The left side of the belt was undamaged. An examination of the

bayonet on the left side belt showed witness marks consistent with the belt being fastened when the crash occurred. The right rear seat lap belt had also been cut. The left side belt was not located.

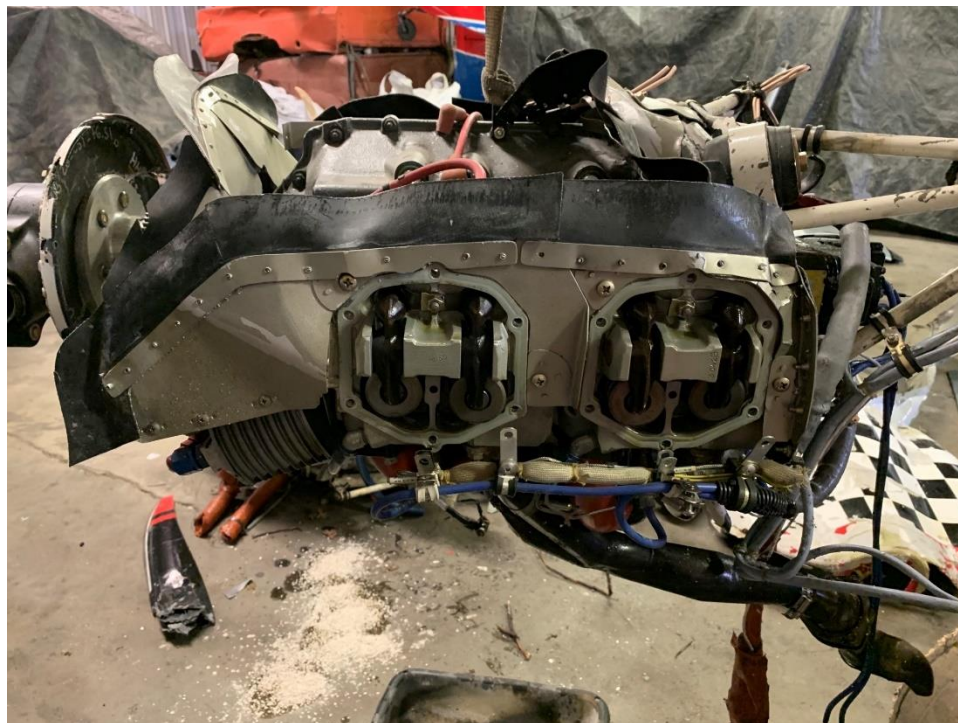
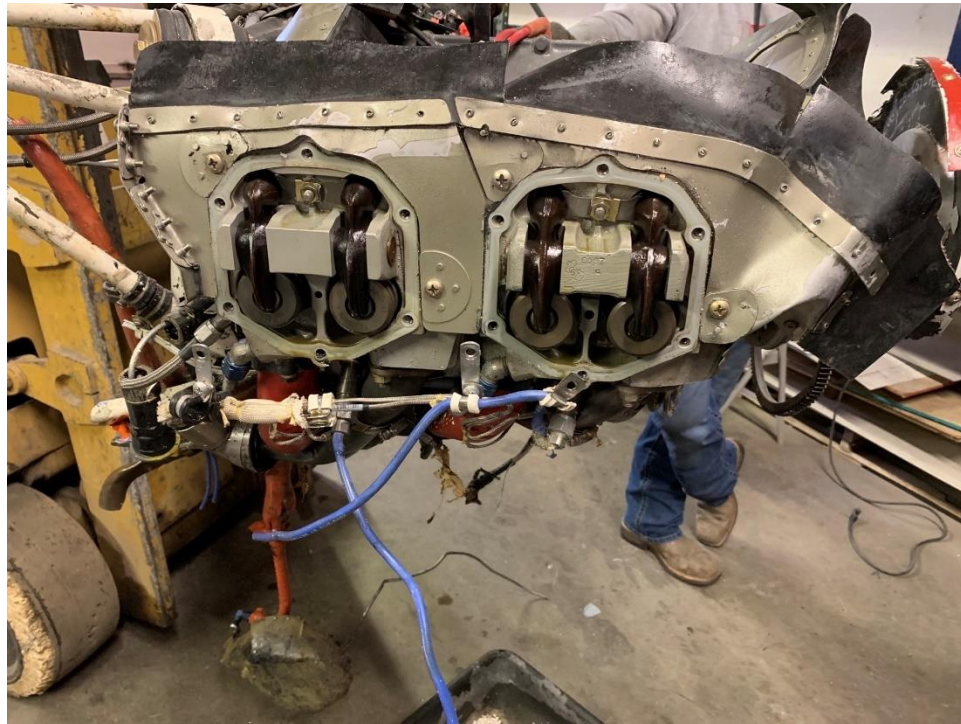
The rocker box covers were removed, and the crankshaft was manually turned. Intake and exhaust valves on all four cylinders moved normally. The crankshaft and camshaft rotated smoothly and the camshaft gear drove the accessory drive gears. Push rods to the lifters and rocker arms moved smoothly.

Internal engine and valve train continuity were confirmed while the engine crankshaft was rotated. Cylinder compression was confirmed by placing a finger over the open spark plug holes and feeling suction and expelled air from each cylinder while the crankshaft was rotated. A borescope examination of each cylinder confirmed no anomalies with the cylinders, pistons, valves, or valve seats.

Figure 8 - Engine Valves and Rockers, Left Side View

Figure 9 - Engine Valves and Rockers, Right Side View

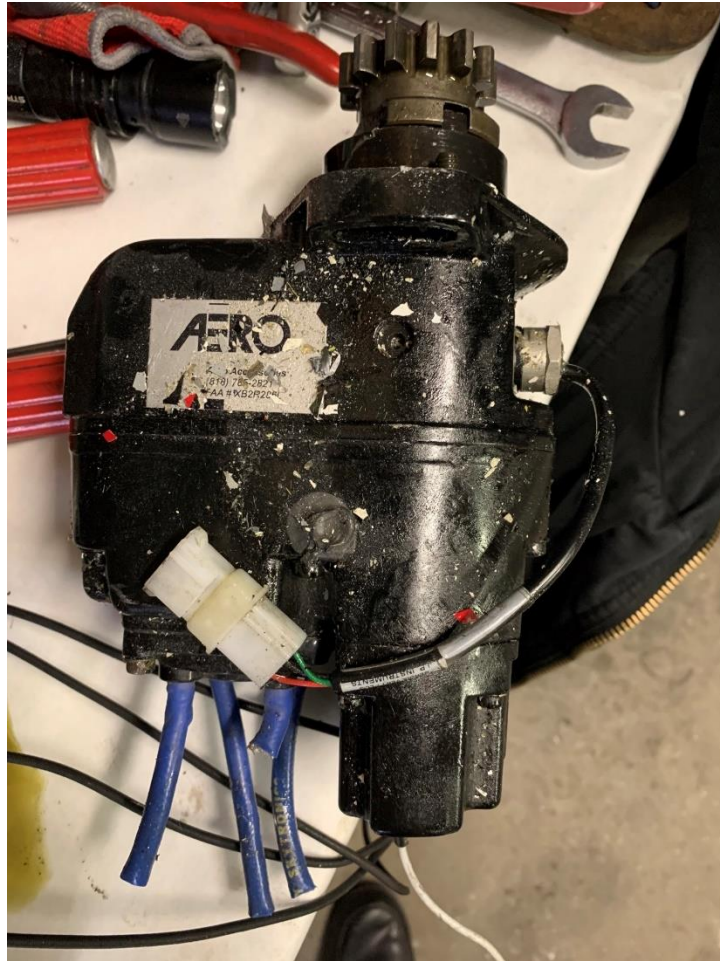
Figure 10 - Engine Driven Magneto

The magneto was in good condition. The wires from the distributor cover were cut and the magneto coupling was turned. The magneto coupling rotated normally. When rotated, spark was observed at all four wires.

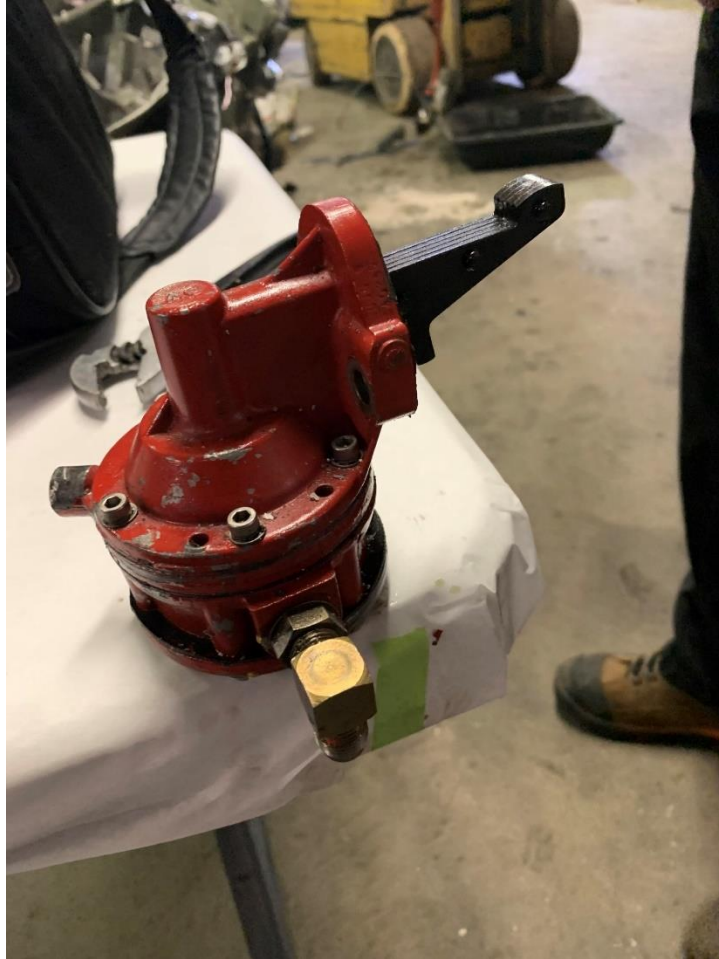
Figure 11 - Engine-Driven Fuel Pump

The engine-driven fuel pump was removed. Fuel dripped from the line connectors. When the drive lever was depressed, air was pushed through the fuel line connectors out of the pump.

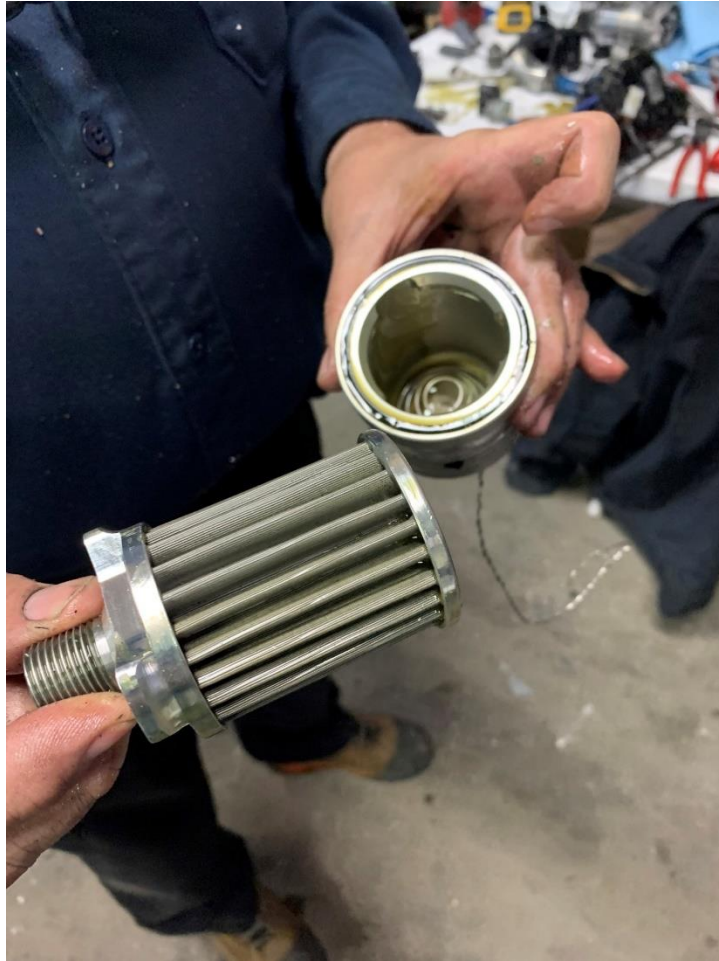
Figure 12 - Oil Screen

The oil filter housing was broken aft from the accessories case. The filter screen was removed from the housing. The screen was clean and showed no debris.

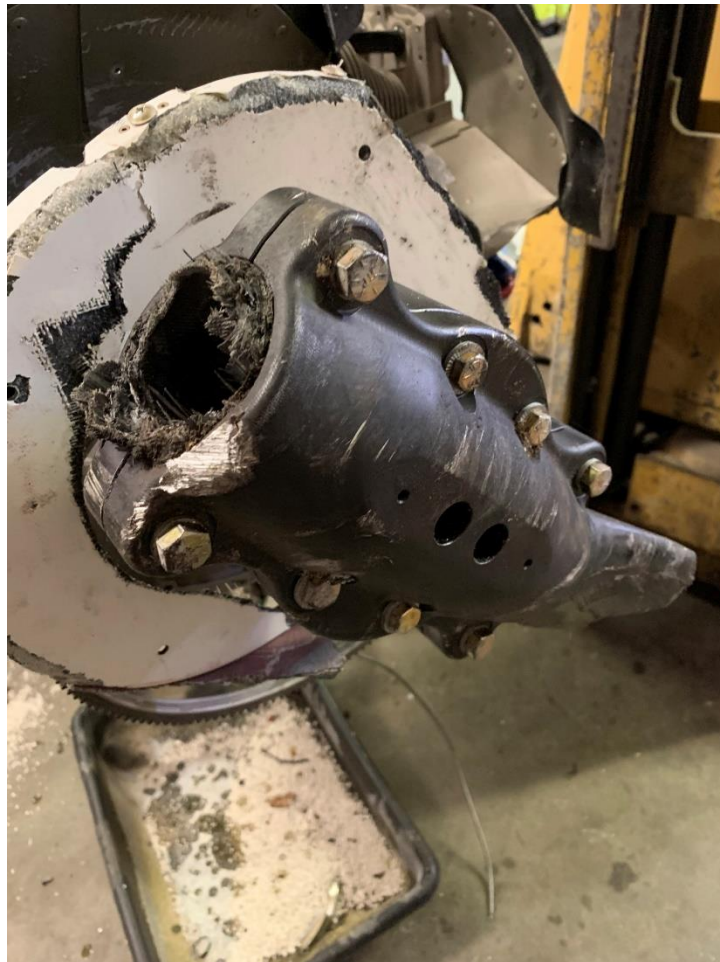
Figure 13 - Propeller Hub

The two-bladed Sensenich composite propeller hub was still attached to the engine flange and crankshaft. The hub showed gouges and scoring marks. One propeller blade was broken laterally and aft at the hub. The other blade was broken aft approximately 5 inches outboard of the hub. That blade showed aft and lateral splintering at the fracture and chordwise scrapes and scratches on the front face.

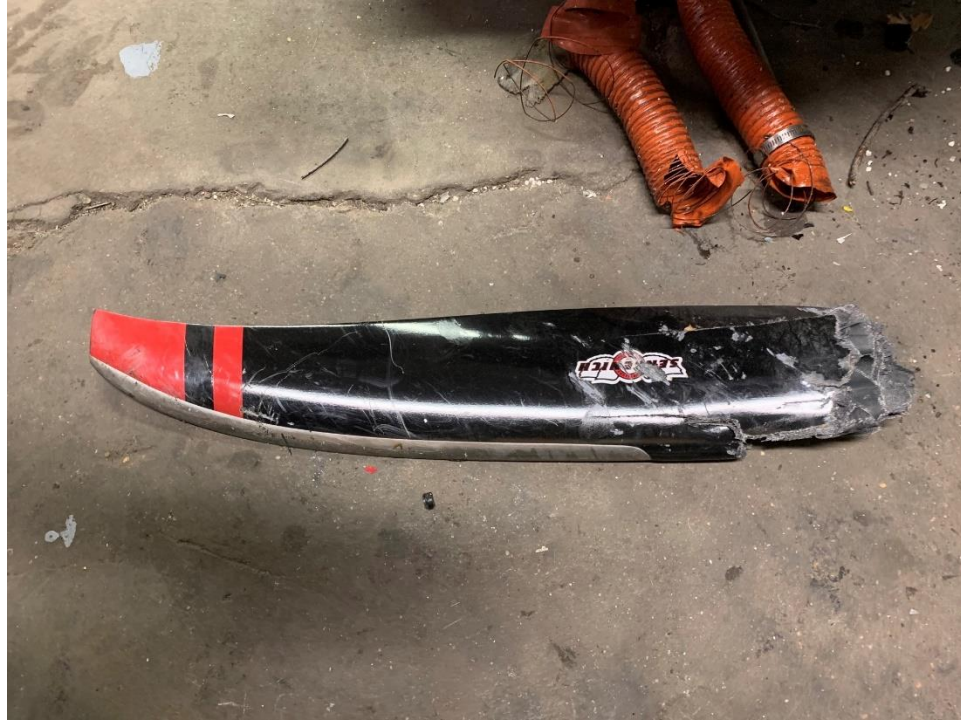
Figure 14 - Propeller Blade

The propeller examination did not reveal any evidence of a preexisting mechanical malfunction or failure that would have prevented normal operation. All physical damage to the propeller was consistent with it turning at ground impact.
