# NATIONAL TRANSPORTATION SAFETY BOARD

## MATERIALS LABORATORY FACTUAL REPORT

Report No. 21-083

Place : Franklin, Arkansas  
Date : 11/30/2020  
Vehicle : Piper PA28-112, N9879T  
NTSB No. : CEN21LA070  
Investigator : John Brannen

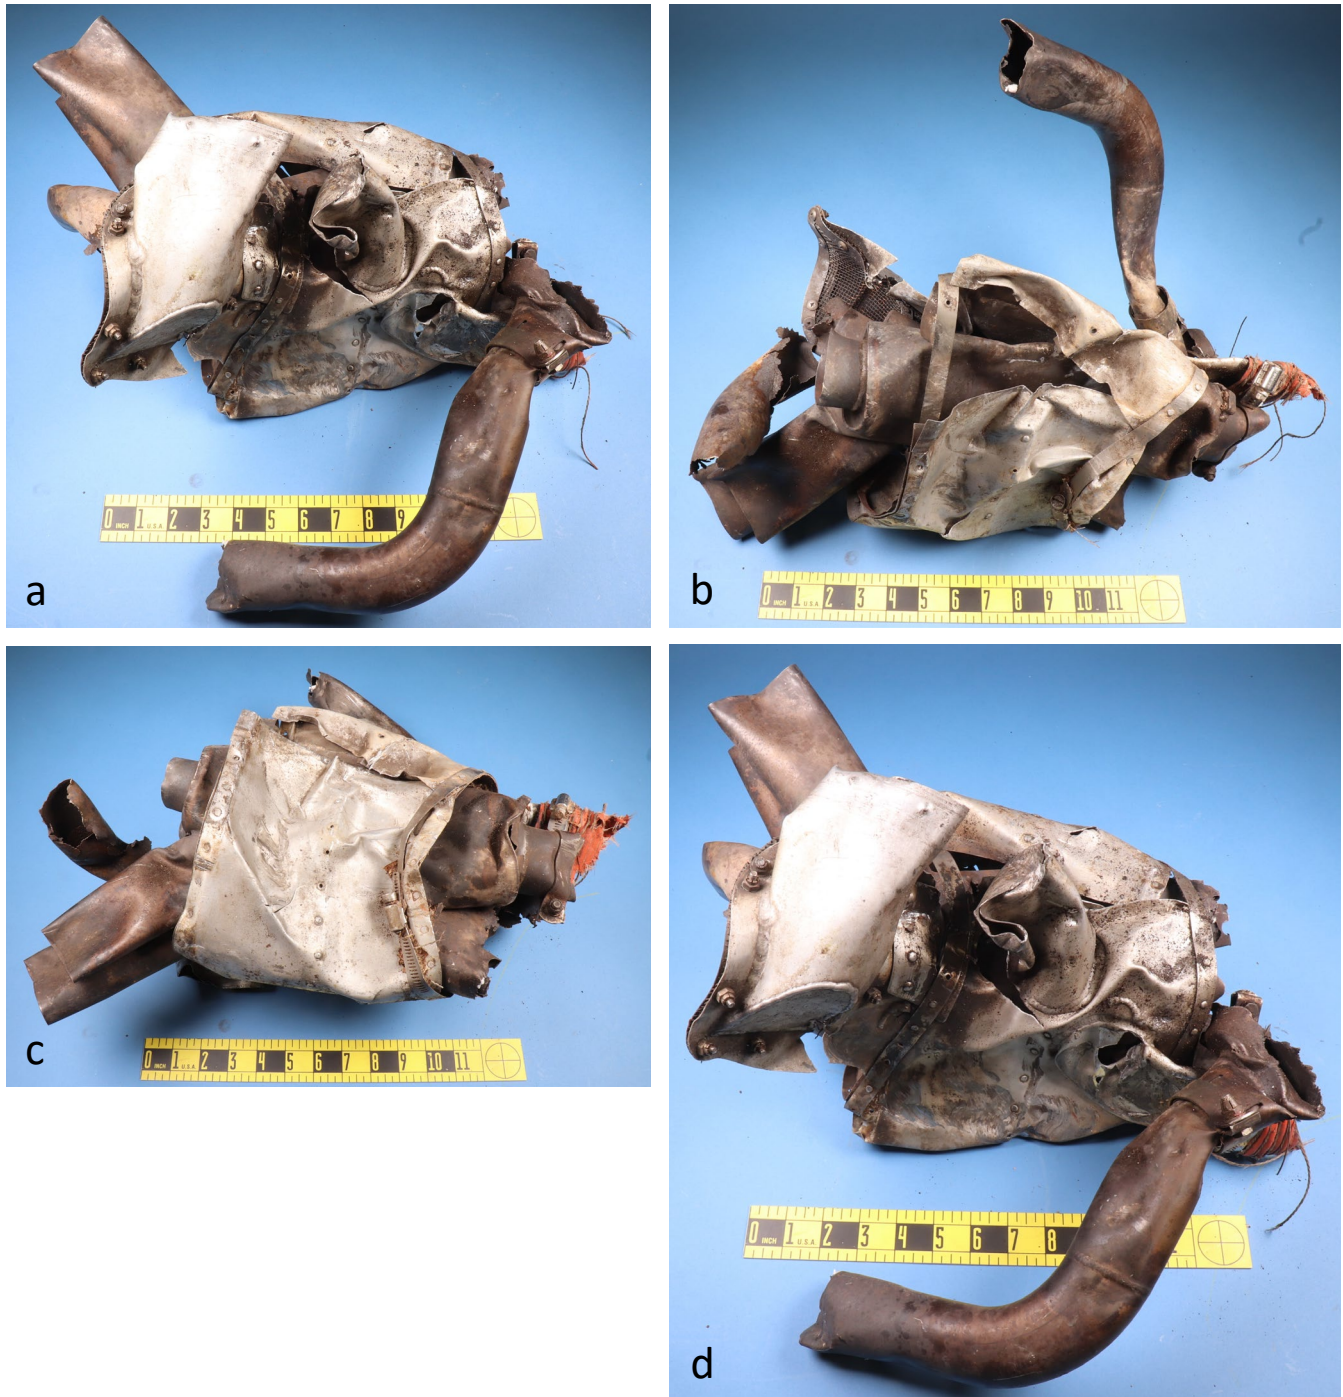
Multiple views of the as-received portion of mufflers and cabin heater shroud assembly are shown in Figure 1. The muffler-shroud assembly was distorted due to the accident crash sequence. It is evident that the shroud, which is secured by two straps, encases two mufflers. The shroud straps were cut using a metal strap cutter to release the muffler assembly inside (see Figures 2 and 3). A close view of the muffler assembly is shown in Figure 3. The mufflers, which have a slender cylindrical shape, were semi-flattened along the longitudinal axis. Figure 4 shows each side of the semi-flat mufflers. The mufflers were arbitrarily numbered 1 and 2 for identification purposes. A close view of side A of muffler 2 reveals multiple branched cracks in the muffler's outer shell.

Figure 1 Multiple views of the as-received portion of mufflers and cabin heater shroud. It is evident that the shroud encases two mufflers. The assembly distortion is associated with accident sequence damage.

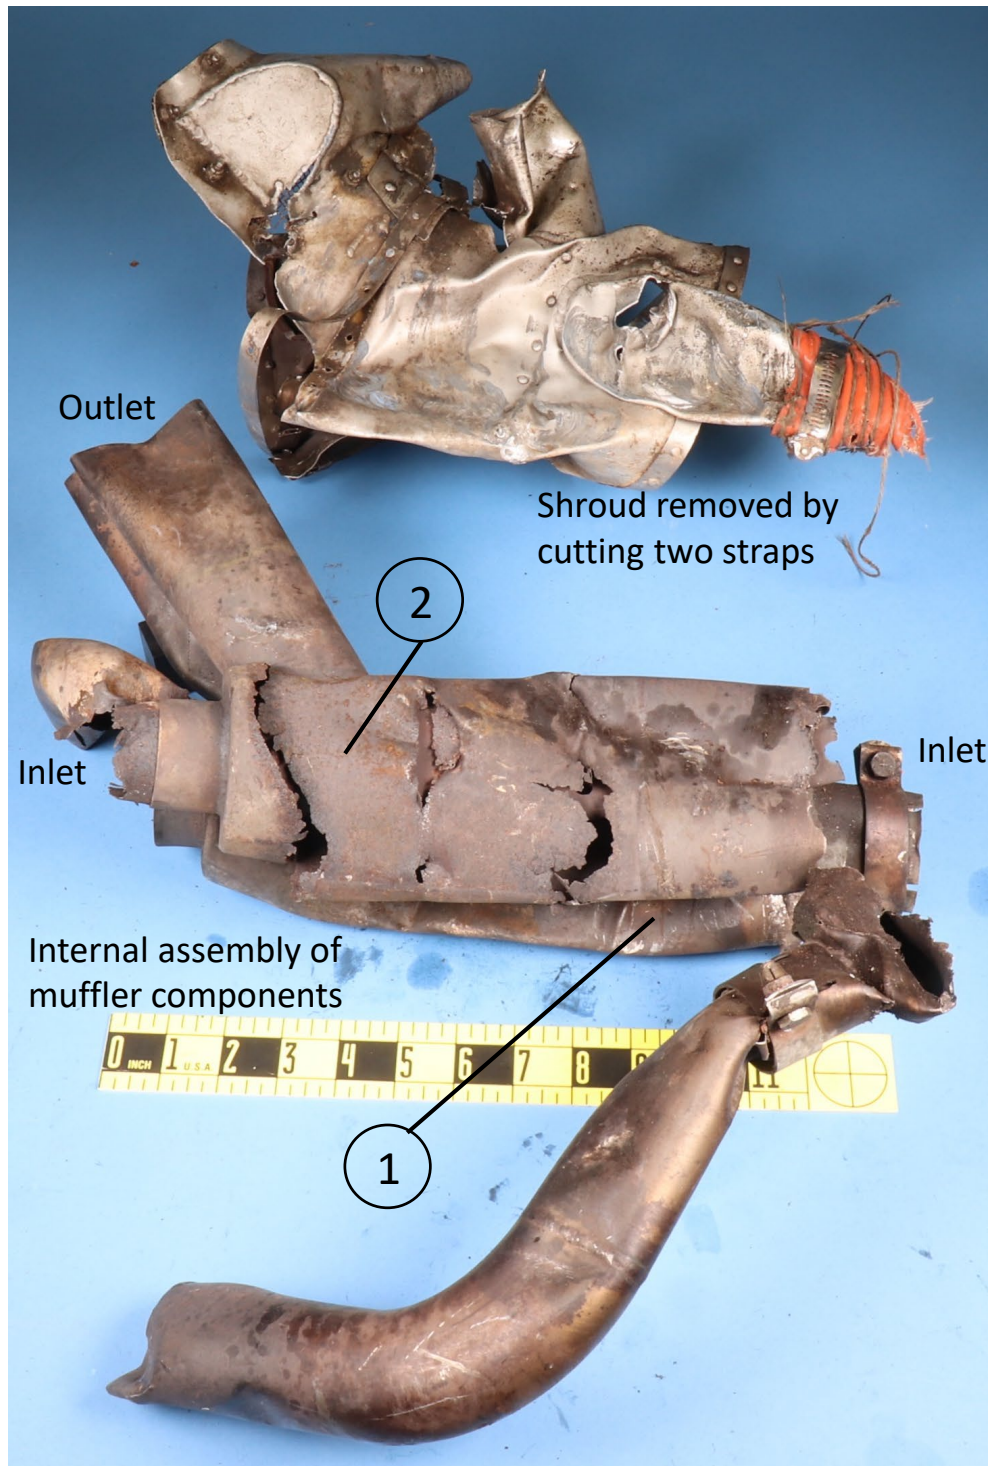
Figure 2 Image showing the muffler assembly removed from the shroud by cutting two straps holding the shroud together. Two mufflers, numbered 1 and 2, are encased within the shroud.

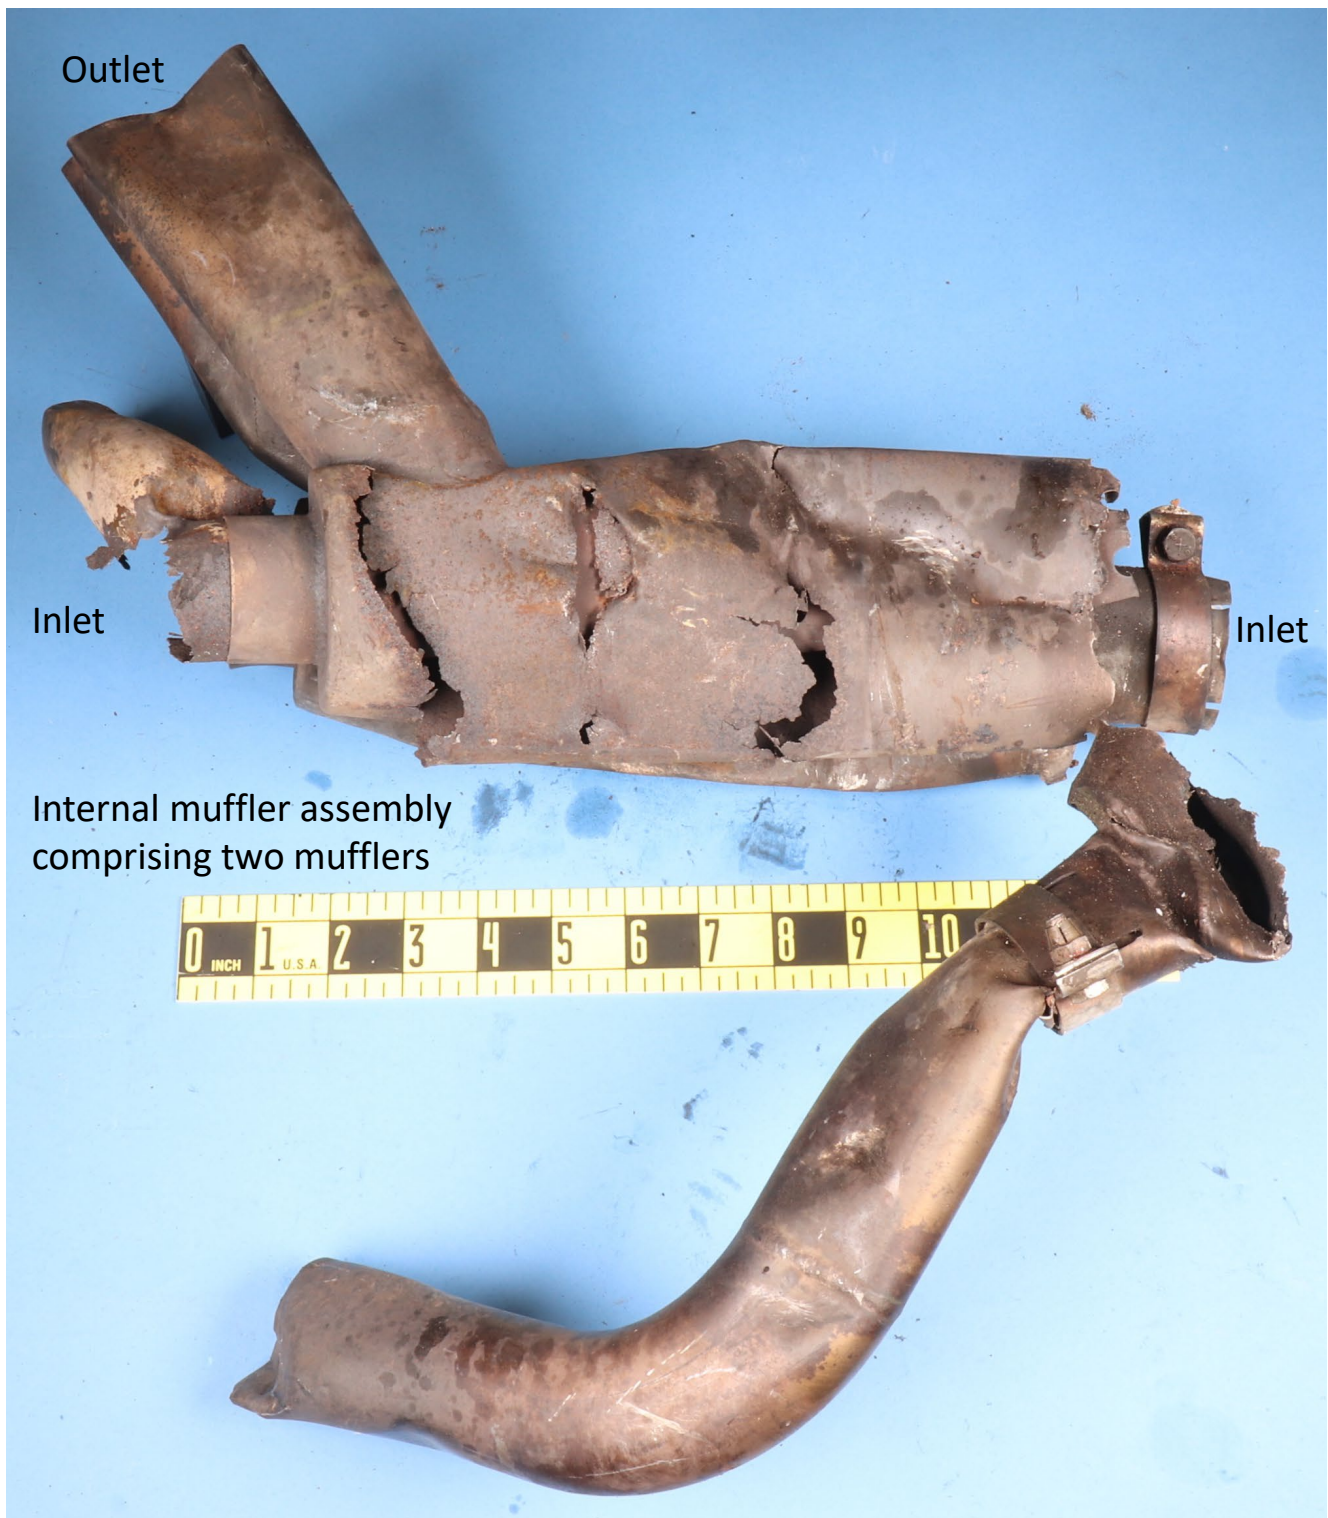
Figure 3 Closer image of the assembly of mufflers encased in the shroud.

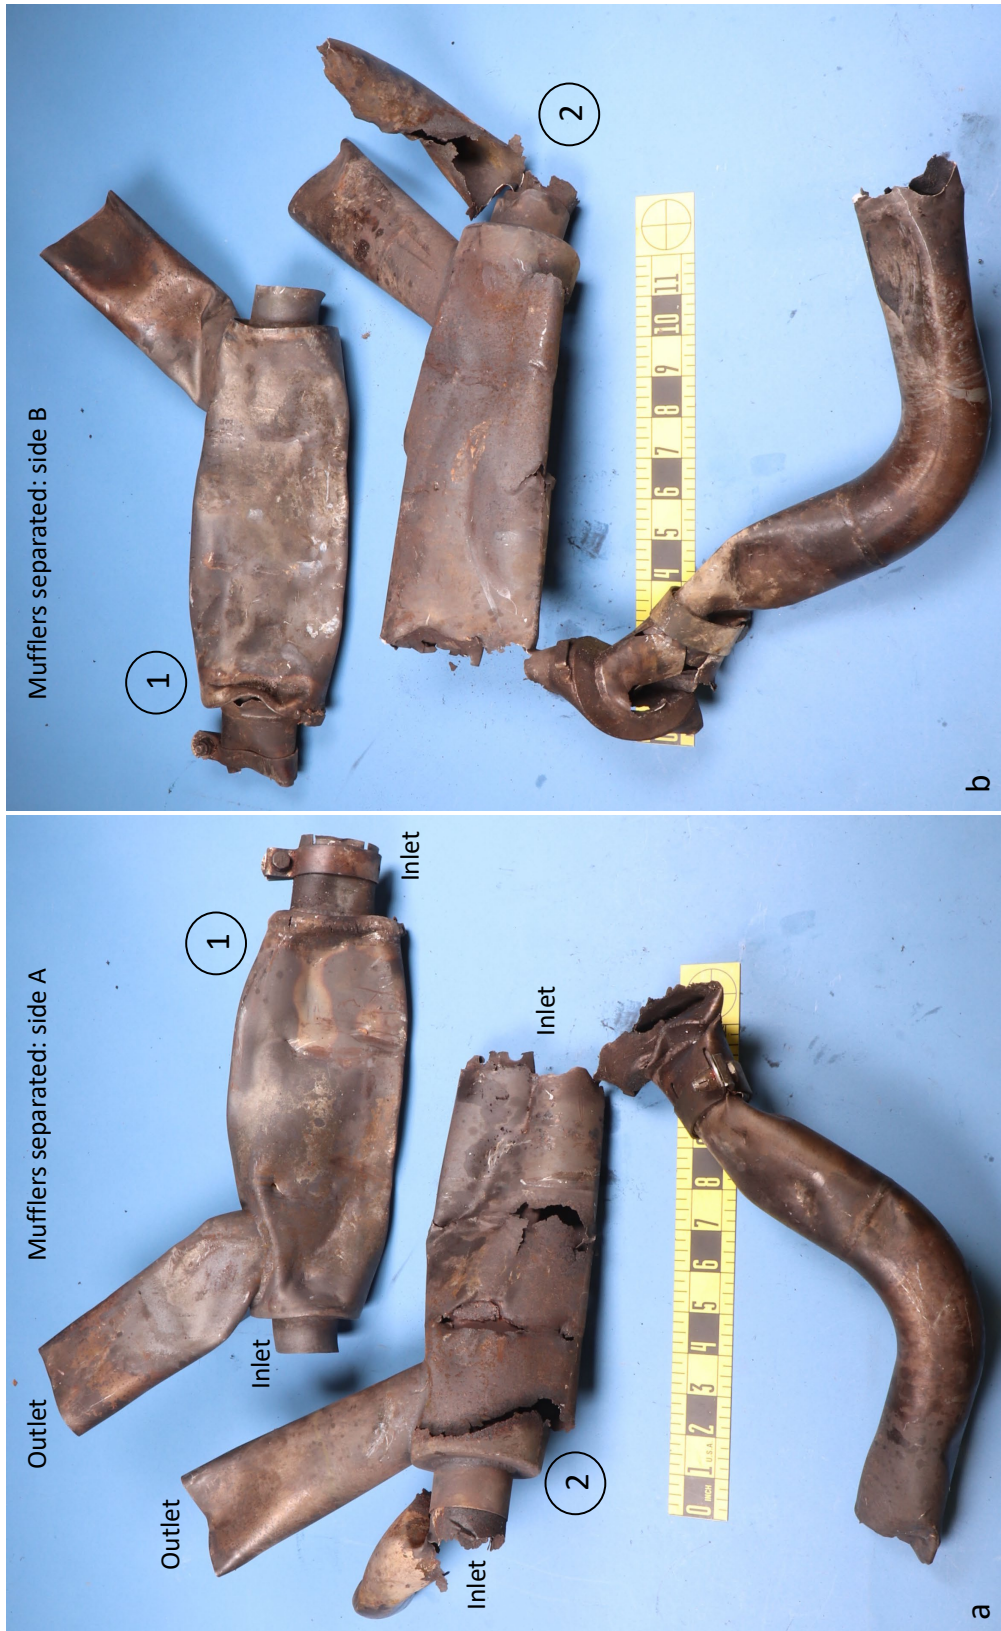
Muffler 1 exhibited a few punctures in the outer shell and a crack adjacent to one of the endplate welds. Such damage was consistent with damage incurred during the accident crash sequence as the fracture surfaces were bright and not oxidized.

Figure 4 Images of the two mufflers (arbitrarily numbered 1 and 2) showing two sides (arbitrarily labelled sides A and B).

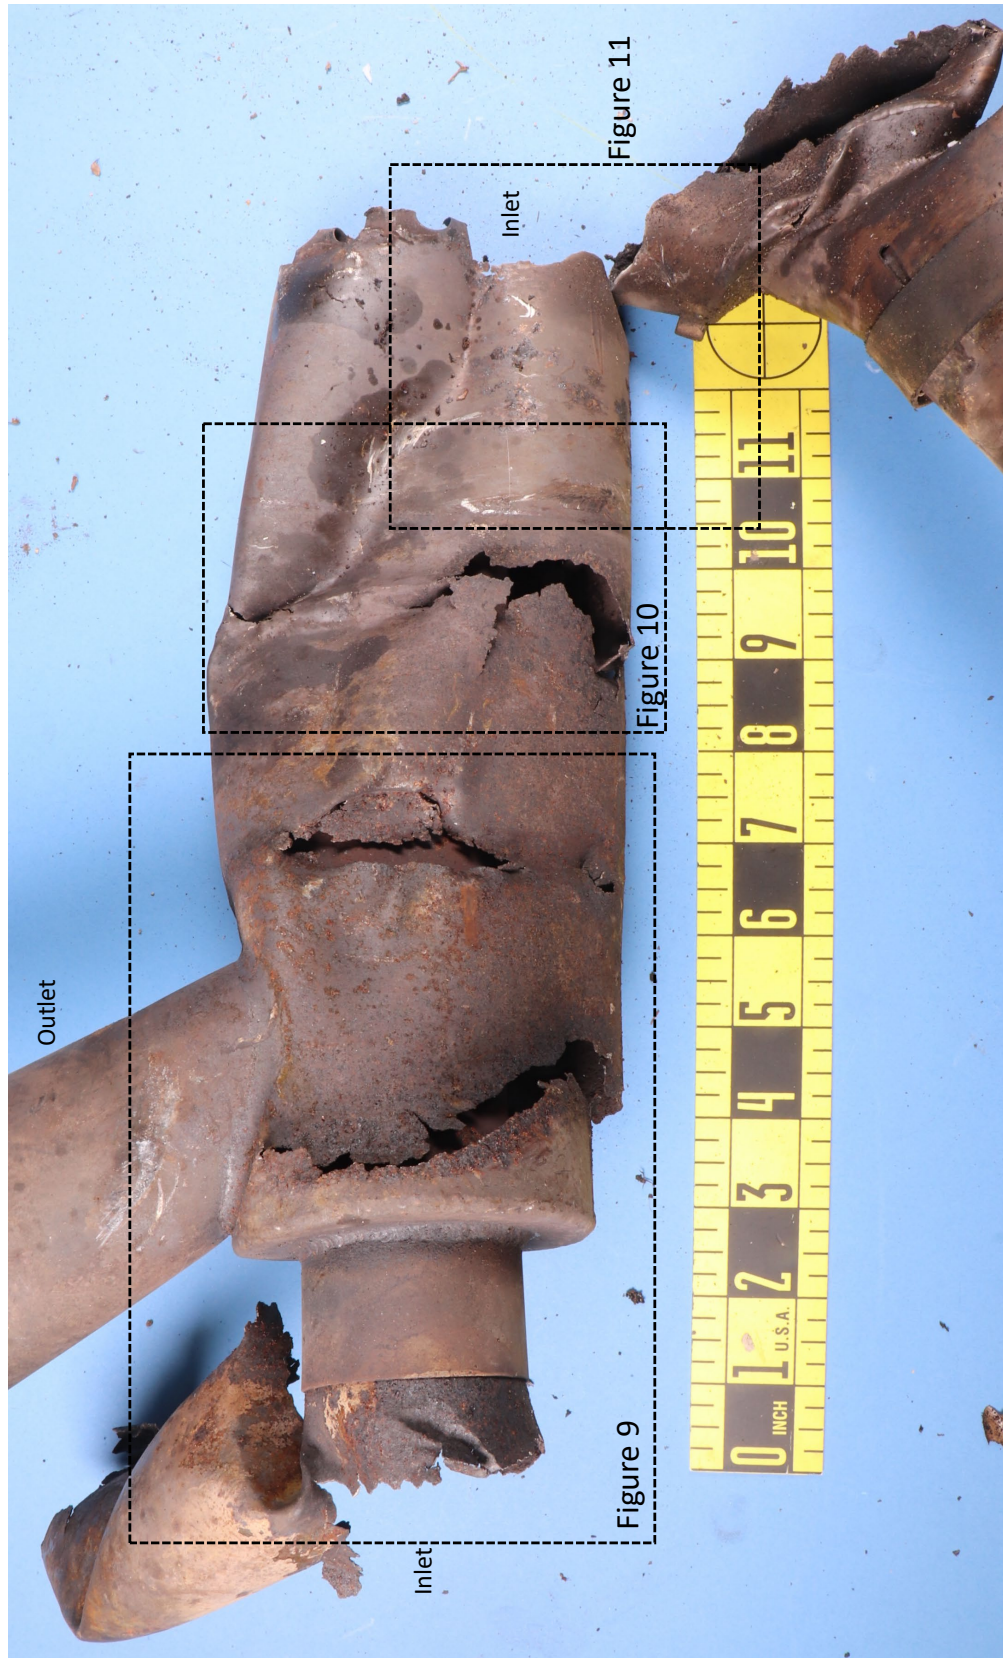
The cracks in muffler 2 are identified in Figure 5. The fracture faces of the cracks were covered with oxidation product, consistent with its presence prior to the accident crash sequence. However, the distortion from the accident crash sequence enlarged the width of the cracks beyond their pre-accident crack widths. Closer views of the cracks are shown in Figures 6-8. Figures 6 and 8 show locations where metallurgical cross sections through the muffler 2 outer shell were taken. Images of the metallurgical cross sections are shown in Figures 9-12. The metallurgical cross sections reveal oxidative degradation that progressed through the thickness of the muffler 2 shell from the inside surface outwards. Some wall thickness loss due to oxidation also occurred on the outside shell surfaces. The micrographs in Figures 10 and 12 suggest that different oxidation mechanisms were in play at different locations of the muffler shell. In the location identified in Figure 6, the shell degraded from an intergranular sensitization and oxidation

Figure 5 View of side A of muffler 2 showing areas of cracks (see Figure 4a). Closer views of the cracks are showing in Figures 6-8.

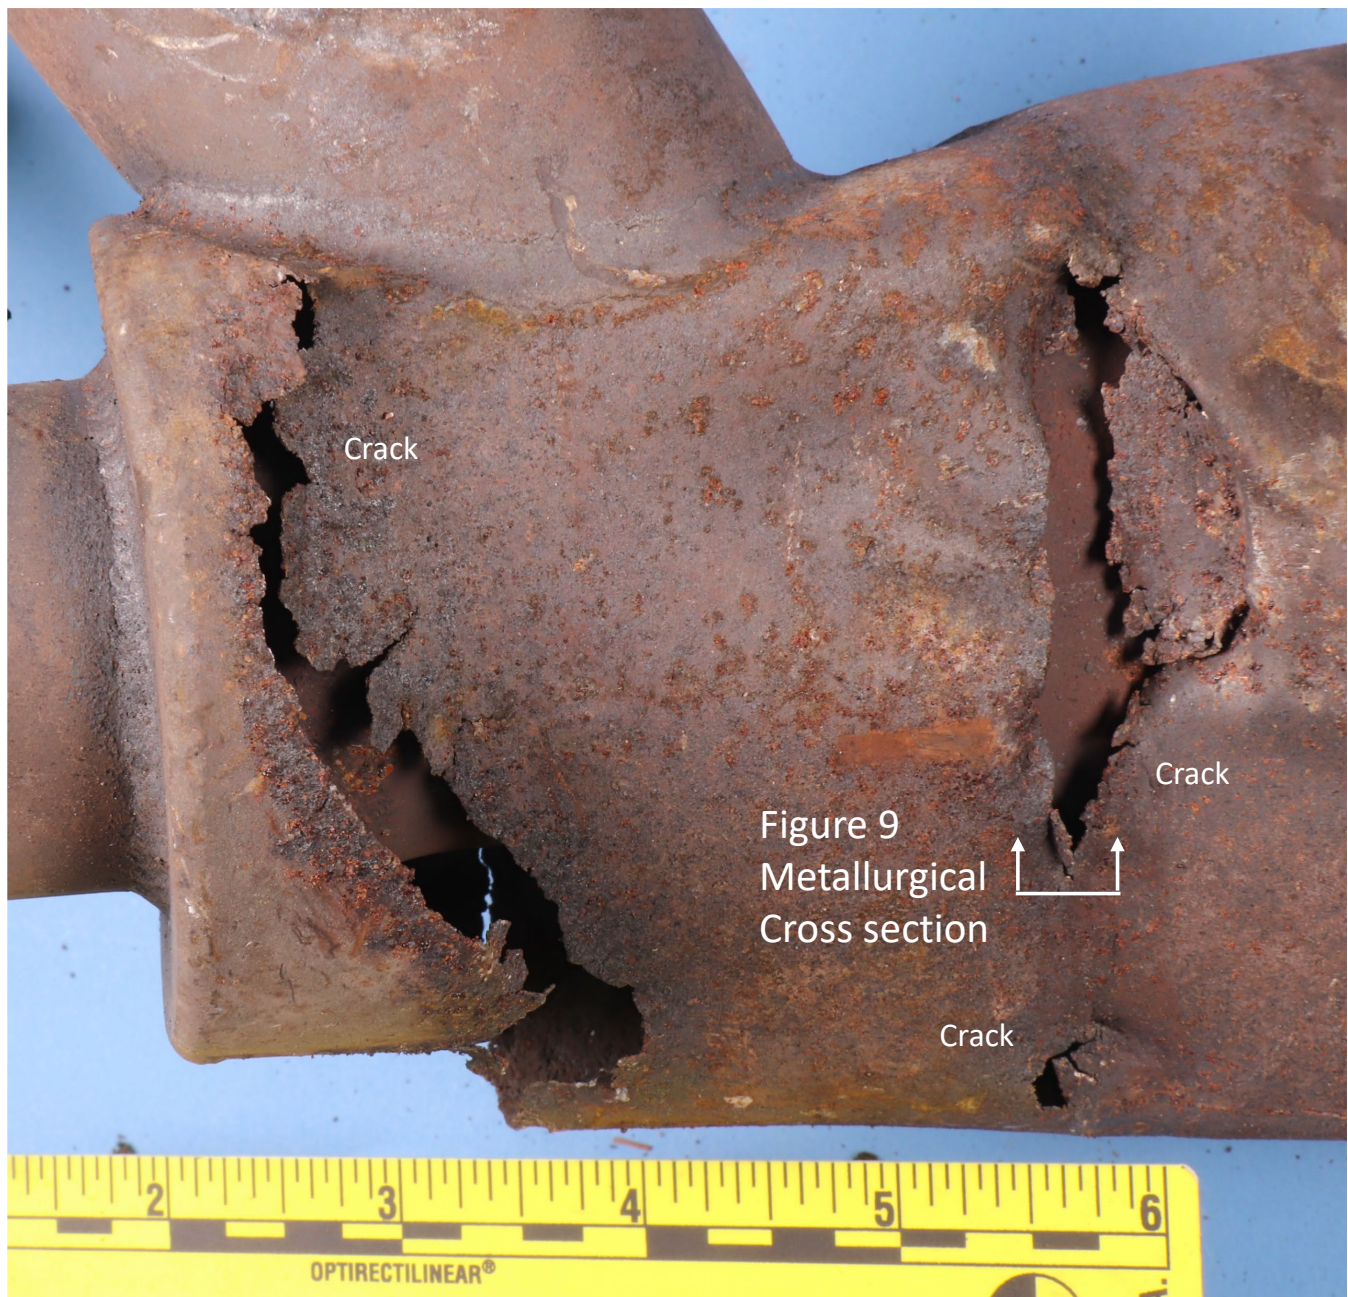
wastage mechanism that occurred on both the inside and outside surfaces of the skin (although to a greater extent on the inside surface), resulting in localized thickness loss of the muffler shell. In the location identified in Figure 8, near an inlet, the formation of a semicontinuous and voluminous general oxide scale developed, reducing the wall thickness of the muffler shell over time at operating temperature.

Figure 6 Cracks in the outer shell in muffler 2 near the outlet tube and adjacent to an inlet. A metallurgical cross section was excised and prepared from the tip of a crack as shown in the image.

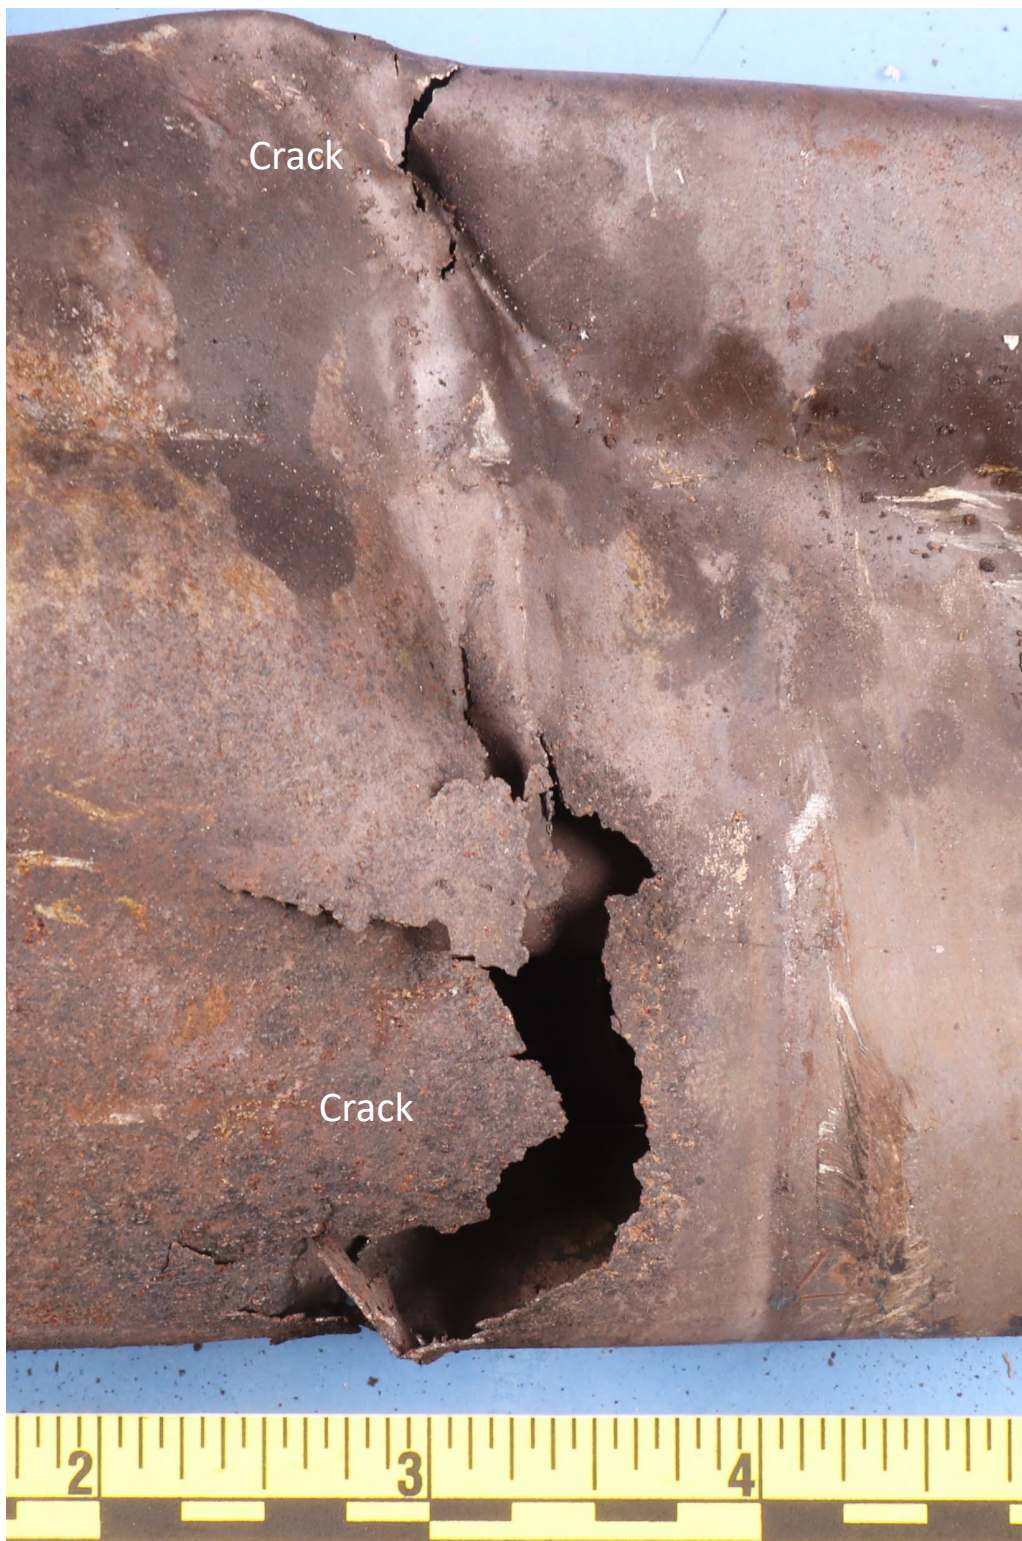
Figure 7 Cracks in muffler 2 in the main body of the outer shell.

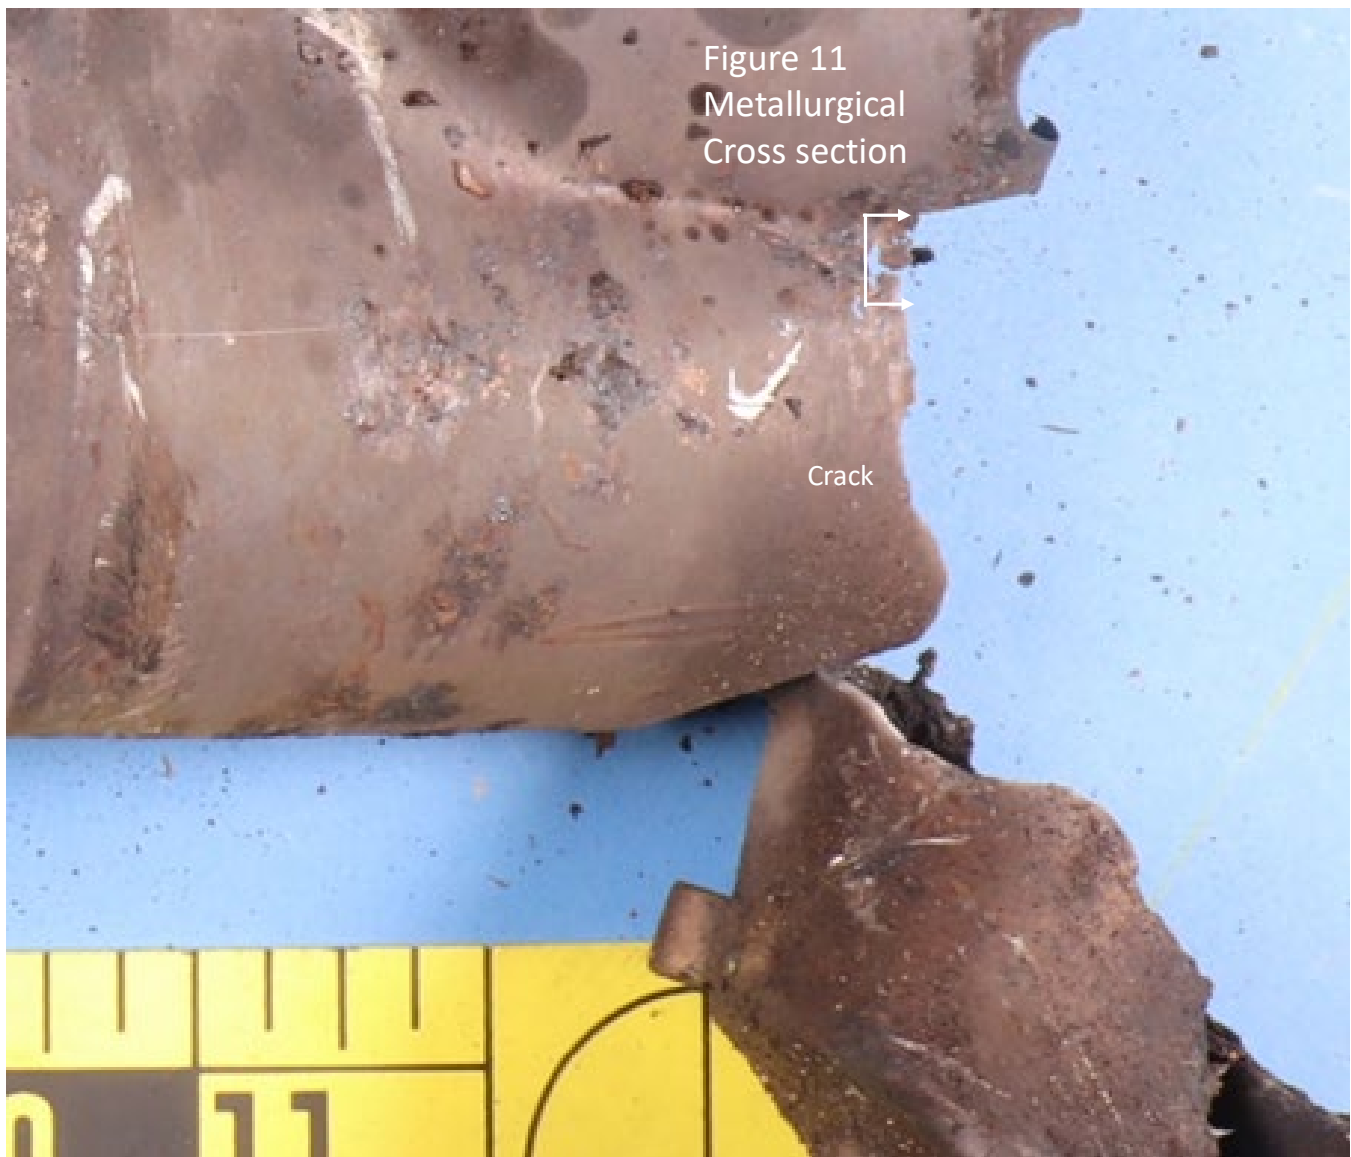
Figure 8 Cracks in the outer shell in muffler 2 near an inlet. A metallurgical cross section was excised and prepared from a cracked area as shown in the image.

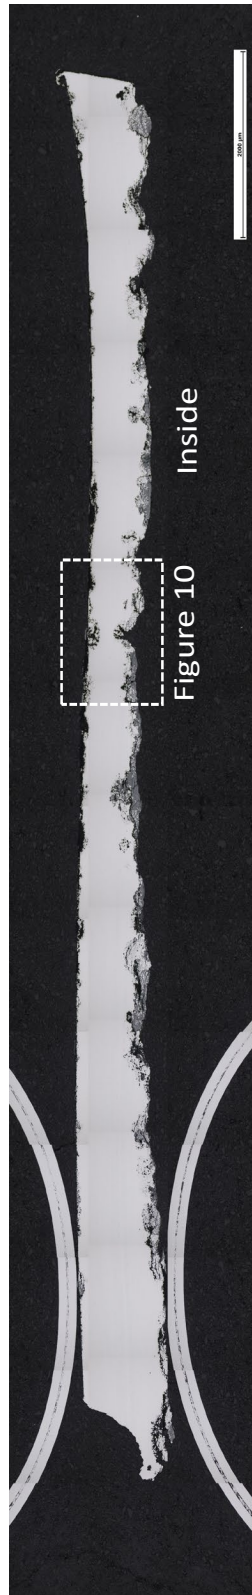
Figure 9 Optical micrograph of a metallurgical cross section adjacent to a muffer 2 crack tip as indicated in Figure 6. The inside side of the muffer is indicated in the image. (Brightfield, unetched, 100X original magnification.)

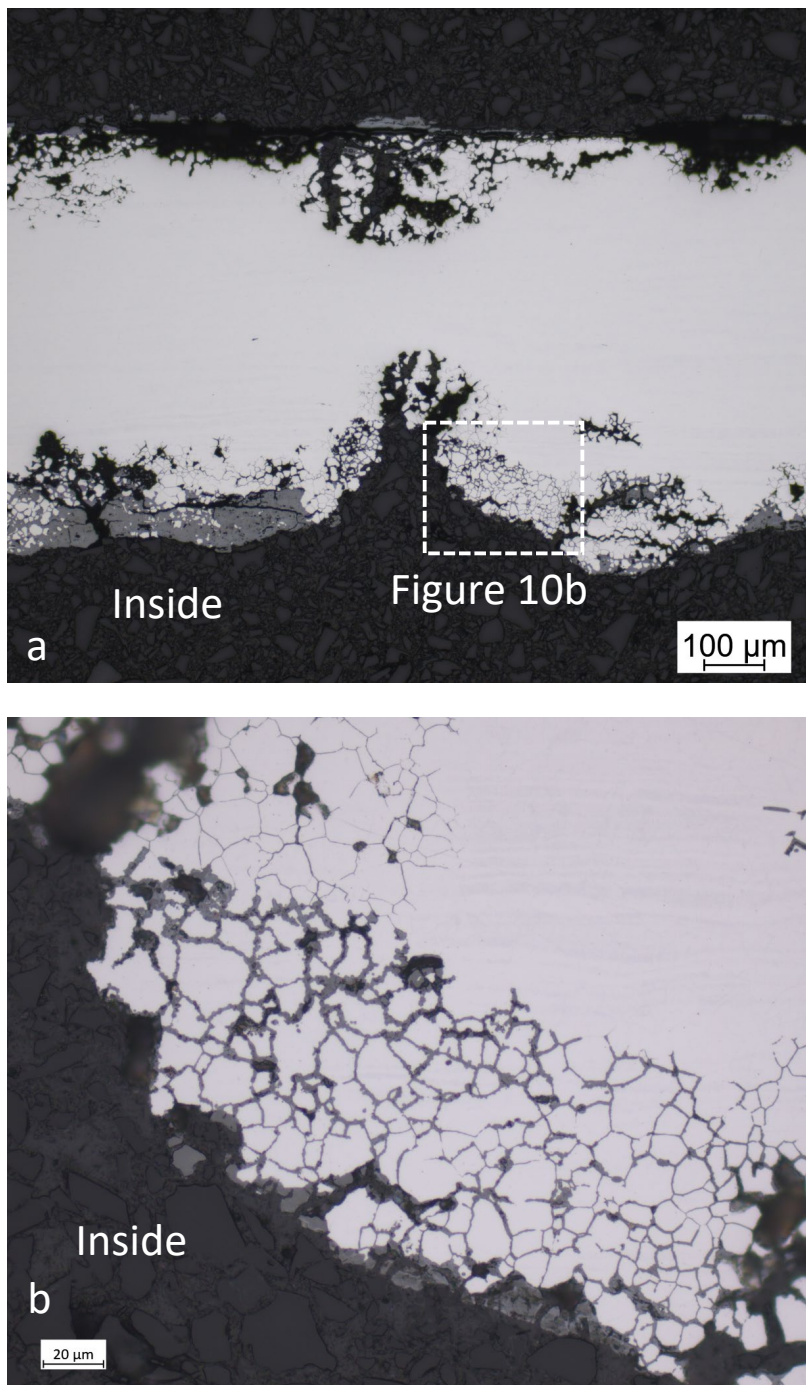
Figure 10 Optical micrograph of a metallurgical cross section adjacent to a muffler 2 crack tip as indicated in Figure 9. The inside side of the muffler is indicated in the image. The microstructure adjacent to the crack tip and in other nearby regions reveals metal wastage associated with intergranular sensitization and thermal oxidation. (Brightfield, unetched, Figure 10a is 200X and Figure 10b is 500X original magnification.)

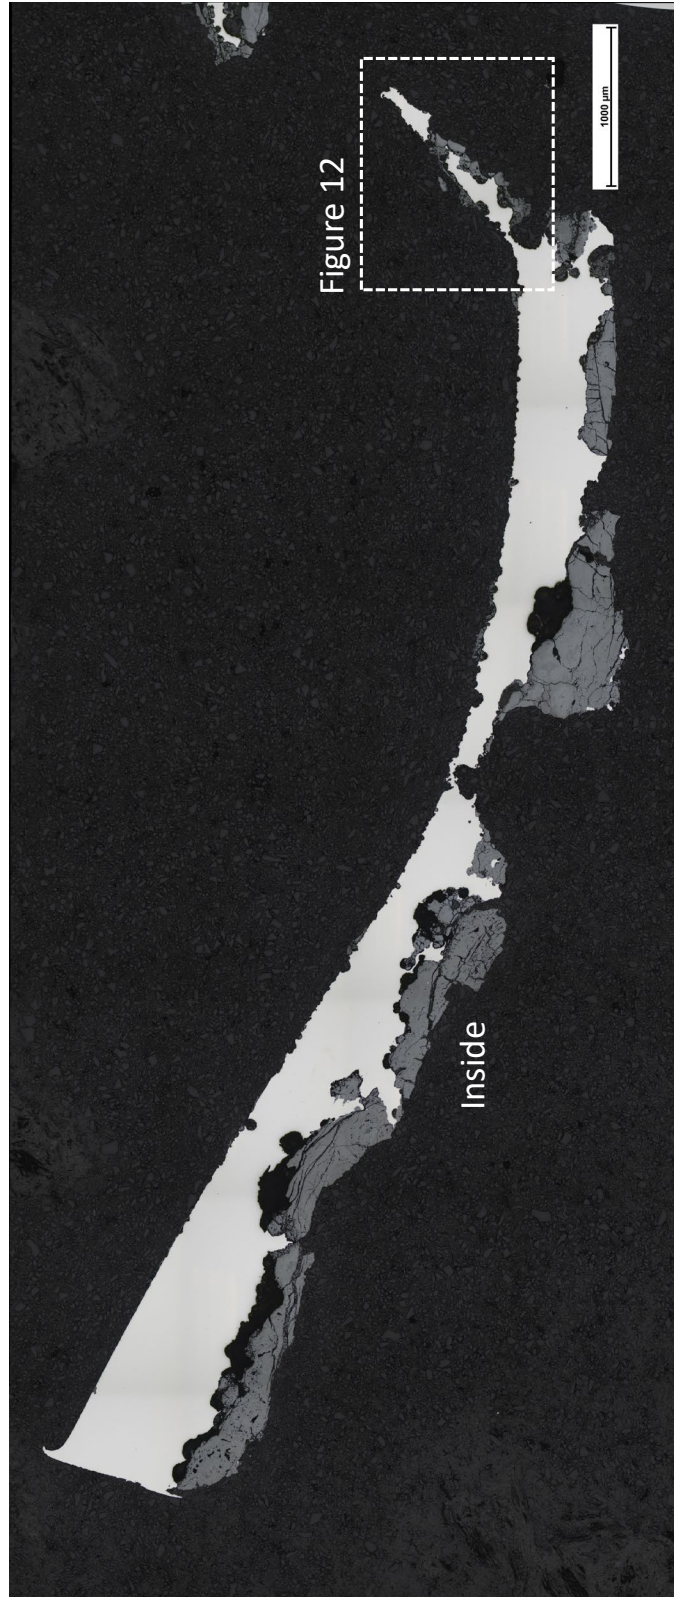
Figure 11 Optical micrograph of a metallurgical cross section adjacent to a muffler 2 crack tip as indicated in Figure 9. The inside side of the muffler is indicated in the image. The microstructure adjacent to the crack tip and in other nearby regions reveal metal wastage associated with thermal oxidation. (Brightfield, unetched, 100X original magnification.)

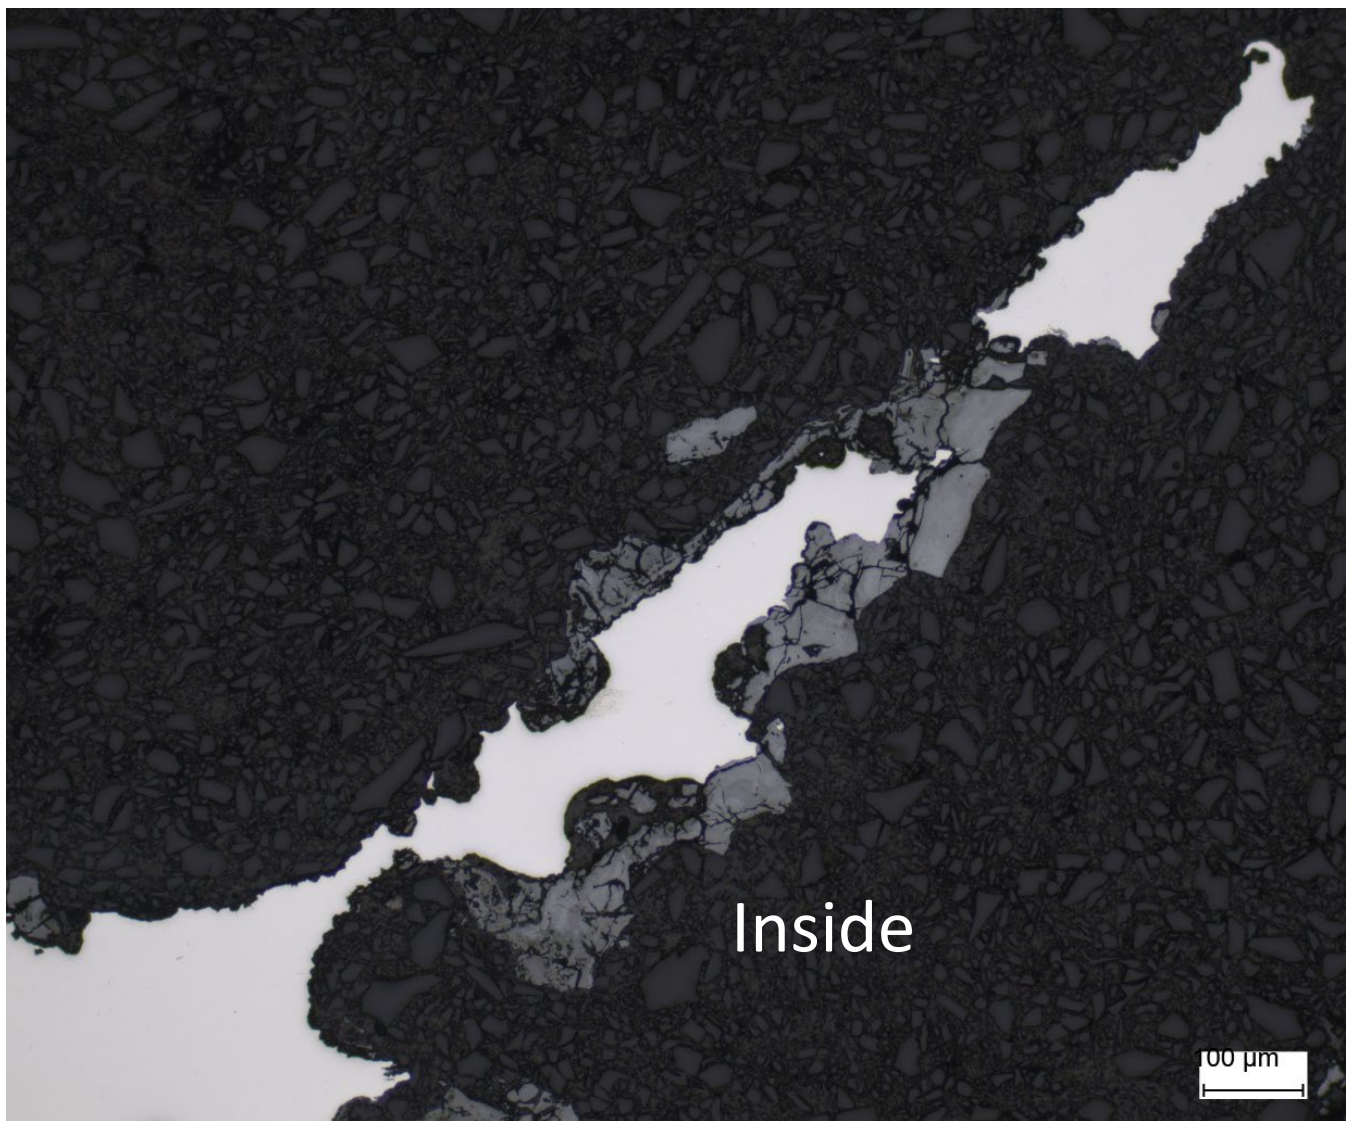
Figure 12 Optical micrograph of a metallurgical cross section adjacent to a muffler 2 crack tip as indicated in Figure 11. The inside side of the muffler is indicated in the image. The microstructure adjacent to the crack tip and in other nearby regions reveal metal wastage associated thermal oxidation. (Brightfield, unetched, 500X original magnification.)
